PROJECT
 項目
INTERMODAL TRANSFER TERMINAL - BONDED VEHICULAR BRIDGE AND ASSOCIATED ROADS

SHEET TITLE
 圖名
 BROAD BRUSH TREE SURVEY PLAN

SHEET NUMBER
 圖號
 FIGURE A

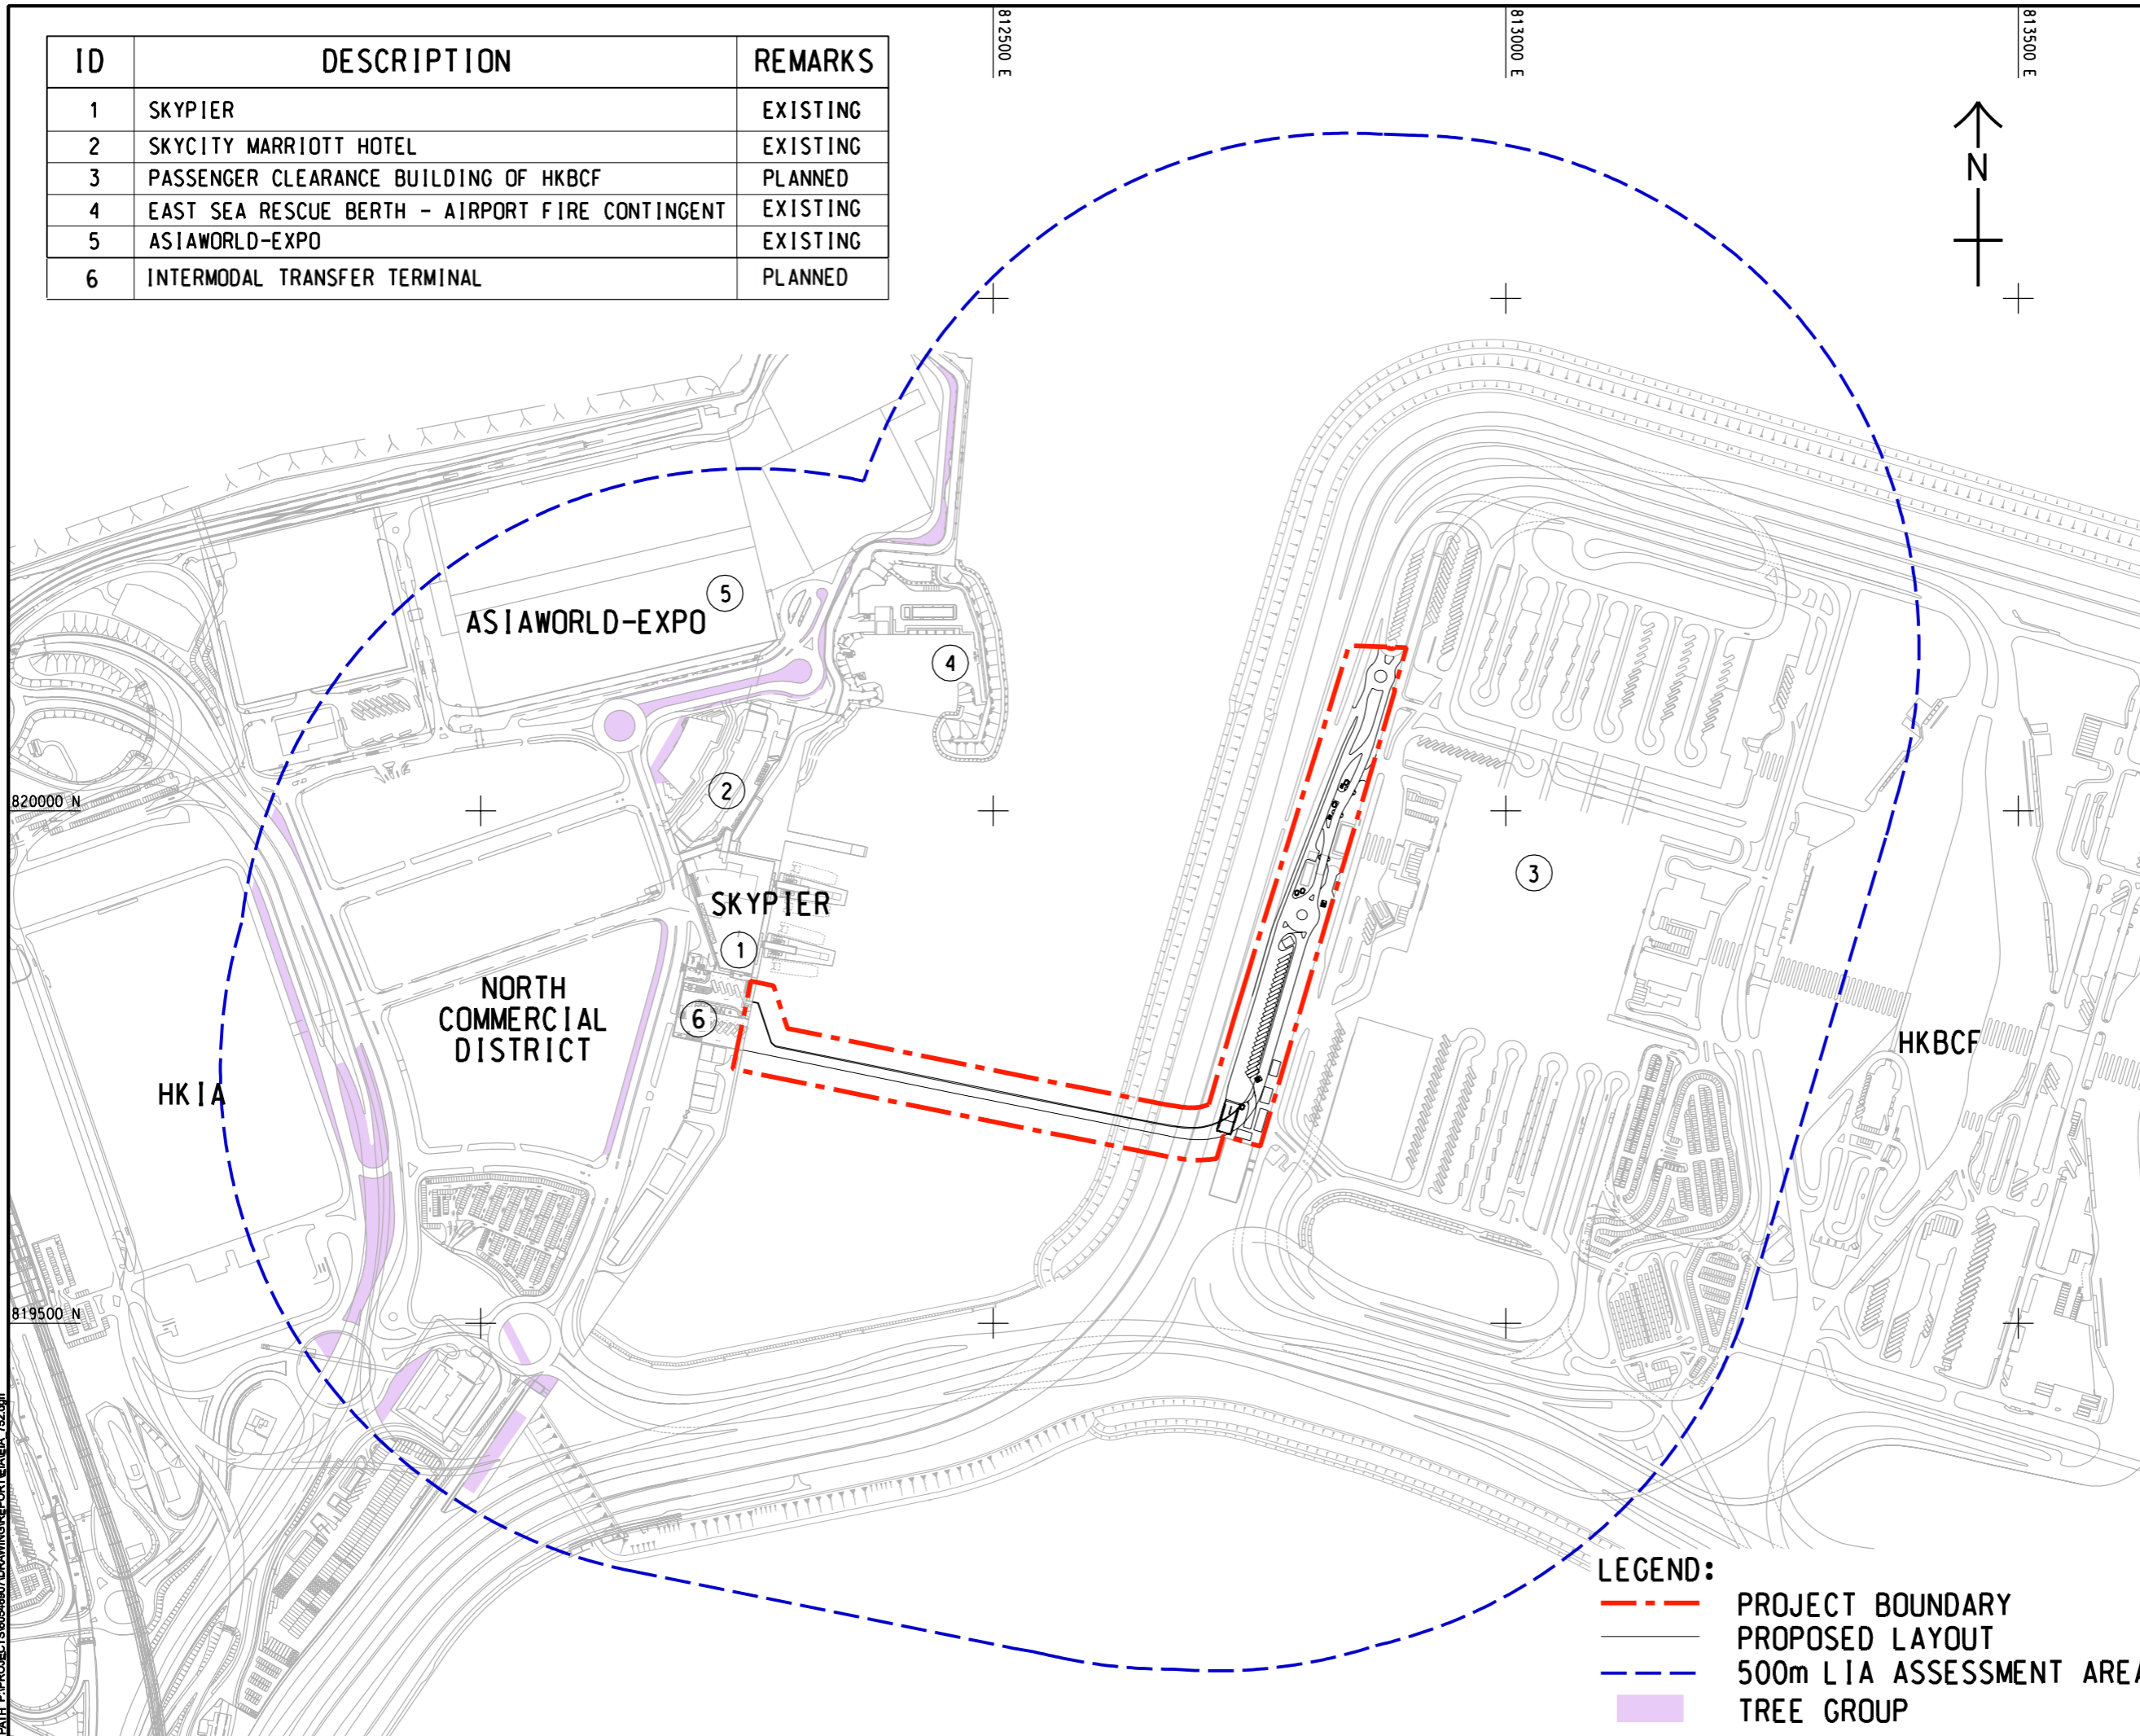
Drawing No.	Species		Tree Measurements			Approx. Quantity of the group	Amenity Value	Form	Health Condition	Structural Condition	Suitability for Transplanting*		Conservation Status	Recommendation (Retain/ Affected)			Department to provide expert advice to LandsD	Justification	Additional Remarks
	Scientific name	Chinese Name	Height (m)	DBH (m)	Crown Spread (m)						(High/Medium/Low)	Remarks		%	Retain	Affected			
Figure A	<i>Chrysalidocarpus lutescens</i>	散尾葵	3	0.095-0.1	2	100	Fair	Fair	Fair	Fair	Medium	NIL	NIL	100% Retain	435	0	DLO	NIL	NIL
Figure A	<i>Leucaena leucocephala</i>	銀合歡	4-6	0.1-0.15	3-4	5	Fair	Poor	Fair	Fair	Low	f,g	NIL				DLO	NIL	NIL
Figure A	<i>Juniperus chinensis</i>	龍柏	3	0.095-0.1	2	20	Fair	Fair	Fair	Fair	Medium	NIL	NIL				DLO	NIL	NIL
Figure A	<i>Hibiscus tiliaceus</i>	黃槿	3-5	0.1-0.2	3-4	52	Fair	Fair	Fair	Fair	Low	b,c	NIL				DLO	NIL	NIL
Figure A	<i>Ravenala madagascariensis</i>	旅人蕉	5-6	0.2-0.25	4-5	50	Fair	Fair	Fair	Fair	Medium	NIL	NIL				DLO	NIL	NIL

Figure A	<i>Cocos nucifera</i>	椰子	9-10	0.25-0.3	2-3	44	Fair	Fair	Fair	Fair	Medium	NIL	NIL				DLO	NIL	NIL
Figure A	<i>Delonix regia</i>	鳳凰木	6	0.15	5	2	Fair	Fair	Fair	Fair	Low	b,c	NIL				DLO	NIL	NIL
Figure A	<i>Ficus microcarpa</i>	細葉榕	10	0.4	10	2	Fair	Fair	Fair	Fair	Low	b,c,d	NIL				DLO	NIL	NIL
Figure A	<i>Acacia auriculiformis</i>	耳果相思	7-8	0.1-0.2	5-6	35	Fair	Fair	Fair	Fair	Low	b,c	NIL				DLO	NIL	NIL
Figure A	<i>Acacia confusa</i>	台灣相思	7-8	0.1-0.2	5-6	35	Fair	Fair	Fair	Fair	Low	b,c	NIL				DLO	NIL	NIL
Figure A	<i>Cassia siamea</i>	鐵刀木	7-8	0.1-0.15	4-5	20	Fair	Fair	Fair	Fair	Low	b,c	NIL				DLO	NIL	NIL
Figure A	<i>Ficus benjamina</i>	垂葉榕	7-8	0.15-0.25	5-6	50	Fair	Fair	Fair	Fair	Low	b,c	NIL				DLO	NIL	NIL
Figure A	<i>Grevillea robusta</i>	銀樺	6-7	0.1-0.15	3-4	20	Fair	Fair	Fair	Fair	Low	b,c	NIL	DLO	NIL	NIL

*No existing trees identified on Figure A are proposed to transplant
