路政署

Agreement No. CE 48/2018 (HY)

Improvement of Lion Rock Tunnel – Investigation

Contamination Assessment Plan (Final)

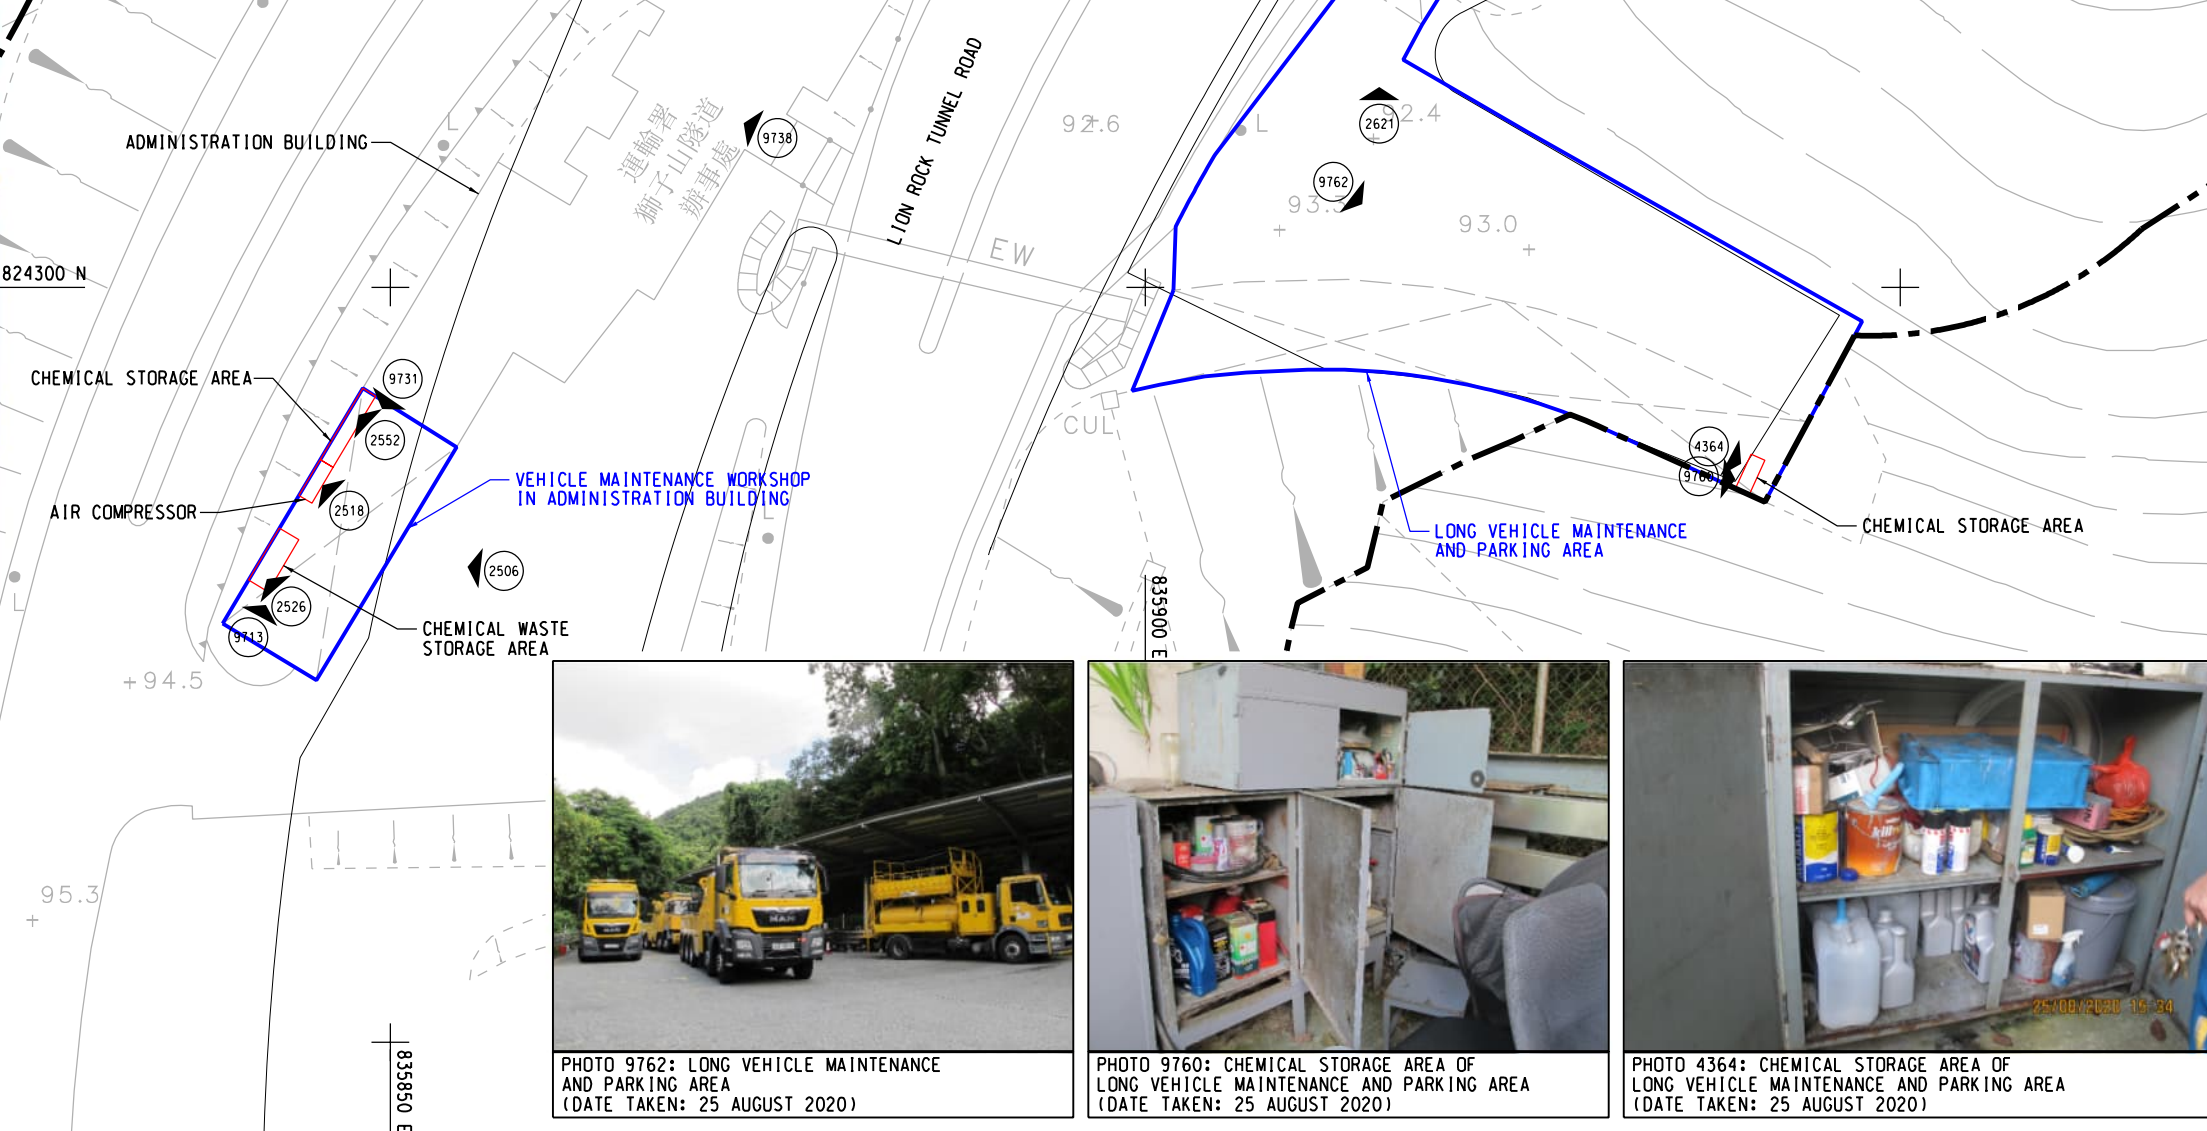
| Concerned Facility / Area (approx. area) | Hotspot (approx. area) | Site Observation / Current Potentially Contaminating Activities | Corresponding Photographic Record Reference in Appendix C | Other Past Potential Contaminating Land Use / Activities | Potential COCs | Future Land Uses | RBRGs Land Use Scenario |
|---|---|--|---|--|---|---|---|
| Long Vehicle Maintenance and Parking Area (810 m ²) | - | A long vehicle maintenance and parking area was observed in the east of the Sha Tin Portal of LRT. As reported by the site representative, maintenance of long vehicles for tunnel operation are carried out at the area. As observed during the site walkover, the entire area was paved with intact concrete noted to be in good condition with no signs of oil stains / chemical spillages observed. | Photo 2621 & 9762 in 60604728/CAPb/PR3 | N/A | Metals, VOCs, SVOCs and PCRs | Roads / Car Park | Lower of Industrial or Public Park |

PHOTO 9762: LONG VEHICLE MAINTENANCE AND PARKING AREA (DATE TAKEN: 25 AUGUST 2020)

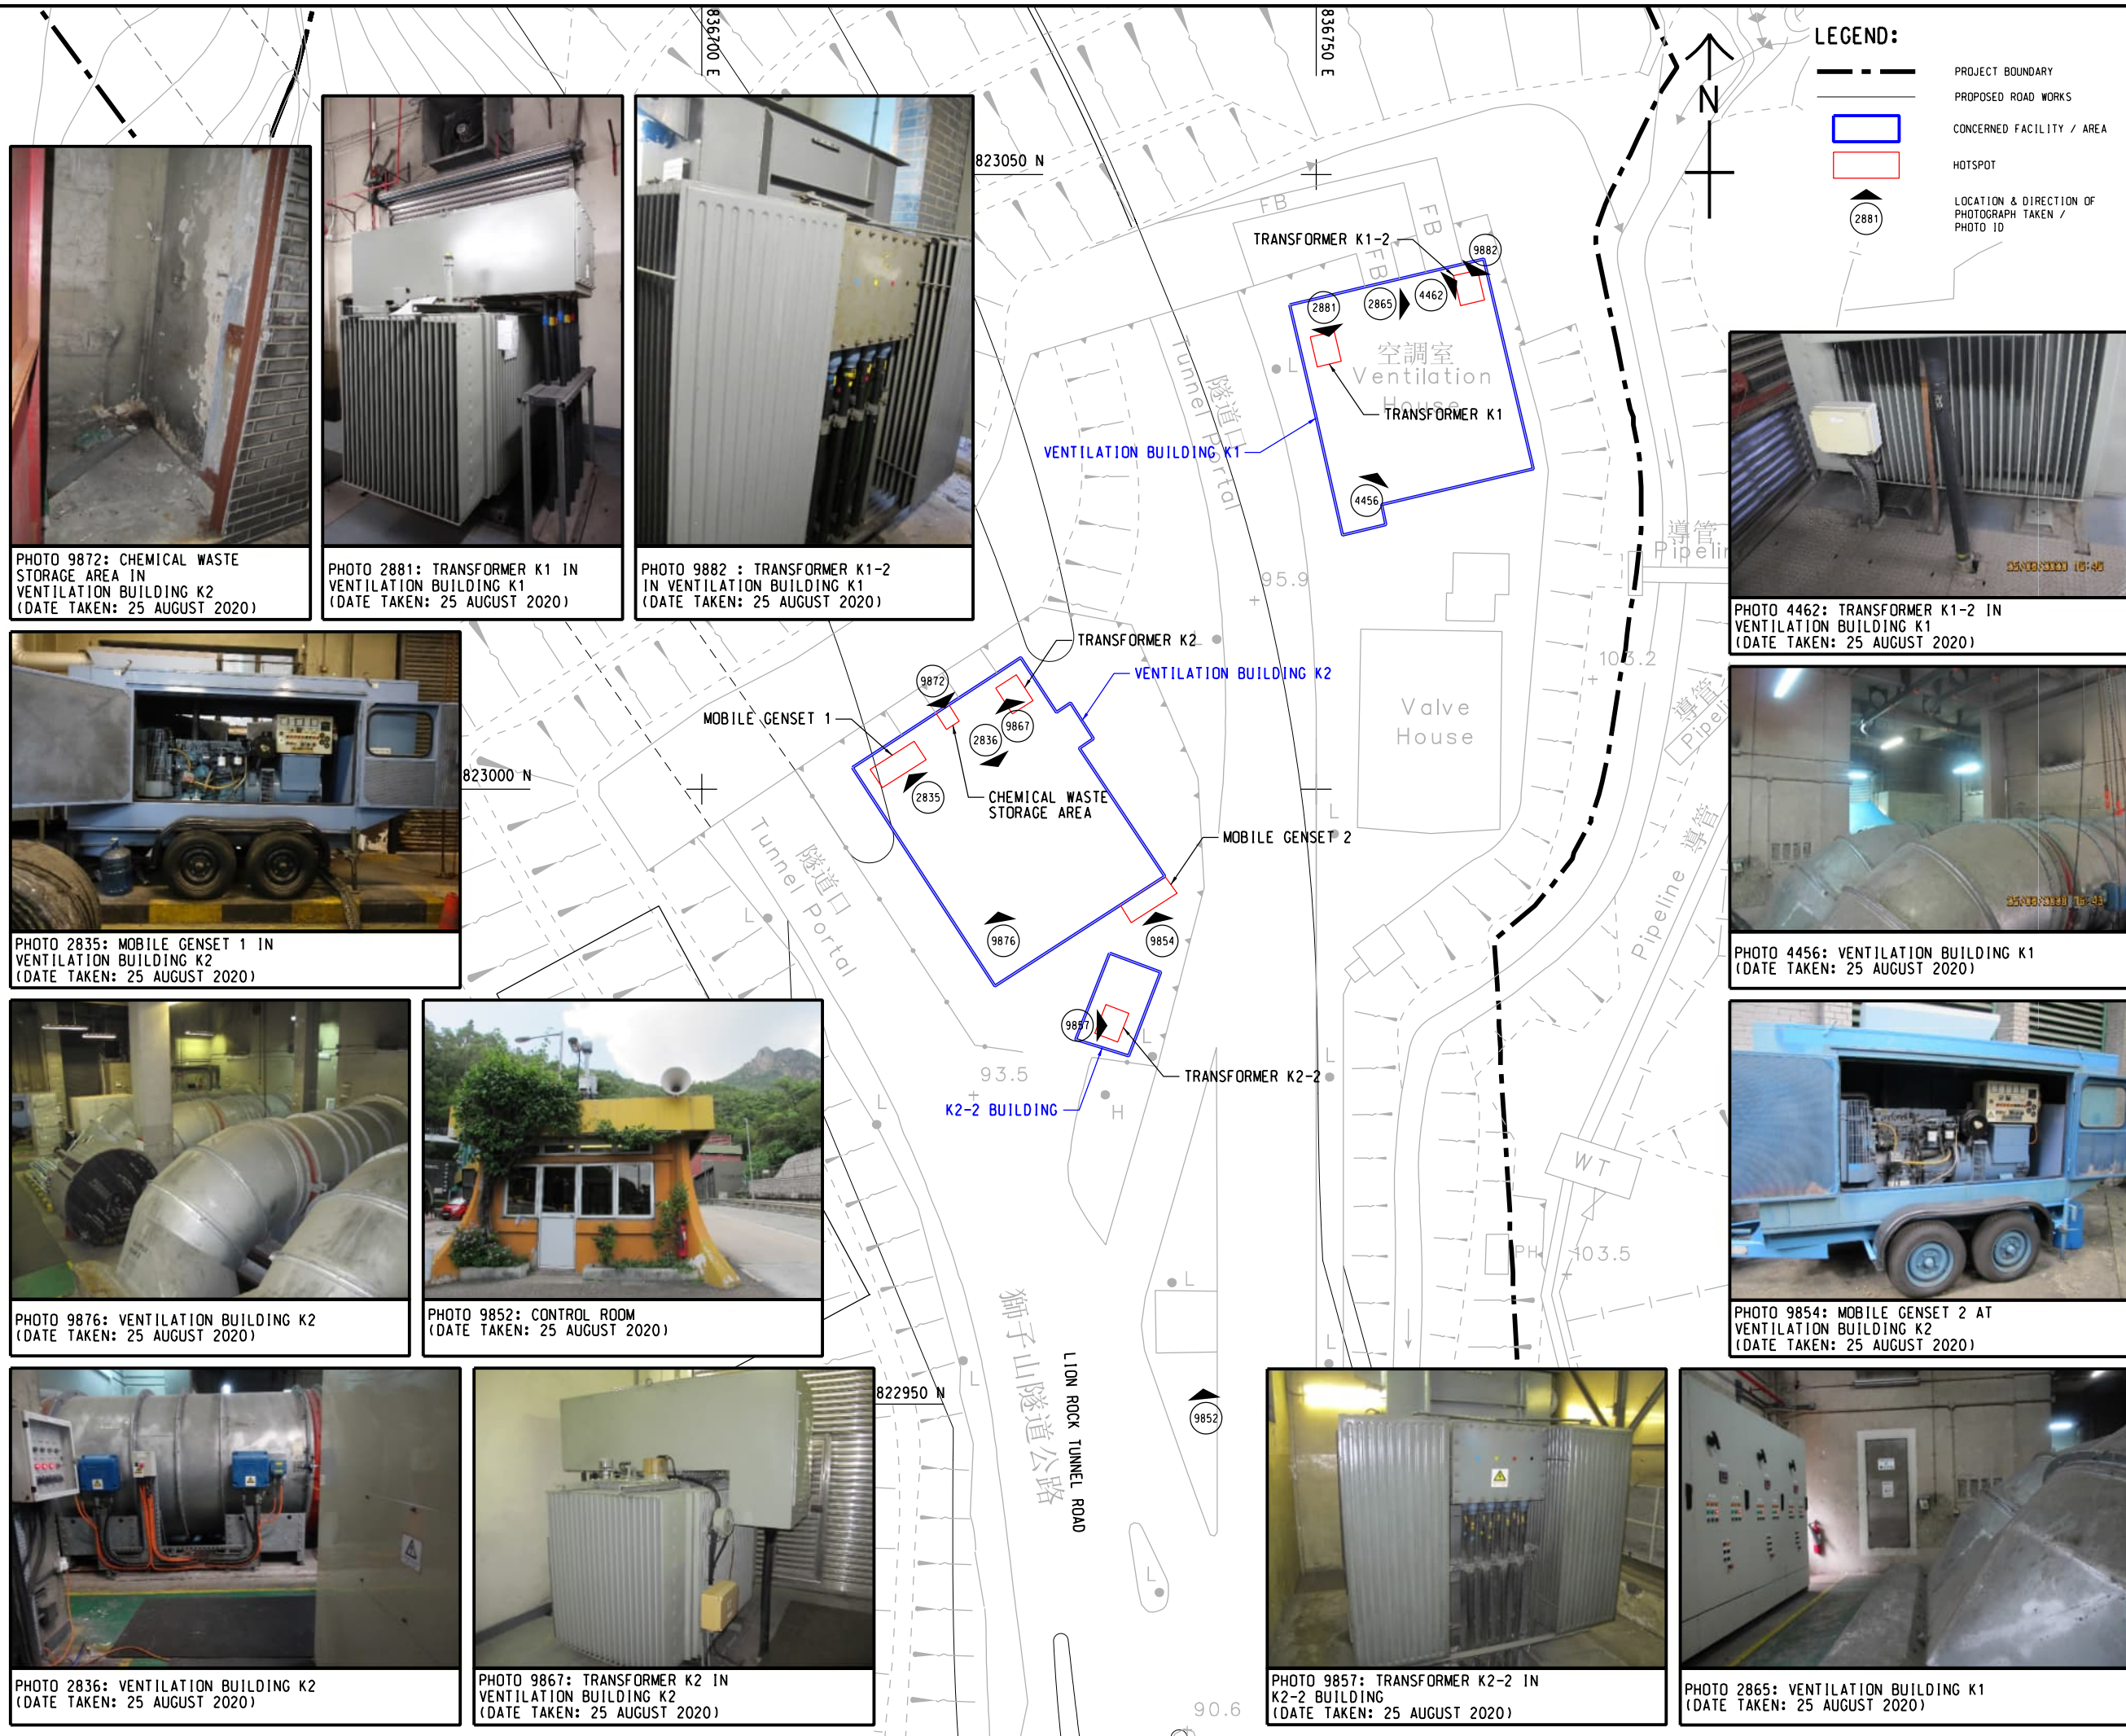
PHOTO 9872: CHEMICAL WASTE STORAGE AREA IN VENTILATION BUILDING K2 (DATE TAKEN: 25 AUGUST 2020)

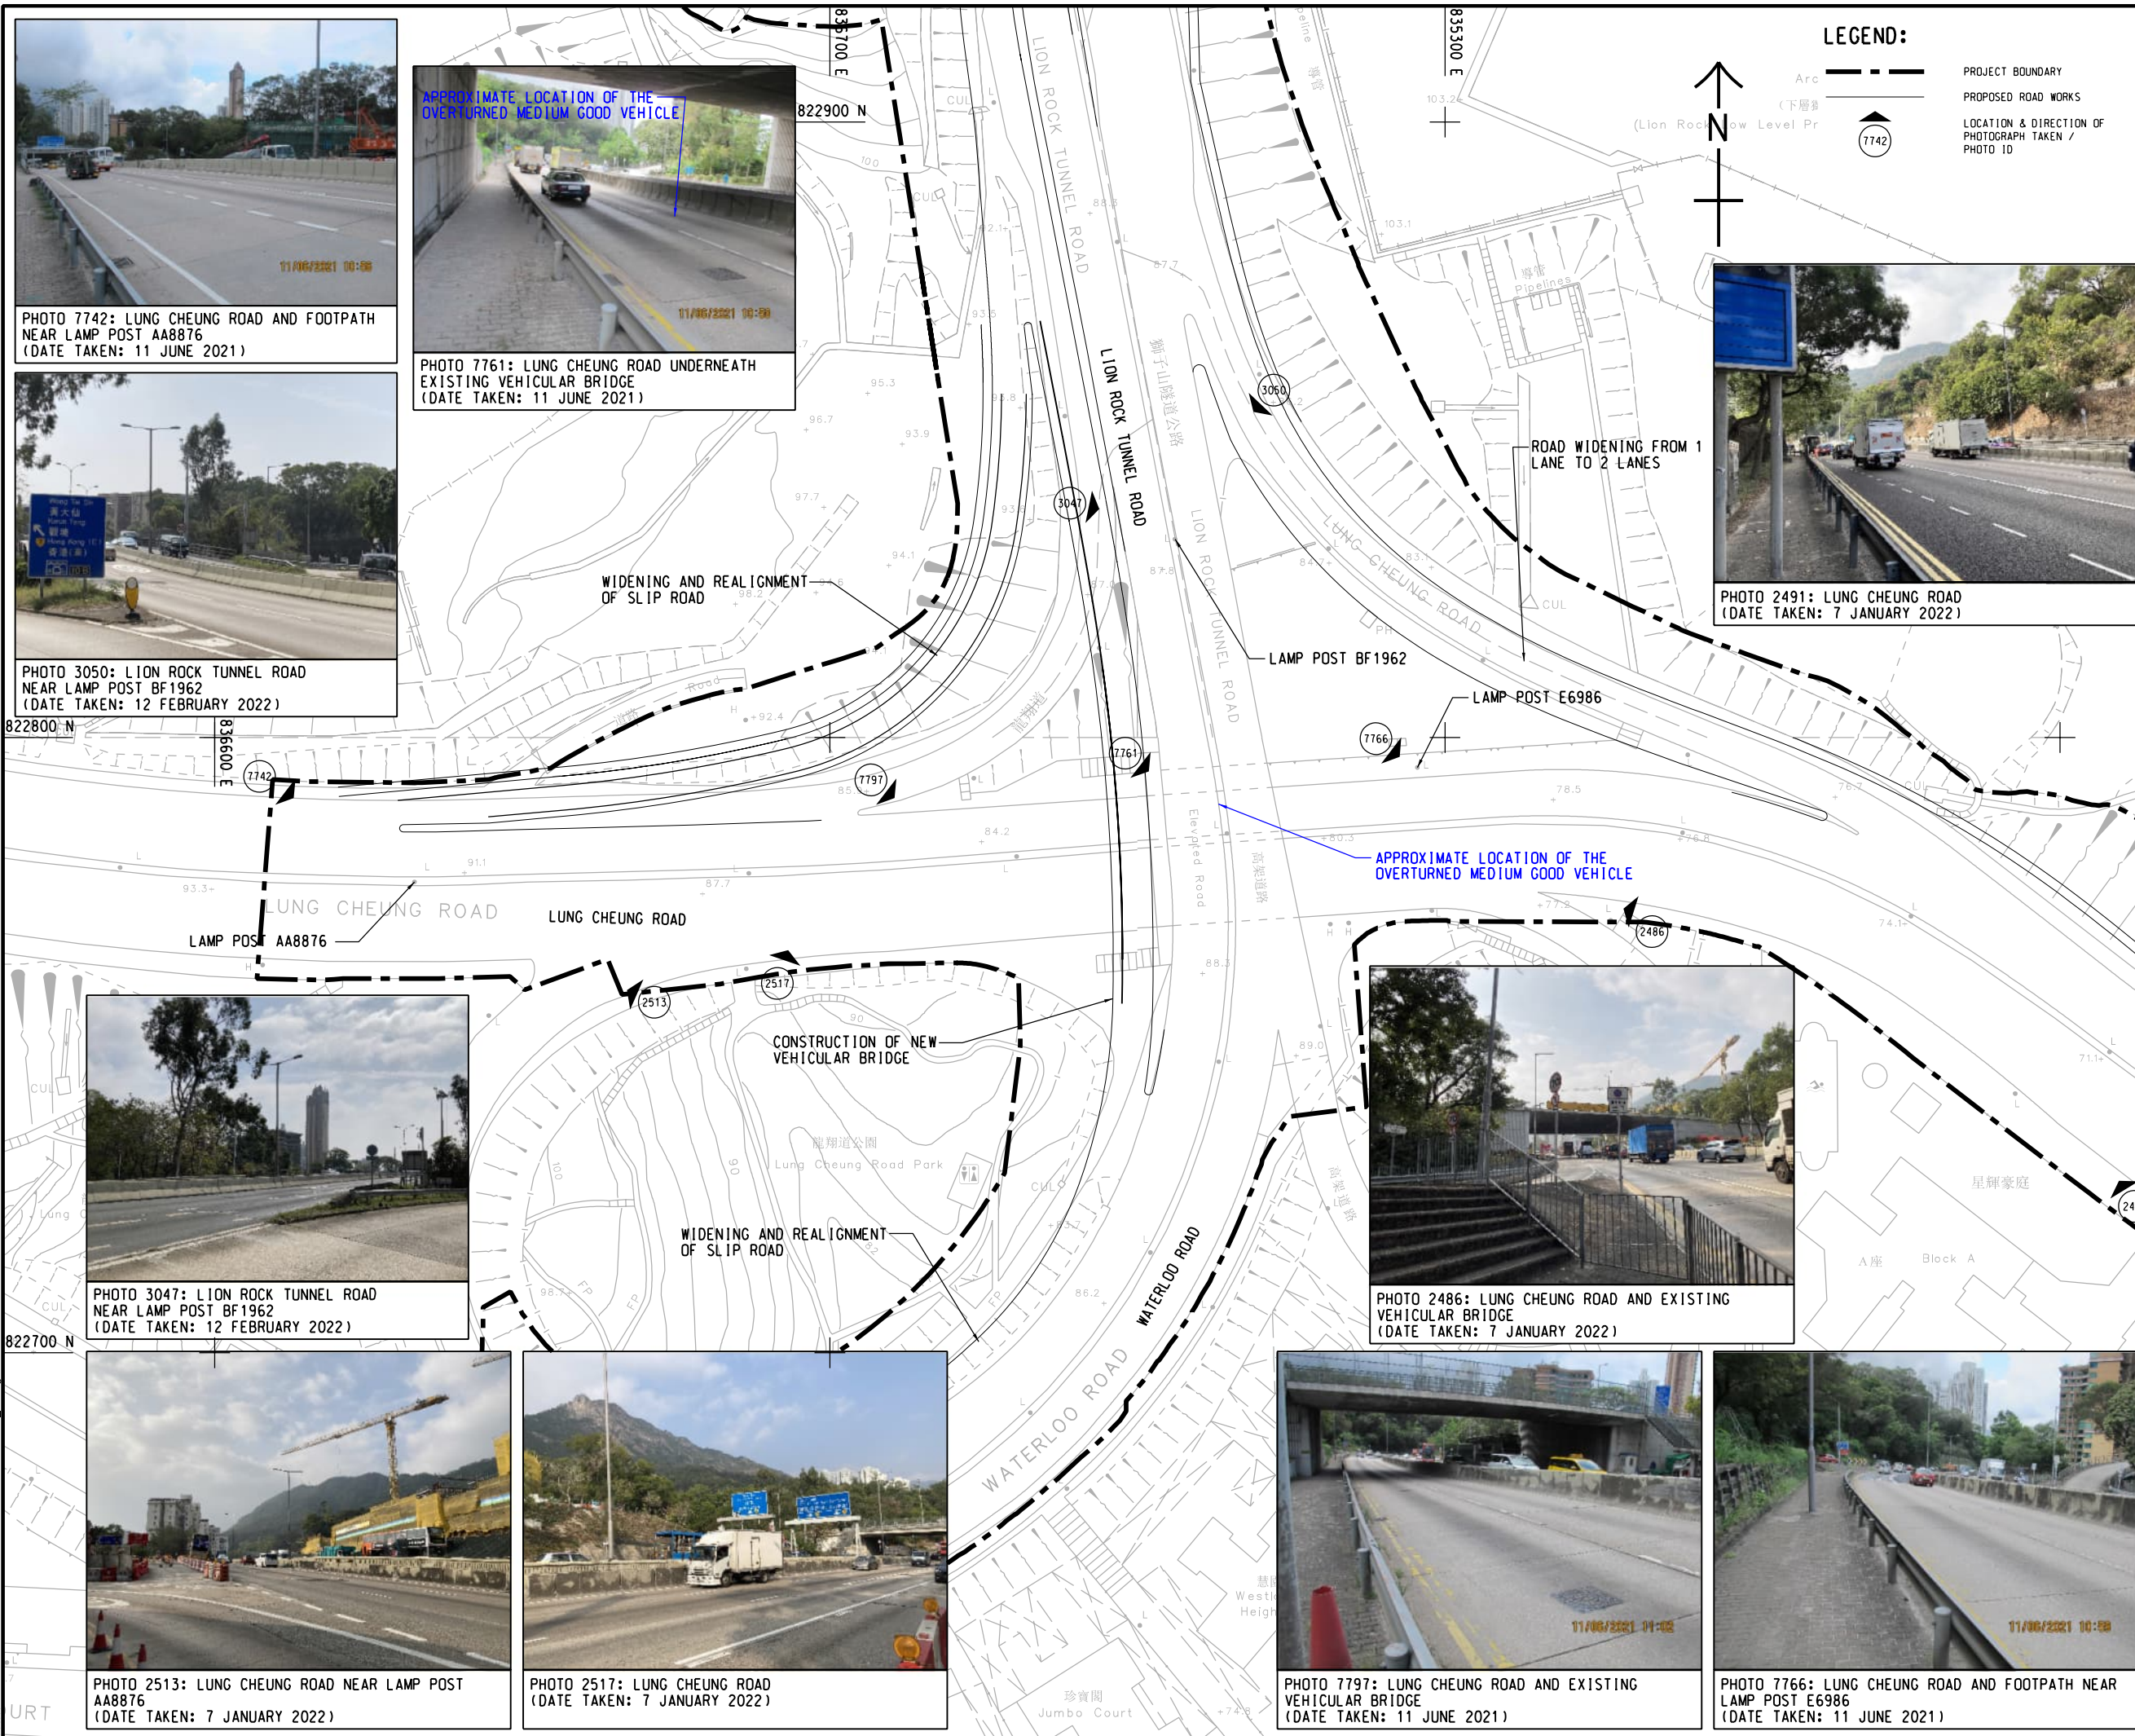
observation from the site walkover, the concerned section of Lung Cheung Road was observed to be paved with intact concrete in good condition and with no stains / spillage / burn marks observed (refer to **60604728/CAPb/PR9** in **Appendix C**). For record No. 8, the stated lamppost is located outside of the Project Area (approximately 170 m west of the Project Area). Given the above, the incidents associated with records No. 6 to 8 were not expected to pose any potential land contamination issues to the Project.

PHOTO 7742: LUNG CHEUNG ROAD AND FOOTPATH NEAR LAMP POST AA8876 (DATE TAKEN: 11 JUNE 2021)
