CONTAMINATION ASSESSMENT PLAN (FINAL)

Upgrading of Tai Po Sewage Treatment
Works – Investigation

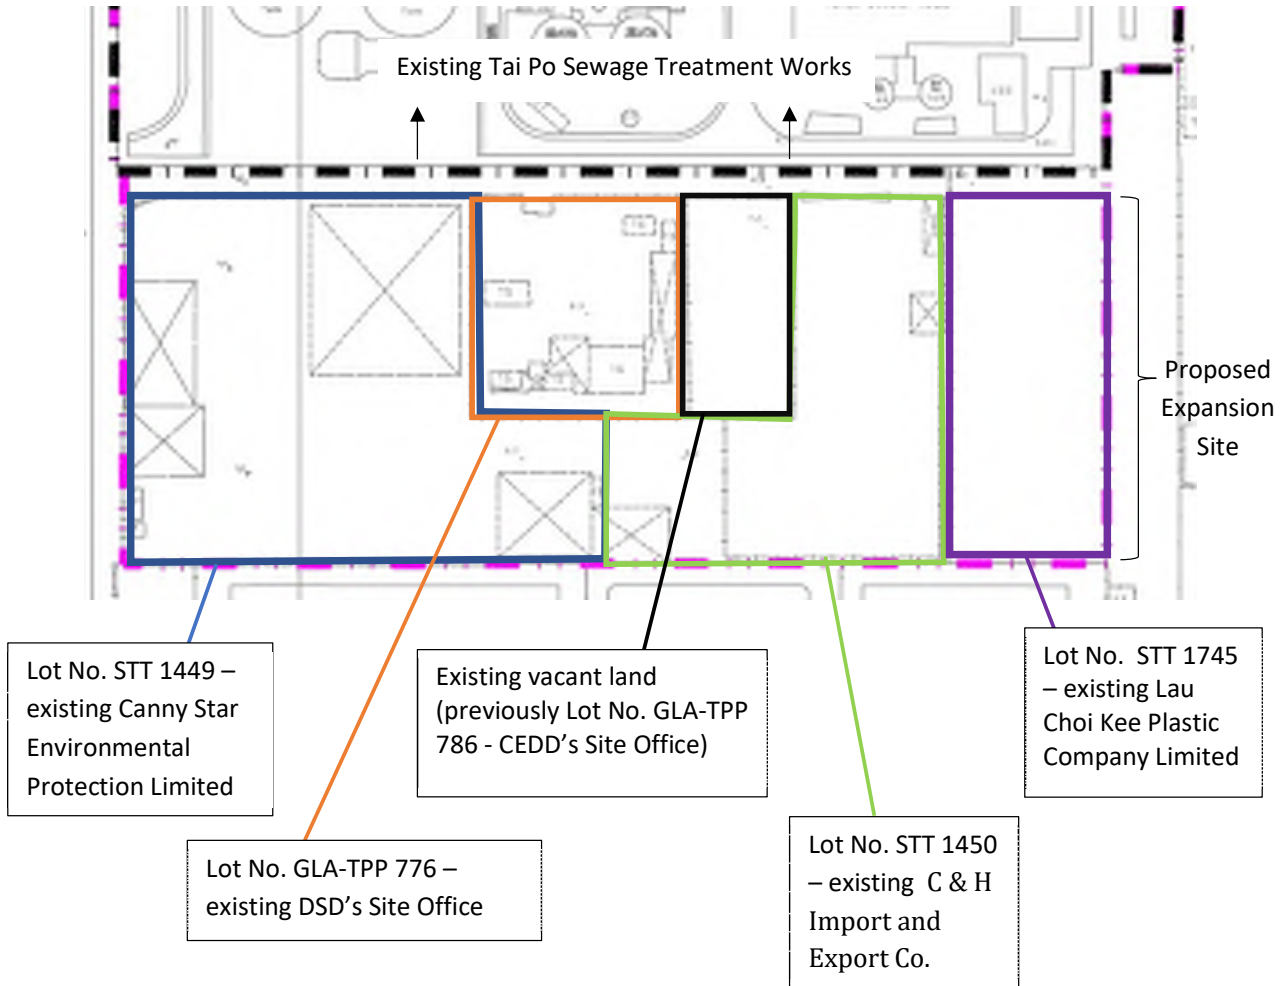
Temporary Government Land Allocation (GLA) and Short Term Tenancies (STT) in the Proposed Expansion Site

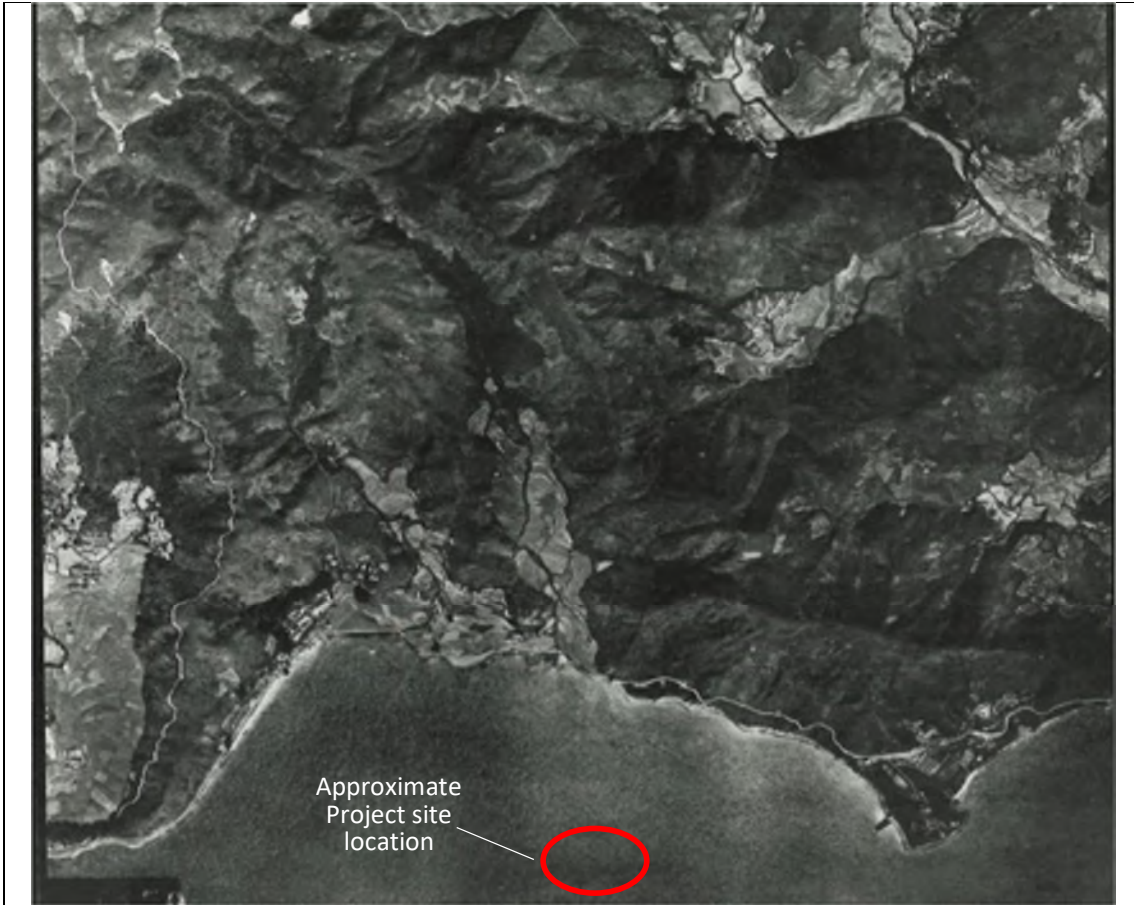
Year:	1945
Remarks:	<p><u>Project Site</u></p> <p>1. The location of the Project site, including the existing Tai Po Sewage Treatment Works (TPSTW) and the proposed expansion site, was the sea.</p> <p><u>Surrounding Off-site Areas</u></p> <p>2. The surrounding off-site areas, including the present Tai Po Industrial Estate (TPIE) and the Shuen Wan Restored Landfill (SWRL), were still the sea. No reclamation is found.</p>

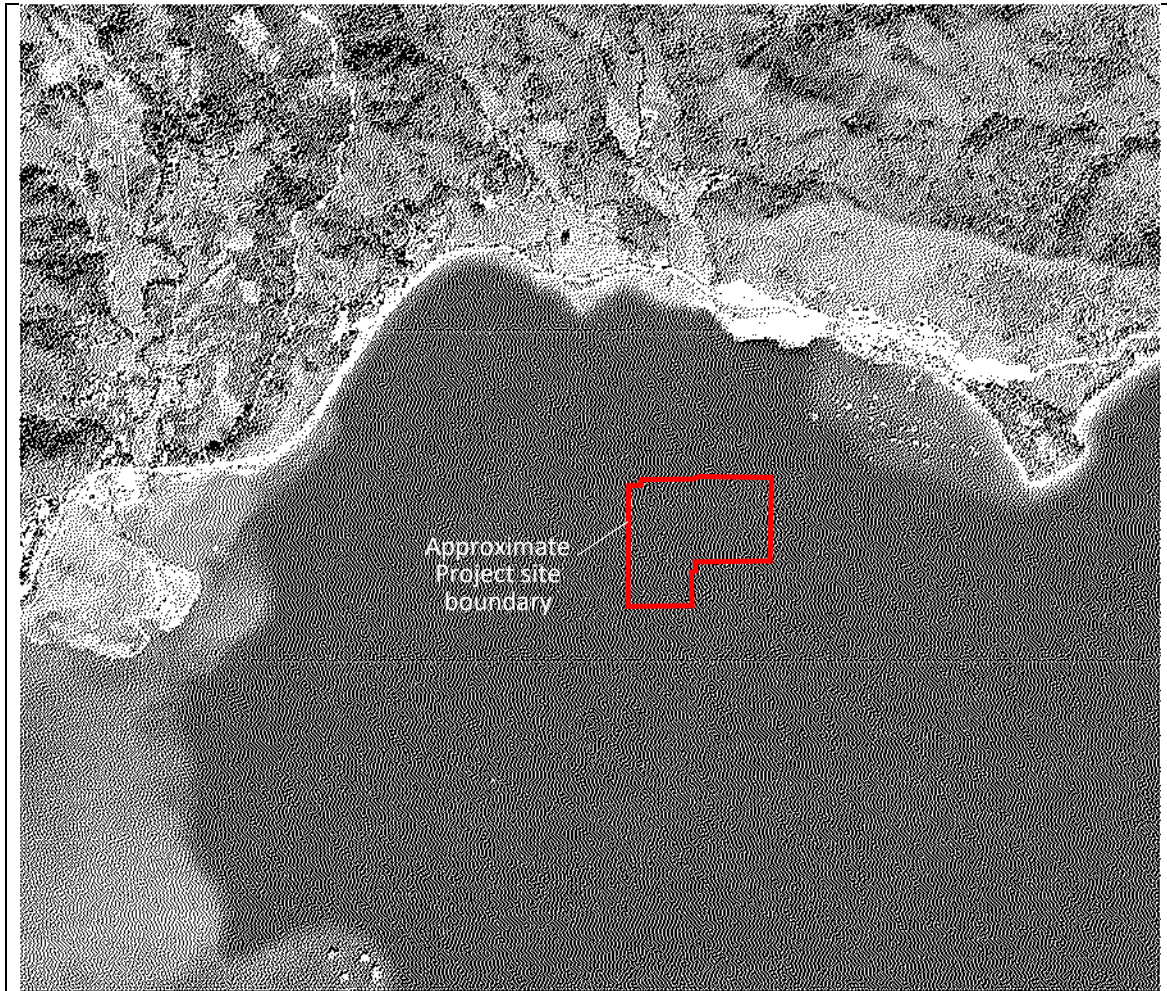
Year:	1973
Remarks:	<p><u>Project Site</u></p> <ol style="list-style-type: none">1. No reclamation is found.2. The land within the Project site was not yet formed. <p><u>Surrounding Off-site Areas</u></p> <ol style="list-style-type: none">3. The areas immediately around the Project site were also the sea.

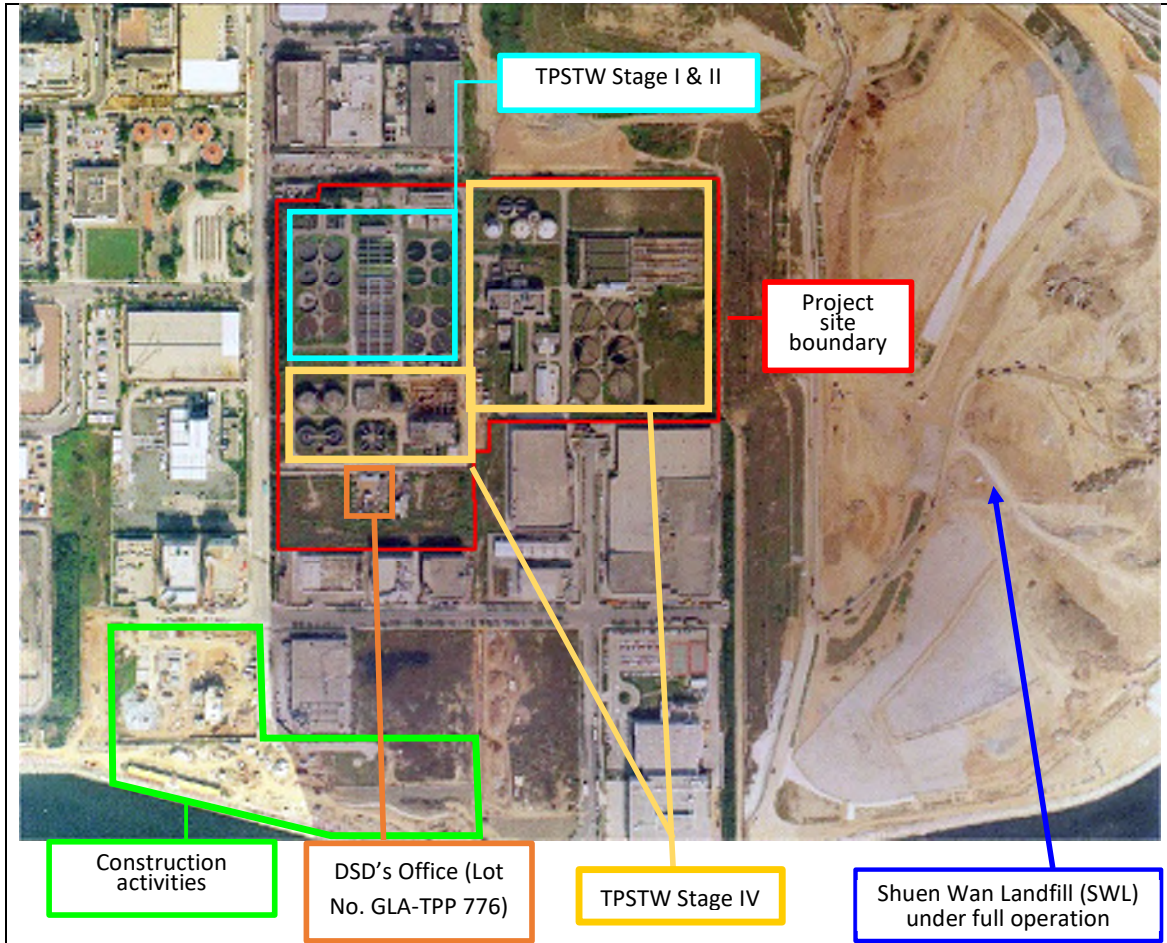
Year:	1993
Remarks:	<p><u>Project Site</u></p> <ol style="list-style-type: none"> 1. TPSTW Stage I and Stage II were in operation. 2. TPSTW Stage IV (covering most of the remaining areas of the present TPSTW site) was under construction 3. A DSD's office was being formed in the proposed expansion site (in Lot No. GLA-TPP 776). 4. The remaining areas of the proposed expansion site were not yet occupied and mostly vegetated. <p><u>Surrounding Off-site Areas</u></p> <ol style="list-style-type: none"> 5. SWL was under full operation. 6. Reclamation for TPIE was fully completed. 7. Industrial buildings were developed around the Project site. 8. Some construction activities were taking place in the southern TPIE near the waterfront.

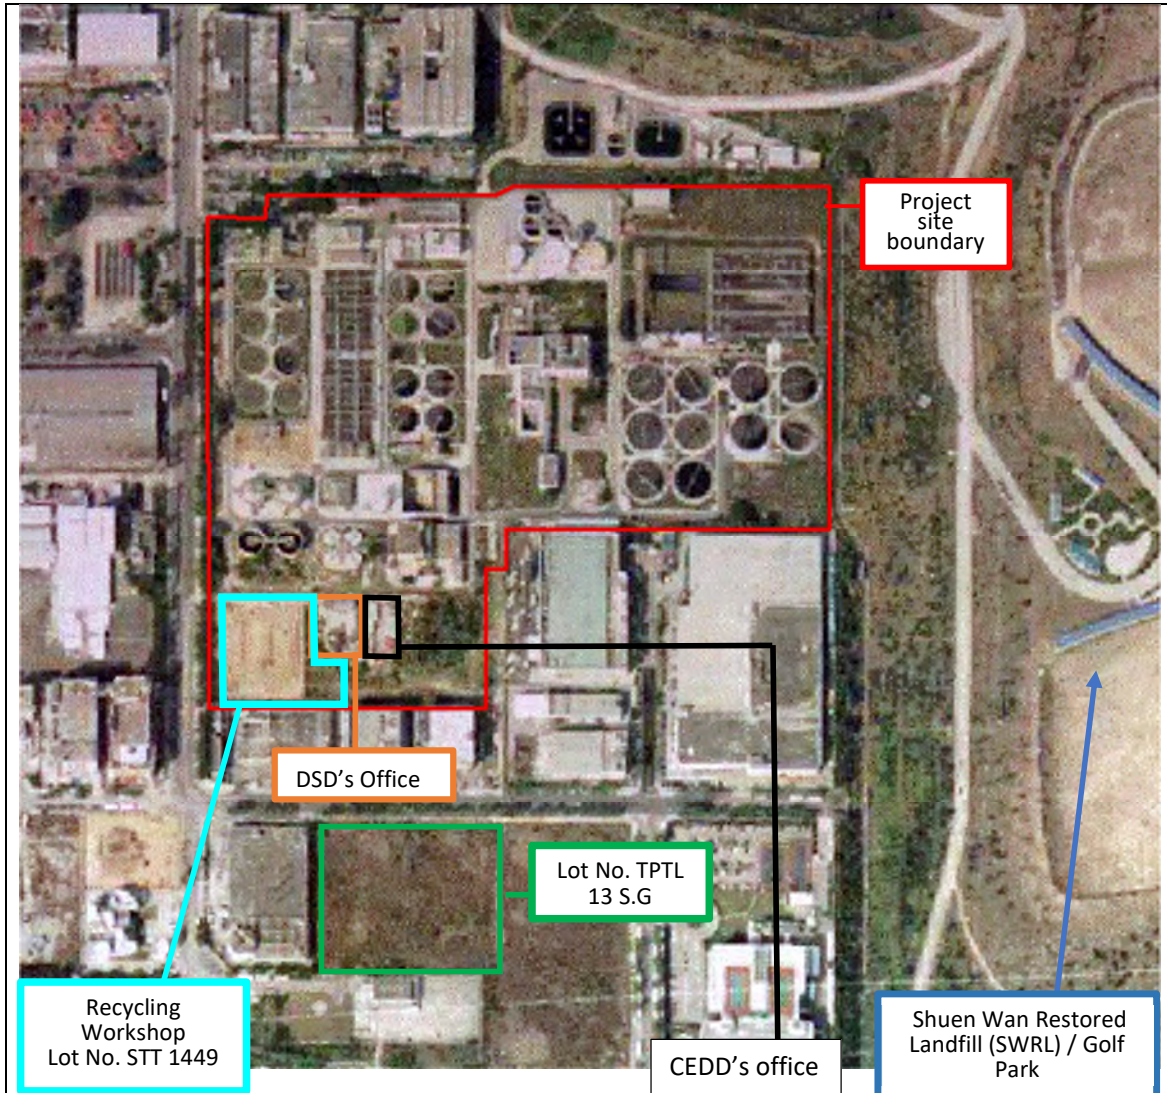
Year:	2000
Remarks:	<p><u>Project Site</u></p> <ol style="list-style-type: none"> 1. A recycling workshop was under construction in the west part of the proposed expansion site (in Lot STT 1449). 2. The CEDD's office in the proposed expansion site (in Lot No. GLA-TPP 786 next to the DSD's office) was in operation. 3. No obvious changes for the other Project areas. <p><u>Surrounding Off-site Areas</u></p> <ol style="list-style-type: none"> 4. The SWRL started to serve as a 145-bay golf driving range for public use. 5. The area (in Lot No. TPTL 13 S.G) in the southern TPIE (previously observed to have exposed soil surface) was vegetated again. 6. No obvious changes in other off-site areas.

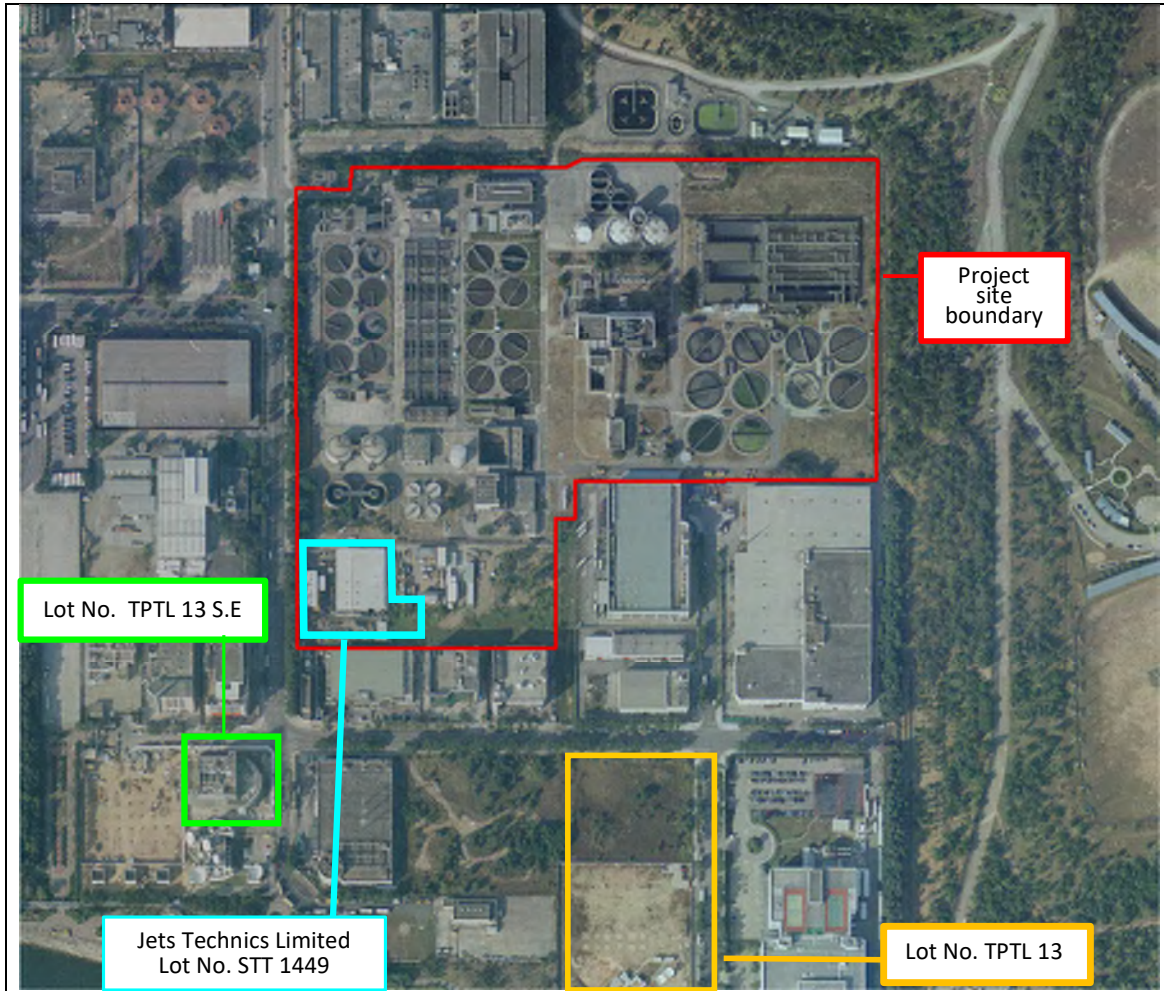
Year:	2003
Remarks:	<p><u>Project Site</u></p> <ol style="list-style-type: none"> 1. According to the Short Term Tenancy (STT) record of Lands Department, Jets Technics Limited (a business in connection with the recovery and recycling of waste materials found in municipal solid waste) was in operation in the west part of the proposed expansion site (in Lot No. STT 1449) since 2003. 2. No obvious changes for other Project areas <p><u>Surrounding Off-site Areas</u></p> <ol style="list-style-type: none"> 3. Lot No. TPTL 13 near the waterfront of TPIE was under construction. 4. New buildings were formed in Lot No TPTL 13 S.E in the southern TPIE. 5. No obvious changes in other off-site areas.

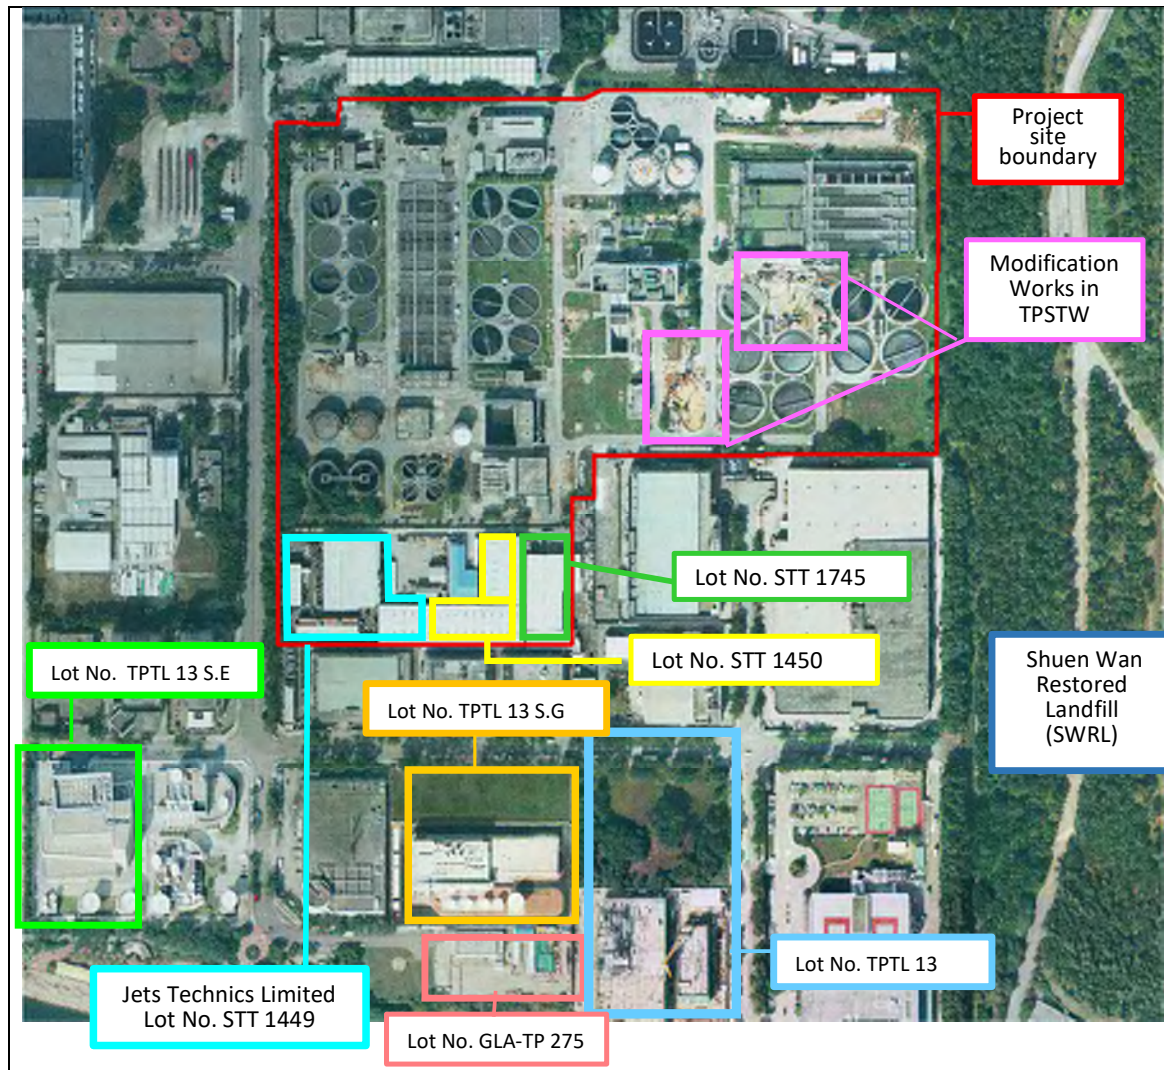
Year:	2005
Remarks:	<p><u>Project Site</u></p> <ol style="list-style-type: none"> 1. Some modification works in the central and eastern areas of TPSTW were observed. 2. More shelters were built in the area of Jets Technics Limited. 3. Temporary structures were found in the eastern lots of the proposed expansion site (in Lot No. STT 1450 and Lot No. 1745). Lands Department has no record of STT at these lots. Occupant information is unknown. Recycling industries were likely operated in these lots. 4. No obvious changes for other Project areas <p><u>Surrounding Off-site Areas</u></p> <ol style="list-style-type: none"> 5. New buildings were formed in the southern TPIE (in Lot No. TPTL 13 S.E, Lot No. TPTL 13 S.G, Lot No. GLA TP-275 and Lot No. TPTL 13). 6. More plantation were observed Lot No. TPTL 13 and in the SWRL. 7. No obvious changes in other off-site areas.

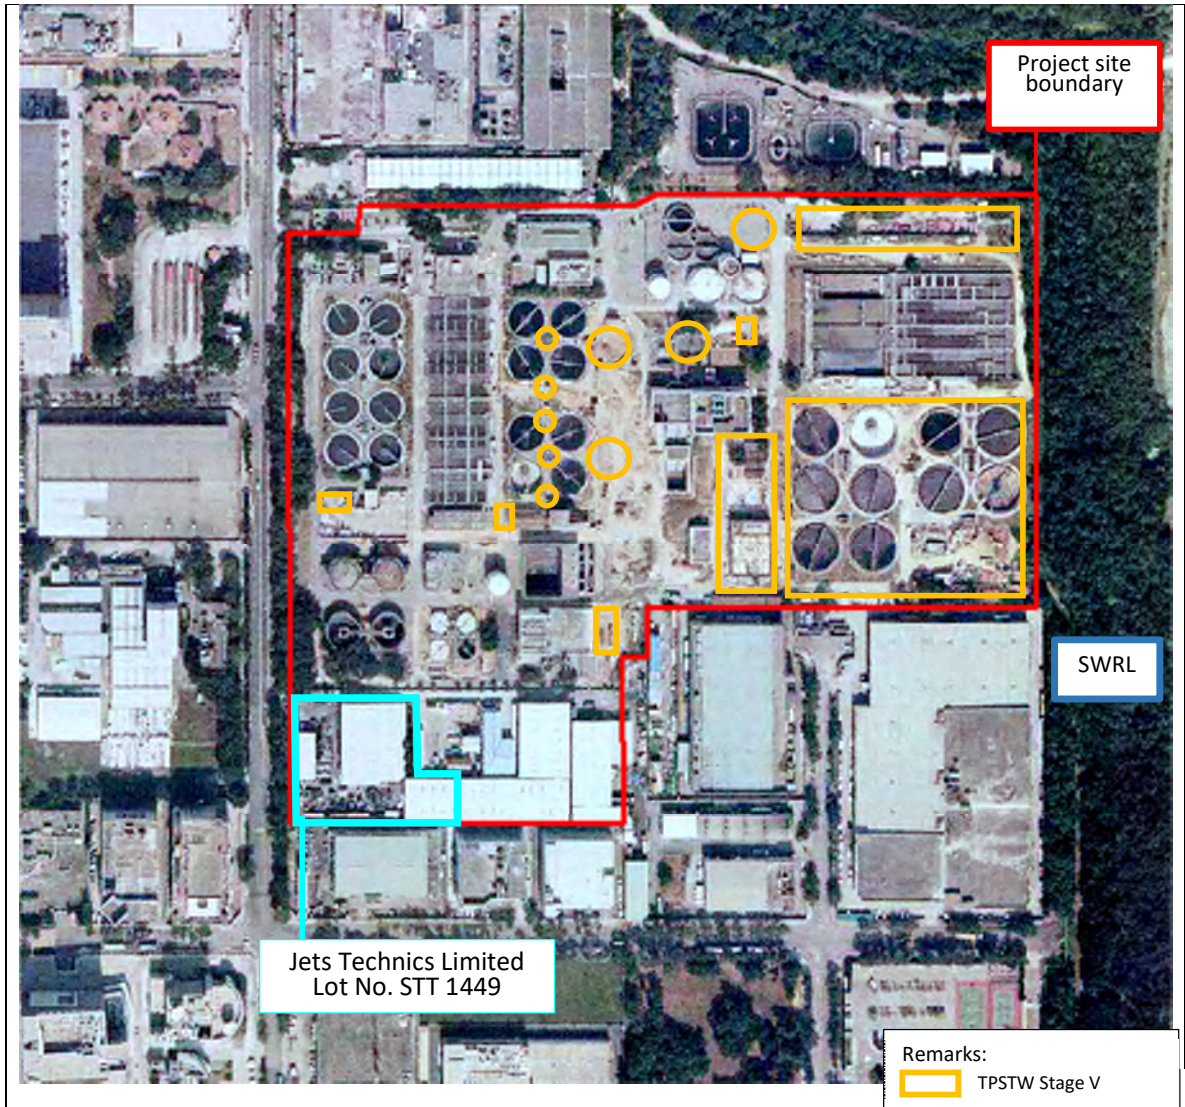
Year:	2006
Remarks:	<p><u>Project Site</u></p> <ol style="list-style-type: none"> 1. Construction of TPSTW Stage V was in progress. 2. One of the shelters of Jets Technics Limited (Lot No. STT 1449) in the proposed expansion site was demolished. 3. No obvious changes in other Project areas <p><u>Surrounding Off-site Areas</u></p> <ol style="list-style-type: none"> 4. Dense plantation is observed in the SWRL. 5. No obvious changes in the other off-site area.

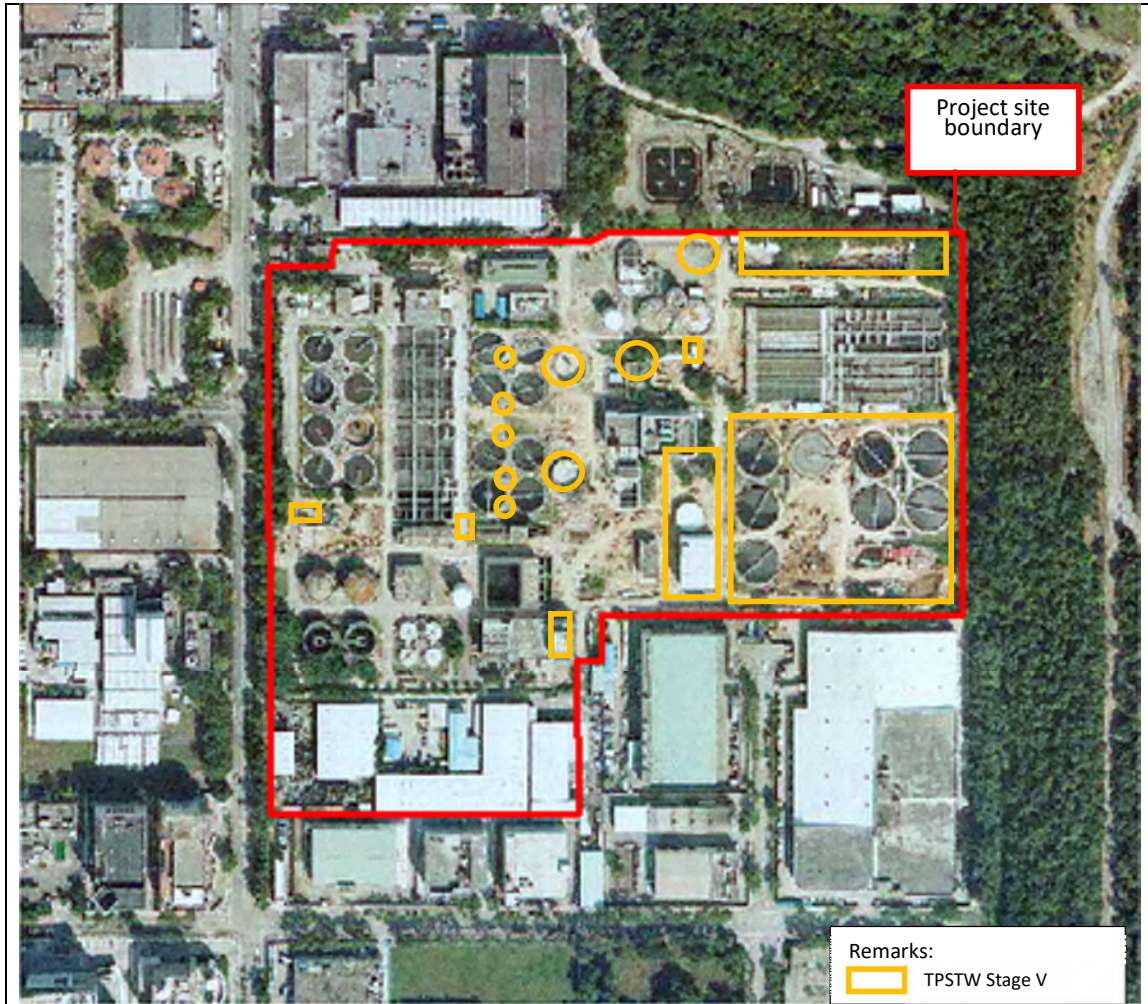
Year:	2007
Remarks:	<p><u>Project Site</u></p> <ol style="list-style-type: none"> 1. Construction of TPSTW Stage V continued. 2. No obvious change in other Project areas. <p><u>Surrounding Off-site Areas</u></p> <ol style="list-style-type: none"> 3. No obvious changes for all surrounding off-site areas.

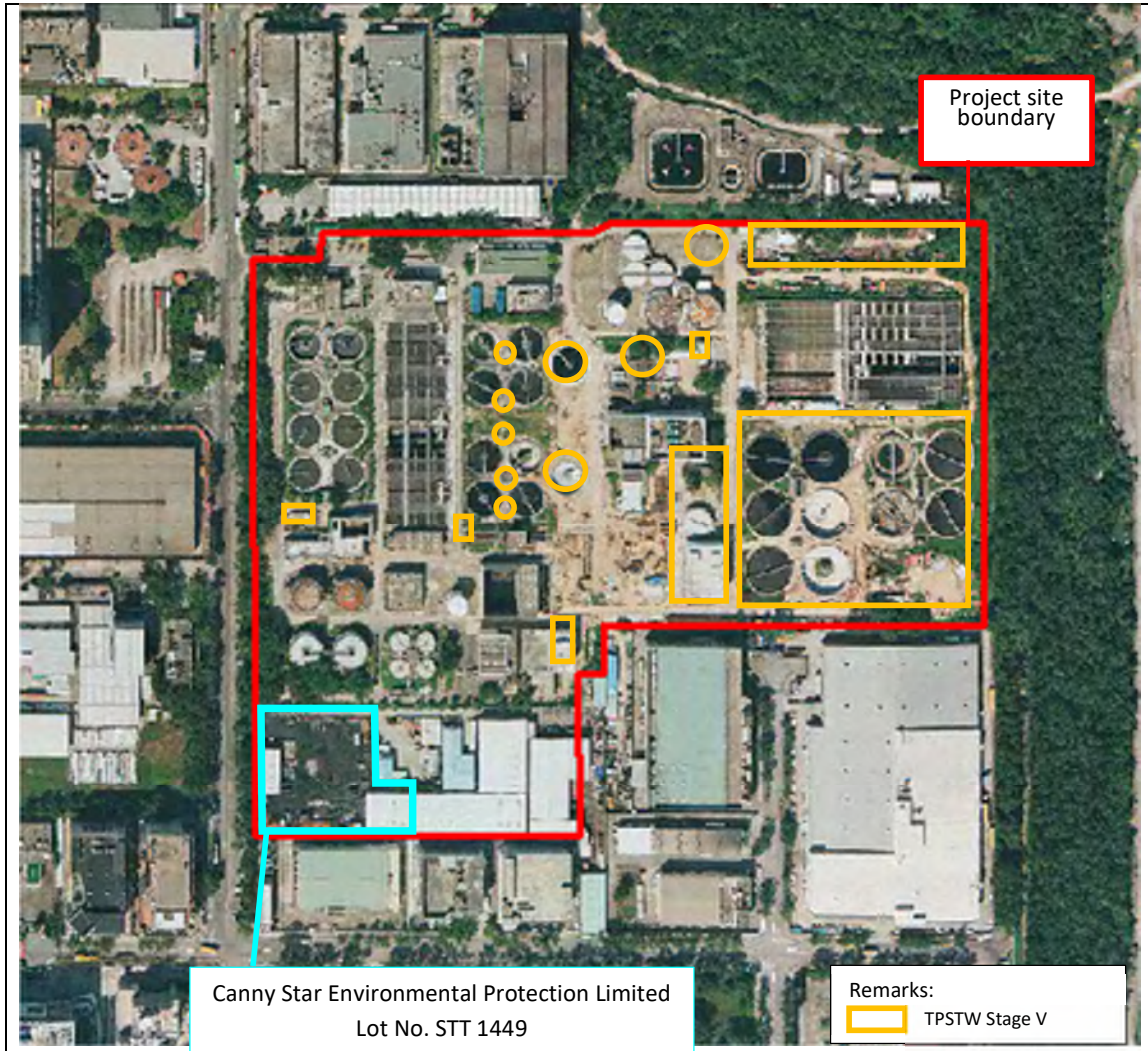
Year:	2009
Remarks:	<p><u>Project Site</u></p> <ol style="list-style-type: none"> 1. Construction of TPSTW Stage V continued. 2. According to the STT record of Lands Department, Canny Star Environmental Protection Limited was in operation in the west part of the proposed expansion site (in Lot No. STT 1449) since 2009. It was a business in the recovery and recycling of metals, paper, plastics, tyres, electrical and electronic appliances, glass, textile and old clothes, wood or furniture or any combination of the above found in municipal solid waste. 3. No obvious changes in other Project areas. <p><u>Surrounding Off-site Areas</u></p> <ol style="list-style-type: none"> 4. No obvious changes for all surrounding off-site areas..

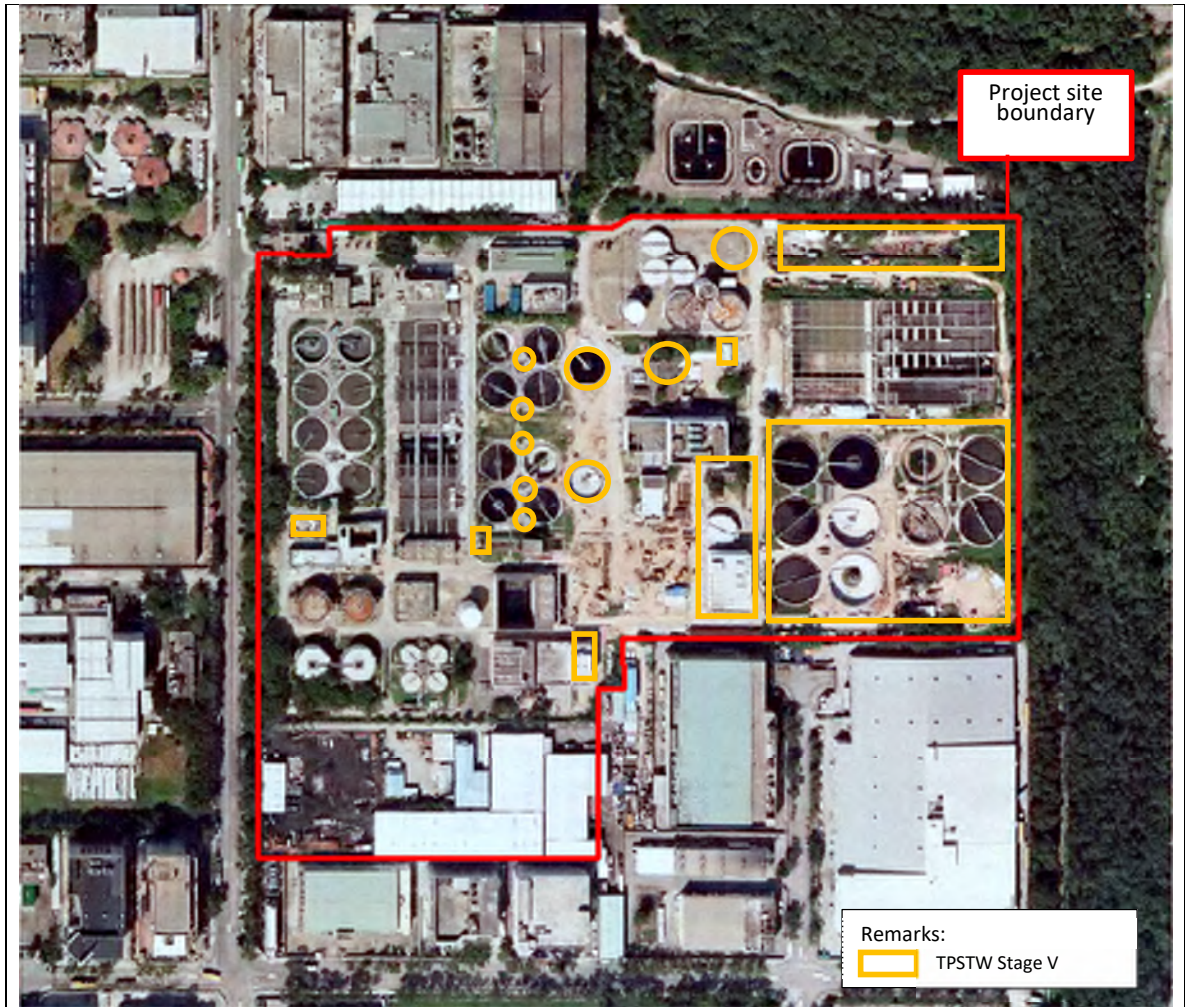
Year:	2011
Remarks:	<p><u>Project Site</u></p> <ol style="list-style-type: none"> 1. Phase 1 of TPSTW Stage V was completed and in operation. 2. Construction of TPSTW Stage V (Phase 2) continued 3. No obvious changes in other Project areas. <p><u>Surrounding Off-site Areas</u></p> <ol style="list-style-type: none"> 4. No obvious changes for all surrounding off-site areas.

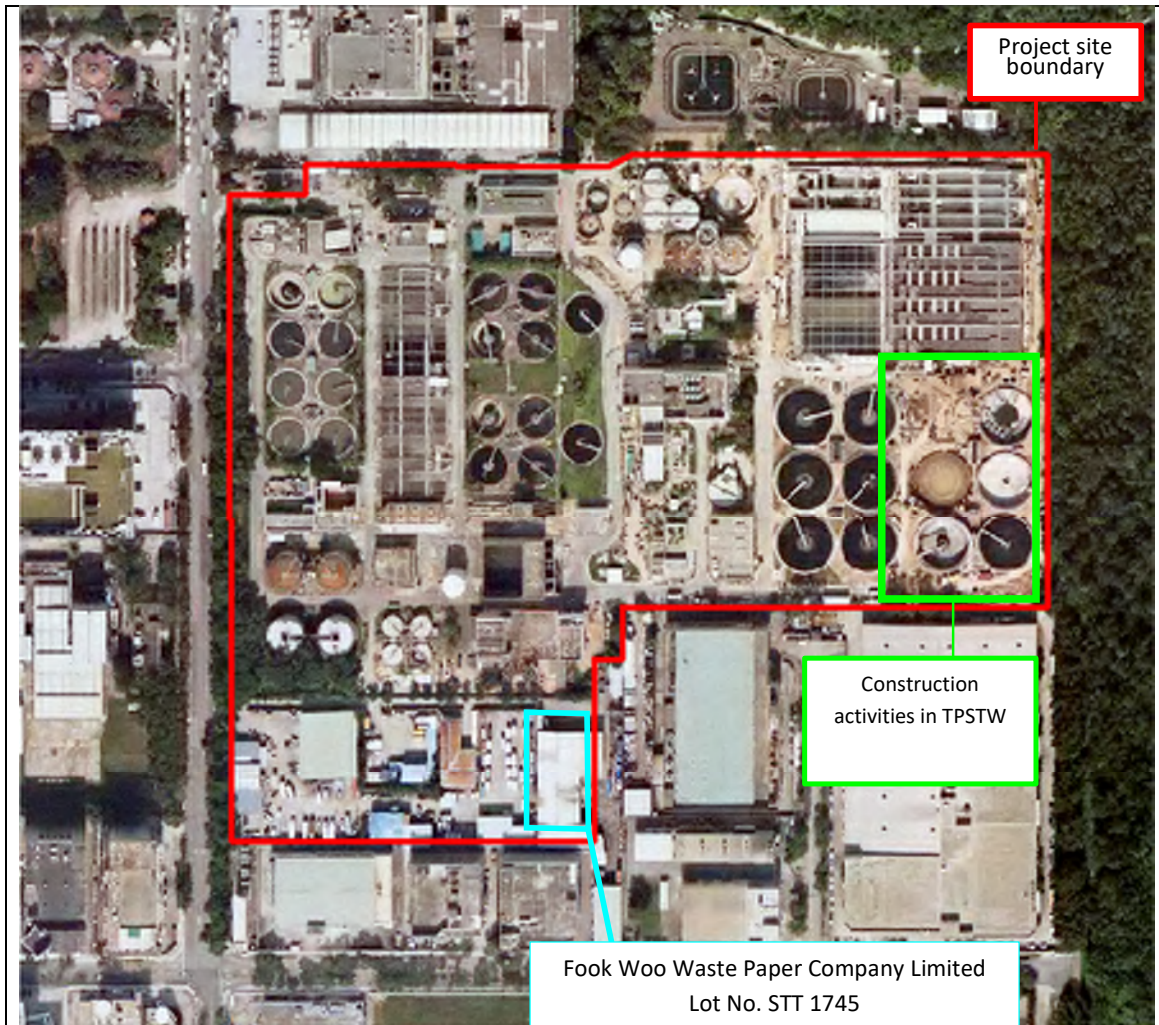
Year:	2012
Remarks:	<p><u>Project Site</u></p> <ol style="list-style-type: none"> 1. Construction of TPSTW Stage V (Phase 2) continued. 2. A shelter was built in the site of Canny Star Environmental Protection Limited in the west part of the proposed expansion site (in Lot No. STT 1449). 3. C & H Import and Export Co. was operated in the east part of the proposed expansion site (in Lot No. 1450). It was a steel recycling workshop and steel warehouse for storage of wasted steel. 4. No obvious changes in other Project areas. <p><u>Surrounding Off-site Areas</u></p> <ol style="list-style-type: none"> 5. No obvious changes for all surrounding off-site areas.

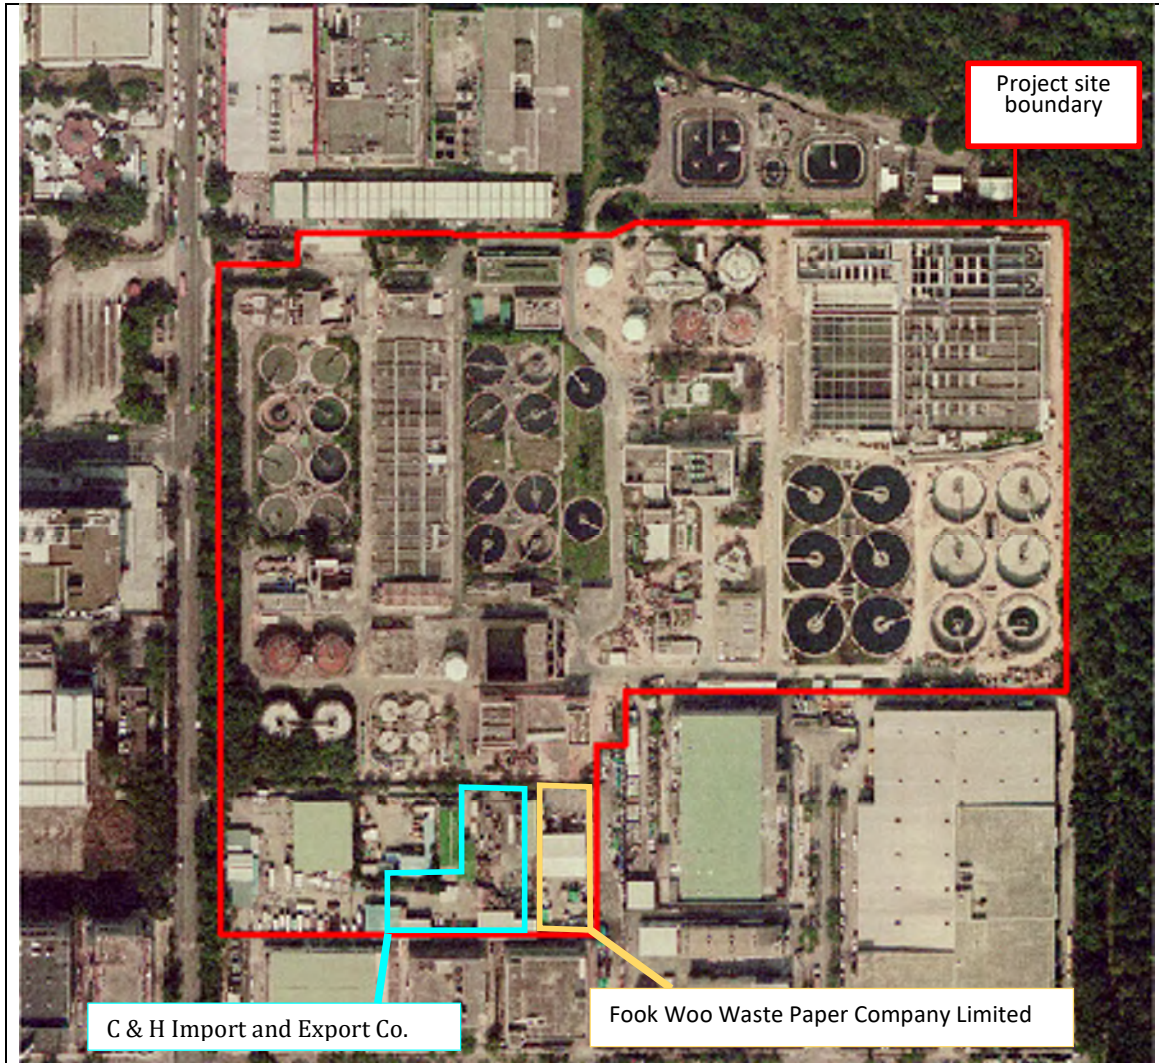
Year:	2015
Remarks:	<p><u>Project Site</u></p> <ol style="list-style-type: none"> 1. Construction of the Final Sedimentation Tanks previously observed in the east part of TPSTW was completed. 2. Some shelters in C & H Import and Export Co. and Fook Woo Waste Paper Company Limited in the eastern lots of the proposed expansion site (Lot No. STT 1450 and 1745) were demolished. 3. No obvious changes in other Project areas. <p><u>Surrounding Off-site Areas</u></p> <ol style="list-style-type: none"> 4. No obvious changes for all surrounding off-site areas.

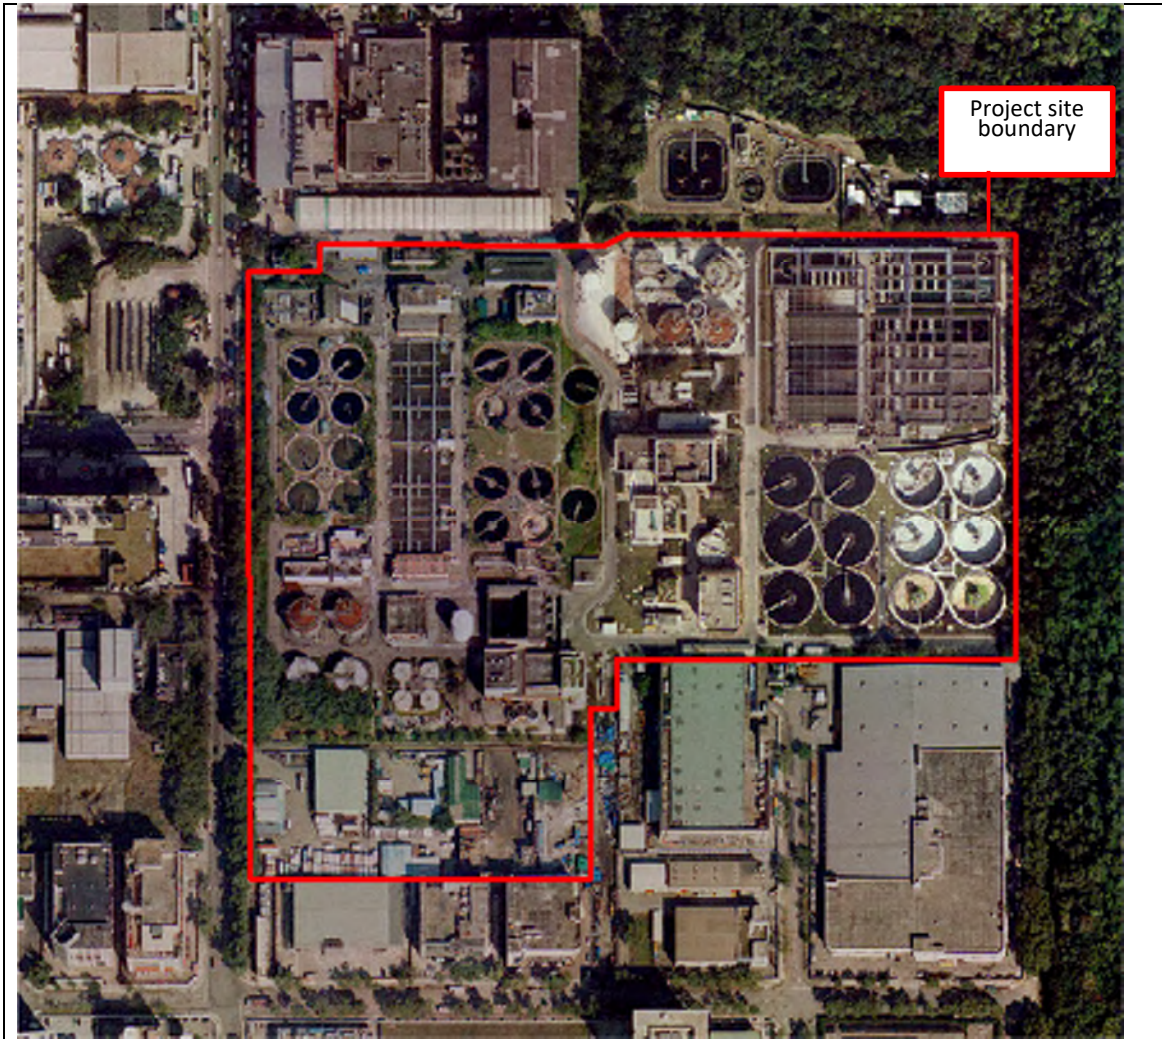
Year:	2016
Remarks:	1. No obvious changes for the Project site and surrounding off-site areas.

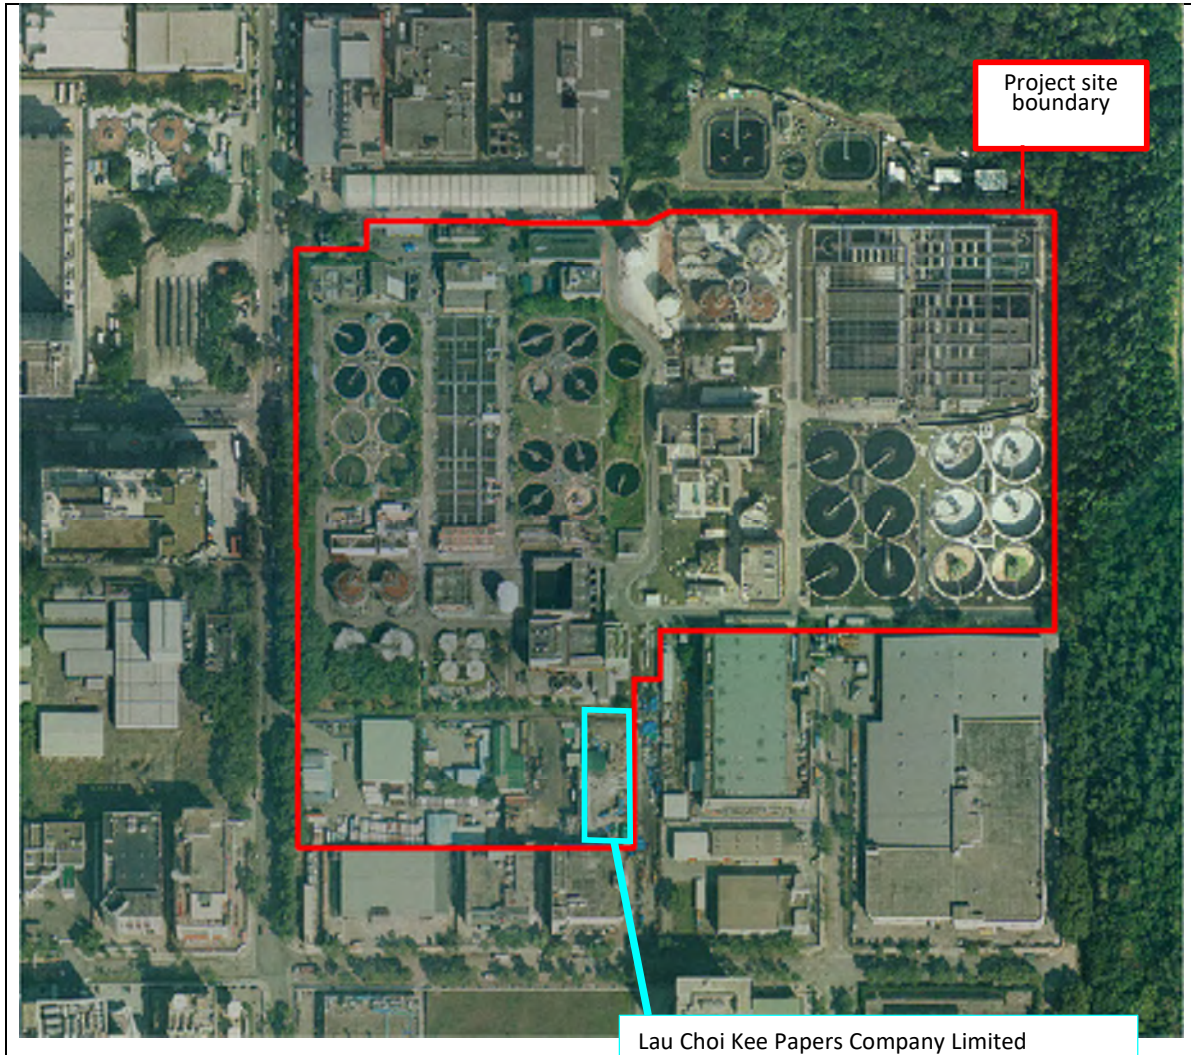
Year:	2018
Remarks:	<p><u>Project Site</u></p> <ol style="list-style-type: none"> 1. According to the STT record of Lands Department, Lau Choi Kee Papers Company Limited was the tenant in the eastern lot of the proposed expansion site (Lot No. STT 1745) since 2017. It was a business in recovery and recycling or in connection with reprocessing of plastics found in and recovered from municipal solid waste. 2. No obvious changes in other Project areas. <p><u>Surrounding Off-site Areas</u></p> <ol style="list-style-type: none"> 3. No obvious changes for all surrounding off-site areas.

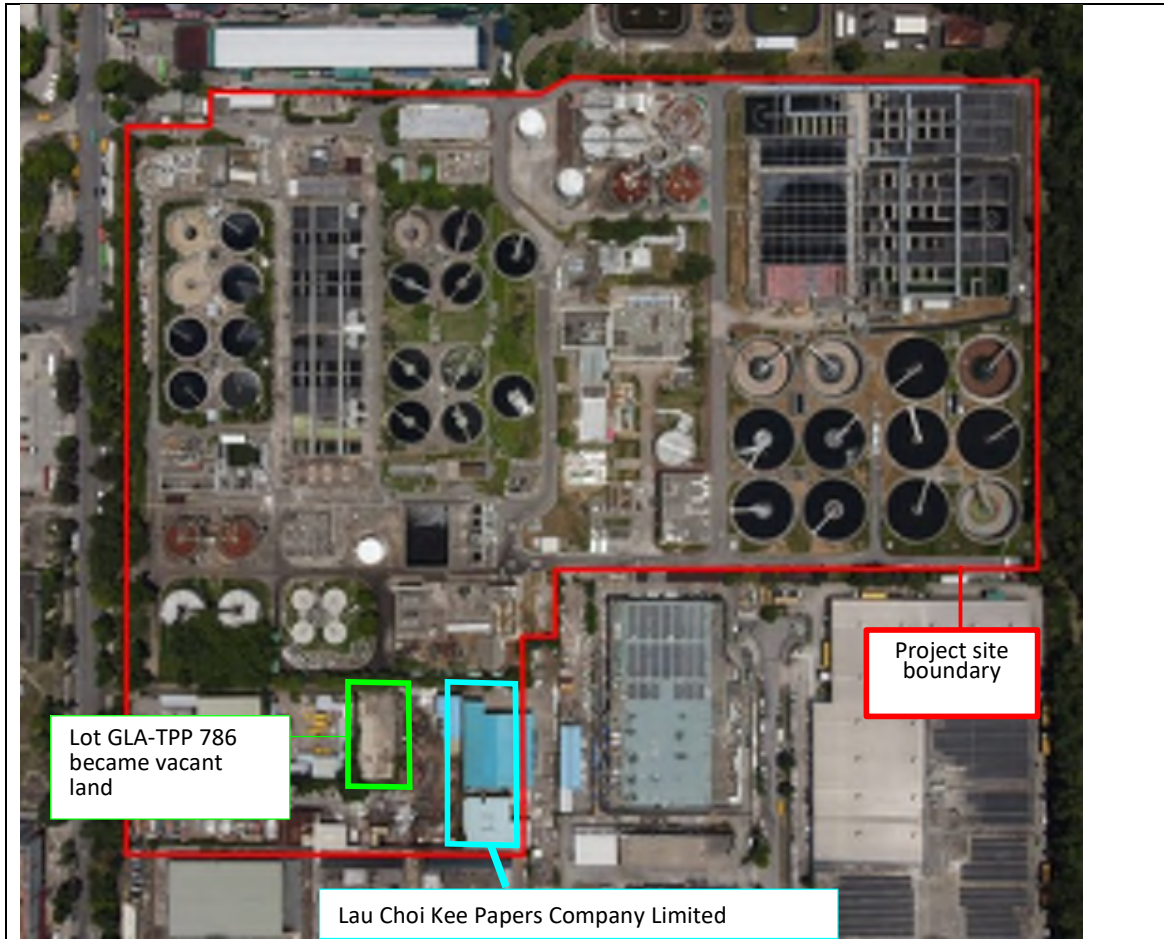
Year:	2020
Remarks:	<p><u>Project Site</u></p> <ol style="list-style-type: none"> 1. Shelters were built in the eastern lot (Lau Choi Kee Papers Company Limited) in the proposed expansion site. 2. The CEDD's office previously observed in the middle of the proposed expansion site (in Lot GLA-TPP 786) was removed and the lot became vacant. 3. No obvious changes in other Project areas. <p><u>Surrounding Off-site Areas</u></p> <ol style="list-style-type: none"> 4. No obvious changes for all surrounding off-site areas.

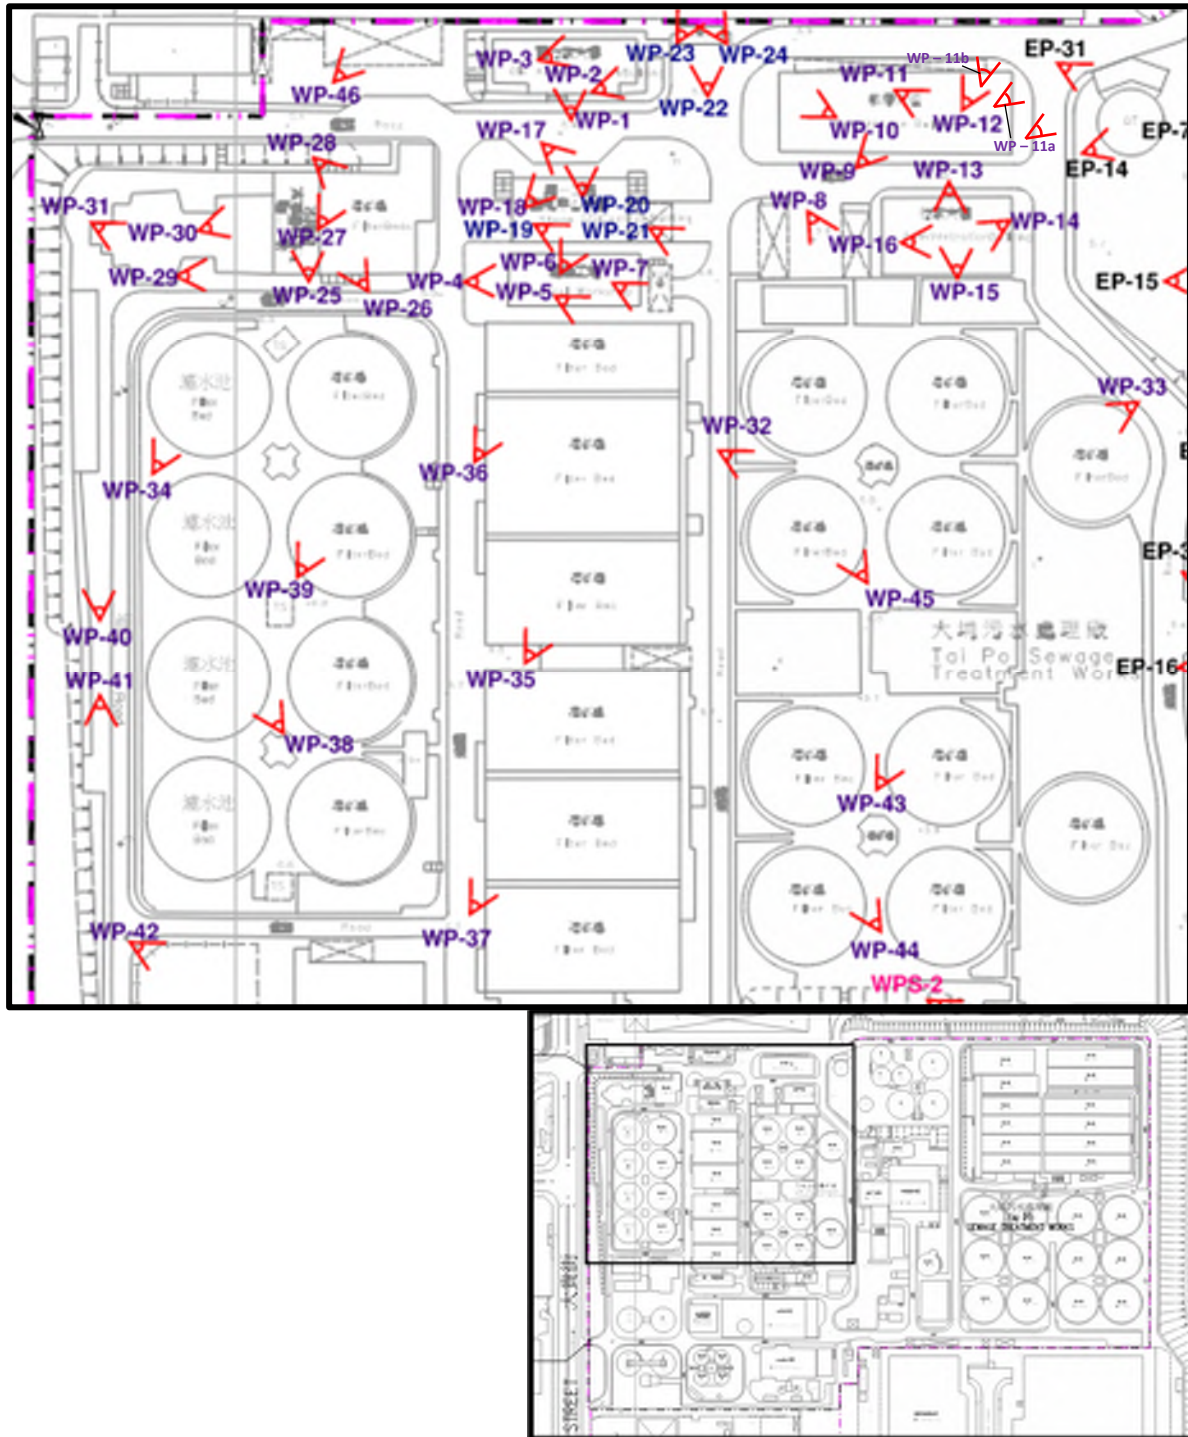
West Plant of TPSTW (Northern Portion) – Index Plan
