CONTAMINATION ASSESSMENT PLAN (FINAL)

Upgrading of Tai Po Sewage Treatment
Works – Investigation

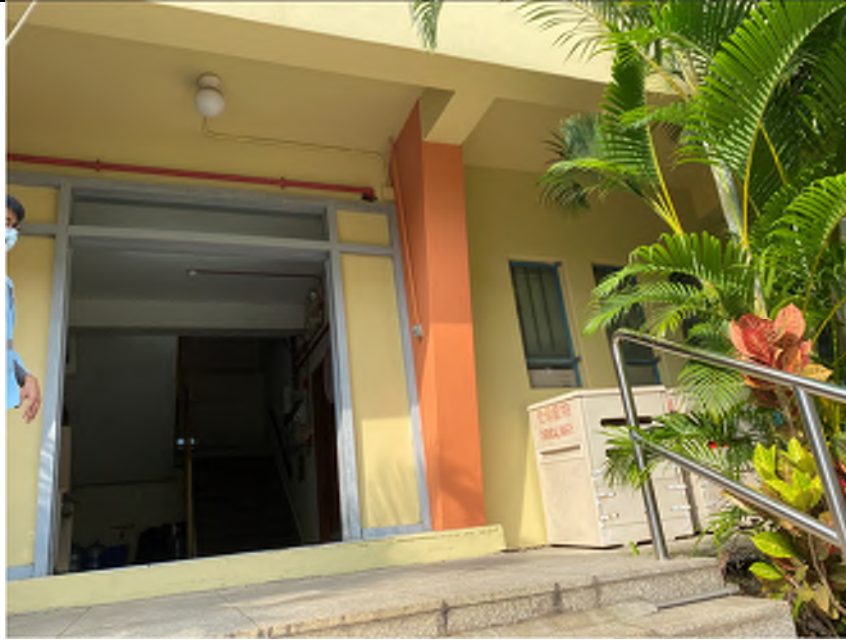
Photo WP-1: Old Administration Building (External View) – It is a two-storey building located on concrete paved floor in good condition. No oil stain/ leakage is observed.

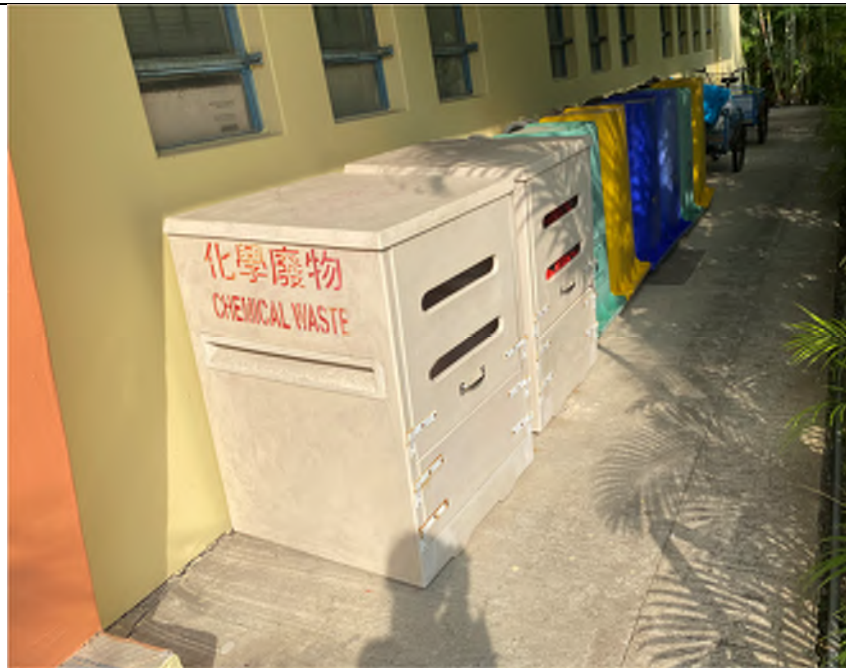
Photo WP-2: Old Administration Building (External Outlet) – Chemical waste were placed inside specific steel box at the outlet of the Administration House. F waste are well contained with no observation of leakage/ spillage.

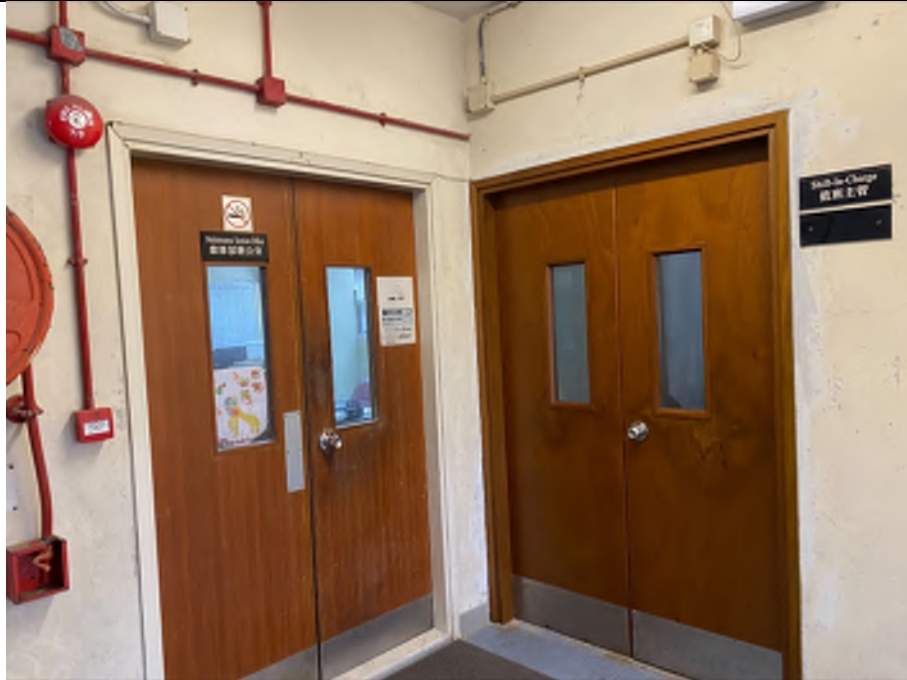
Photo WP-3: Old Administration Building – The second floor of the Old Administration Building is paved with concrete slab, the Maintenance Section Office is located on the second floor.

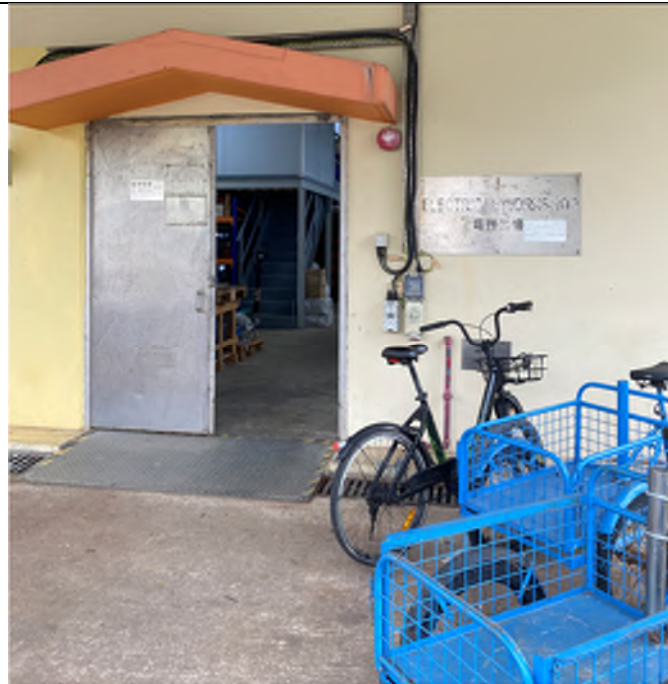
Photo WP-4: Electrical Workshop (External View) – No oil stain / floor leakage observed.

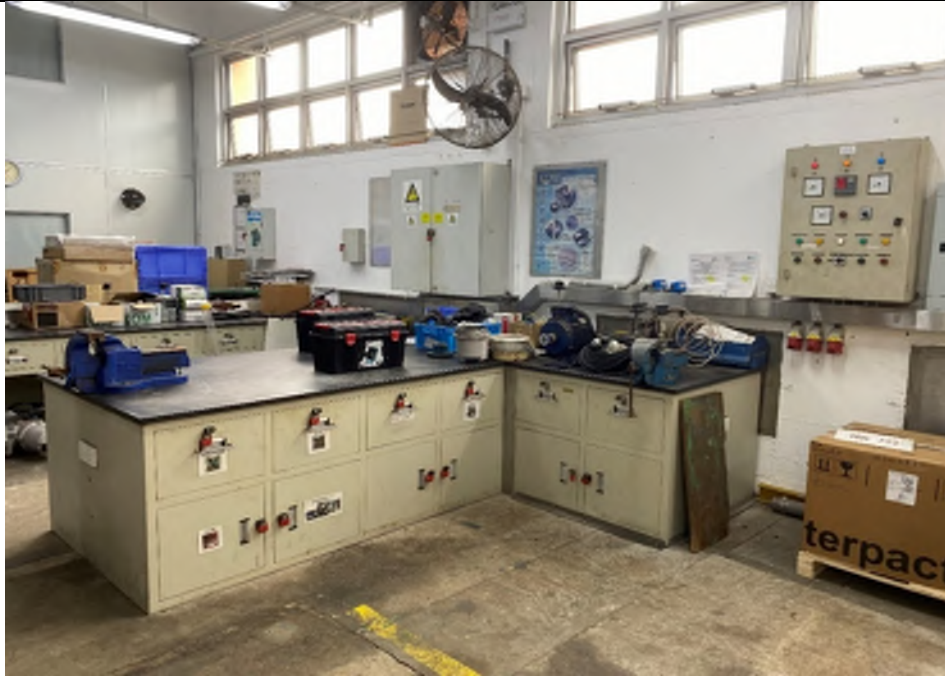
Photo WP-5: Electrical Workshop - The tool desks are located on concrete paved floor with small area of water stain is observed. Maintenance work of small equipment was carried out. Cracks were observed on the floor. No oil stain / leakage is observed.

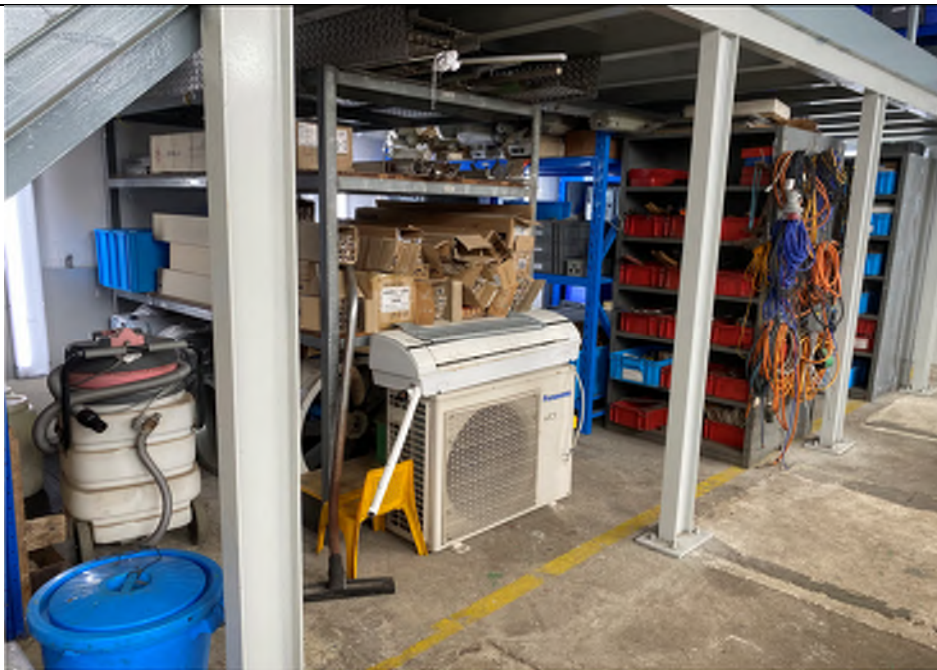
Photo WP-6: Electrical Workshop – Tools and equipment are stored on racks. The floor is paved with concrete in good condition with no oil stain / leakage observed.

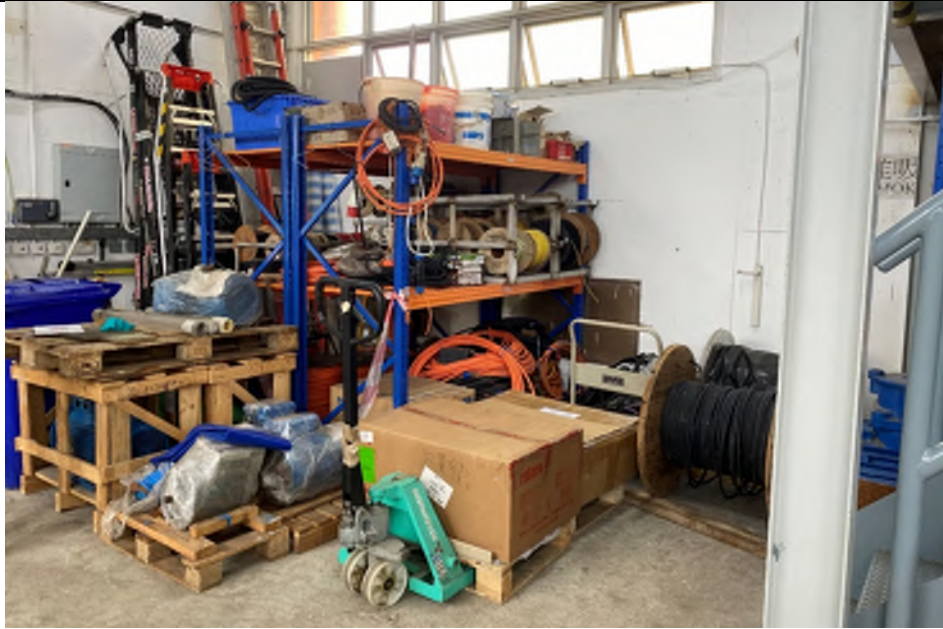
Photo WP-7: Electrical Workshop – Tools and equipment are stored on racks or wooden panel. The floor is paved with concrete in good condition with no oil stain / leakage observed.

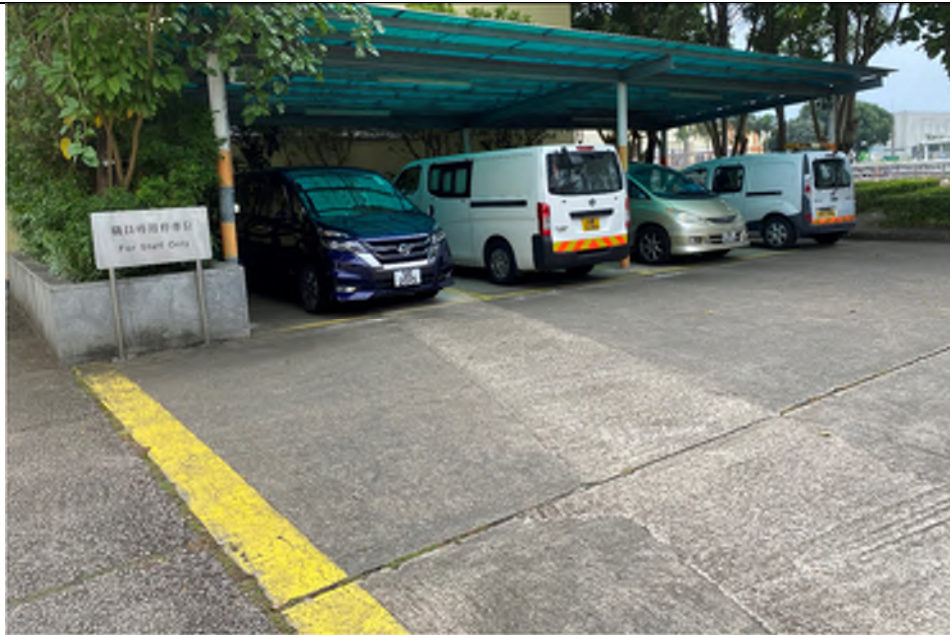
Photo WP-8: Staff Car Park - The car park is located on concrete paved floor, shelter is built for protecting workers and their vehicles from weather. No oil stain / leakage is observed in the area of the car park.

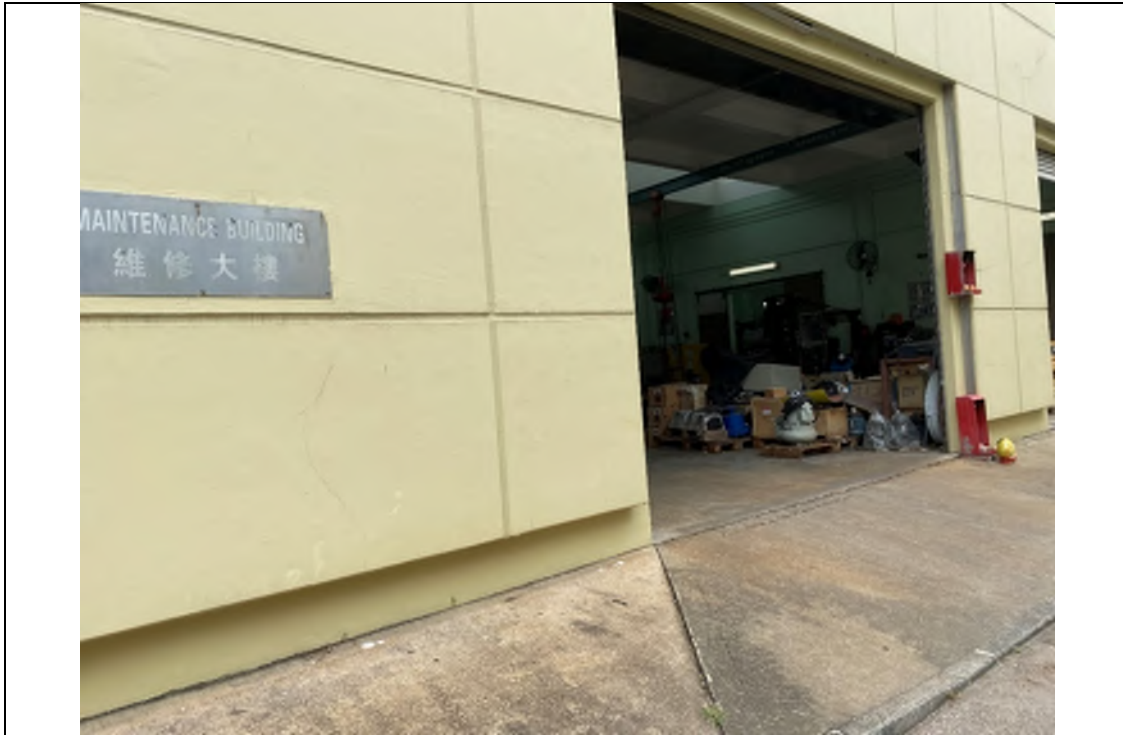
Photo WP-9: Maintenance Building (External View) – The building is located on concrete paved floor, stain caused by weathering can be observed. No oil stain / leakage is observed.

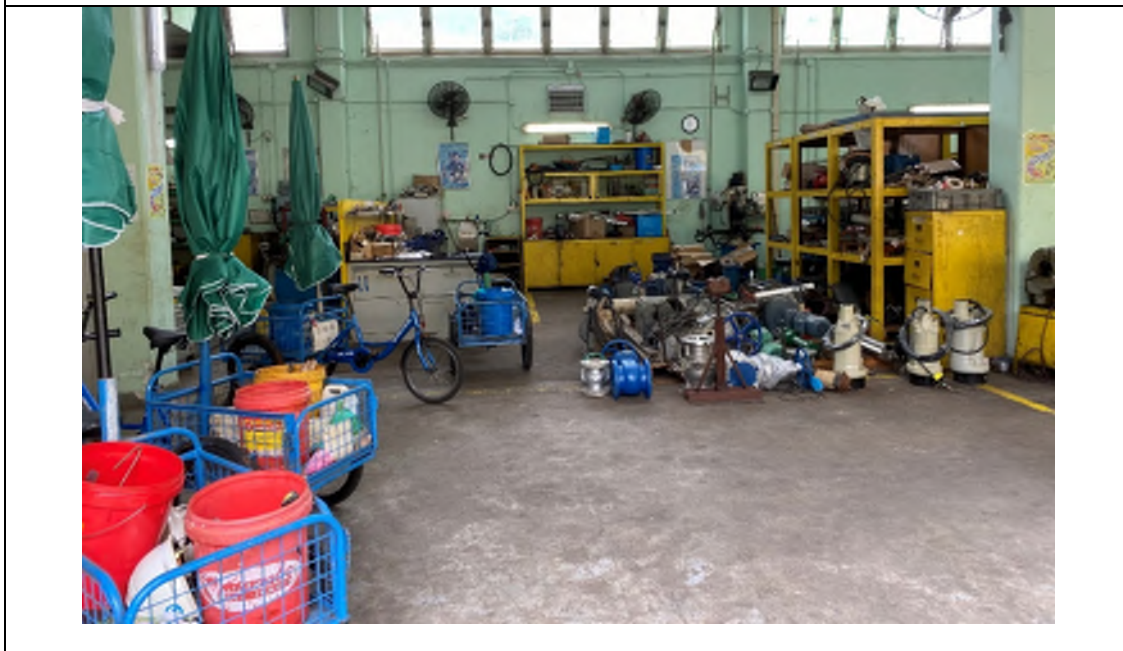
Photo WP-10: Maintenance Building – The floor is paved with concrete, small tools and equipment are placed on racks. Some other equipment was placed on the floor, there are some bicycle carrying cleaning tools parked here. No oil stain / leakage is observed.

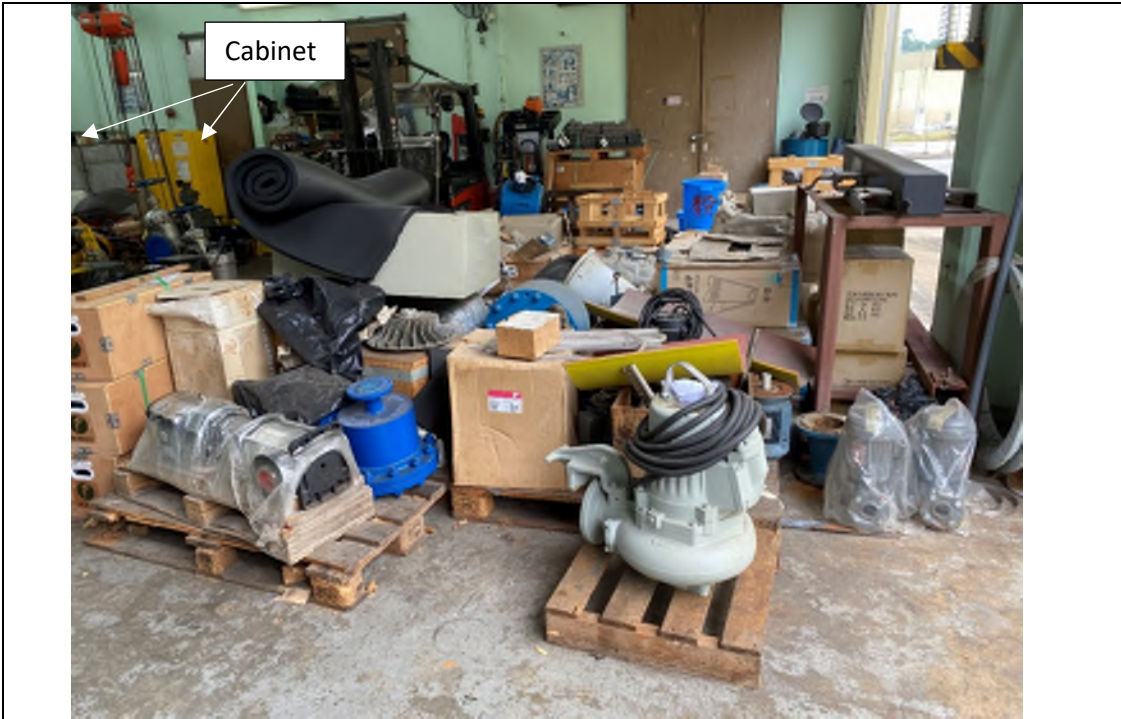
Photo WP-11: Maintenance Building – The floor is paved with concrete, no oil stain / leakage is observed. Equipment were located on wooden panel, some equipment were placed on the floor. Some unpacked paper boxes were placed here for storage.

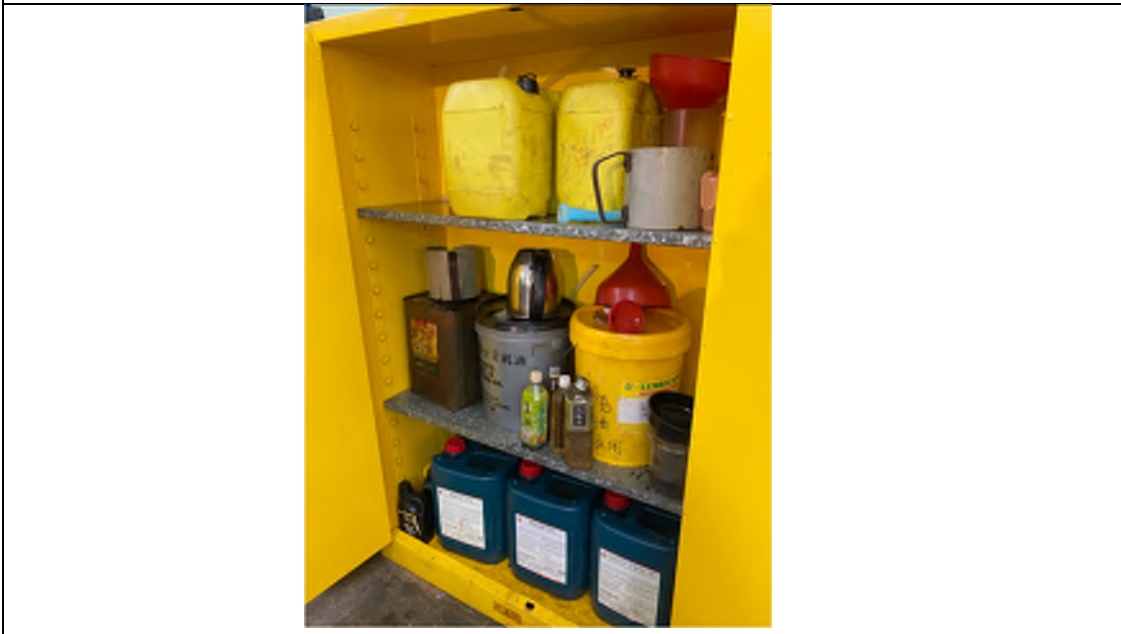
Photo WP-11a: Cabinet No.1 – About 6 buckets of Lubricant Oil, 1 bucket of Cutting Oil and 3 bottles of waste oil are stored inside the Cabinet No.1, the condition of the cabinet is fair and is located on concrete paved floor. No leakage or spillage was observed, and no oil stain was observed.

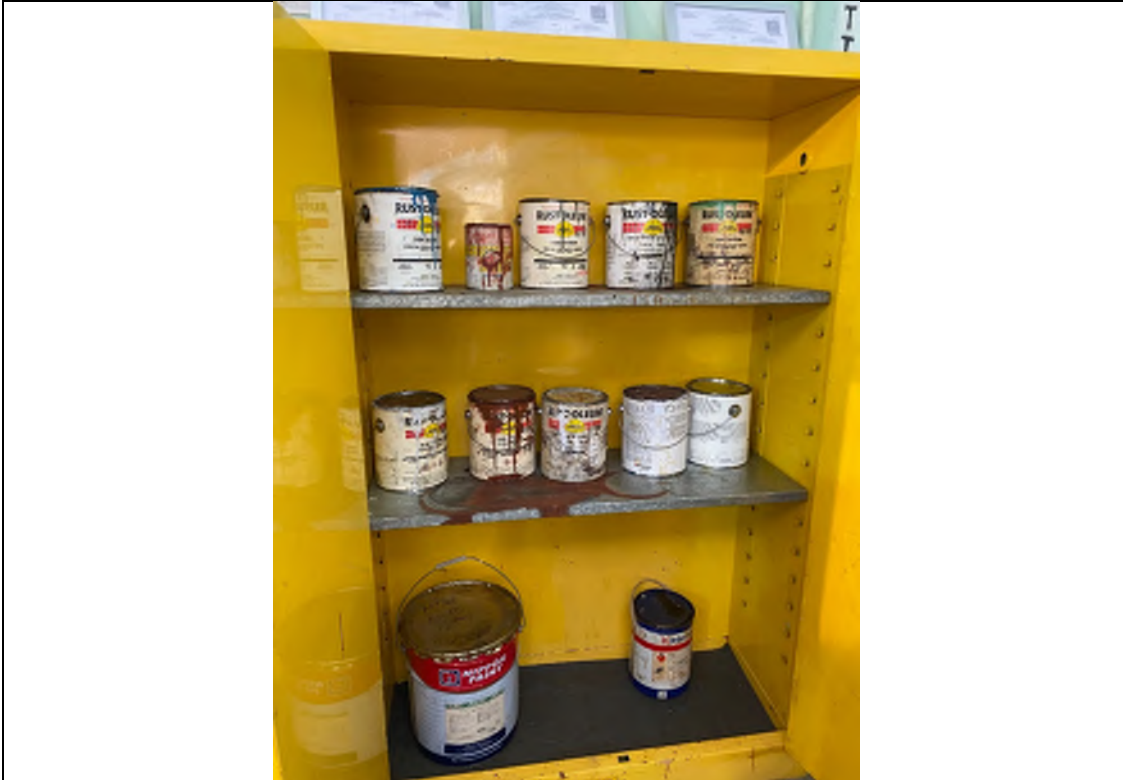
Photo WP-11b: Cabinet No.2 – Paint (about 12 cans of Paint) are stored inside the Cabinet No.2, the condition of the cabinet is fair and is located on concrete paved floor. No leakage or spillage was observed, and no oil stain was observed.

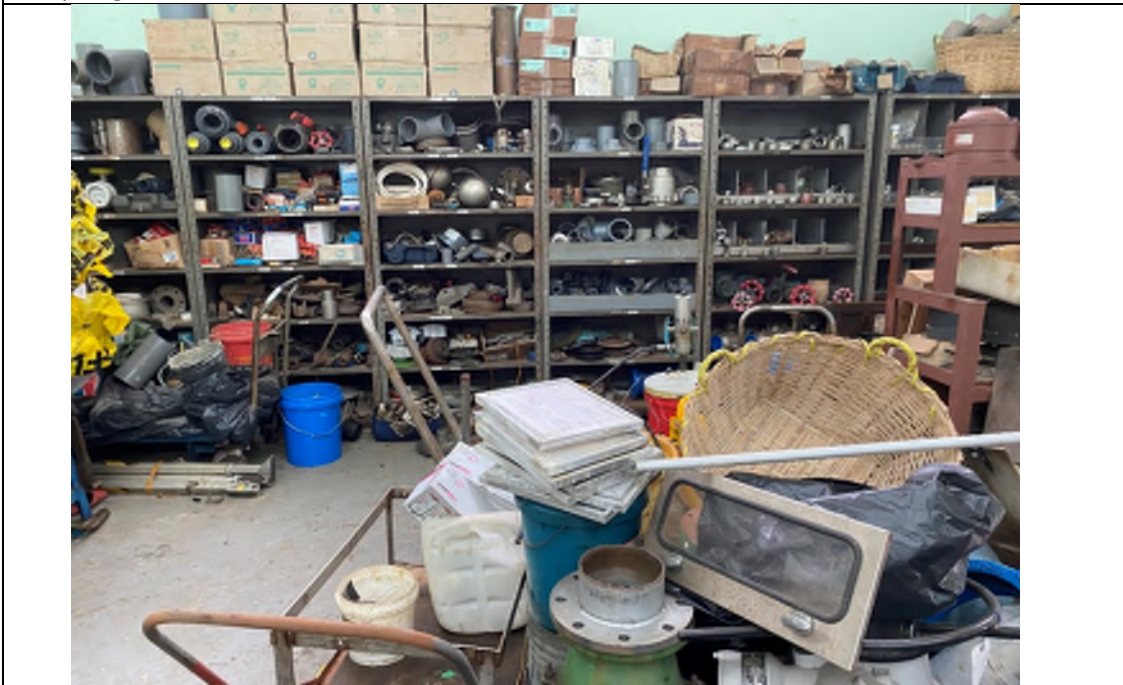
Photo WP-12: Maintenance Building – The floor is paved with concrete, tools and equipment were placed on steel racks in good manner. Some wheelbarrow were used for carrying wasted materials.

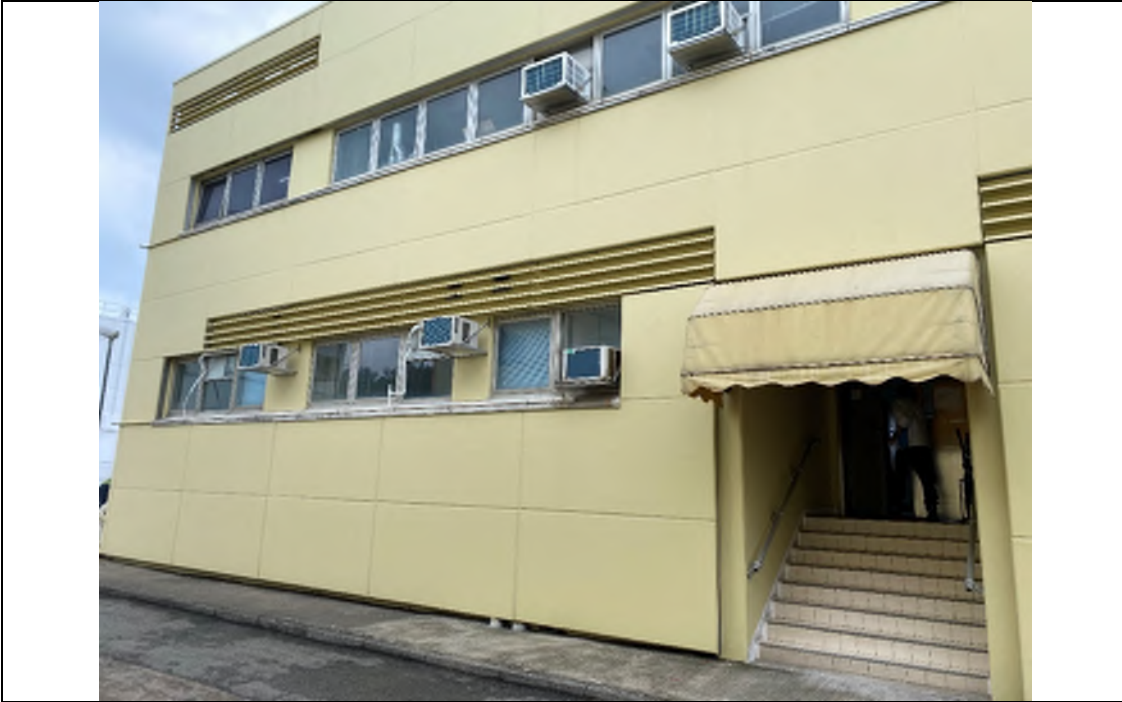
Photo WP-13: Administrative Building (External view) - The building is a two-storey building located on concrete paved floor in good condition. No oil stain/leakage is observed.

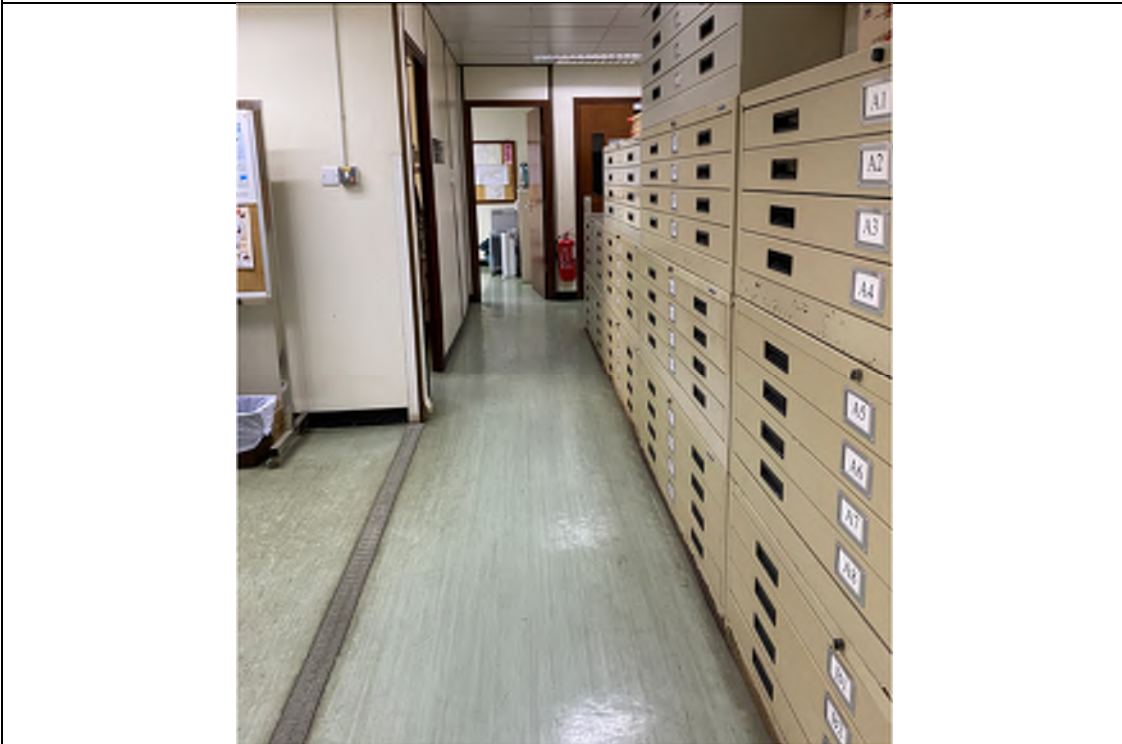
Photo WP-14: Administrative Building (First Floor) - The floor is paved with flooring plate and concrete in good condition floor. This floor is mainly used for office and administration works.No oil stain/ spillage is observed.

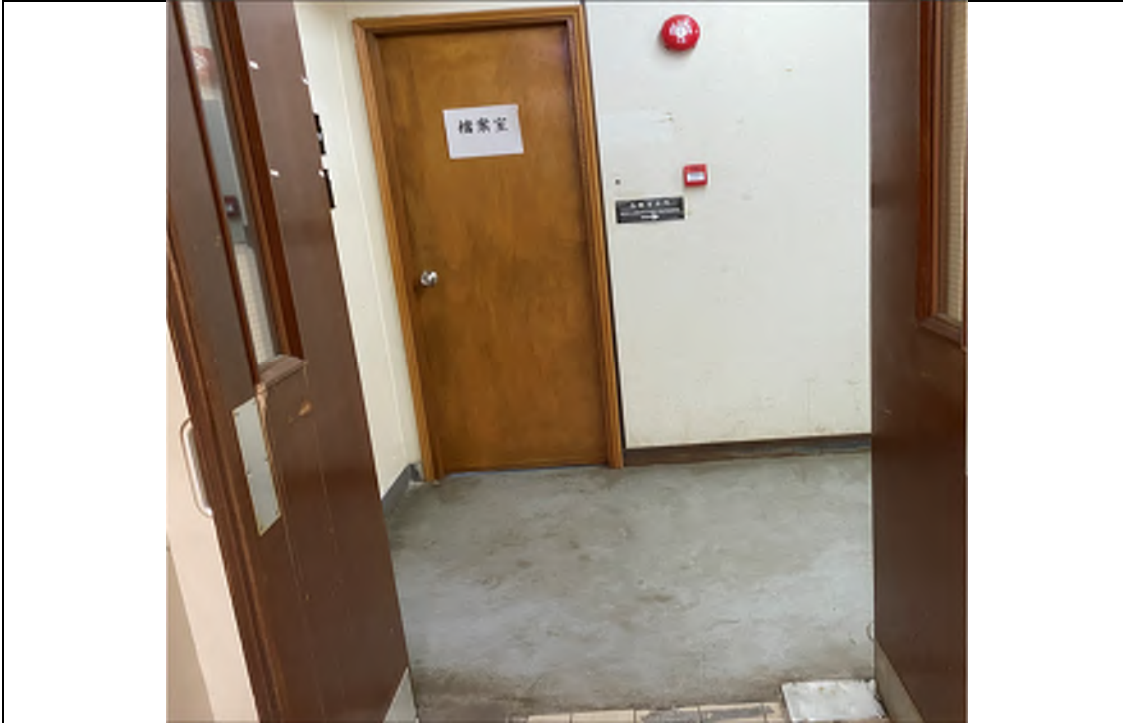
Photo WP-15: Administrative Building (Second Floor) – The Document Room is located on concrete paved floor opposite to the laboratory. No oil stain/ leakage is observed.

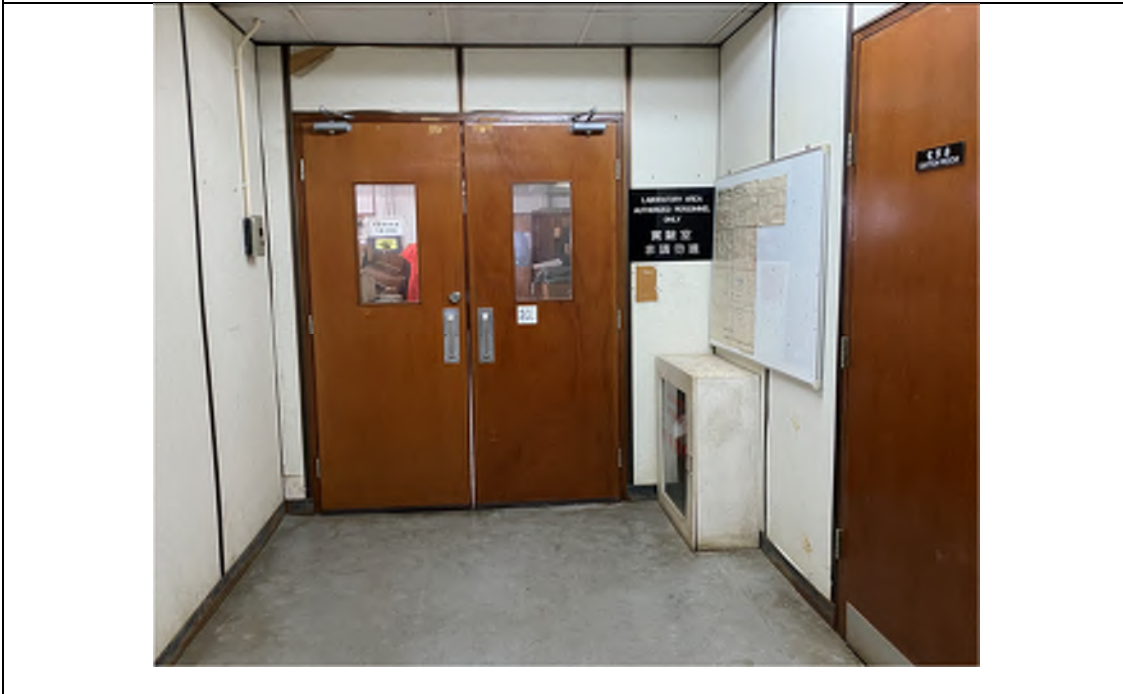
Photo WP-16: Administrative Building (Second Floor) - The Laboratory is located on this floor next to the Switch Room on concrete paved floor in good condition

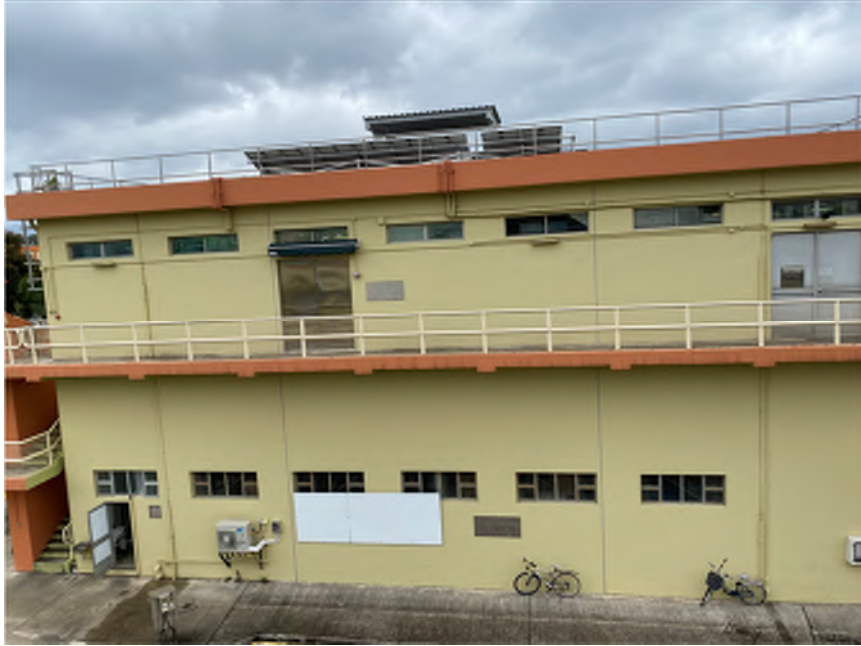
Photo WP-17: Control and Storage House (External View) – It is a two-storey building with the storage room of equipment on the ground floor and the control room on the second floor. The building is located on concrete paved floor, water stain was observed, no oil stain/leakage is observed.

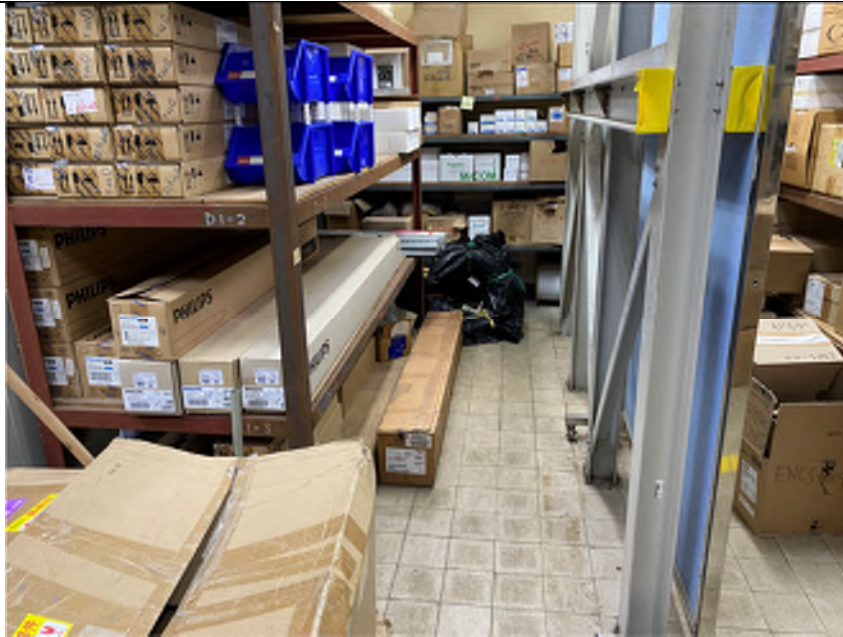
Photo WP-18: Control and Storage House (Storage Room on First Floor) - Most of the equipment are stored on steel racks, some are being put on the floor inside cardboard box. The floor is paved with ceramic tile and concrete. No damage/ broken parts is observed, and no oil stain/leakage is observed.

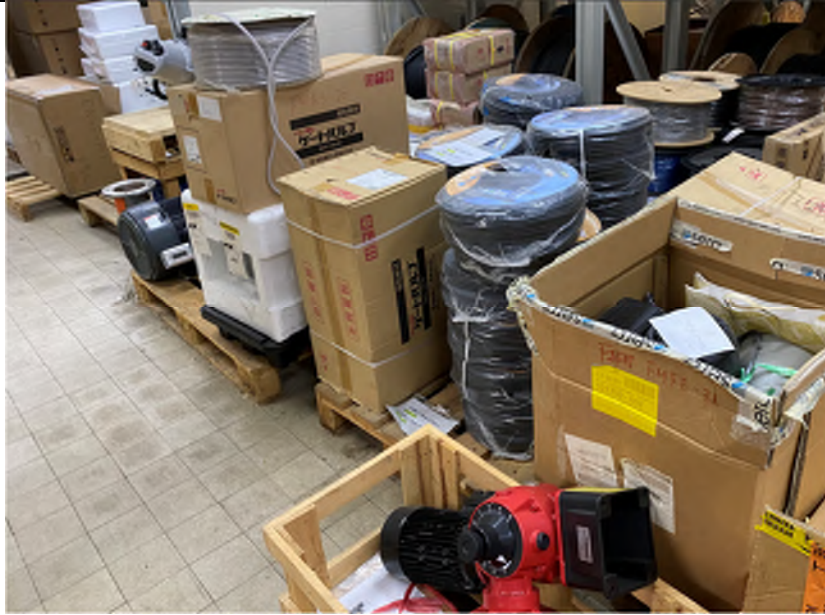
Photo WP-19: Control and Storage House (Storage Room on First Floor) - Equipment (electronic wire) was being put on wooden panel or wooden box. The floor is paved with ceramic tile and concrete in good condition. No oil stain/leakage is observed.

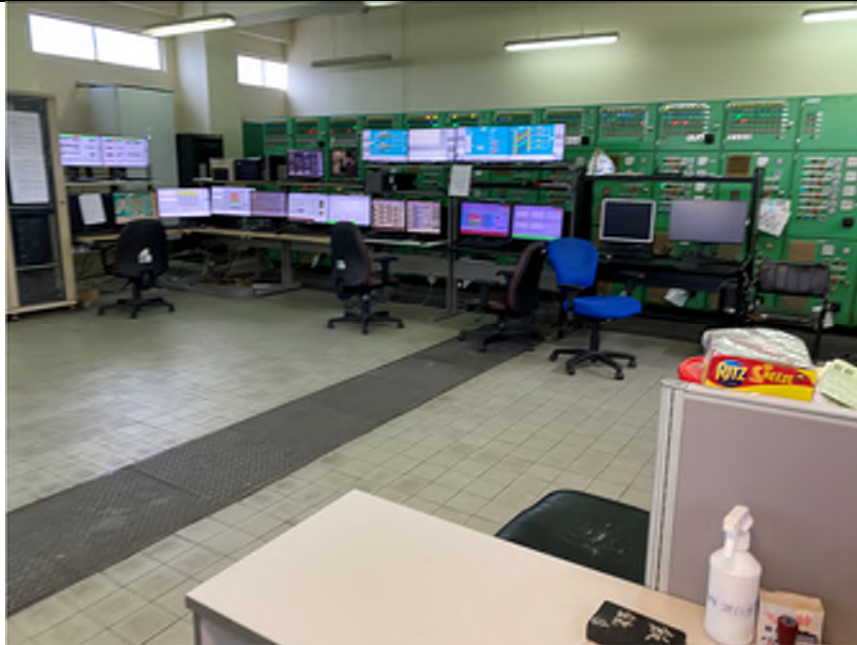
Photo WP-20: Control and Storage House (Control Room with Control Panels on Second Floor) - The floor is paved with ceramic tile and concrete in good condition. No oil stain/leakage is observed.

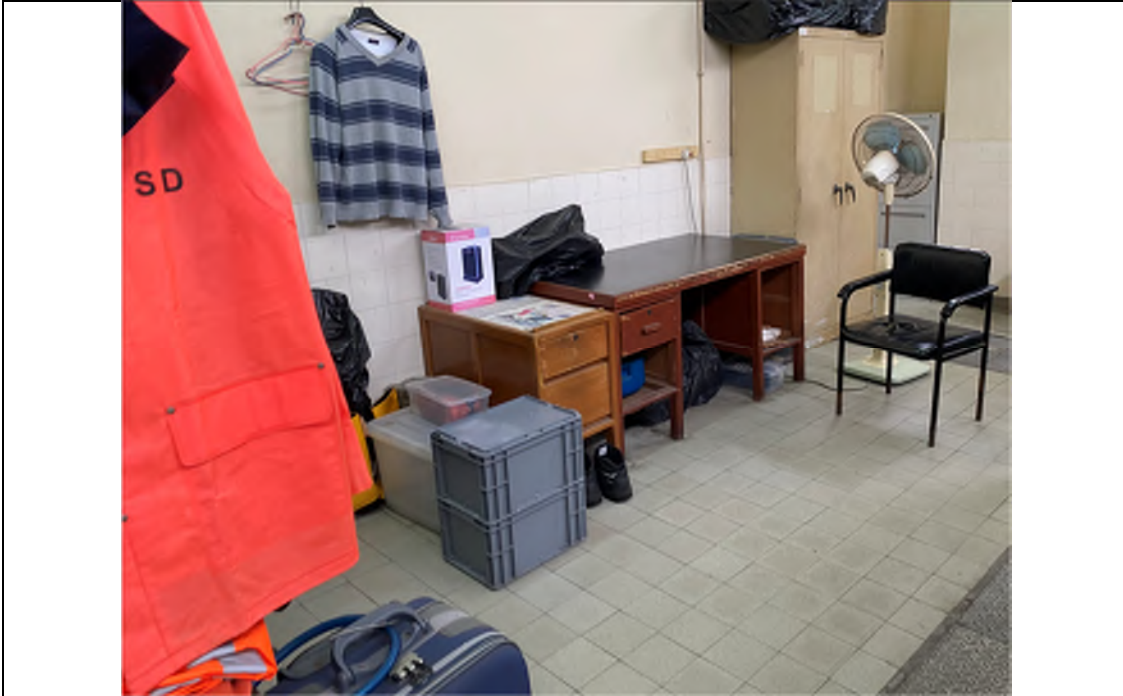
Photo WP-21: Control and Storage House (Staff Room on Second Floor) – It is next to the Control Room. The floor is paved with ceramic tile and concrete in good condition. No oil stain/leakage is observed.

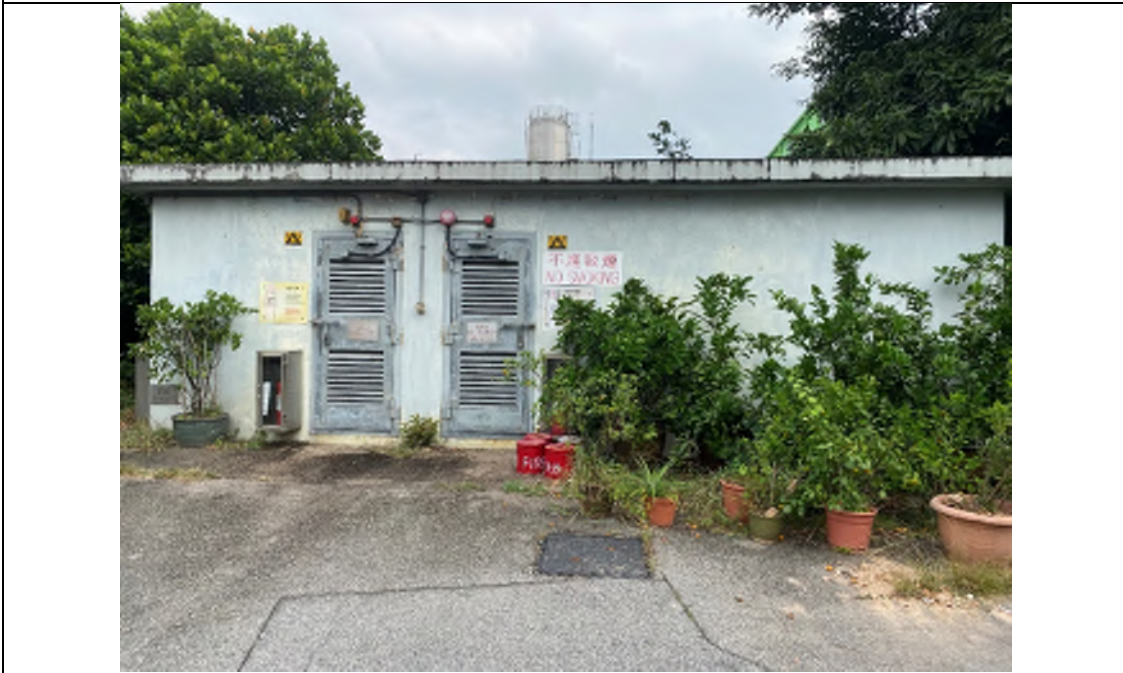
Photo WP-22: Dangerous Goods (DG) Store (External View) - The DG Store is located on concrete paved floor. No oil stain/ leakage is observed.

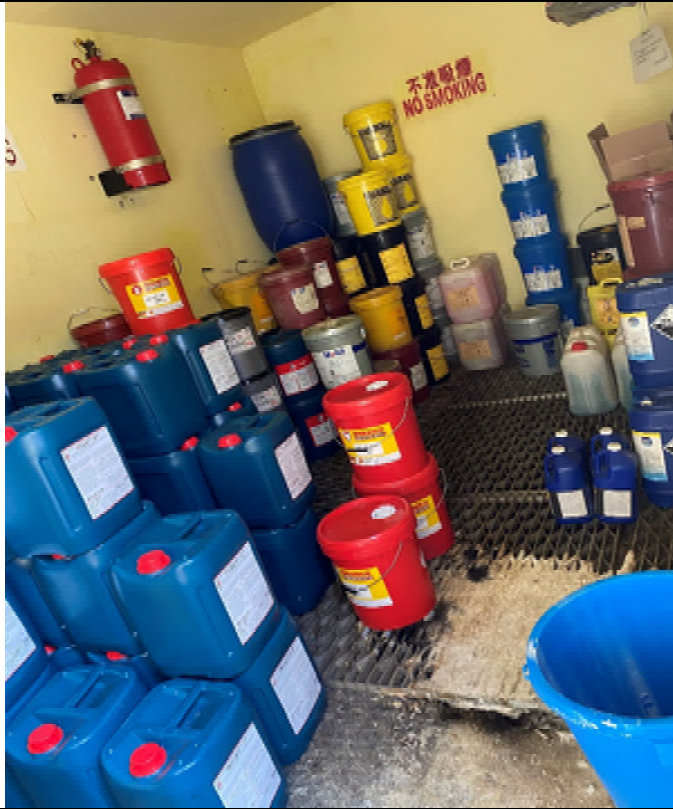
Photo WP-23: Dangerous Goods (DG) Store – The soluble cutting oil, hydraulic oil, lubricant oil, gear oil were stored inside the DG store. DG were located on steel panel and concrete paved floor. No oil stain/ leakage is observed.

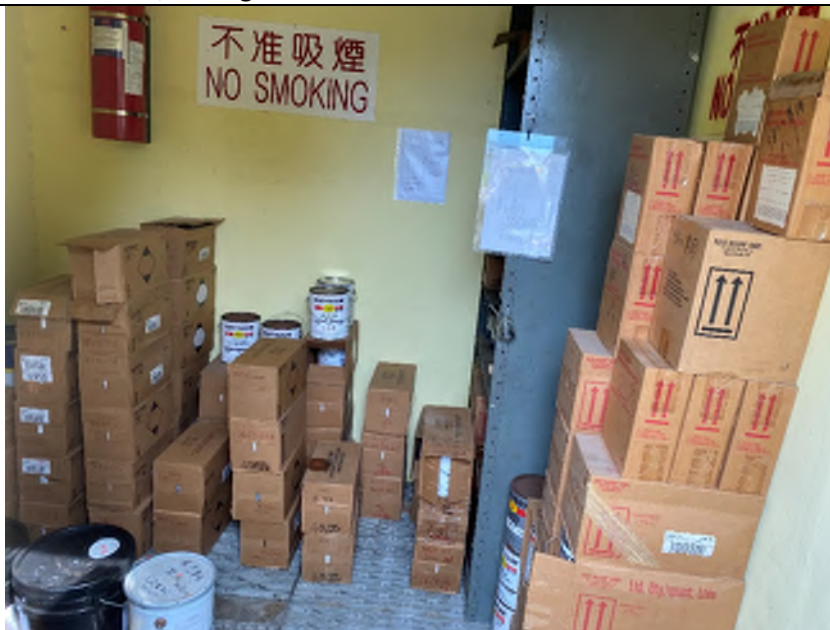
Photo WP-24: Dangerous Goods (DG) Store – Paint were stored inside the DG Store. Some paint were placed on the steel panel inside the container and the cardboard box; Some were stored inside the steel rack. No oil stain/leakage is observed.

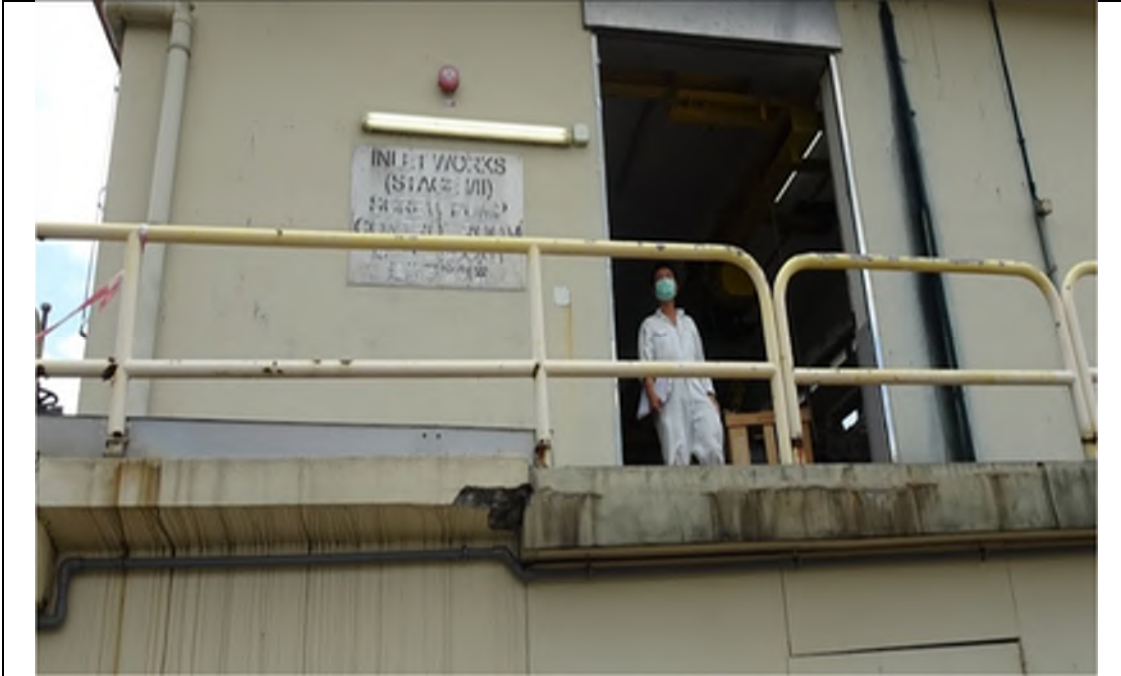
Photo WP-25: Inlet Pumping Station of West Plant (Screw Pump Control Room) – No oil stain / floor leakage observed.

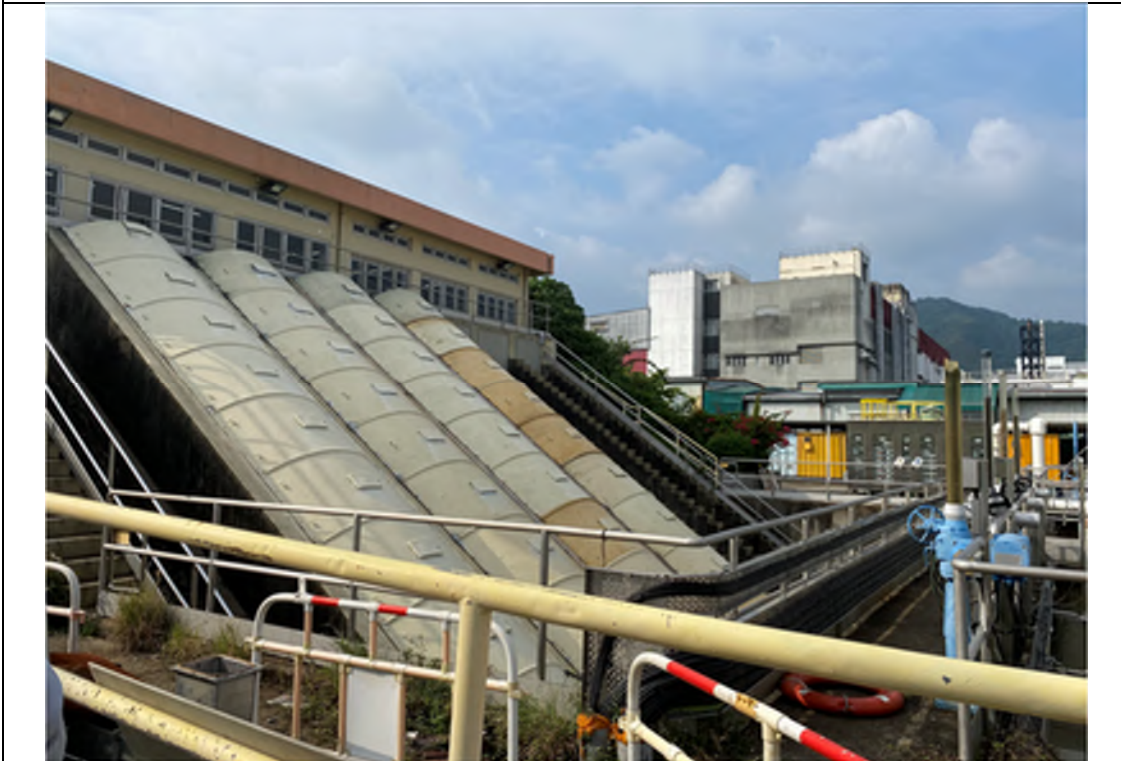
Photo WP-26: Inlet Pumping Station of West Plant (External view of Screw Pump) – The Screw Pumps are located on concrete paved floor at 3.4 m above the ground level. All accessible concrete surfaces around the pumps are in good condition with no oil stain observed.

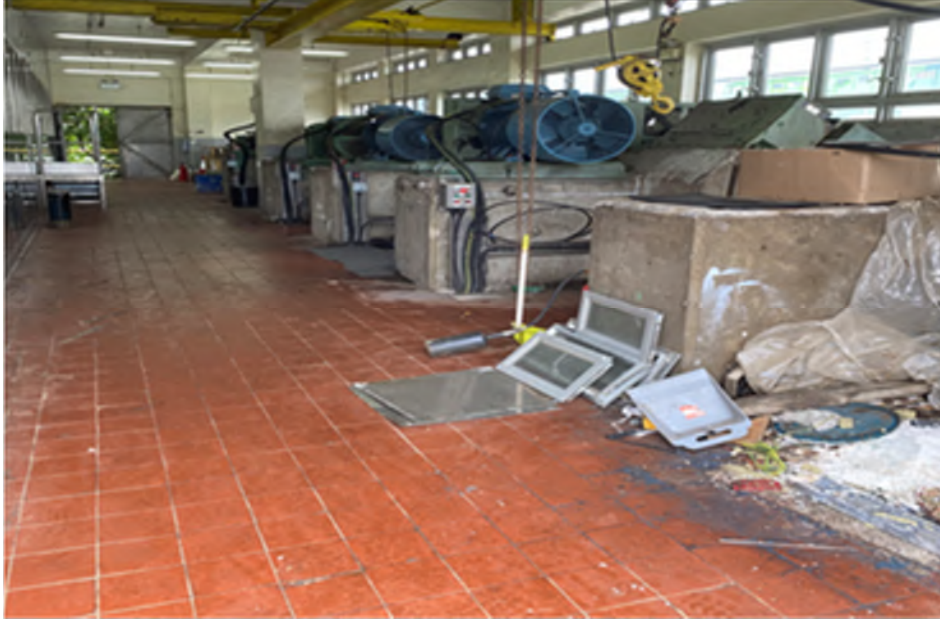
Photo WP-27: Inlet Pumping Station of West Plant (Screw Pump Control Room) – The room floor is located above ground on top of the screw pumps (at +20mPD) and is paved with concrete and ceramic tile, dirty stain and debris is observed, trash and other used materials(e.g. windows) are being placed on the floor at one corner of the room. No oil stain/ leakage is observed.

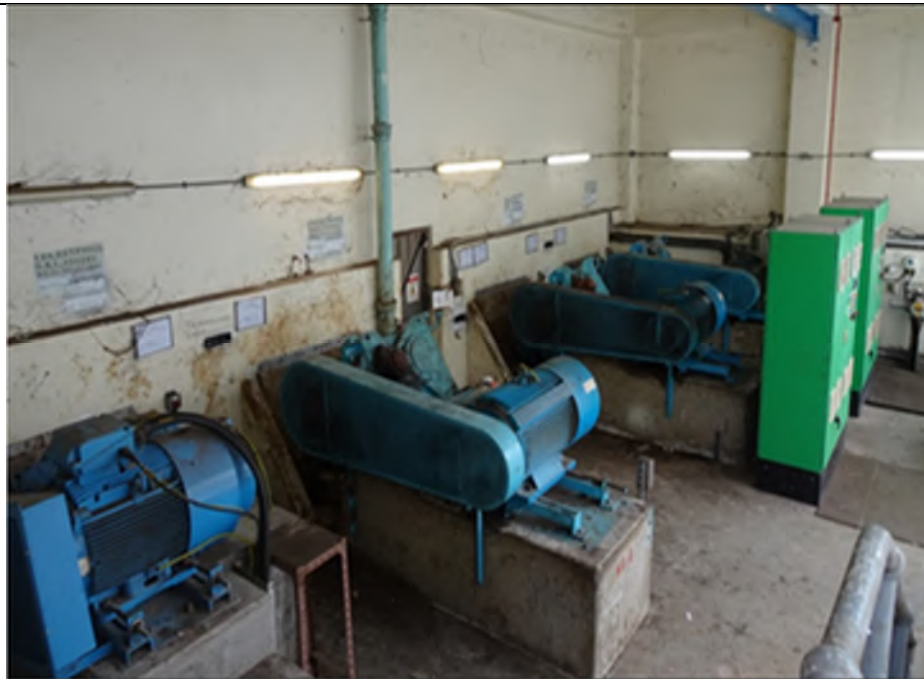
Photo WP-28: Inlet Pumping Station of West Plant (Screw Pump Control Room) – The room floor is located above ground on top of the screw pumps (at +20 mPD) and is paved with concrete, dirty stain and rusty stain is observed. No damage of the pumps and the floor is found. No oil stain/ leakage is observed.

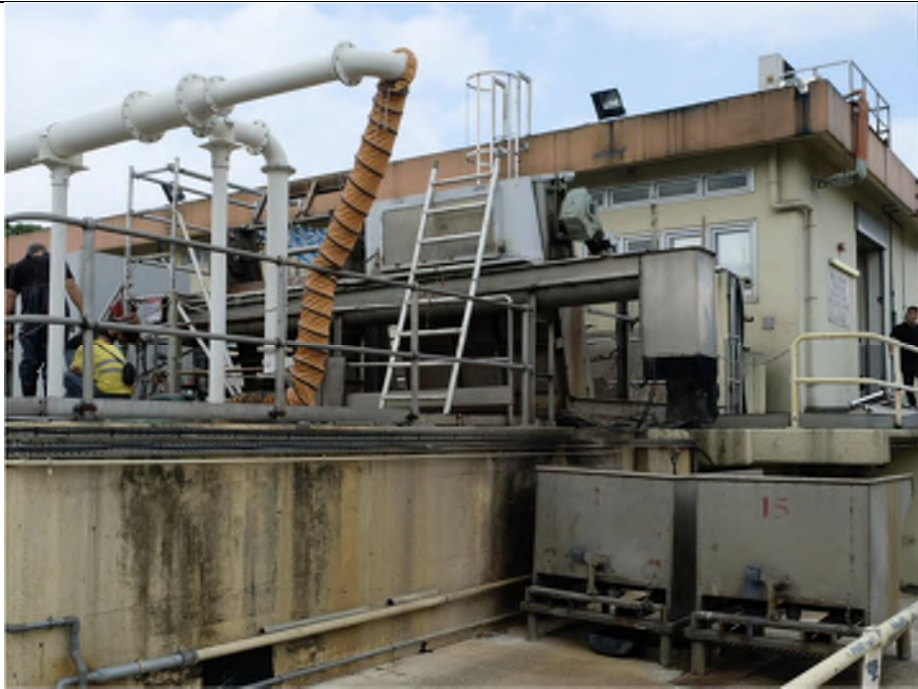
Photo WP-29: Screen House of West Plant – The Outlet of Screen House is located on an elevated concrete paved floor, with no oil stain observed. Water stain caused by handling of sludge is observed.
