CONTAMINATION ASSESSMENT PLAN (FINAL)

Upgrading of Tai Po Sewage Treatment
Works – Investigation

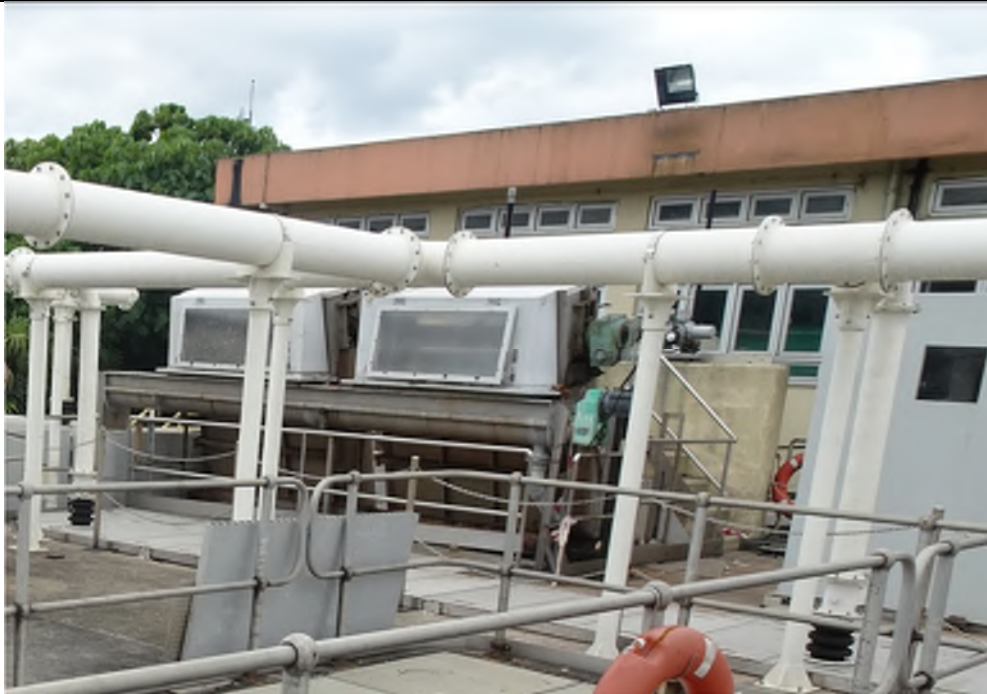
Photo WP-30: Outlet of Screen House (in West Plant) – The floor is paved with concrete in good condition, with no oil stain observed.

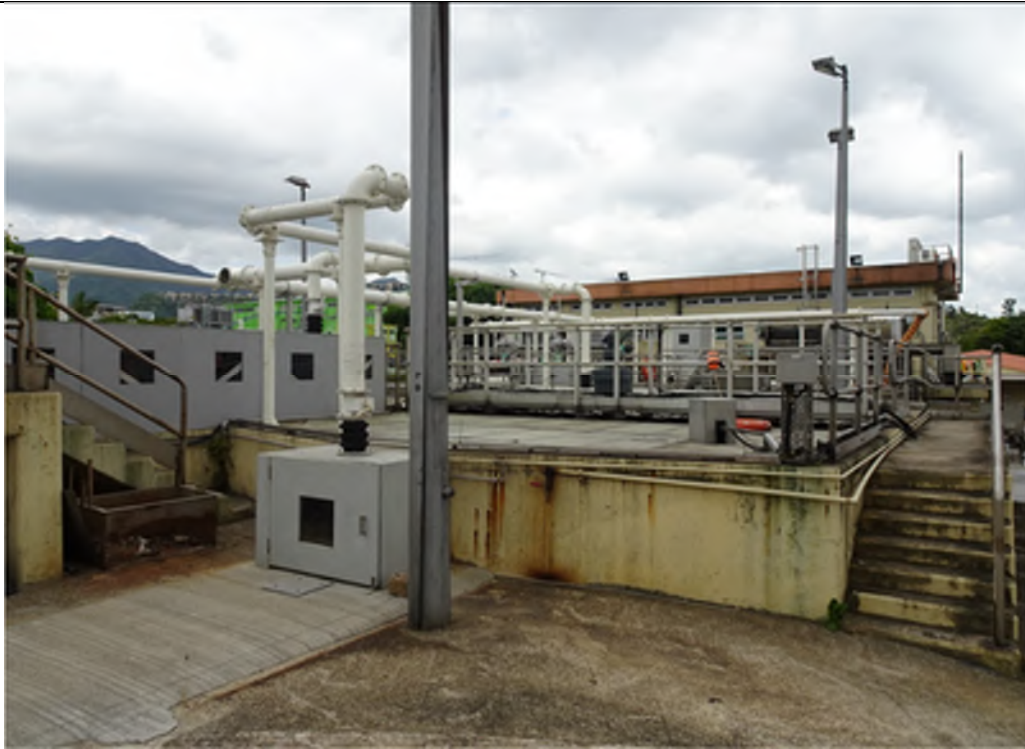
Photo WP-31: Detritors of West Plant– Detritors are located on elevated concrete paved floor next to the Outlet of Screen House with no oil stain observed.

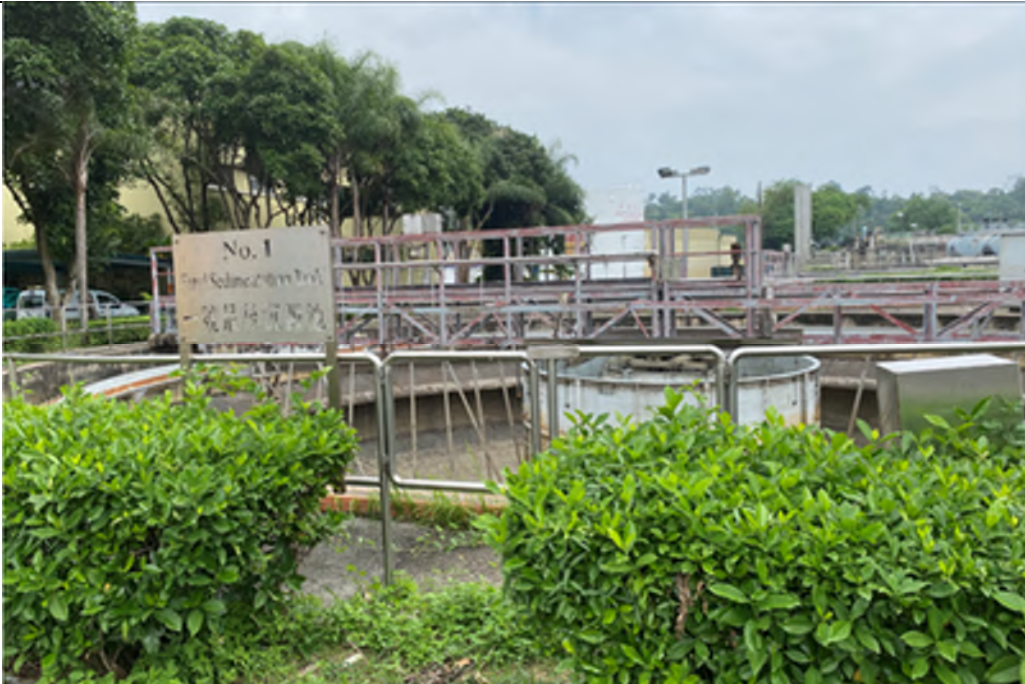
Photo WP-32: Final Sedimentation Tanks of West Plant – The tanks are located on concrete paved floor in good condition with no oil stain/stressed vegetation observed.

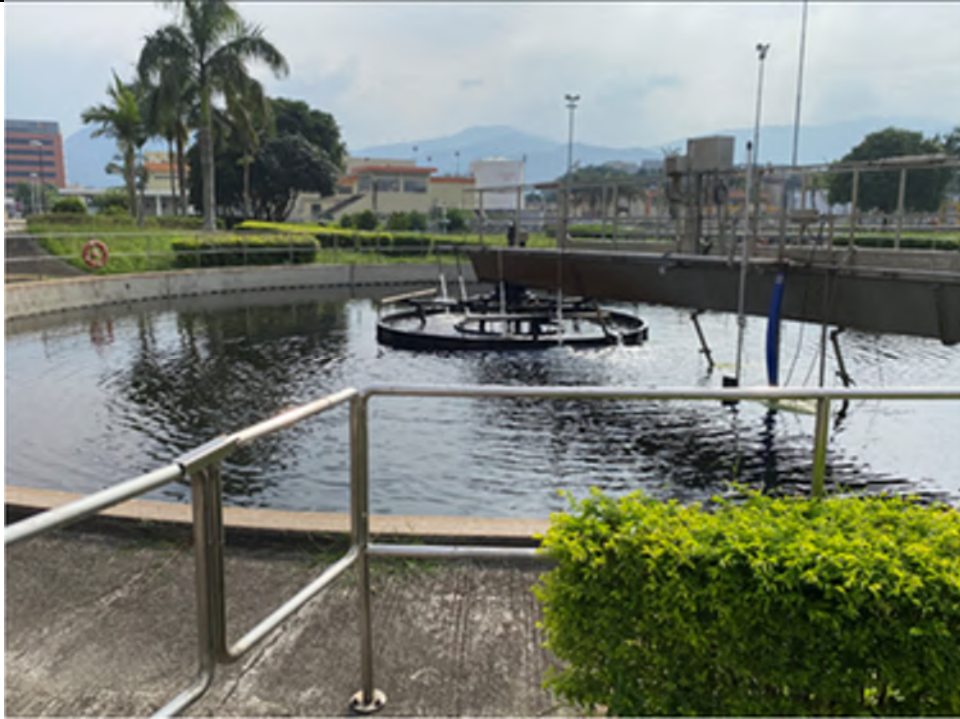
Photo WP-33: Final Sedimentation Tanks of West Plant - The tanks are located on concrete paved floor in good condition with no oil stain/stressed vegetation observed.

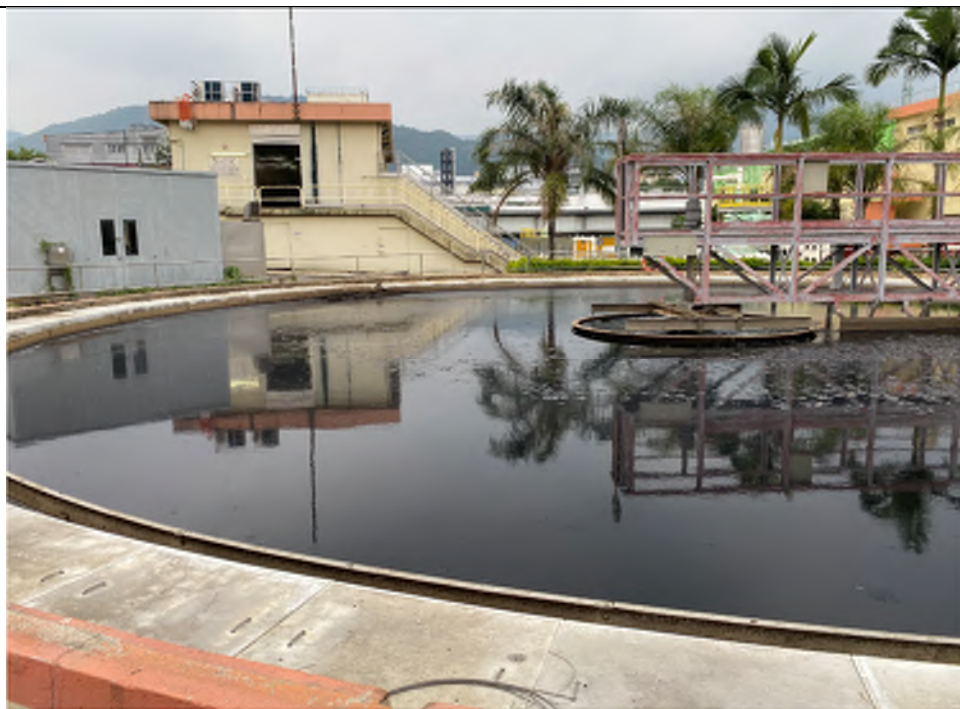
Photo WP-34: Primary Sedimentation Tanks of West Plant - The tanks are located on concrete paved floor in good condition with no oil stain/stressed vegetation observed.

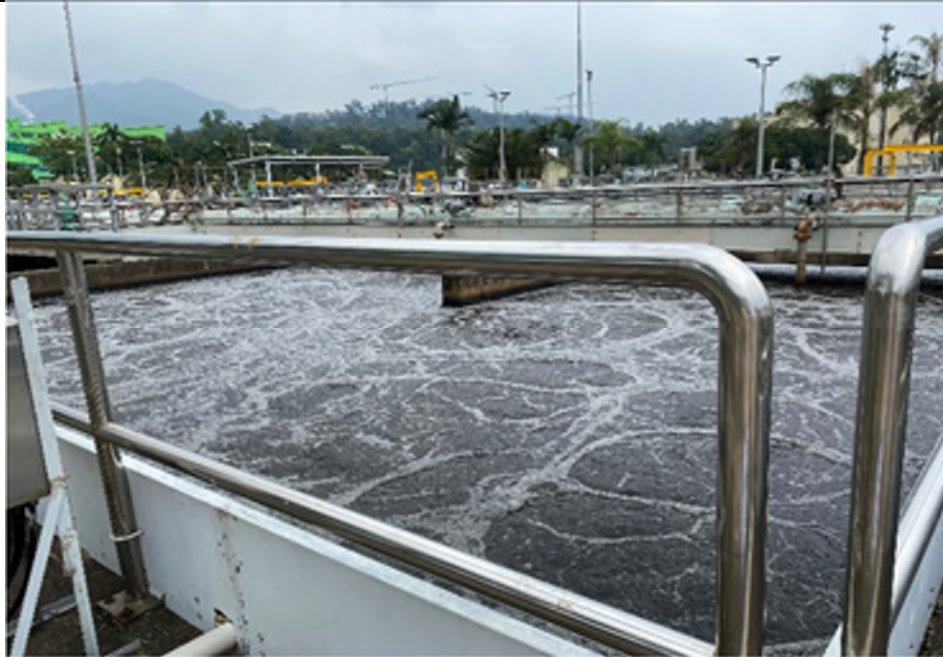
Photo WP-35: Aeration Tanks of West Plant – The tanks are located on concrete paved floor in good condition with no oil stain/stressed vegetation observed.

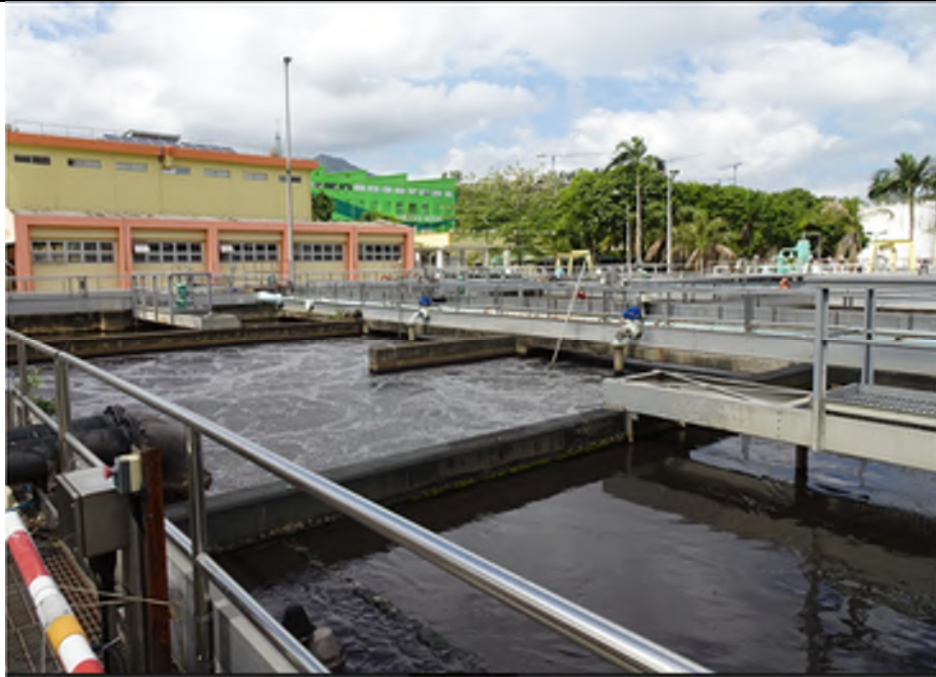
Photo WP-36: Aeration Tanks of West Plant - The tanks are located on concrete paved floor in good condition with no oil stain/stressed vegetation observed.

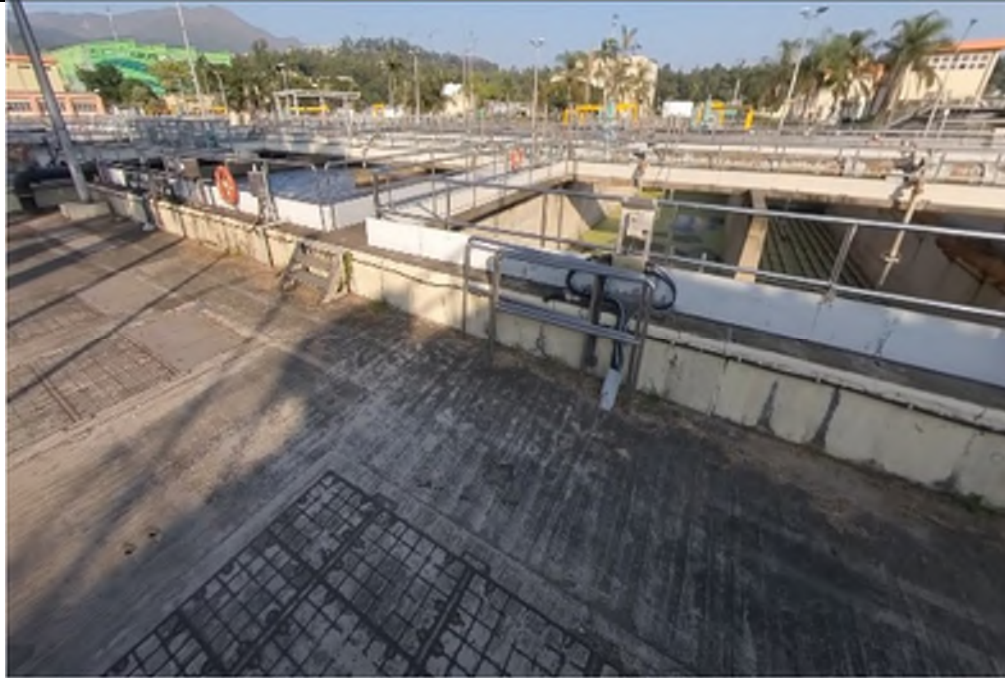
Photo WP-37: Aeration Tanks of West Plant - The tanks are located on concrete paved floor in good condition with no oil stain/stressed vegetation observed.

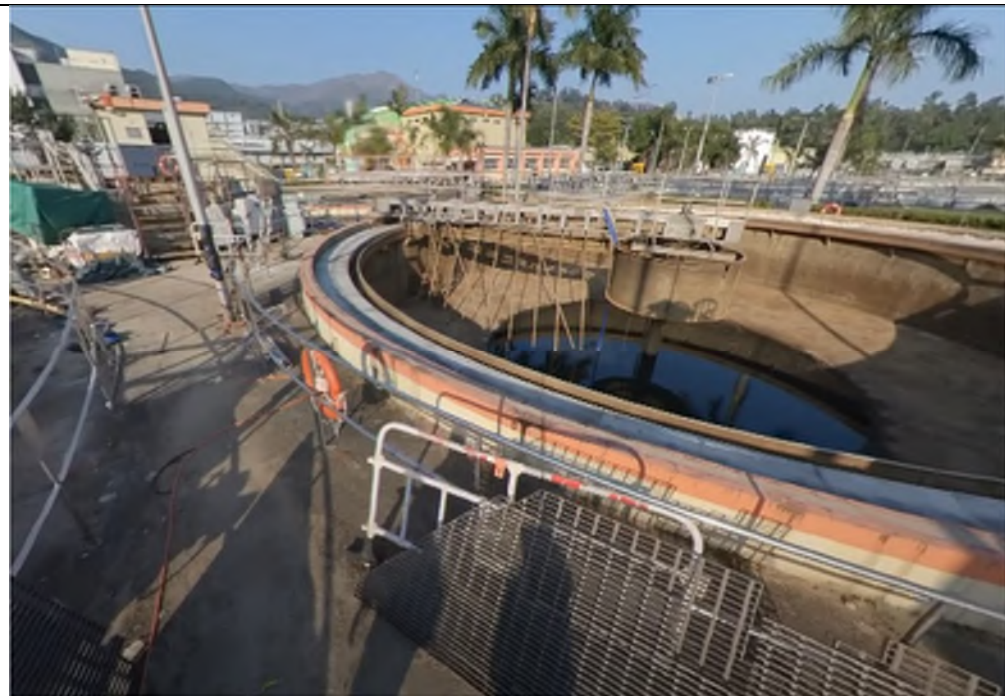
Photo WP-38: Primary Sedimentation Tanks of West Plant – The tanks are located on concrete paved floor in good condition with no oil stain/stressed vegetation observed.

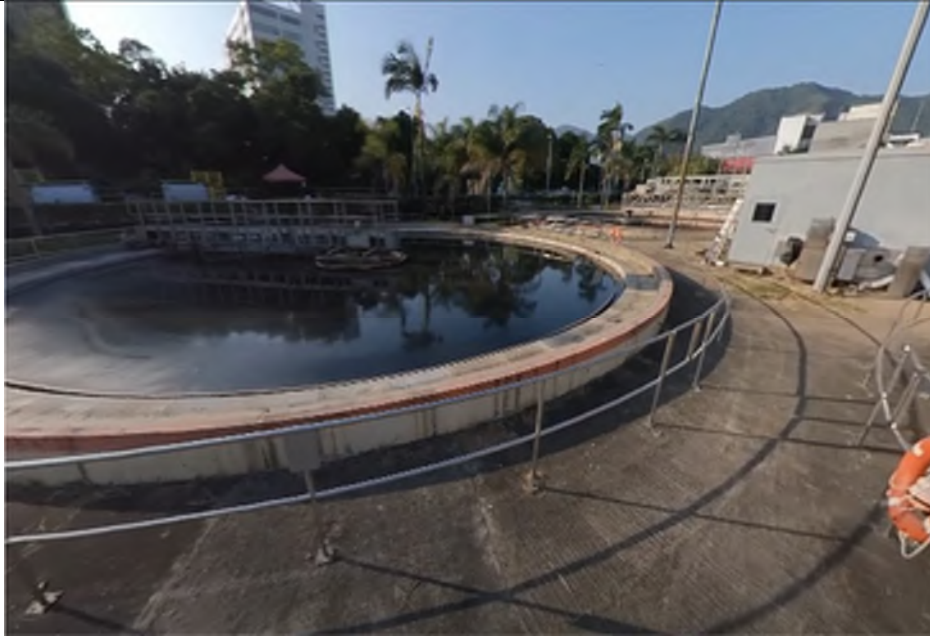
Photo WP-39: Primary Sedimentation Tanks of West Plant - The tanks are located on concrete paved floor in good condition with no oil stain/stressed vegetation observed.

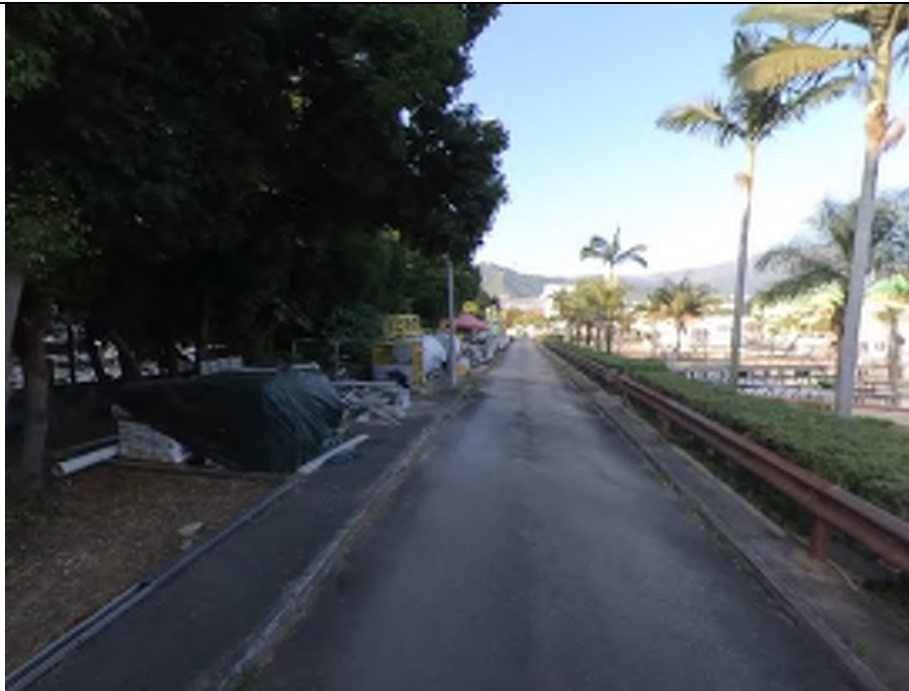
Photo WP-40: Road next to Primary Sedimentation Tanks of West Plant – The road is paved with concrete in good condition with no oil stain observed.

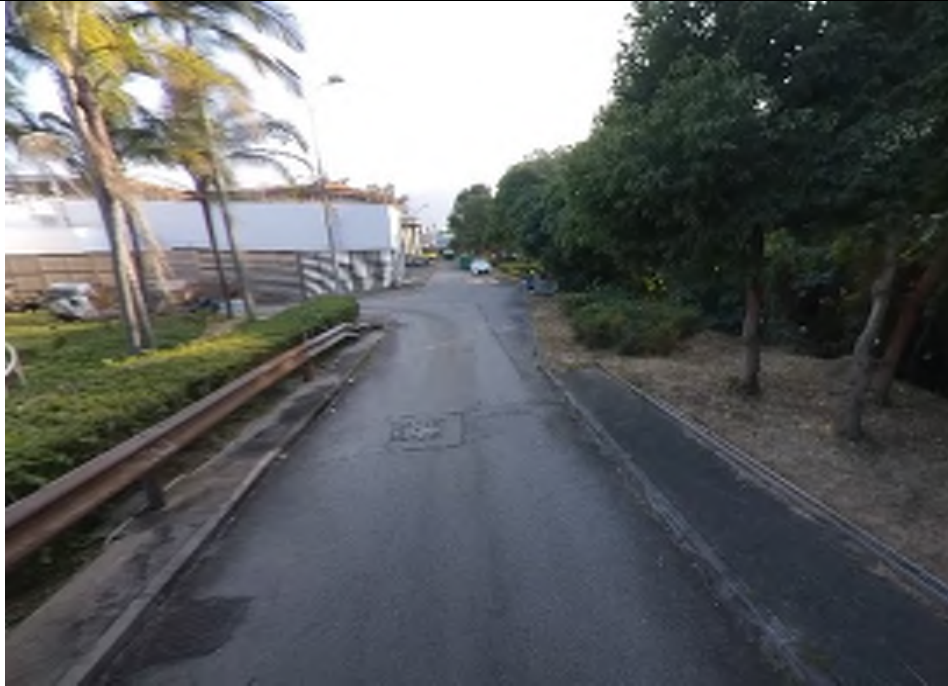
Photo WP-41: Road next to Primary Sedimentation Tanks of West Plant - The road is paved with concrete in good condition with no oil stain observed.

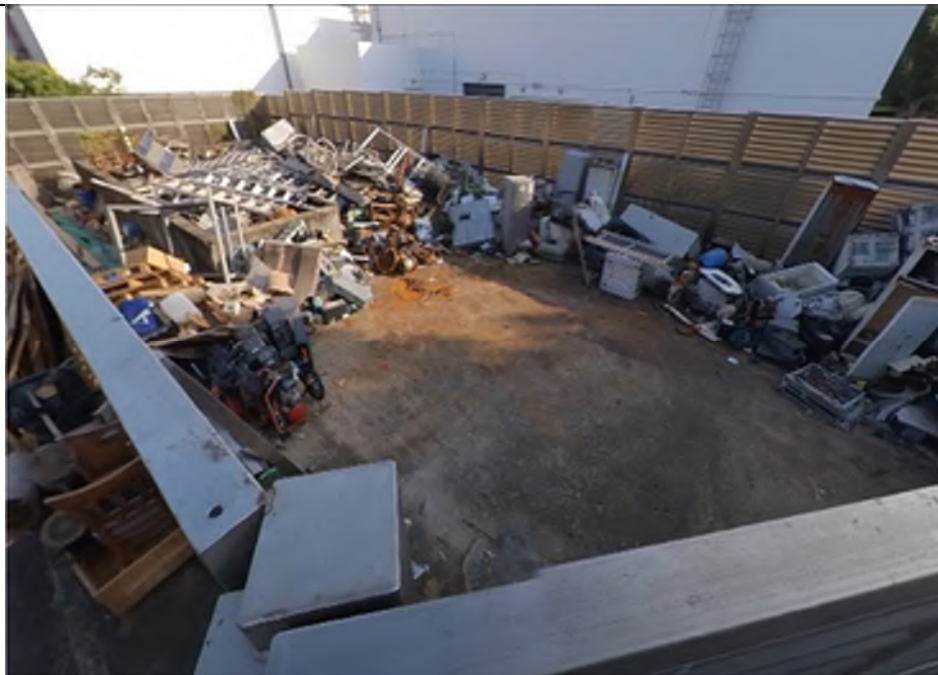
Photo WP-42: Waste Storage – The waste storage area is paved with concrete floor. No oil stain was observed. No chemical storage is allowed in the area. No chemical waste was ever been disposed of in the area since operation of TPSTW.

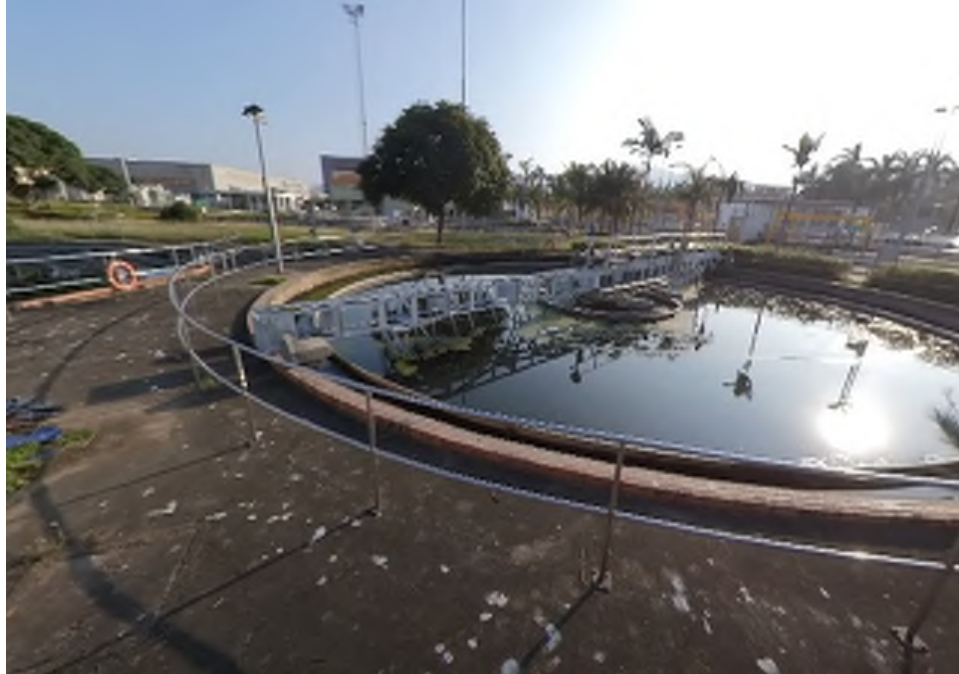
Photo WP-43: Final Sedimentation Tanks of West Plant- The tanks are located on concrete paved floor in good condition with no oil stain/stressed vegetation observed.

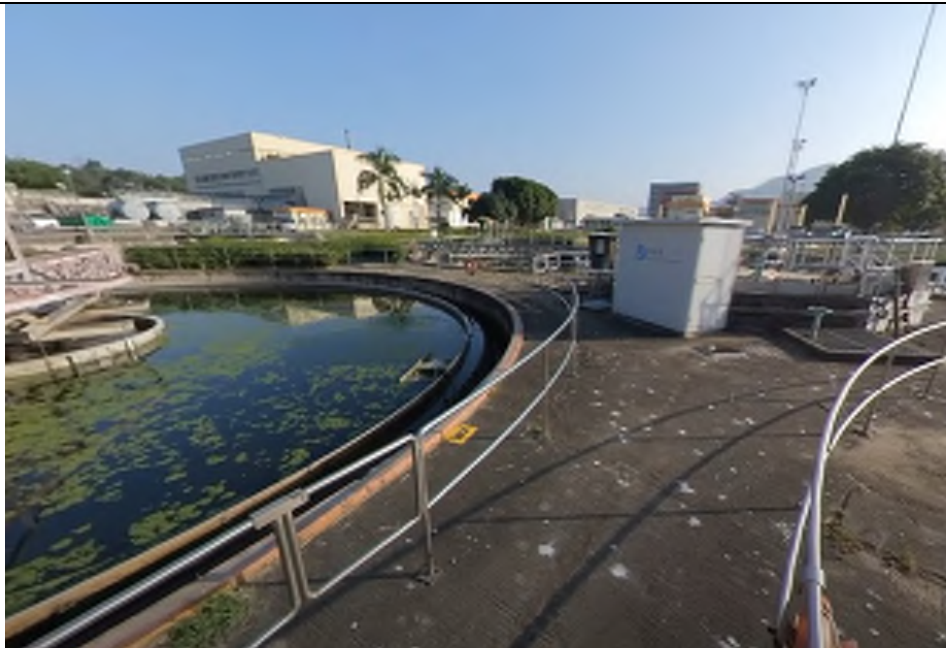
Photo WP-44: Final Sedimentation Tanks of West Plant - The tanks are located on concrete paved floor with no oil stain/stressed vegetation observed.

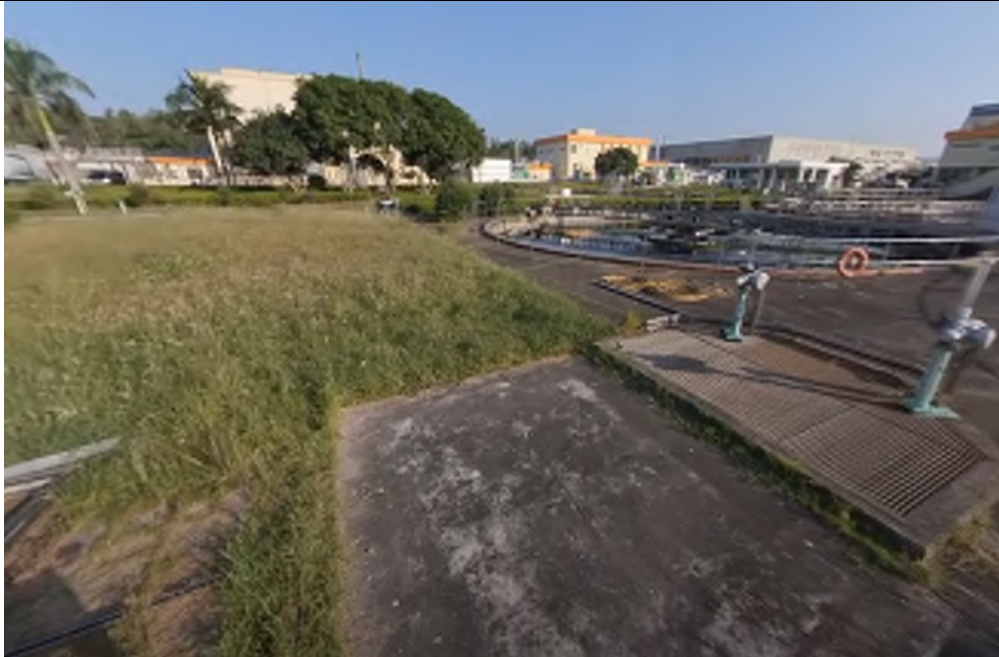
Photo WP-45: Area between Final Sedimentation Tanks in West Plant– The area is paved with concrete floor and vegetation surrounding in good condition, no oil stain/stressed vegetation is observed.

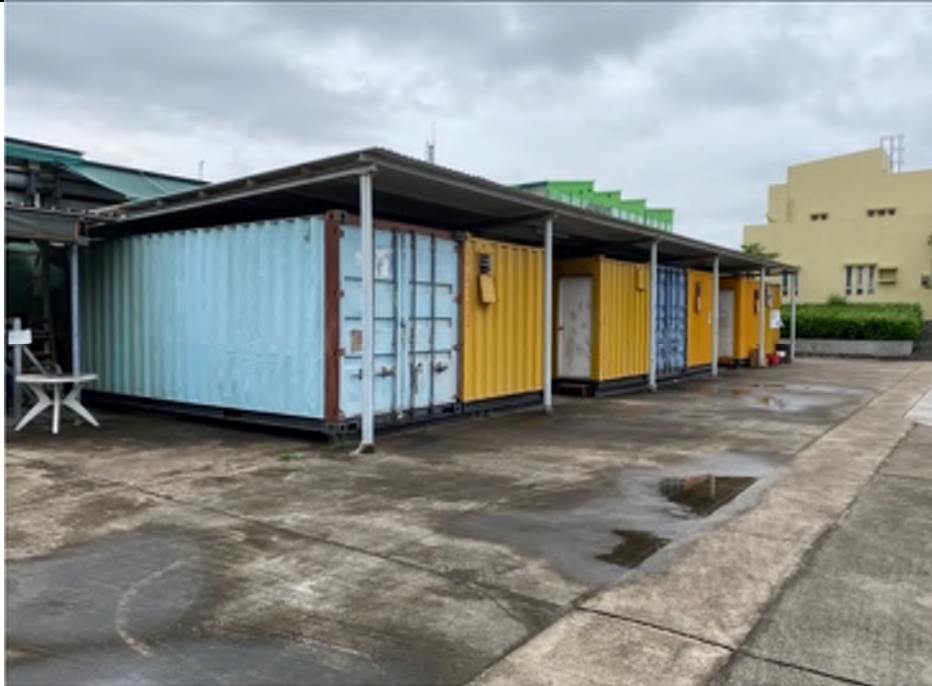
Photo WP-46 : Workshop : The Workshop is located on concrete paved slab with shelters on the top of the workshops area. Water stain is observed due to bad weather, no oil stain/leakage is observed in this location.

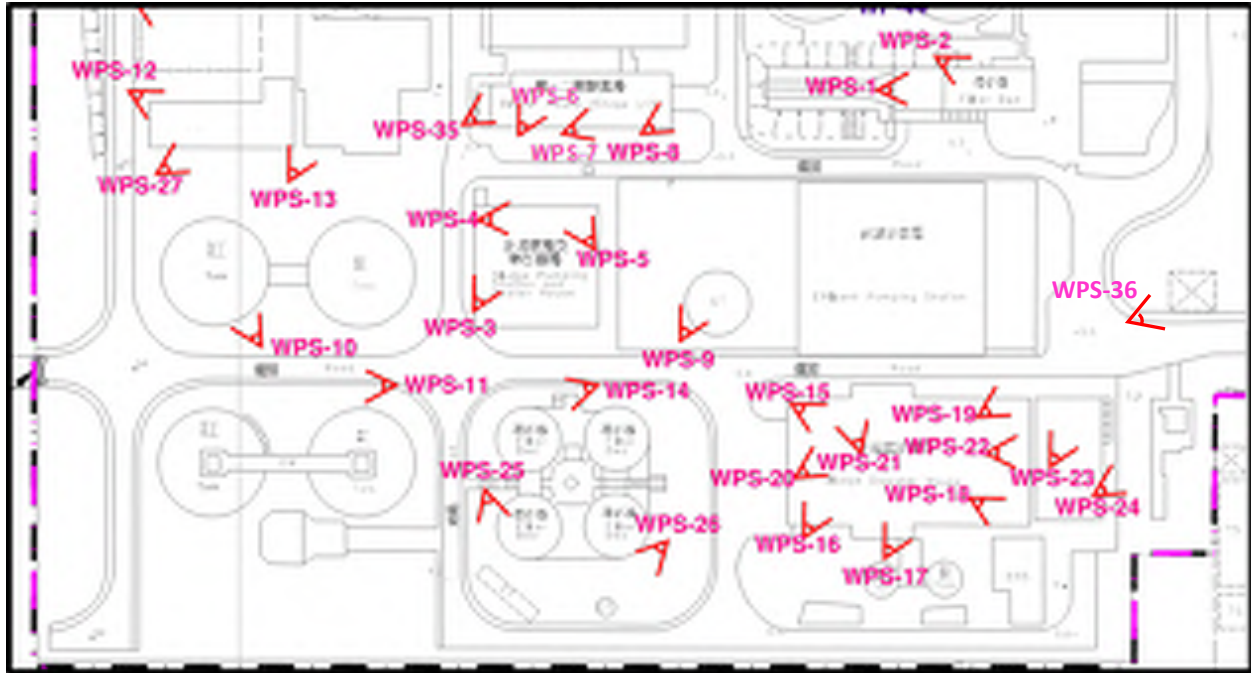
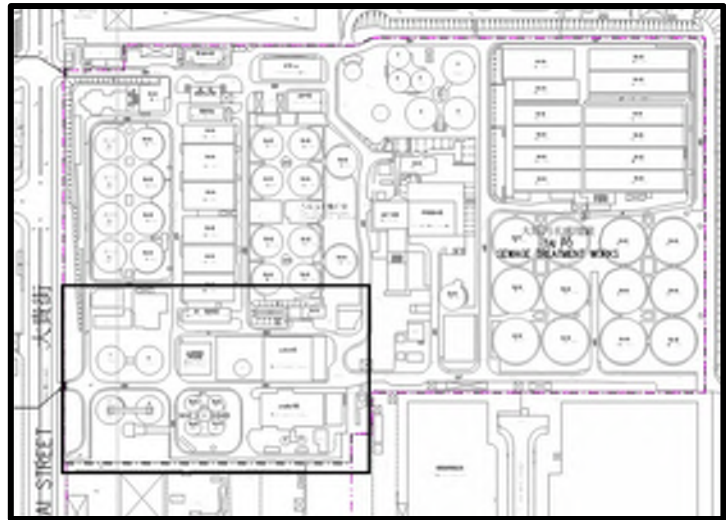
West Plant of TPSTW (Southern Portion) – Index Plan

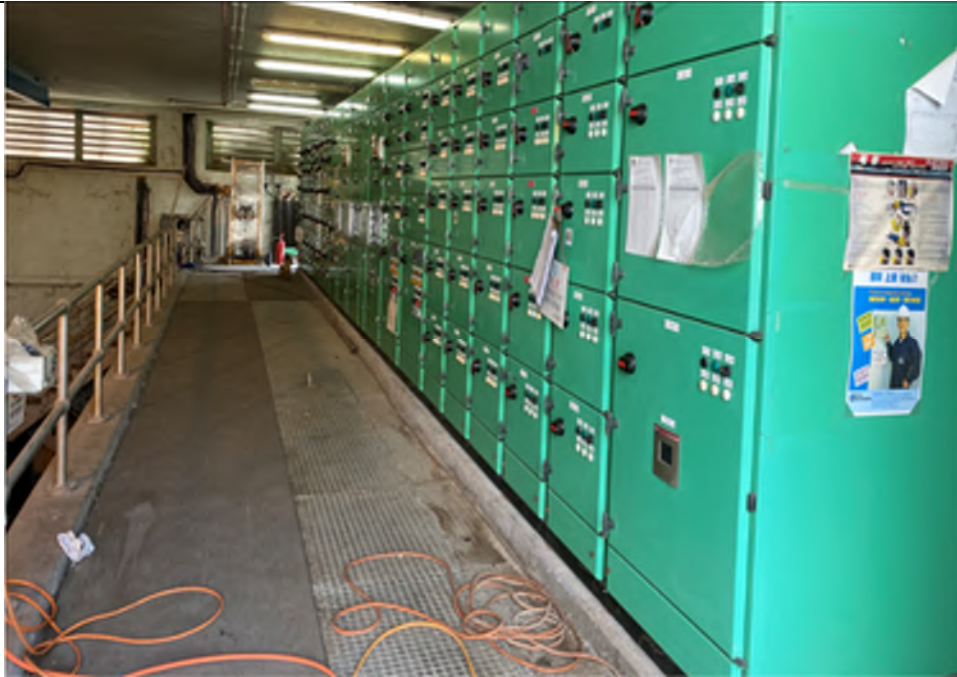
Photo WPS-1: Return Activated Sludge Pumping Station (Control Room) – The Control Panel is located above the basement level of the station, no oil stain is observed.

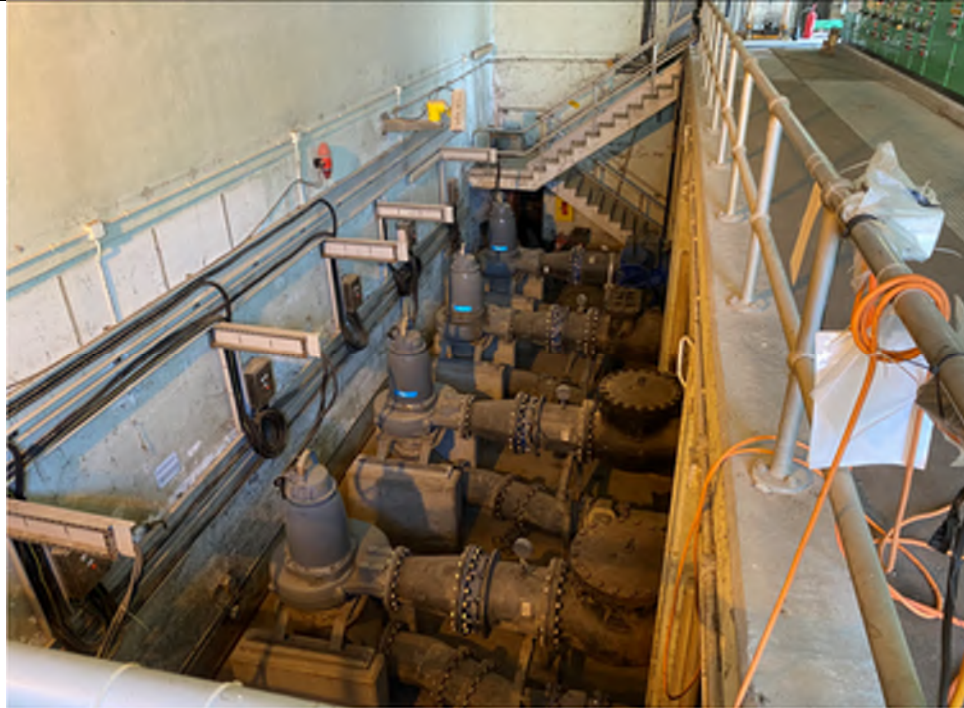
Photo WPS-2: Return Activated Sludge Pumping Station (Below Ground Level) – The Sludge Pumps are located on concrete floor in good condition with no oil stain.

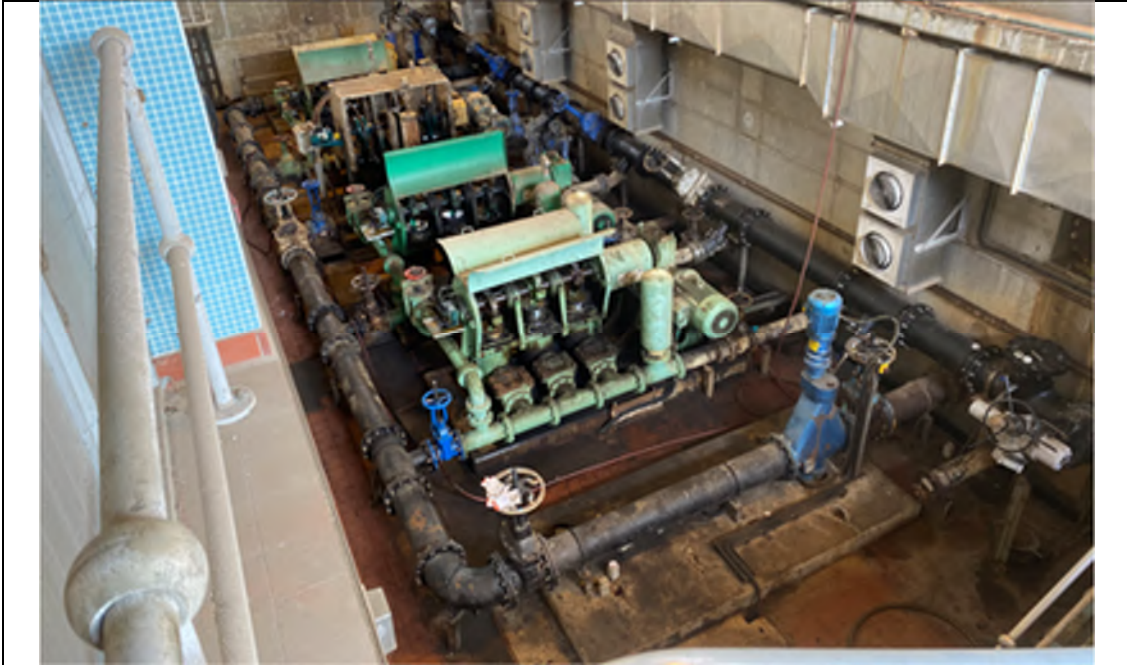
Photo WPS-3: Sludge Pumping Station (Below Ground Level) - The Sludge Pumps are located on concrete floor in good condition with no oil stain. The stains observed were stains of sewage sludge.

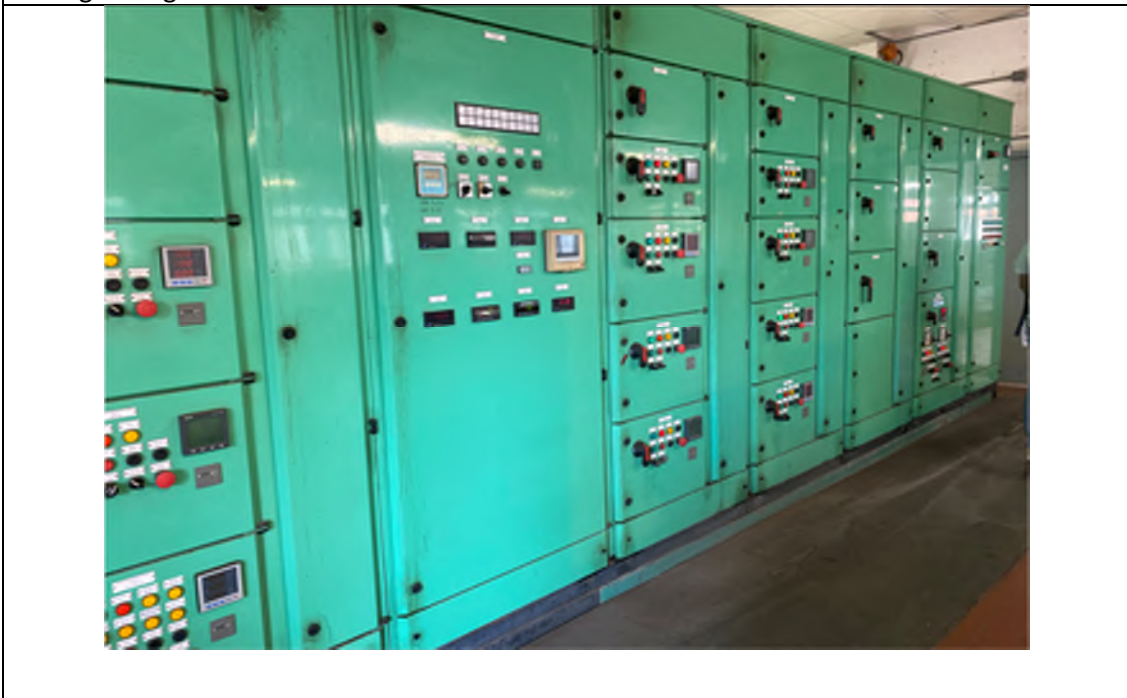
Photo WPS-4: Sludge Pumping Station – The Control Panel is located above the basement level with concrete paved floor in good condition with no oil stain observed.

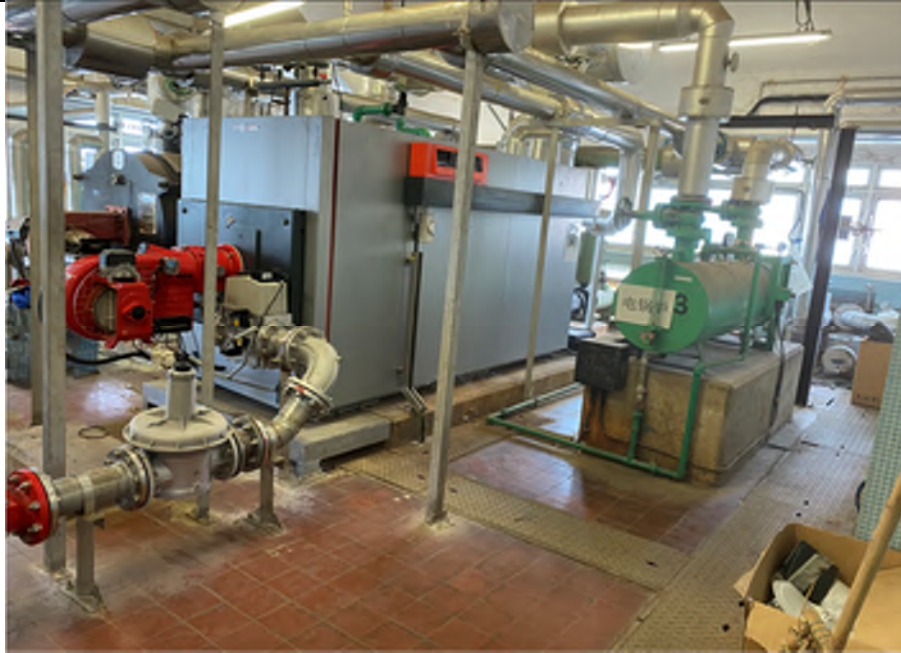
Photo WPS-5: Sludge Pumping Station (Electronic Boiler)– The boiler is located above the basement level with ceramic tiles and concrete paved floor in good condition with no oil stain observed.

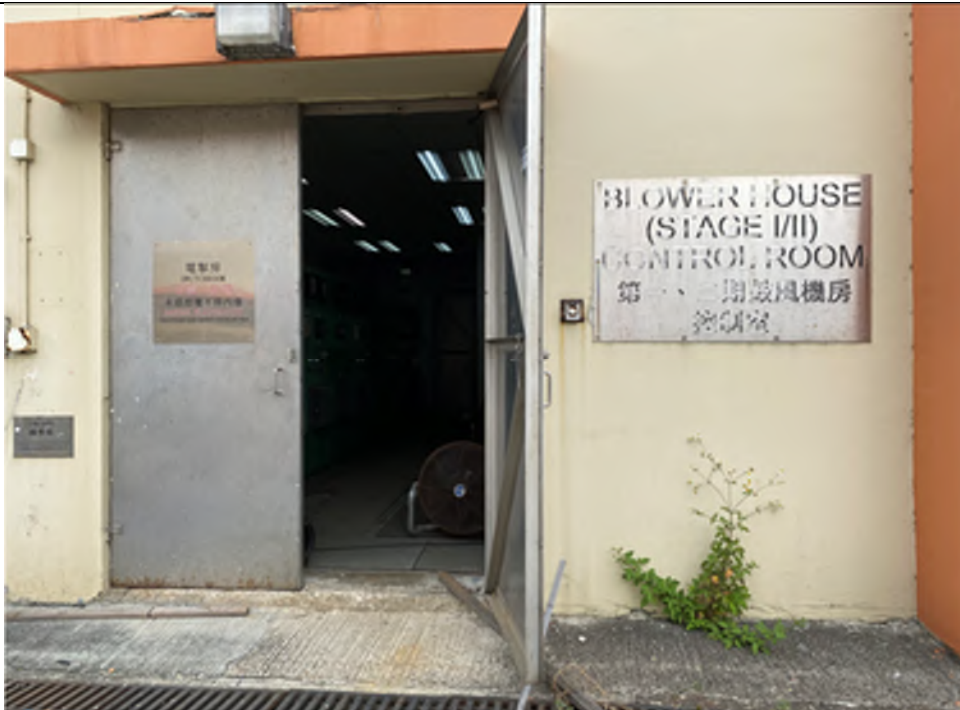
Photo WPS-6: Blower House (Entrance) – The external floor of the Blower House is paved with concrete floor in good condition with no oil stain/ stressed vegetation observed.

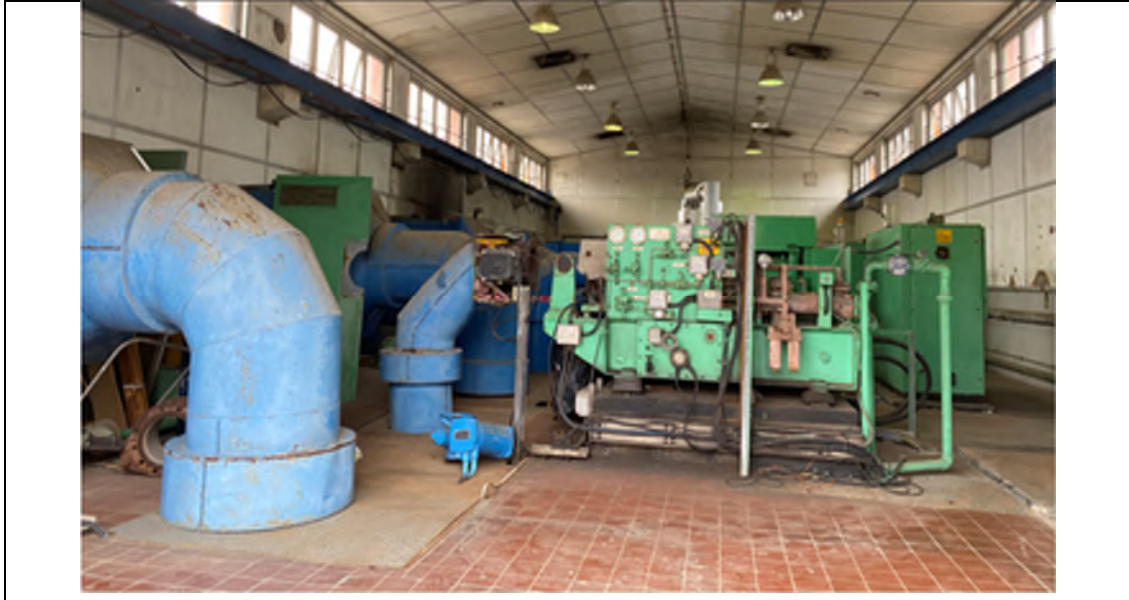
Photo WPS-7: Blower House (Air Blowers on Ground Floor) – The air blowers are located on ceramic tiles and concrete paved floor in good condition with no oil stain observed.

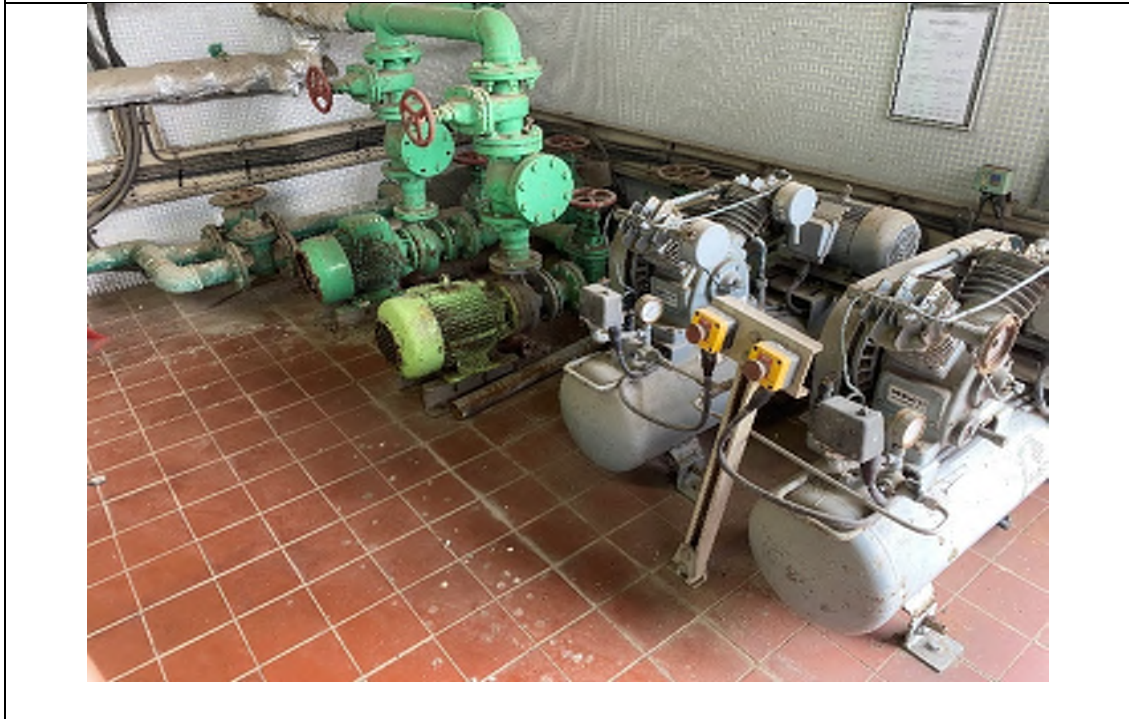
Photo WPS-8: Blower House (Pumps on Ground Floor) – Pumps are located on ceramic tiles and concrete paved floor in good condition with no oil stain observed.

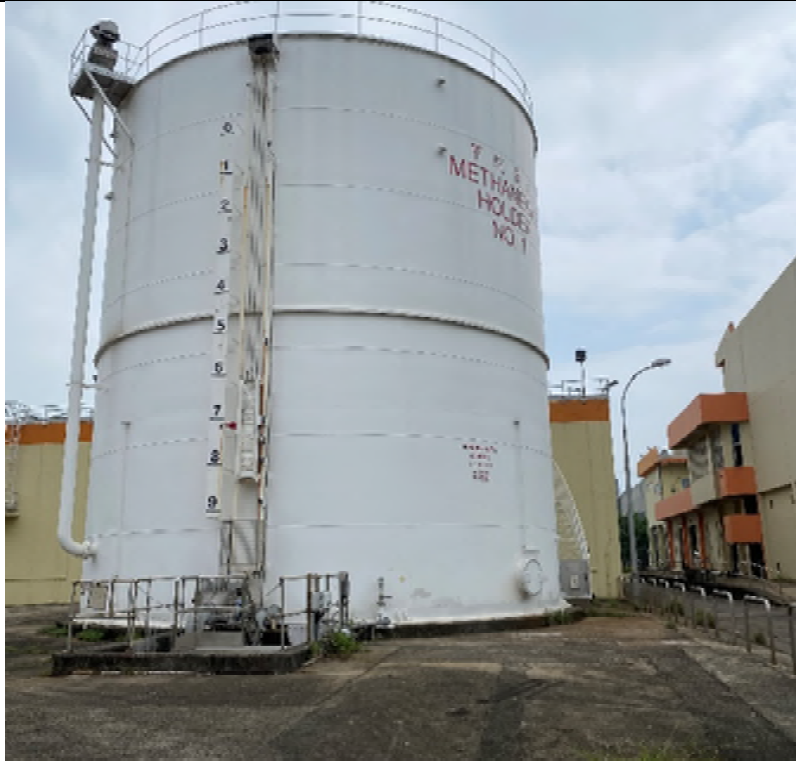
Photo WPS-9: Bio-Gas Holding Tank of West Plant– The Bio-Gas Holding Tank is located on concrete paved floor in good condition with no oil stain observed.

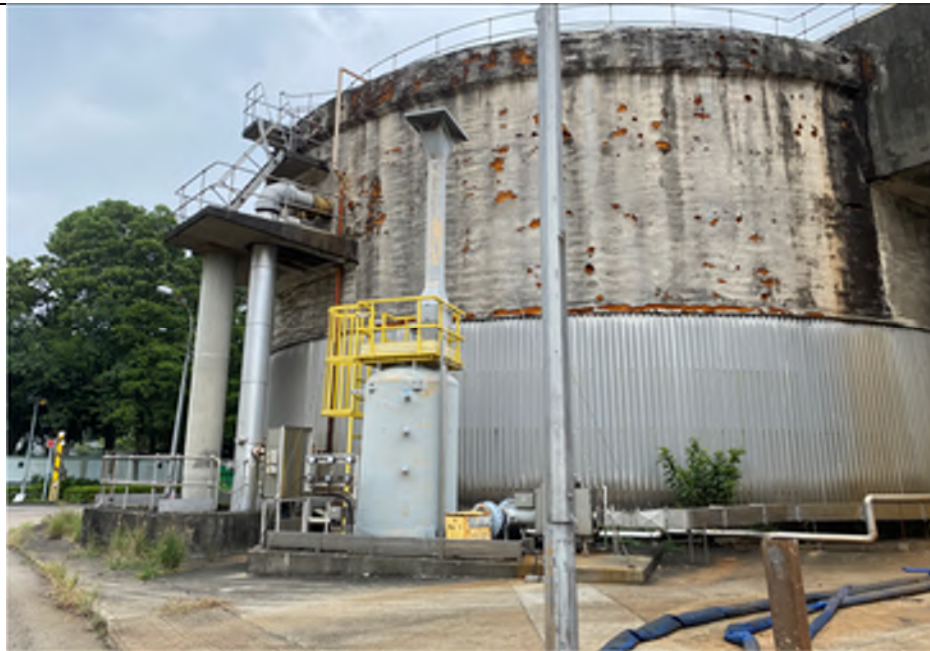
Photo WPS-10: Sludge Digestion Tank of West Plant – The tank is located on concrete paved floor in good condition with no oil stain/stressed vegetation observed.

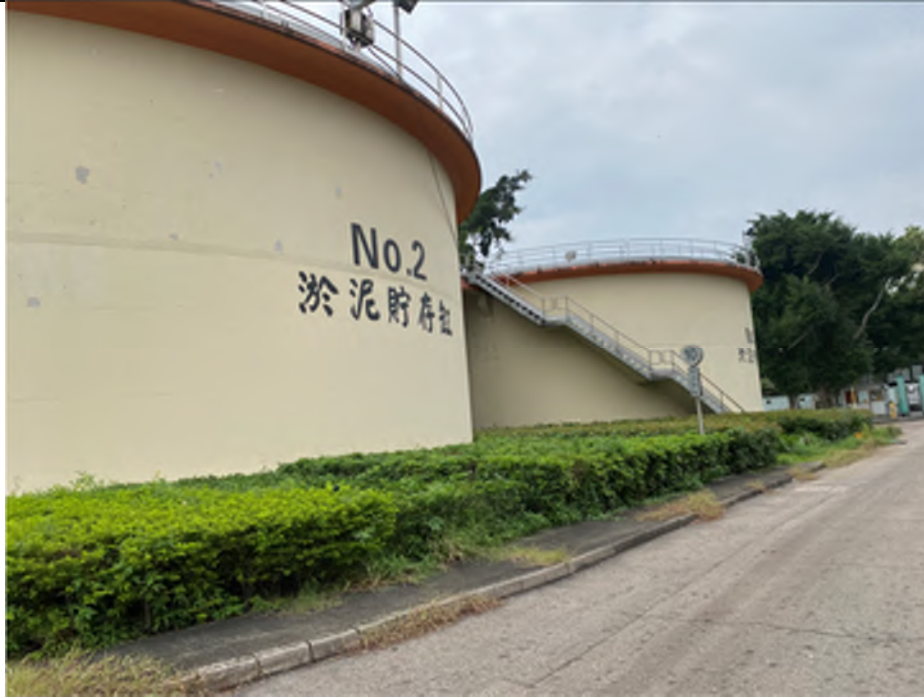
Photo WPS-11: Sludge Consolidation Tanks of West Plant - The tanks are located on concrete paved floor in good condition with no oil stain/stressed vegetation observed.

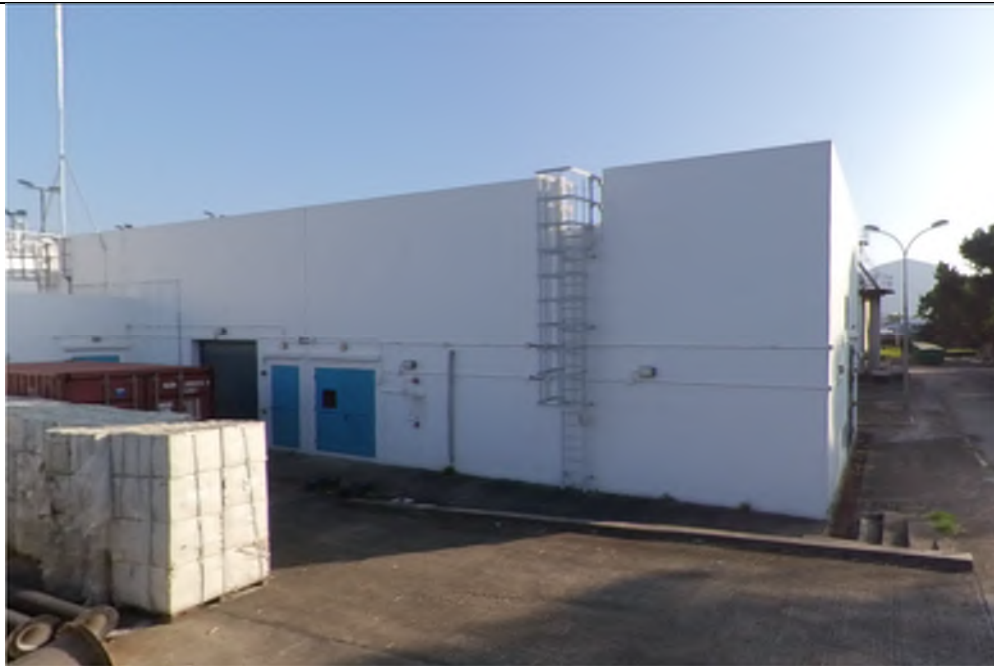
Photo WPS-12: Filtrate Treatment Complex – It is located on concrete paved panel in good condition, no oil stain is observed.

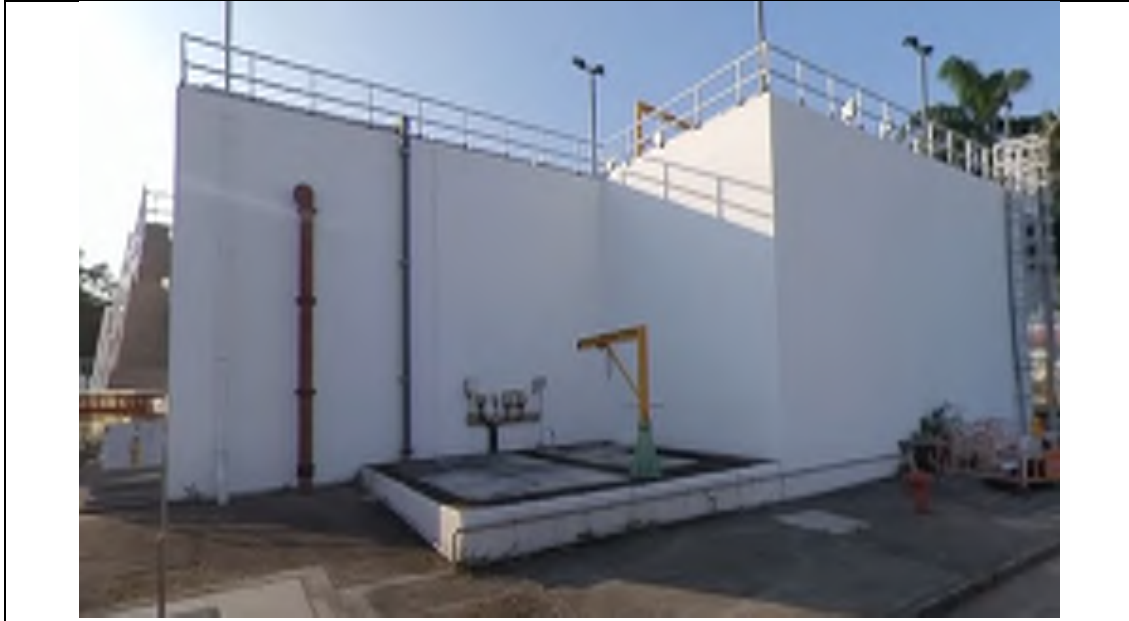
Photo WPS-13: Filtrate Treatment Units – The Filtrate Treatment Units is constructed with concrete located on concrete paved ground in good condition with no oil stains / stressed vegetation or potentially contaminating activities observed in the area.
