CONTAMINATION ASSESSMENT PLAN (FINAL)

Upgrading of Tai Po Sewage Treatment
Works – Investigation

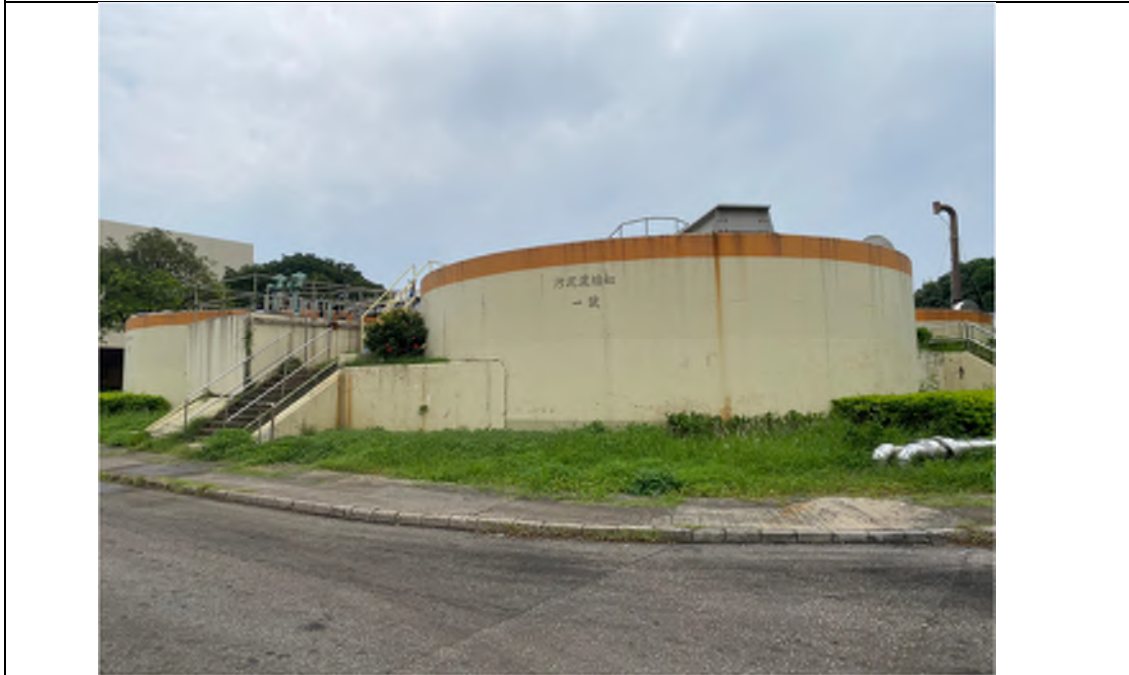
Photo WPS-14: Primary Sludge Gravity Thickeners of West Plant– The thickeners are located on concrete paved floor with vegetation surrounding in good condition. No oil stain is observed.

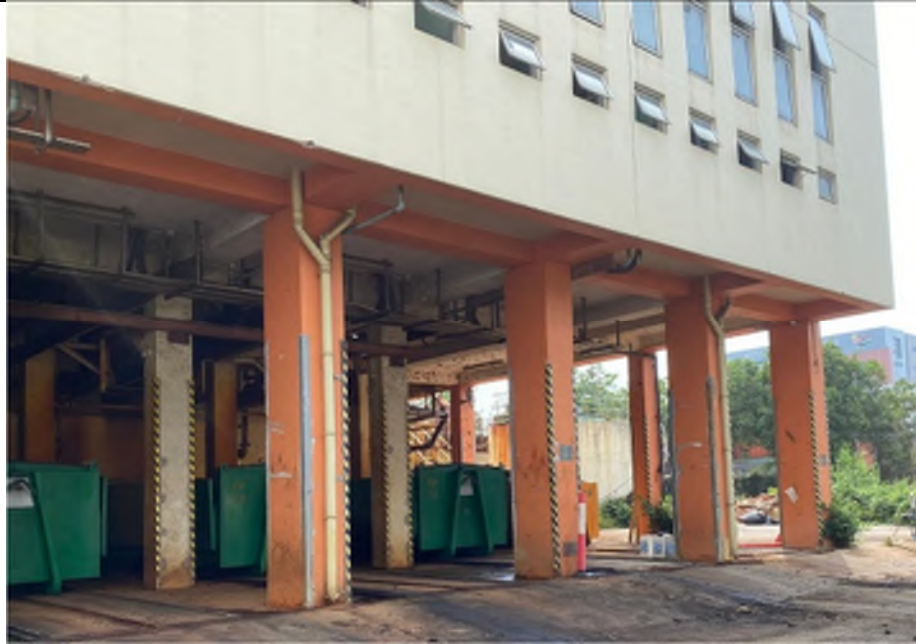
Photo WPS-15: Sludge Dewatering House (Ground Floor) – This is the sludge loading located on concrete paved floor with no oil stain/stressed vegetation observed. The stains on the floor were caused by handling of sewage sludge. There is a basement below the ground.

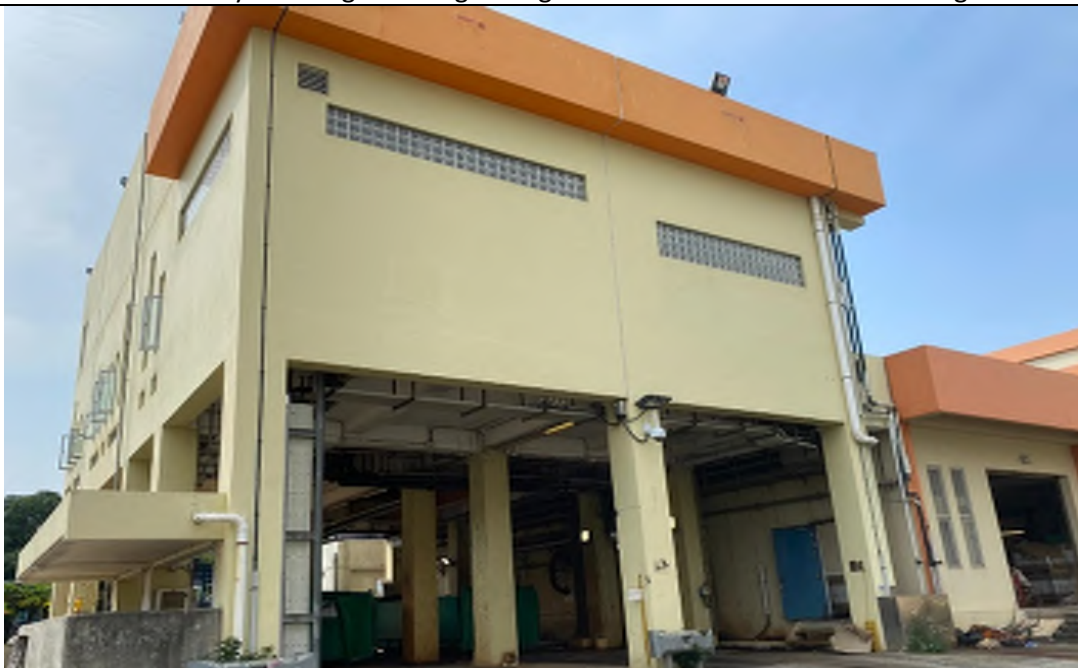
Photo WPS-16: Sludge Dewatering House – The house is located on concrete paved floor with no oil stain observed.

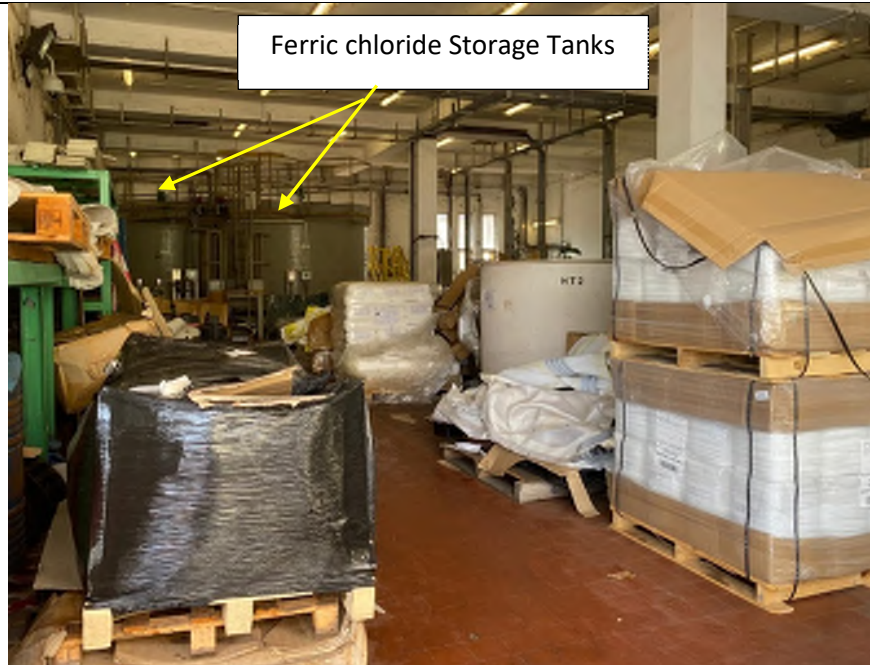
Photo WPS-17: Chemical House – Equipment are stored and placed on wood panel inside the Chemical House with ceramic tiles with concrete paved floor. Only Ferric Chloride Storage Tanks were observed at this location, no other chemicals are stored at Chemical House. No oil stain is observed

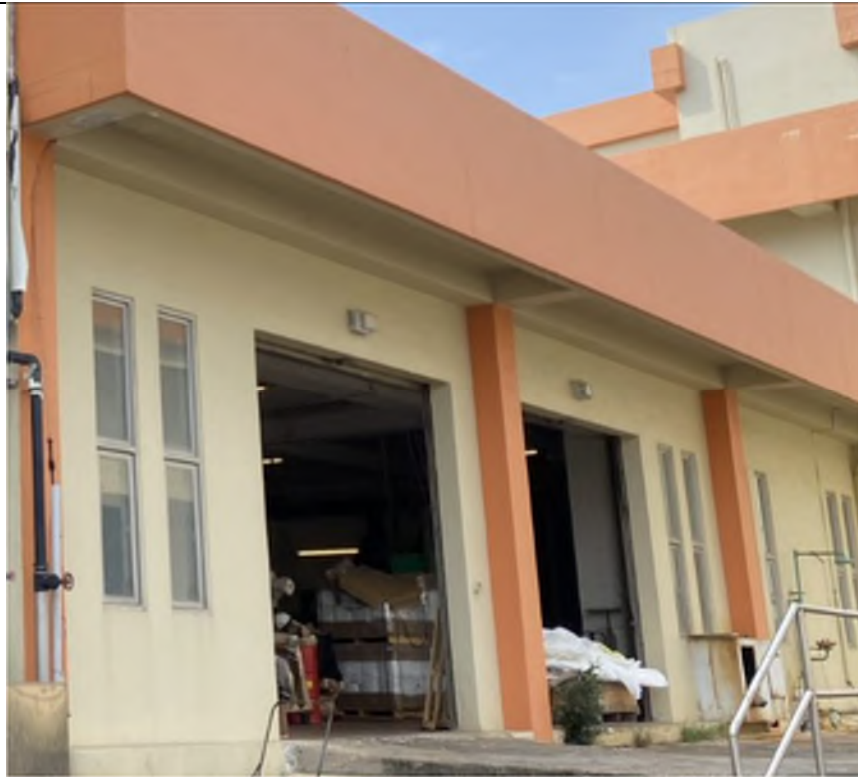
Photo WPS-18: Chemical House –The Chemical House is paved with concrete floor in good condition with no oil stain observed.

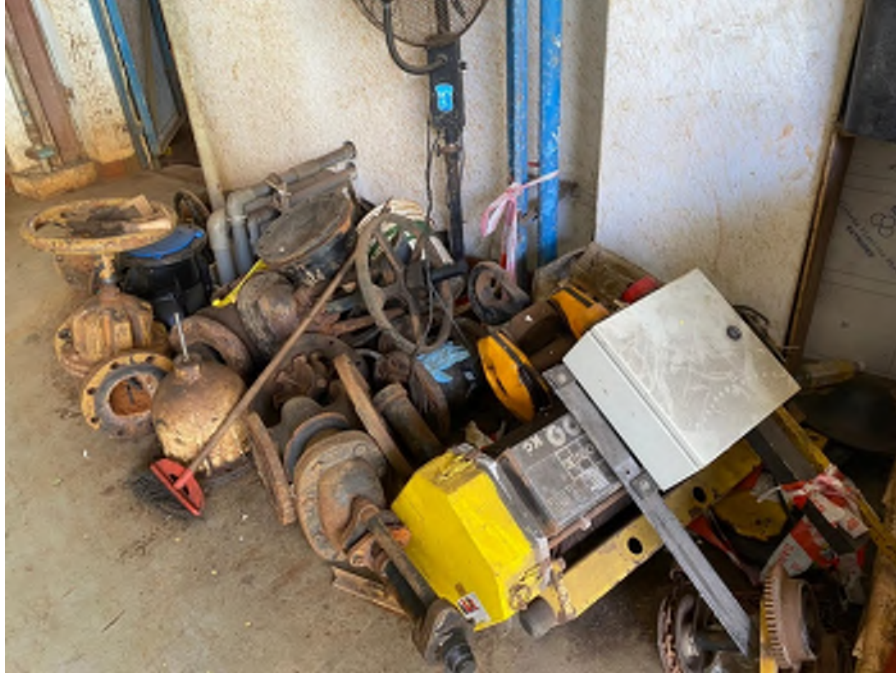
Photo WPS-19: Chemical House – Some tools and equipment are placed on concrete paved floor, no oil stain is observed. No storage of COC is recorded / observed.

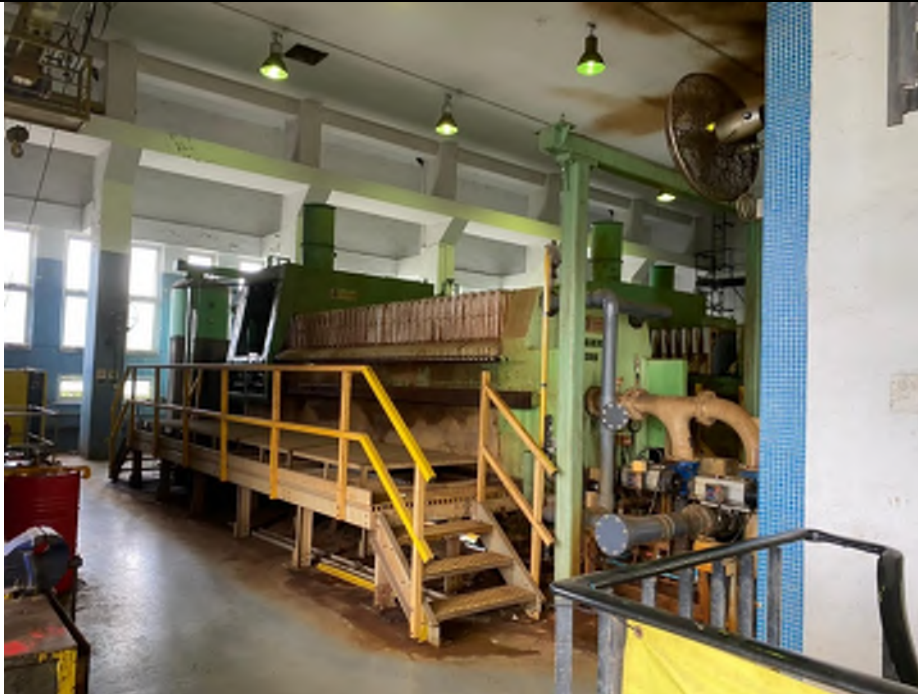
Photo WPS-20: Sludge Dewatering House (Upper Floor) – The upper floor is paved with concrete in good condition. The area is clean and dry with no oil stain.

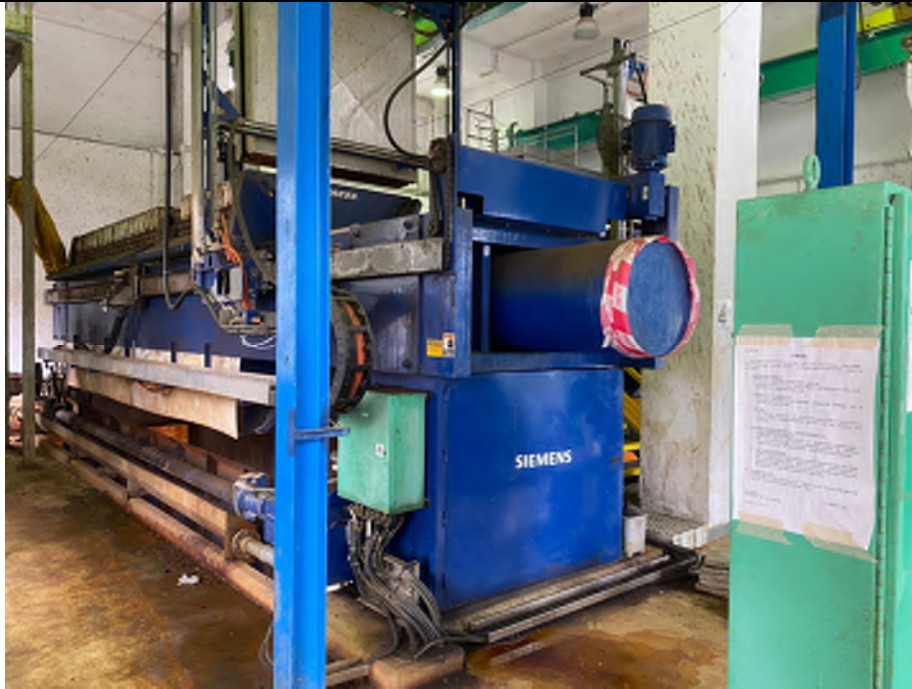
Photo WPS-21: Sludge Dewatering House (Second Floor) - The floor is paved with concrete in good condition with no oil stain. The water stains observed on the floor were caused by handling of sewage sludge only. Land contamination from the operations in upper floor is not expected.

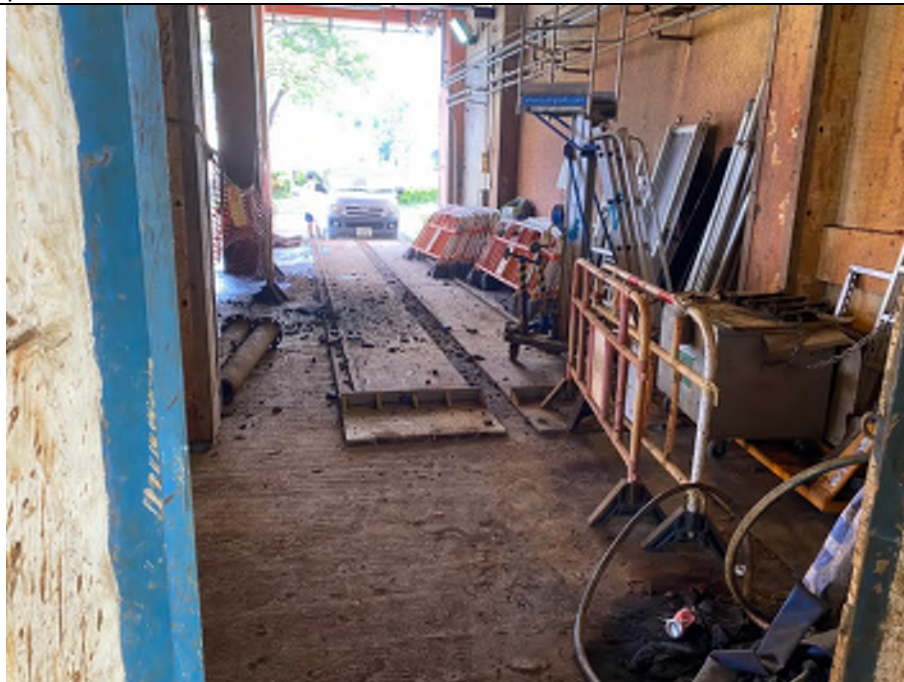
Photo WPS-22: Extension of Sludge Dewatering House – The ground floor is paved with concrete. No floor leakage is observed. The debris observed on the floor was debris of sewage sludge. There is a basement below the ground floor.

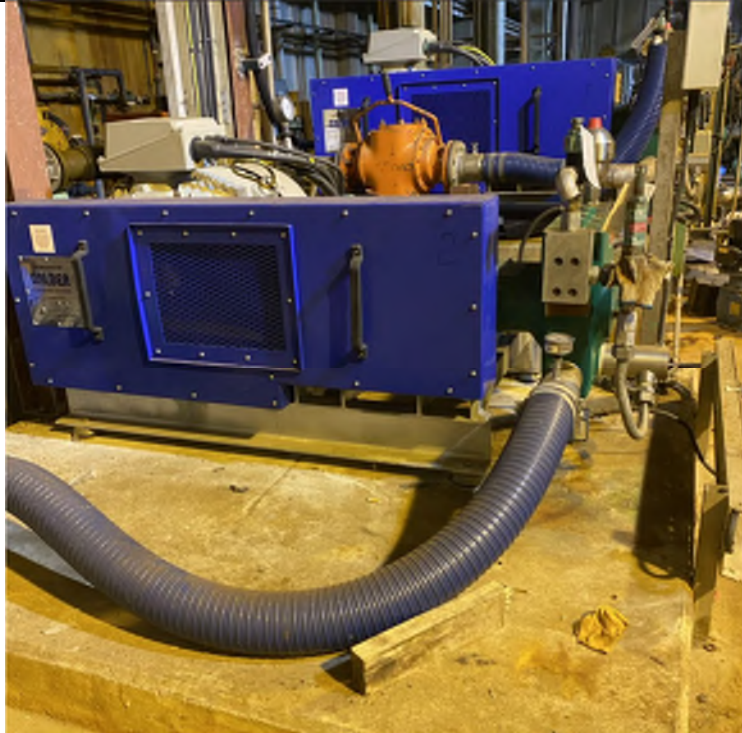
Photo WPS-23: Extension of Sludge Dewatering House – The pumps are located at the basement floor which is paved with concrete with no oil stain / floor leakage were observed.

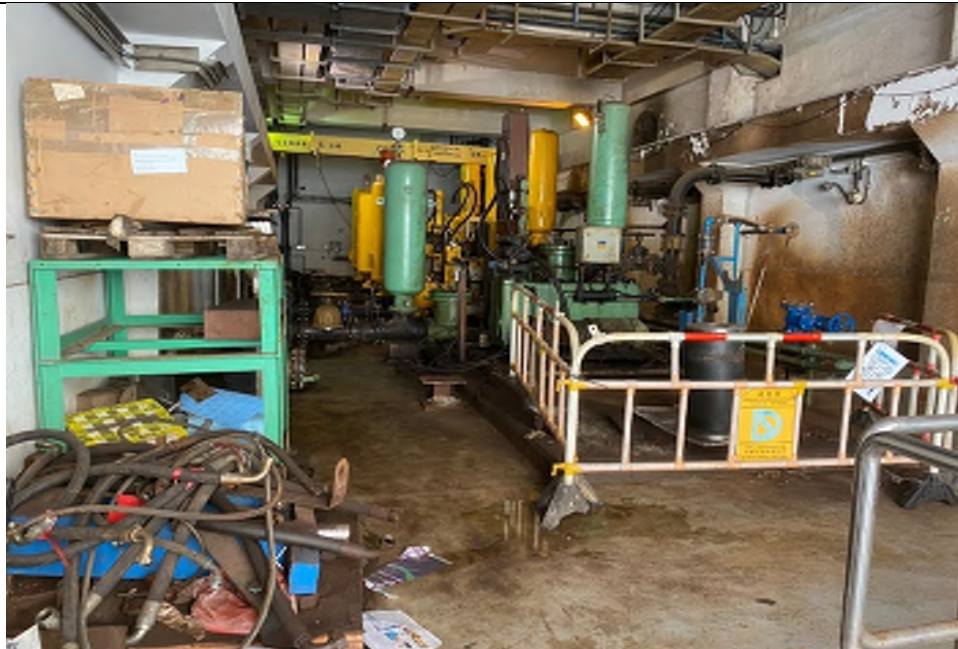
Photo WPS-24: Extension of Sludge Dewatering House – The pumps are located at basement on paved with concrete in good condition with no oil stain. The water stains on the floor were caused by handling of sewage sludge.

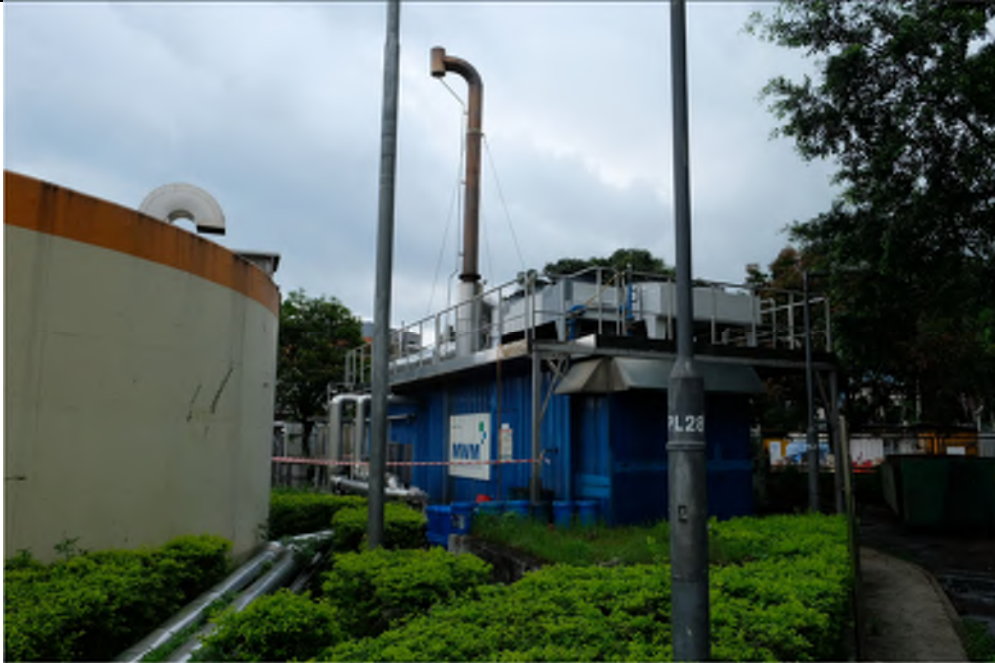
Photo WPS-25: Combined Heat And Power Generating System of West Plant - The generating system is located on paved with concrete in good condition. No oil stain and stressed vegetation are observed.

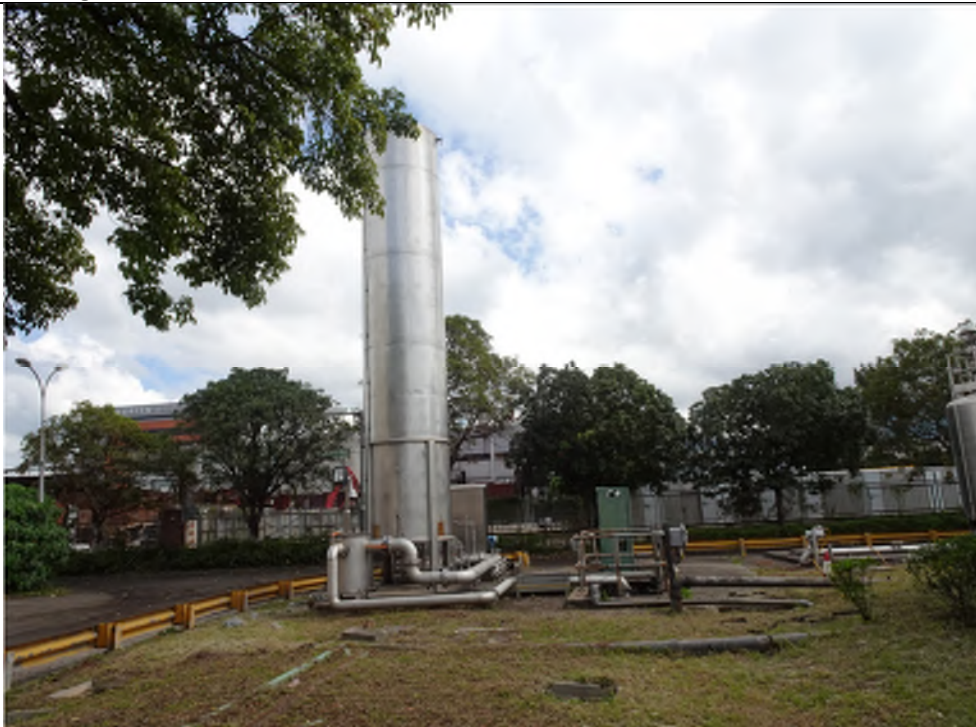
Photo WPS-26: Combined Heat And Power Generating System of West Plant- The generating system is paved with concrete in good condition. No oil stain and stressed vegetation are observed.

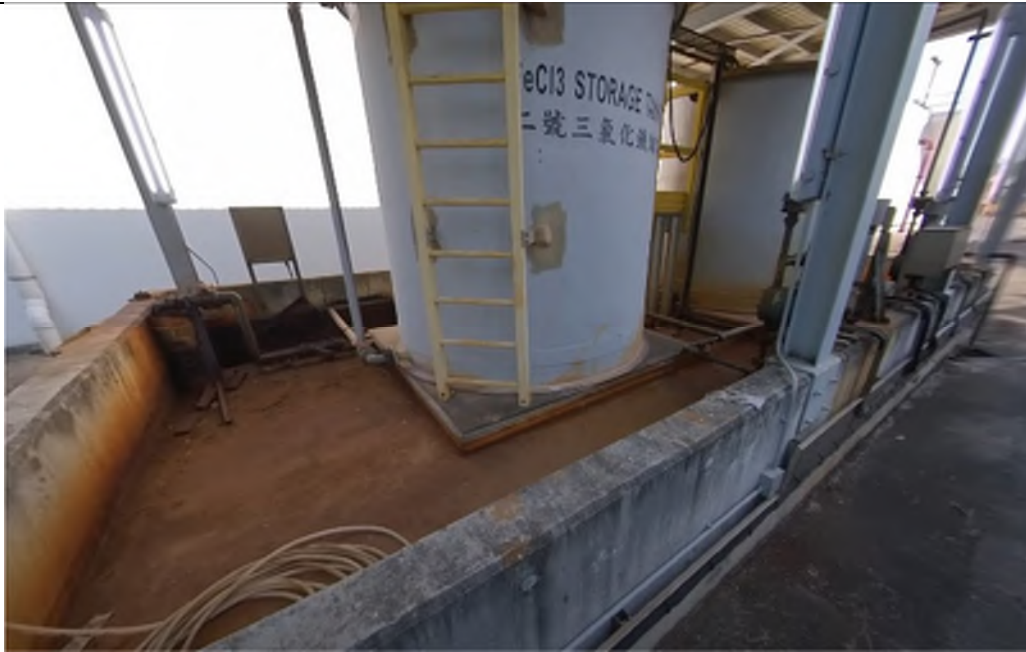
Photo WPS-27 :Ferric Chloride Dosing System #1 - The system is located on an elevated platform with concrete slab. Two FeCl3 Storage Tanks are located under the shelter.

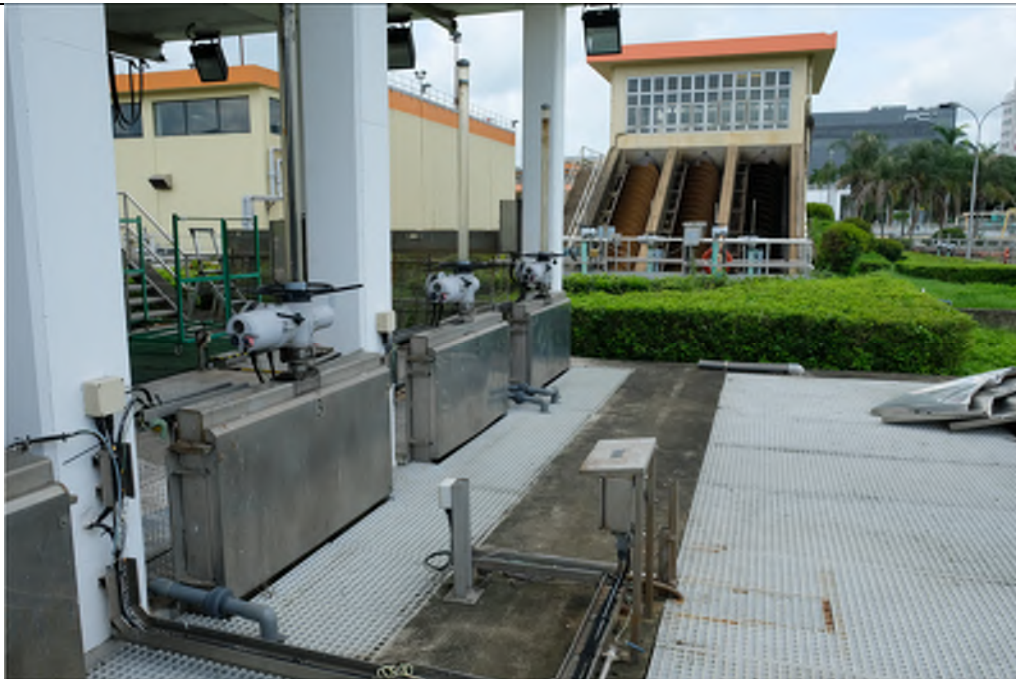
Photo WPS-28: UV Disinfection Facilities – The UV Disinfection Facilities is located on concrete paved slab. Vegetation is observed near the facilities in good condition. No oil stain/ leakage is observed.

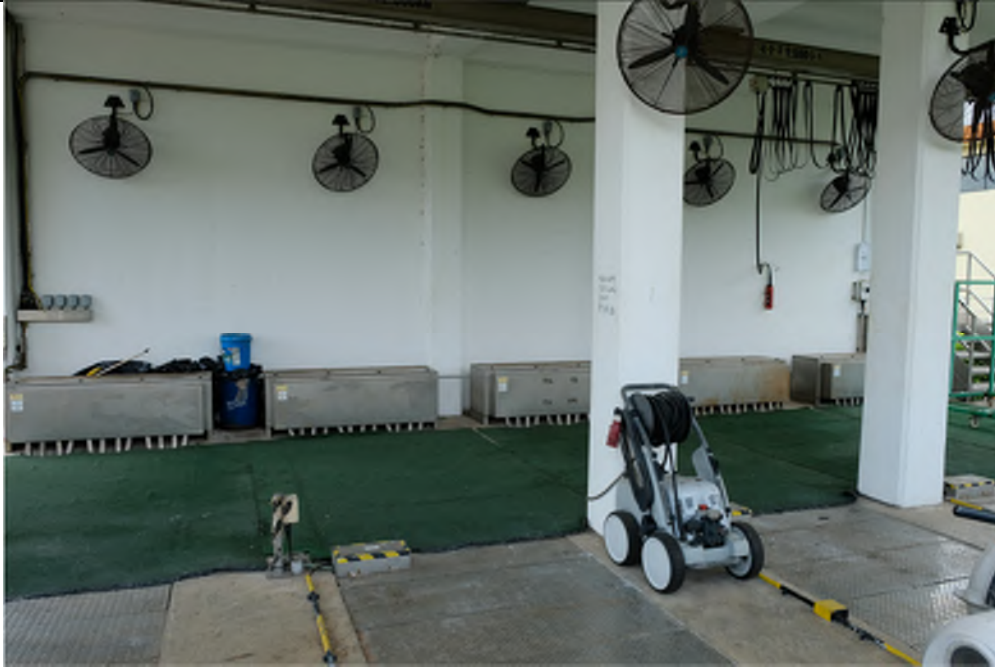
Photo WPS-29: UV Disinfection Facilities – The floor under the shelter of the UV Disinfection Facilities is paved with concrete slab and covered by green floor mat. No oil stain /leakage is observed in this location.

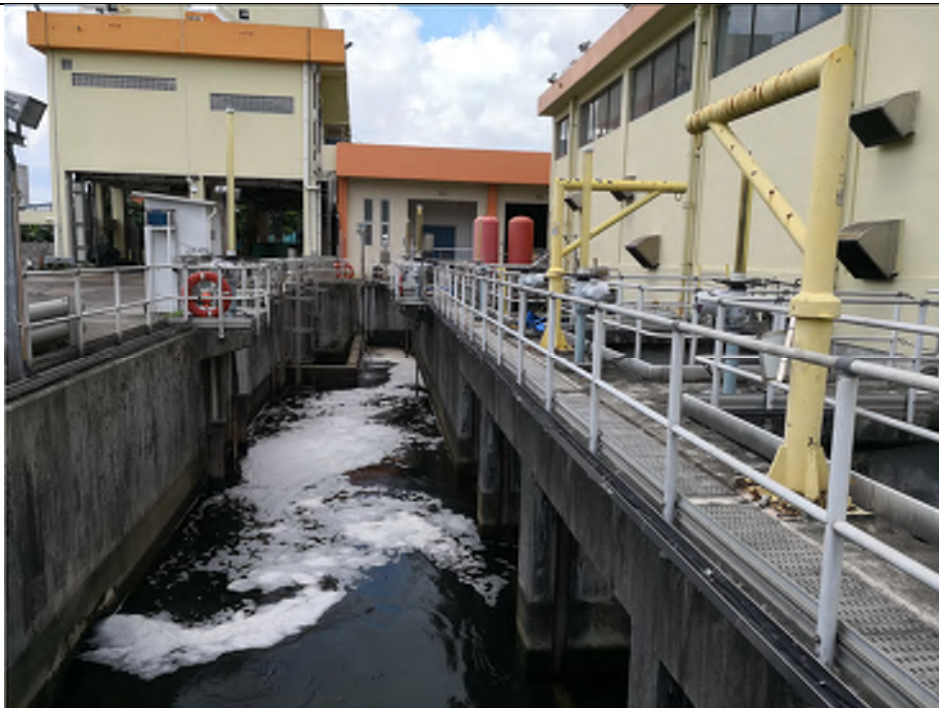
Photo WPS-30: Effluent Pumping Station – The Wet Well is constructed with concrete paved bund wall, treated effluent is transferred from the UV disinfection facilities and stored in the wet well. No oil stain/leakage is observed.

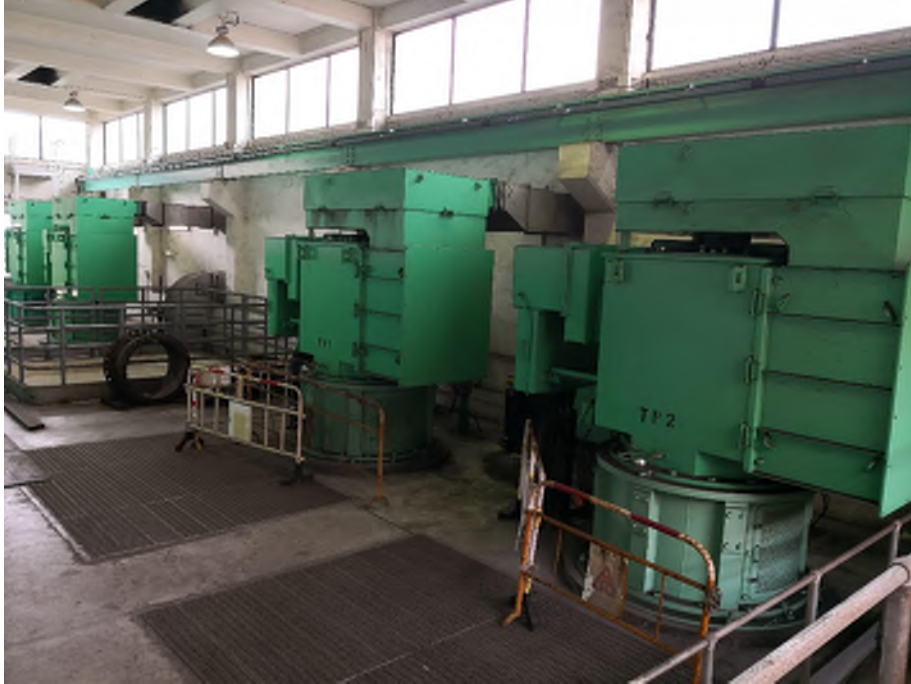
Photo WPS-31: Effluent Pumping Station – The transfer pumps, gear boxes and monitors are located on the ground floor of the Effluent Pumping Station. The floor is paved with concrete slab, no oil stain/leakage observed.

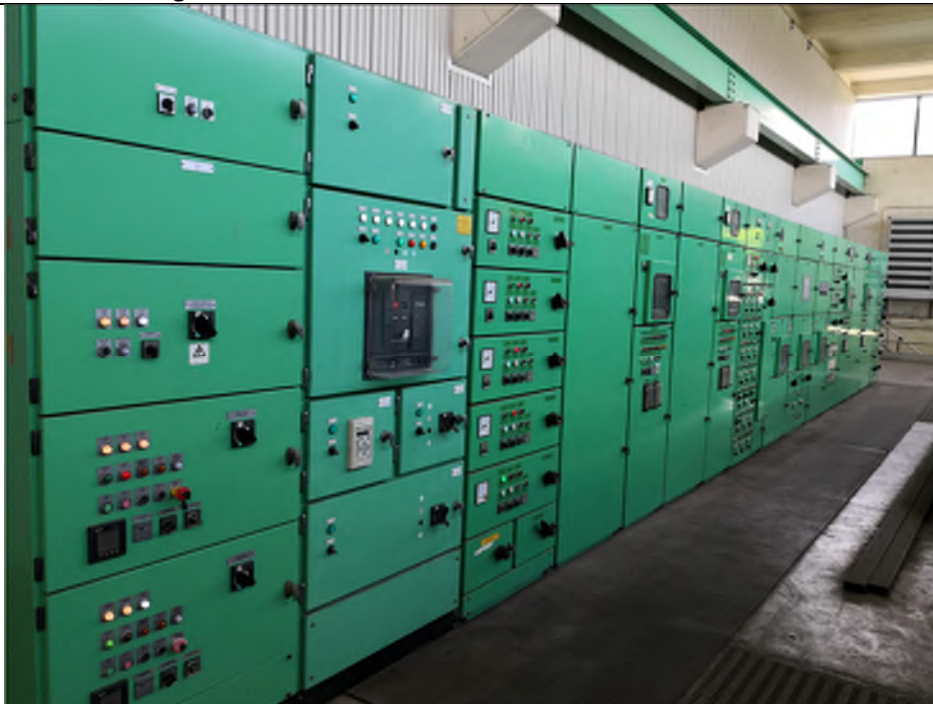
Photo WPS-32: Effluent Pumping Station -The Control Panel is located on the ground floor of the Effluent Pumping Station on concrete paved floor. No oil stain/leakage is observed.

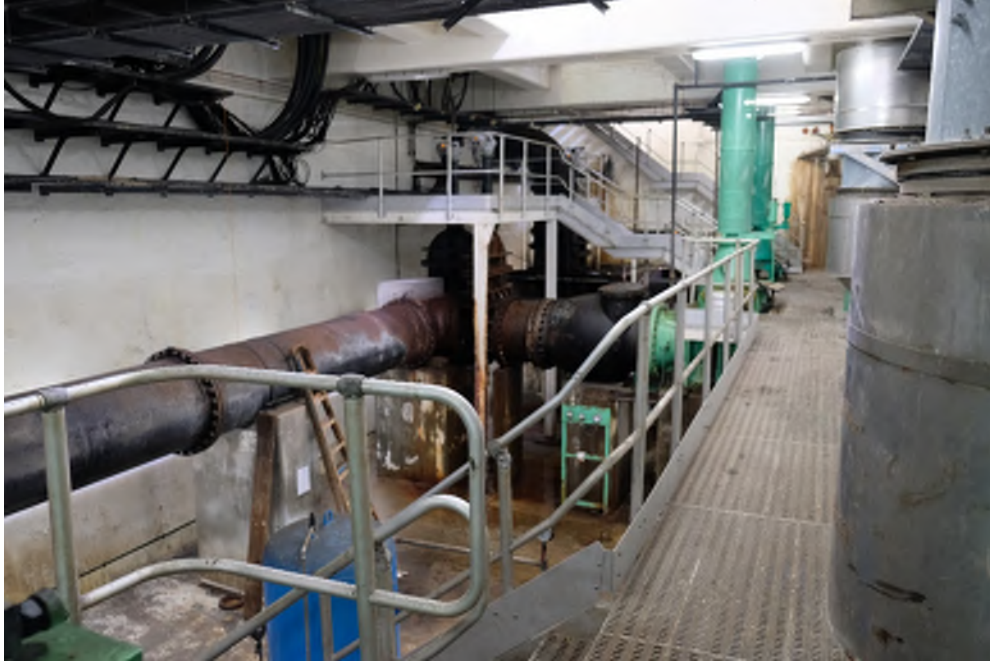
Photo WPS-33: Effluent Pumping Station – The transfer pumps are located under the ground floor. Assessible path is constructed with steel panel. No oil stain/leakage is found in this located.

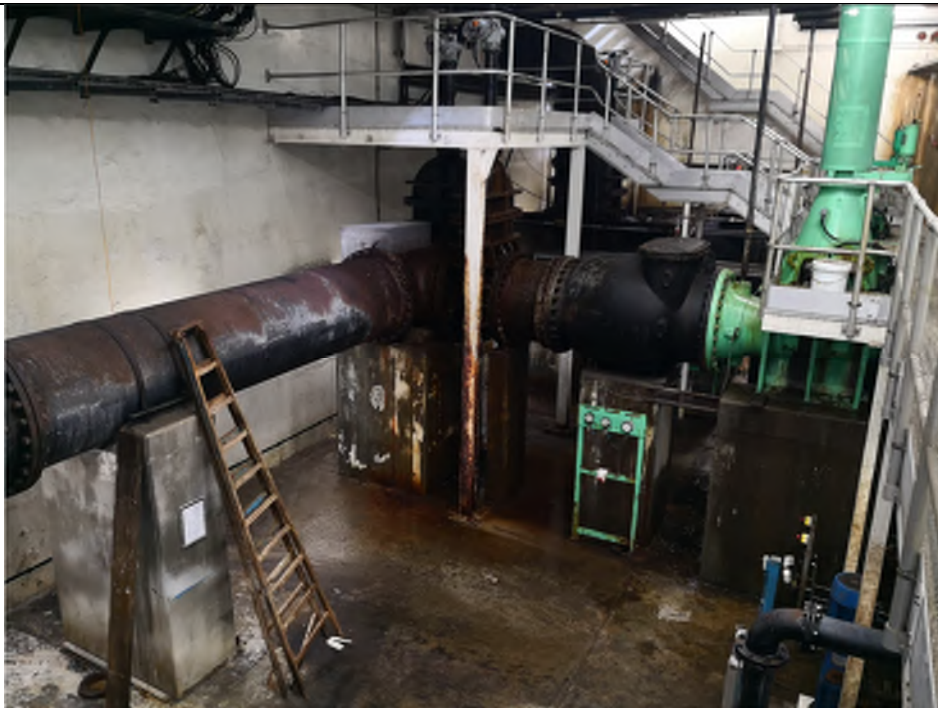
Photo WPS-34: Effluent Pumping Station – The Gate Valve is located under the ground floor. The Gate Valve is connected to the Wet Well of the Effluent Pumping Station. Water stain is observed due to handling of effluent. No oil stain/leakage is observed.

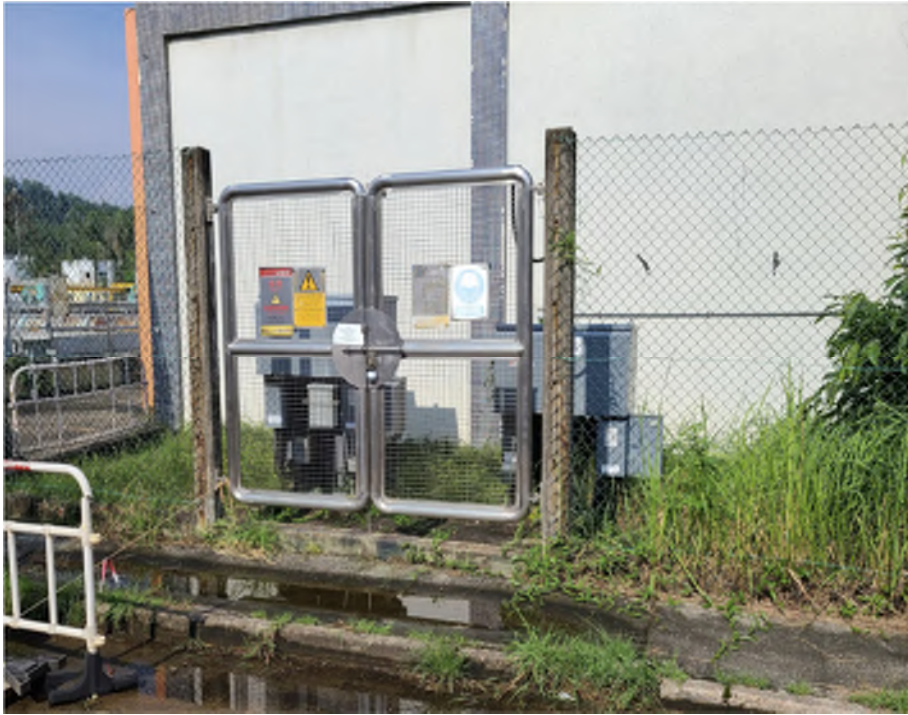
Photo WPS-35: Transformer – The transformer is located on concrete paved floor surrounded by vegetation. Cracks are observed near the transformer. However, the transformer is in good condition and maintained by CLP no leakage of transformer oil is observed. No oil stain/leakage is found in this location.

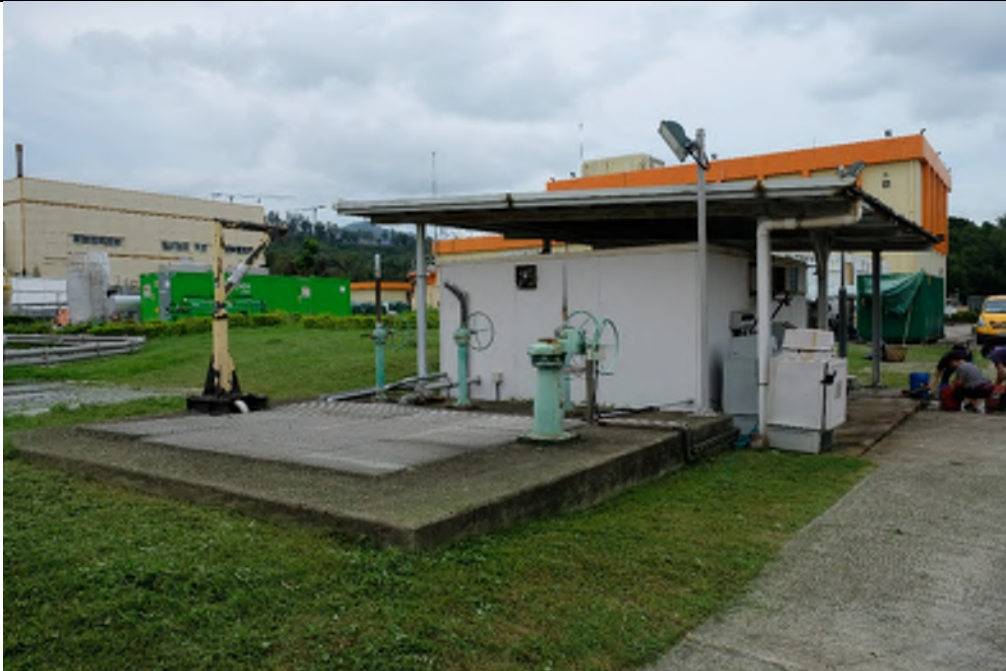
Photo WPS-36: Effluent Sampling shelter – Effluent sampling equipment is observed in this location. The facility is surrounded by vegetation and concrete paved surface. No sign of land contamination such as oil stains is identified.

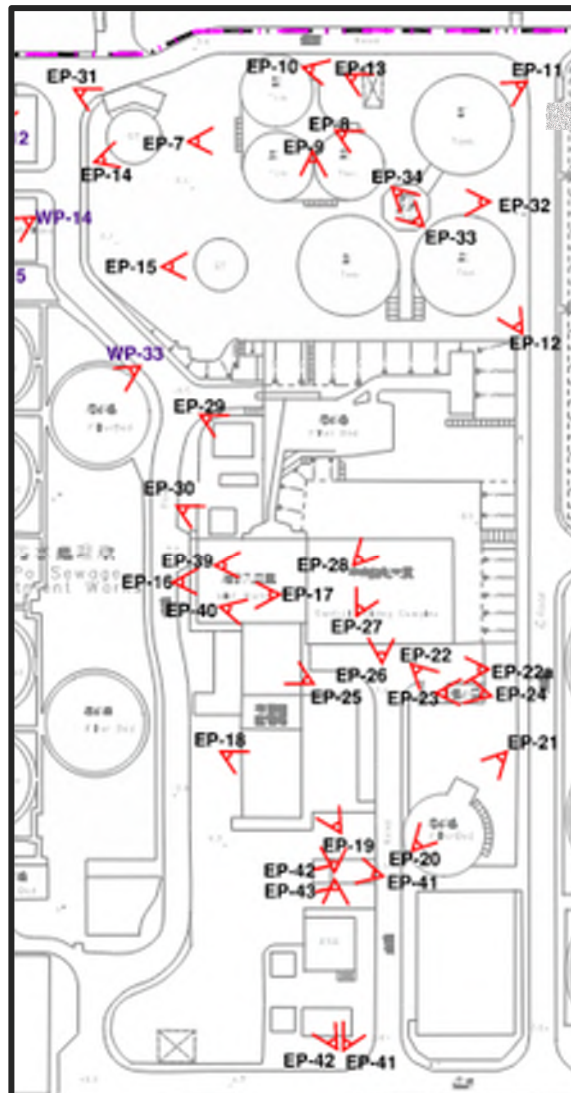
Photo Nos. EP-1 to EP-6, EP-35 and EP-36 are not used.

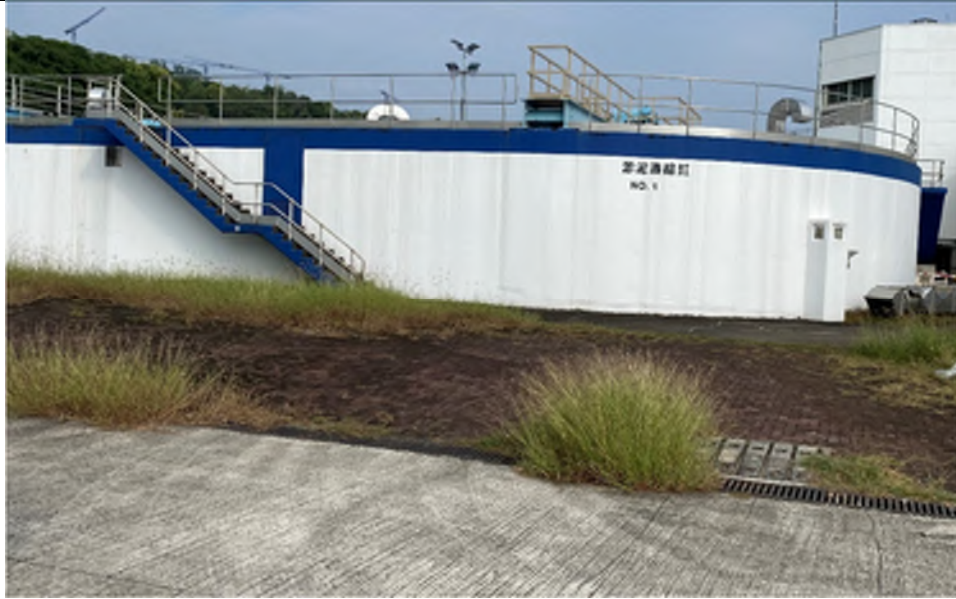
Photo EP-7: Sludge Consolidation Tanks of East Plant– The tanks are located on concrete paved floor. There is a two-storey building near the sludge consolidation tanks. Only dirty stain caused by weathering is observed, no oil stain/ stressed vegetation is observed.

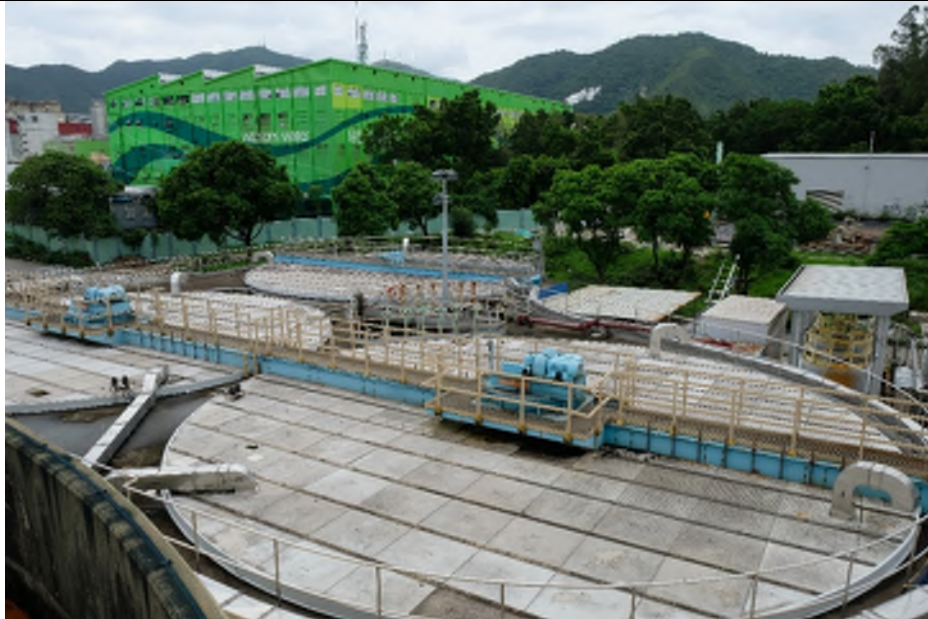
Photo EP-8: Sludge Consolidation Tanks of East Plant (Upper Floor) – All accessible path are paved with concrete, water stain is observed due to handling of sludge. The tanks are in good condition, no damage or broken parts found. No oil stain/ leakage is observed.

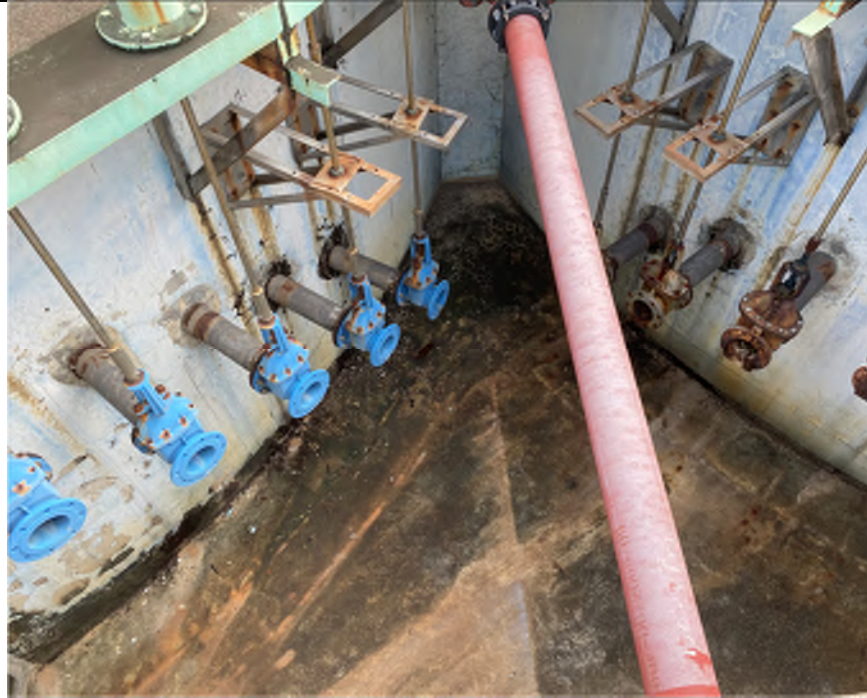
Photo EP-9: Sludge Consolidation Tanks of East Plant (Ground Floor) - The floor is paved with concrete, dirty stain and water stain caused by weathering and handling of sludge is observed. There is no damage or broken tools observed.

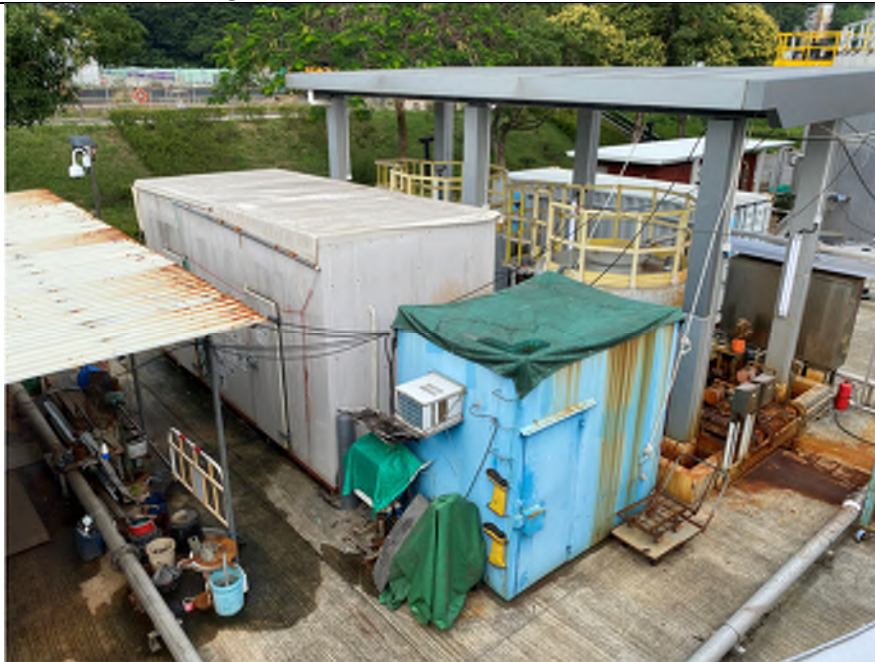
Photo EP-10: Ferric Chloride Dosing System #2 (to the north of sludge Consolidation Tanks in East Plant) – This system is located on concrete paved floor. water stain and rusty stain were observed due to weathering and cleaning activities. Shelter is built to protect facility from being damaged by extreme weather.

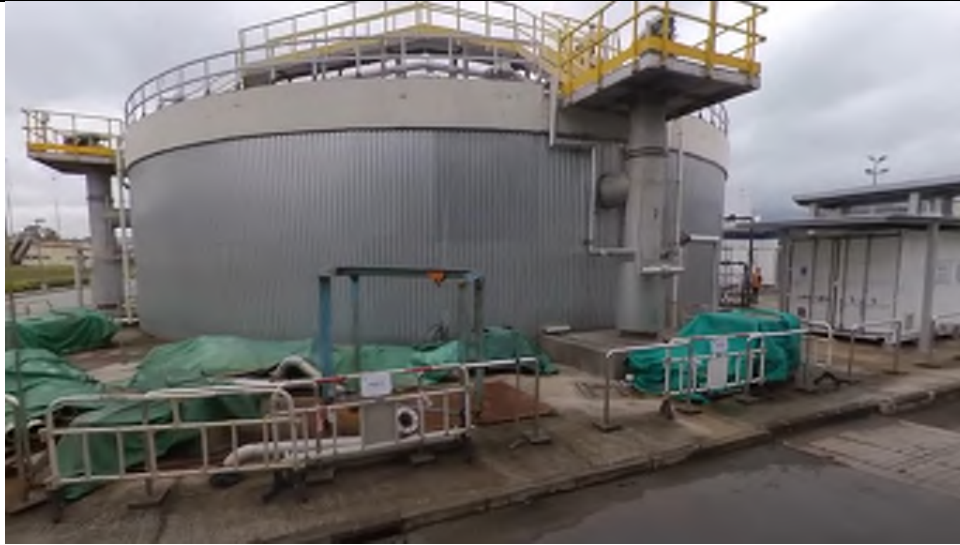
Photo EP-11: Sludge Digestion Tanks of East Plant– The tanks are connected to the Service Tower Building. The Tanks and the Service Tower Building are located on concrete paved floor. No damage / leakage is observed. Only stain caused by weathering and water stain is observed.

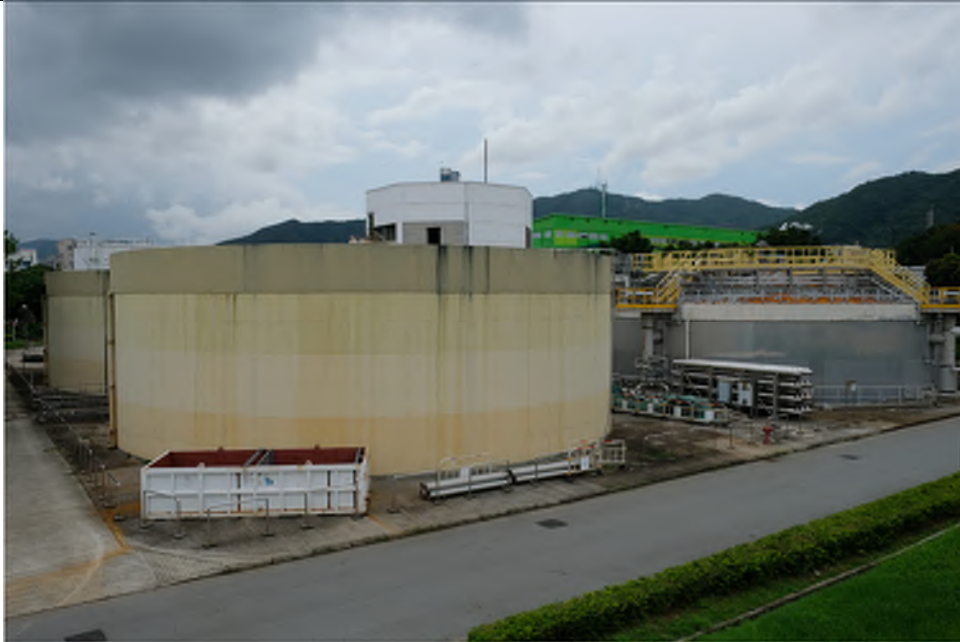
Photo EP-12: Sludge Digestion Tanks of East Plant -There are total 3 Sludge Digestion Tanks surrounding the Service Tower Building, where 3 of them are located on concrete paved ground. No oil stain, leakage or damage is observed.

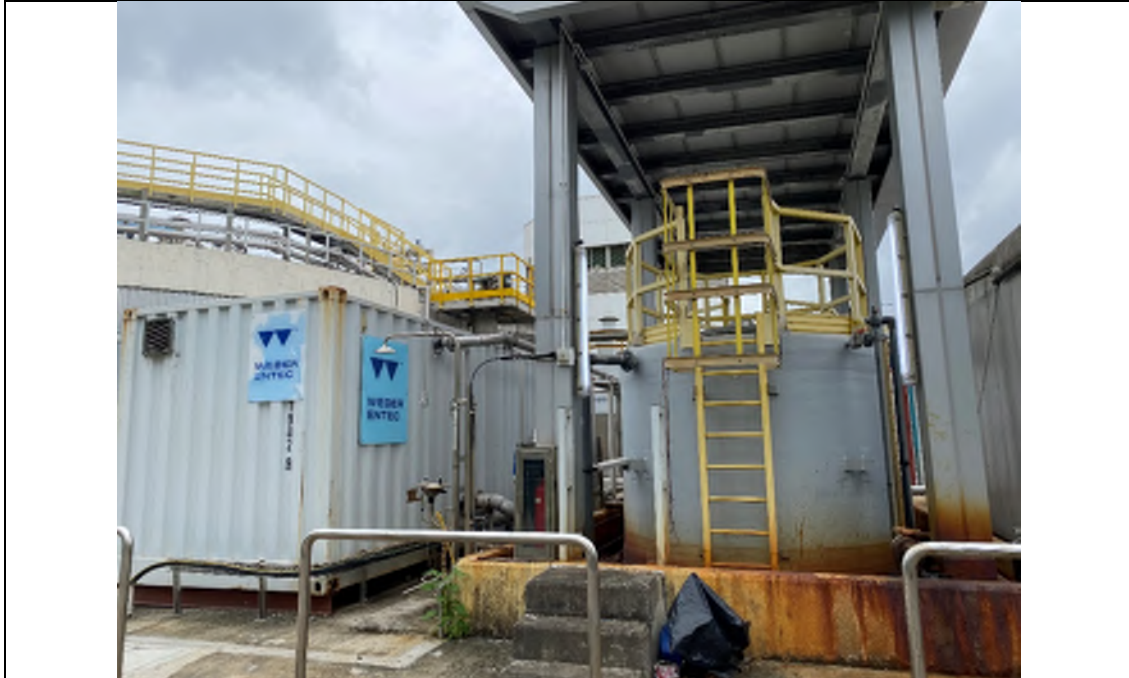
Photo EP-13: Ferric Chloride Dosing System #2 – The system is located on an elevated platform with concrete slab. Two FeCl₃ Storage Tanks are located under the shelter. Ferric Chloride stain is observed.

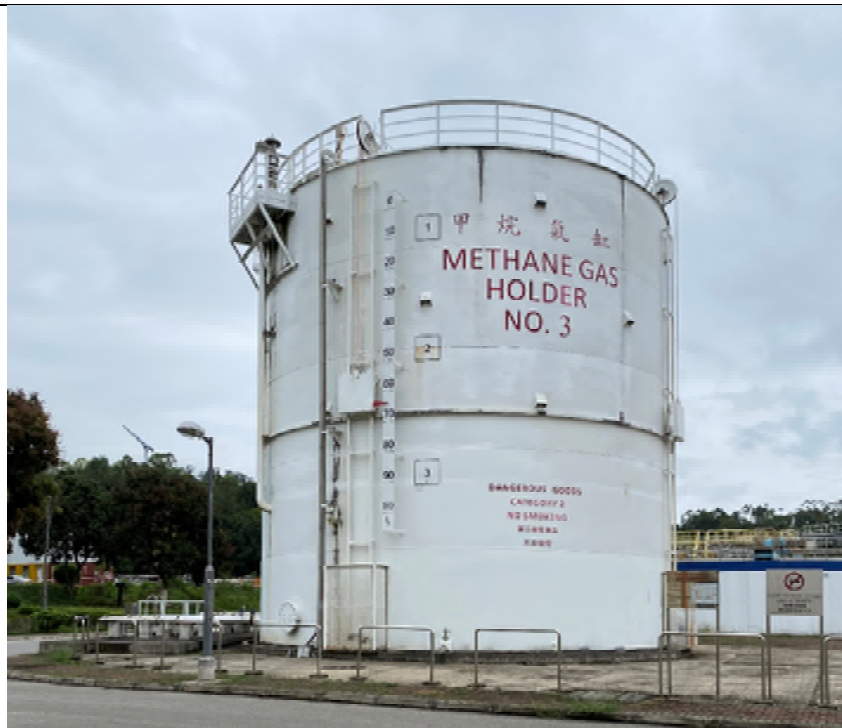
Photo EP-14: Bio-gas Holding Tank #1 (to the west of Sludge Consolidation Tanks) in East Plant - The tank is located on concrete paved floor with no stressed vegetation/ leakage is observed. The tank is in good condition no damage/ leakage is observed.

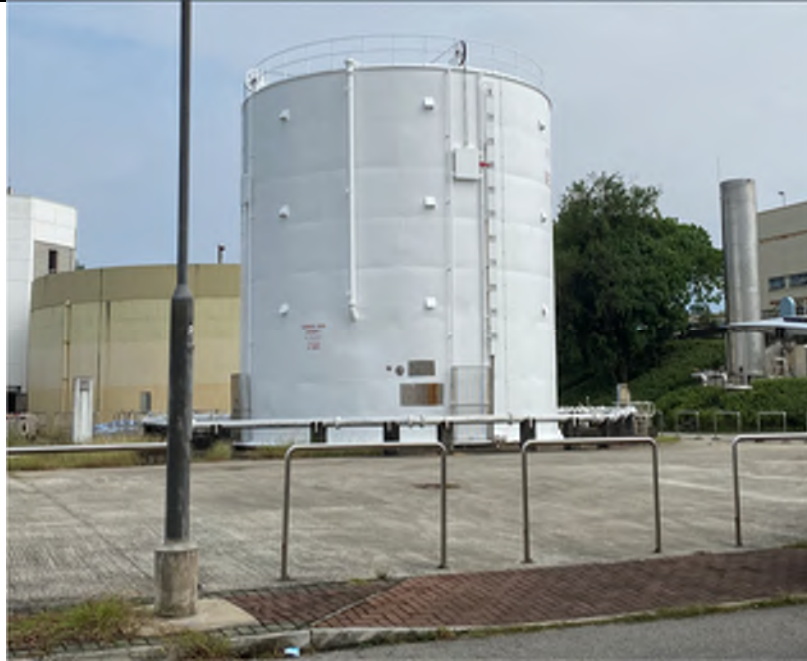
Photo EP-15: Bio-gas Holding Tank #2 (to the west of Sludge Digestion Tanks) in East Plant – The tank is located on concrete paved floor with no stressed vegetation/ leakage is observed. The tank is in good condition no damage/ leakage is observed.
