CONTAMINATION ASSESSMENT PLAN (FINAL)

Upgrading of Tai Po Sewage Treatment
Works – Investigation

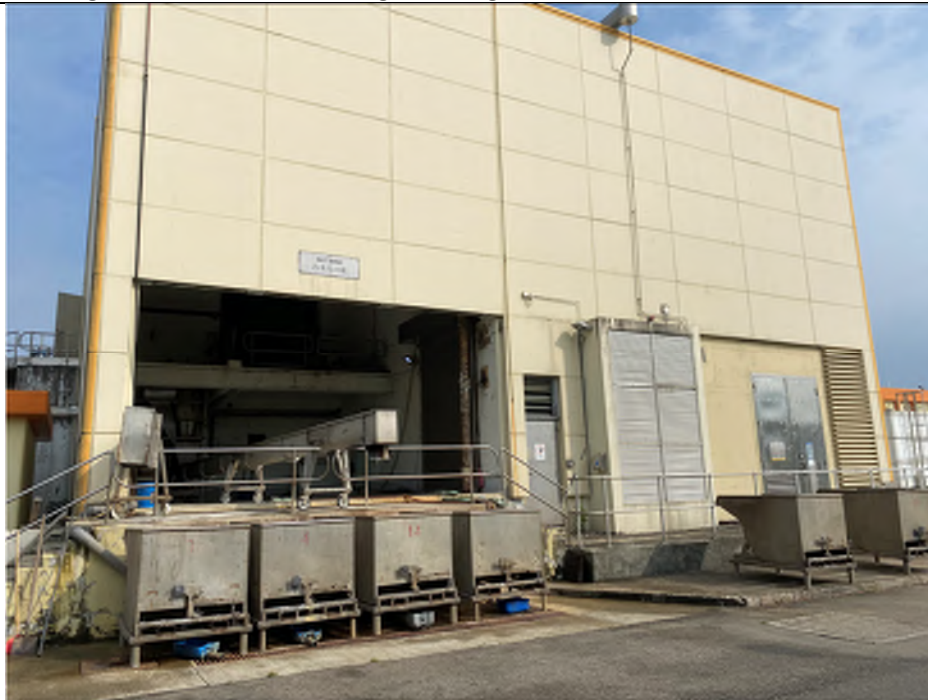
Photo EP-16: Screens House of East Plant (External View) -The house is located on concrete paved floor. Water stain is observed, no oil stain/leakage is observed.

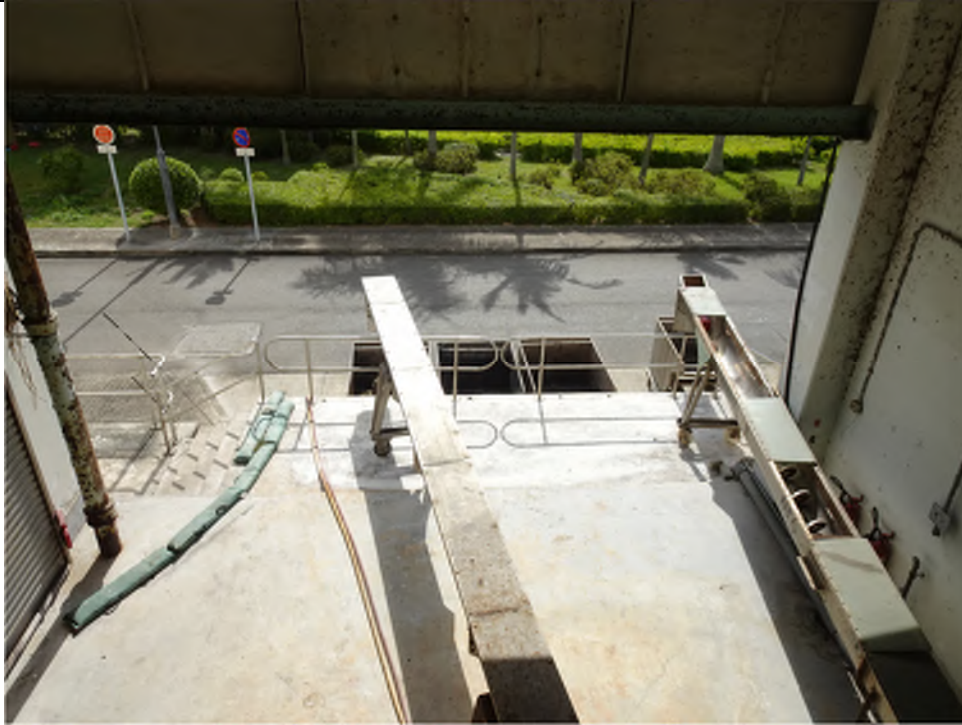
Photo EP-17: Screen House – The first floor of the screen house is located above ground level with concrete paved floor in good condition, no stain is observed.

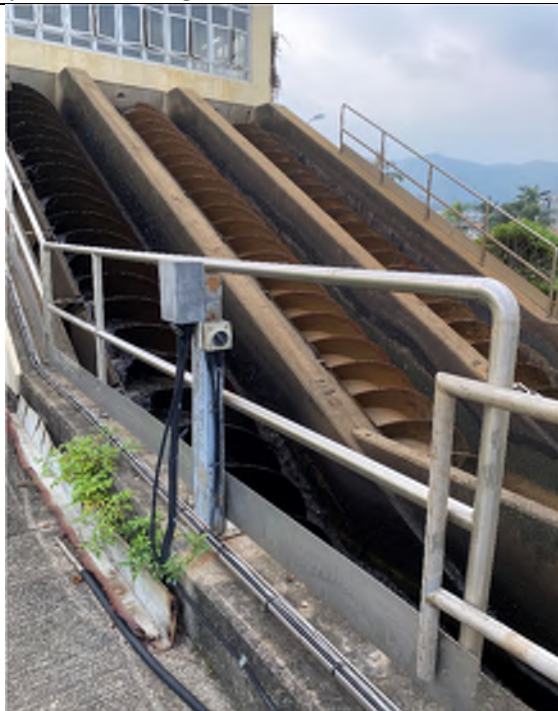
Photo EP-18: Inlet Pumping Station of East Plant (External View of Screw Pumps) – The pumps are located on concrete paved floor at 3.4 m above the ground level. All accessible surfaces around the pumps are paved with concrete, steel panels are installed to prevent spillage. No observation of oil stain/ leakage is anticipated.

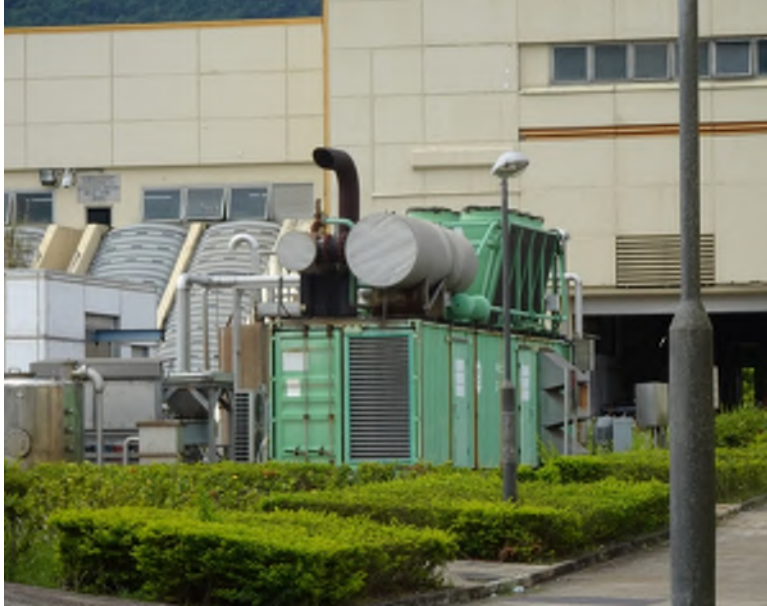
Photo EP-19: Combined Heat and Power Generating System of East Plant – The system is located on concrete paved floor with vegetation surrounding. No stressed vegetation is observed and the system is in good condition with no damage observed. No oil stain/ leakage is observed in the area.

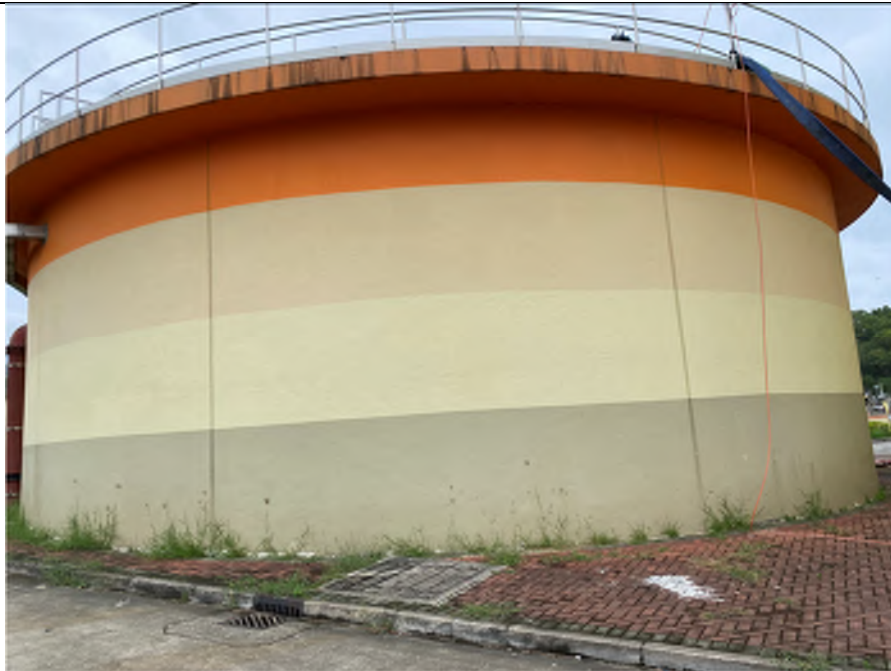
Photo EP-20: Primary Sludge Gravity Thickener of East Plant – The thickener is located on concrete paved floor surrounding by vegetation. The condition of the floor is good, no damage observed, and the gravity thicker is well-maintained. No leakage/ stressed environment is observed.

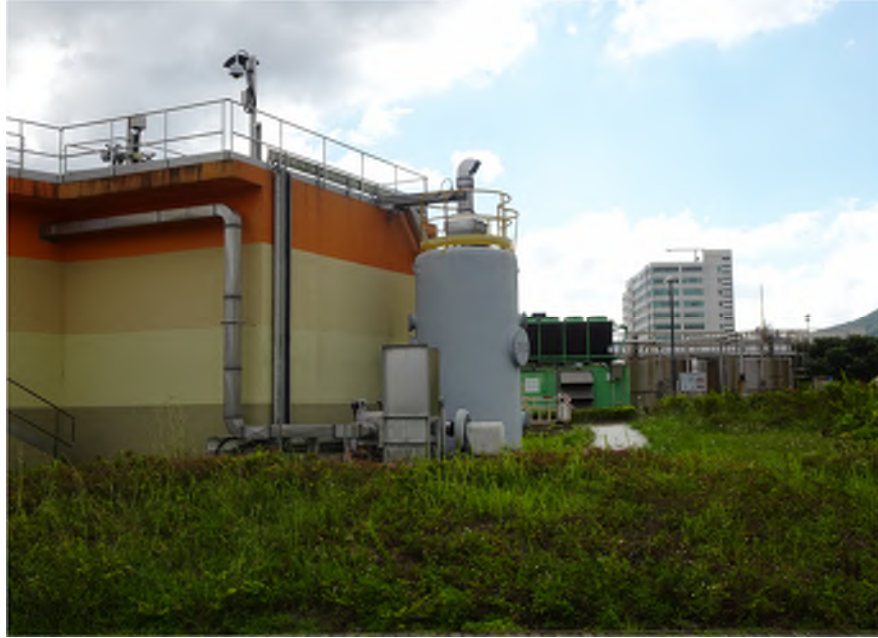
Photo EP-21: Decanting Chamber – The chamber is located on concrete paved floor connecting to the Primary Sludge Gravity Thickener surrounding by vegetation. There is no stressed vegetation/ leakage is observed. The chamber is in good condition where no damage or large area of dirty stain is found.

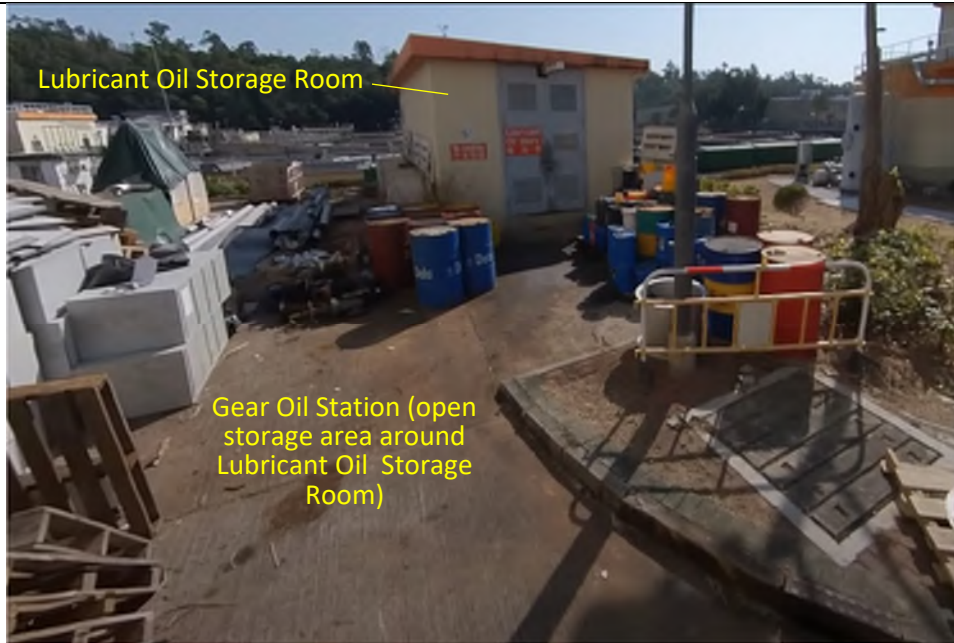
Lubricant Oil Store consists of a Gear Oil Station and a Lubricant Oil Storage Room

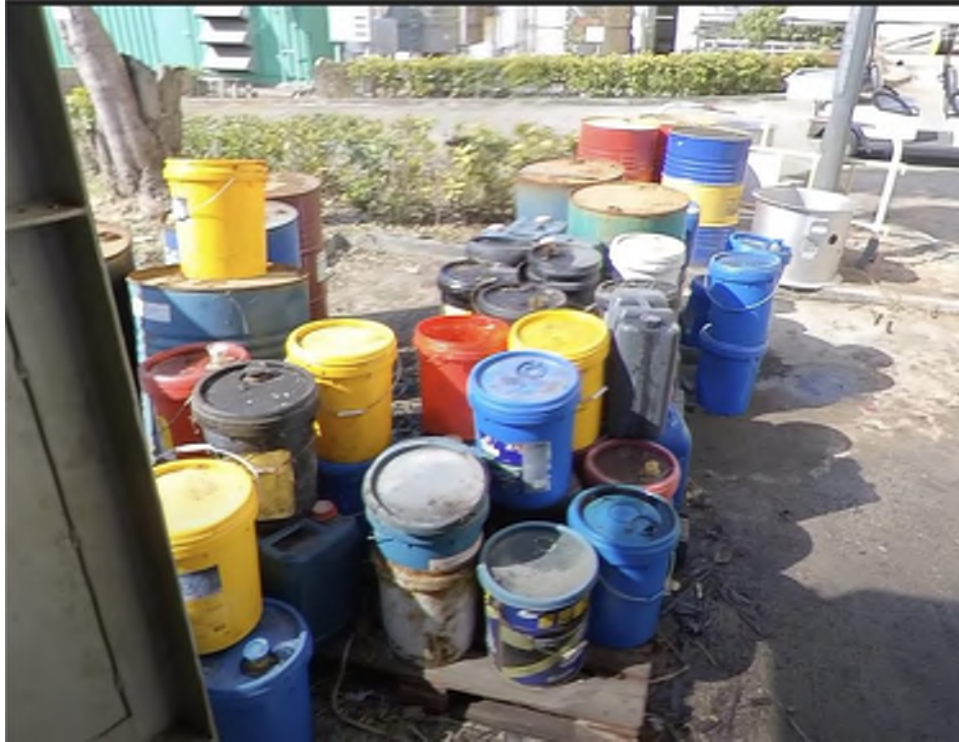
Photo EP-22a: Lubricant Oil Store (Gear Oil Station) - Spent chemical waste is stored in this location.

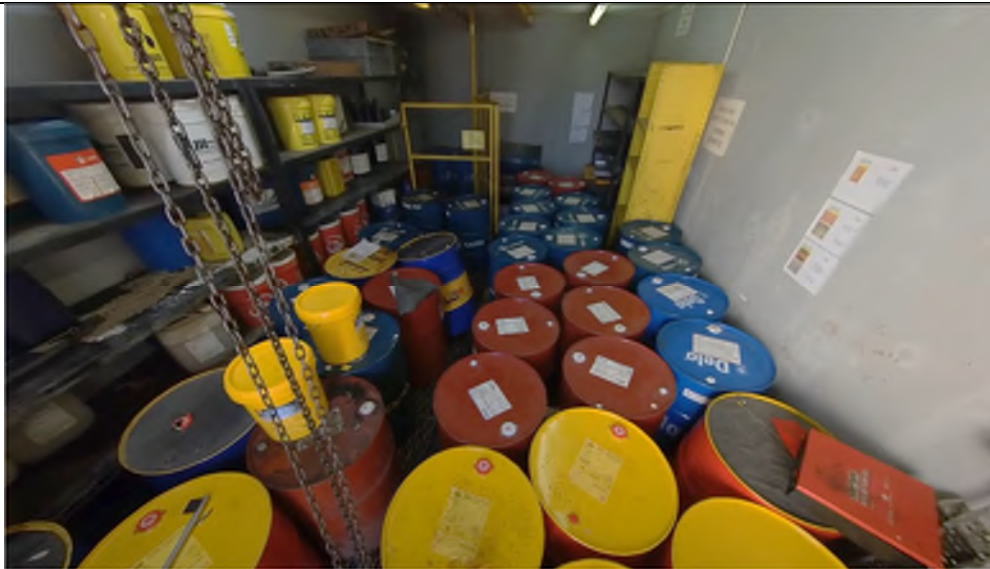
Photo EP-23: Lubricant Oil Store (Lubricant Oil Storage Room) – Lubricant Oil are stored inside the room on steel panel and concrete paved floor. Some Lubricant oil area stored on steel racks. Oil stain /leakage is observed on the floor of the Lubricant Oil Store. Potential land contamination issue is anticipated.

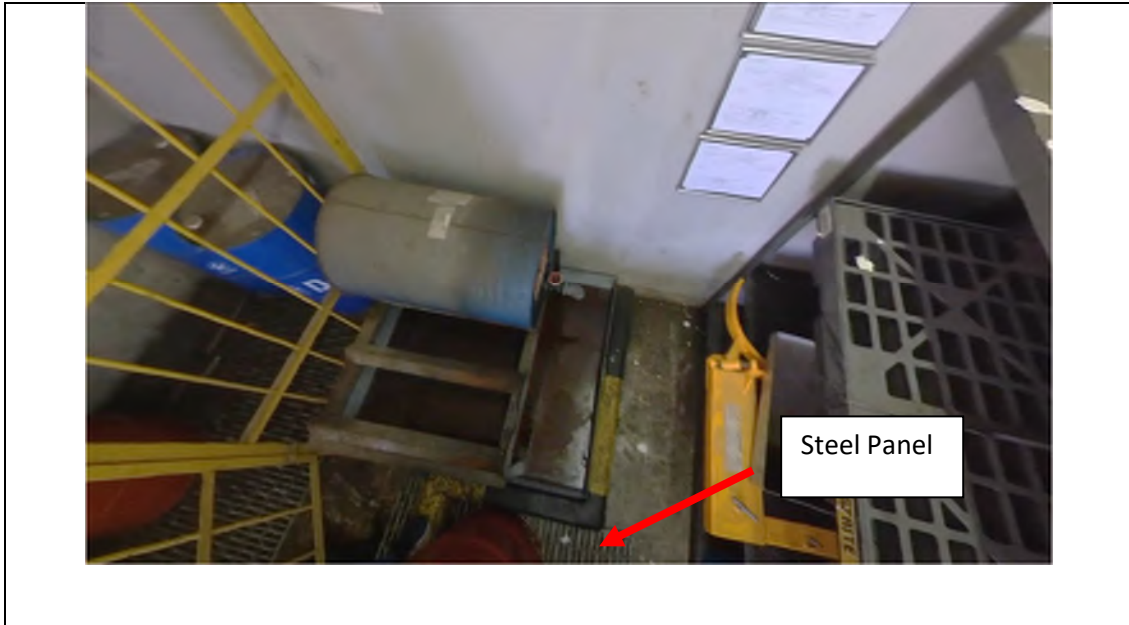
Photo EP-24: Lubricant Oil Store (Lubricant Oil Storage Room) – The floor of the room is paved with concrete and steel panel. Oil stain and leakage is observed on the floor of the storage room. Spillage is observed during the site walk. Potential land contamination issue is anticipated.

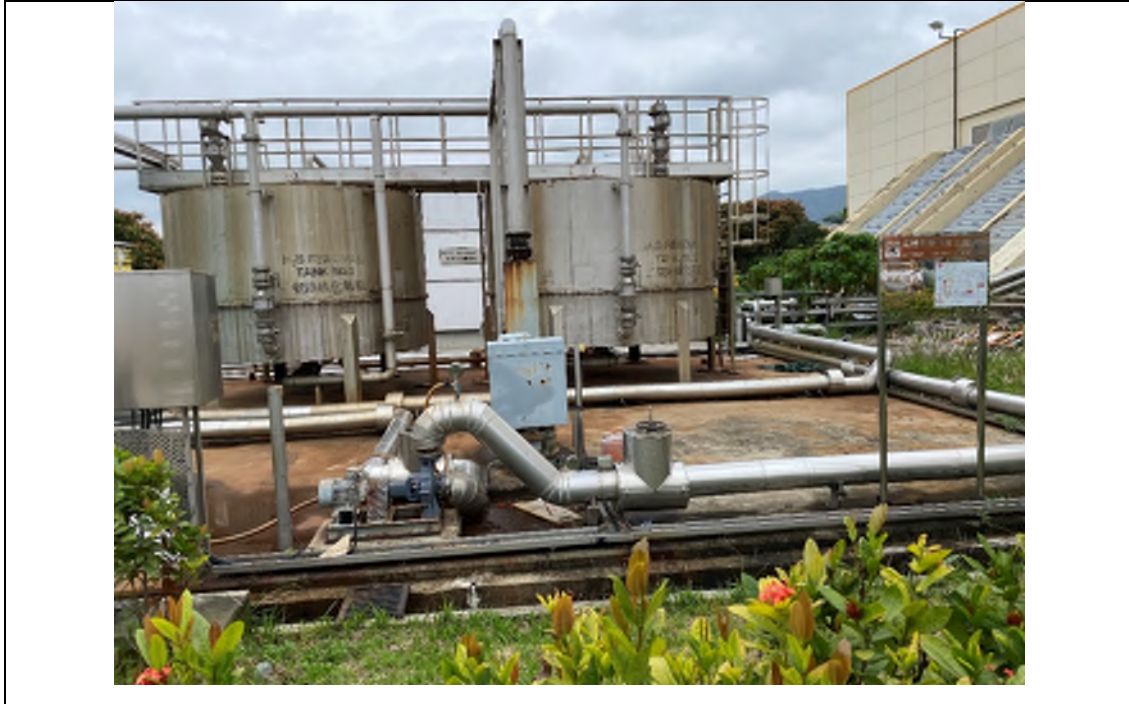
Photo EP-25: Combined Heat and Power Generating System of East Plant – The system is located on concrete paved floor with vegetation surrounding. No stressed vegetation is observed and the system is in good condition with no damage observed. No oil stain/leakage is observed in the area. Rusty stain is observed in this location.

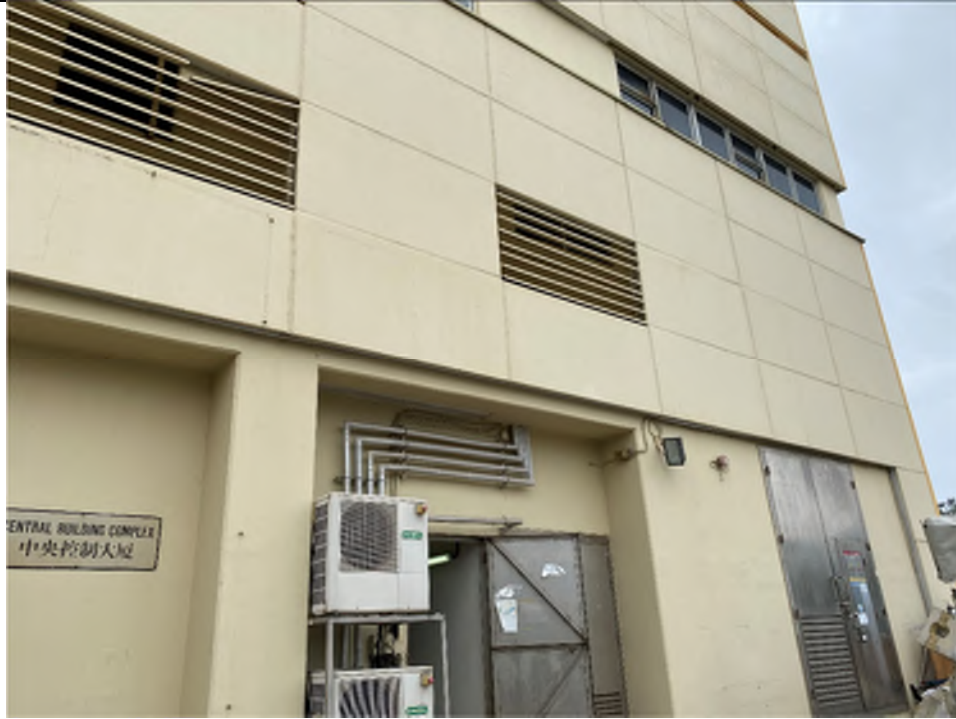
Photo EP-26: Central Building Complex (External View) – The complex is a two-storey building and is located on concrete paved floor. No oil stain/leakage was observed in this location.

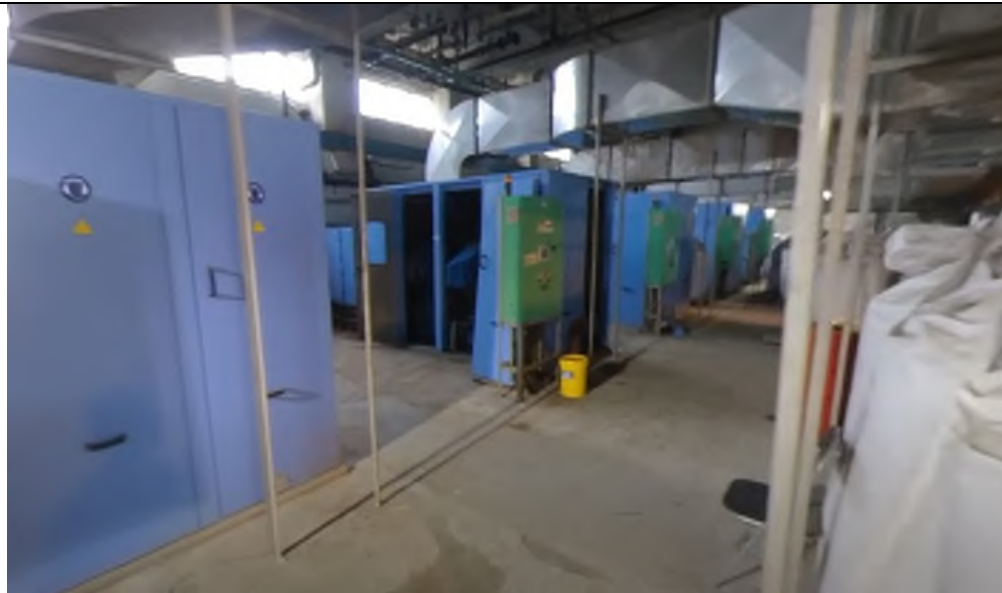
Photo EP-27: Central Building Complex – The Control Panel is located on the first floor of the Central Building Complex on concrete paved floor in good condition. No oil stain/leakage is observed in this location.

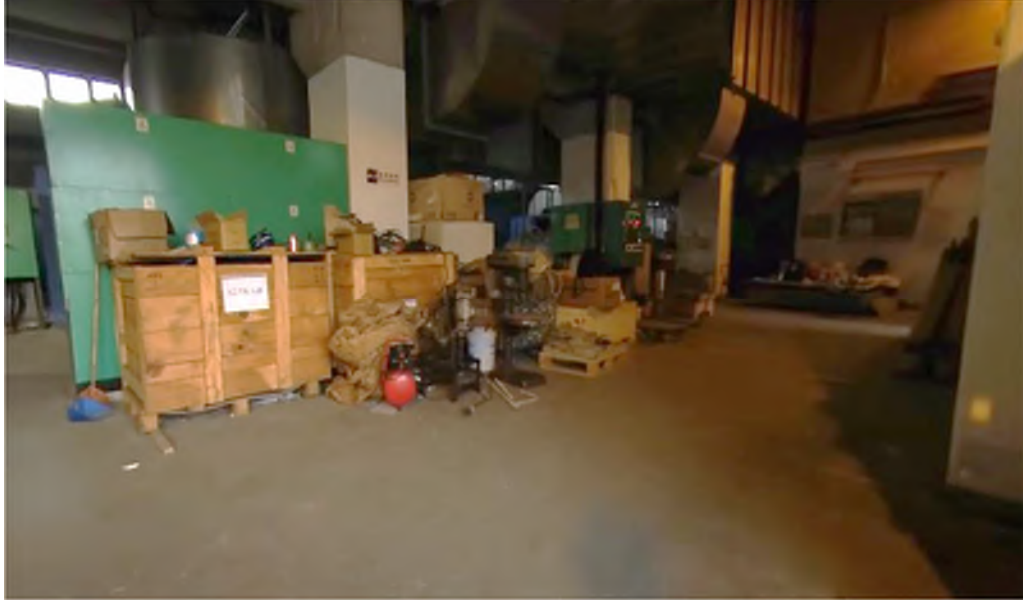
Photo EP-28: Central Building Complex – The first floor of the Central Building Complex is paved with concrete and some equipment were stored here inside the wooden box/on the wooden panel. Some other equipment are placed on the floor. No oil stain/leakage is observed.

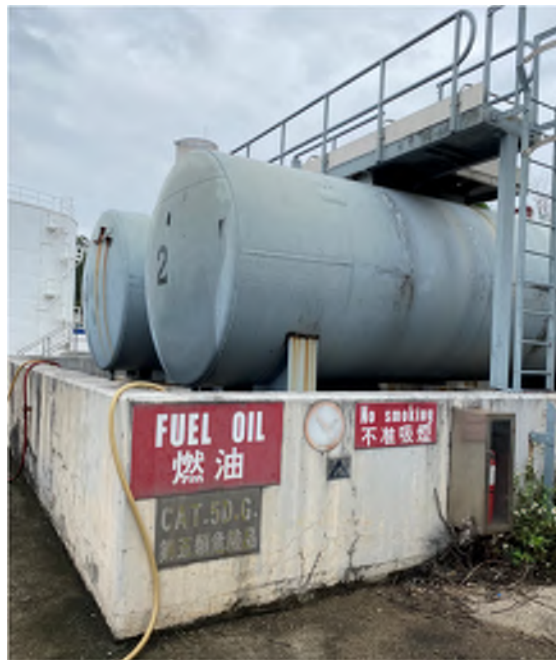
Photo EP-29: Waste Bio-Gas Burner – The burner is located on an elevated platform with concrete slab on concrete paved floor. Fuel oil tanks are within bunded area and protected by concrete slab. No oil stain/ leakage is observed.

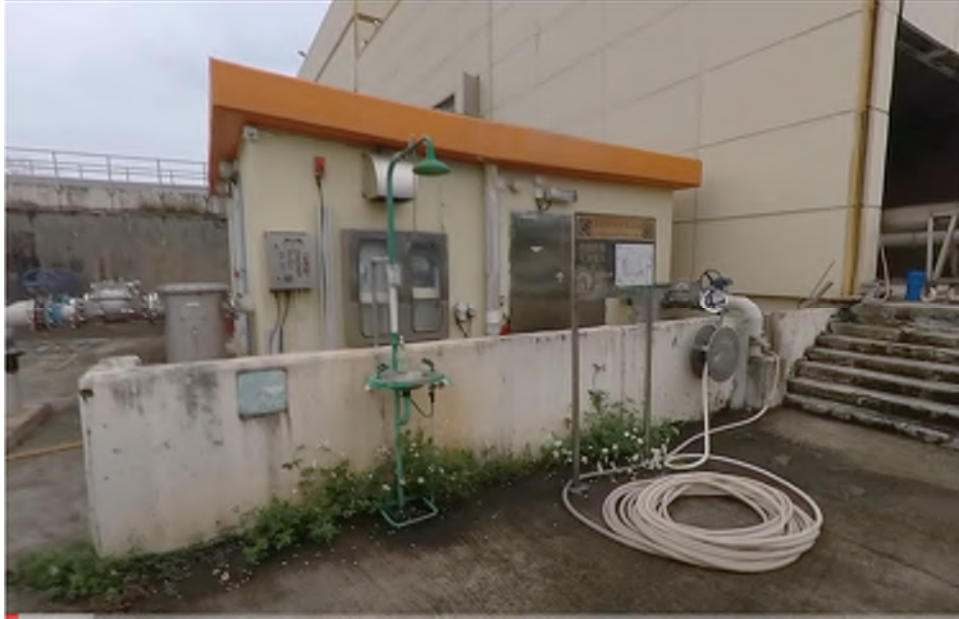
Photo EP-30: Gas Transfer Station – The Gas Transfer Station is located on concrete paved floor next to the Screen House. No oil stain / leakage is observed in this location.

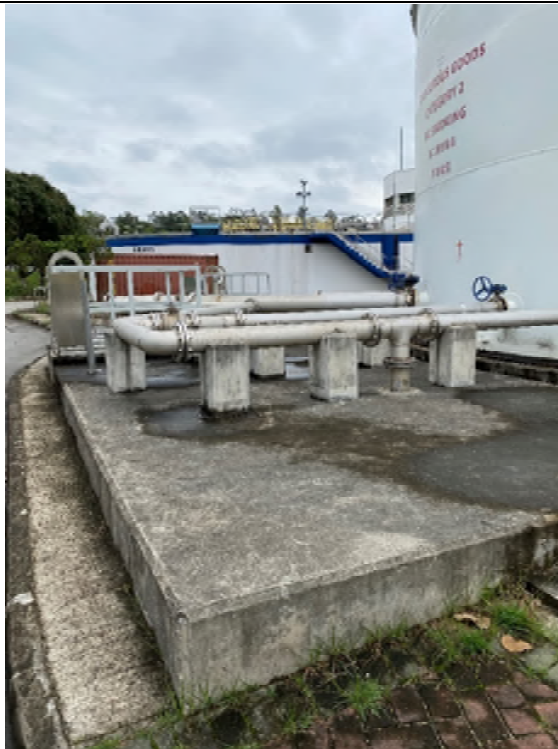
Photo EP- 31: Bio-Gas Holding Tank Valve Chamber – The Ferric Chloride Dosing System is located on elevated platform next to the Bio-gas Holding Tank. Water stain is observed, no oil stain/leakage is observed.

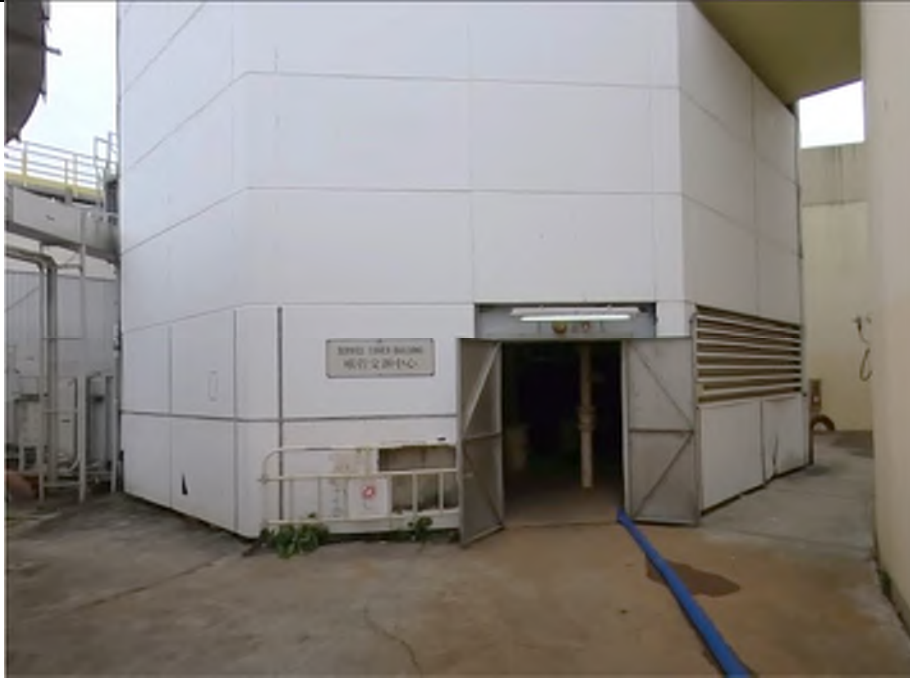
Photo EP-32: External View of the Service Tower Building – The Service Tower Building is located on concrete paved floor, it is a three-storey building. No oil stain/leakage is observed.

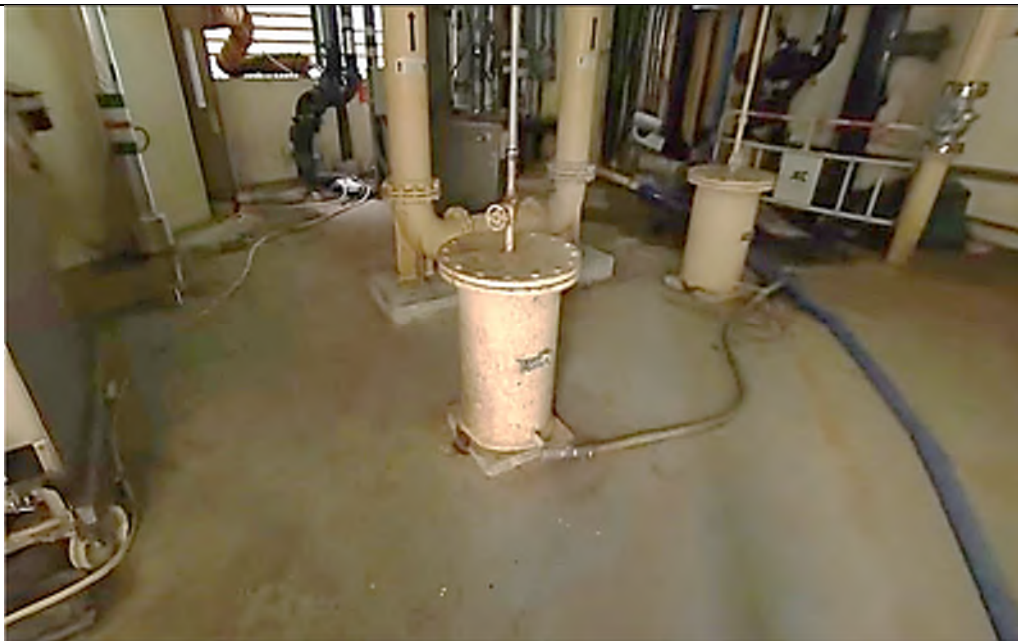
Photo EP-33: Service Tower Building – The ground floor of the Service Tower Building is paved with concrete. Pumps are connected to the Sludge Digestion Tanks of East Plant outside the Tower. Rusty stain is observed, no oil stain/ leakage is observed.

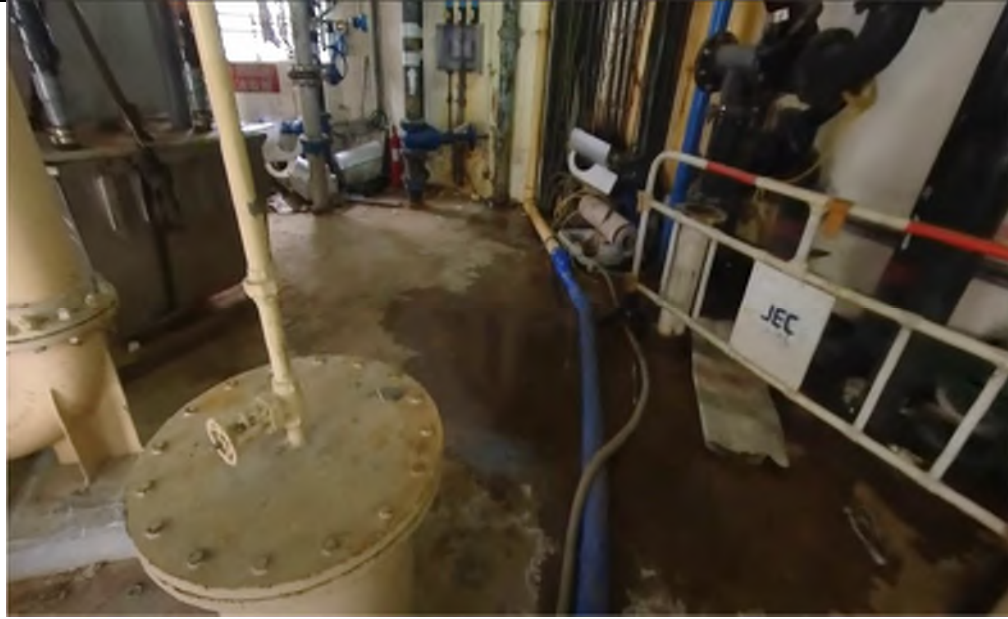
Photo EP-34: Service Tower Building - The ground floor of the Service Tower Building is located on concrete paved floor. Water stain is observed due to handling of sludge. No oil stain/leakage is observed.

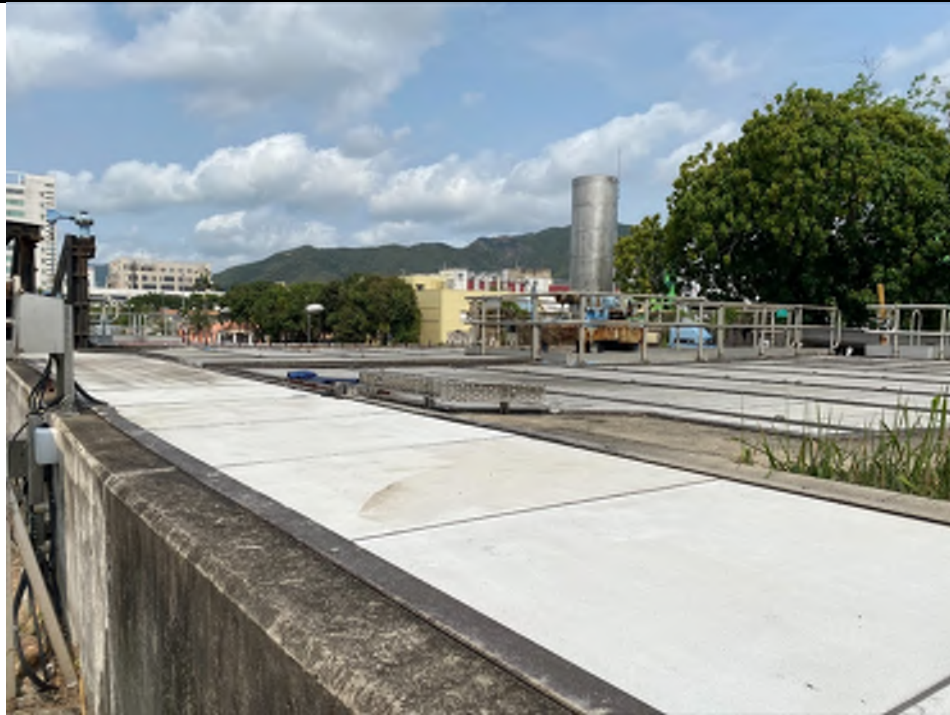
Photo EP-37: Detritors – The 2 Detritors are located on elevated slope with a concrete paved platform surrounding by vegetation. No oil stain/ leakage is observed.

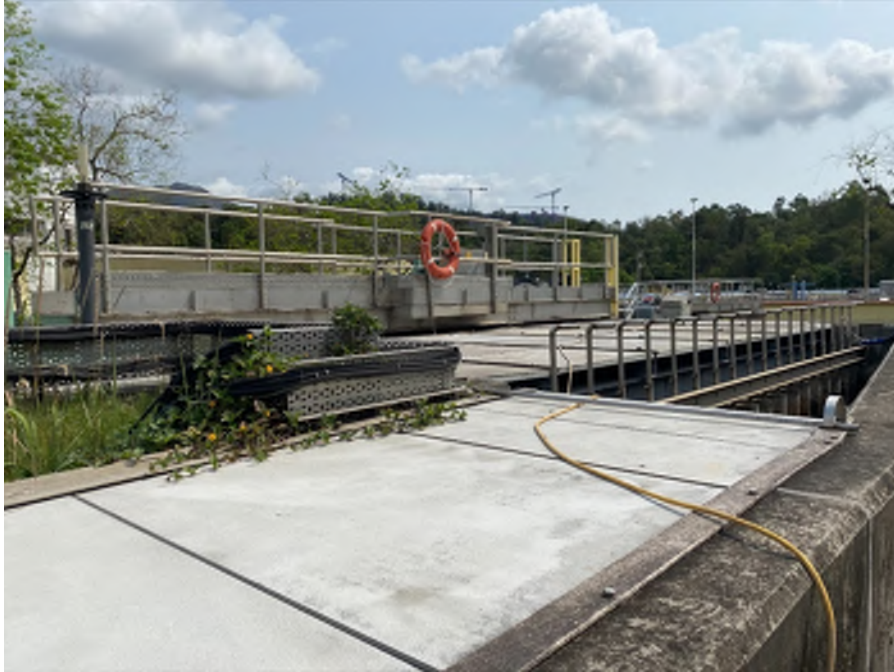
Photo EP-38: Primary Sedimentation Tank Distribution Chamber – The Primary Sedimentation Tank Distribution Chamber is connected to the two Detritors on the elevated slope with a concrete paved platform surrounding by vegetation. No oil stain/ leakage is observed.

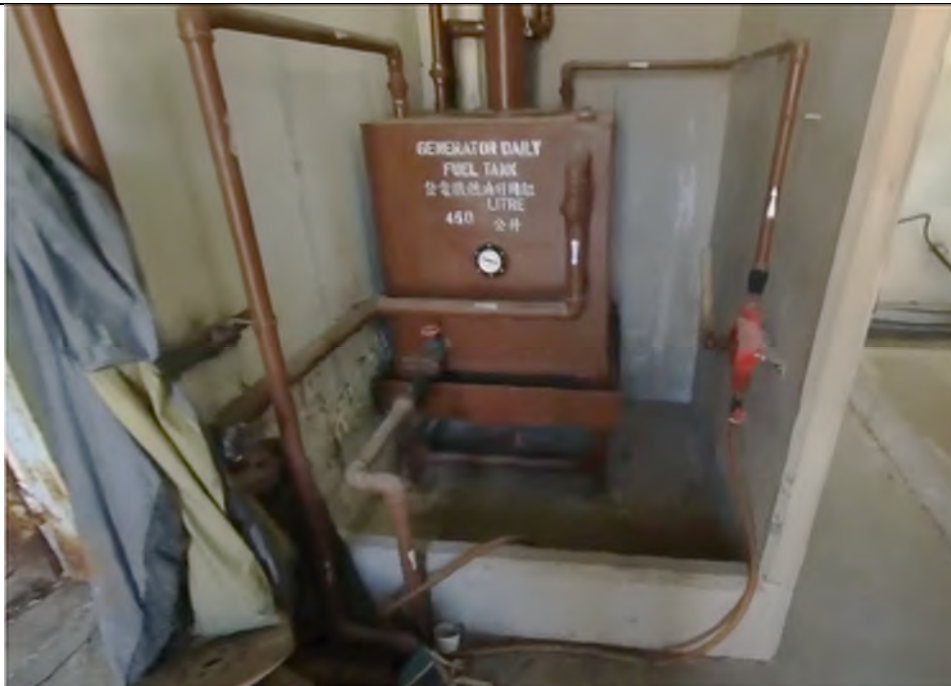
Photo EP-39: Screen House – One Generator Daily Fuel Tank (450 L) Is located within the Screen House. The floor is paved with concrete slab. The Generator Daily Fuel Tank is located in bund wall constructed with an elevated concrete platform. No oil stain/leakage is observed in this located.

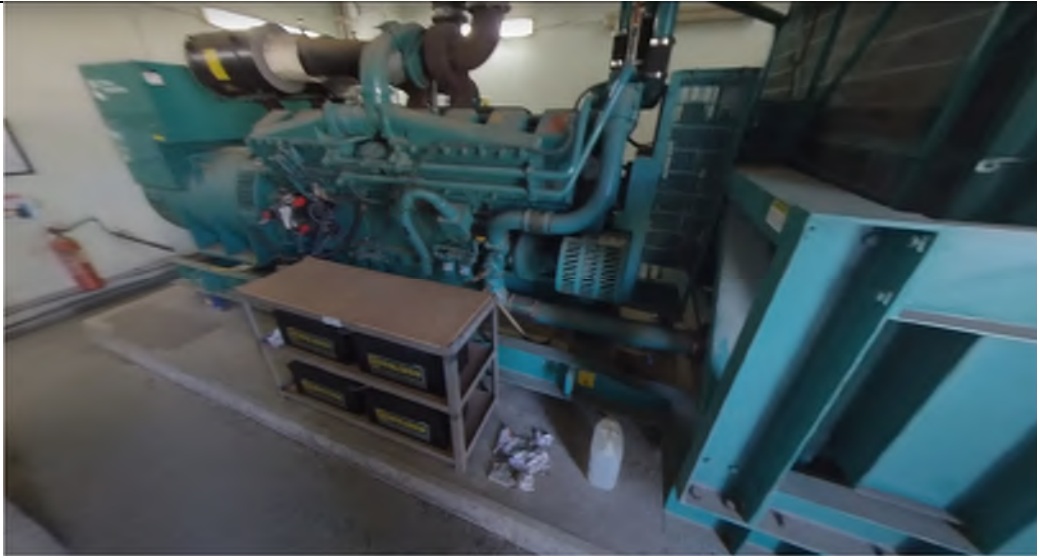
Photo EP-40:Screen House –Emergency generators are located within the Screen House. The floor is paved with concrete slab next to the Generator Daily Fuel Tank on elevated concrete paved platform. No oil stain/leakage is observed in this located.

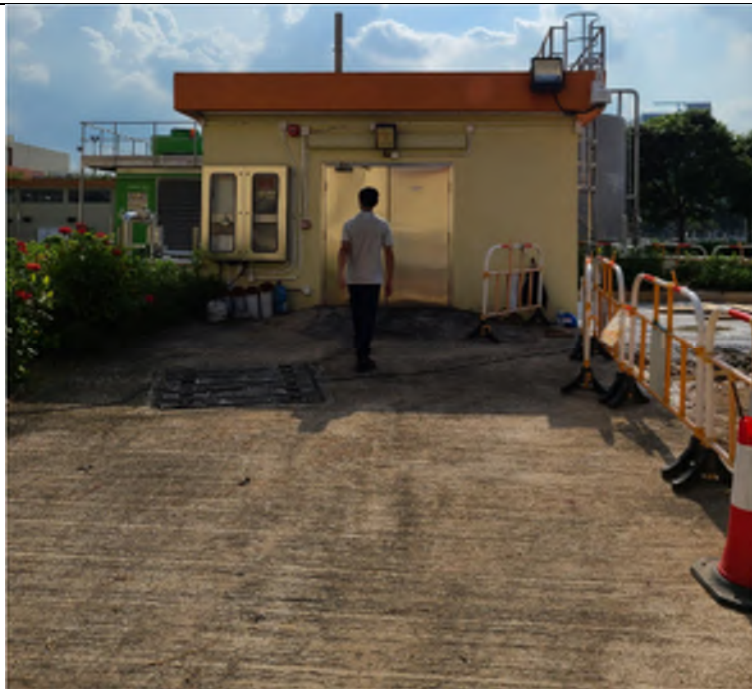
Photo EP-41: Chemical Store – The chemical store is located on concrete paved floor. No oil stain/ leakage is observed.

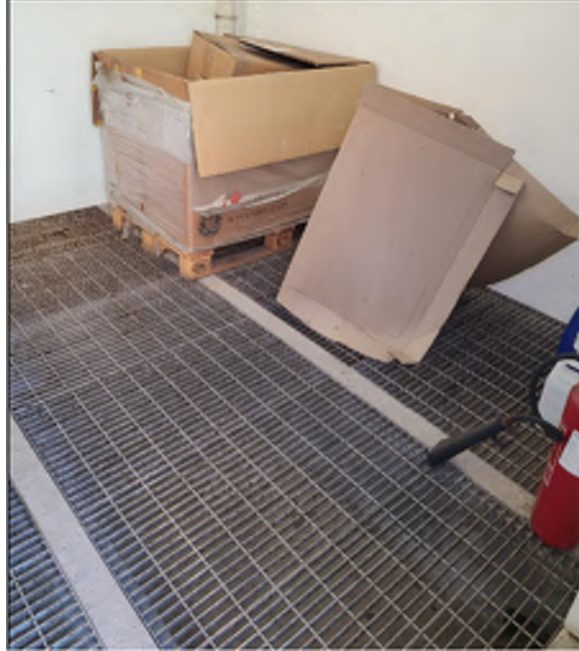
Photo EP-42: Chemical Store – Leatheroid are found on steel panel inside the chemical store above concrete paved floor. Some leatheroid are located on wooden panel. No oil stain/leakage is observed.

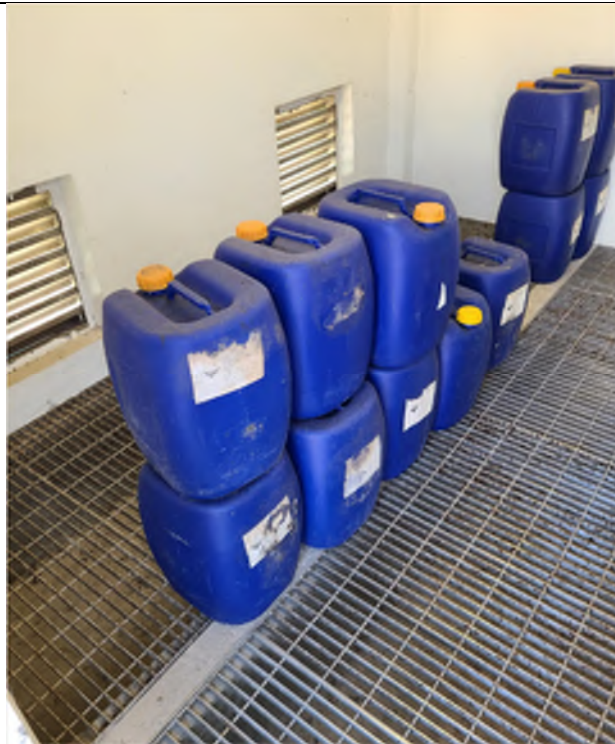
Photo EP-43: Chemical Store –Caustic Soda (about 14 drums) are found inside the chemical store on steel panel above the concrete paved floor. No oil stain/leakage is observed.

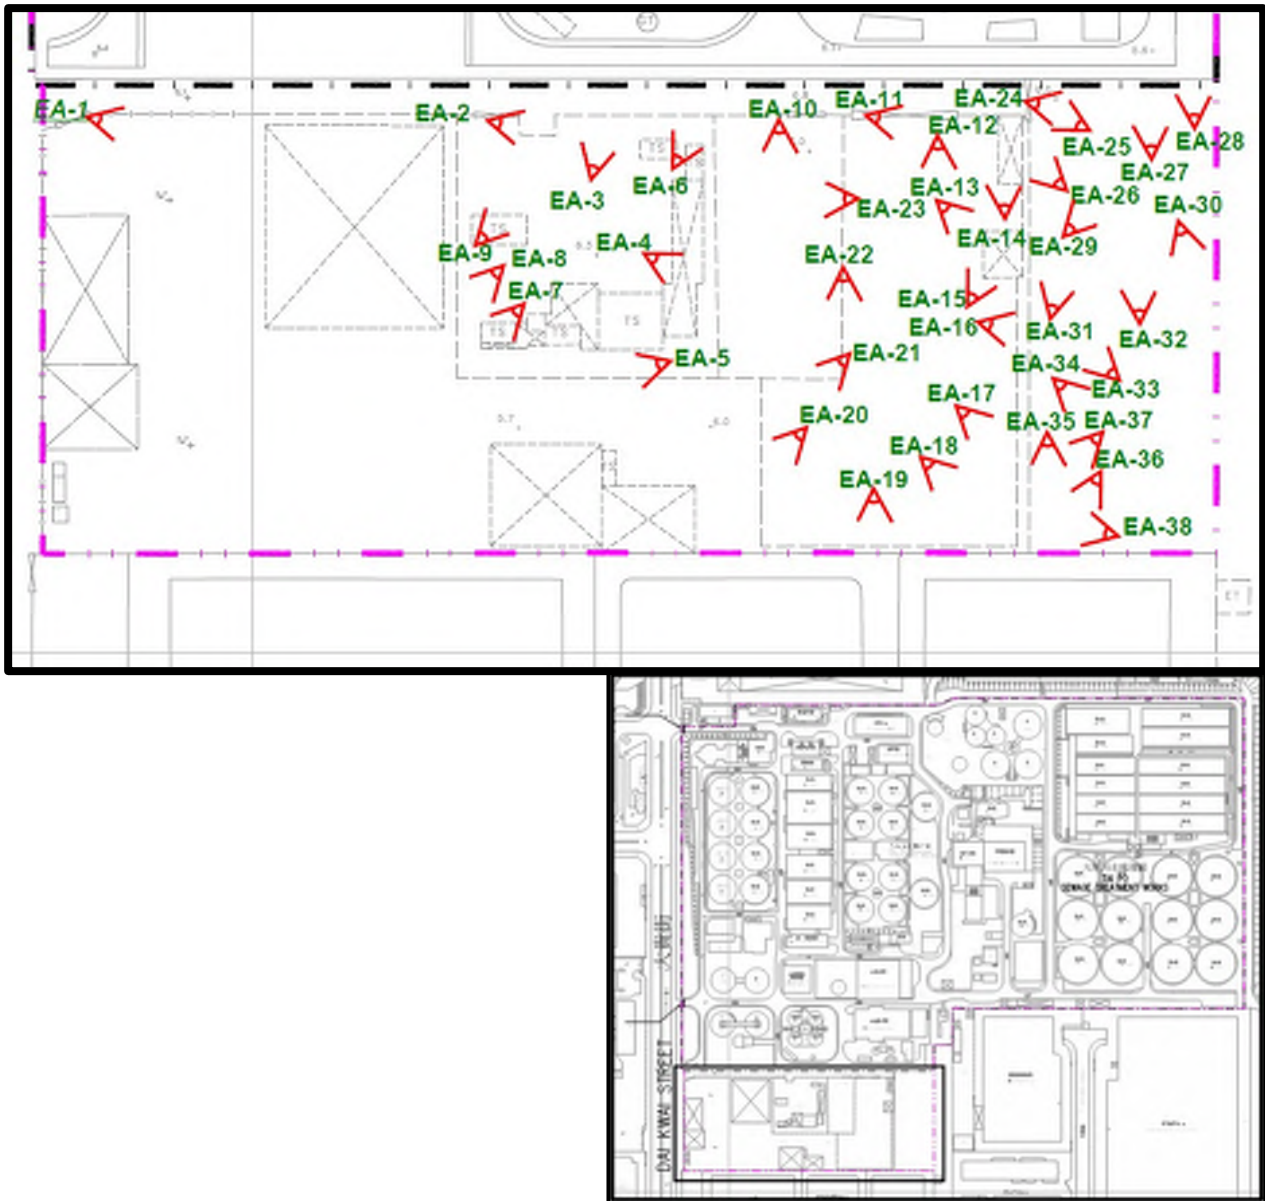
Proposed Expansion Site – Index Plan

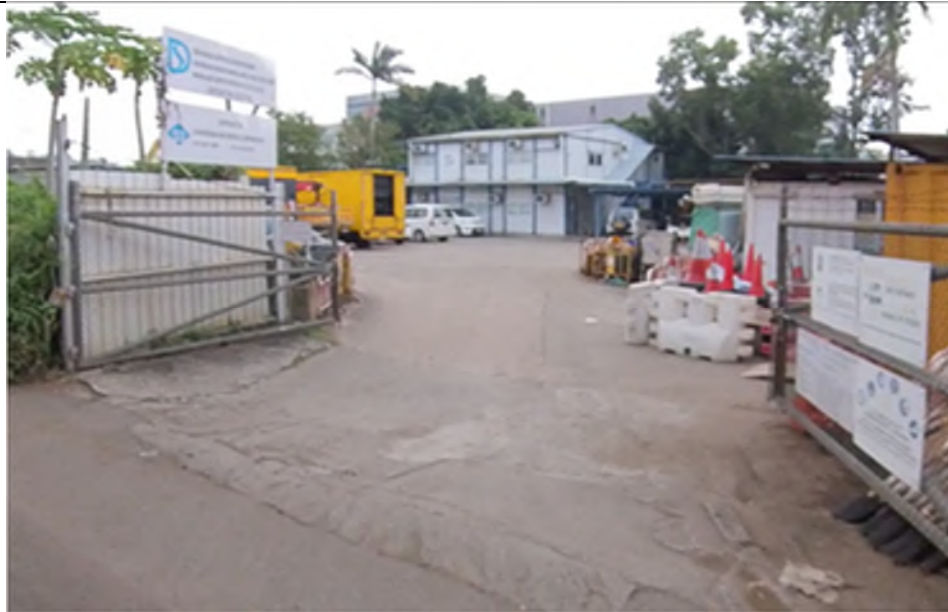
Photo EA-2: Lot No. GLA-TPP 776 - Existing DSD's and Contractor's Site Office (Entrance) – The floor is paved with concrete with no oil stain/stressed vegetation observed.

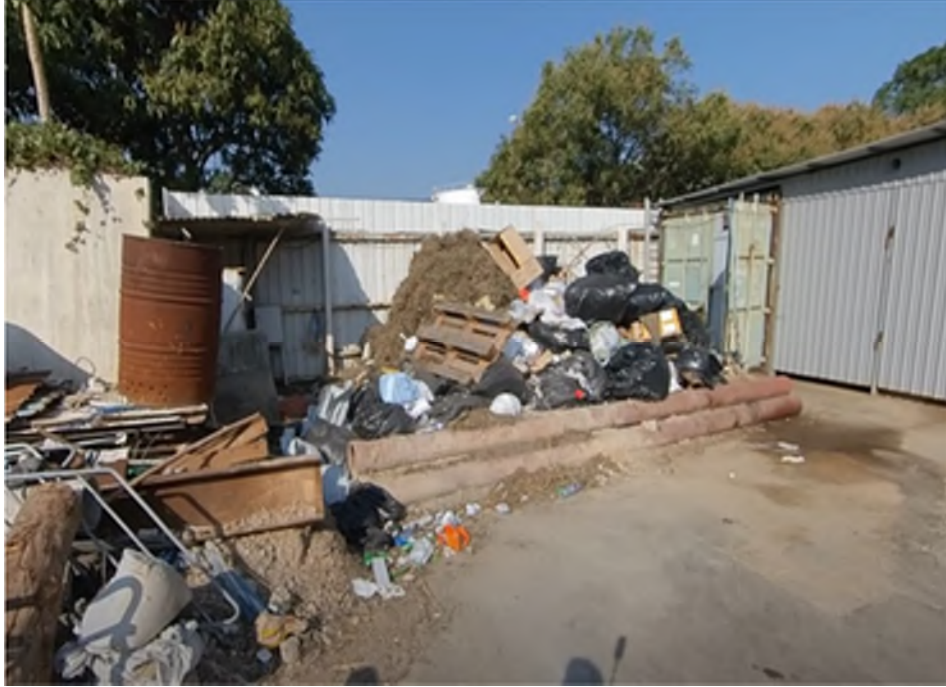
Photo EA-3: Lot No. GLA-TPP 776 – Existing DSD’s and Contractor’s Site Office (Waste Storage Area) – General waste and garbage are stored on concrete paved floor with no leakage. No chemical storage is allowed in the area.

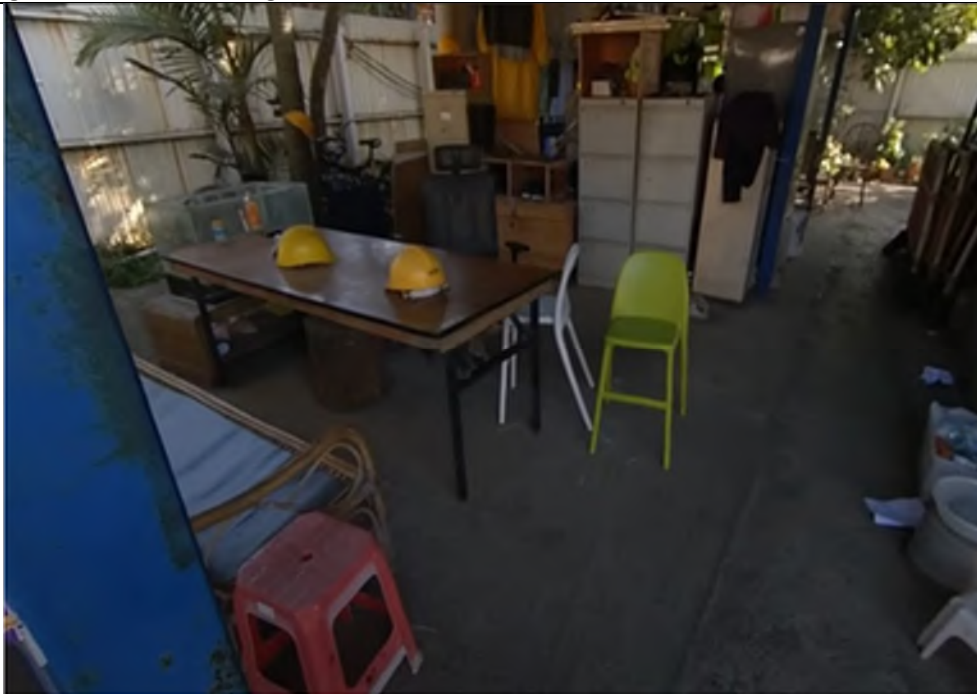
Photo EA-4: Lot No. GLA-TPP 776 – Existing DSD’s and Contractor’s Site Office (Staff Resting Area) – The area is paved with concrete floor with no oil stain observed.

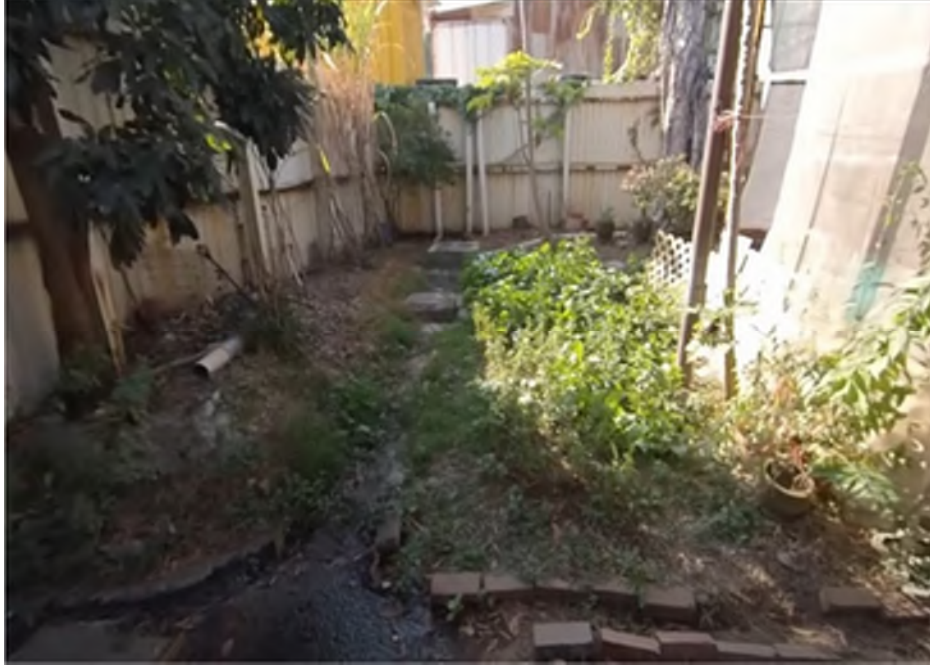
Photo EA-5: Lot No. GLA-TPP 776 - Existing DSD's and Contractor's Site Office (Planting Area) – The planting area is in good condition, no oil stain/stressed vegetation is observed.

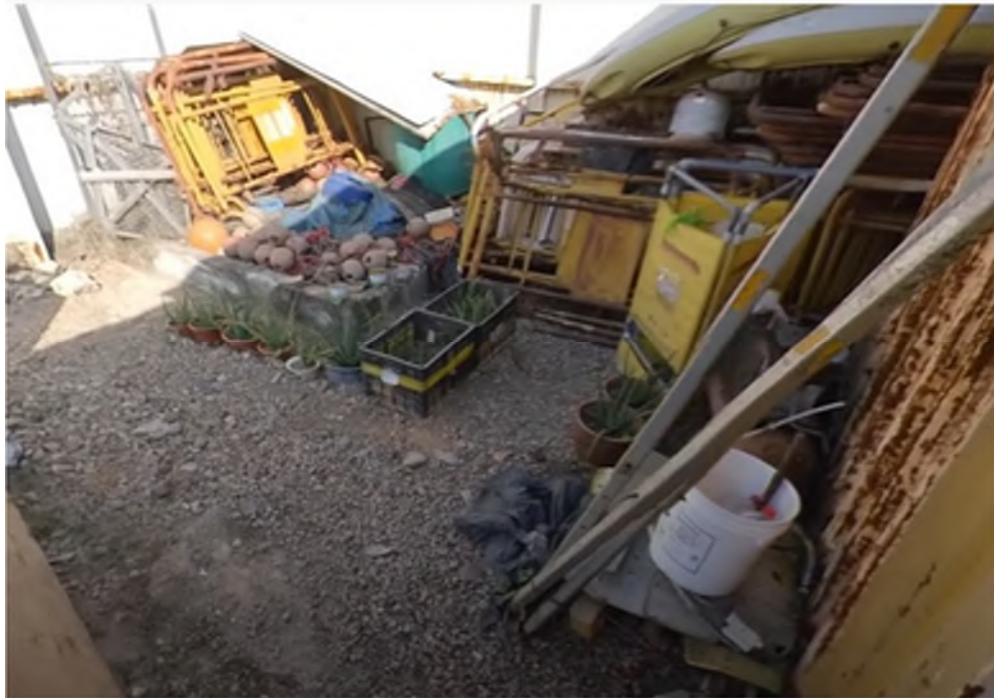
Photo EA-6: Lot No. GLA-TPP 776 - Existing DSD's and Contractor's Site Office (Storage Area) - No oil stain/stressed vegetation is observed. No chemical storage is allowed in the area.

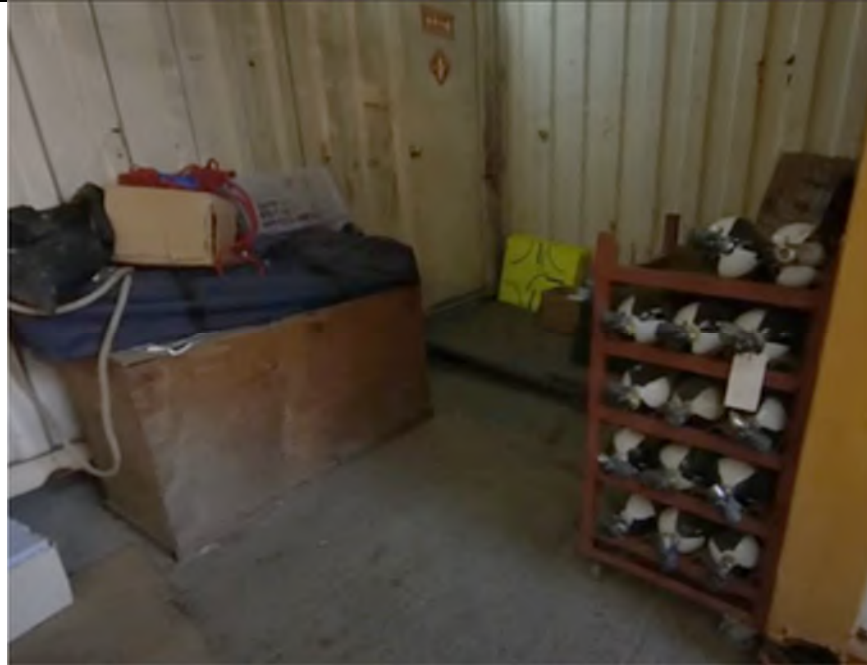
Photo EA-7: Lot No. GLA-TPP 776 - Existing DSD's and Contractor's Site Office (Storage Area) – Equipment are stored on racks. The floor is paved with concrete in good condition. No oil stain is observed. No chemical is stored in the area.
