CONTAMINATION ASSESSMENT PLAN (FINAL)

Upgrading of Tai Po Sewage Treatment
Works – Investigation

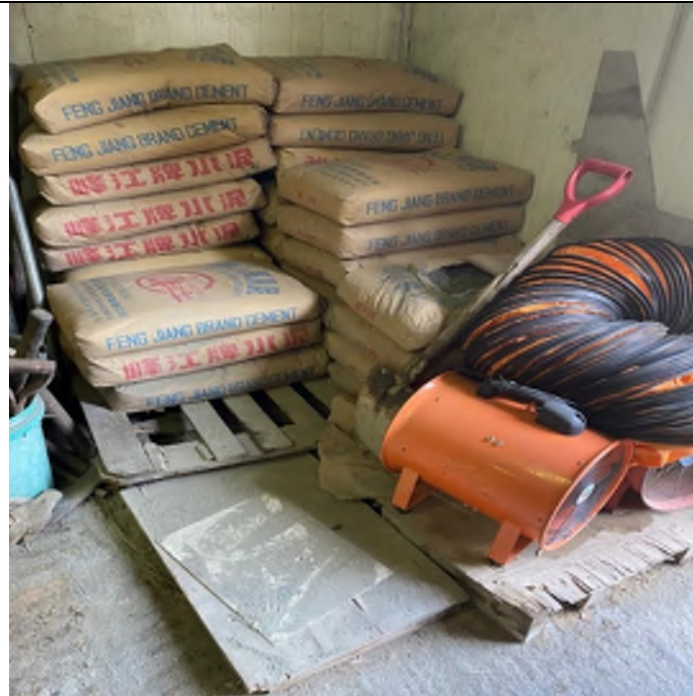
Photo EA-8: Lot No. GLA-TPP 776 - Existing DSD's and Contractor's Site Office (Store Room) – The tools and cement are placed on wood panel, and the floor is paved with concrete . No oil stain/ floor leakage is observed. No chemical is stored in the area.

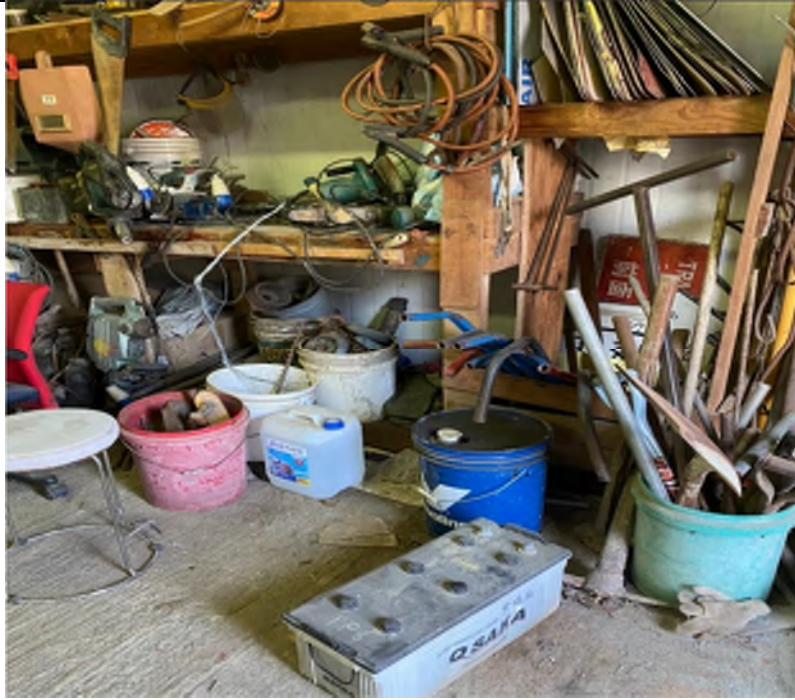
Photo EA-9: Lot No. GLA-TPP 776 - Existing DSD's and Contractor's Site Office (Store Room) -Tools are stored on the racks and in the plastic buckets. The floor is paved with concrete. No oil stain/ floor leakage is observed. No chemical is stored in the area.

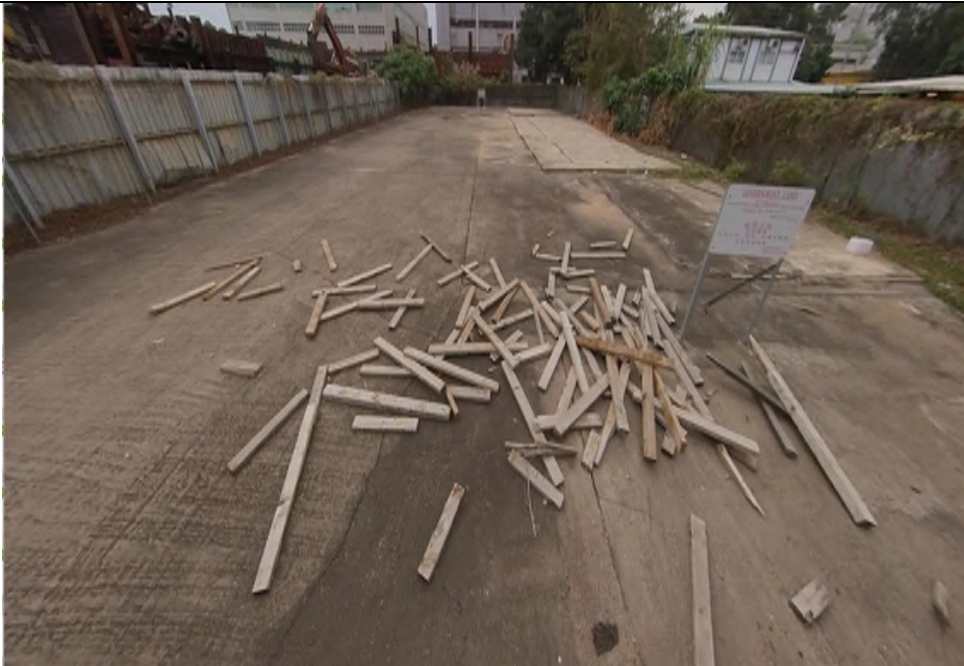
Photo EA-10: Existing Vacant Land (Previously Lot No. GLA-TPP 786 - CEDD's Site Office) – The land is paved with concrete floor in good condition with no oil stain observed.

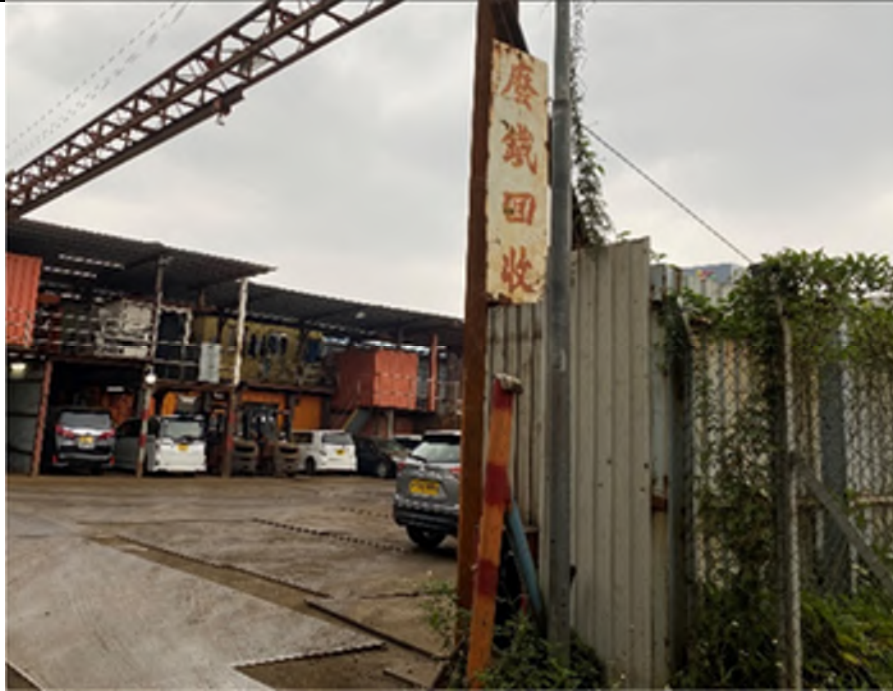
Photo EA-11: Lot No. STT 1450 - Existing C & H Import & Export Co. (Entrance) – The floor is paved with concrete and covered with iron shard. Cars were parked in the area.

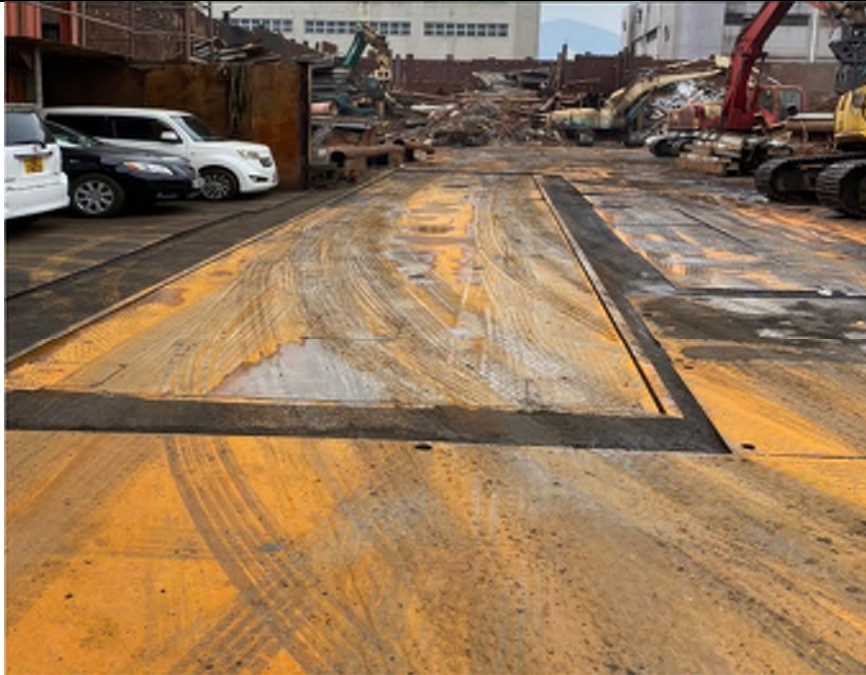
Photo EA-12: Lot No. STT 1450 – Existing C & H Import & Export Co. – The site floor (viewing from entrance) is paved with concrete and covered with iron shard. Large machineries were operated on-site. Stockpiles of metal wastes were observed.

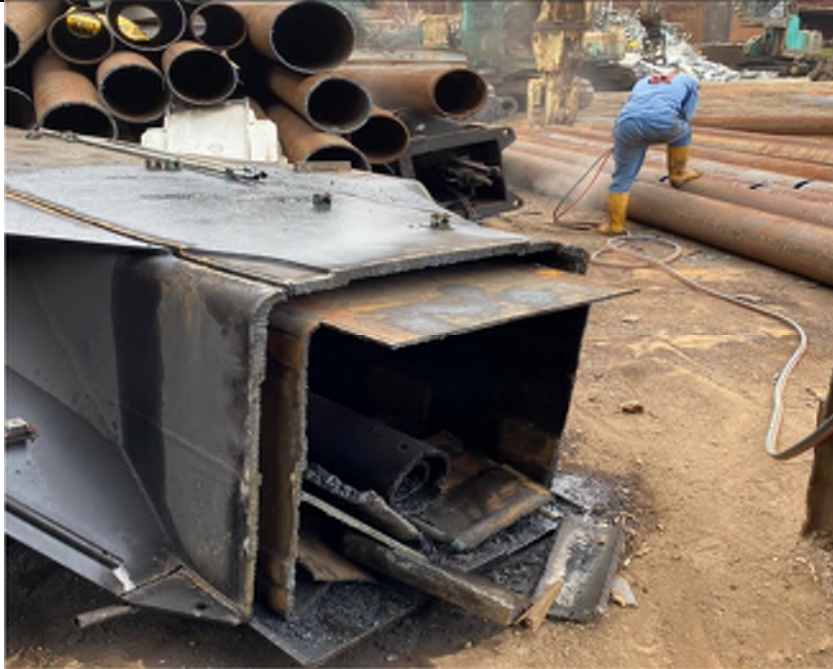
Photo EA-13: Lot No. STT 1450 - Existing C & H Import & Export Co. - Metal wastes were lying around the site. Most ground surfaces were covered with wastes and debris.

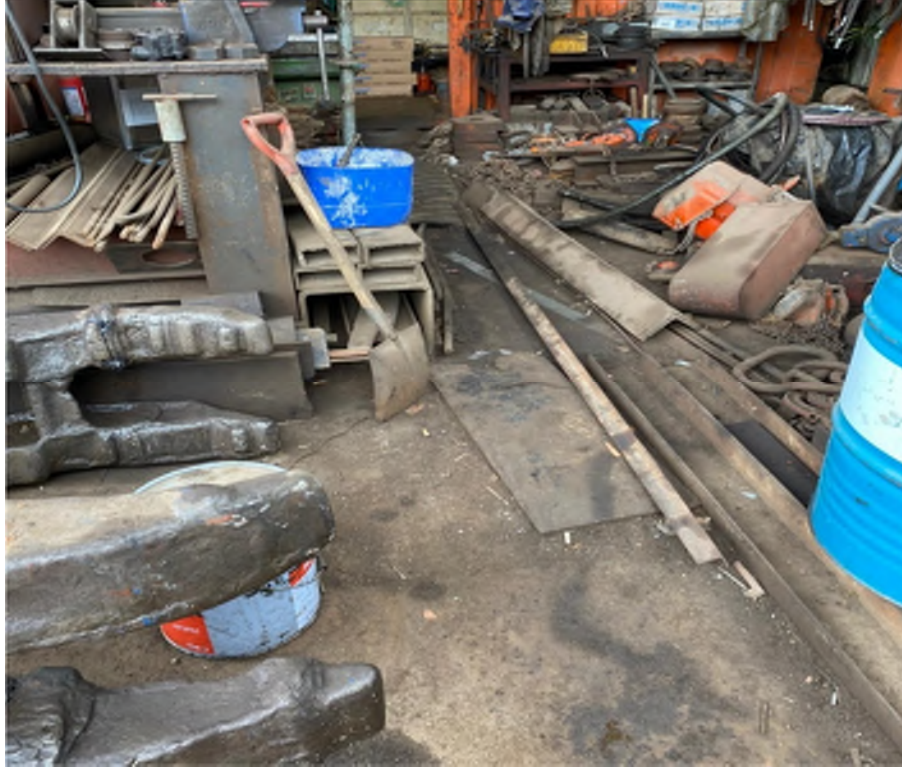
Photo EA-15: Lot No. STT 1450 - Existing C & H Import & Export Co. – Material storage area was observed

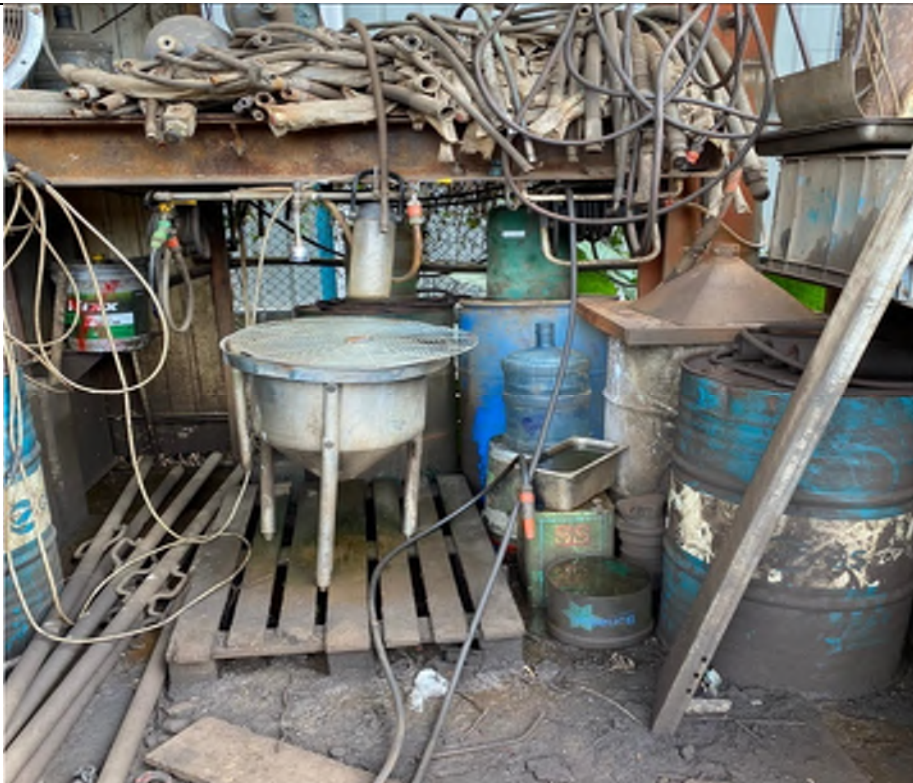
Photo EA-16: Lot No. STT 1450 - Existing C & H Import & Export Co. - Material storage area was observed

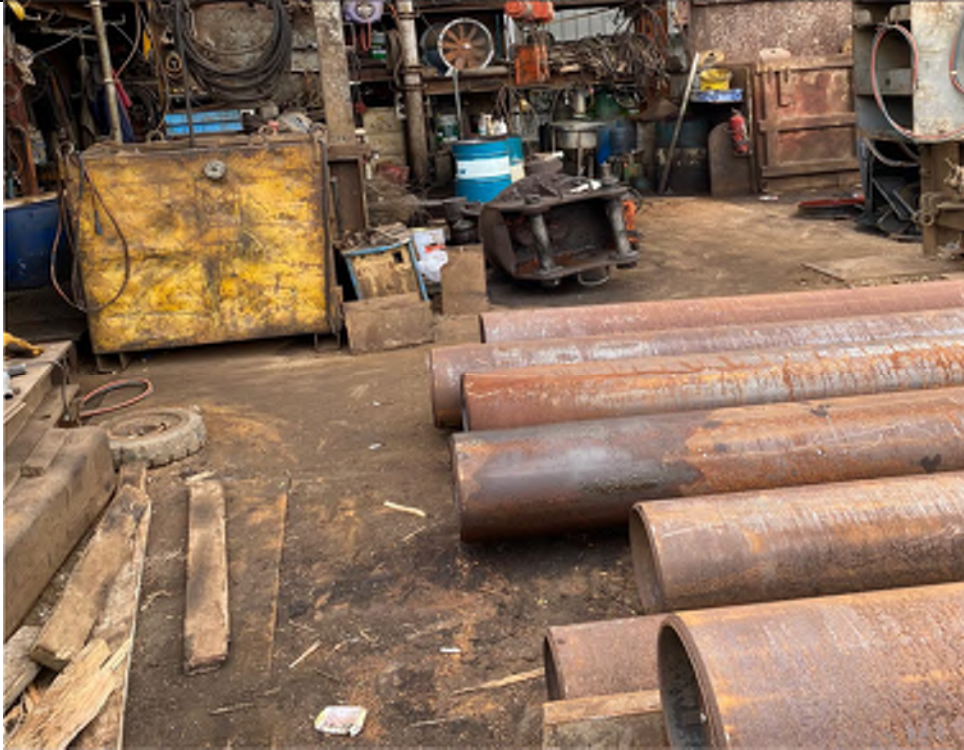
Photo EA-17: Lot No. STT 1450 - Existing C & H Import & Export Co. – Most of the site surfaces were covered with equipment, wastes, debris and dirt.

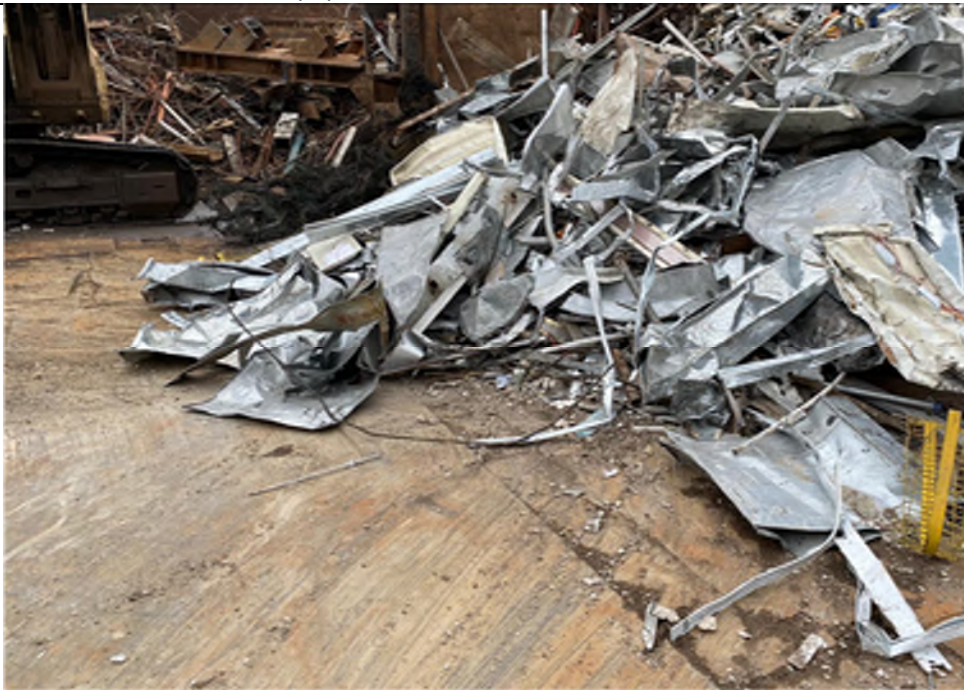
Photo EA-18: Lot No. STT 1450 - Existing C & H Import & Export Co. – Open stockpiles of metal wastes were observed.

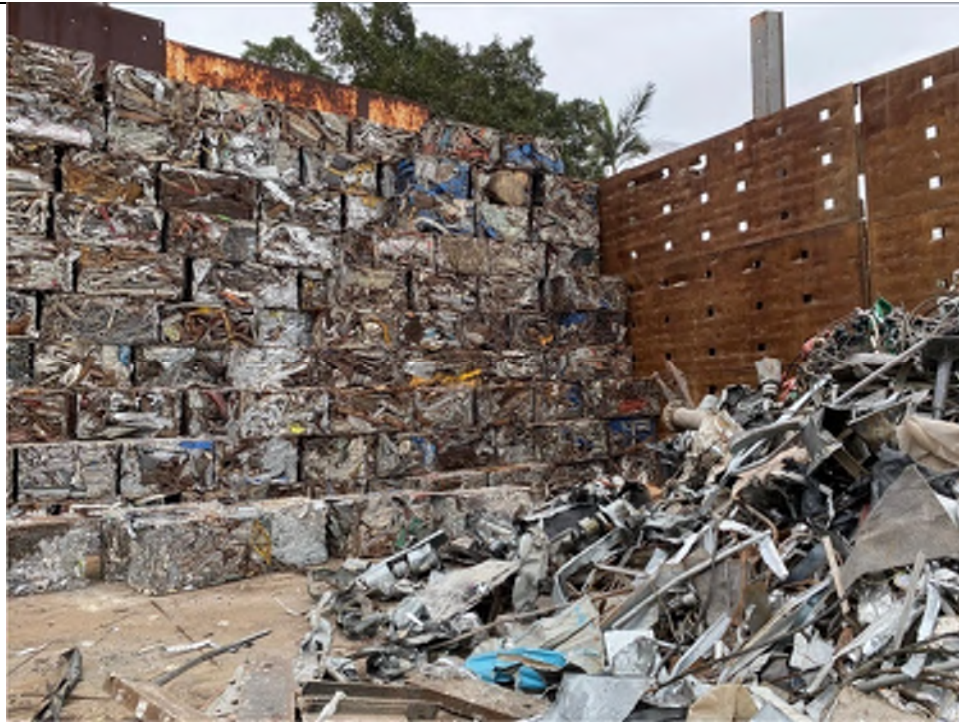
Photo EA-19: Lot No. STT 1450 - Existing C & H Import & Export Co. – Open stockpiles of metal wastes were observed.

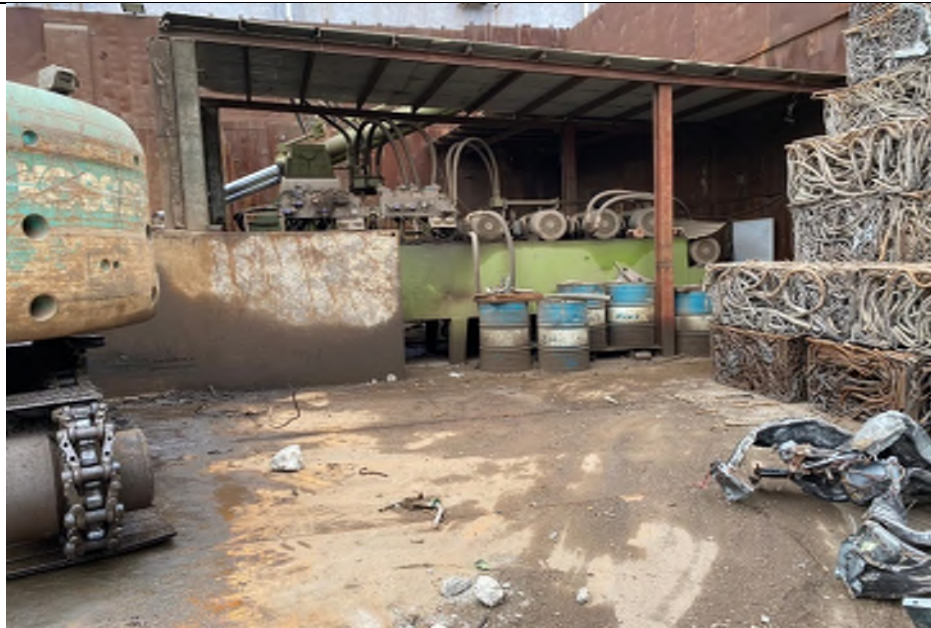
Photo EA-20: Lot No. STT 1450 - Existing C & H Import & Export Co. – Engine oils (stored in tanks) were placed at the edge of a sheltered area together with other large pieces of equipment and tools, with no bund wall and no secondary containment. Stockpiles of metal wastes and machineries were found in open area.

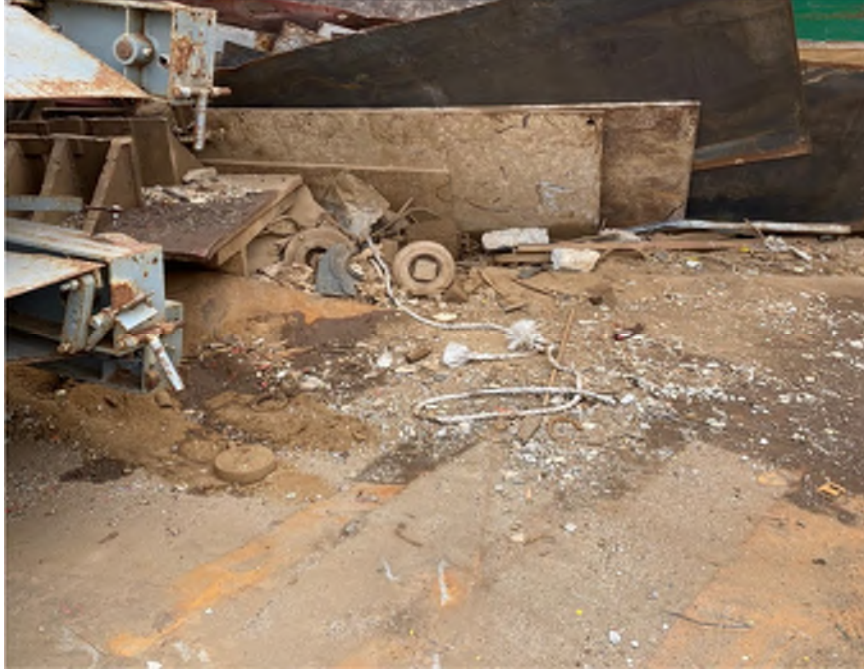
Photo EA-21: Lot No. STT 1450 - Existing C & H Import & Export Co. – Metal wastes and debris were observed in open site area.

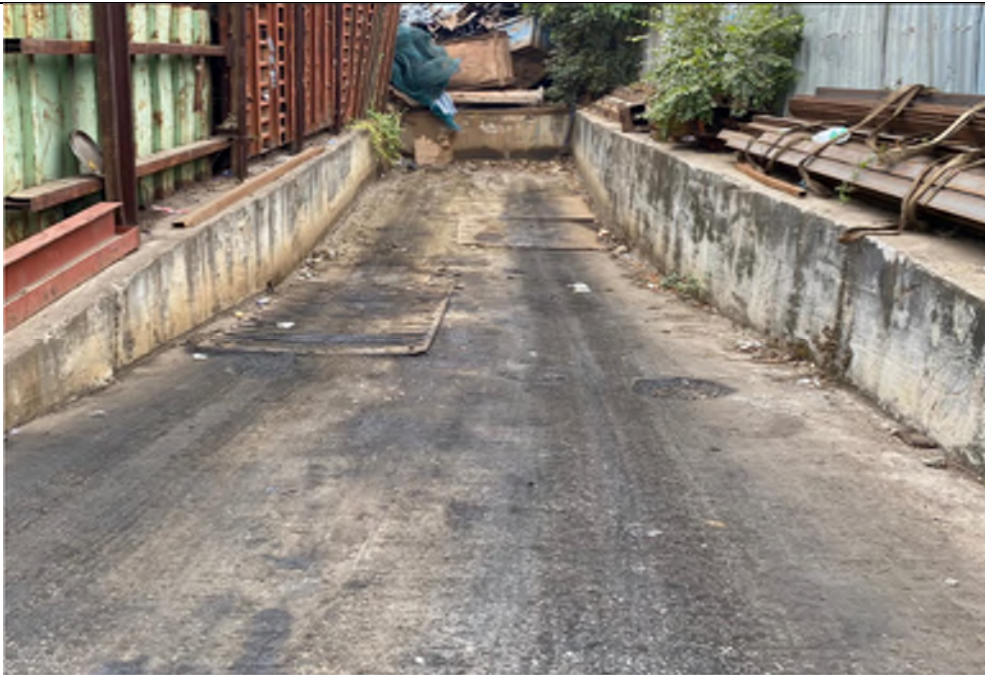
Photo EA-22: Lot No. STT 1450 - Existing C & H Import & Export Co. – Car road is paved with concrete. Debris and stains were observed on road surfaces.

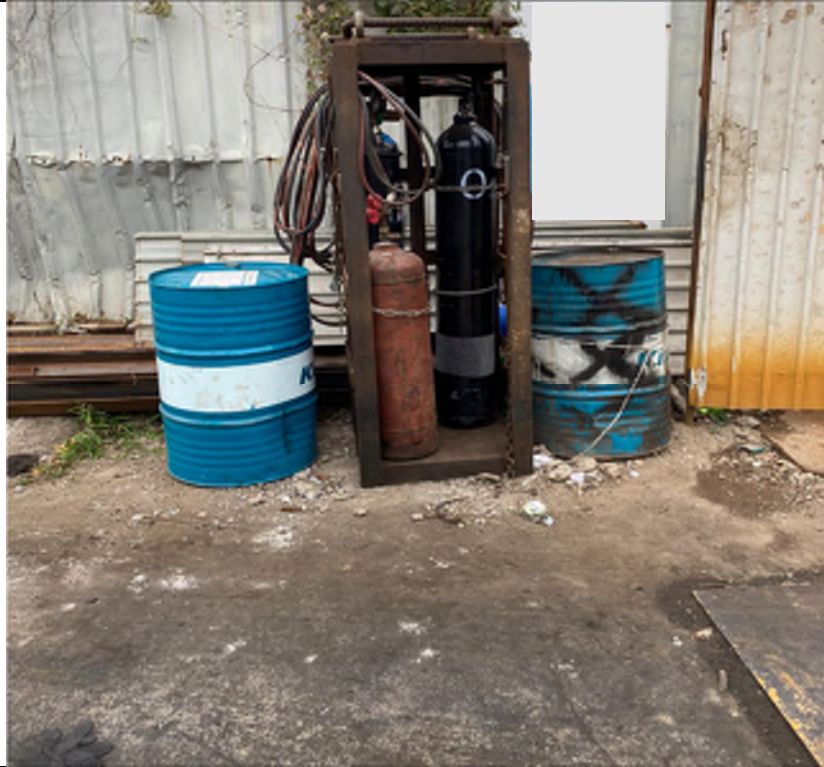
Photo EA-23: Lot No. STT 1450 - Existing C & H Import & Export Co. - Engine oils are stored in tanks in open area with no bund wall and no secondary containment.

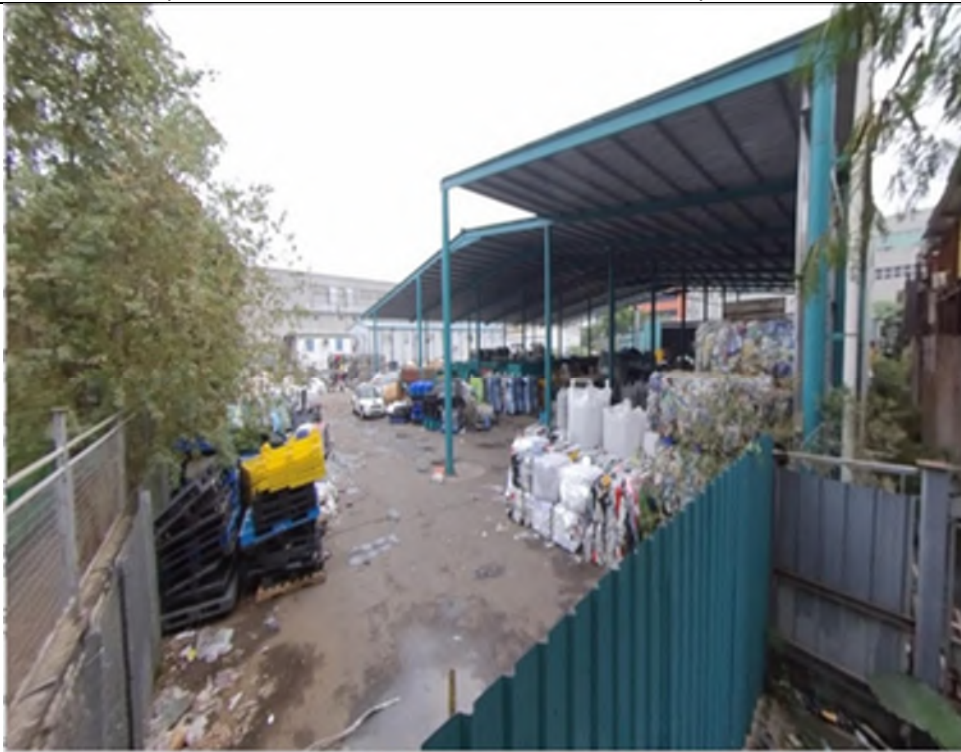
Photo EA-24: Lot No. STT 1745 - Existing Lau Choi Kee Plastic Company Limited (Entrance) – Stockpiles of waste materials were observed.

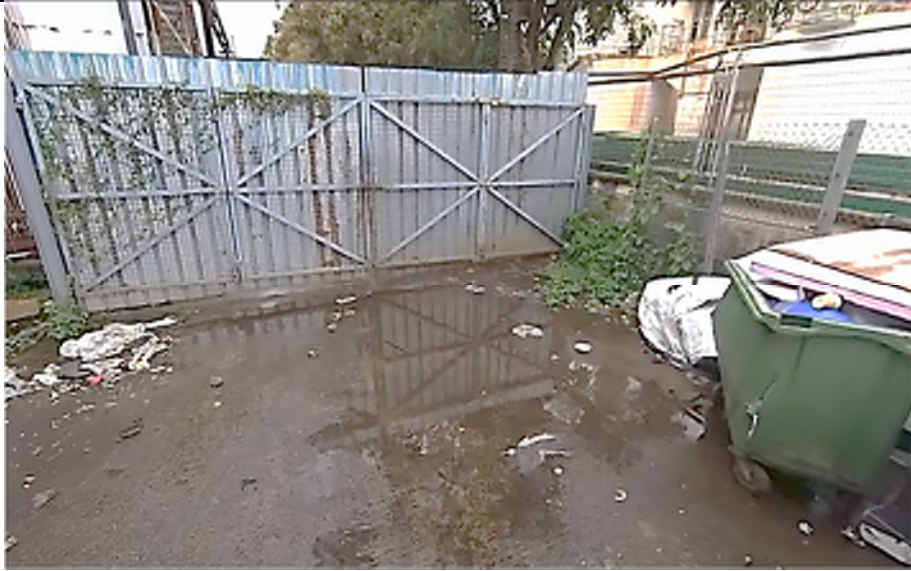
Photo EA-25: Lot No. STT 1745 - Existing Lau Choi Kee Plastic Company Limited – Water Stain, debris were observed on the unpaved floor within the site area. Vegetation were found along the boundary of the site area. Overflowing rubbish bin was found near the entrance of the site. No oil stain/ leakage is found in this location.

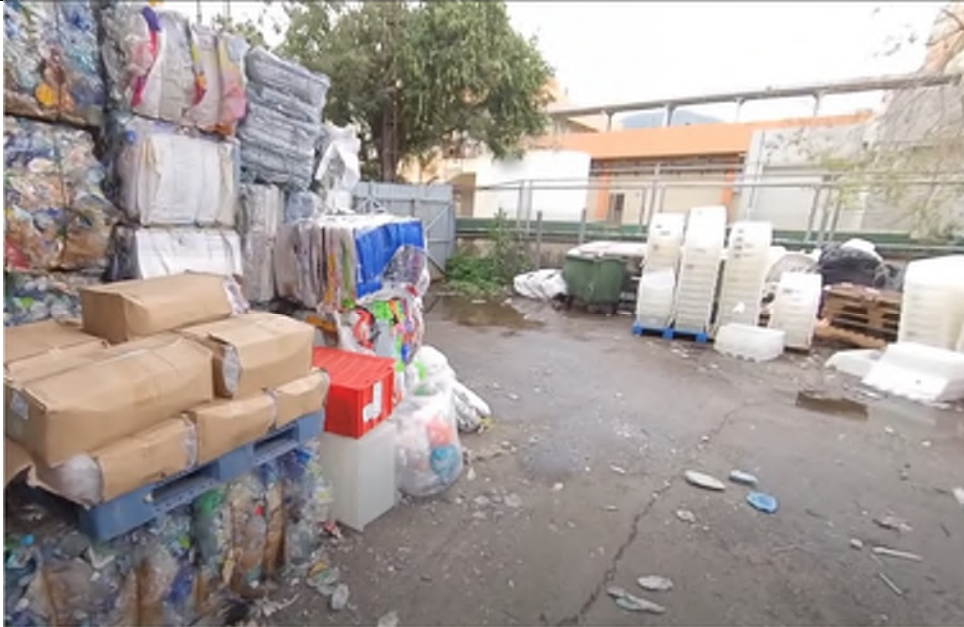
Photo EA-26: Lot No. STT 1745 - Existing Lau Choi Kee Plastic Company Limited – Stockpiles of plastic waste cubes were located on the site's unpaved floor. Water stain and debris were observed on the floor. Cracks were observed on the floor and vegetation were observed along the boundary. No oil stain /leakage was observed in this area.

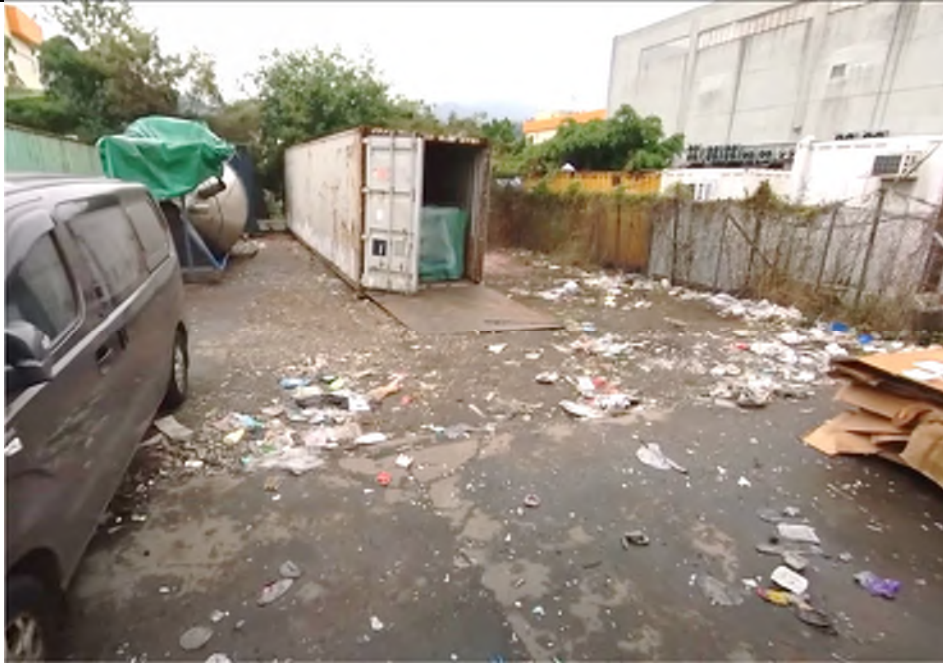
Photo EA-27: Lot No. STT 1745 - Existing Lau Choi Kee Plastic Company Limited – Debris were observed all over the site area, dirty stain and stockpile of cardboards were observed on the unpaved floor. There was a car parked in this area. No oil stain/leakage is observed in this location.

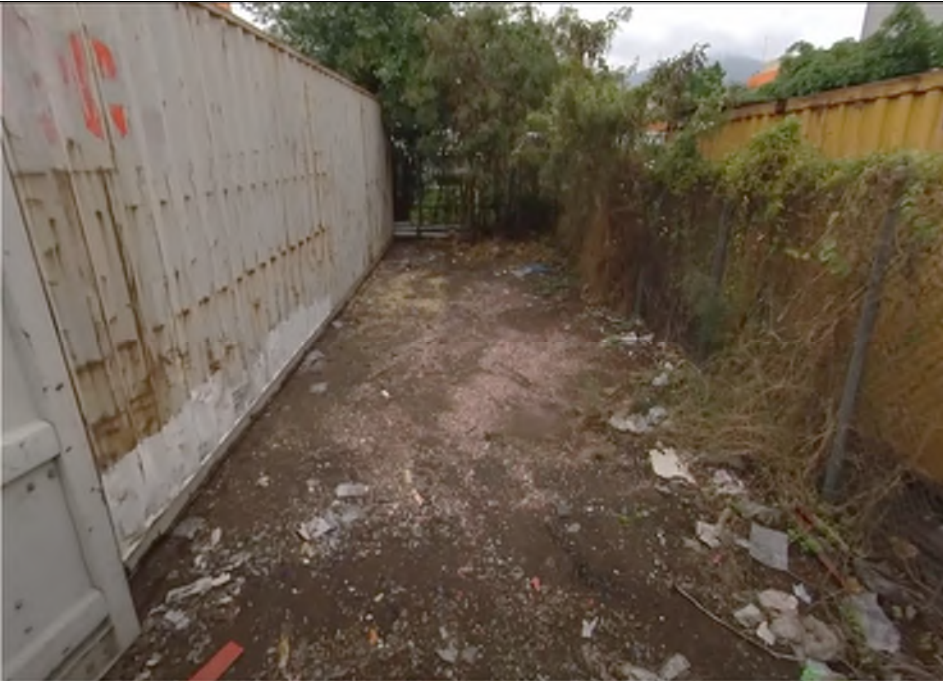
Photo EA-28: Lot No. STT 1745 - Existing Lau Choi Kee Plastic Company Limited – Dirty stain, dying vegetation and debris were found in this area near the cargo on the unpaved floor.

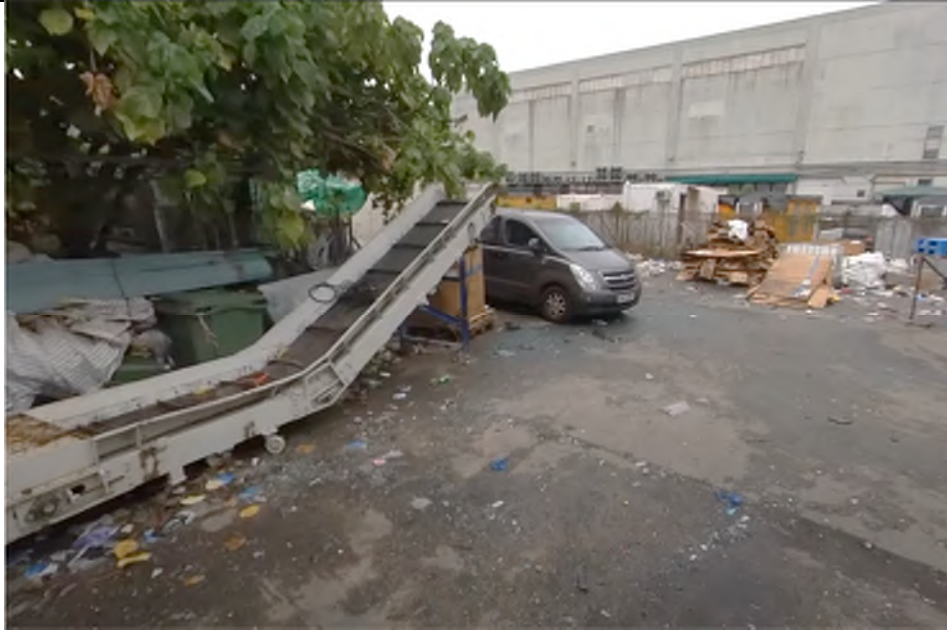
Photo EA-29: Lot No. STT 1745 - Existing Lau Choi Kee Plastic Company Limited – Machine was located in open area on the unpaved floor within the site area. Debris and dirty stain were found in this location.

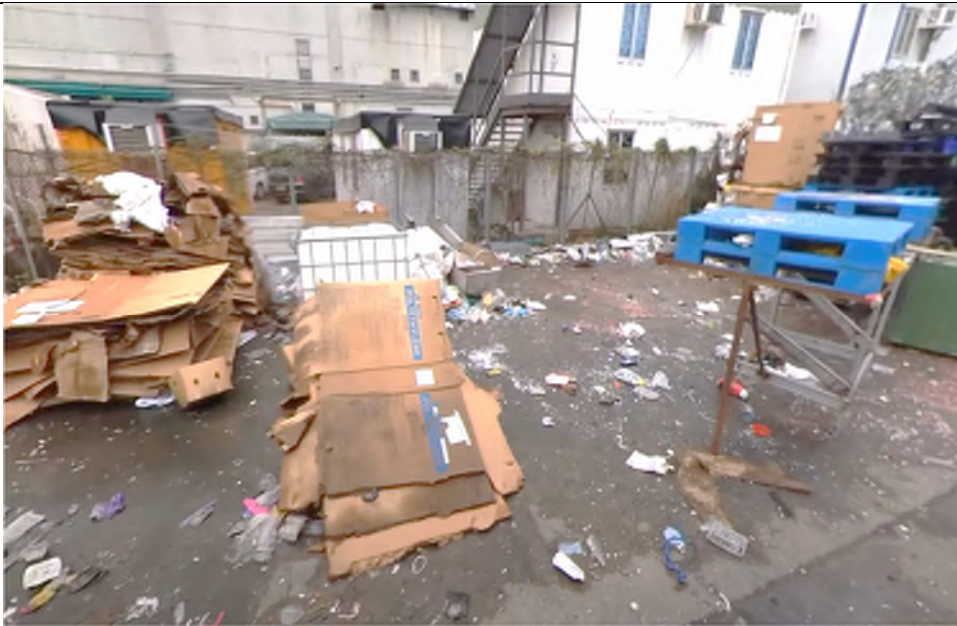
Photo EA-30: Lot No. STT 1745 - Existing Lau Choi Kee Plastic Company Limited – Waste cardboards, debris were found scattered all over the site area on unpaved floor. Dirty stain was observed in this area, with no oil stain/ leakage observed in this location.

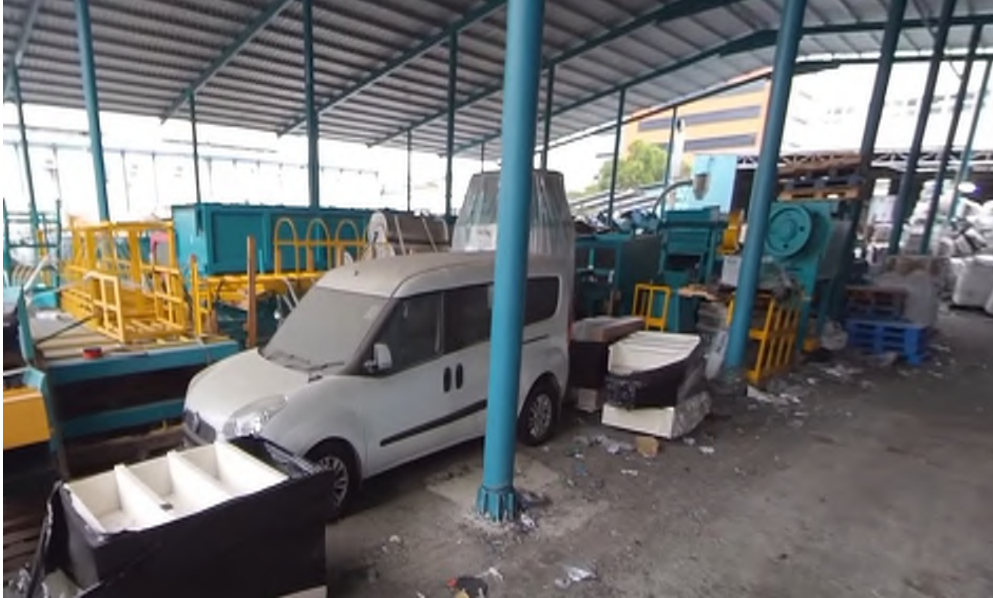
Photo EA-31: Lot No. STT 1745 - Existing Lau Choi Kee Plastic Company Limited – Equipment and machine not in operation were located under shelter. Some plastic wastes were being put in this area near the machine. A car was parked in this location. No oil stain/spillage observed in this location.

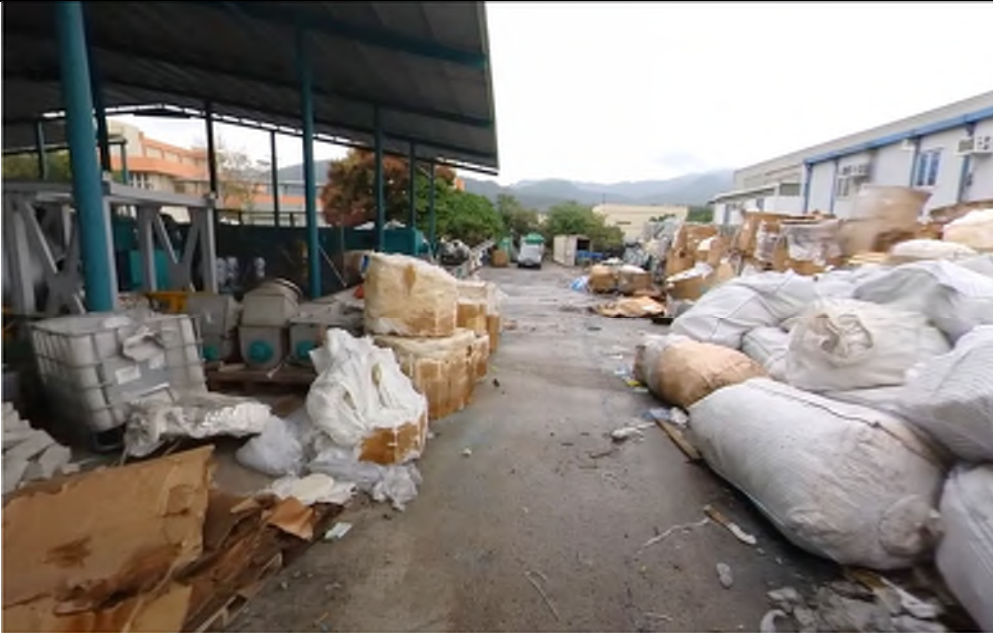
Photo EA-32: Lot No. STT 1745 - Existing Lau Choi Kee Plastic Company Limited – Fragment of plastic waste were being put into bags and located on the assessable road within the site area.

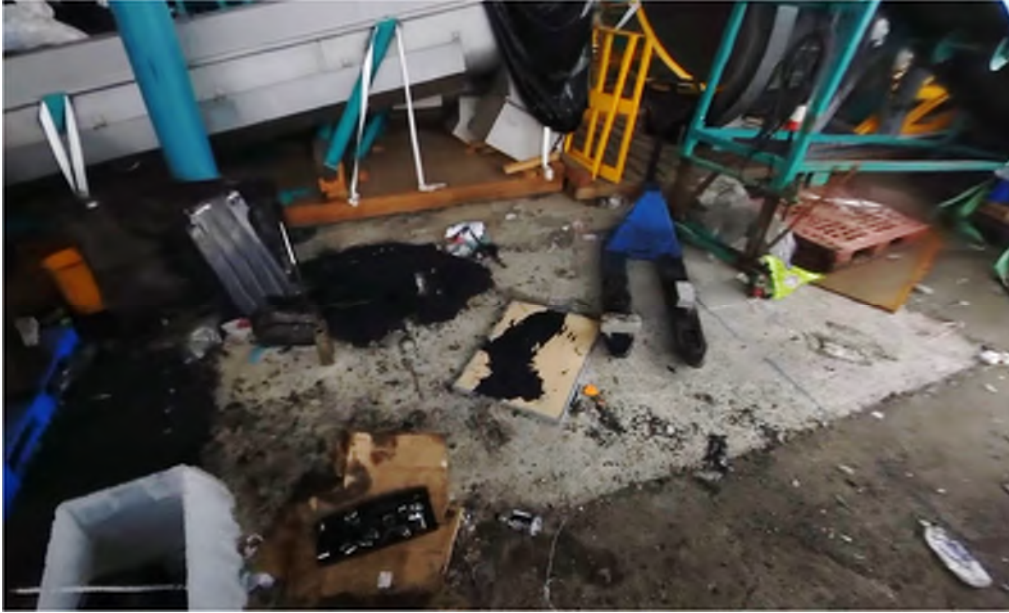
Photo EA-33: Lot No. STT 1745 - Existing Lau Choi Kee Plastic Company Limited –Lubricant oil were stored on the unpaved floor . Oil stain was found in this location on unpaved floor with no panel or secondary containment. Potential land contamination issue is anticipated.

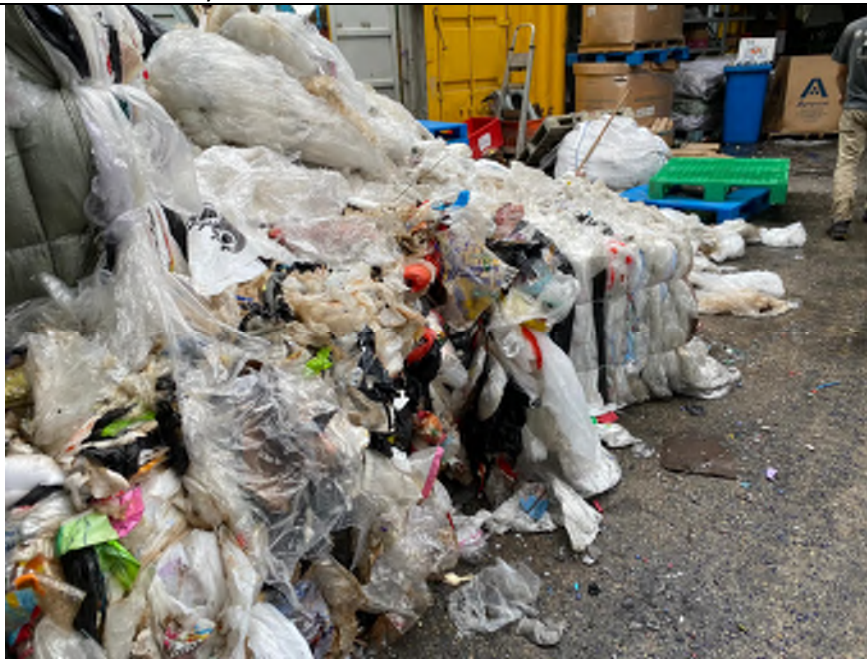
Photo EA-34 : Lot No. STT 1745 - Existing Lau Choi Kee Plastic Company Limited – Plastic waste were found in this location near the plastic making machines. No oil stain/leakage is found in this location.

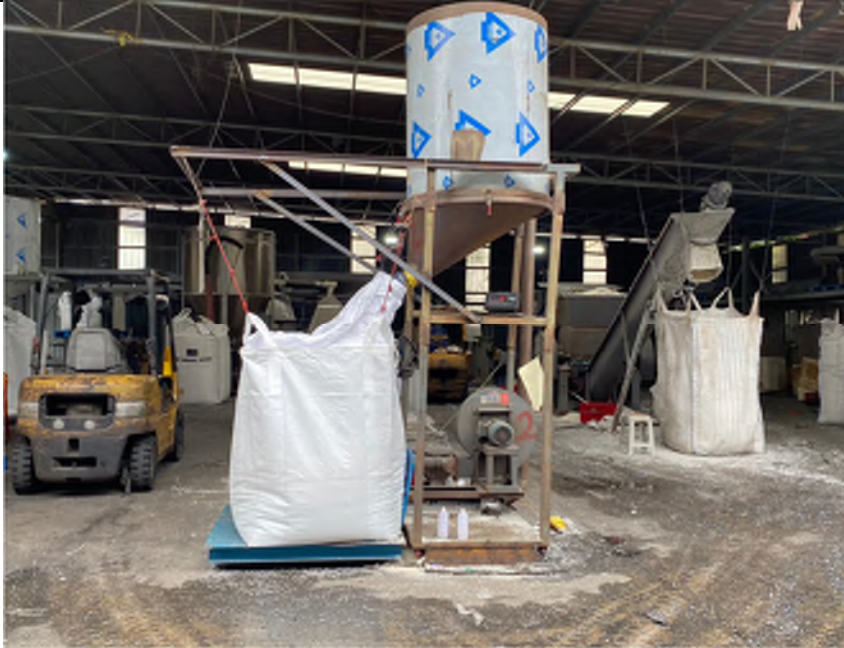
Photo EA-35: Lot No. STT 1745 - Existing Lau Choi Kee Plastic Company Limited – The plastic breaking machine was located inside a warehouse together with other machines on unpaved floor.

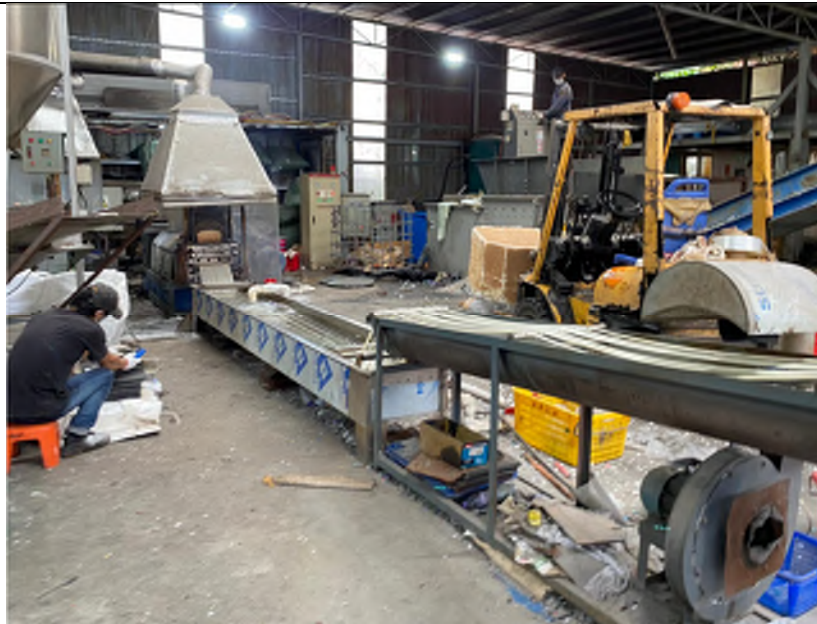
Photo EA-36: Lot No. STT 1745 - Existing Lau Choi Kee Plastic Company Limited – The plastic making machine was located inside the warehouse on unpaved floor. Fragment of plastic waste were observed scattered on the floor.

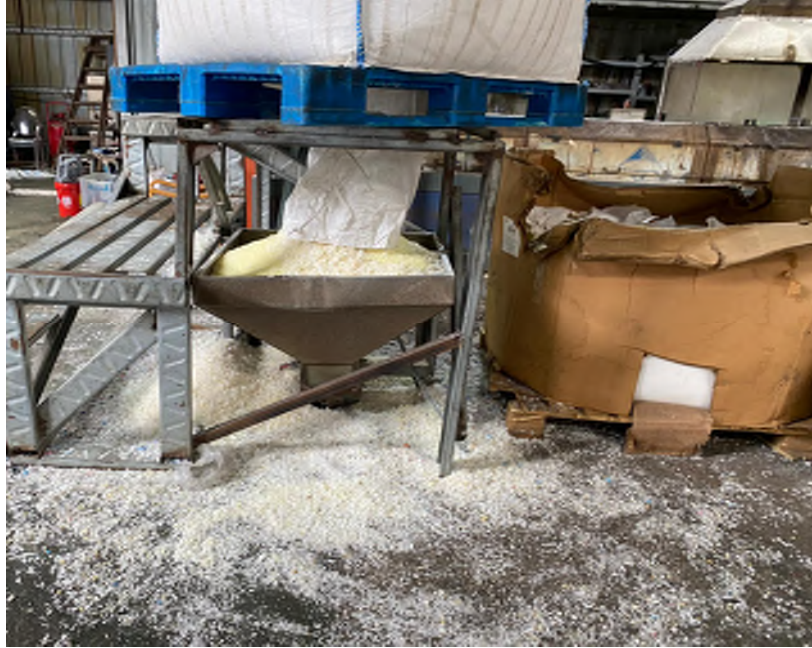
Photo EA-37: Lot No. STT 1745 - Existing Lau Choi Kee Plastic Company Limited – The plastic breaking machine was located on unpaved floor inside the warehouse, the fragment of plastic waste was scattered on the floor. No oil stain/ leakage was observed.

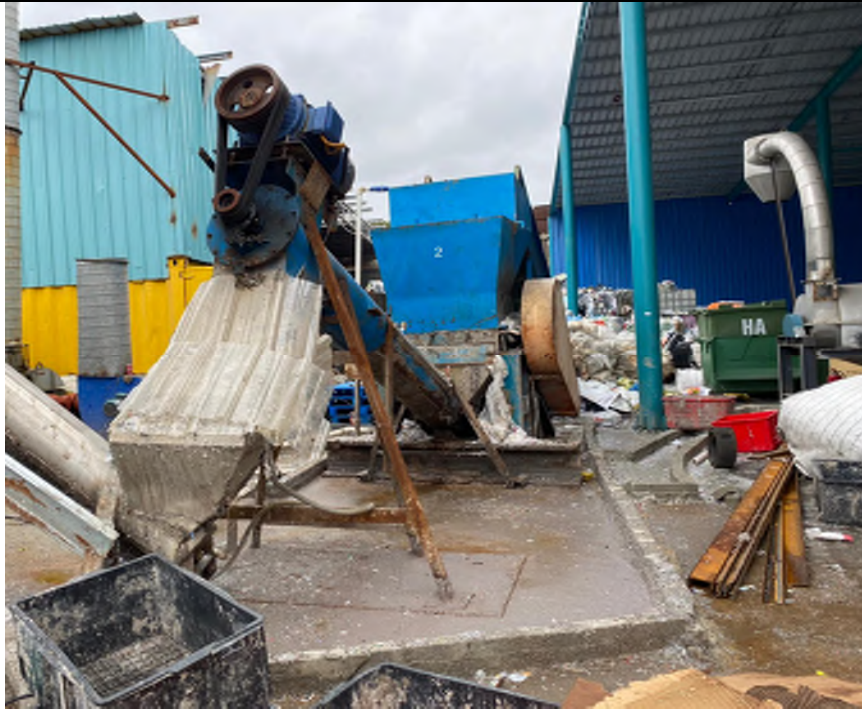
Photo EA-38: Lot No. STT 1745 - Existing Lau Choi Kee Plastic Company Limited – The waste water pumping machine was located outside the warehouse and shelters. Concrete made barriers were observed surrounding the machine on the floor to prevent water from leaking out. Dirty stain and debris were observed with no oil stain/leakage was observed.

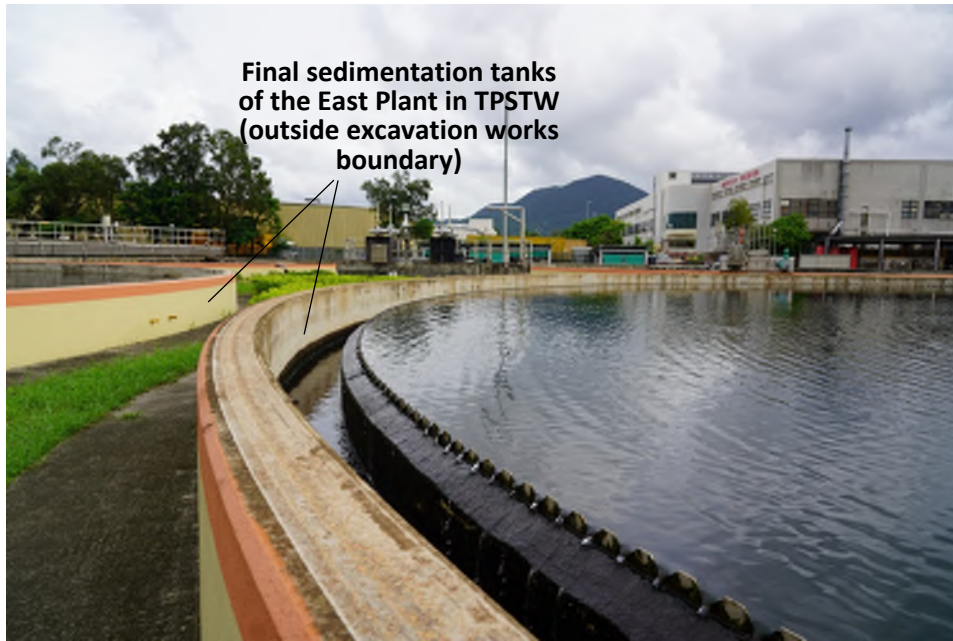
Final sedimentation tanks of the East Plant in TPSTW (outside excavation works boundary)

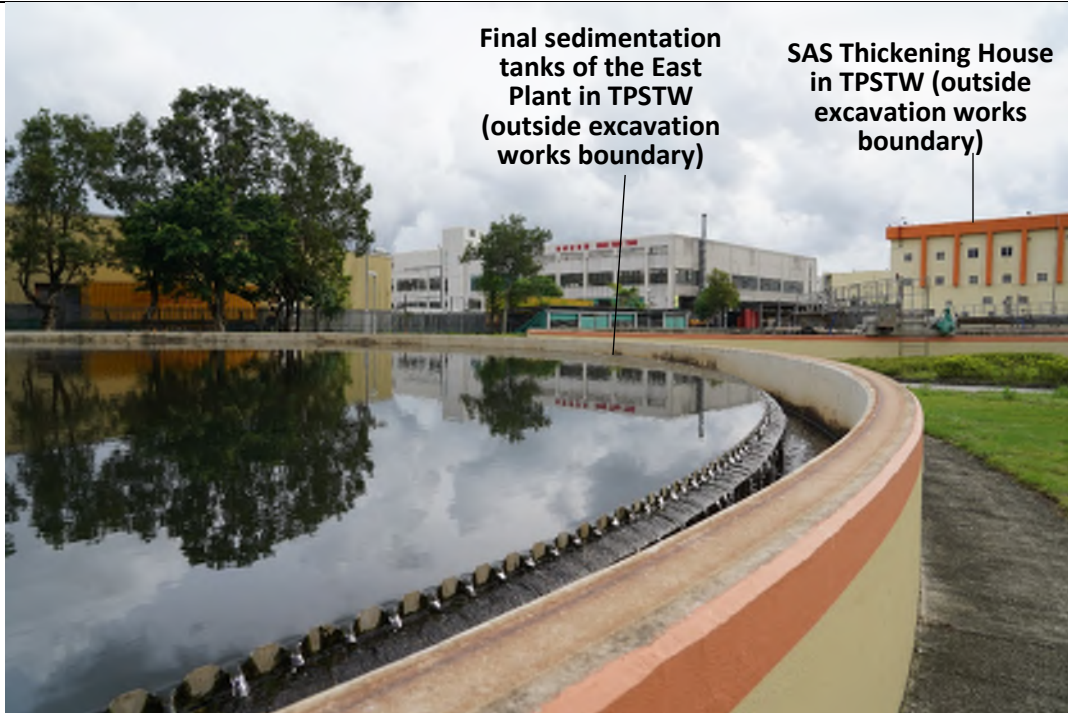
Final sedimentation tanks of the East Plant in TPSTW (outside excavation works boundary)

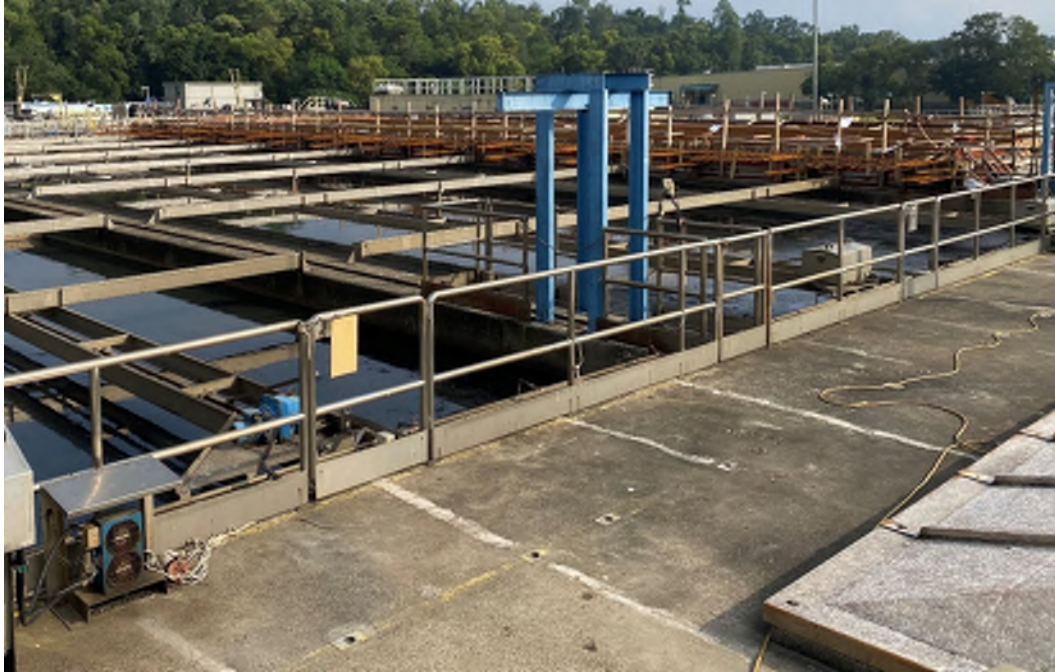
Photo V6: Primary Sedimentation Tanks of East Plant – The tanks are constructed with concrete on a raised slope. Only stain caused by weathering is observed, no oil stain/ leakage is observed in the area.

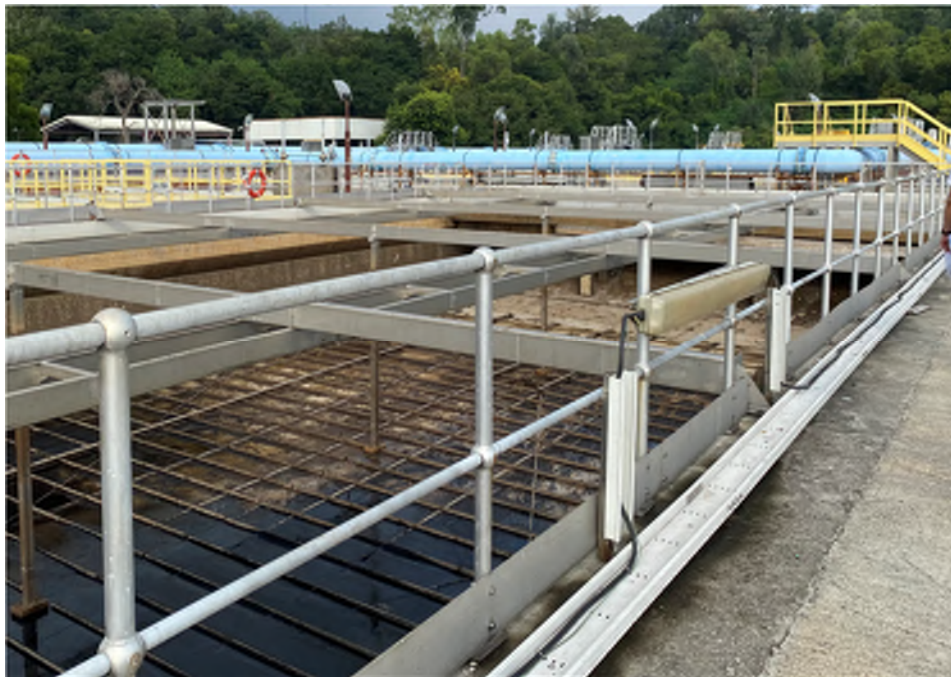
Photo V7: Primary Sedimentation Tanks of East Plant –The tanks are constructed with concrete, steel panel are installed in order to avoid spillage of sludge onto the passage road, and to prevent any substance from falling into the tanks. No leakage/ spillage is observed in the area.
