CONTAMINATION ASSESSMENT PLAN (FINAL)

Upgrading of Tai Po Sewage Treatment
Works – Investigation

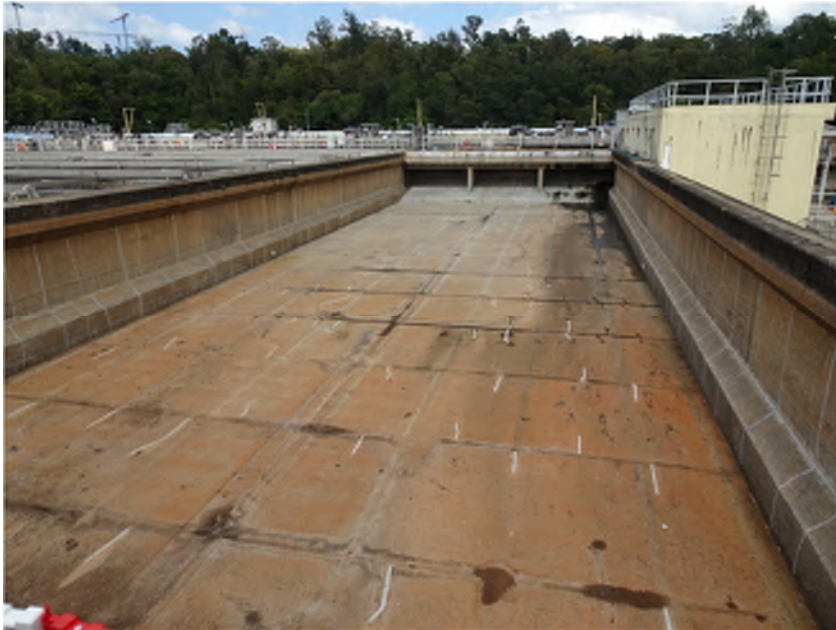
Photo V8: Primary Sedimentation Tanks of East Plant – A tank was under maintenance. The tank is constructed with concrete. No observation of damage/ leakage is observed. Only water stain and stain caused by years of functioning is observed.

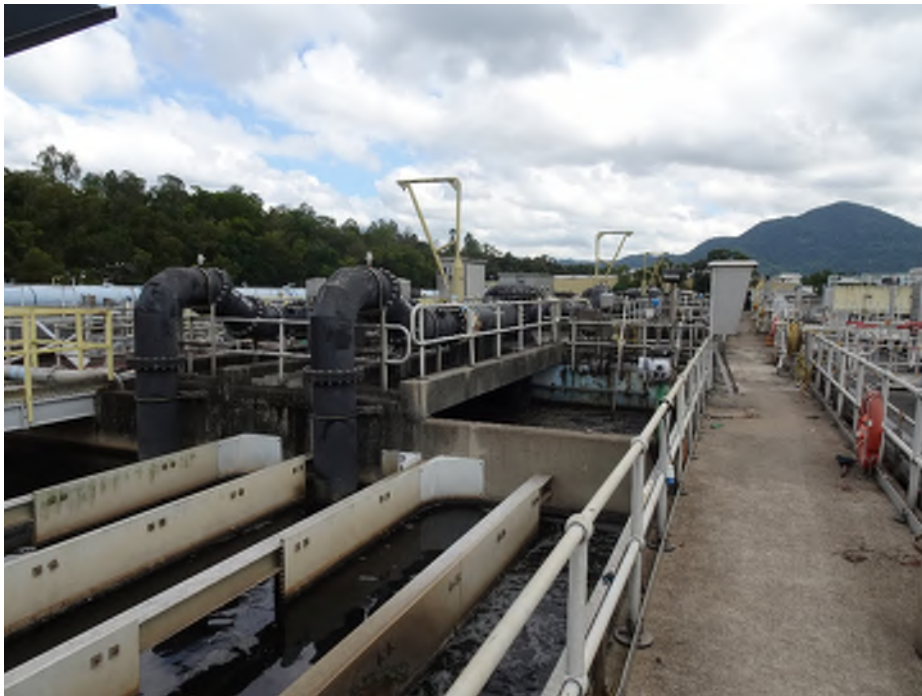
Photo V9: Aeration Tanks of East Plant – The tanks are constructed with concrete, and located below ground level. The assessable road is paved with concrete. Water stain caused by handling of sludge is observed, no oil stain/ spillage observed.

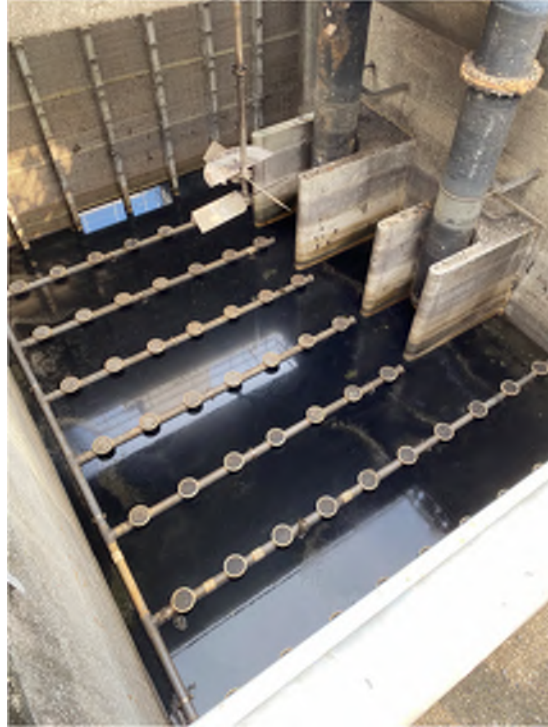
Photo V10: Aeration Tanks of East Plant– The tanks are constructed with concrete, no broken or damage is observed. Just stain caused by weathering is observed.

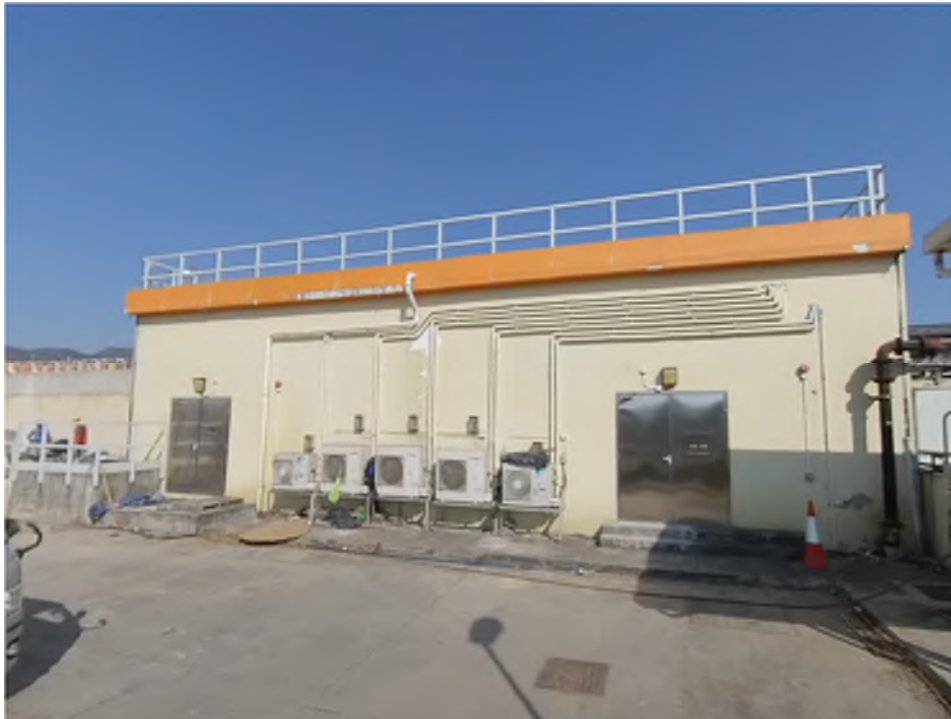
Photo V11 : Switch Room – The Switch Room is located on concrete paved floor, it is a one-storey building. No oil stain/leakage is observed.

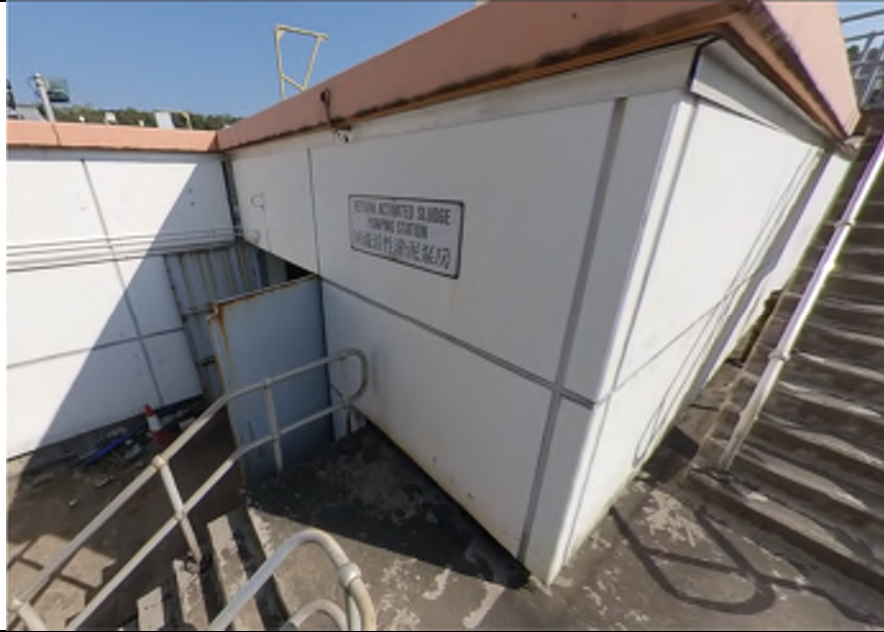
Photo V12: Return Activated Sludge Pumping Station – The Station is located on floor paved with concrete, stain caused by weathering is observed. No oil stain/leakage is observed.

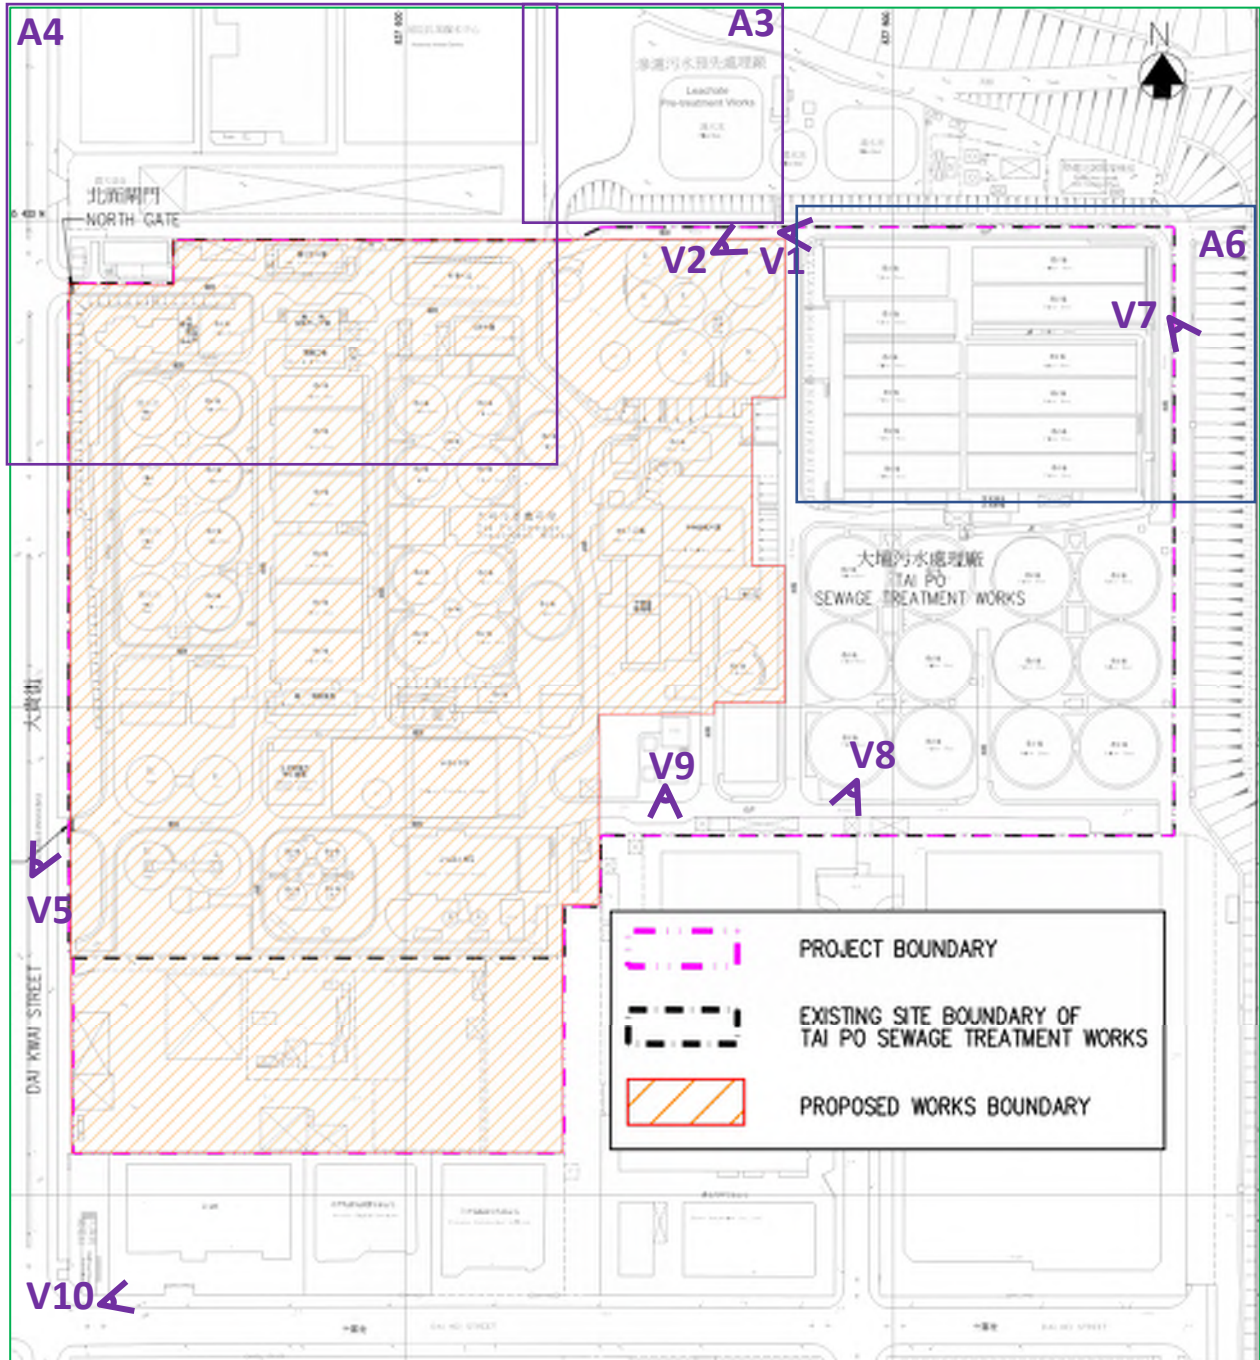
Index Plan - Areas Surrounding the Project Site

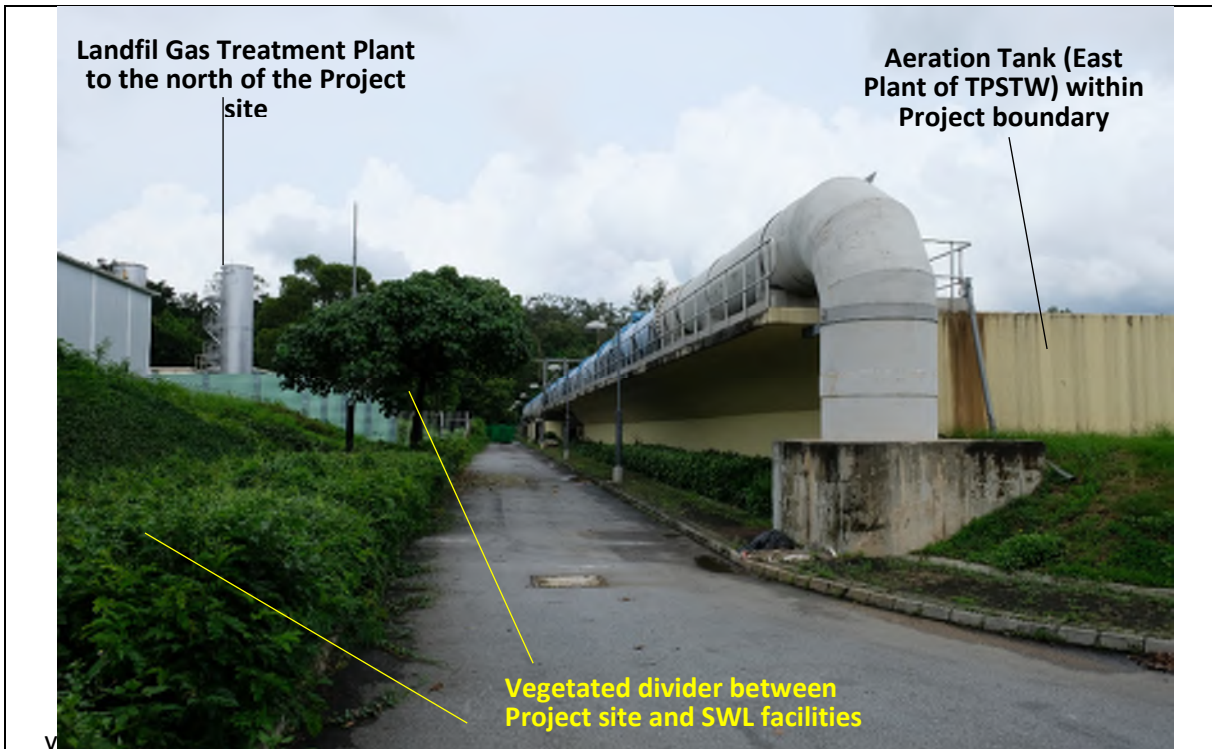
Photo V1: Areas to the immediate north of the Project site are vegetation. Further north are Shuen Wan Landfill (SWL) facilities. No sign of contamination such as stressed plant is observed.

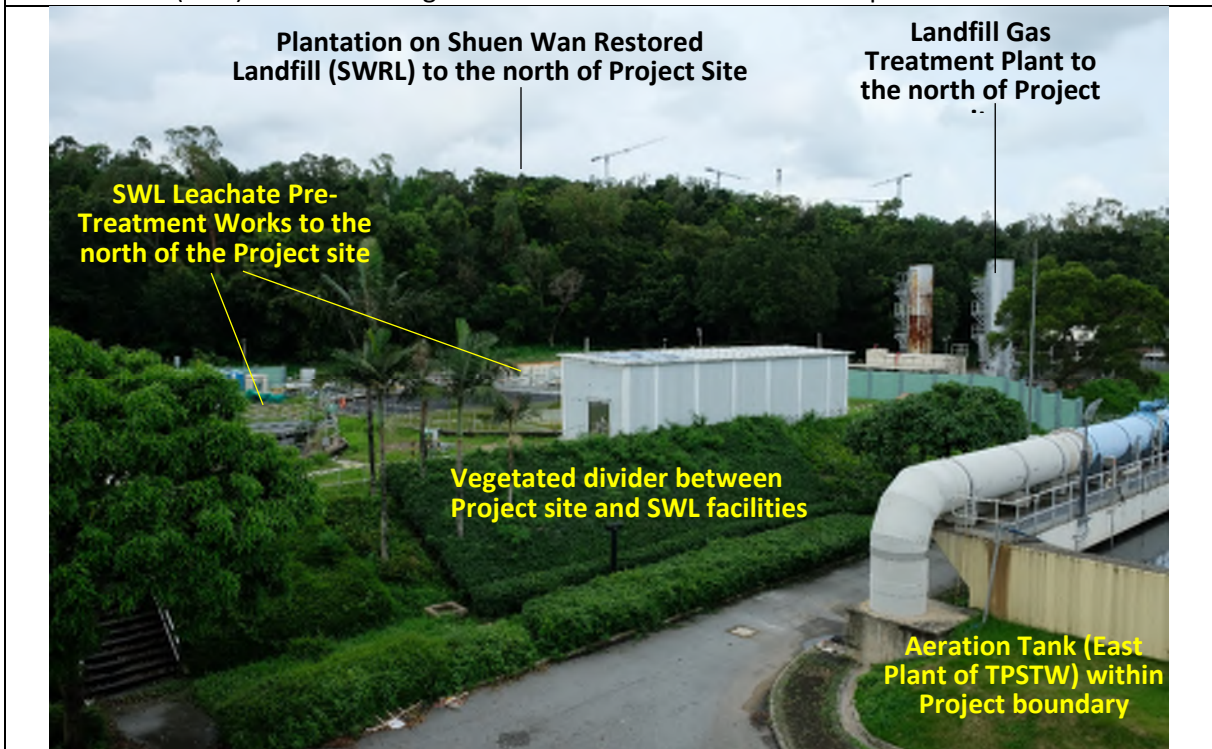
Photo V2: Areas to the north of the Project site are SWL Leachate Pre-treatment Works and SWL Gas Treatment Plant. Greening and vegetations are found within and around the SWL facilities. No land contamination issue associated with the Project works is identified.

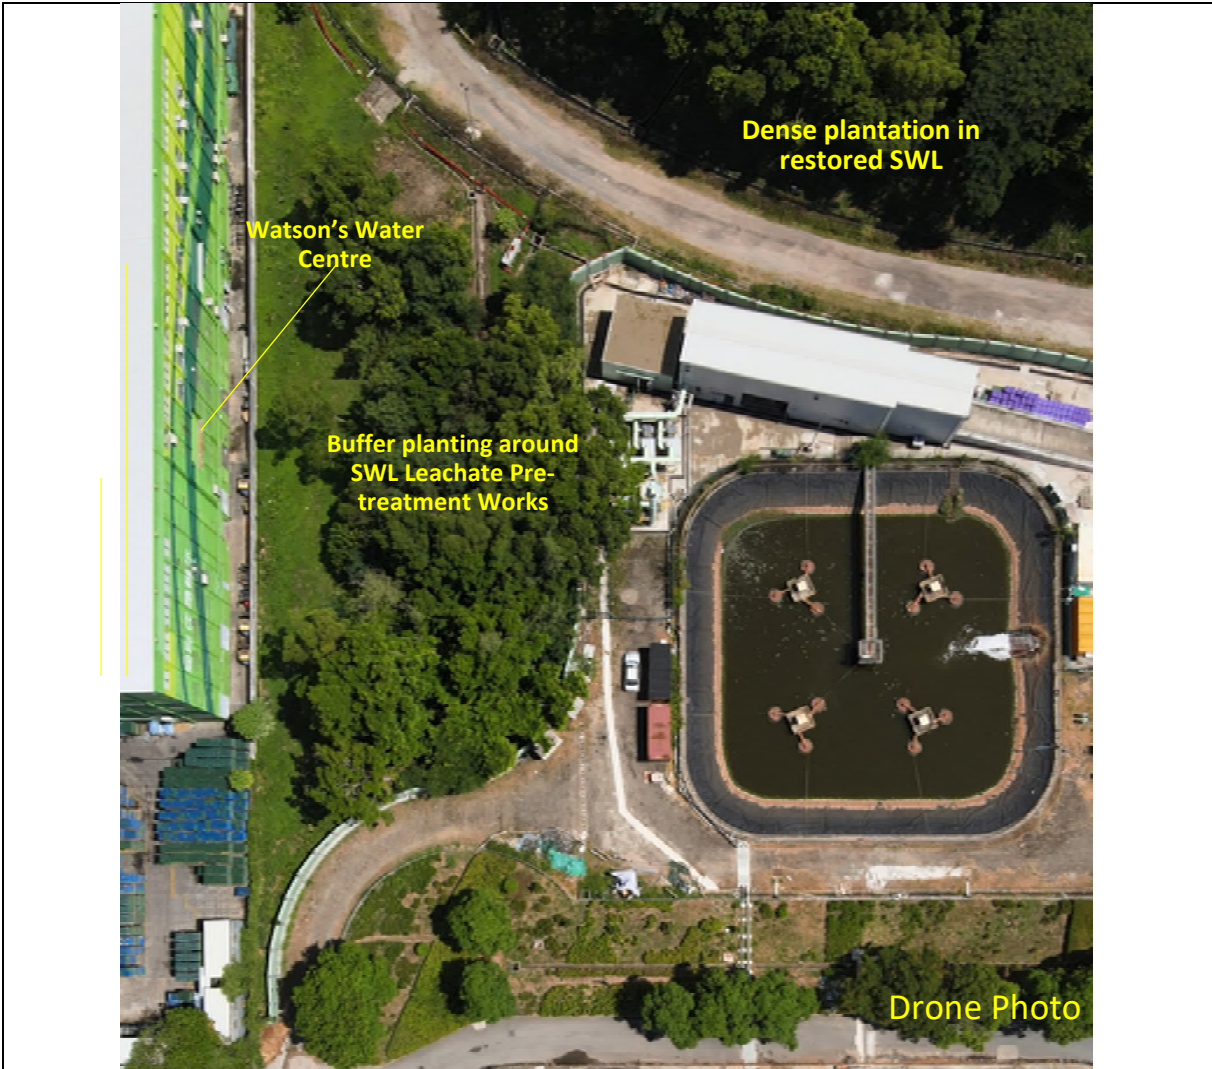
Photo A3: Leachate Pre-treatment Works to the north of the Project site are concrete paved. The Project works will not disturb the restored SWL facilities including the active leachate collection and multi-layer lining system. No land contamination issue associated with the Project works is identified.

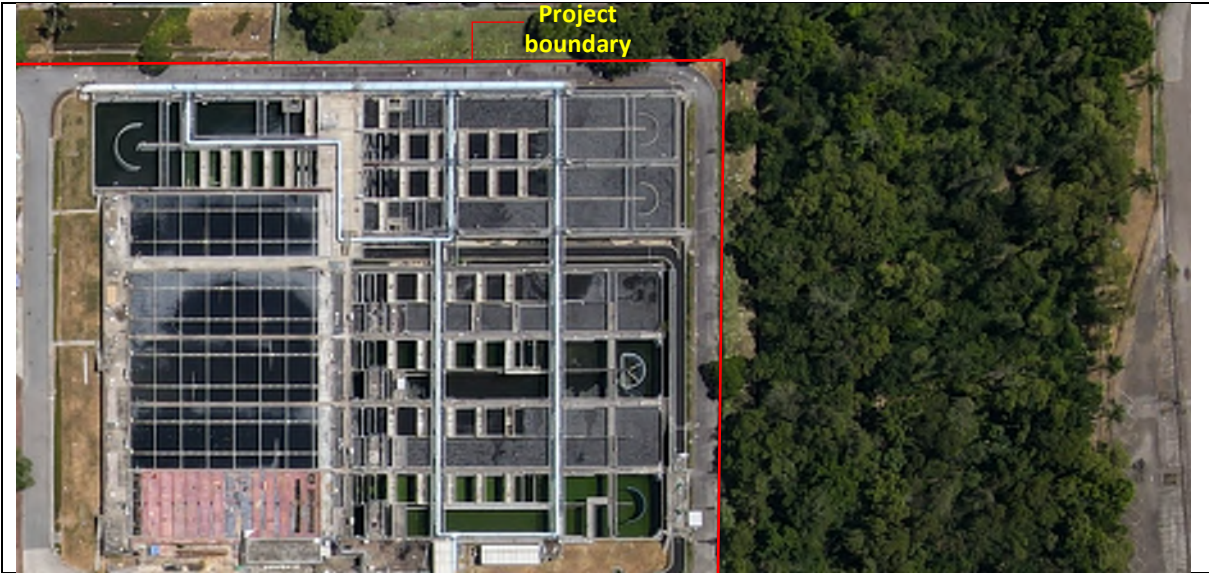
Photo A6: Area to the east of the Project site are heavily vegetated. No sign of land contamination issue is found.

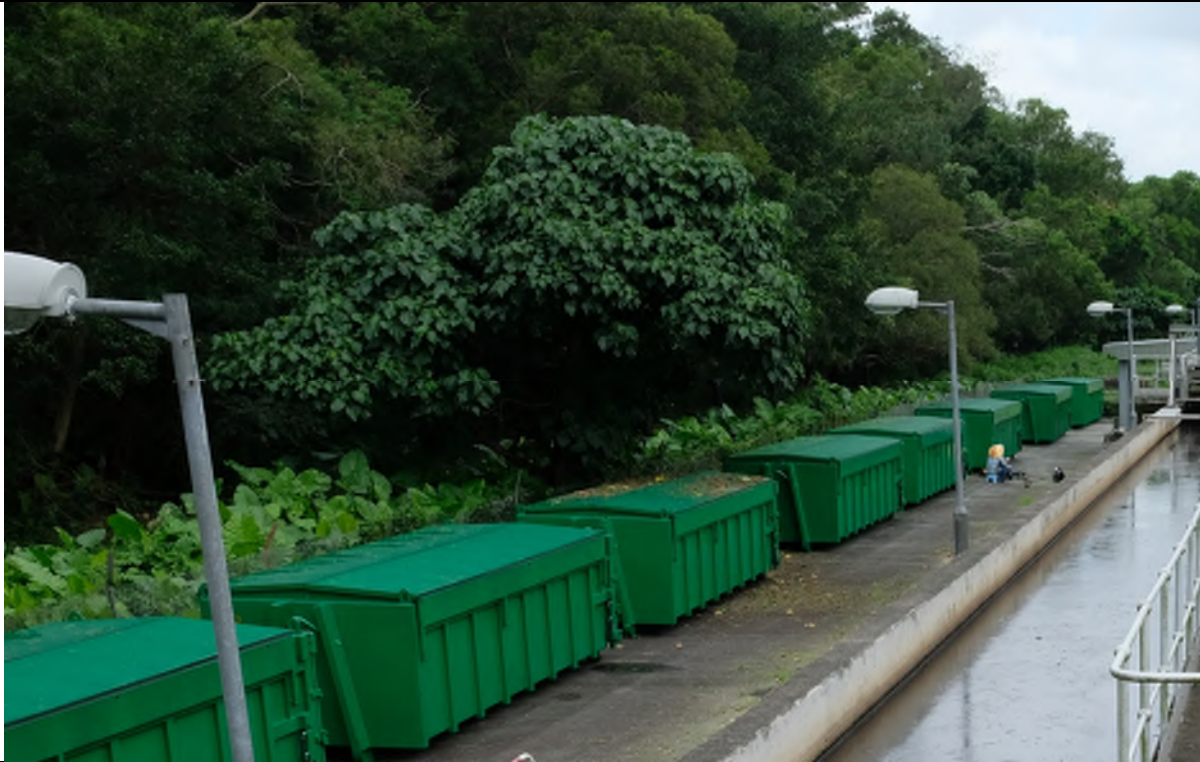
Photo V7 Area to the east of the Project site are heavily vegetated. No sign of land contamination issue is found.

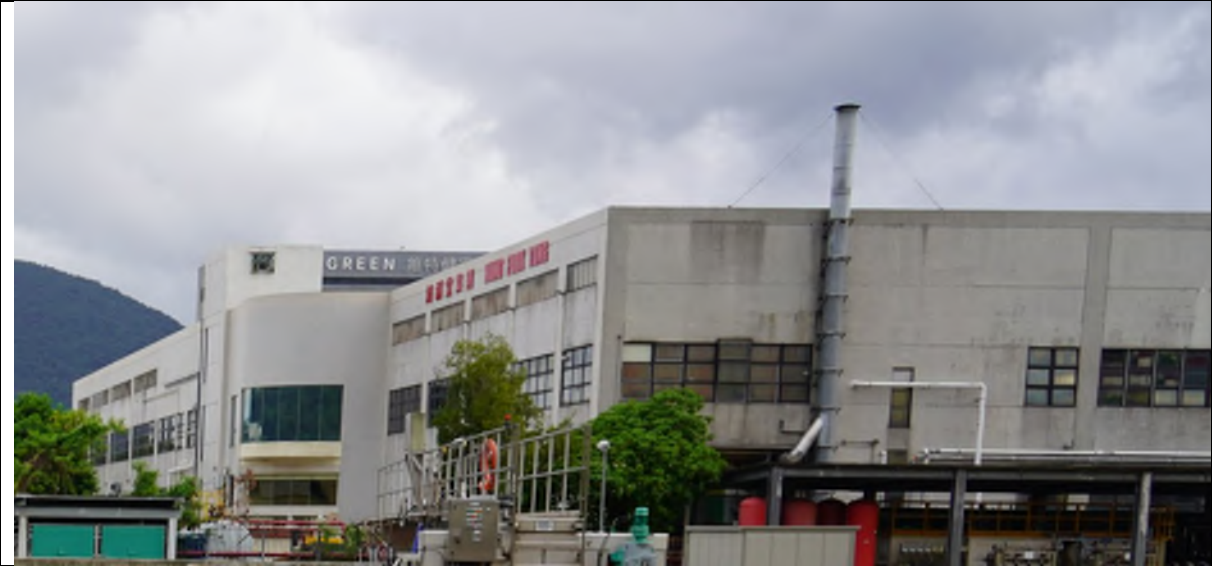
Photo V8 Hung Fook Tong Goup Limited to the immediate north of the Project site.
