Application for Variation of an Environmental Permit

C1. Name of the Current Environmental Permit Holder :
Highways Department
C2. Application No. of the Current Environmental Permit : EP-541/2017
C3. The Current Environmental Permit was Issued in : month / year

**CE72/2015 (HY) Flyover from Kwai Tsing Interchange Upramp to
Kwai Chung Road**

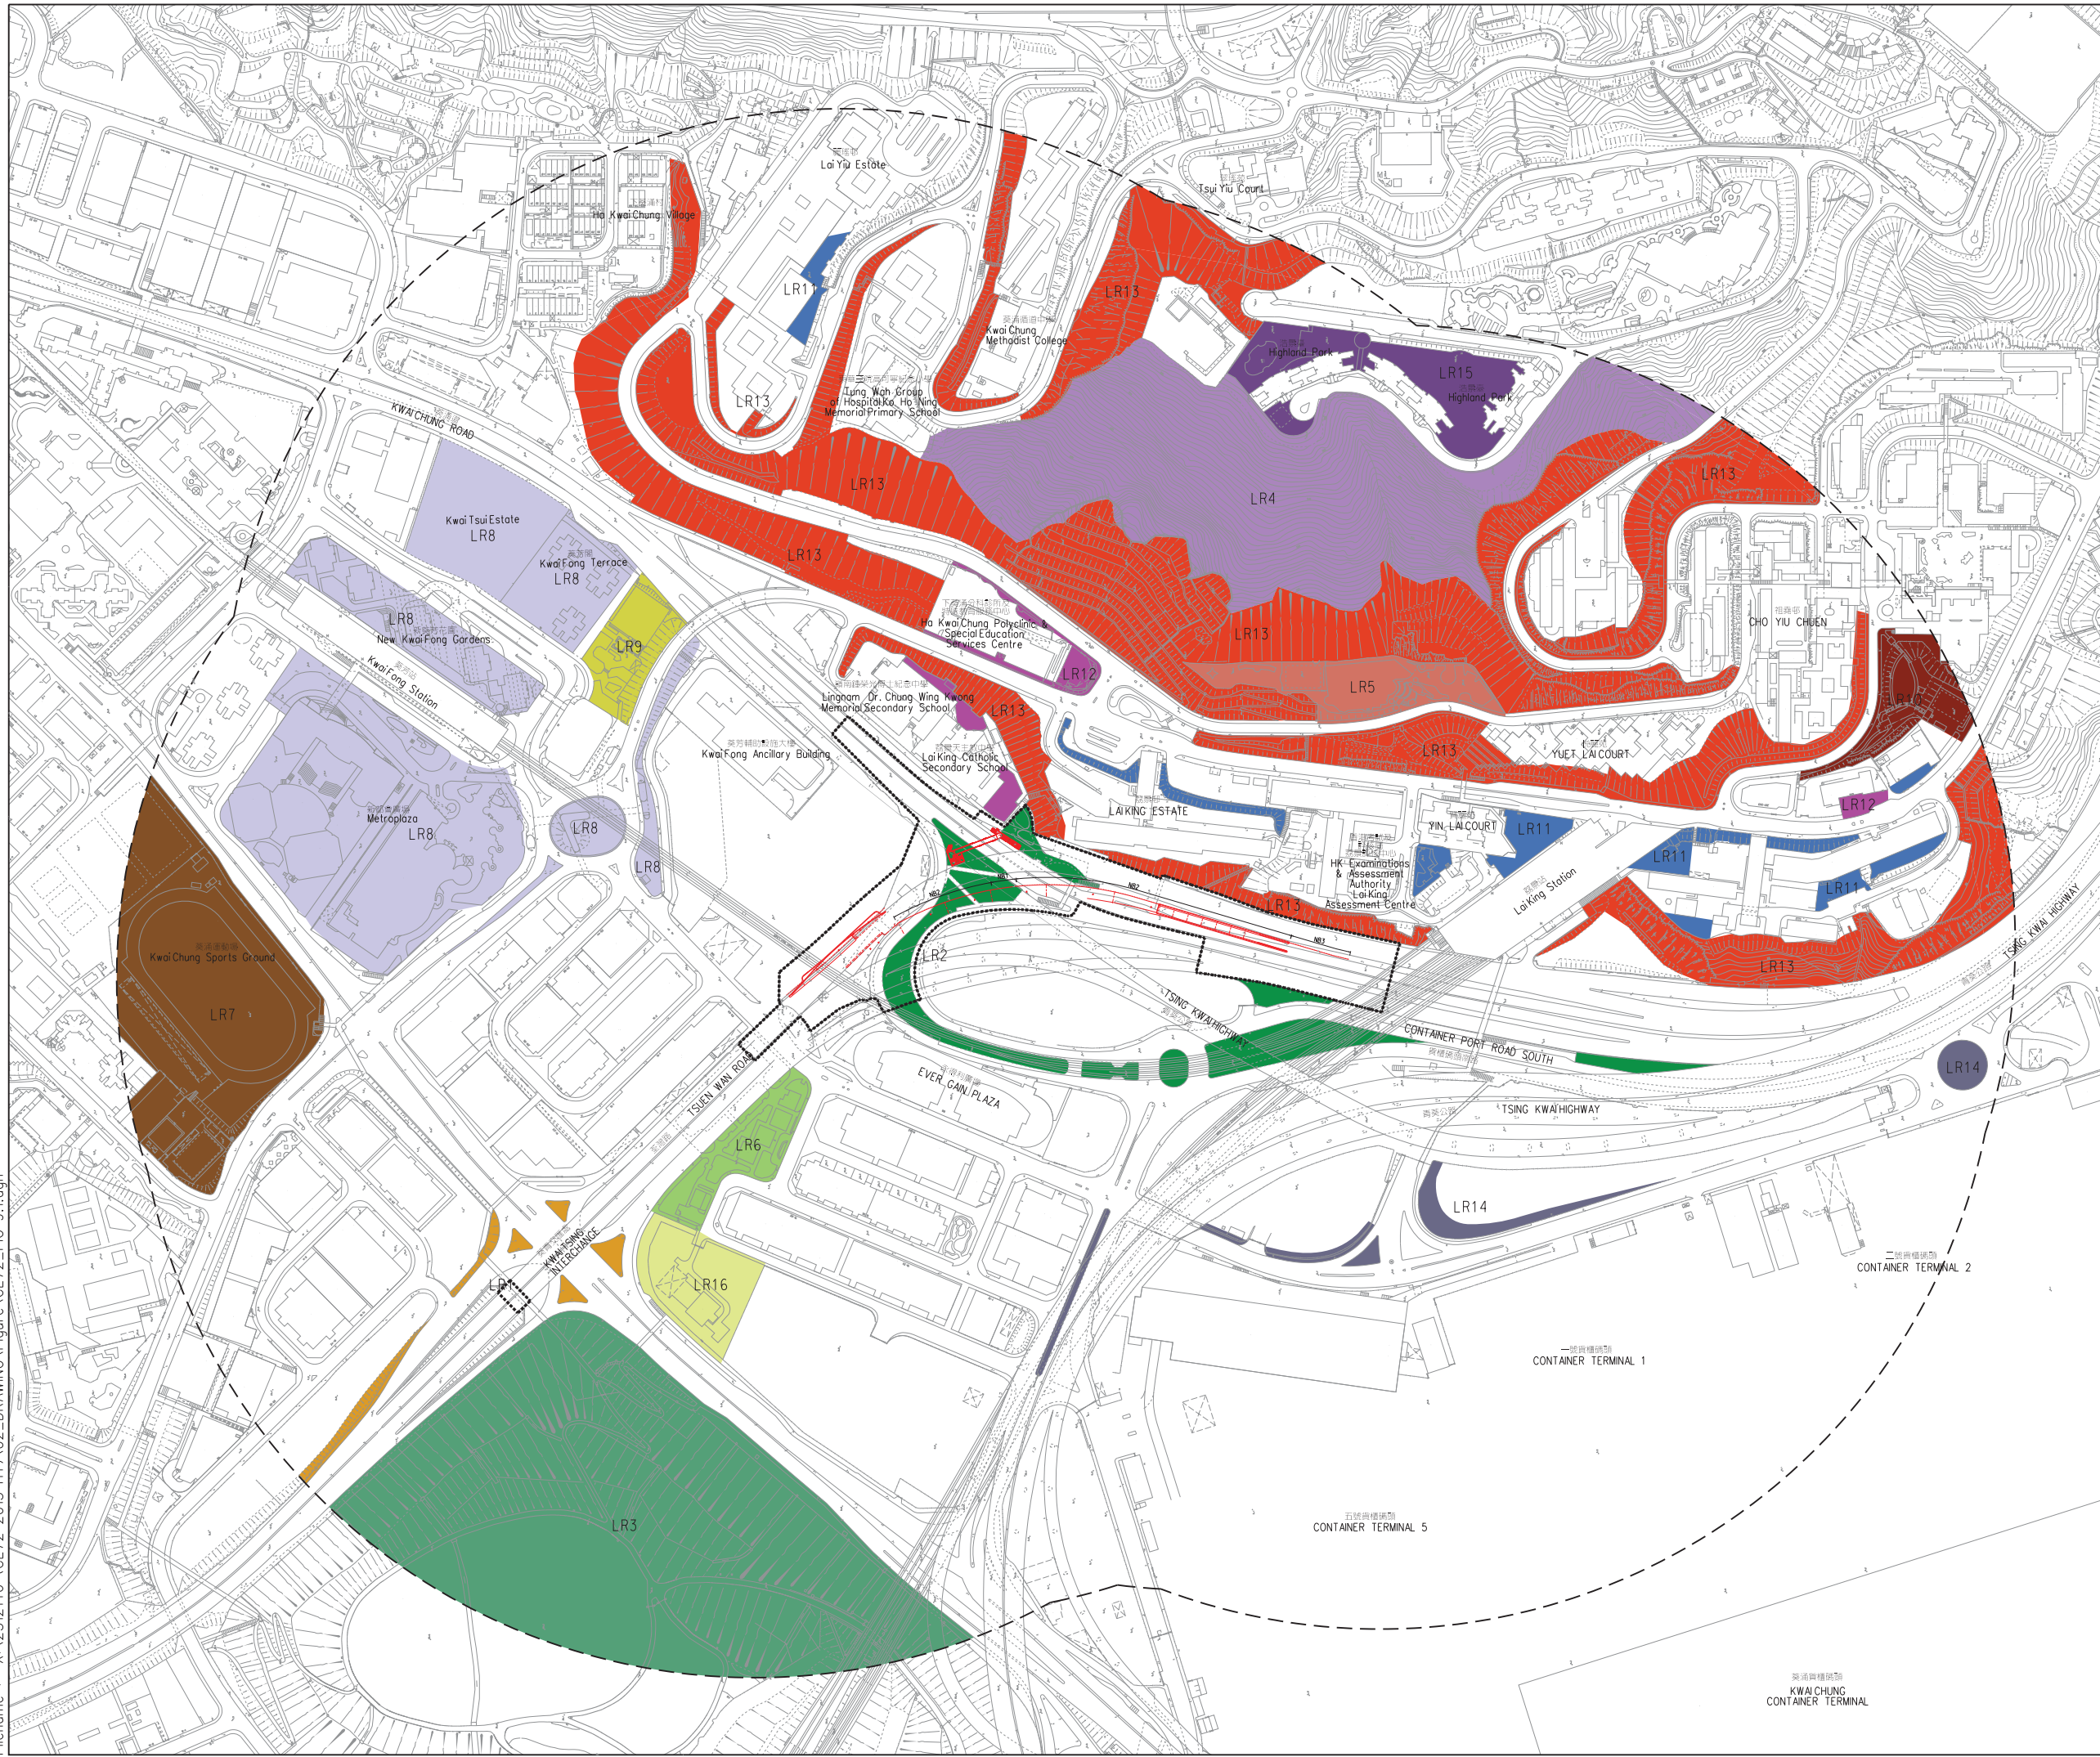
- LEGEND :**
- LIMIT OF WORKS AREA
 - LR LANDSCAPE RESOURCE
 - LR1 TREE PLANTING ALONG TSUEN WAN ROAD
 - LR2 TREE PLANTING AT KWAI CHUNG ROAD INTERCHANGE AREA

- LR3 KWAI CHUNG PARK
 - LR4 PLANTING AT FOOTHILLS OF LAI KING HILL
 - LR5 LAI KING SPORTS CENTRE
 - LR6 KWAI SHUN STREET PLAYGROUND
 - LR7 KWAI SHUN SPORTS GROUND

- 8.3.1 The extended areas have been overlaid to the Landscape Resources (LR) Plan and Landscape Character Area (LCA) Plan and shown in **Figure 8.1** and **Figure 8.2** and 1 LR and 3 LCAs will be affected. The recommended landscape and visual mitigation measures in the approved EIA Report is shown in **Appendix 8.2**. The location of these recommended mitigation measures will be adjusted to suit the proposed layout, but the recommended mitigation measures will remain the same as the approved EIA Report.

- 8.3.3 Detailed description for each affected LR and LCA are as follows:
- 8.3.4 LR2 Tree Planting by Kwai Chung Road Interchange is rated to have high sensitivity in the approved EIA Report. The affected area of LR2 will be increased by 750m². During construction phase, planting within the road interchange area will be removed due to the temporary road diversion works. 130 nos. of trees will be affected, with 106 nos. proposed to be felled and 24 nos. proposed to be transplanted back into LR2. Recommended mitigation measures CP1, CP2, OP3 and OP4 in the approved EIA Report will still be effective. During operation phase, LR2 will be reinstated with 89 nos. of compensatory tree planting and shrub planting (OP3). Part of the paved area in the approved EIA Report has been amended to a planting area. Hence, there will be an additional 600m² of roadside and amenity planting. Since this LR will be reinstated and enhanced with amenity planting in the operation phase, residual impact significance is expected to remain the same as the approved EIA Report.

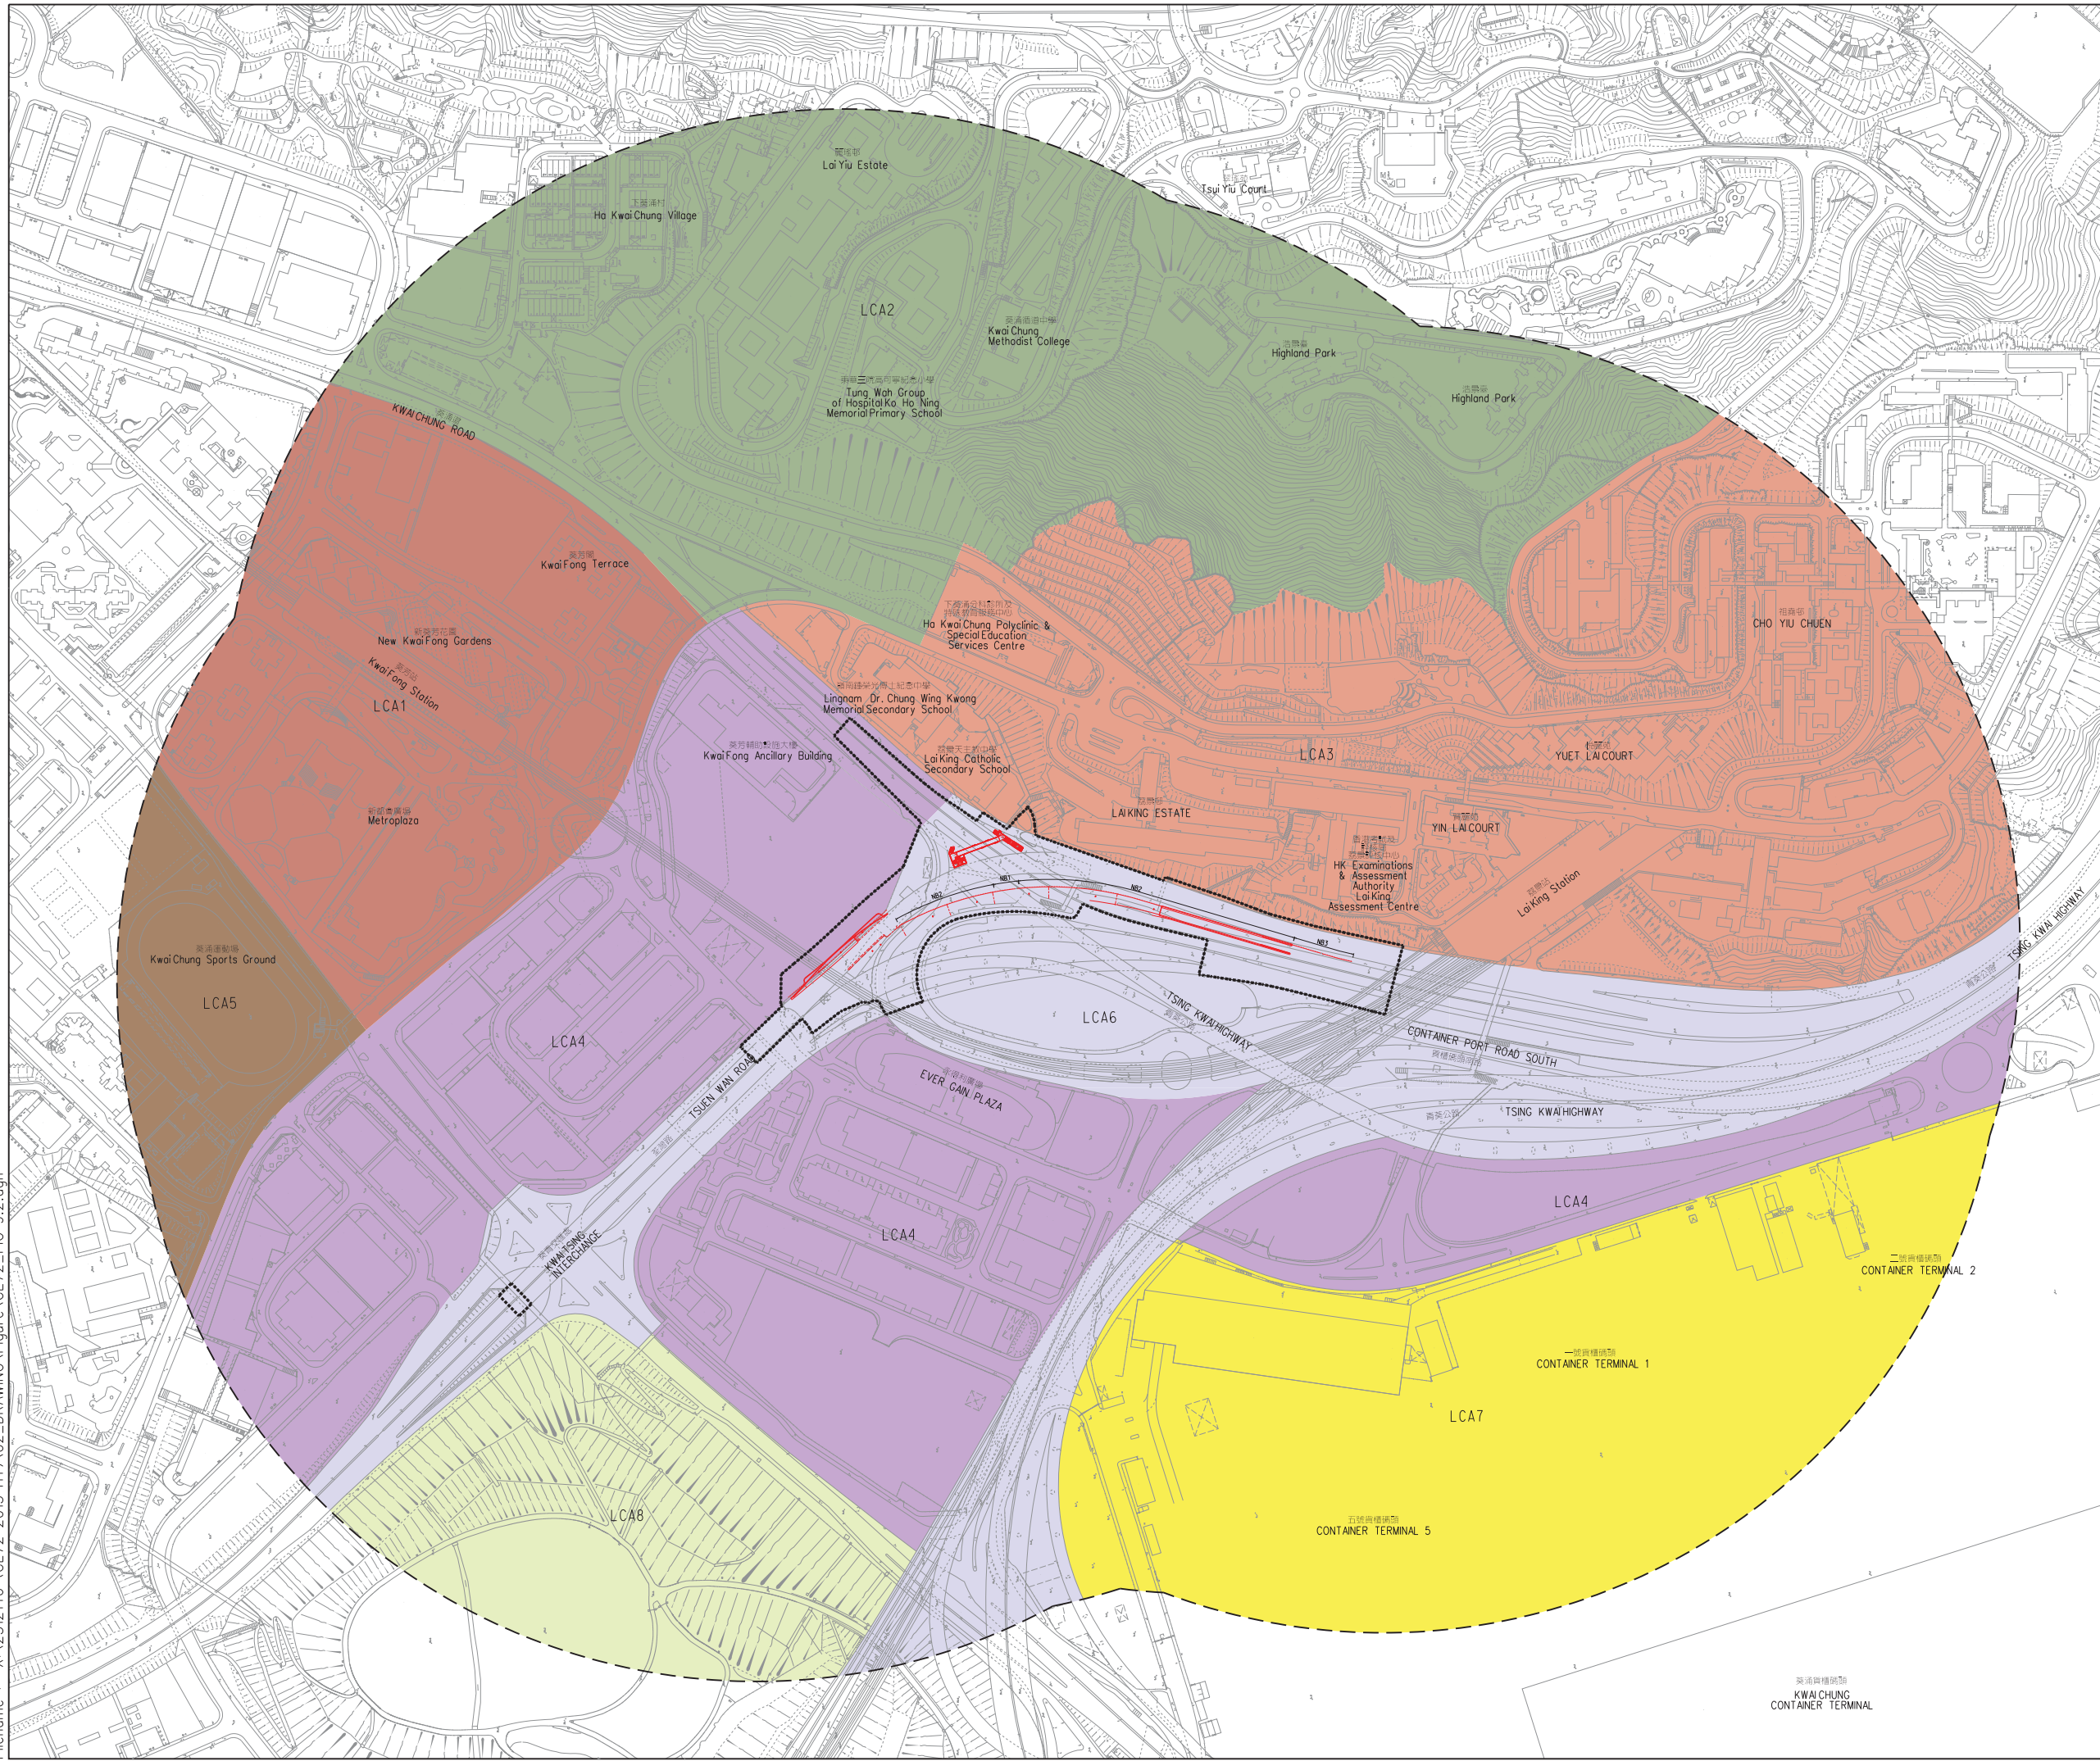
- LEGEND :**
- LIMIT OF WORKS AREA
 - LCA LANDSCAPE CHARACTER AREAS
 - LCA1 MIXED RESIDENTIAL AND COMMERCIAL SURROUNDING KWAI FONG MTR STATION
 - LCA2 RESIDENTIAL AT HIGHER LEVEL OF LAI KING HILL
 - LCA3 RESIDENTIAL AT LOWER LEVEL OF LAI KING HILL
 - LCA4 INDUSTRIAL & OPEN STORAGE AREA ALONG TSUEN WAN ROAD
 - LCA5 KWAI CHUNG SPORTS GROUND
 - LCA6 KWAI CHUNG ROAD INTERCHANGE
 - LCA7 KWAI CHUNG CONTAINER TERMINAL
 - LCA8 KWAI CHUNG PARK
 - PROPOSED FLYOVER / FOOTBRIDGE
 - NB PROPOSED NOISE BARRIER ON PROPOSED FLYOVER
 - NB1 5.5m HIGH VERTICAL BARRIER
 - NB2 5.5m HIGH BARRIER WITH 2.5m CANTILEVER AT 45 DEG.
 - NB3 5.5m HIGH BARRIER WITH 3.5m CANTILEVER AT 45 DEG.
 - 500m STUDY AREA

- 8.3.5 LCA3 Residential at Lower Level of Lai King Hill along Tsing Kwai Highway is rated to have medium sensitivity in the approved EIA Report. The affected area within LCA3 will increase by approximately 75m². The footbridge works and layout are similar to the approved EIA Report. The increased size of affected area is due to the changes in works areas. Recommended mitigation measures CP1, CP2, OP1, OP2, OP3 and OP4 in the approved EIA Report will still be effective. Temporary affected areas will be reinstated in the operation phase, thus there will be no changes to the overall landscape character. Residual impact significance will be the same as the approved EIA Report.

- 8.3.6 LCA4 Industrial & Open Storage Area along Tsuen Wan Road is rated to have low sensitivity. LCA4 was located outside the site boundary and thus was rated to have negligible magnitude of change in the approved EIA Report. However, LCA4 will be affected due to the temporary road diversion works along Tsuen Wan Road. The affected area is approximately 4,315m². The duration of the impact is temporary because a portion of Kwai Chung Road will require temporary road diversion during the construction phase. The magnitude of change is small in the construction phase. Recommended mitigation measures for LCA4 are CP1, OP1 and OP2. With mitigation measures in place, the residual impact in the construction phase will be slightly adverse. In Day 1 and Year 10 of the operation phase, LCA4 will be reinstated, thus

8.3.7 LCA6 Kwai Chung Road Interchange is rated to have low sensitivity in the approved EIA Report. Affected area of LCA6 will be increased by approximately 3,670m². The duration of the impact is temporary when a portion of Tsuen Wan Road and Tsing Kwai Highway require road diversion during the construction phase. Recommended mitigation measures CP1, CP2, OP1, OP2, OP3 and OP4 in the approved EIA Report will still be effective. Temporary affected areas will be reinstated in the operation phase and no changes to the landscape character are expected. The residual impact significance will be the same as the approved EIA Report.

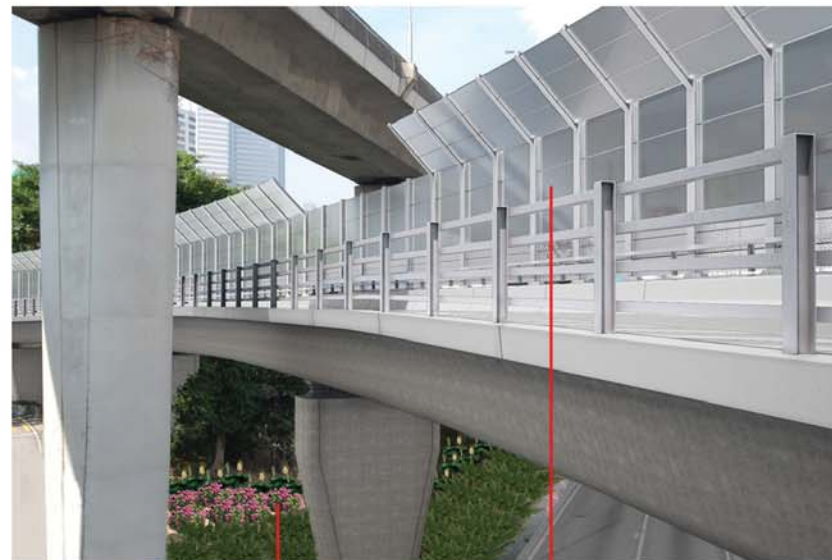
Photomontage C

Provision of planter on proposed footbridge

Improvement in streetscape and planting
Provision of noise barrier

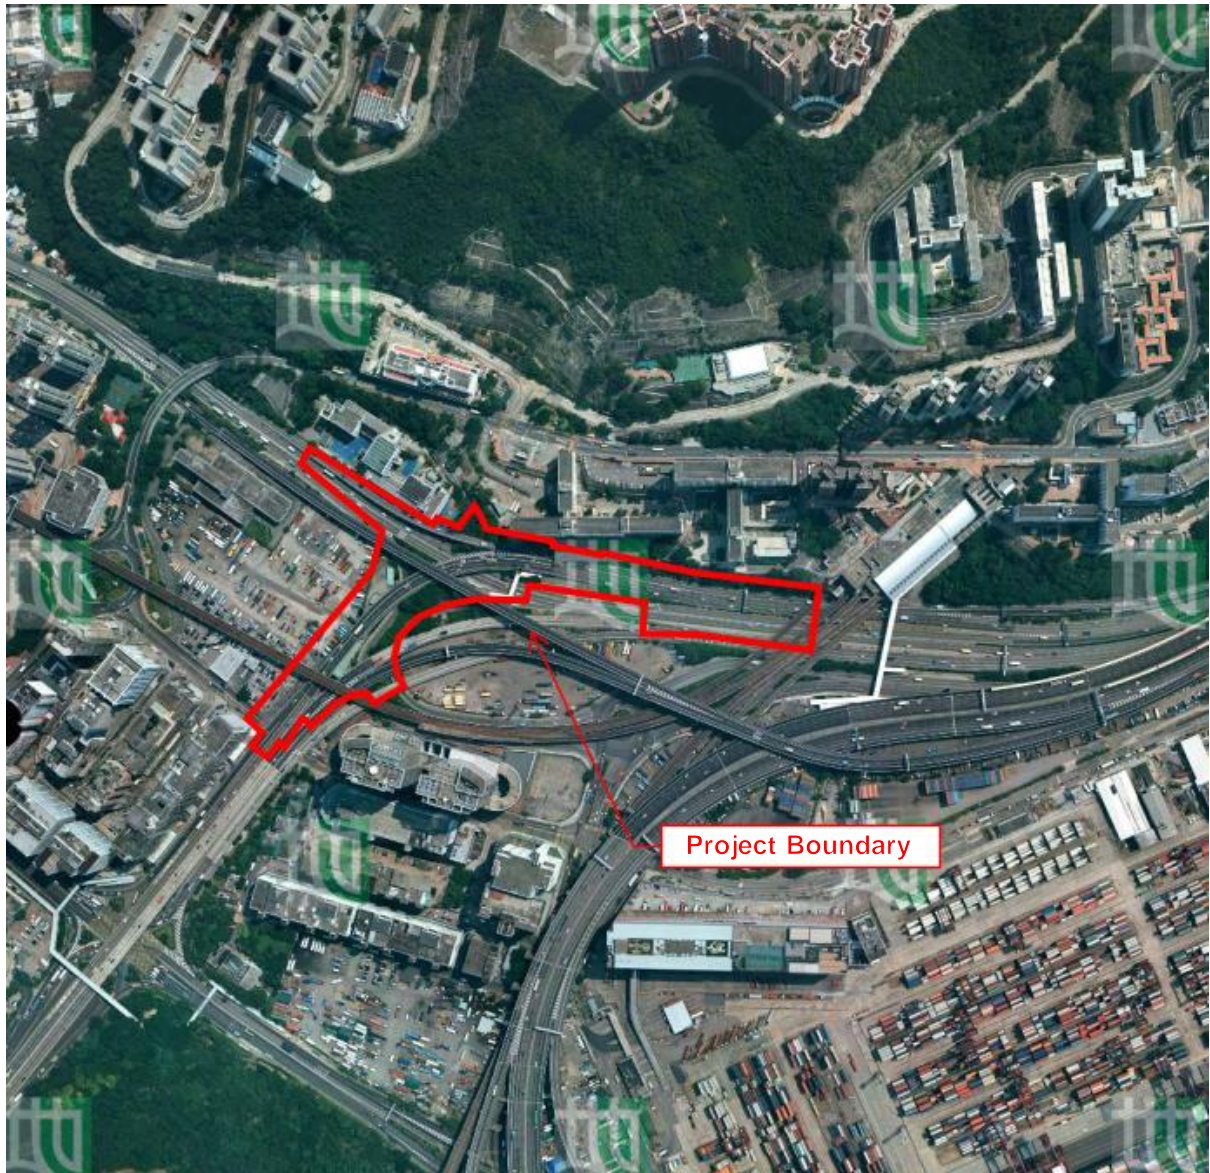
Photo No. CS39662

No observable changes since 1999.

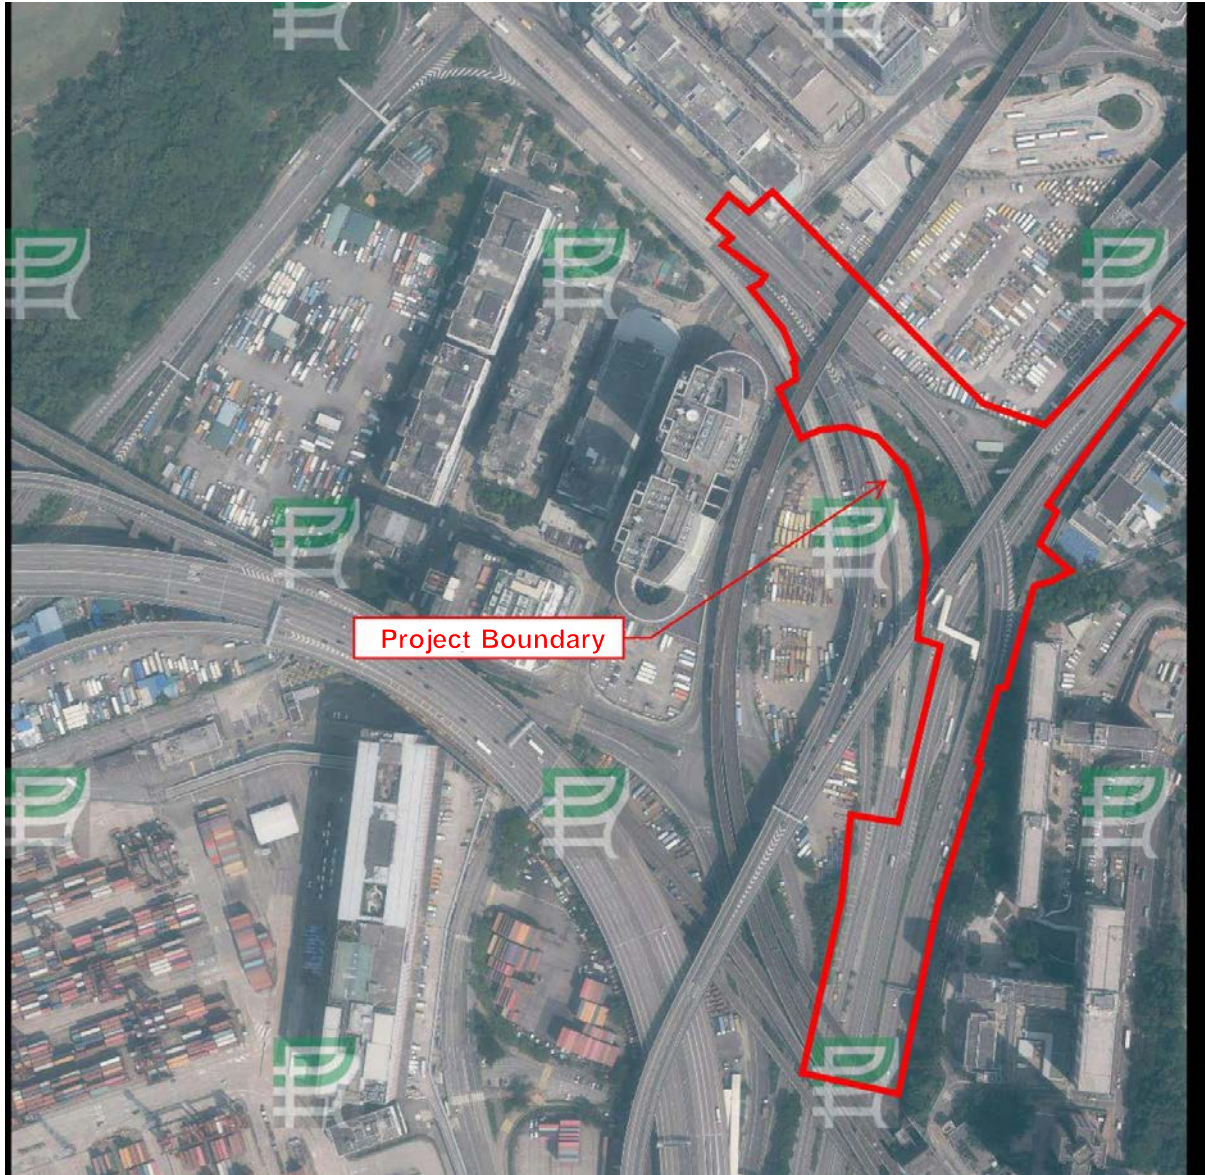
Photo No. E069365C

No observable changes since 1999.

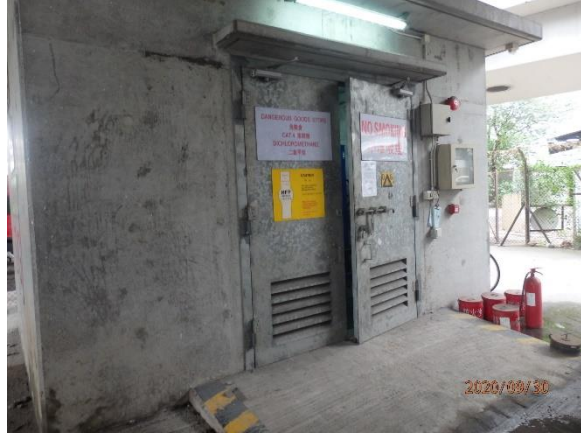
Photo 2. Store for Dichloromethane constructed in 2014

5 Observations	
Are chemical storage areas provided with secondary containment (i.e. bund walls and floors)?	Yes, in Dangerous Goods Store for Methylene Chloride Solvent (PWRL)
What are the conditions of the bund walls and floors?	Good
Are any surface water drains located near to drum storage and unloading areas?	No
Are any solid or liquid waste (other than wastewater) generated at the site?	Yes, Spent Methylene Chloride (PWRL)
Is there a storage site for the wastes?	Yes
Is there an on-site landfill?	No
Were any stressed vegetation noted on site during the site reconnaissance?	No
Were any stained surfaces noted on-site during the site reconnaissance?	Yes, observed in the Dangerous Goods Store (PWRL)
Are there any potential off-site sources of contamination?	No
Does the site have any equipment which might contain polychlorinated biphenyls (PCBs)?	Transformer (PWRL)
Are there any sumps, effluent pits, interceptors or lagoons on site?	Yes, Effluent Pits (PWRL)

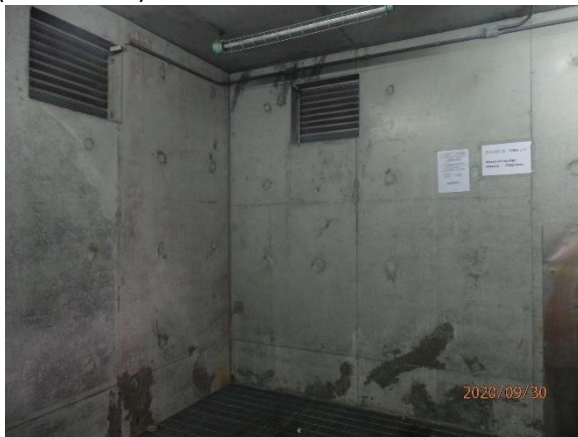
Photo 3. Store for Dichloromethane

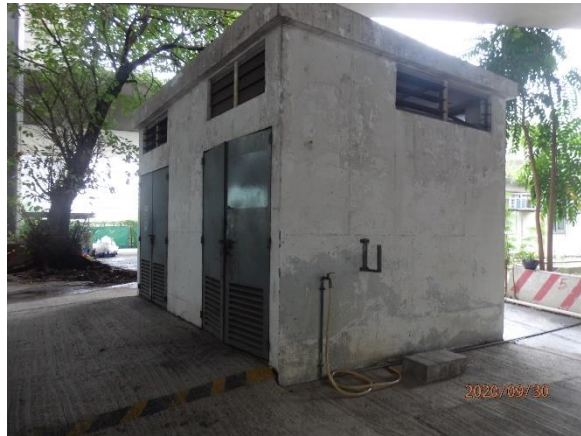
Photo 6. Abandoned Store for Dichloromethane

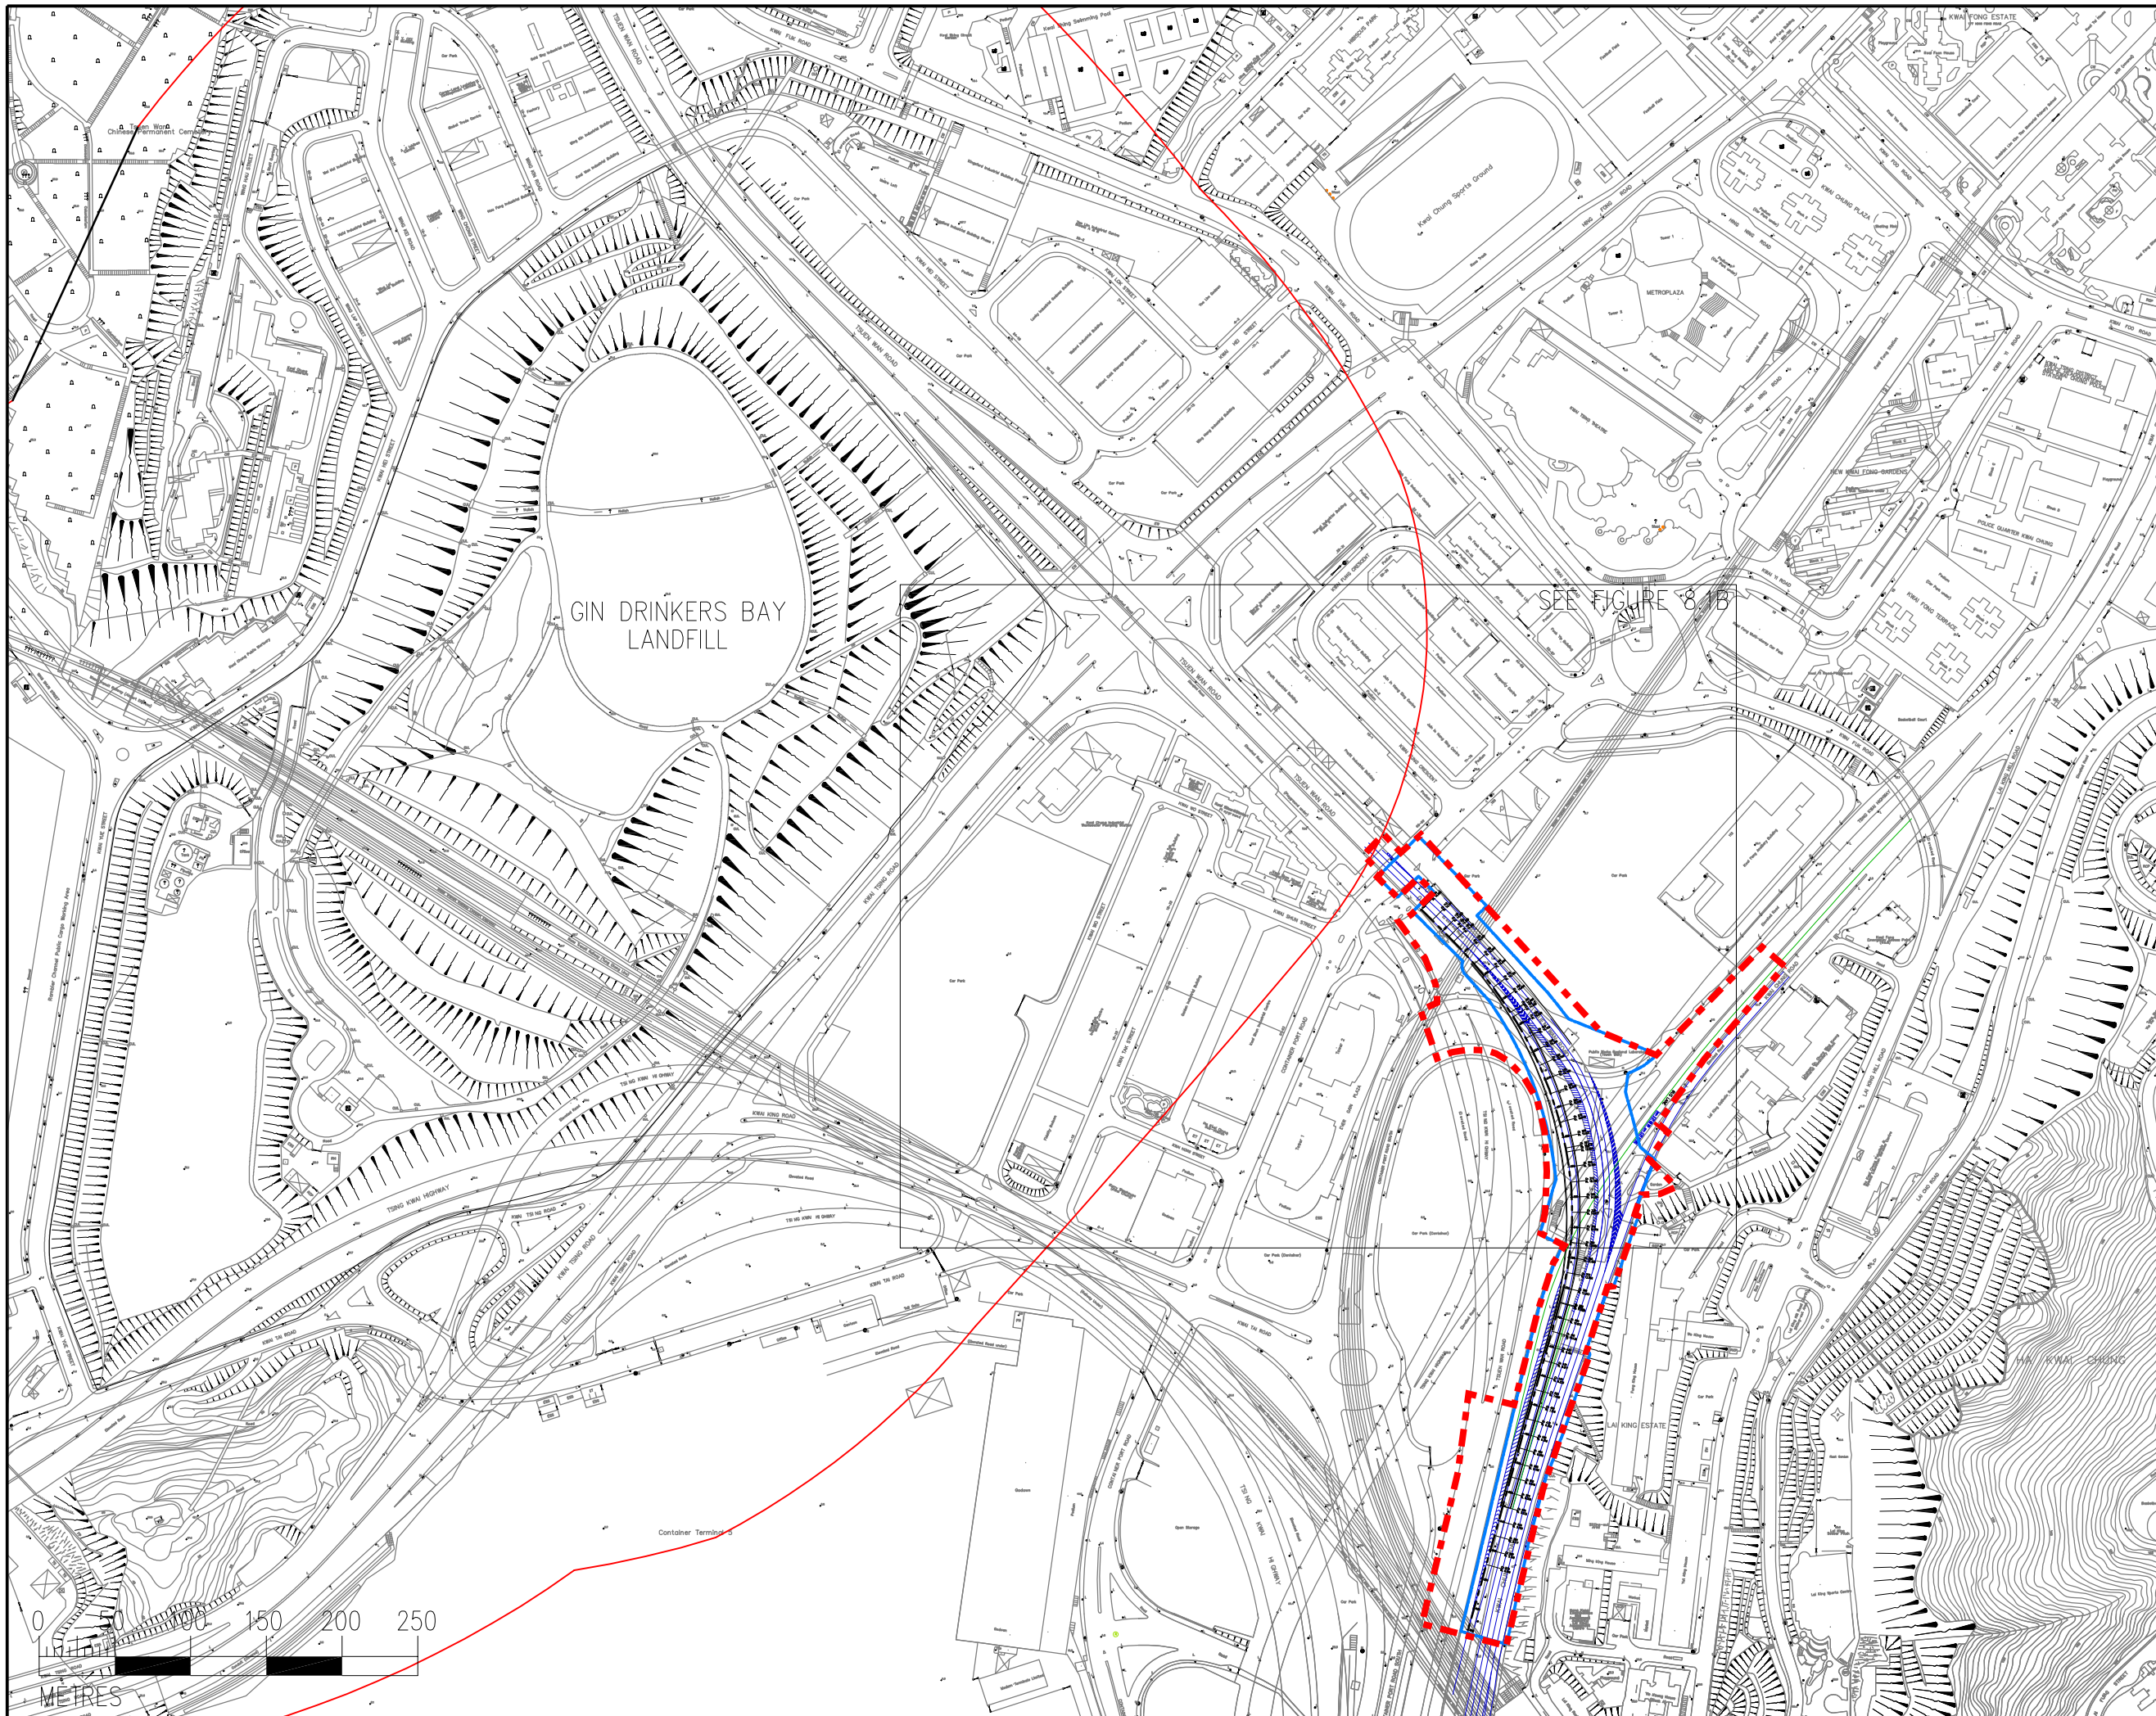
GIN DRINKERS BAY LANDFILL
CONSULTATION ZONE AND
PROPOSED BOUNDARY

- GIN DRINKERS BAY LANDFILL 250m CONSULTATION ZONE
- PROJECT CONSTRUCTION BOUNDARY
- REVISED PROJECT BOUNDARY

7.3.2 Therefore, the LFG hazard assessment is considered not necessary unless there is any possible change(s) on the design in the future that the project/construction boundary shows encroachment on the Consultation Zone and include any ground excavation or new underground utility connection within the landfill gas Consultation Zone.
