AGREEMENT NO. CE 18/2004 (GE)

10 YEAR EXTENDED LPM PROJECT

PHASE 5, PACKAGE H

Report of Baseline Survey for *Philautus romeri*

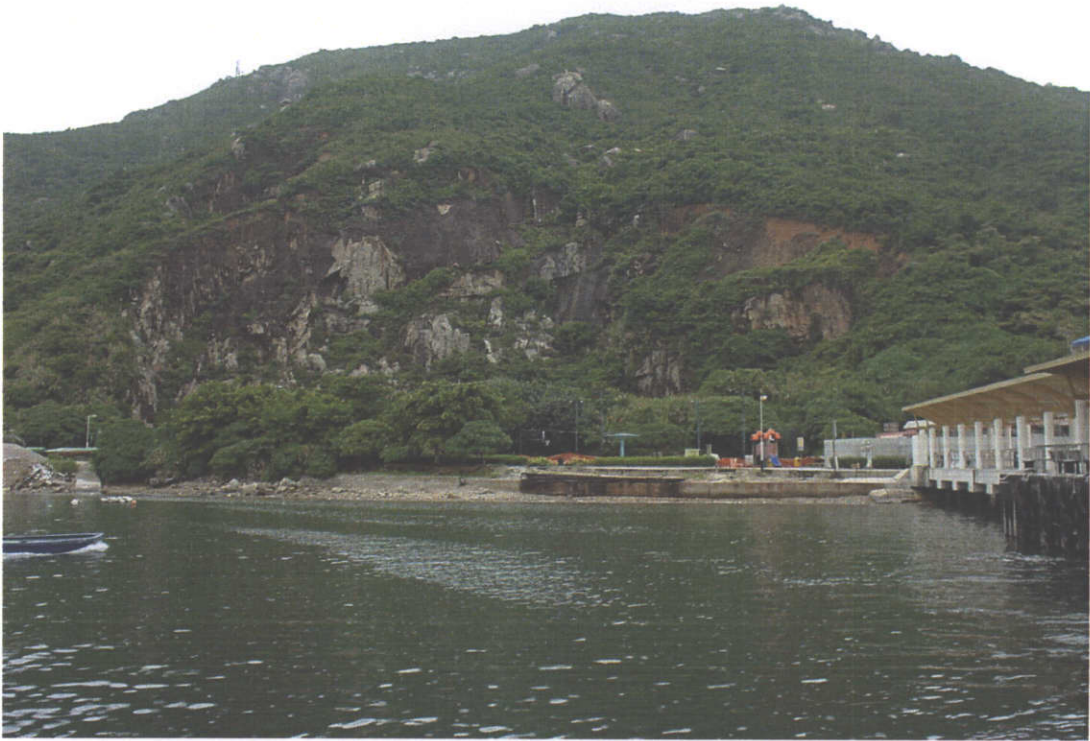
Plate 1: General view of the project site

The vast majority of Romer's Tree Frogs were found in the southern end of the project site where there is a healthy stand of small trees forming a young forest. This is as expected as this species is a forest floor species (Lau, 1998) (Plates 1 to 3). The exceptional case was on 28<sup>th</sup> August when one male was heard calling in the marsh in the northern side of the project site (Plate 4).

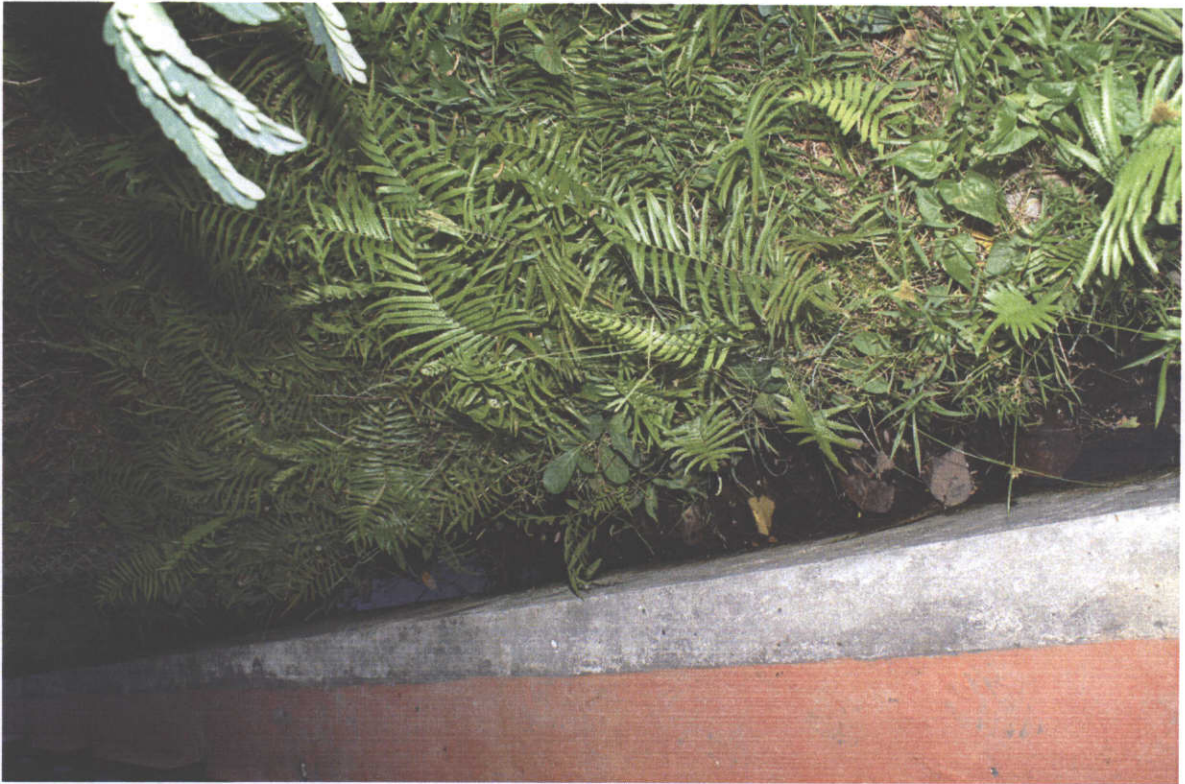
Plate 5: Ditch at the southern part of the project site

Romer's Tree Frogs used a variety of breeding habitats within the project site. These include the section of concrete ditch in the southern side (Plate 5), grassy marshes (Plate 6), seepage pools (Plate 7) and rainwater pools (Plate 8). This species is found to be adaptable and uses a wide range of breeding habitats including those listed (Lau, 1998).
