**NGONG PING VILLAGE SEWERAGE
(CONTRACT NO.: DC/2005/05)**

MONTHLY EM&A REPORT

(FEBRUARY 2007)

Report No.: ENA70139

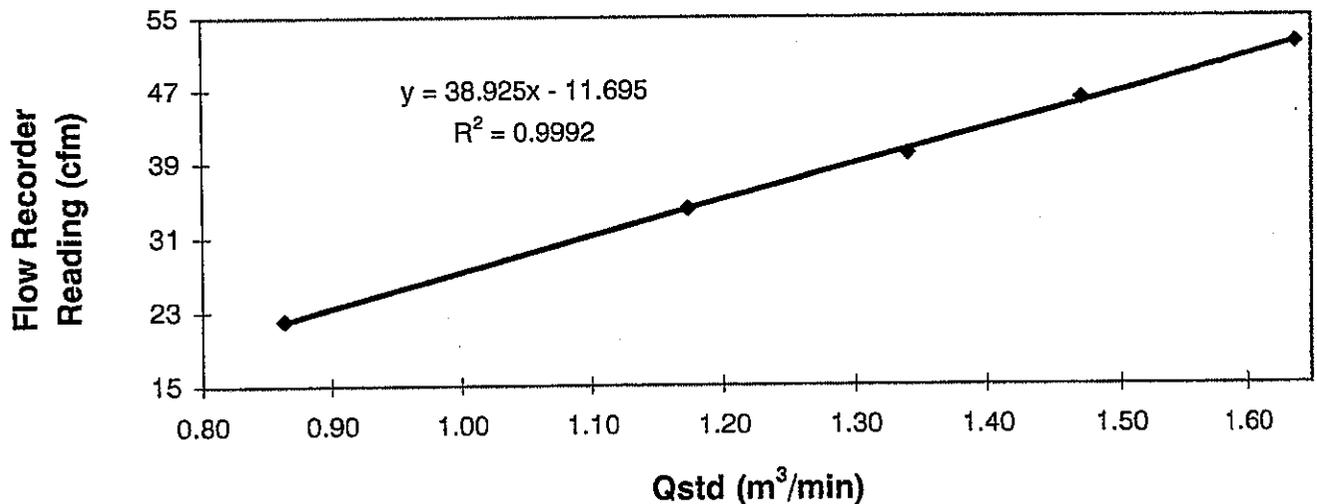
**Sampler9865 Calibration Curve
Site: Ngong Ping Monitoring Station A1
Date of Calibration: 24 January 2007**

Acceptance Criteria : Correlation coefficient (r) of the calibration curve greater than 0.990 after a 5 point calibration

The high volume sampler complies * / ~~does not comply~~ * with the specified requirements and is deemed acceptable * / ~~unacceptable~~ * for use.

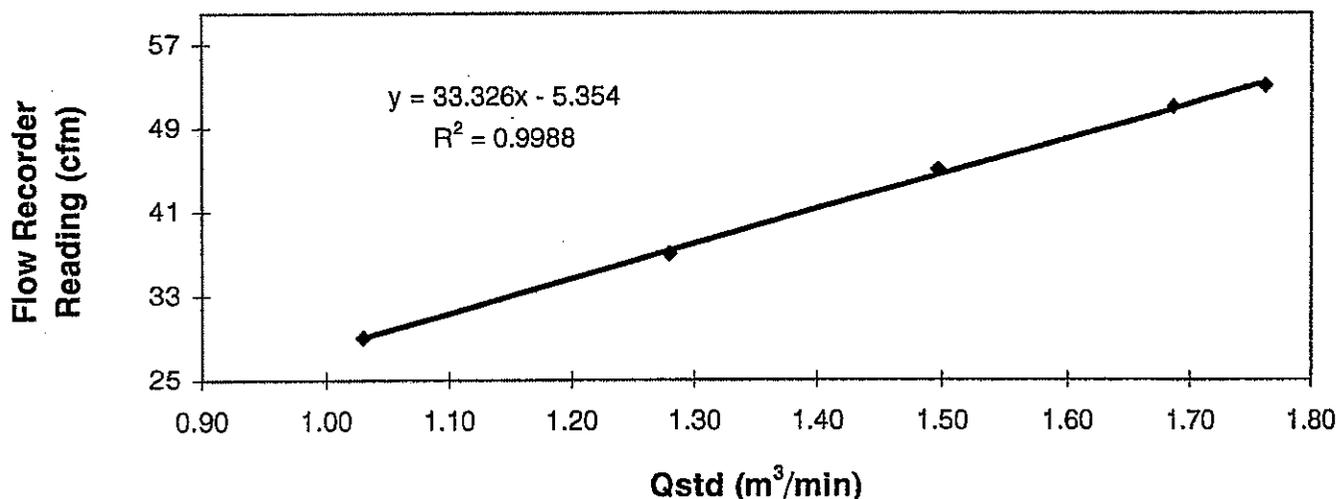
Sampler9035 Calibration Curve
Site: Ngong Ping Monitoring Station A2
Date of Calibration: 24 January 2007

Acceptance Criteria : Correlation coefficient (r) of the calibration curve greater than 0.990 after a 5 point calibration

The high volume sampler complies * / ~~does not comply~~ * with the specified requirements and is deemed acceptable * / ~~unacceptable~~ * for use.

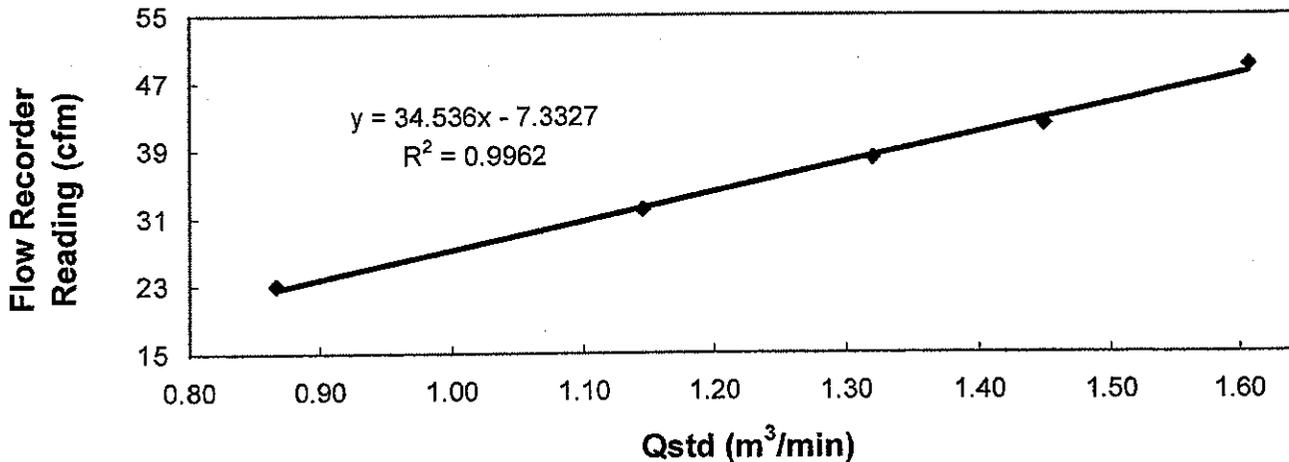
**Sampler9865 Calibration Curve
Site: Ngong Ping Monitoring Station A1
Date of Calibration: 22 November 2006**

Acceptance Criteria : Correlation coefficient (r) of the calibration curve greater than 0.990 after a 5 point calibration

The high volume sampler complies * / does not comply * with the specified requirements and is deemed acceptable * / unacceptable * for use.

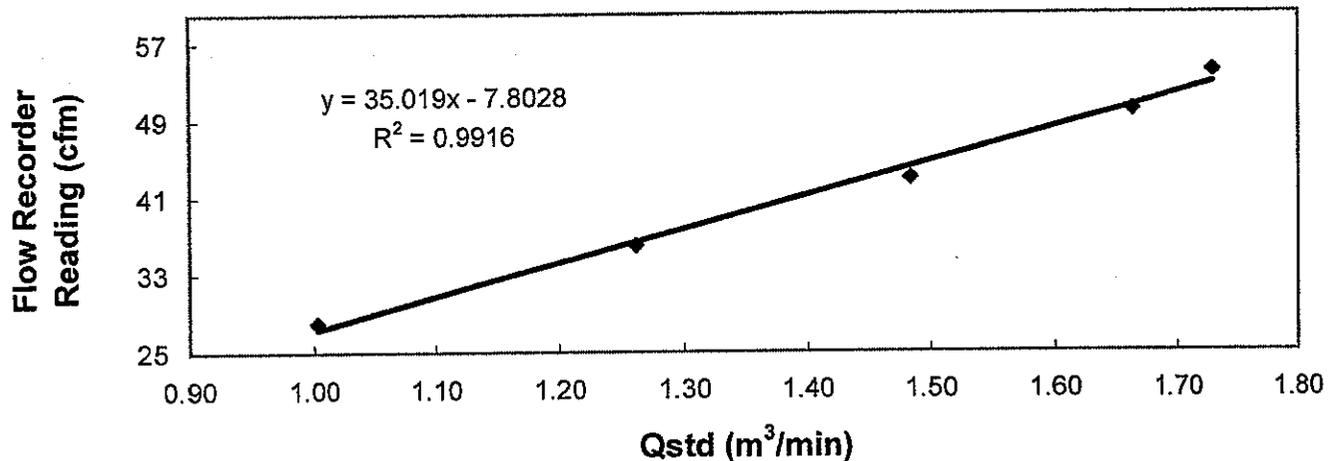
**Sampler9035 Calibration Curve
Site: Ngong Ping Monitoring Station A2
Date of Calibration: 22 November 2006**

Acceptance Criteria : Correlation coefficient (r) of the calibration curve greater than 0.990 after a 5 point calibration

The high volume sampler complies * / ~~does not comply~~ * with the specified requirements and is deemed acceptable * / unacceptable * for use.
