THE OCEANWAY CORPORATION LTD

FINAL MONITORING  
REPORT,  
TUNG PING CHAU MARINE  
PARK

THE IMPROVEMENT WORKS TO  
THE TUNG PING CHAU PIER

April 2007

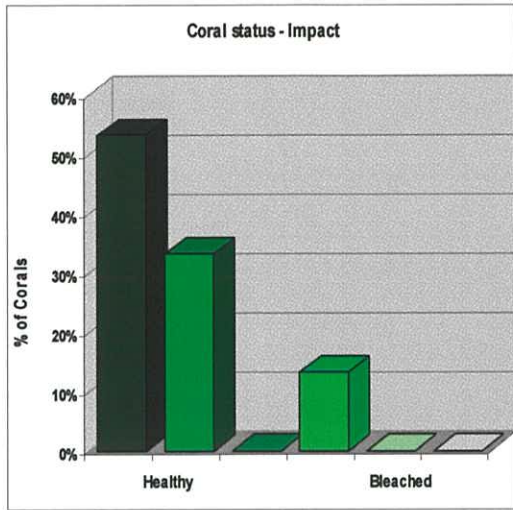
Figure 2a. The baseline CoralWatch result for the Impact Colonies.

A comparison of CoralWatch for these colonies between baseline and recent data is in Figure 2. The Cumulative Average was calculated to be 3.95 for this survey, whereas that of baseline was 4.57. A historical Cumulative Average was also included (Fig.3). Note that the Cumulative Average figure has a range from 1~6 with 6 being no stress and 1 being maximum stress.

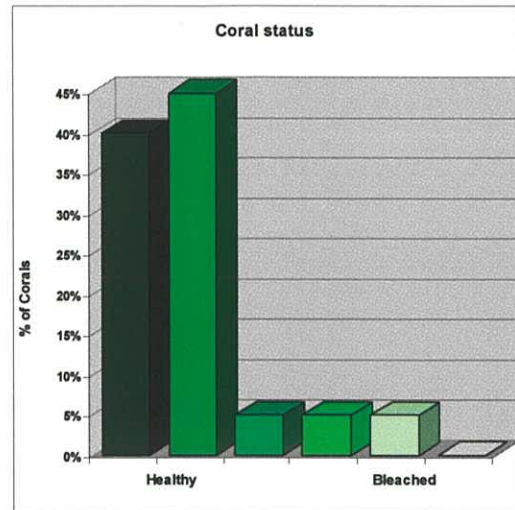
Figure 2b. The final CoralWatch result for the Impact Colonies.

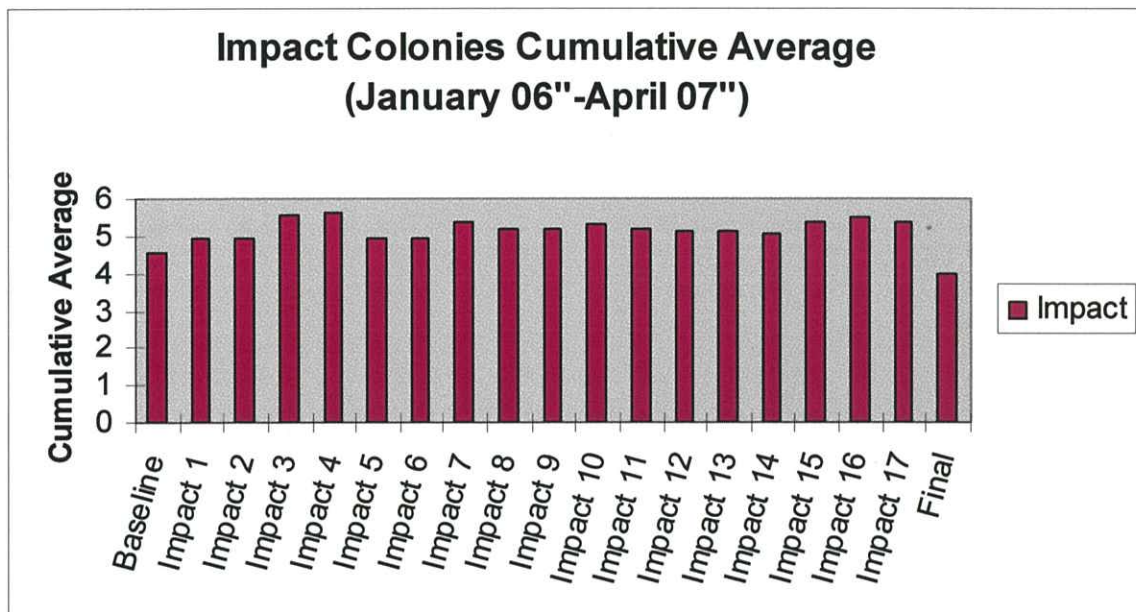
Figure 3. Respective Cumulative Average data recorded for Impact Colonies from baseline survey until final monitoring survey.

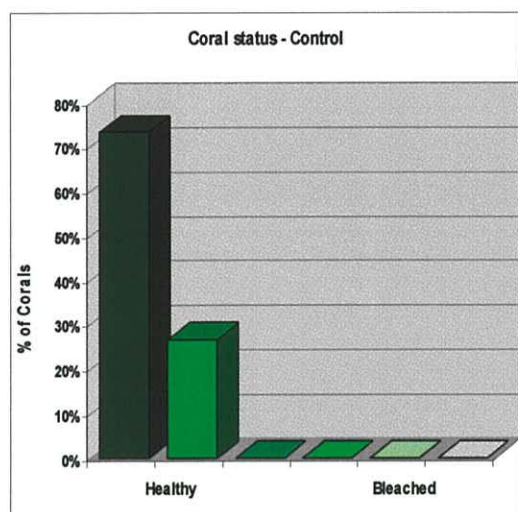
**Figure 4a. The baseline CoralWatch result for the Control Colonies.**

The CoralWatch data for these colonies is in Figure 4. The recorded data from baseline survey to post monitoring survey was presented in Figure 5. The Cumulative Average was calculated to be 4.15 as compared to 4.47 in 2006 when baseline data was obtained. Note that the Cumulative Average figure has a range from 1~6 with 6 being no stress and 1 being maximum stress.

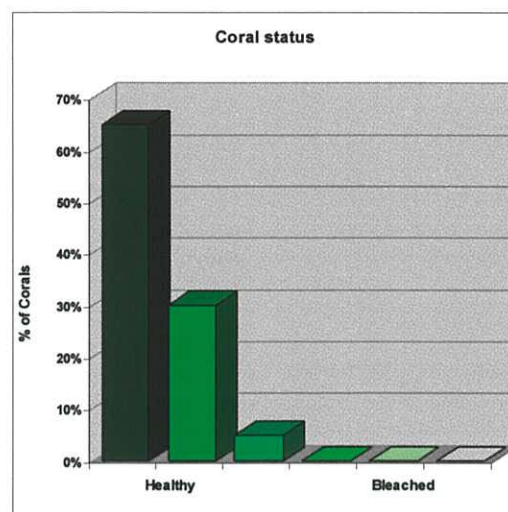
**Figure 4b. The final CoralWatch result for the Control Colonies.**

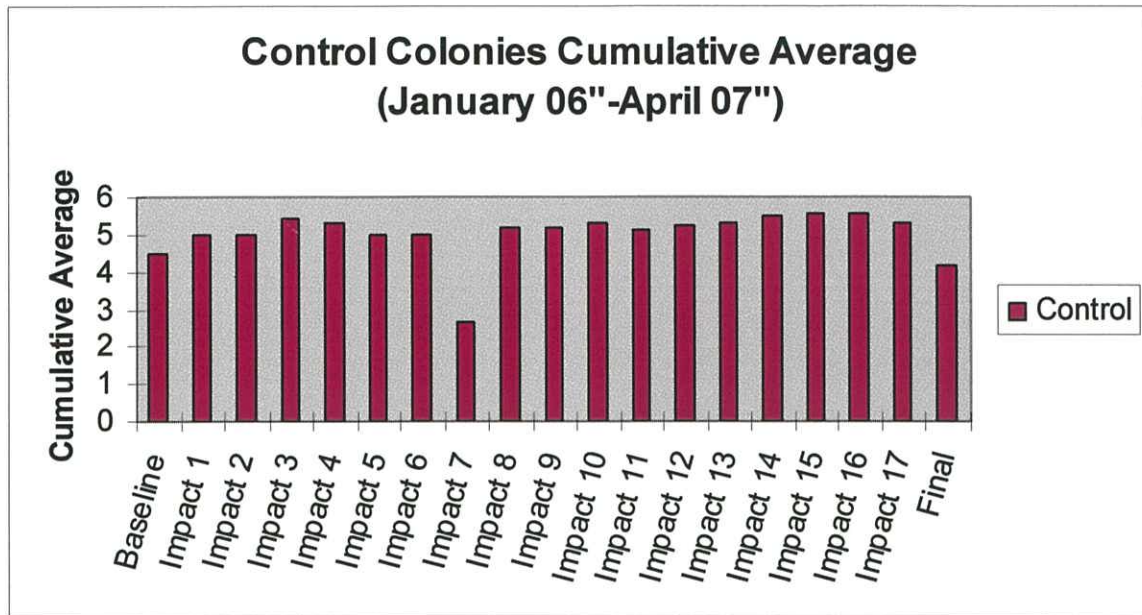
Figure 5. Respective Cumulative Average data recorded for Control Colonies from baseline survey until final monitoring survey.

Note that the sudden drop in CA during Impact Survey 7 was due to Typhoon Prapiroon.

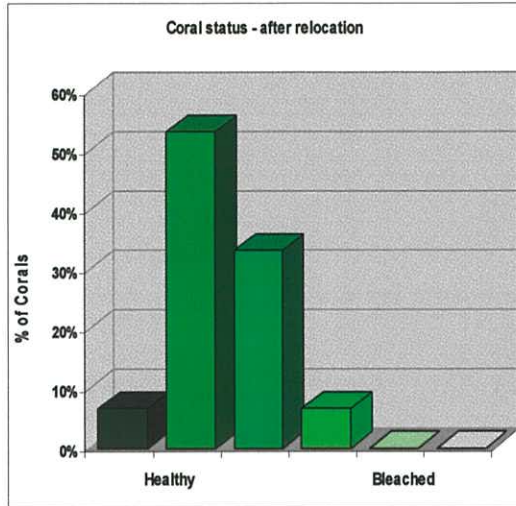
Figure 6a. CoralWatch results after the relocation in April 2006.

The results of the survey are in Figure 6b with the relative results from last year in Figure 6a. The Cumulative Average dropped from a value of 4.03 to 3.98 at this monitoring. Cumulative Average data from all the surveys done can be found in figure 7. Note that the Cumulative Average figure has a range from 1~6 with 6 being no stress and 1 being maximum stress.

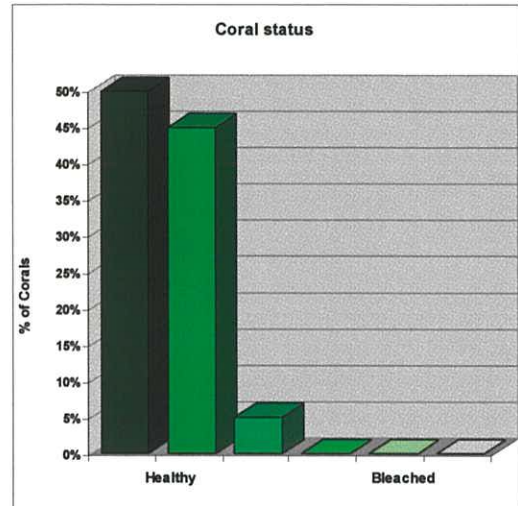
Figure 6b. CoralWatch, current surveyed status of the Relocated Corals.

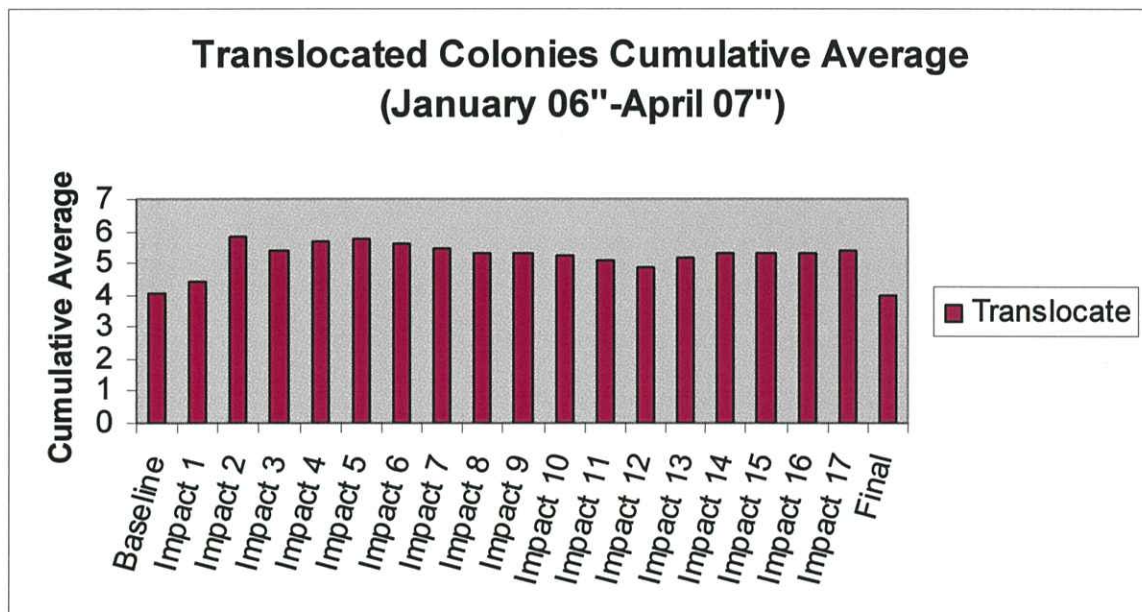
Figure 7. Respective Cumulative Average data recorded for Translocate Colonies from baseline survey until final monitoring survey.

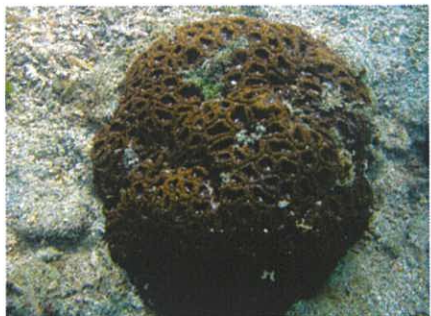
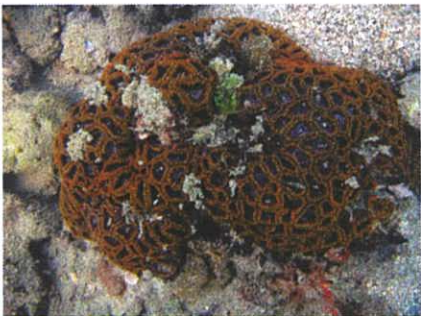
Note: Coral tagged I1 has been replaced by I1a after the typhoon incident in August 2006.

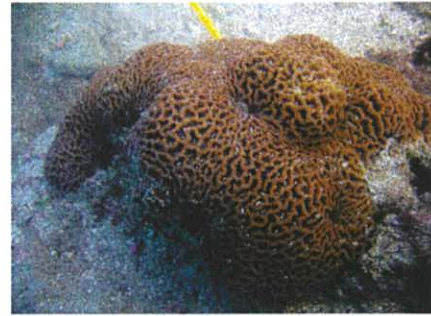
<p>I8</p>

All of the coral areas around the works area survived with minimal impact from the works. Only one colony (tagged colony I8), other than those damaged during Typhoon Prapiroon, was found dislodged during impact survey 17 however it is not possible to determine that the works were the reason why the colony separated from its substratum. The colony has already been re-attached.

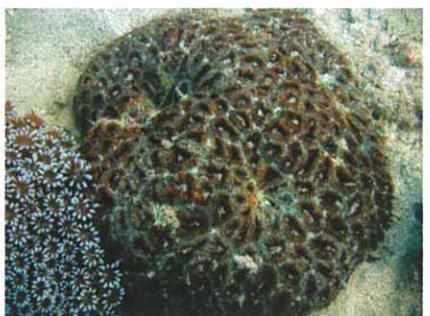
<p>C9</p>

Note: Corals tagged C9, C10, C11...C15 have been replaced by C9a, C10a, C11a...C15a after the typhoon incident in August 2006.

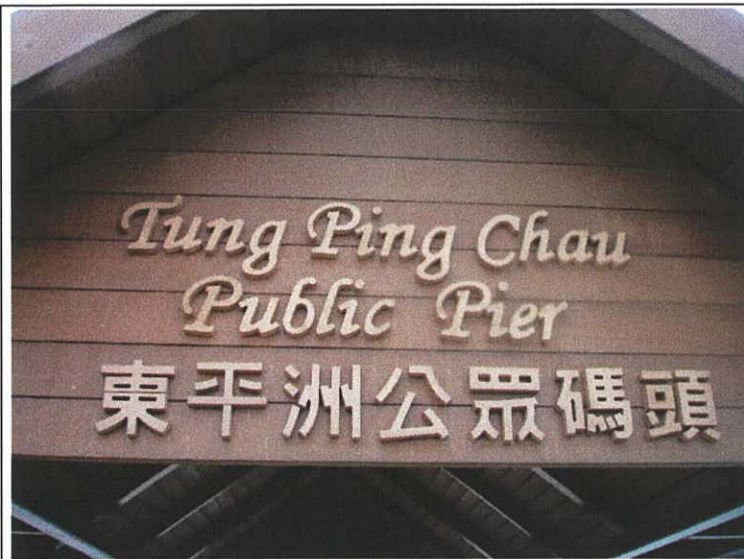
**Plate 1.** The new look Tung Ping Chau Pier.

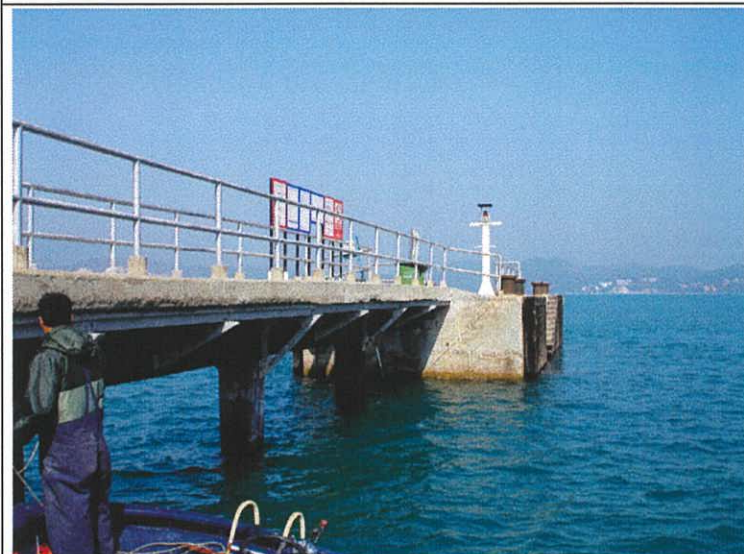
**Plate 2.** The old pier before the renovation works began.

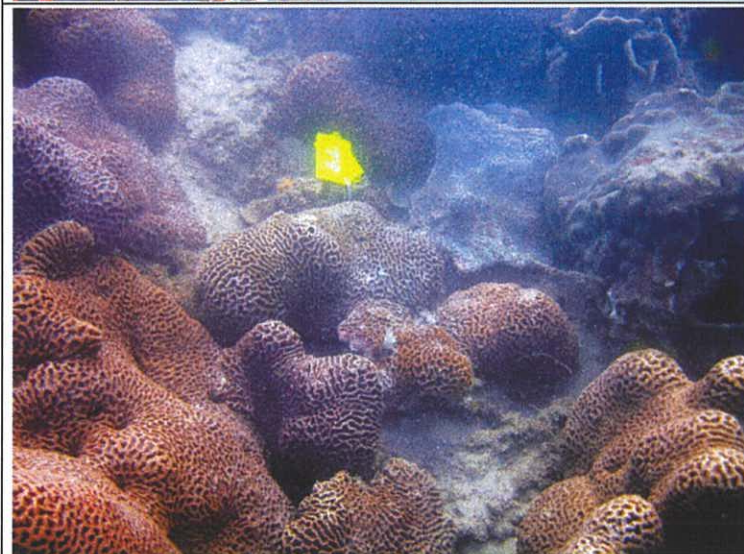
**Plate 3.** The area was tagged for identifying purpose with Perspex tags.

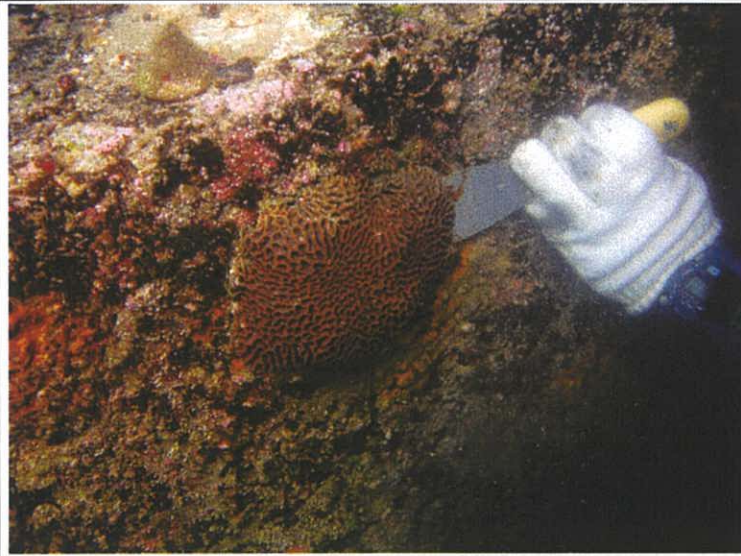
**Plate 4.** Removing a small encrusting coral from the pier foundation before the works started.

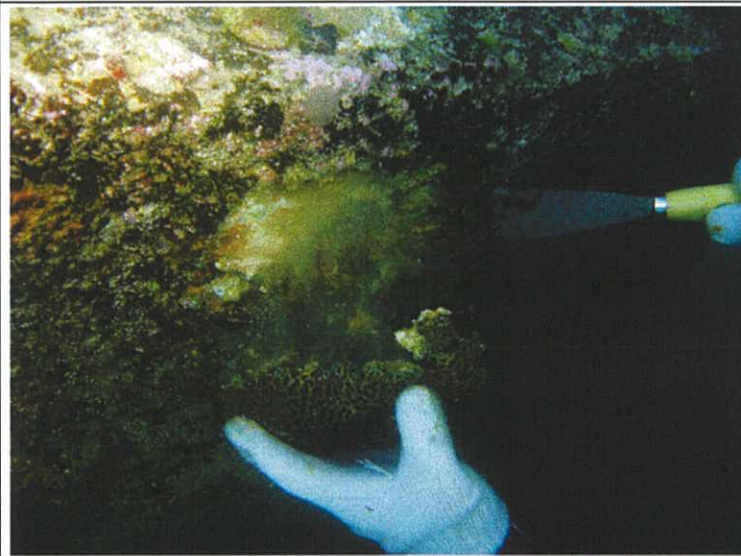
**Plate 5.** The same coral as in Plate 4 above. Now removed. This coral colony was one of the 41 relocated to another area.

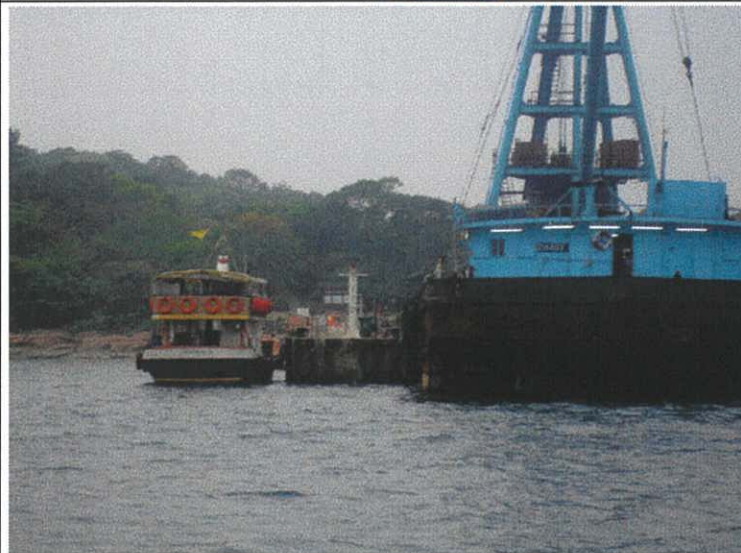
**Plate 6.** The location of the Works Barge. The addition of this vessel allowed the pier to be kept clear of construction equipment and debris.

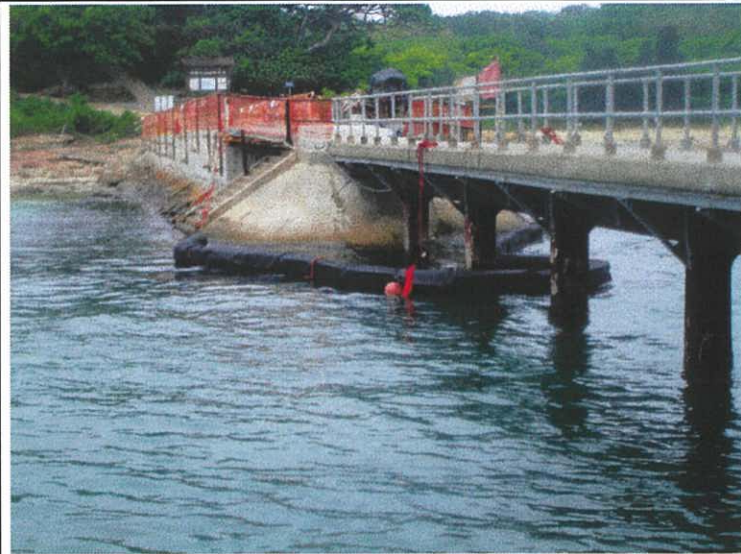
**Plate 7.** A sediment curtain was added to limit the fallout of sediment and to contain any concrete overspill. There were coral colonies within 2m of this curtain.

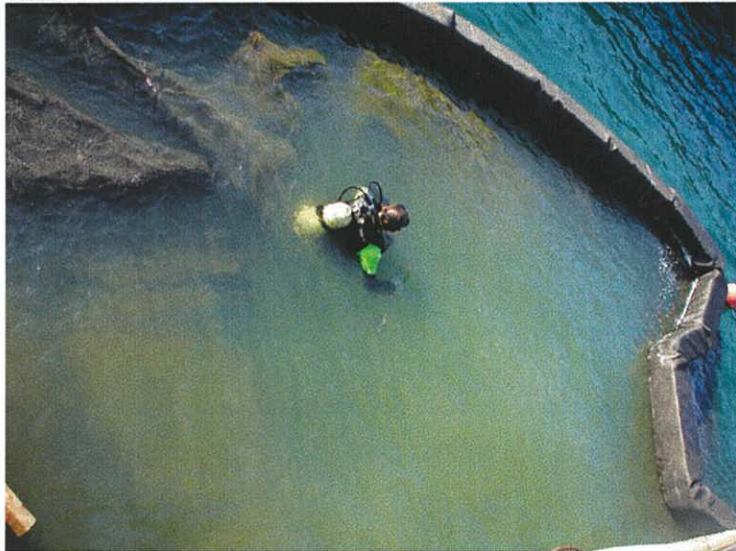
**Plate 9.** A diver working inside the sediment curtain removing rocks so that the caisson piles could be installed under the pier.

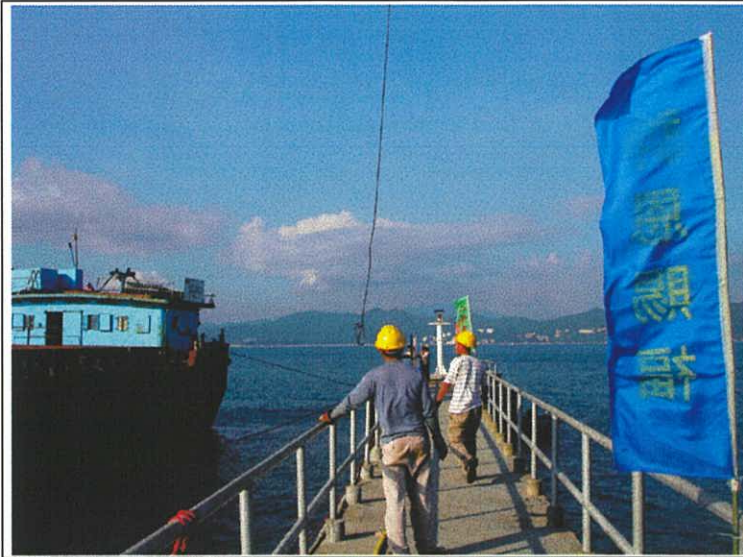
**Plate 10.** Coordination of the temporary removal of the burnishing stones from the foot of the old pier. These rocks were lifted out one by one.

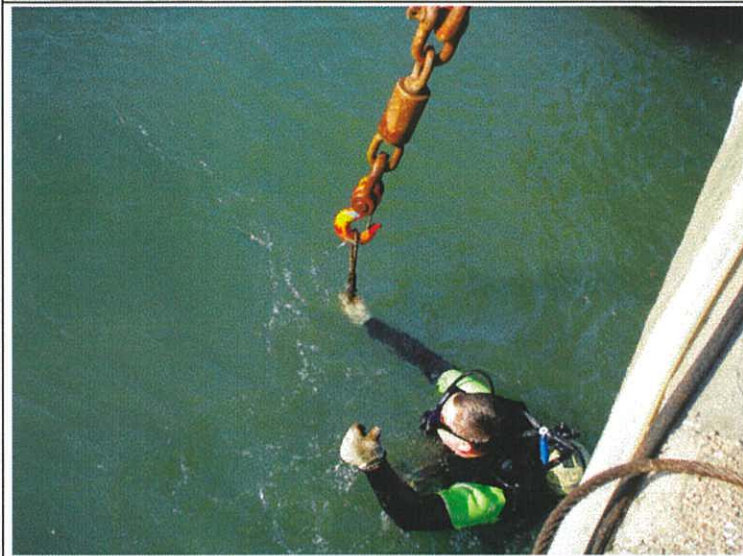
**Plate 11.** A diver working with the crane operator to remove the rocks around the old pier structure. Some of these rocks weighted nearly one tonne.

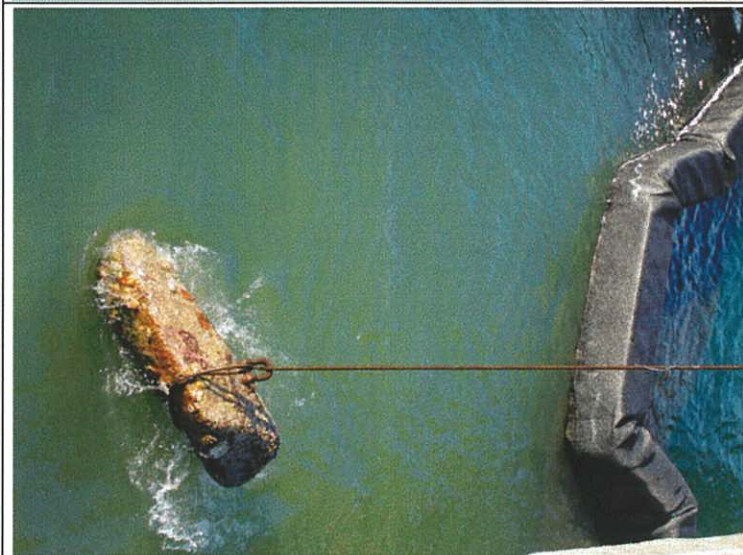
**Plate 12.** A foundation rock being lifted out.

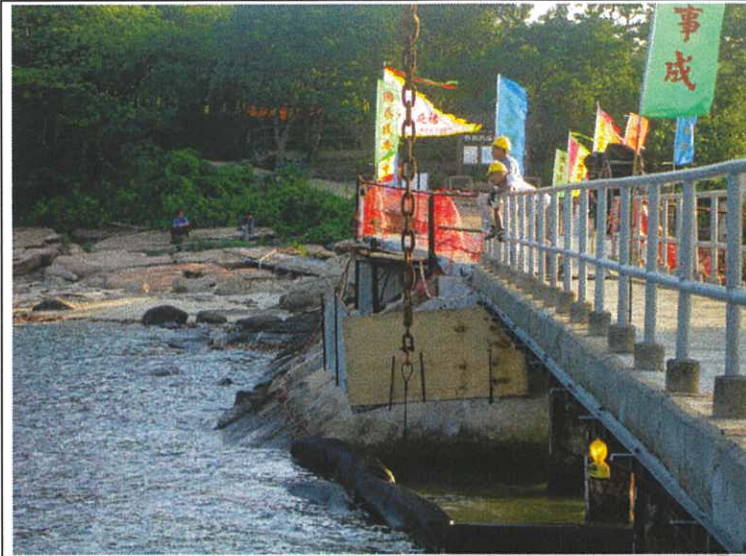
**Plate 13.** Reinforcing the pier footing to allow it to take the weight of the new pier section.

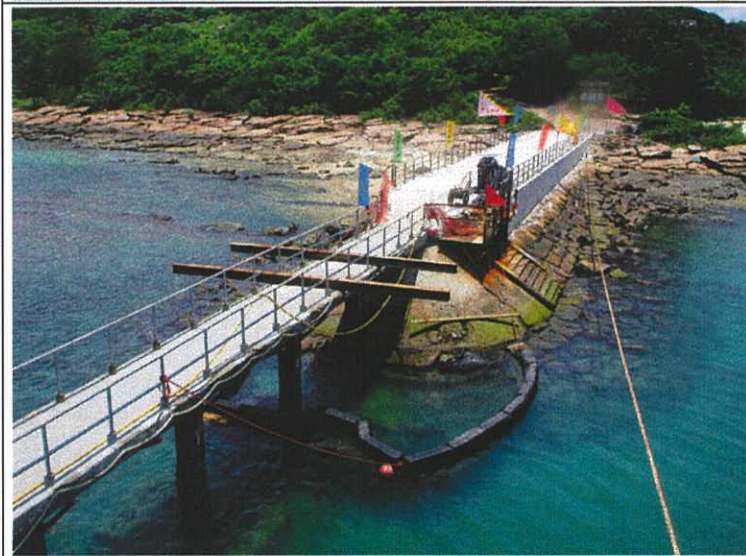
**Plate 14.** A view of the worksite showing the installation of the guides for the caisson piles.

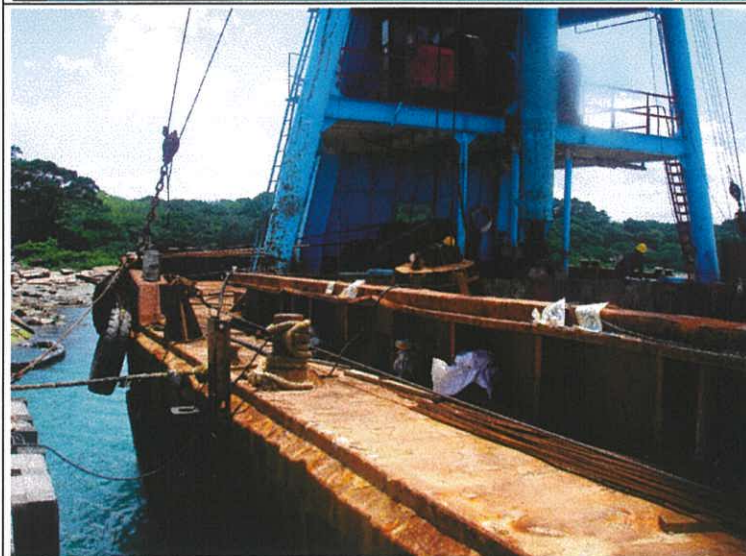
**Plate 15.** The Work Barge for this project. All material had to be kept in the hold to ensure that nothing could fall onto the corals below.

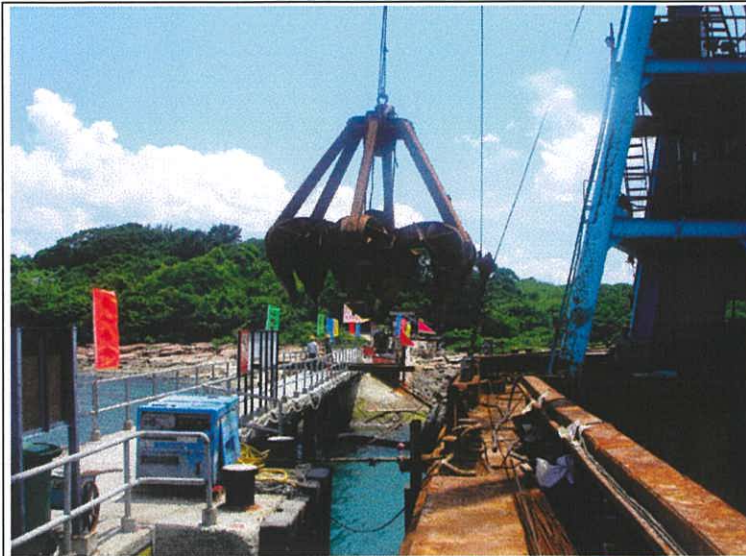
**Plate 16.** The deeper foundation for the caisson piles was dug using a rock grab. Both surface and in water guiding of this work phase was carried out.

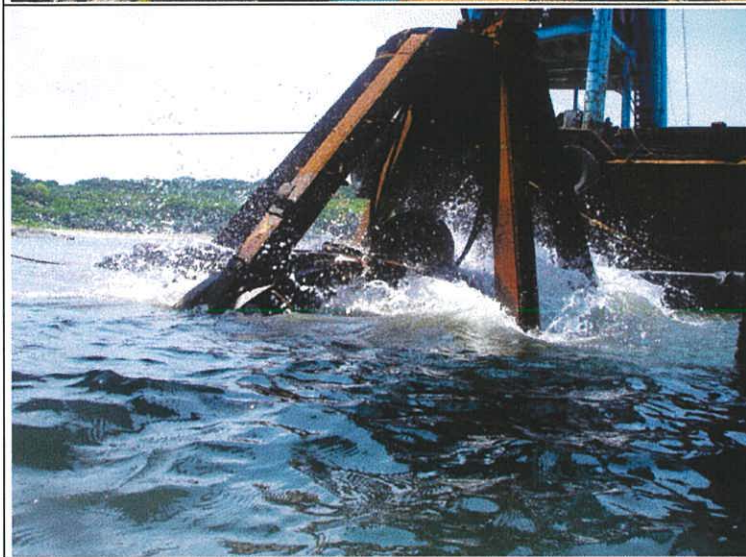
**Plate 17.** The rock grab in action. Only one day was required for this work.

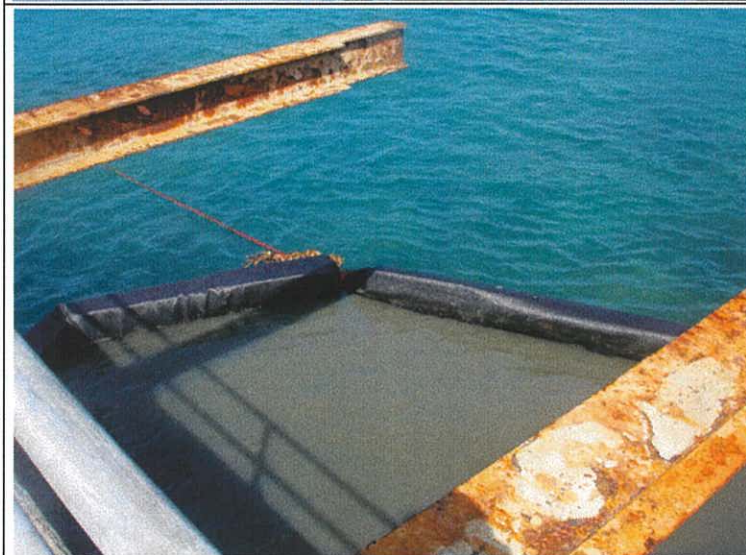
**Plate 18.** The caisson guides were used to align the grab. Note the effectiveness of the sediment curtain.

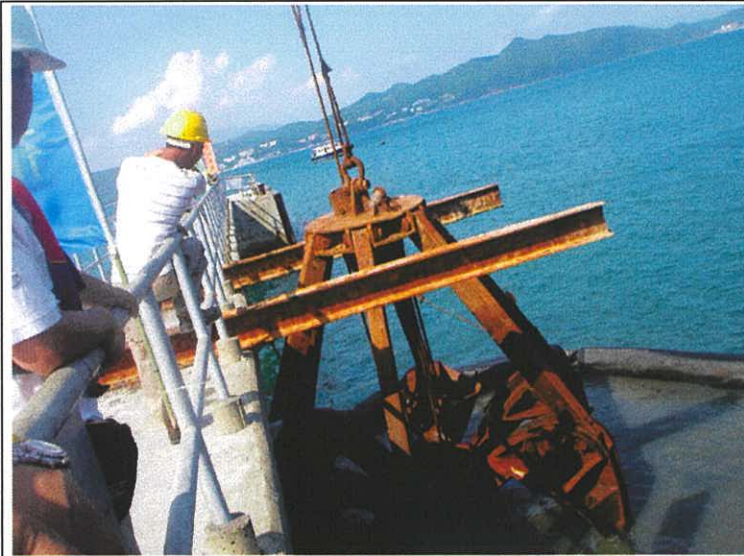
**Plate 19.** Accurate grabbing within metres of a coral area. This work was supervised from the surface in-water. No coral damage resulted. A similar technique had been applied during the Pak A project.

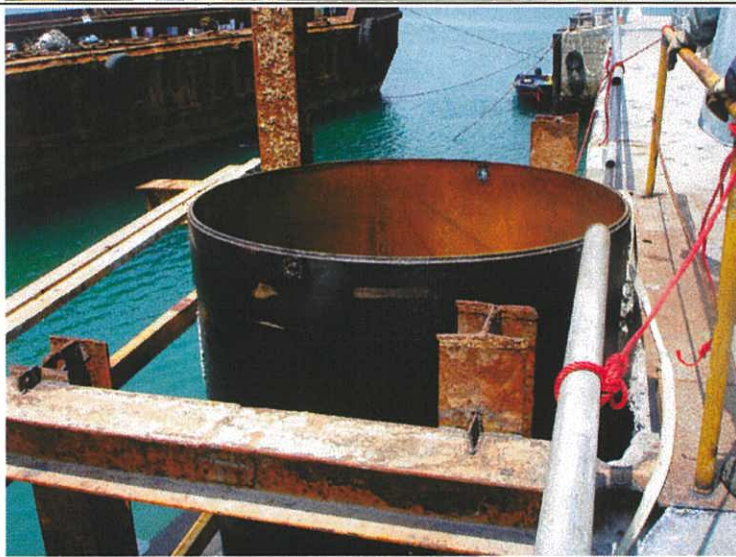
**Plate 20.** Finally the first caisson goes in. It was gently vibrated through the sand until it reached firm bed-rock.

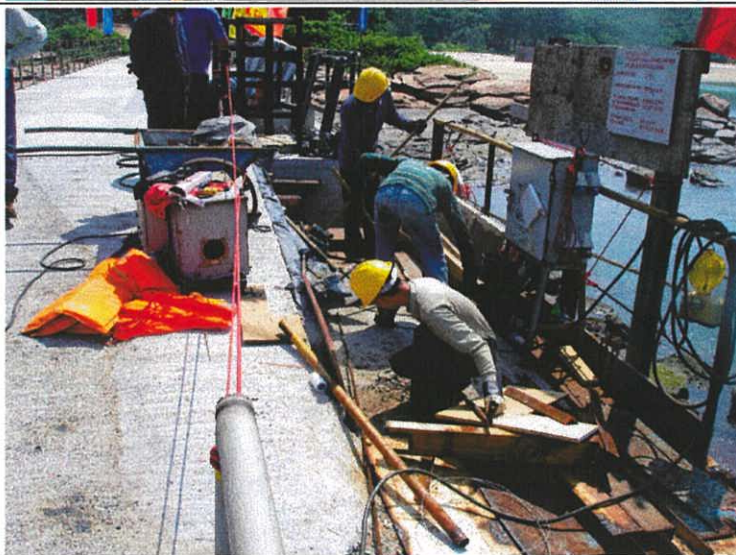
**Plate 21.** The pier was not closed to the public during this renovation so there were limited areas on the pier for the construction crew to work. This is one such area.

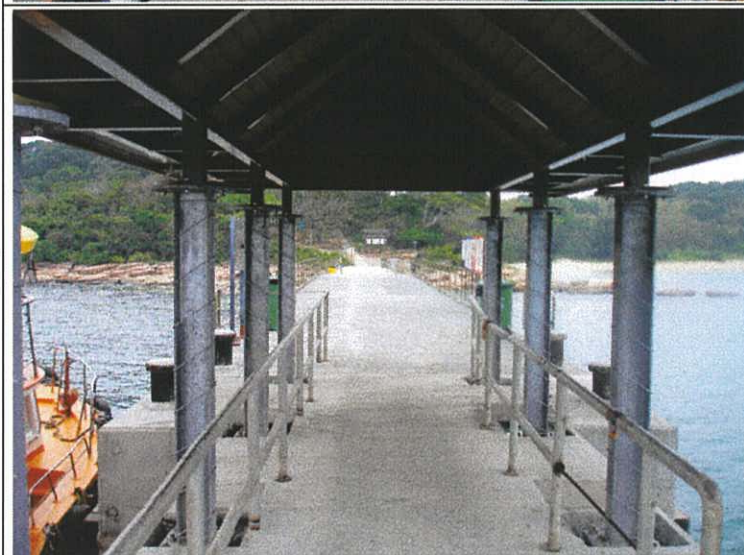
**Plate 24.** A photograph along the new pier. Only some of the railings had not been installed.

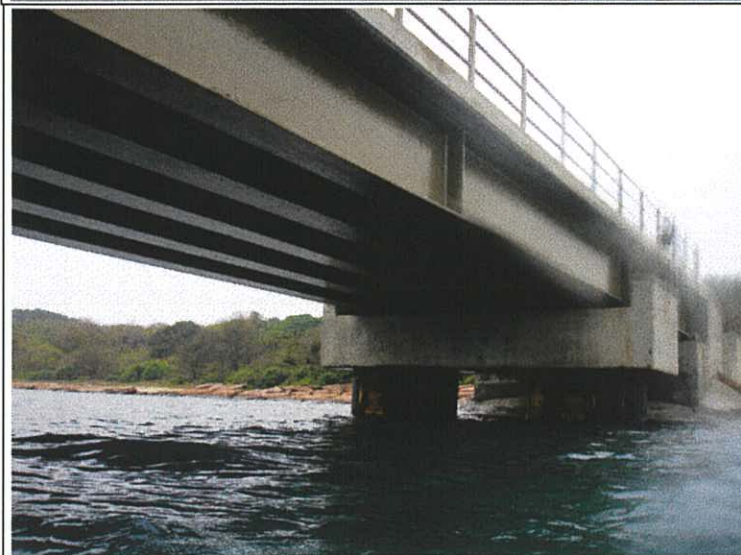
**Plate 27.** Underneath view of the new pier. The two caissons are shown in this photograph.  
(April 2007)

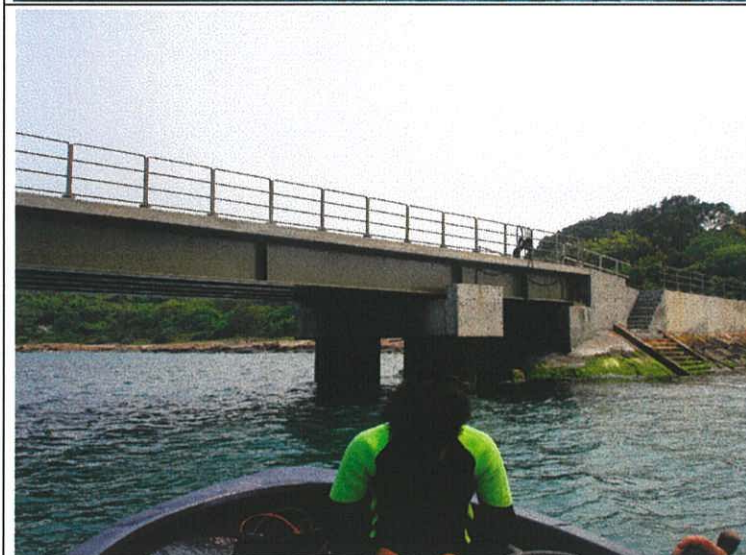
**Plate 30.** The completed product. A new pier at Tung Ping Chau.
