THE OCEANWAY CORPORATION LTD

CORAL SURVEY,
PIER AREA
TUNG PING CHAU MARINE
PARK

Coral Translocate and Baseline

April 2006

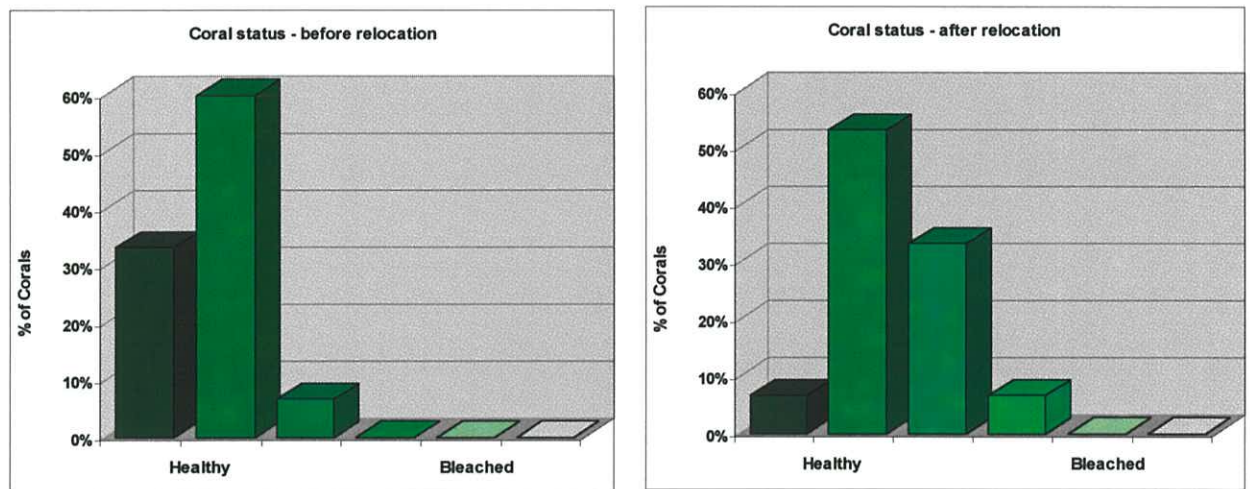
Figure 2. CoralWatch results from the Relocated Corals, before and after the relocation.

A CoralWatch survey was carried out on the tagged colonies immediately before and after the translocation. The results of the survey are in Figure 2. There is a visible reduction in coral health between the before and after data sets. The Cumulative Average also dropped from a value of 4.50 before to 4.03 after the relocation was carried out. Note that the Cumulative Average figure has a range from 1~6 with 6 being no stress and 1 being maximum stress.

The results of the coral relocation indicate that it was successfully carried out. This was the first time that a CoralWatch Survey was carried out immediately prior to the relocation and then immediately after the reattachment of the colonies. The whole operation took only five hours and already the corals were showing signs of stress. These corals will be monitored using the same frequency as the Impact Monitoring. The EM&A specifies that bleaching, partial mortality, sediment and other relevant data concerning all colonies be recorded. This data will also be recorded for the translocated colonies. As well as this data CoralWatch data will be collected so that a comparison with other areas and between past surveys can be carried out. The results of the monitoring of the relocated colonies will form part of the Coral Performa as required by this project. The results will be separated from the figures used to determine whether any action limits have been exceeded for this project. Appendix D contains photographs of the relocation process.

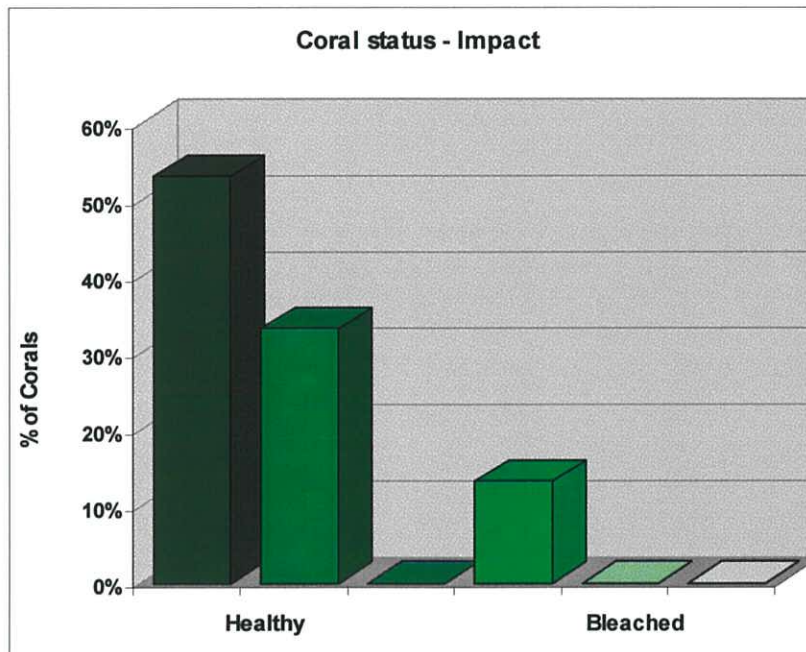
Figure 3. The CoralWatch result for the Impact Colonies.

The CoralWatch data for these colonies is in Figure 3. The Cumulative Average was calculated to be 4.57. Note that the Cumulative Average figure has a range from 1~6 with 6 being no stress and 1 being maximum stress.

These results indicate that on the whole, the area of corals around the pier is slightly healthier than the corals in the control area. However, some colonies at the pier area have slightly more bleaching/blanching than the control colonies.

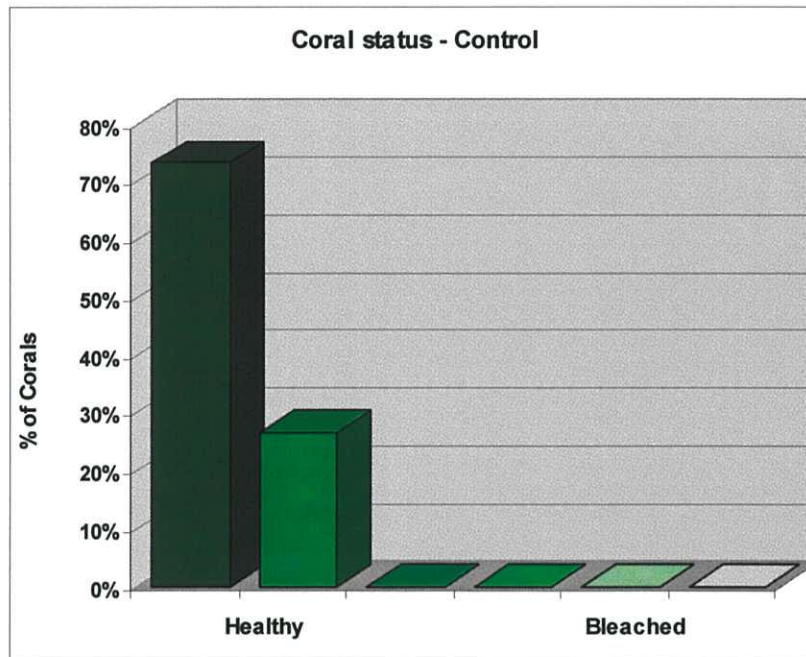
Figure 4. The CoralWatch result for the Control Colonies.

The CoralWatch data for these colonies is in Figure 4. The Cumulative Average was calculated to be 4.47. Note that the Cumulative Average figure has a range from 1~6 with 6 being no stress and 1 being maximum stress.

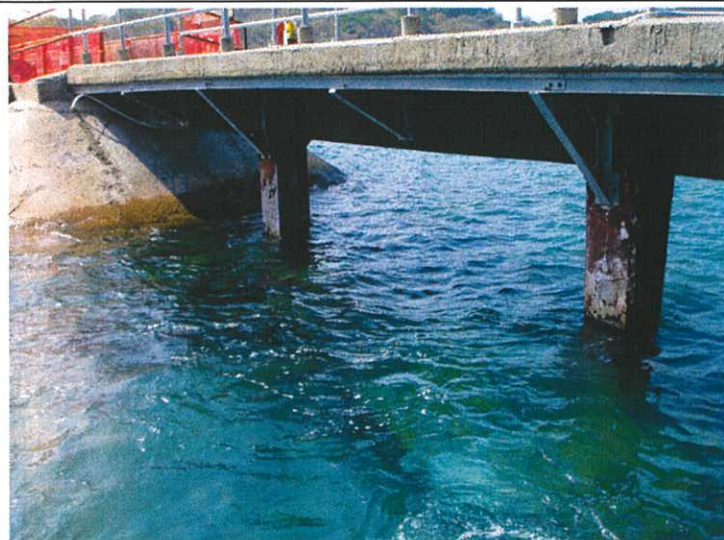
Plate 1. The donor area under the pier. The white area in the foreground are the bubbles of the divers carrying out the translocation works.

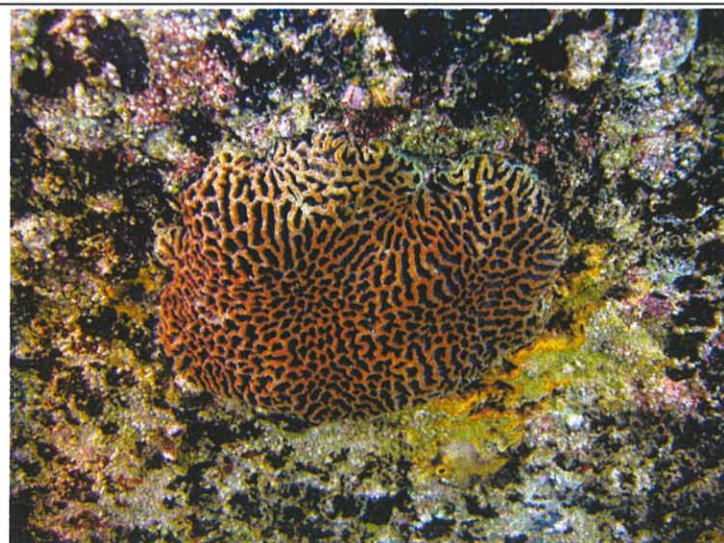
Plate 3. A coral colony on the pier footing selected for removal and translocation.

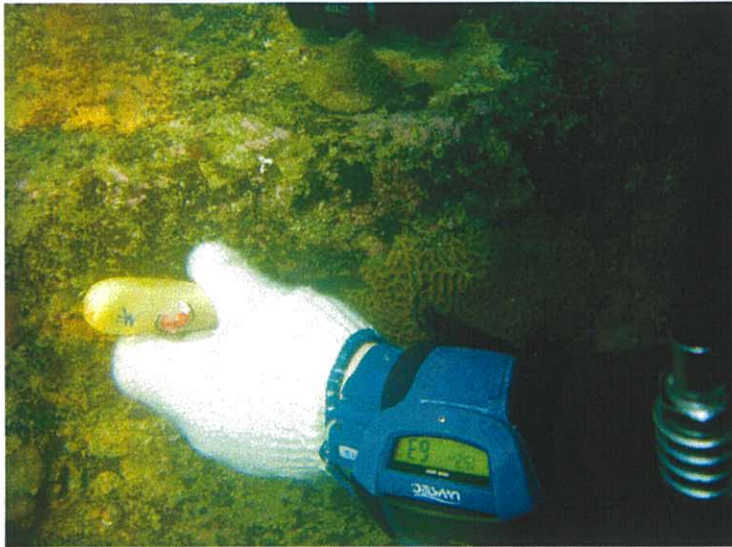
Plate 4. Detaching one side of the coral colony, shown in Plate 3, from the substrate.

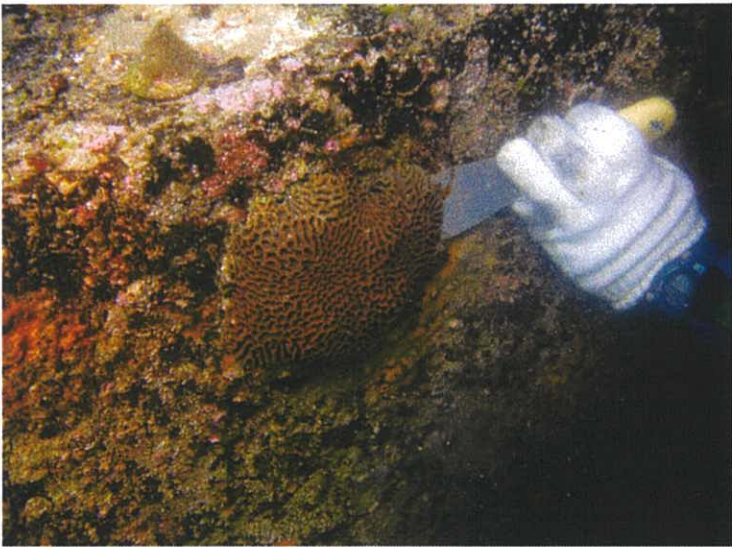
Plate 5. Detaching the other side of the coral colony, shown in Plate 3, from the substrate.

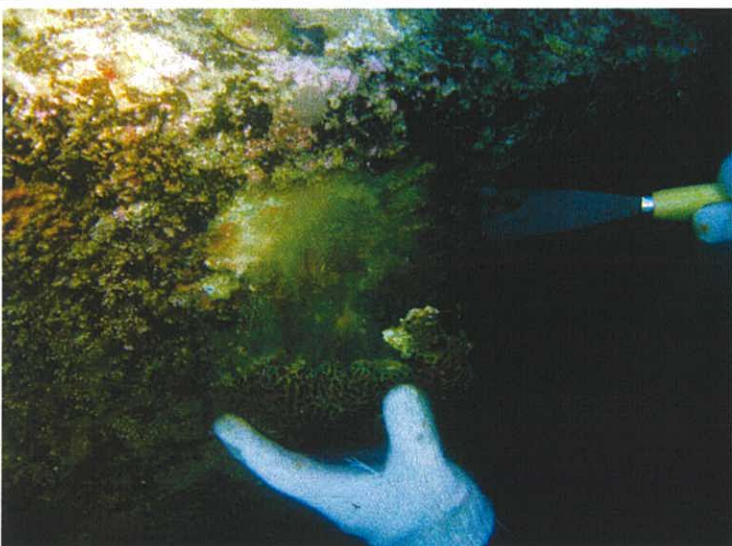
Plate 6. Successful detachment of the colony shown in Plate 3.

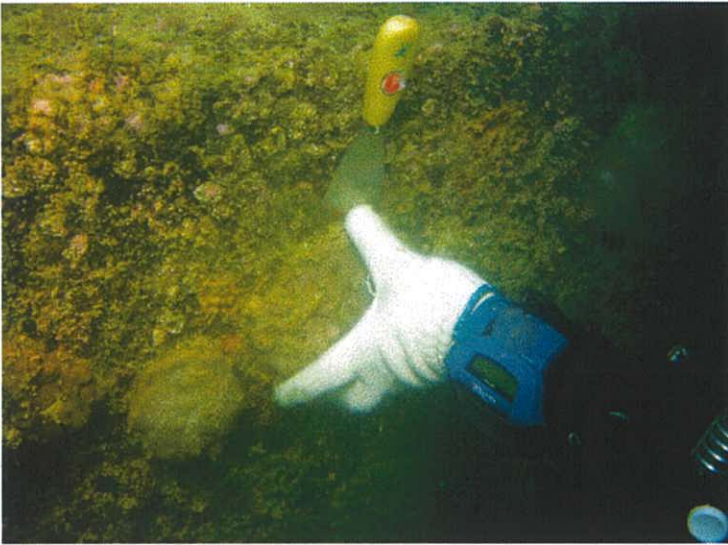
Plate 7. Another nearby colony being detached from the pier footing.

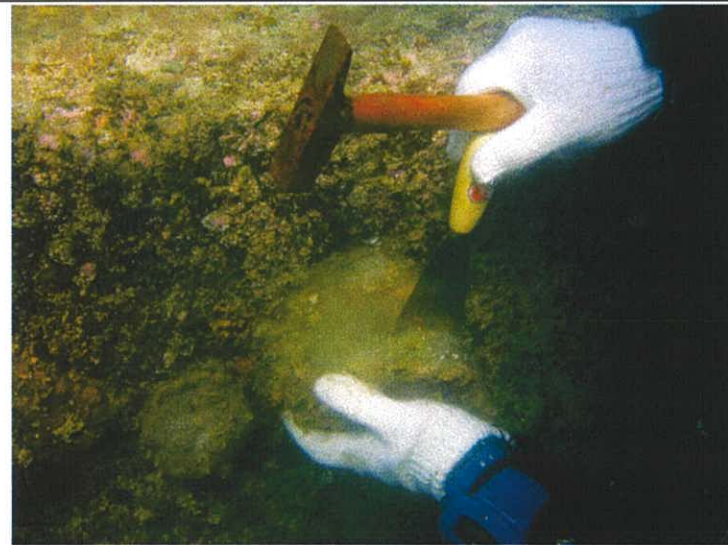
Plate 8. The colony shown in Plate 7. successfully detached.

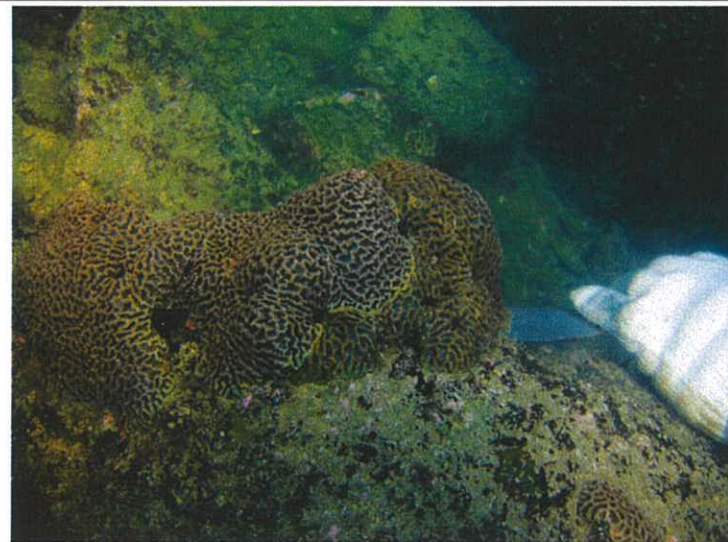
Plate 9. More coral colonies being detached from the pier footing.

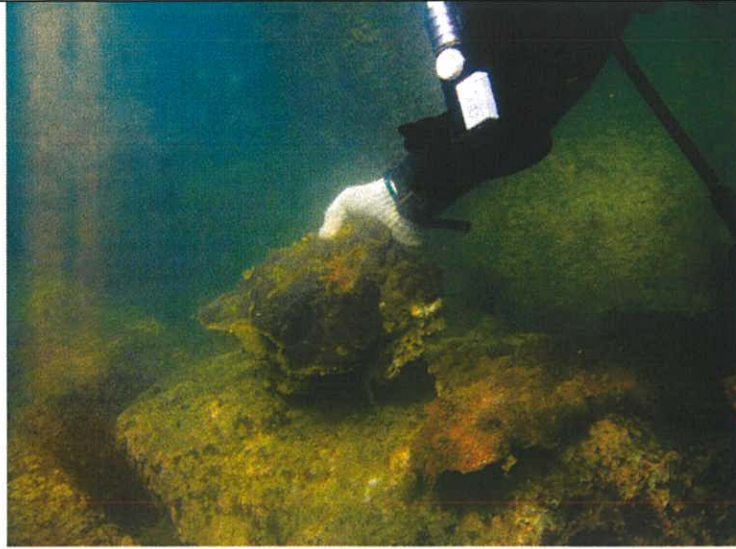
Plate 10. A coral colony being moved to the temporary holding area before transportation to the Receiver Area.

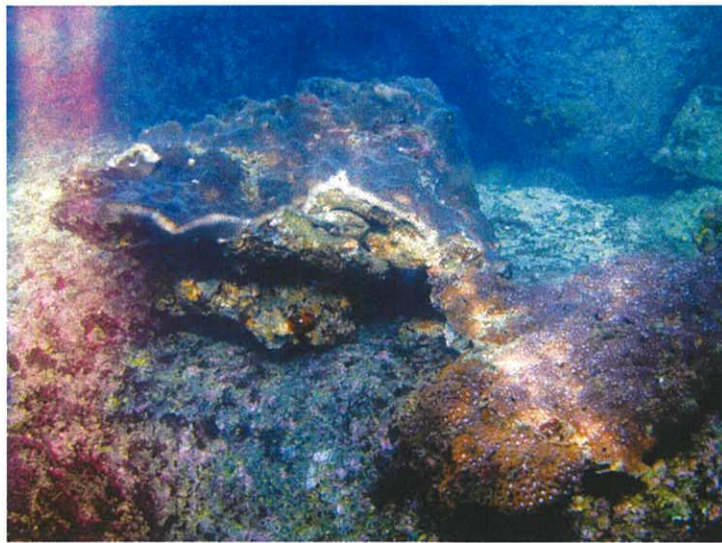
Plate11. Colonies at the holding area pending transportation to the Receiver Area.

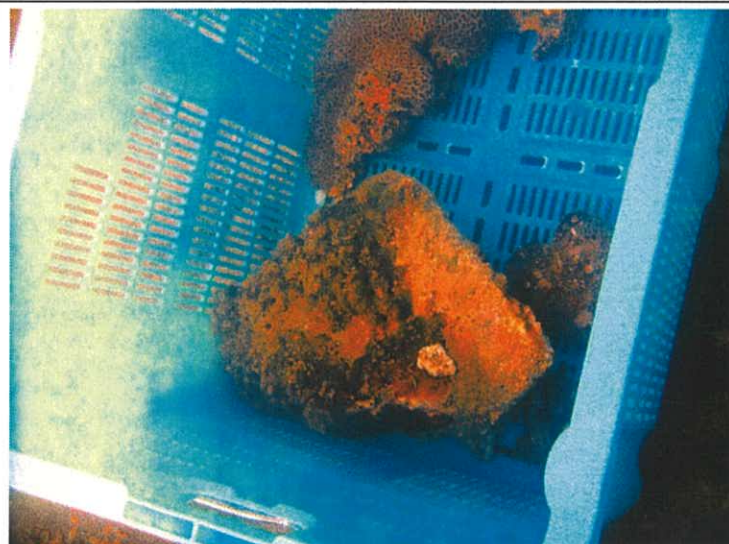
Plate 12. Colonies loaded onto the small 100kg lifter basket.

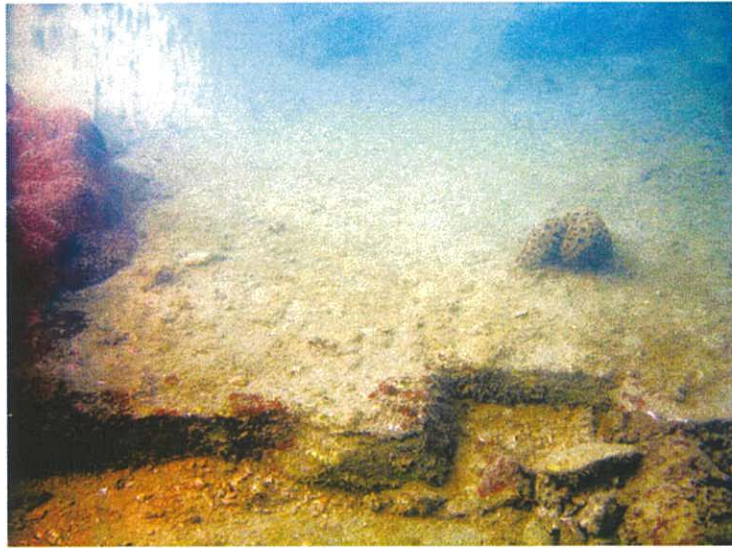
Plate 13. The Receiver Area before the corals arrived.

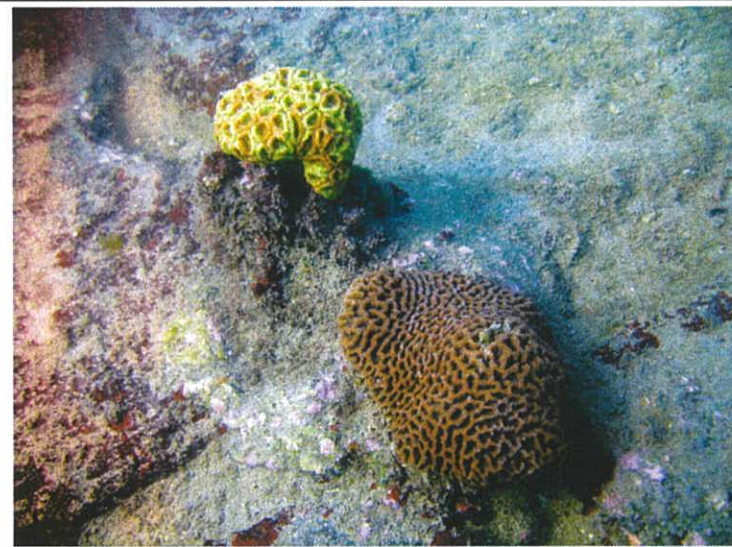
Plate 14. Two of the previously cemented coral colonies. The previous mitigation of the Receiver Area was carried out 12 months ago.

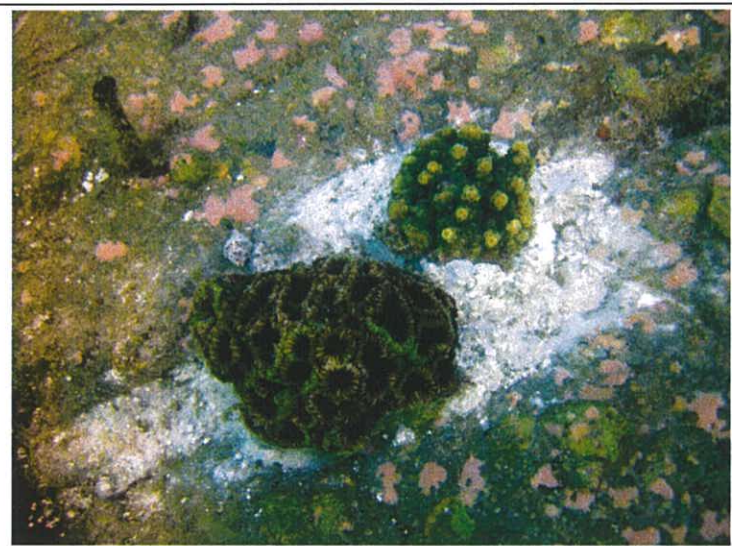
Plate 15. Freshly attached translocates in the Receiver Area.

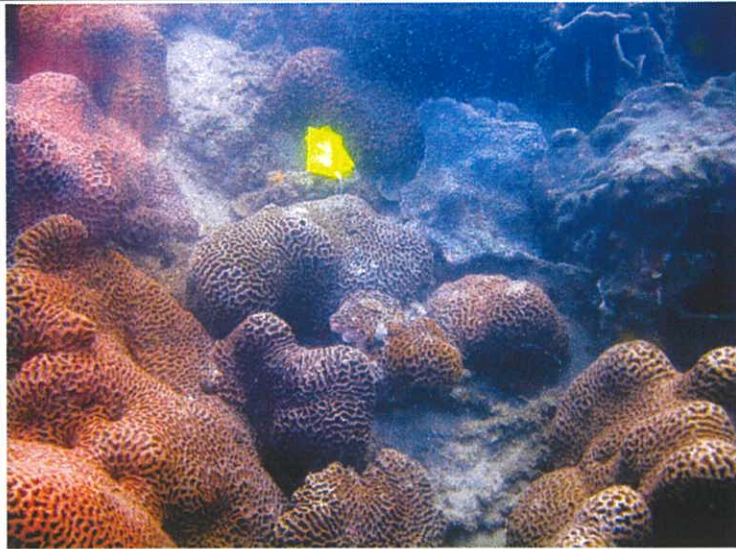
Plate 16. A section of the Receiver Area after the translocation was completed.

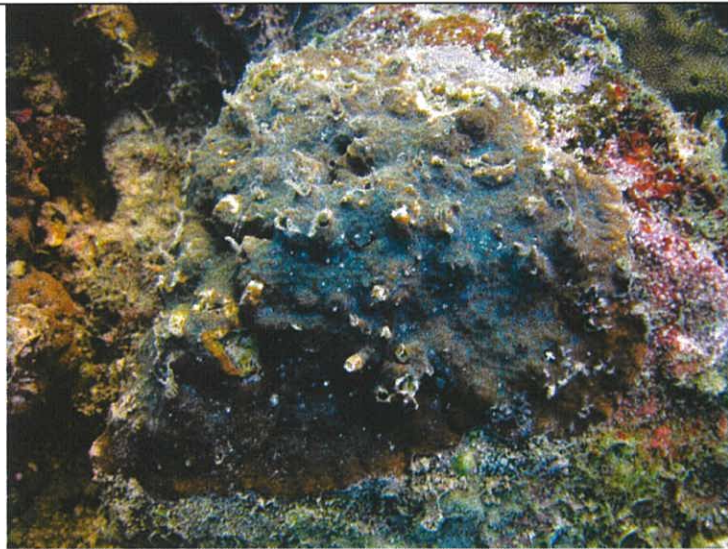
Plate 17. One of the difficult to get at colonies relocated in the Receiver Area. The colony was eventually relocated along with the substratum it was attached to.

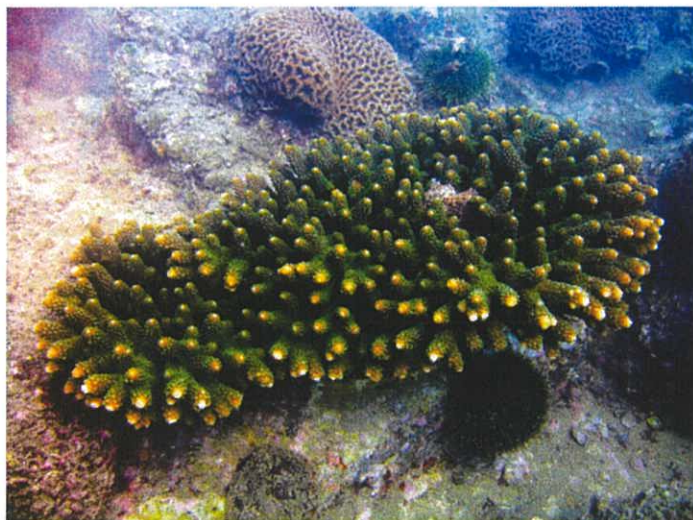
Plate 18. A healthy reattached coral colony 12 months post mitigation.
