**Agreement No. CE 18/2002 (EP)**  
**Construction of Helipads at Peng Chau and Yung Shue Wan,  
Lamma Island**

**Report for  
Coral Monitoring Surveys (September 2007)**

**Report for**  
**Six Coral Monitoring Surveys**  
**at Yung Shue Wan in September 2007**

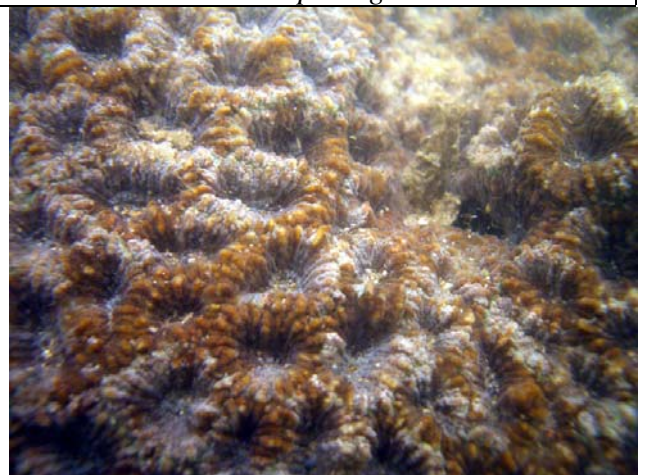
A02

- 4.1.2 Two of the colonies (A02 and A05) in IMS showed relatively stable increase in sedimentation cover by 5% over the first month of monitoring; no bleaching or mortality, however, were evidenced. Further observation in the subsequent monitoring is necessary to evaluate for any patterned increment.

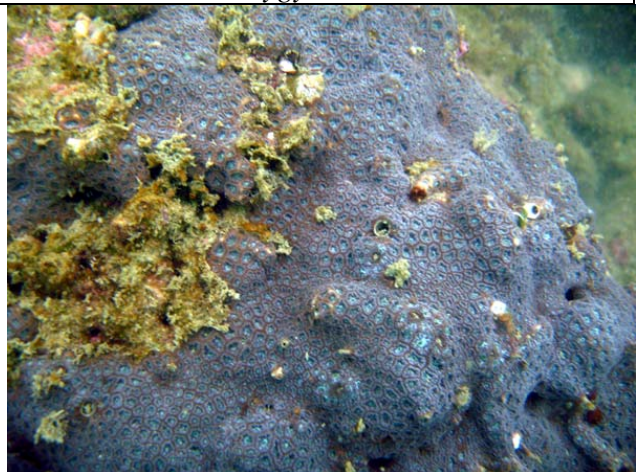
- 3.1.5 One colony (B08) was found broken into few pieces during the survey on 23 September. The damage was believed to be caused physically by anchoring or fishing activity. This colony was, therefore, considered not suitable for further monitoring. A new colony was identified and tagged on 29 September for replacement. The new colony (*Leptastrea pruinosa*) belongs to the same genus as the damaged one (*Leptastrea purpurea*), and is in healthy condition for monitoring purpose (Table 3.2)

Colony B08 (*Leptastrea purpurea*) was found physically damaged on 23 September, a new colony B08\* (*Leptastrea pruinosa*) was tagged on 29 September for subsequent monitoring survey.
