Contract No. DC/2009/09
Construction of Tai Po Sewage Treatment
Works – Stage V Phase II B

Monthly Environmental Monitoring and Audit Report for August 2010

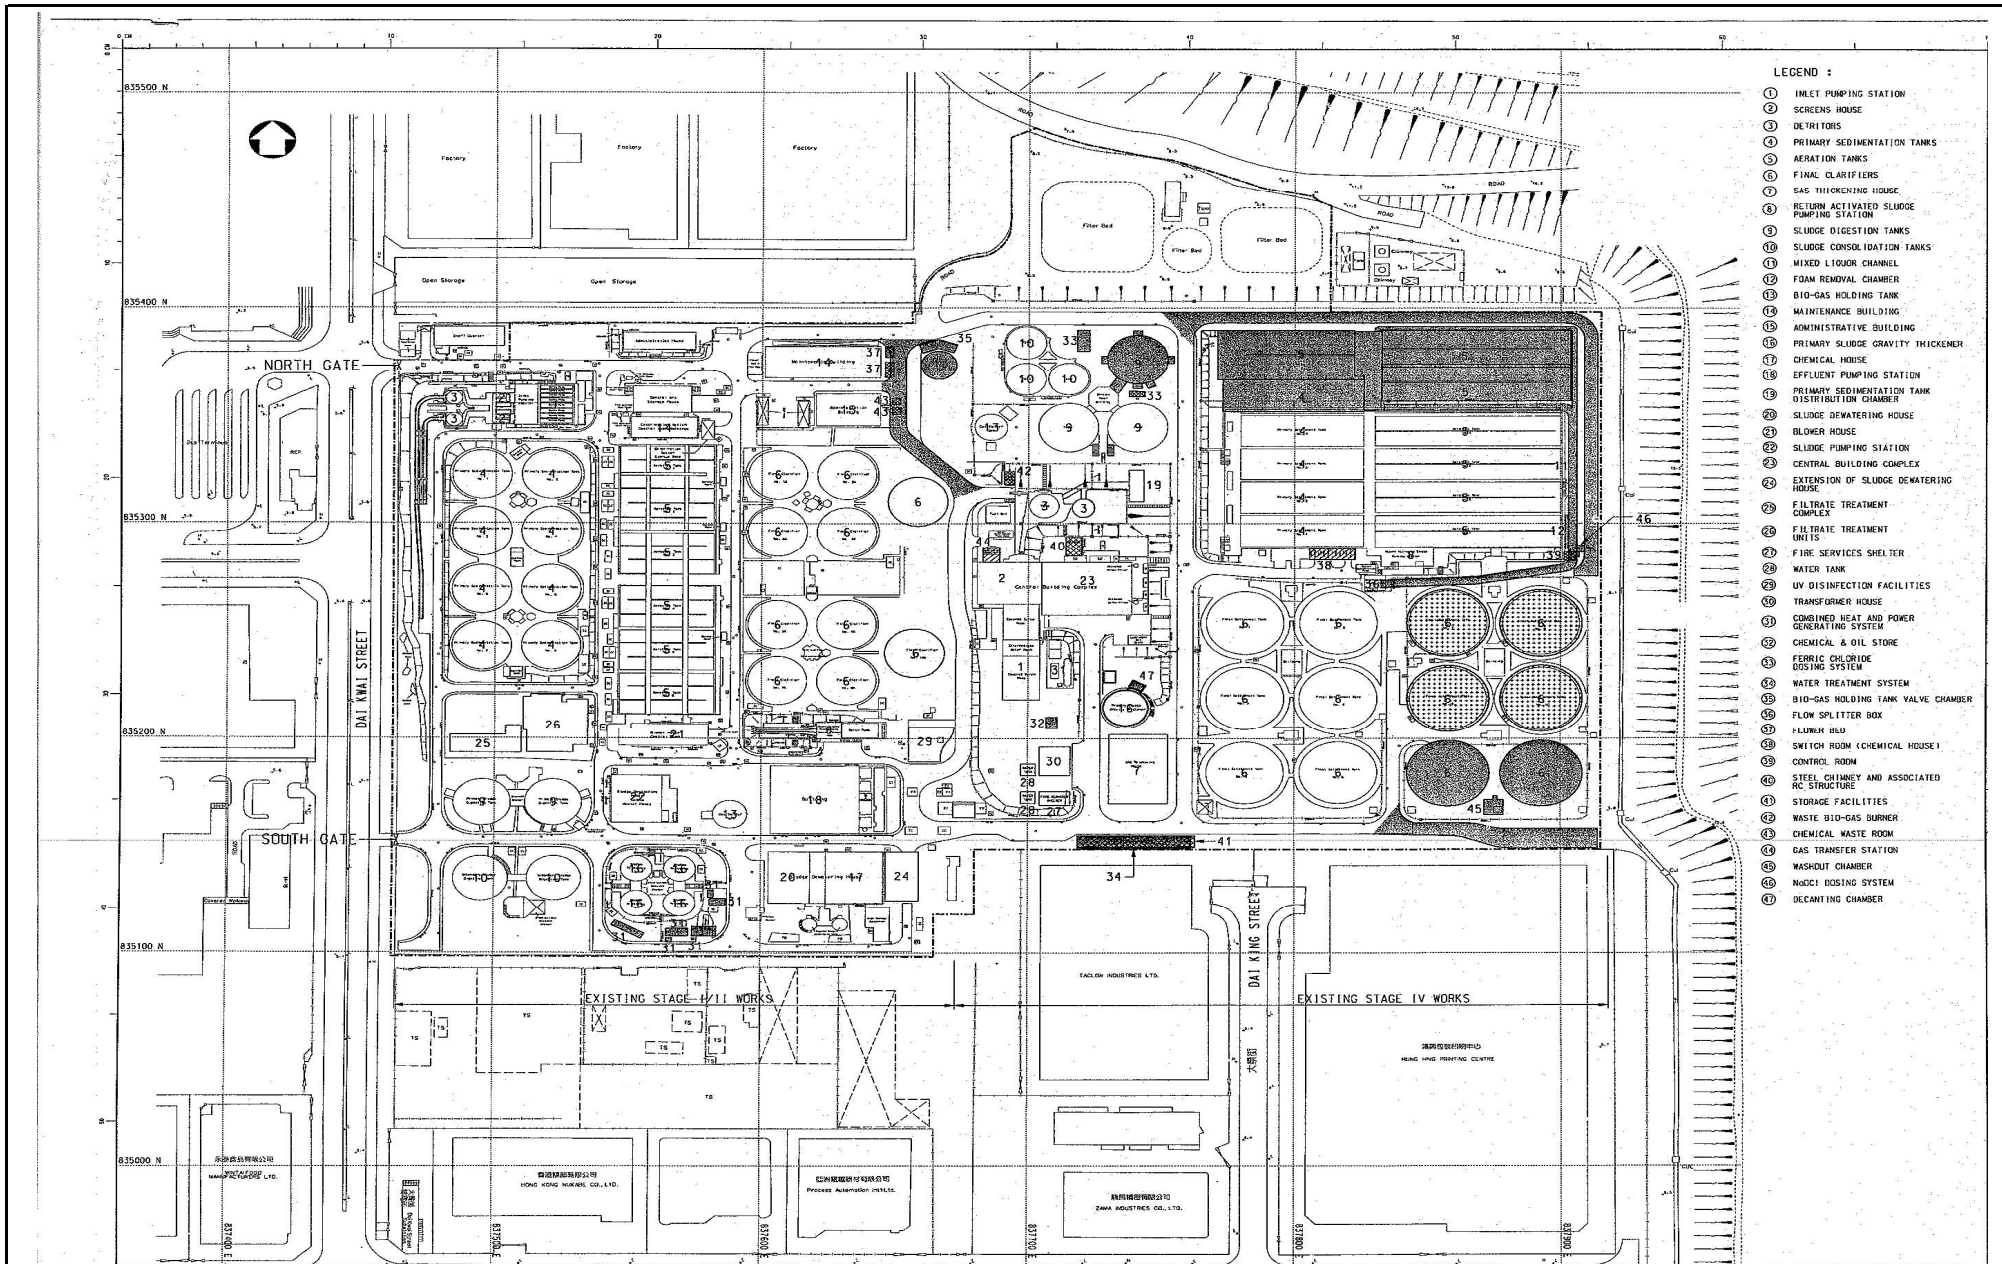
Scale	N.T.S	Project No.	MA0010	CINOTECH
Date	Jul-10	Figure	1.1

PROJECT SITE LAYOUT PLAN (TPSTW)

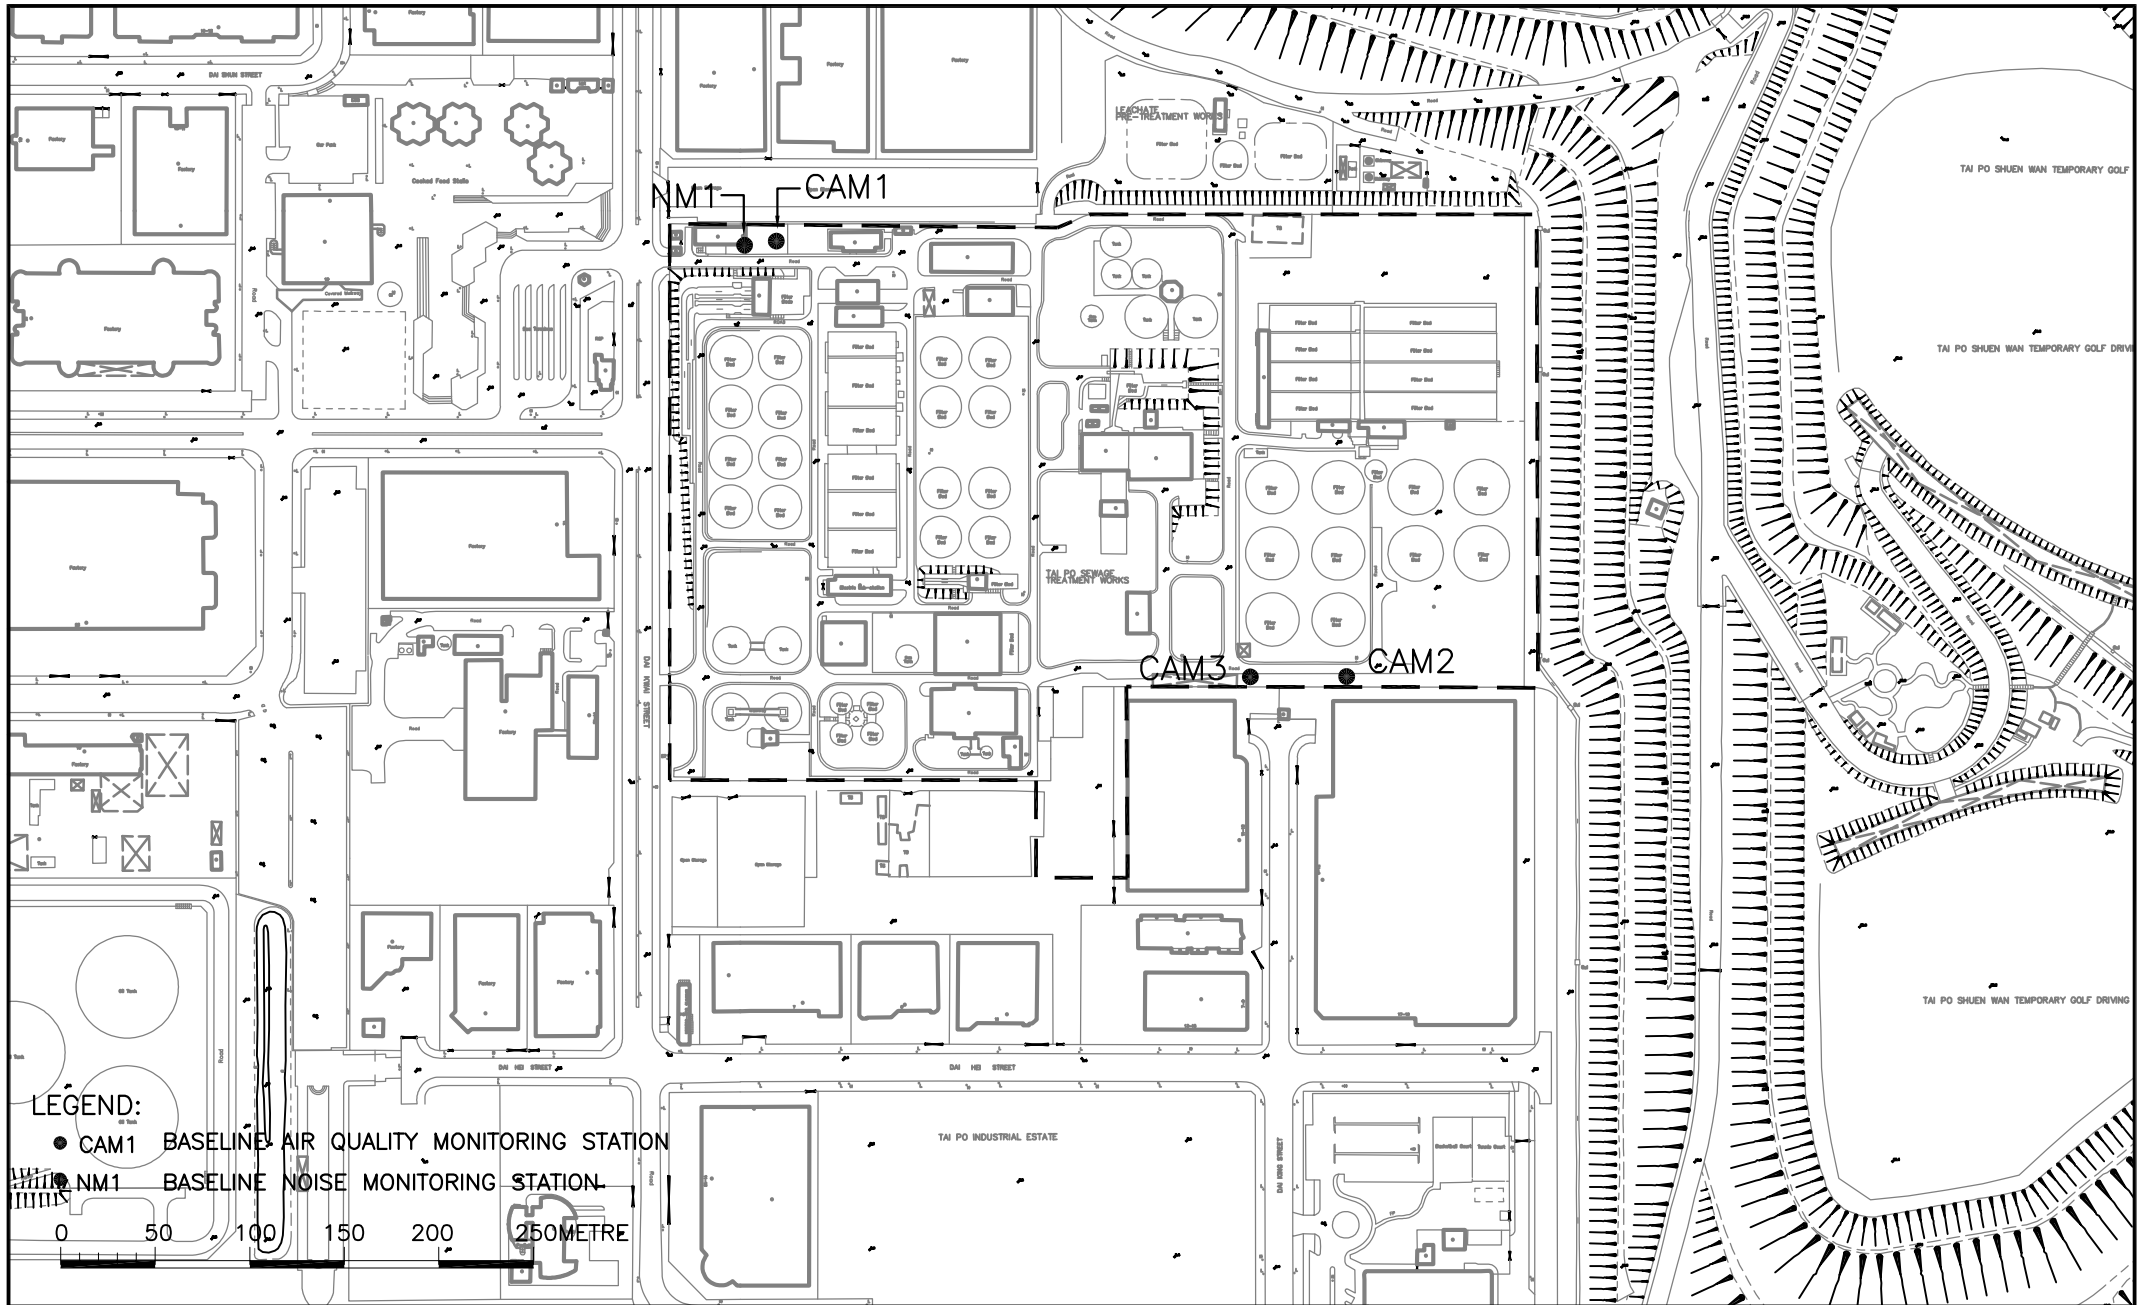
SCALE	A4 1:4000	DATE	2010	
CHECK	IT	DRAWN	SL	
JOB No.	MA0010	DRAWING No.	1.2	REV —

- CAM1 BASELINE AIR QUALITY MONITORING STATION
- NM1 BASELINE NOISE MONITORING STATION

LOCATIONS OF AIR QUALITY AND NOISE MONITORING STATIONS

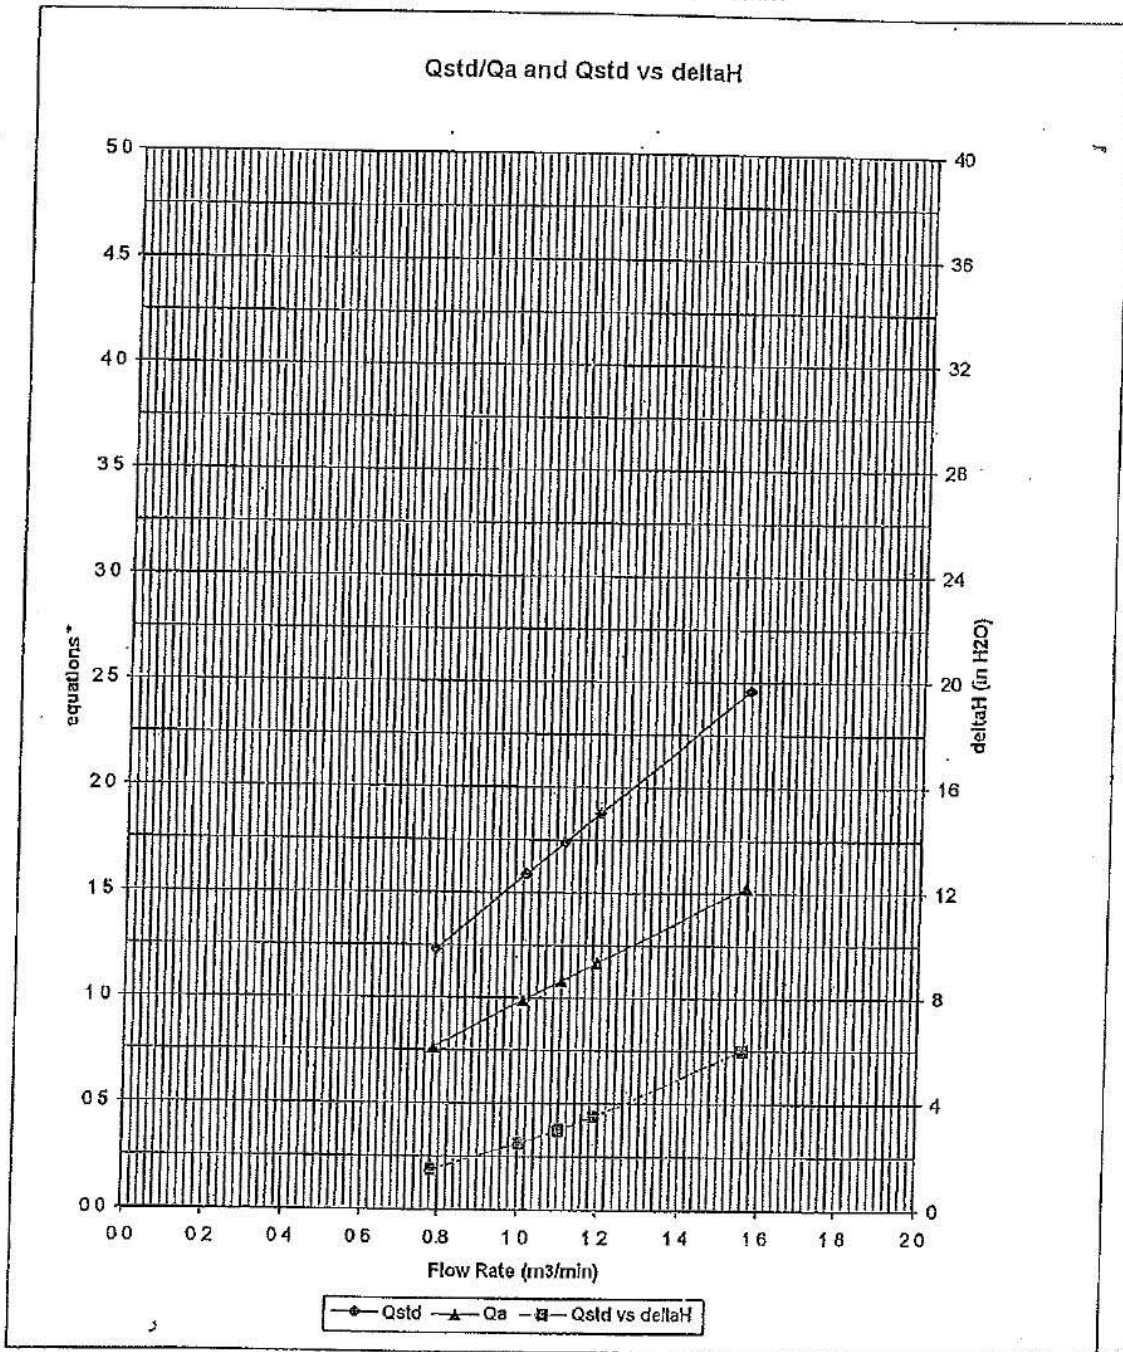
AIR POLLUTION MONITORING EQUIPMENT

* y-axis equations:

Qstd series:
$$\sqrt{\Delta H \left(\frac{P_a}{P_{std}} \right) \left(\frac{T_{std}}{T_a} \right)}$$

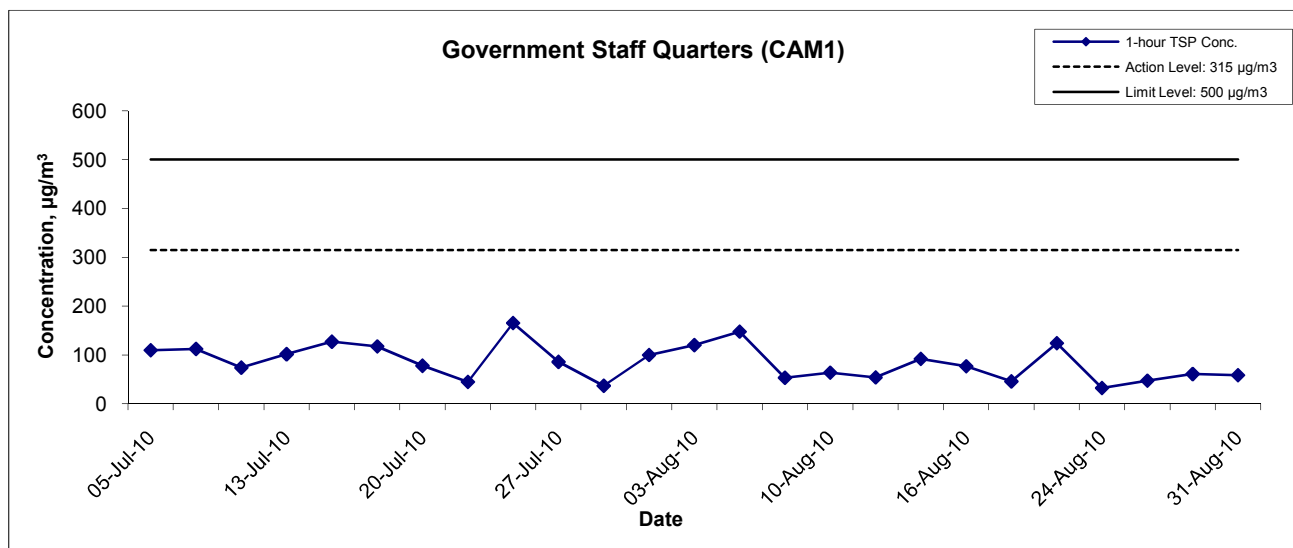
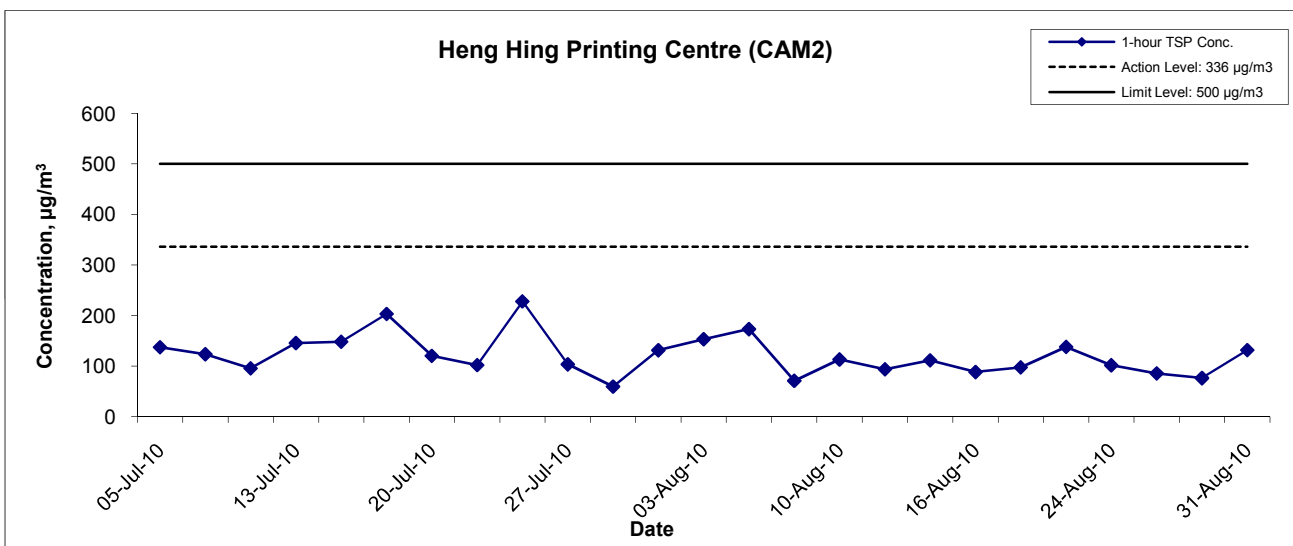
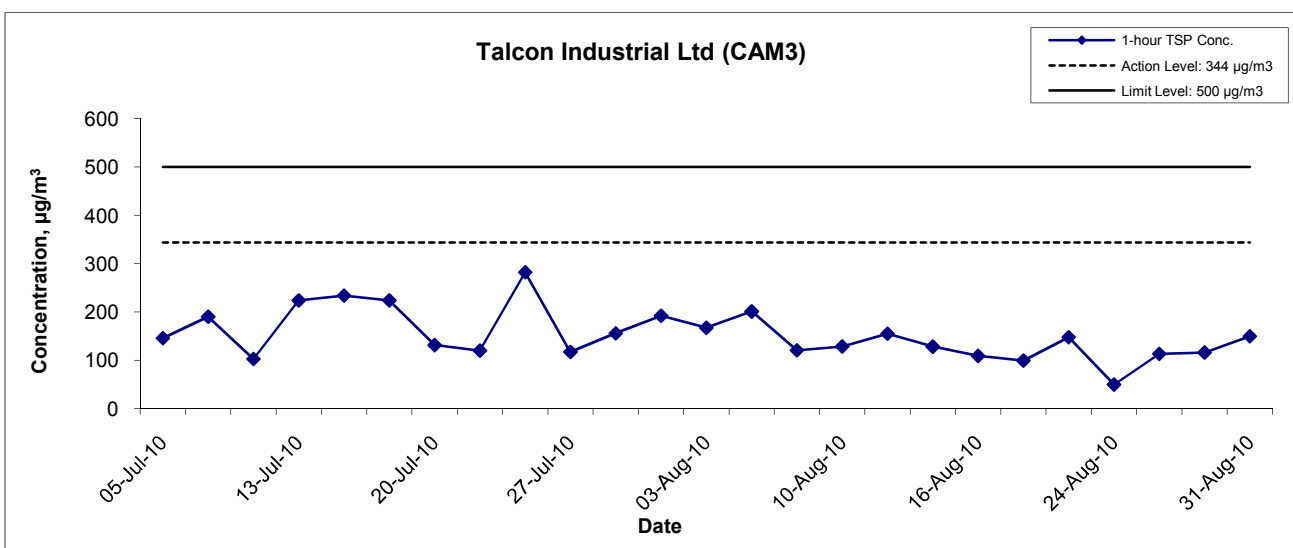
1-hr TSP Concentration Levels

Title
 Contract No. DC/2009/09
 Construction of Tai Po Sewage Treatment Works - Stage V Phase II B
 Graphical Presentation of 1-hour TSP Impact Monitoring Results

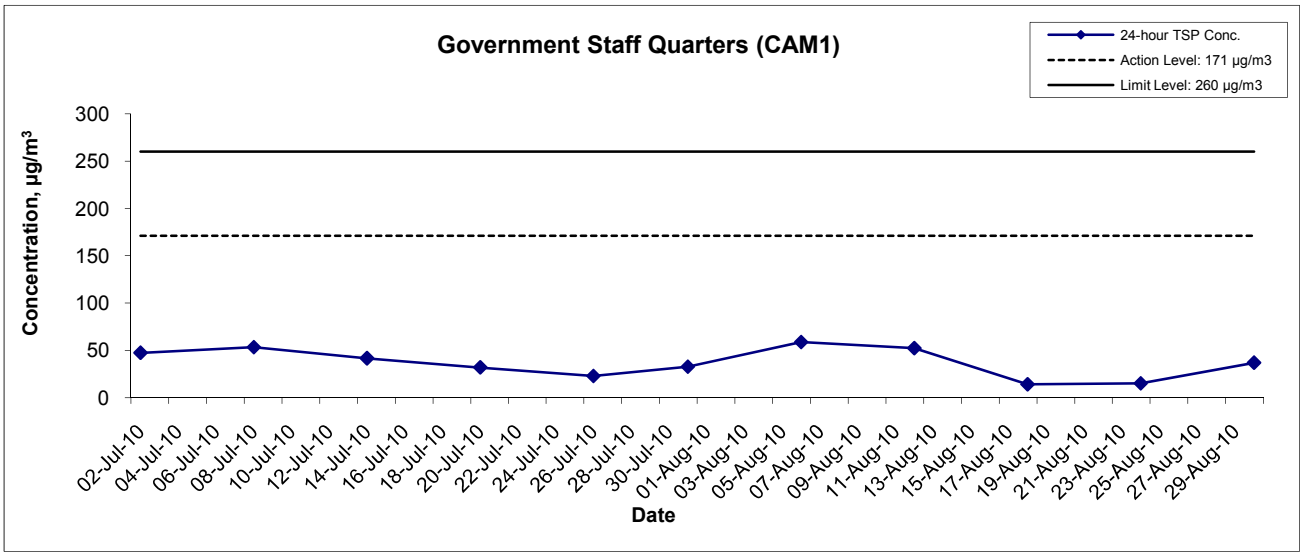
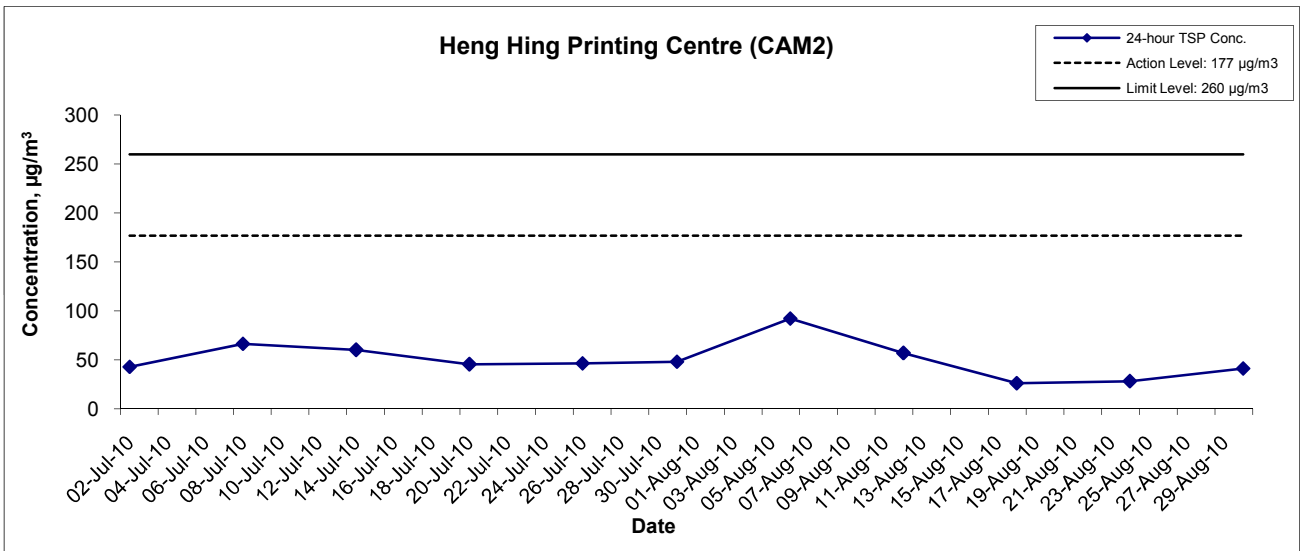
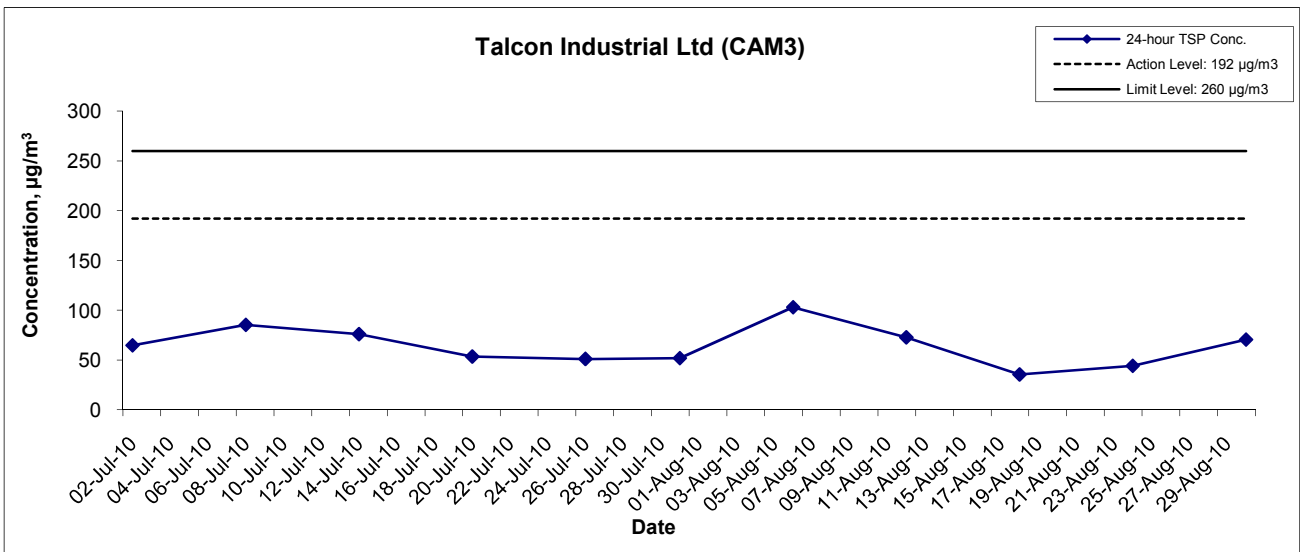
24-hr TSP Concentration Levels

Title Contract No. DC/2009/09 Construction of Tai Po Sewage Treatment Works - Stage V Phase II B Graphical Presentation of 24-hour TSP Impact Monitoring Results	Scale N.T.S	Project No. MA0010	CINOTECH
	Date Aug 10	Appendix E

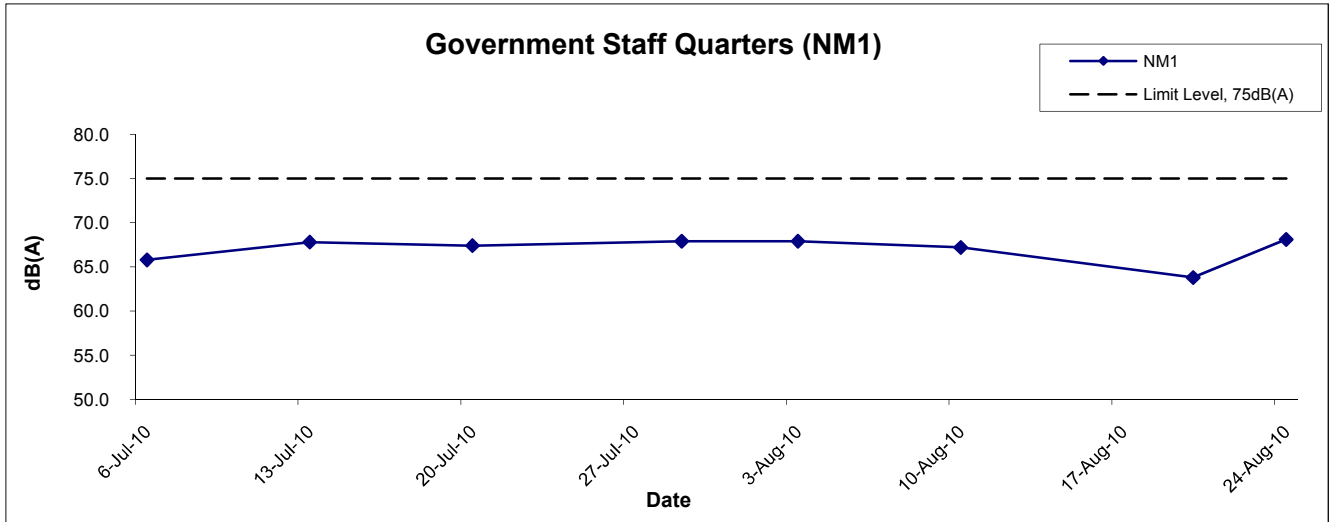
Noise Levels

Title Contract No. DC/2009/09 Construction of Tai Po Sewage Treatment Works - Stage V Phase II B Graphical Presentation of Construction Noise Monitoring Results	Scale N.T.S	Project No. MA0010	
	Date Aug 10	Appendix F

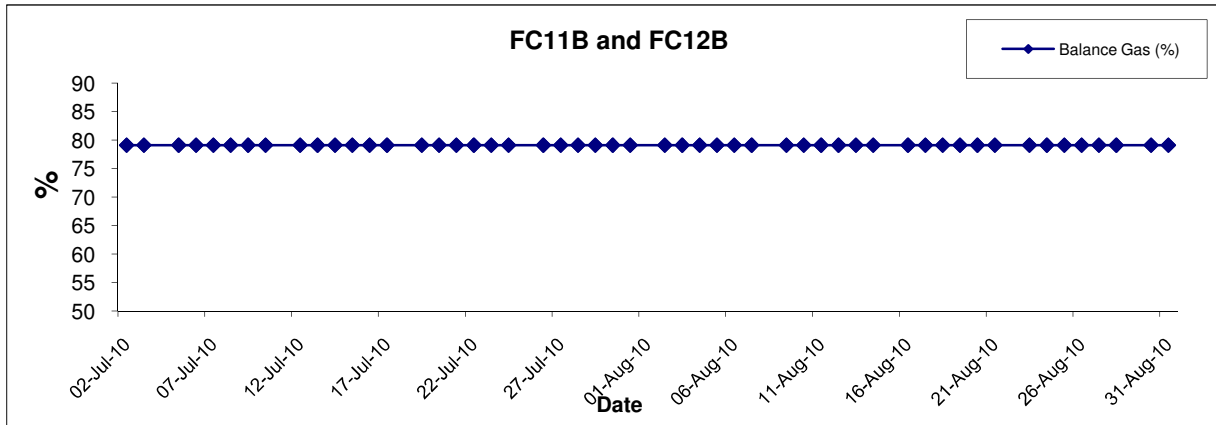
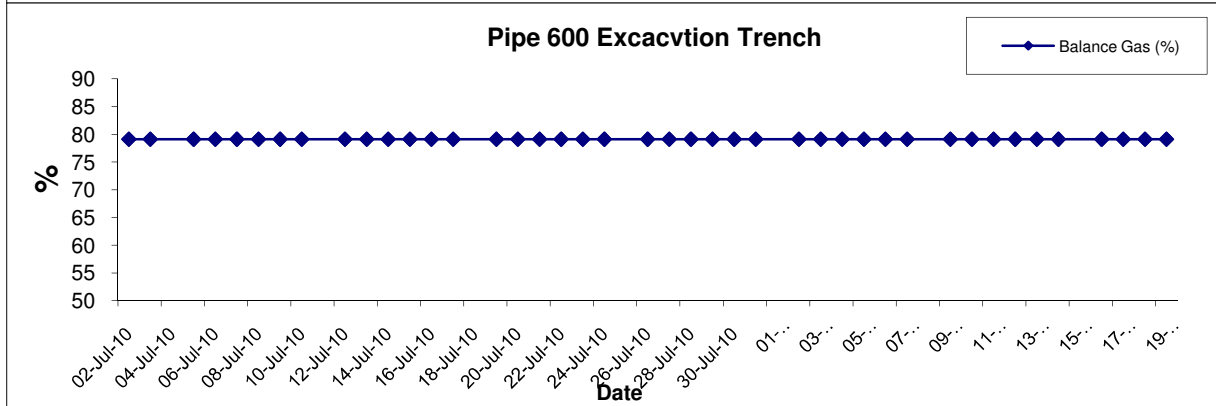
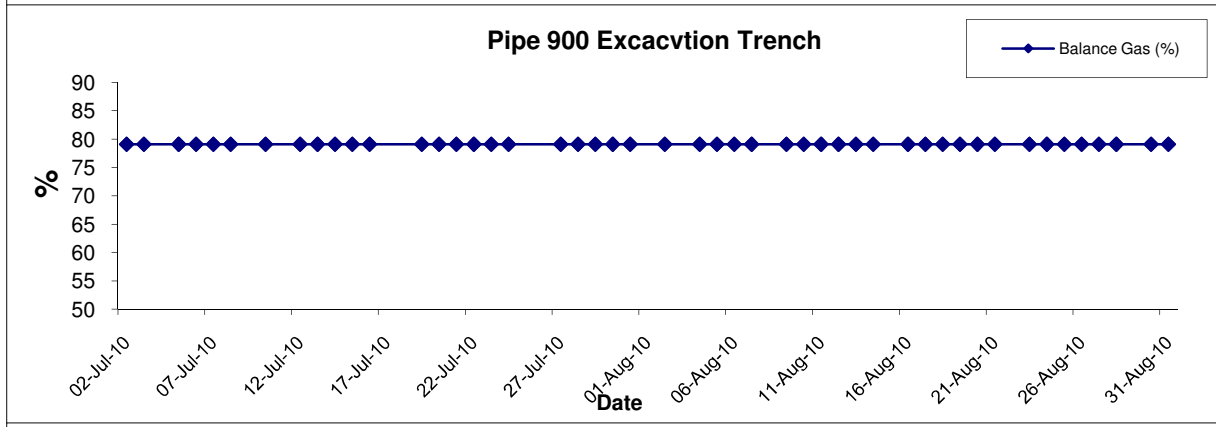
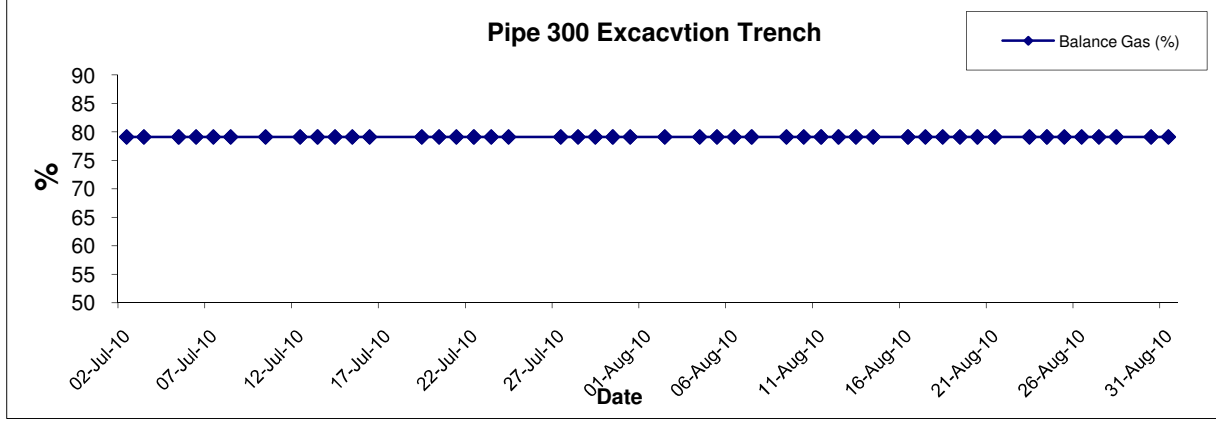
Balance Gas

Title Contract No. DC/2009/09 Construction of Tai Po Sewage Treatment Works - Stage V Phase II B Graphical Presentation of Landfill Gas Measurement	Scale N.T.S	Project No. MA0010	
	Date Aug 10	Appendix G

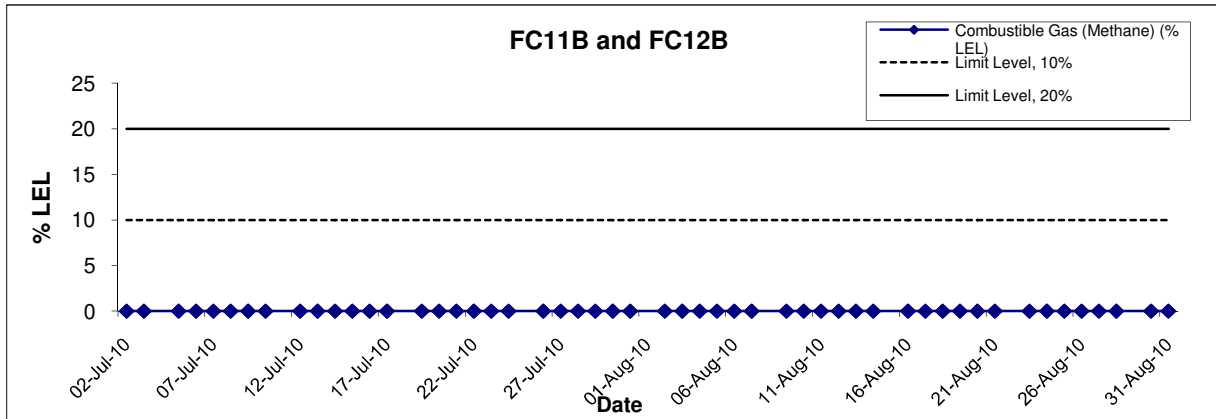
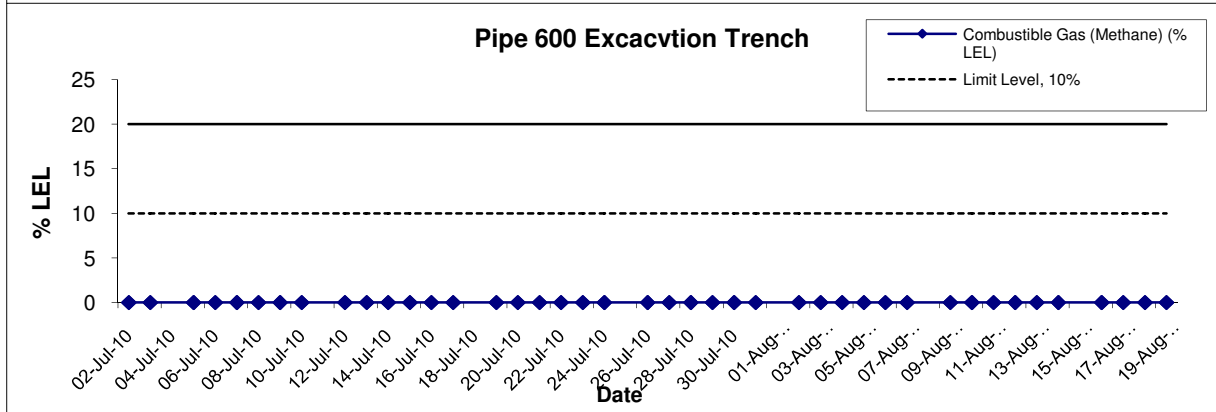
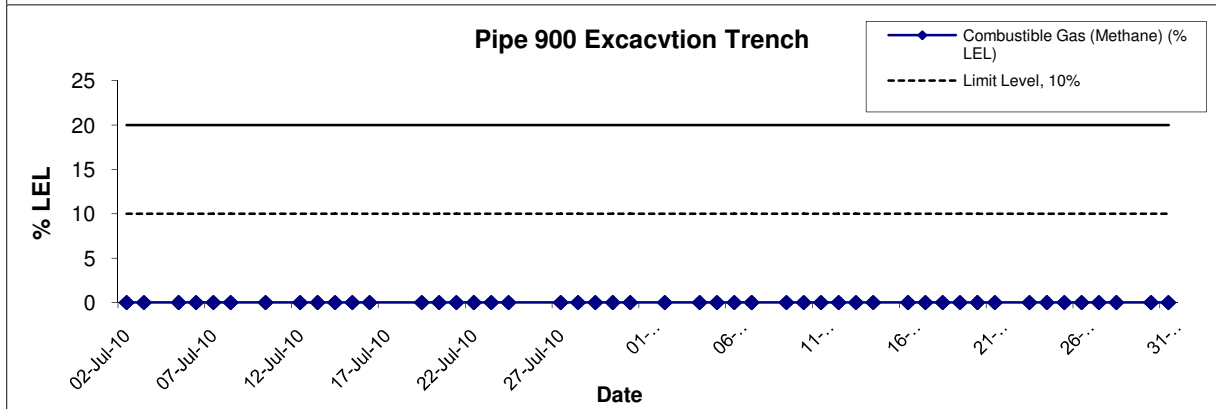
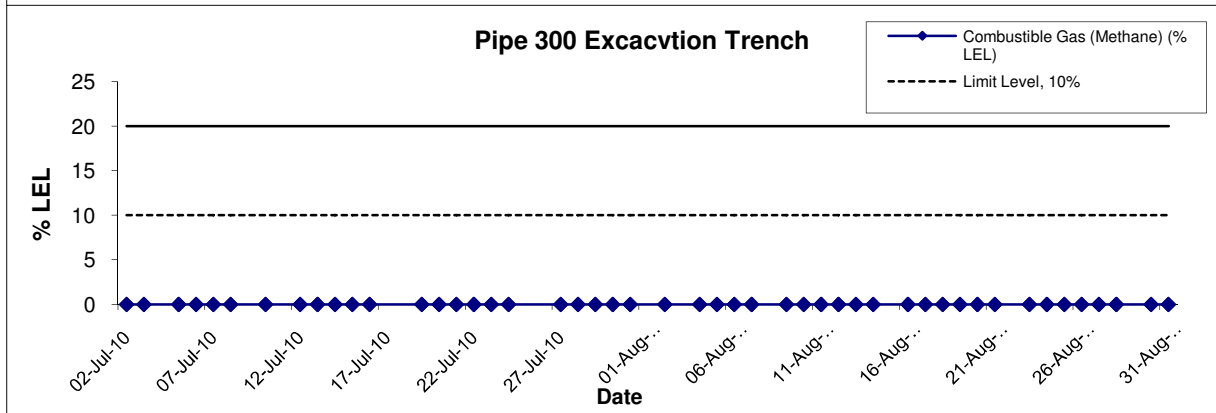
Combustible Gas (Methane)

Title
 Contract No. DC/2009/09
 Construction of Tai Po Sewage Treatment Works - Stage V Phase II B
 Graphical Presentation of Landfill Gas Measurement

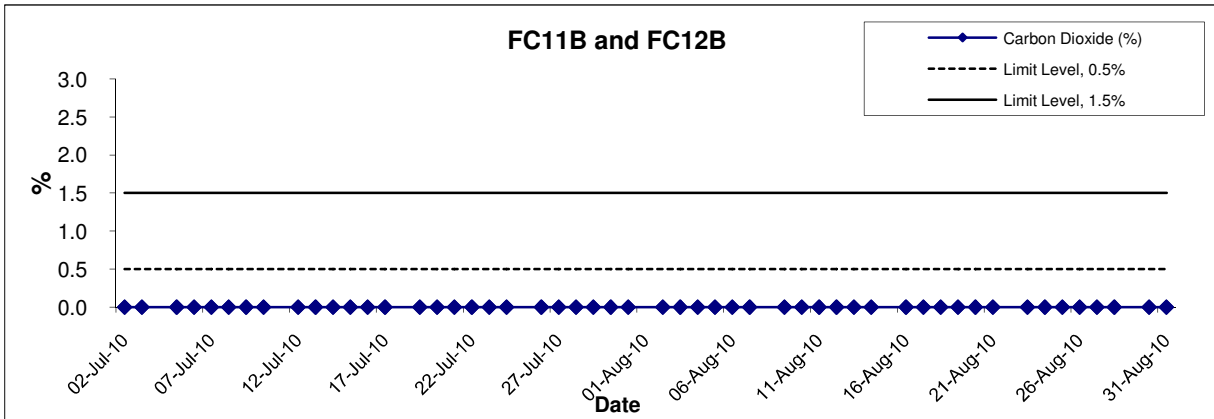
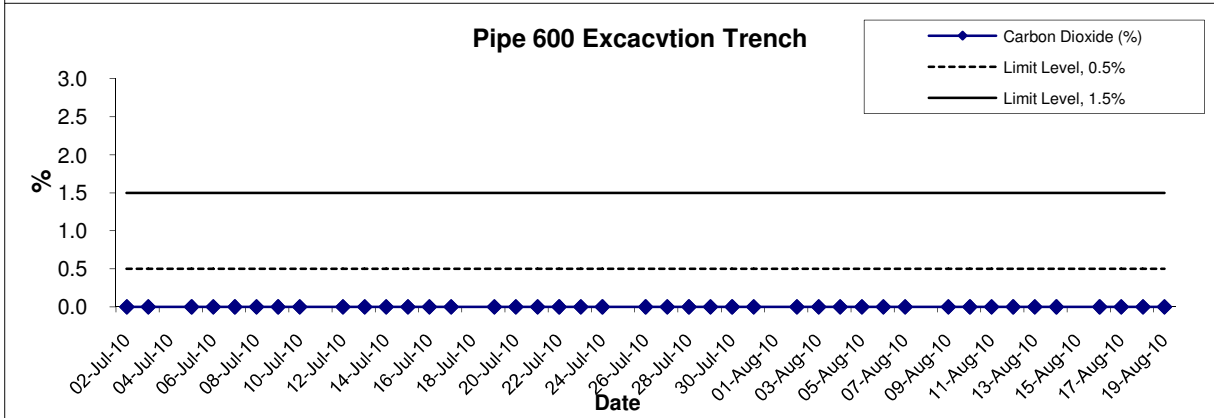
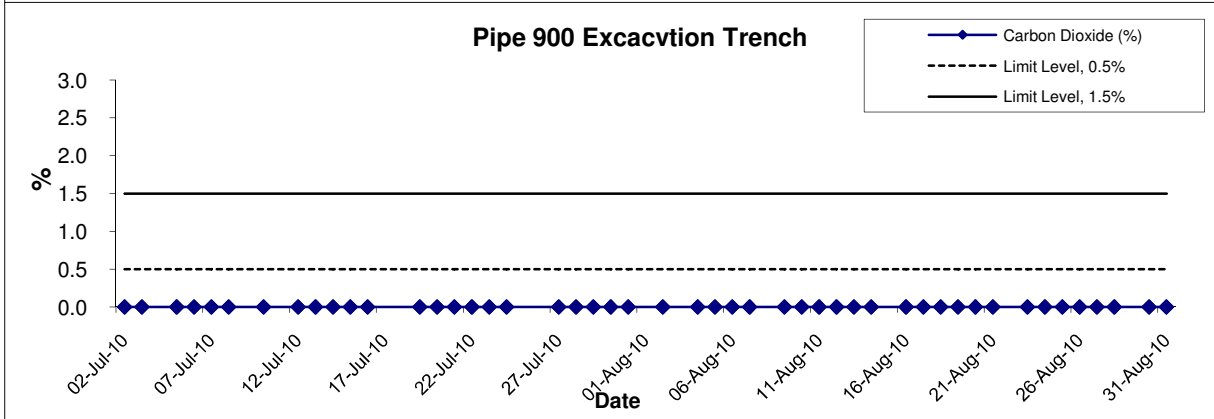
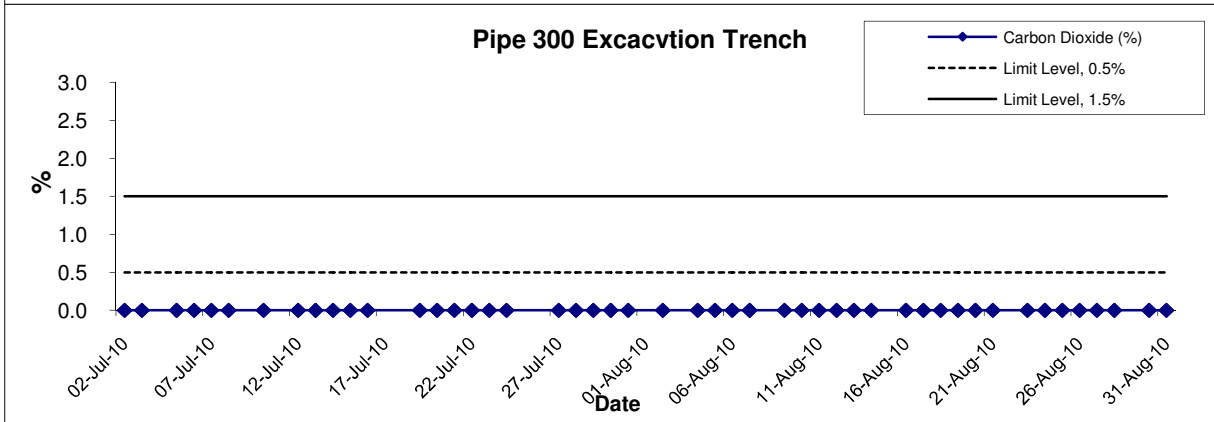
Carbon Dioxide

Title Contract No. DC/2009/09
 Construction of Tai Po Sewage Treatment Works - Stage V Phase II B
 Graphical Presentation of Landfill Gas Measurement

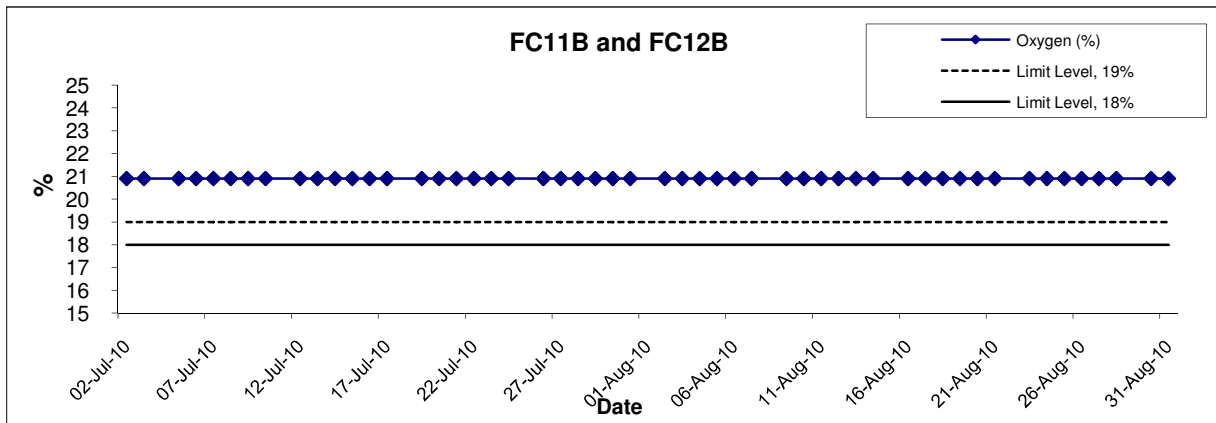
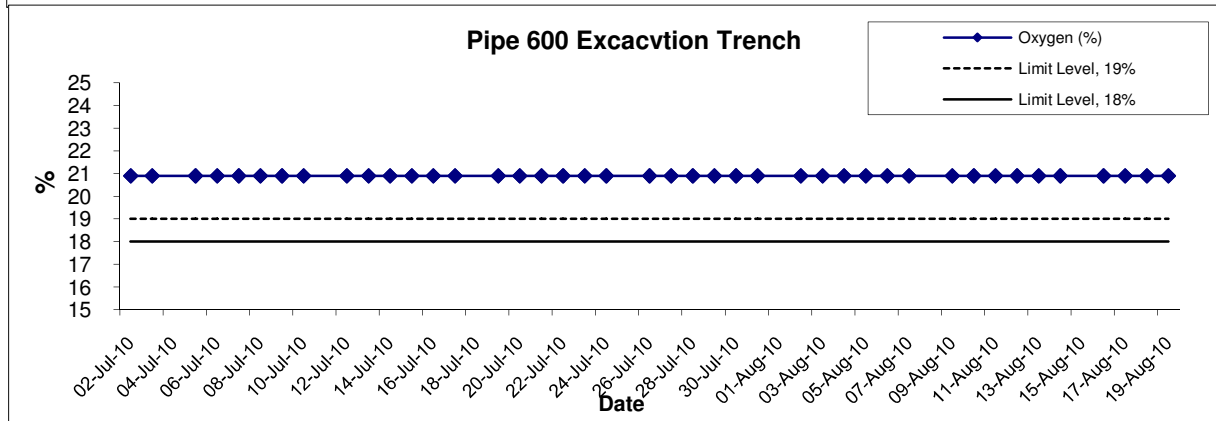
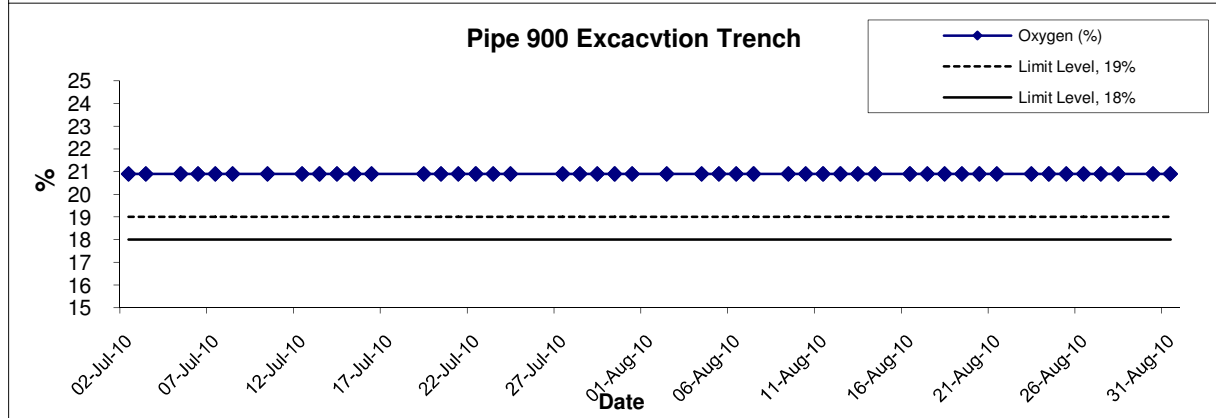
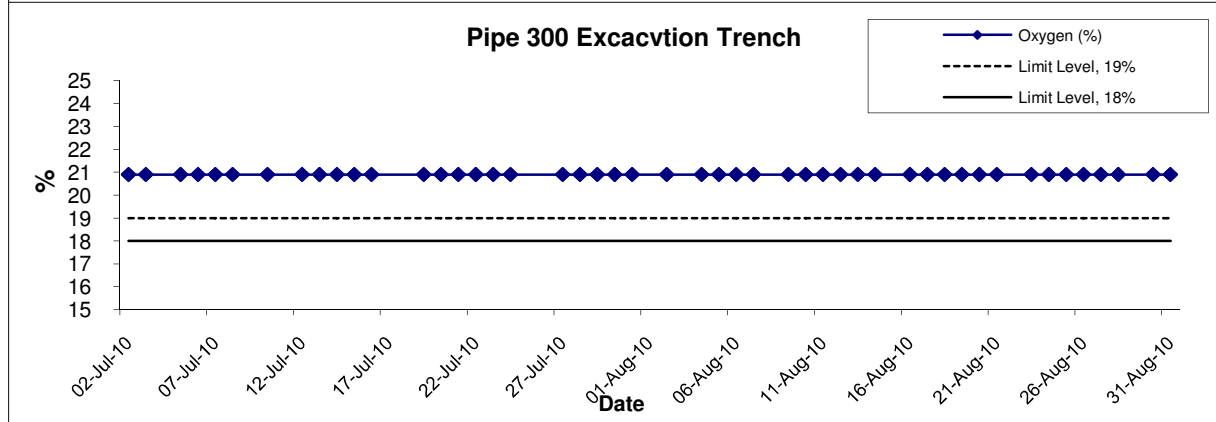
Oxygen

Title
 Contract No. DC/2009/09
 Construction of Tai Po Sewage Treatment Works - Stage V Phase II B
 Graphical Presentation of Landfill Gas Measurement
