Contract No. DC/2009/09  
Construction of Tai Po Sewage Treatment  
Works – Stage V Phase II B

## Monthly Environmental Monitoring and Audit Report for December 2010

(Version 1.0)

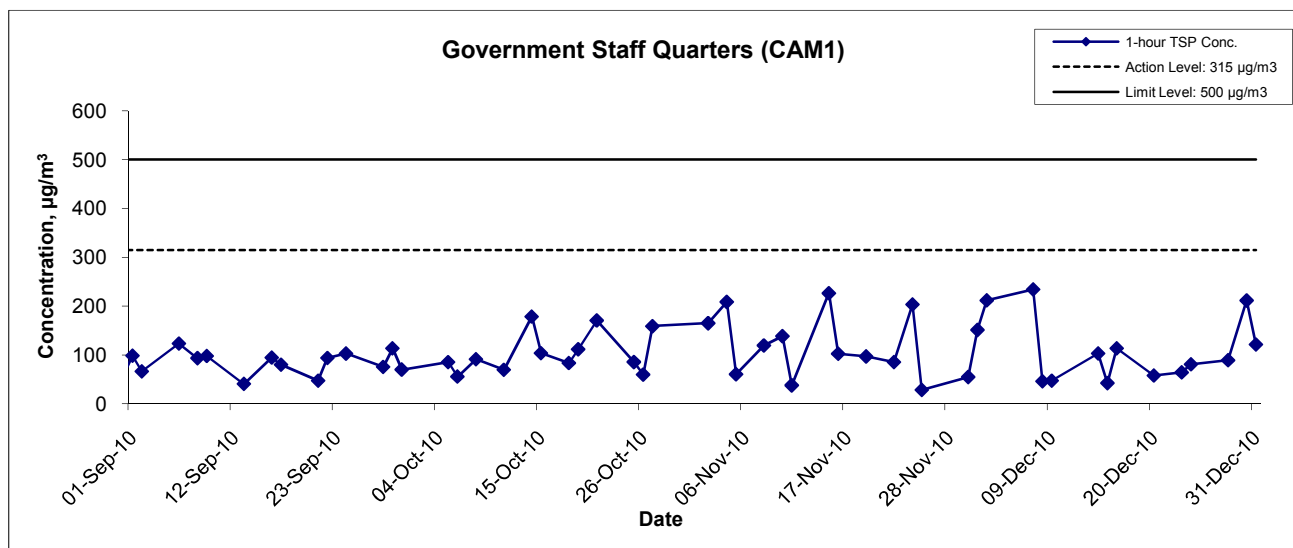
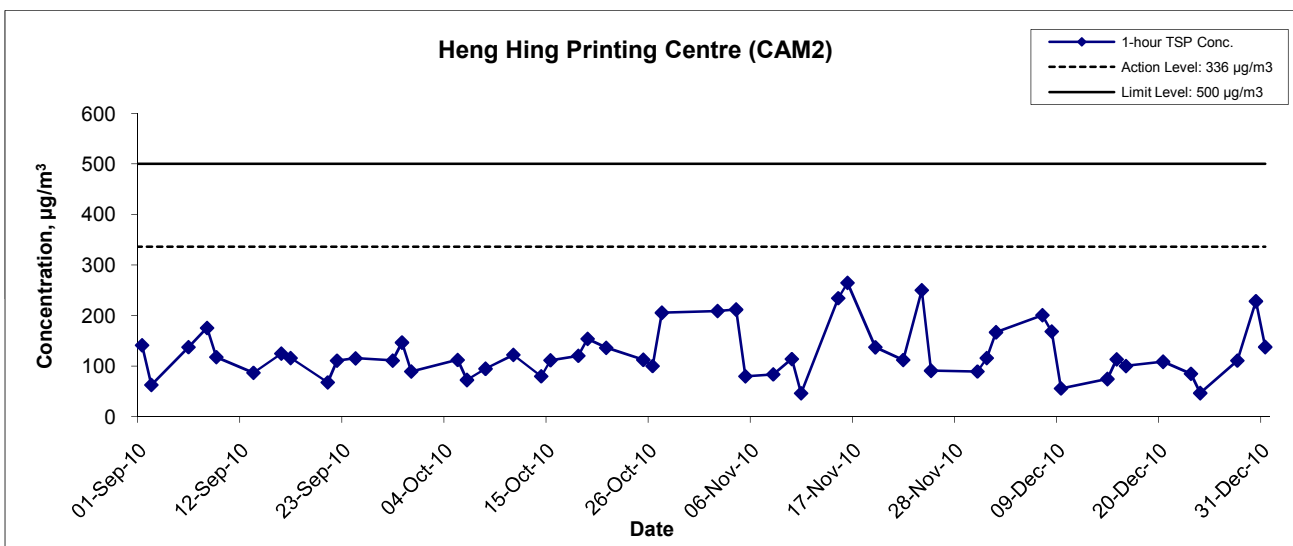
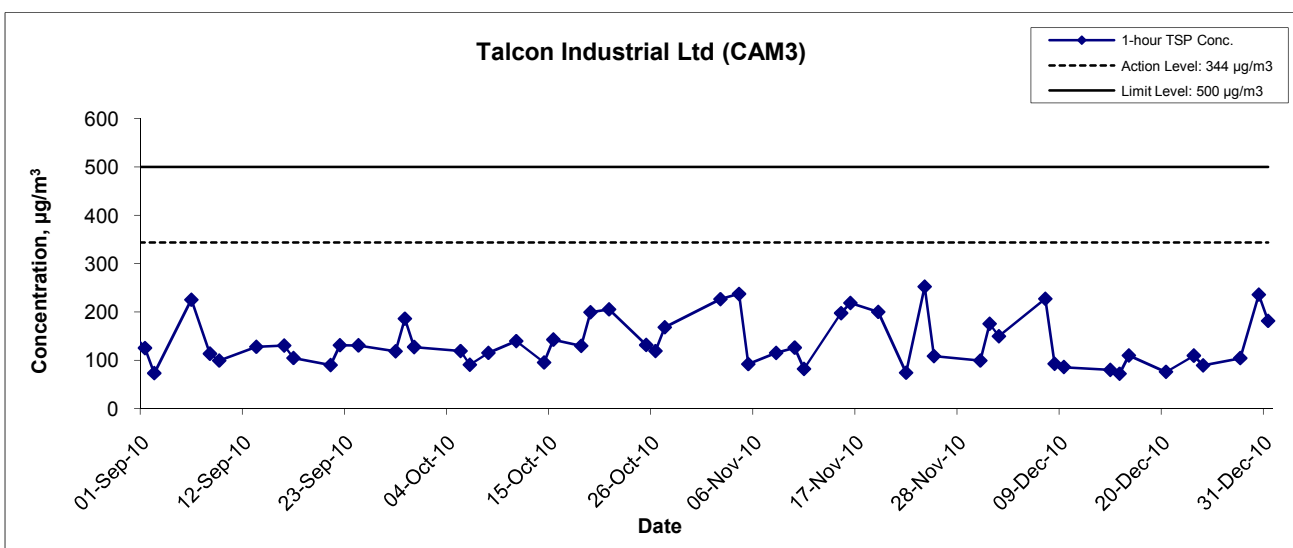
Title Contract No. DC/2009/09 Construction of Tai Po Sewage Treatment Works - Stage V Phase II B Graphical Presentation of 1-hour TSP Impact Monitoring Results	Scale	Project No.		
		N.T.S		MA0010
	Date	Dec 10		Appendix D

### 1-hr TSP Concentration Levels

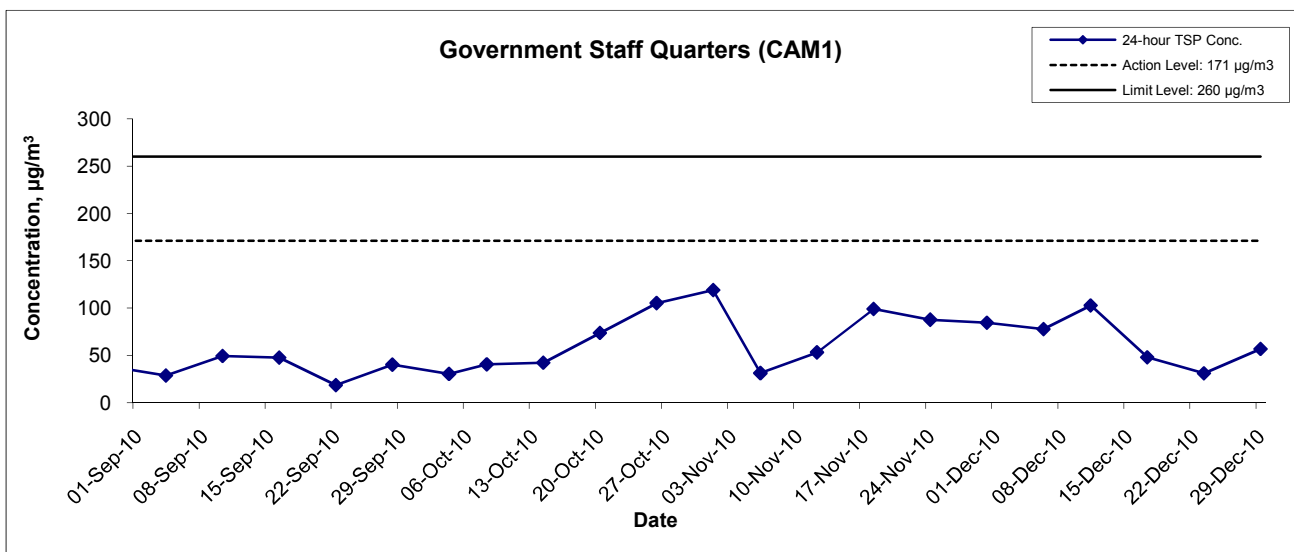
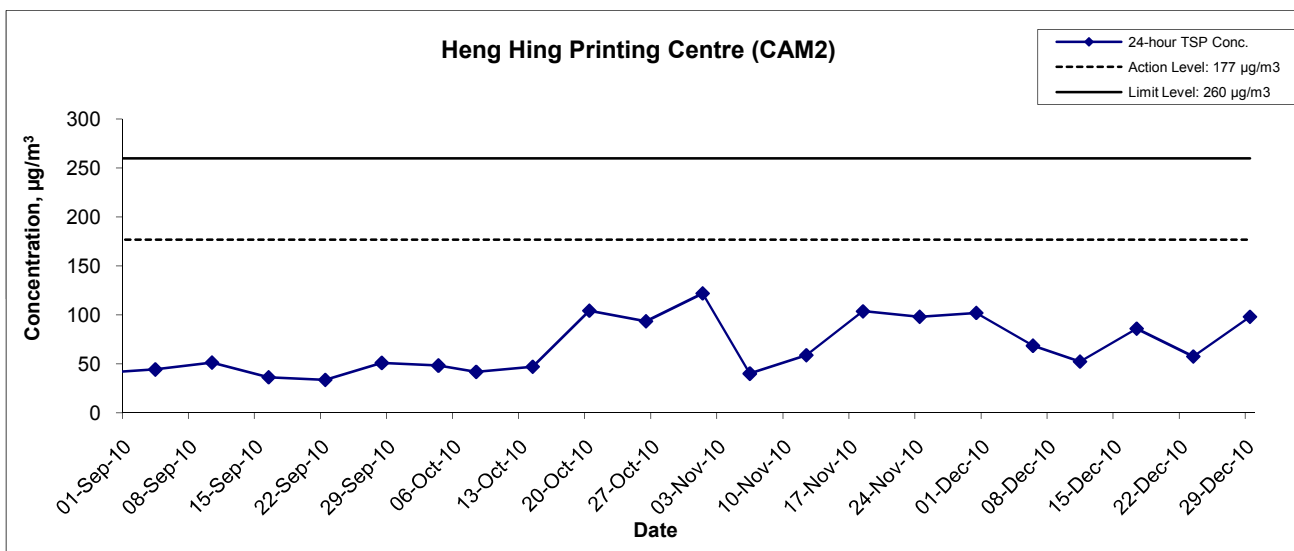
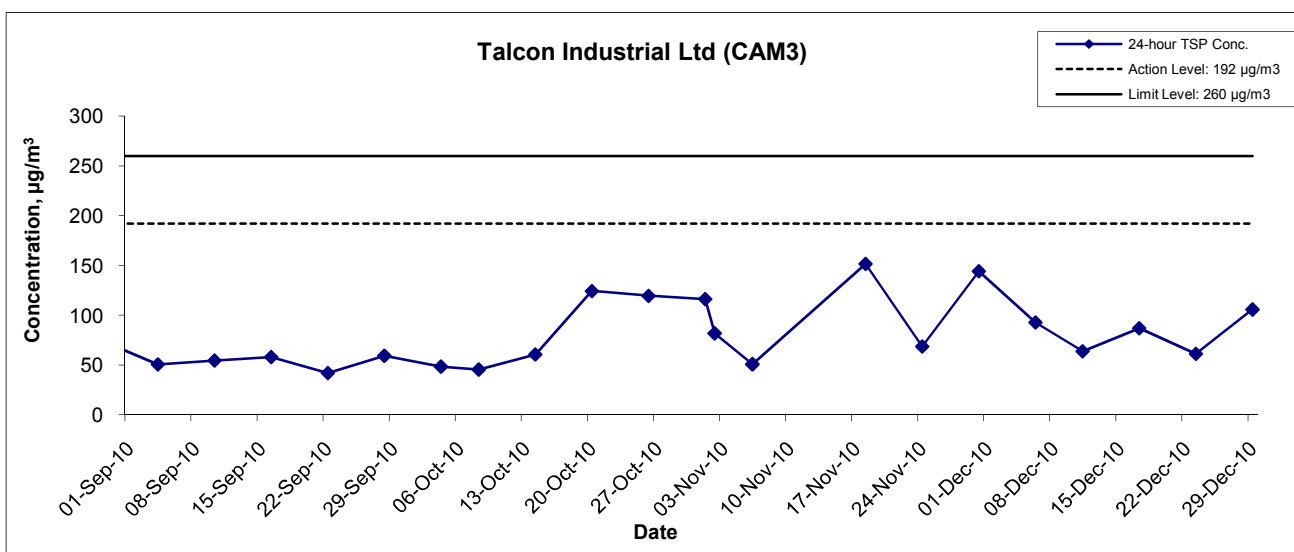
Title Contract No. DC/2009/09 Construction of Tai Po Sewage Treatment Works - Stage V Phase II B Graphical Presentation of 24-hour TSP Impact Monitoring Results	Scale	Project No.		
		N.T.S		MA0010
	Date	Dec 10		Appendix E

### 24-hr TSP Concentration Levels

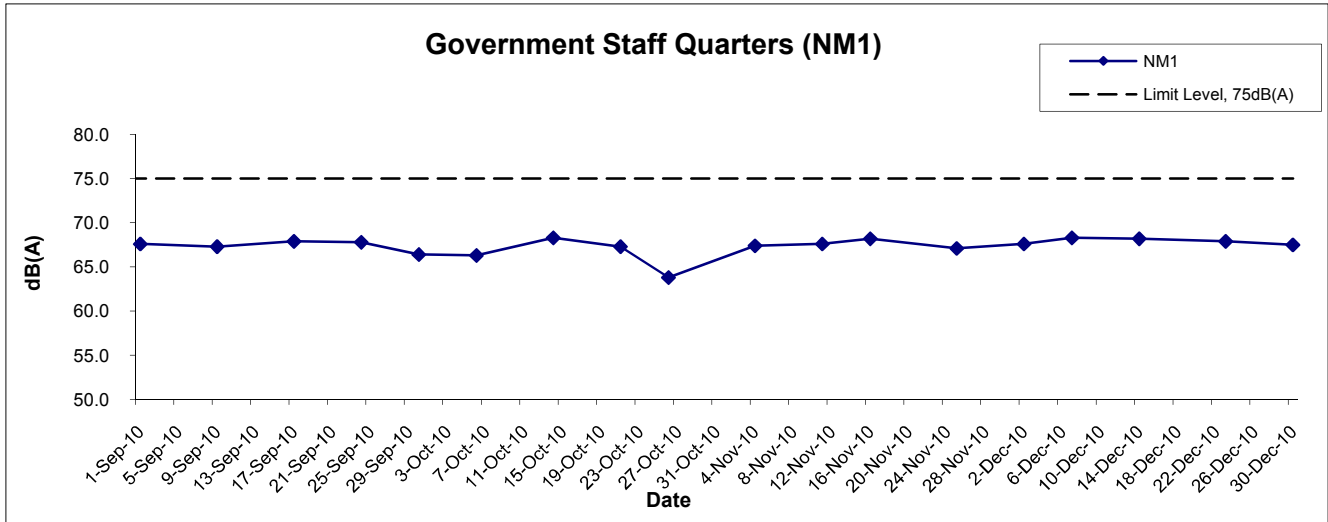
Title Contract No. DC/2009/09 Construction of Tai Po Sewage Treatment Works - Stage V Phase II B  Graphical Presentation of Construction Noise Monitoring Results	Scale N.T.S	Project No. MA0010	
	Date Dec 10	Appendix F

## Noise Levels

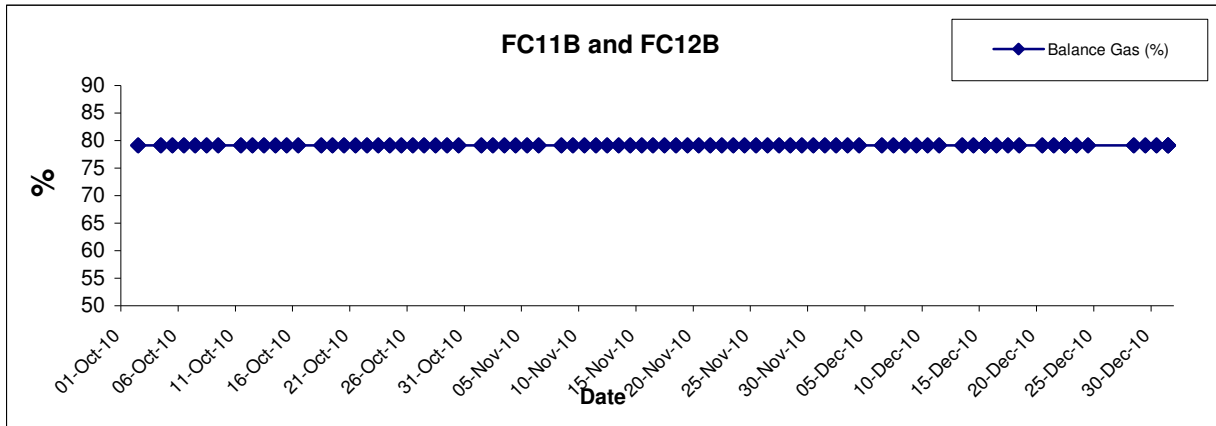
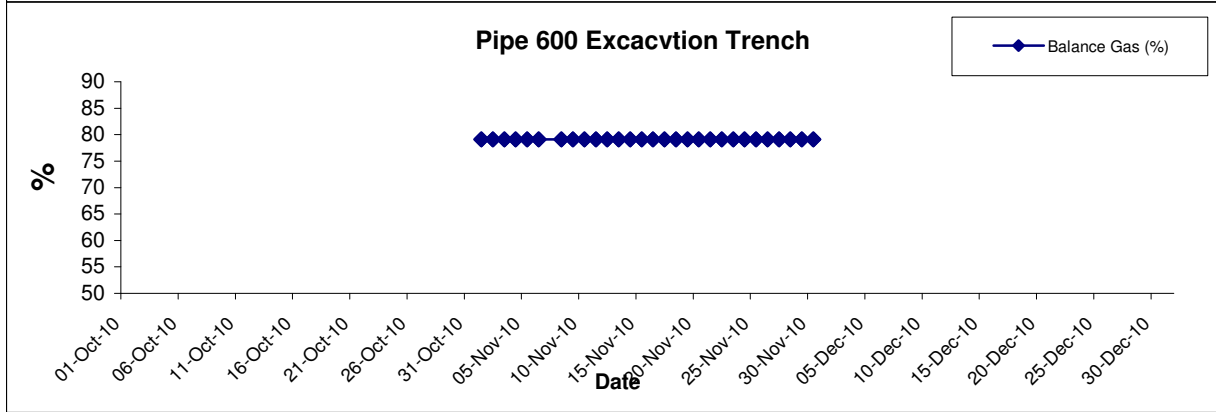
Title Contract No. DC/2009/09 Construction of Tai Po Sewage Treatment Works - Stage V Phase II B  Graphical Presentation of Landfill Gas Measurement	Scale N.T.S	Project No. MA0010	<b>CINOTECH</b>
	Date Dec 10	Appendix G

### Balance Gas

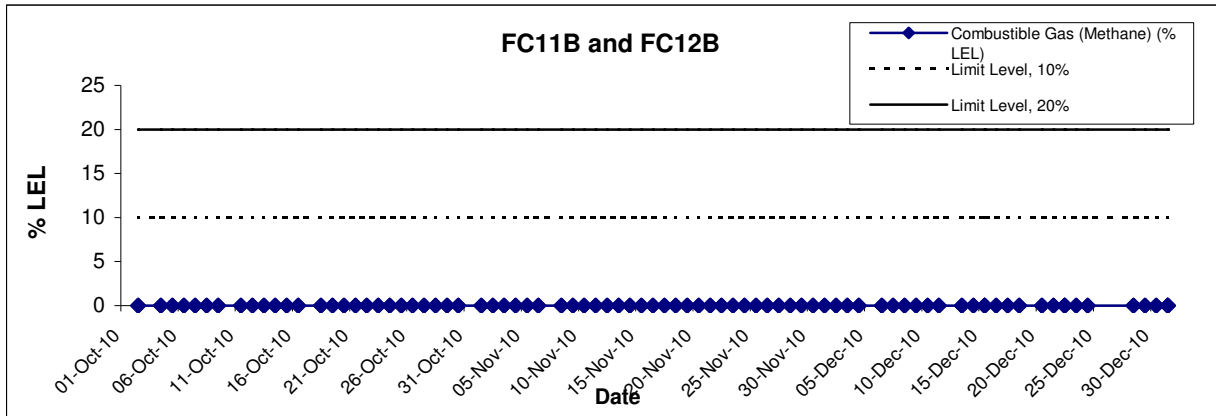
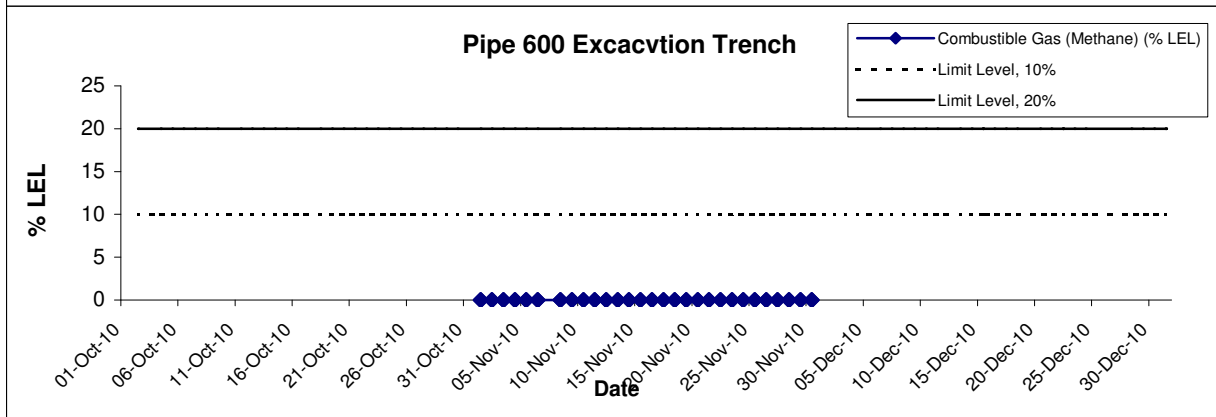
Title Contract No. DC/2009/09 Construction of Tai Po Sewage Treatment Works - Stage V Phase II B  Graphical Presentation of Landfill Gas Measurement	Scale	N.T.S	Project No. MA0010	CINOTECH
	Date	Dec 10	Appendix G

### Combustible Gas (Methane)

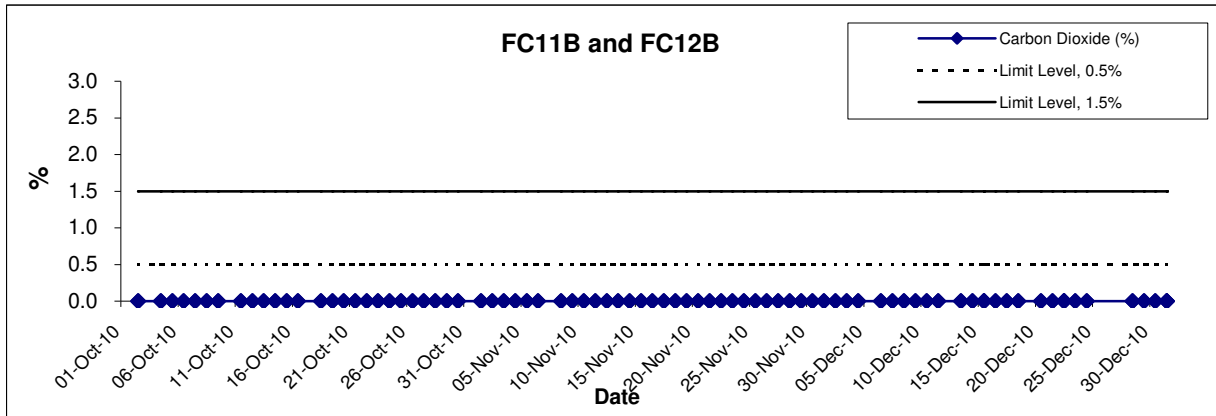
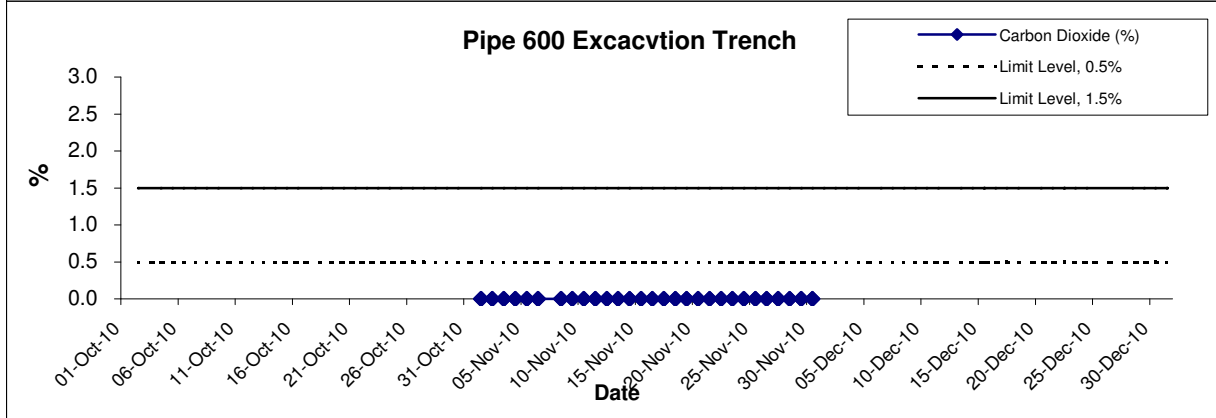
Title Contract No. DC/2009/09 Construction of Tai Po Sewage Treatment Works - Stage V Phase II B Graphical Presentation of Landfill Gas Measurement	Scale N.T.S	Project No. MA0010	<b>CINOTECH</b>
	Date Dec 10	Appendix G

### Carbon Dioxide

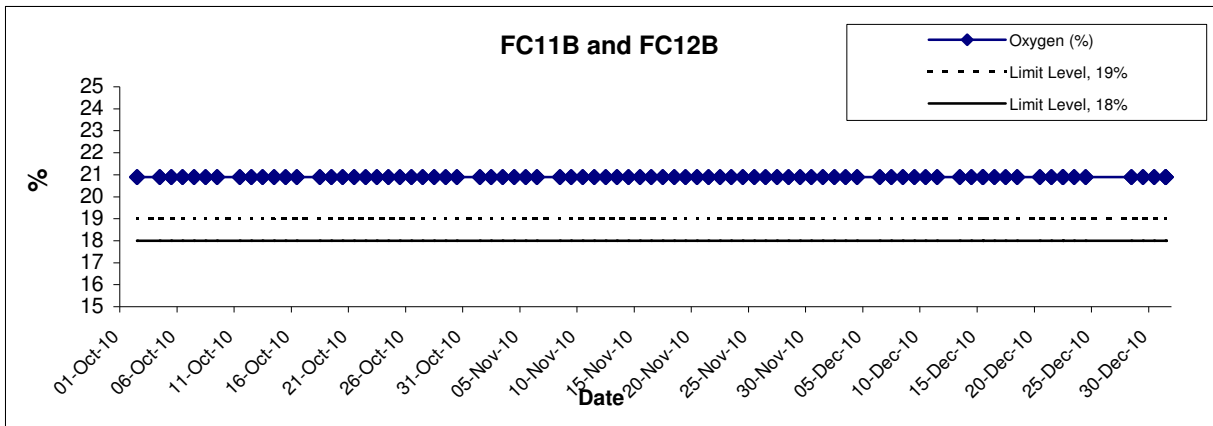
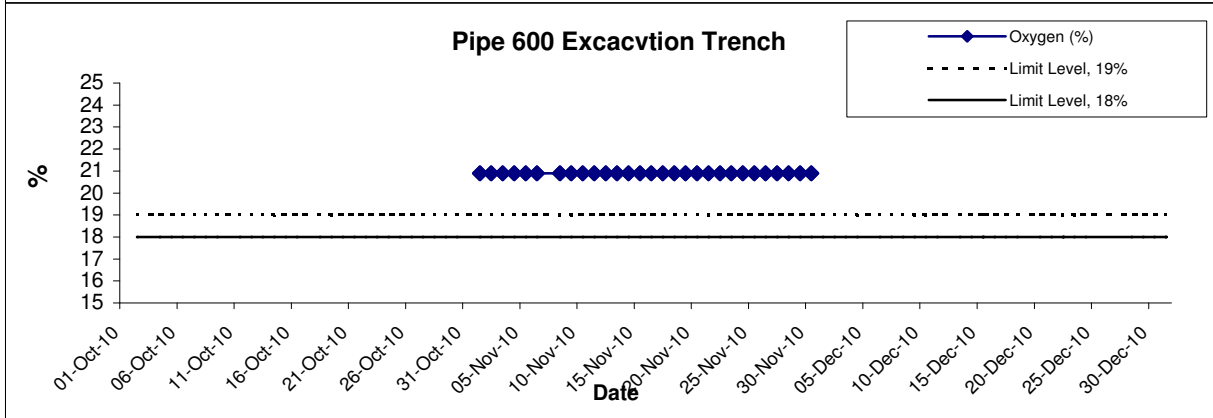
Title Contract No. DC/2009/09 Construction of Tai Po Sewage Treatment Works - Stage V Phase II B  Graphical Presentation of Landfill Gas Measurement	Scale N.T.S	Project No. MA0010	CINOTECH
	Date Dec 10	Appendix G

## Oxygen
