Contract No. DC/2009/09
Construction of Tai Po Sewage Treatment
Works – Stage V Phase II B

Monthly Environmental Monitoring and Audit Report for January 2011

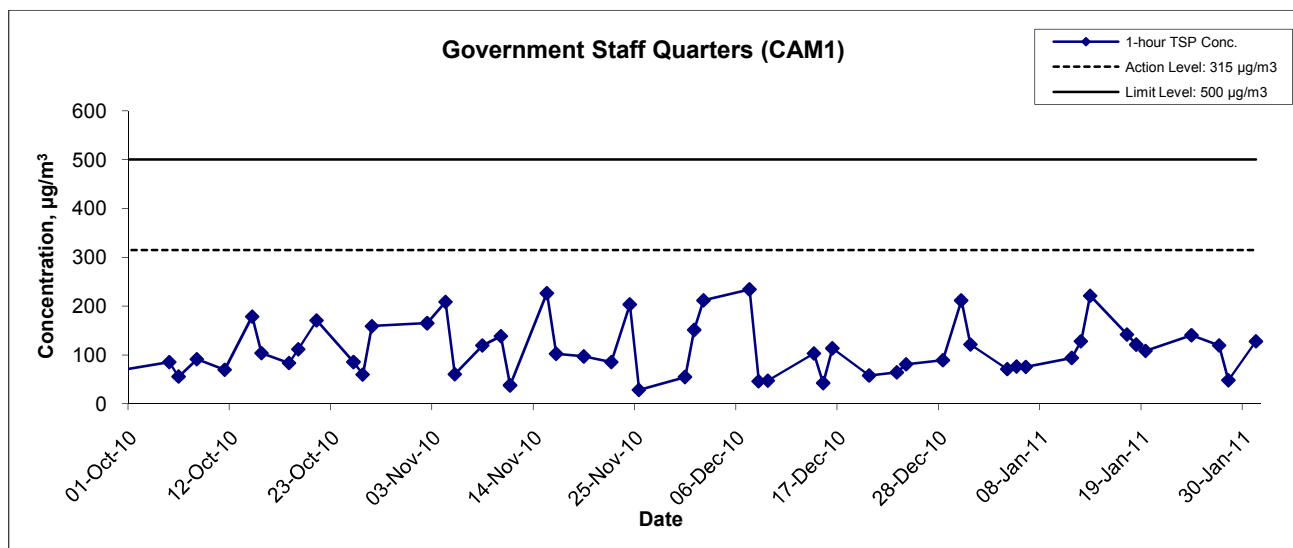
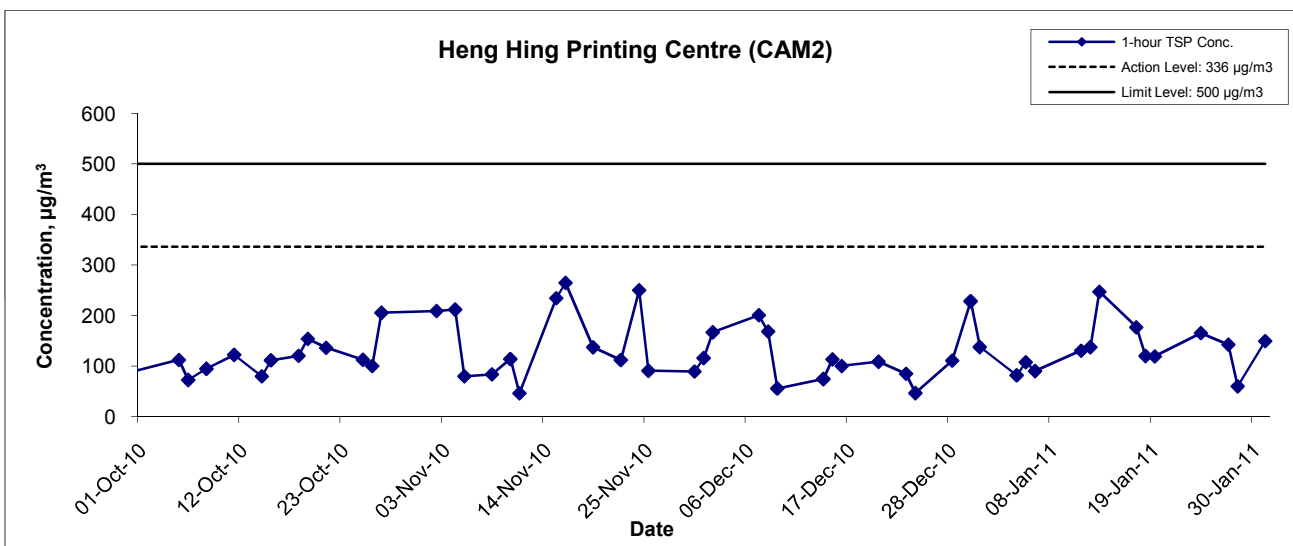
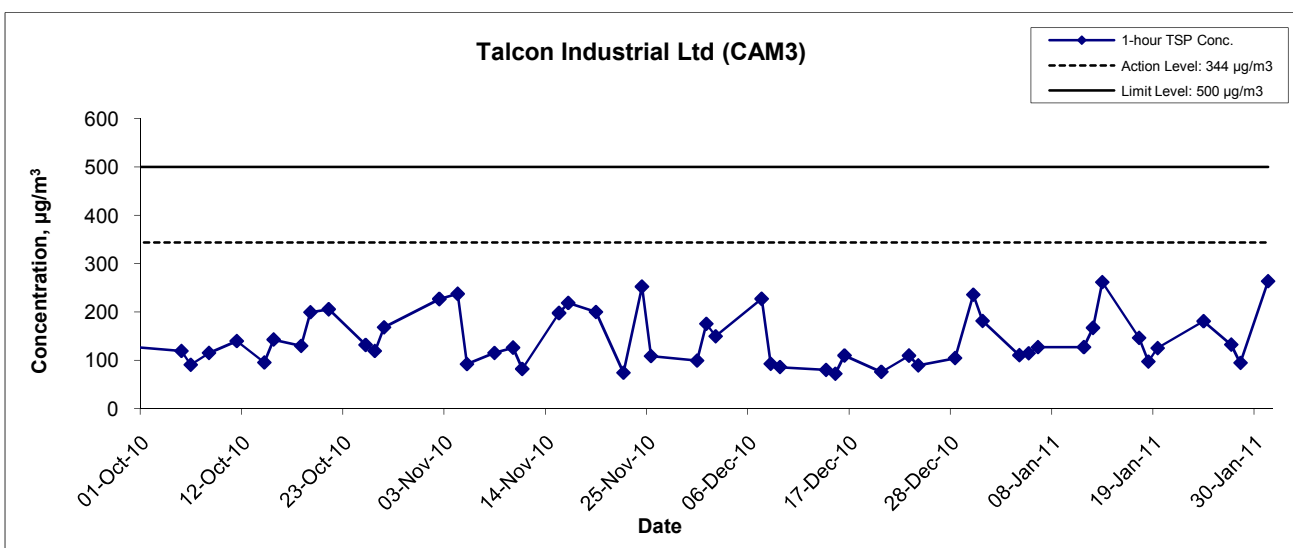
Title Contract No. DC/2009/09 Construction of Tai Po Sewage Treatment Works - Stage V Phase II B Graphical Presentation of 1-hour TSP Impact Monitoring Results	Scale N.T.S	Project No. MA0010	
	Date Jan 11	Appendix D

1-hr TSP Concentration Levels

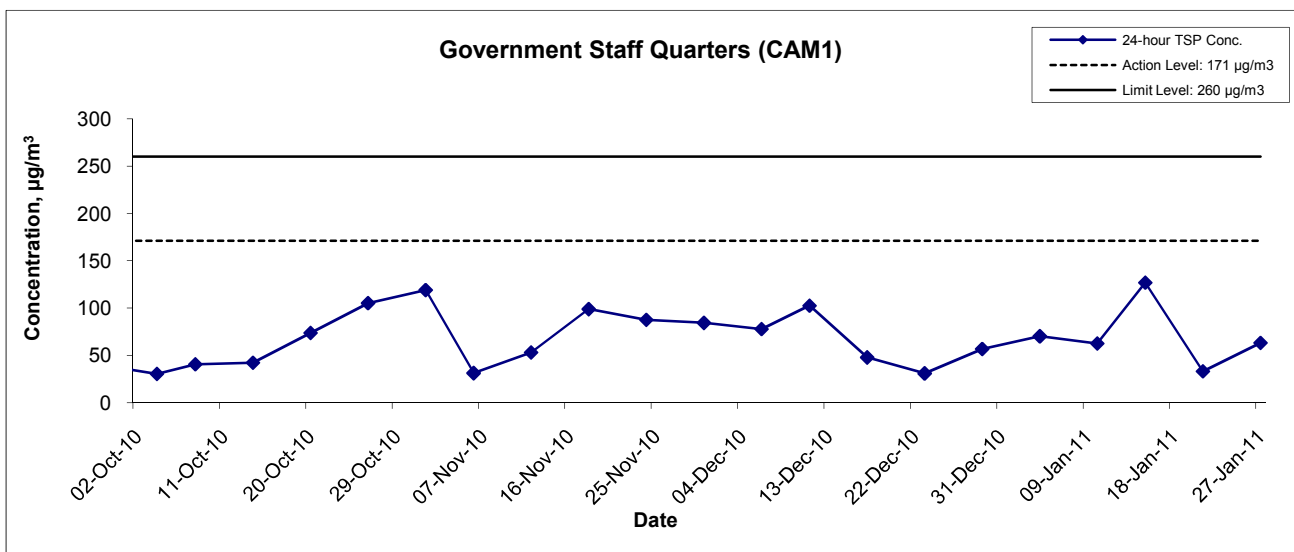
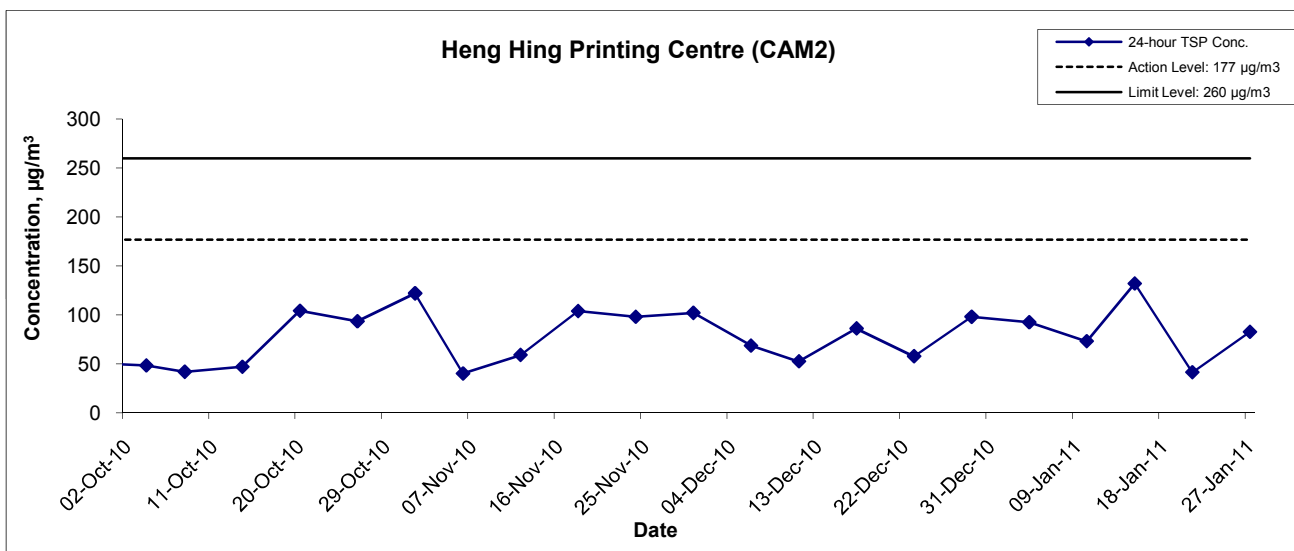
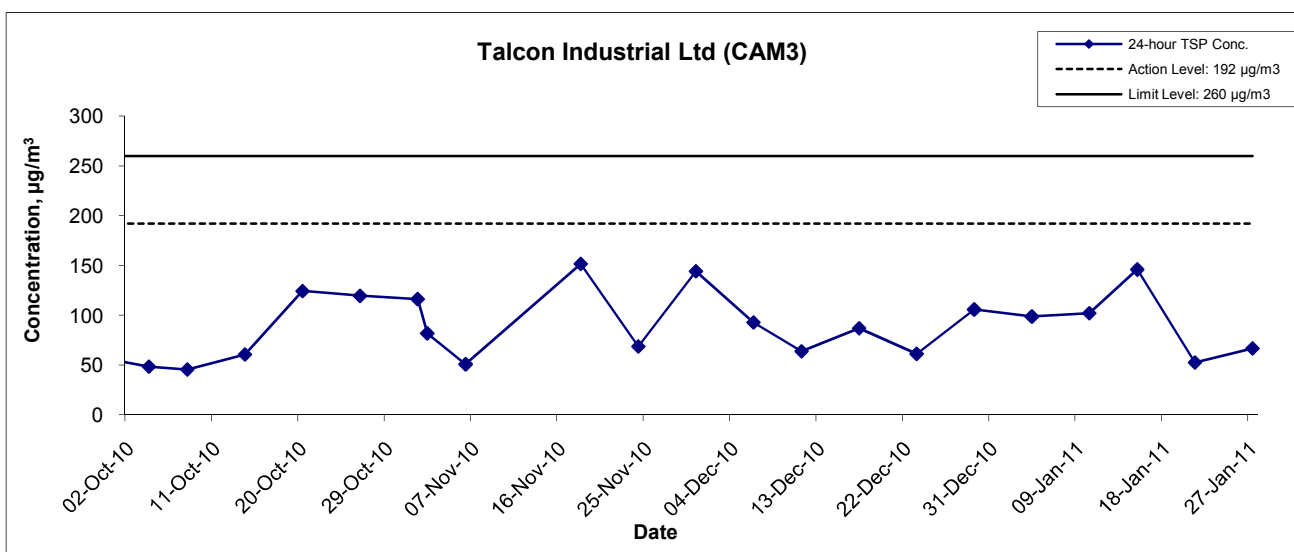
Title Contract No. DC/2009/09 Construction of Tai Po Sewage Treatment Works - Stage V Phase II B Graphical Presentation of 24-hour TSP Impact Monitoring Results	Scale	Project No.		
		N.T.S		MA0010
	Date	Jan 11		Appendix E

24-hr TSP Concentration Levels

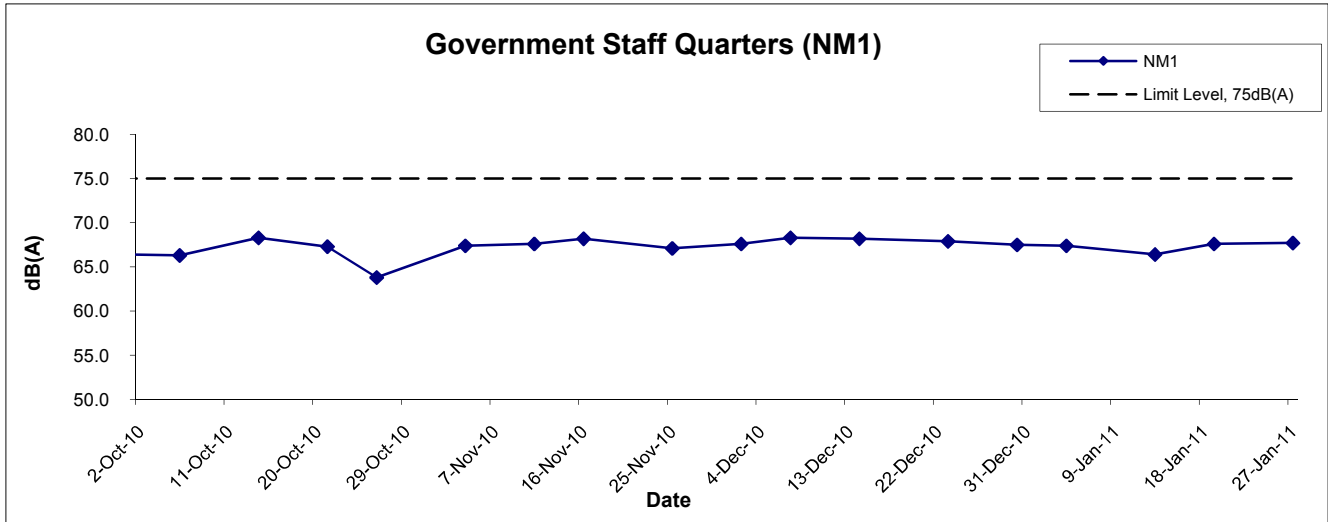
Title Contract No. DC/2009/09 Construction of Tai Po Sewage Treatment Works - Stage V Phase II B Graphical Presentation of Construction Noise Monitoring Results	Scale N.T.S	Project No. MA0010	
	Date Jan 11	Appendix F

Noise Levels

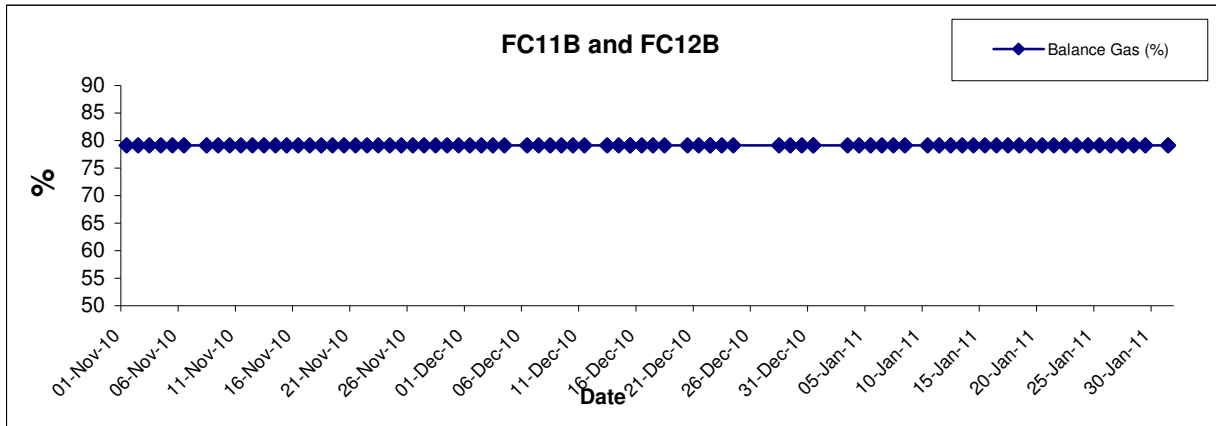
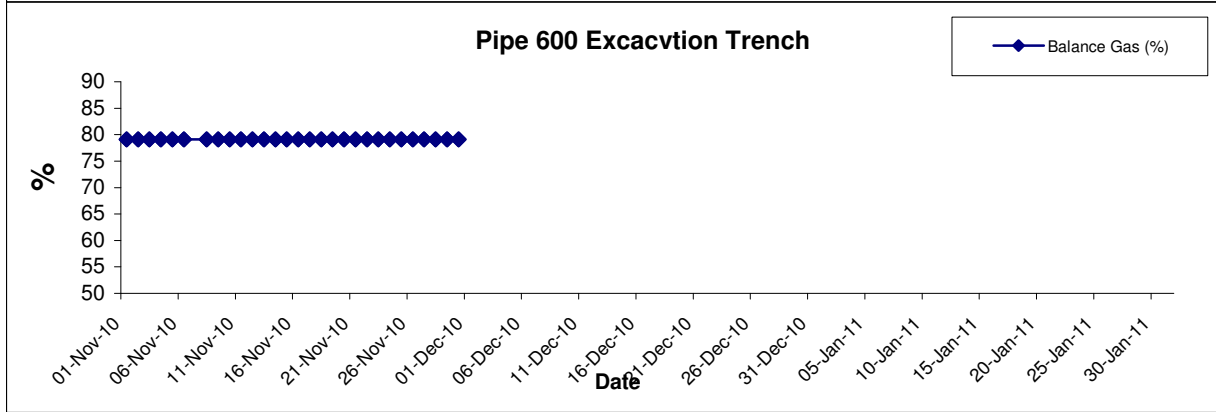
Title Contract No. DC/2009/09 Construction of Tai Po Sewage Treatment Works - Stage V Phase II B Graphical Presentation of Landfill Gas Measurement	Scale N.T.S	Project No. MA0010	CINOTECH
	Date Jan 11	Appendix G

Balance Gas

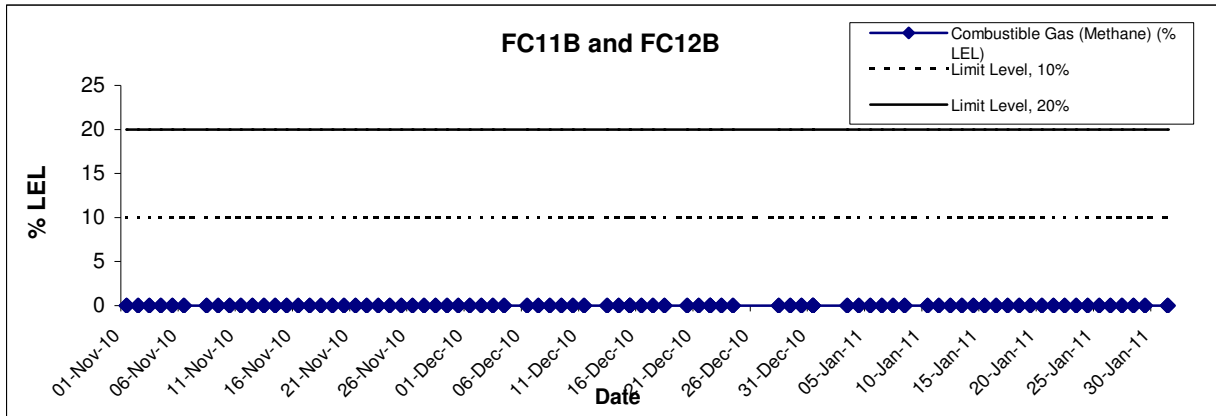
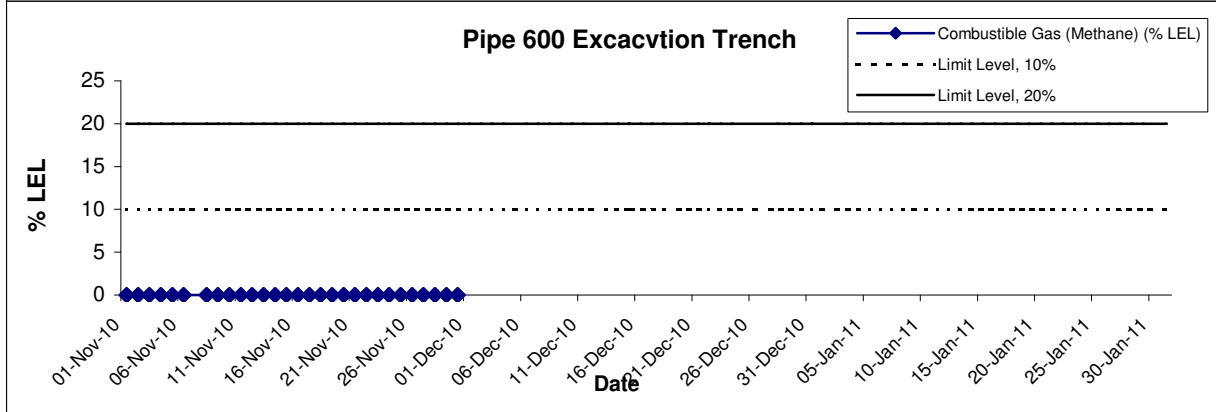
Title Contract No. DC/2009/09
 Construction of Tai Po Sewage Treatment Works - Stage V
 Phase II B
 Graphical Presentation of Landfill Gas Measurement

Combustible Gas (Methane)

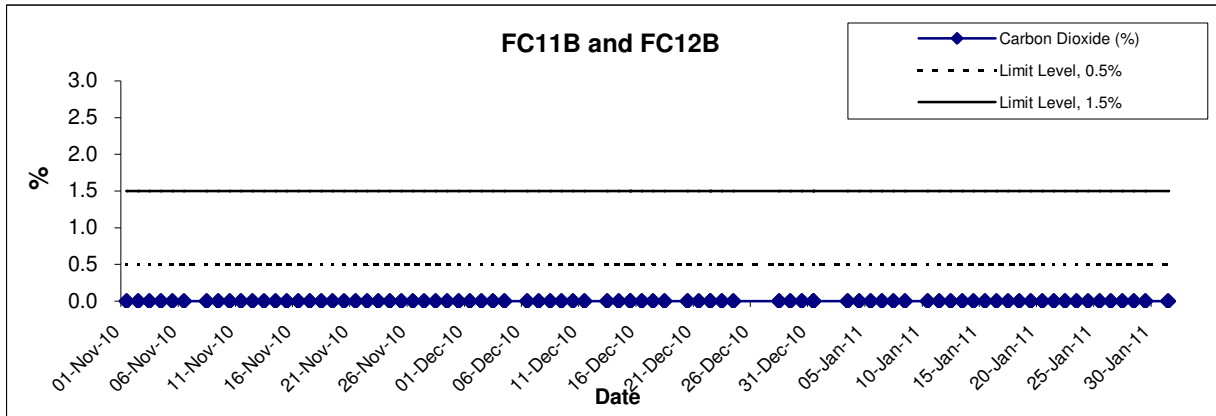
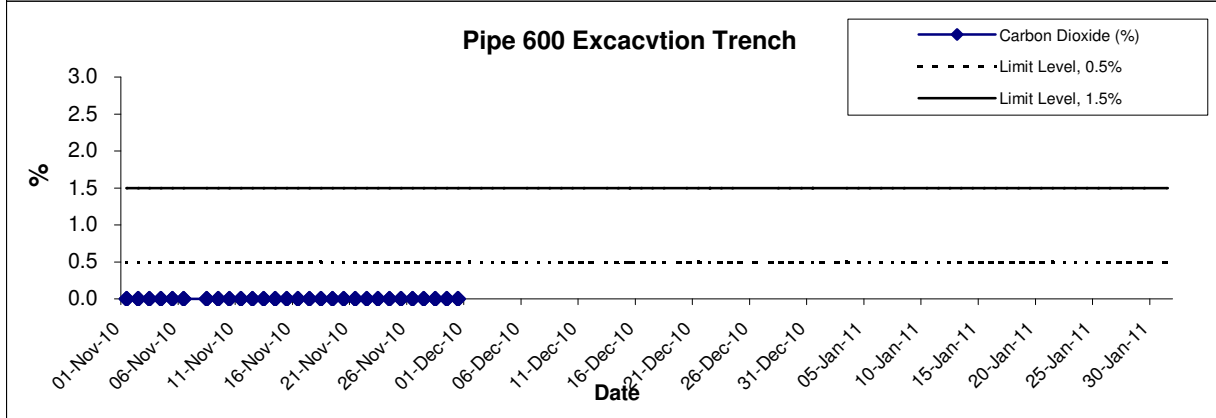
Title Contract No. DC/2009/09 Construction of Tai Po Sewage Treatment Works - Stage V Phase II B Graphical Presentation of Landfill Gas Measurement	Scale	Project	
	N.T.S	No. MA0010	
Date	Appendix		
Jan 11	G

Carbon Dioxide

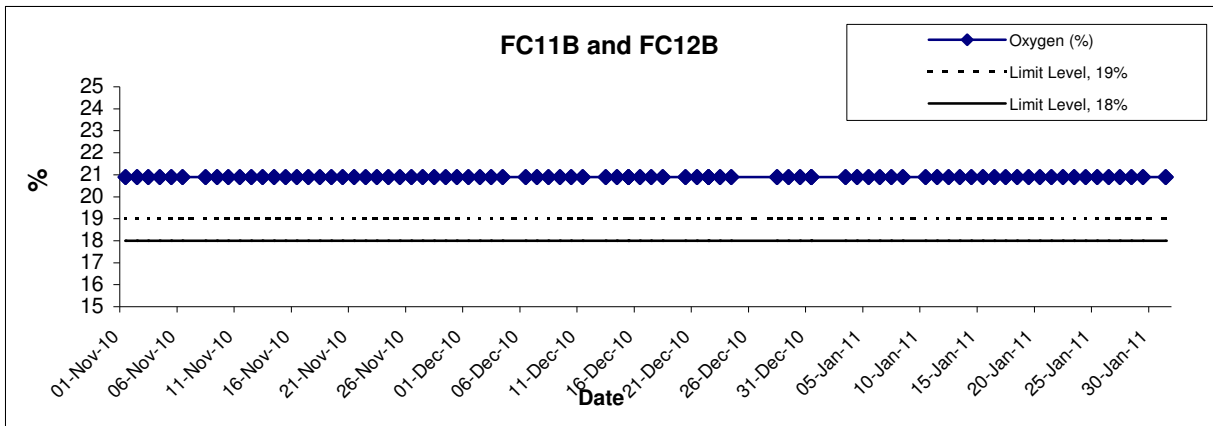
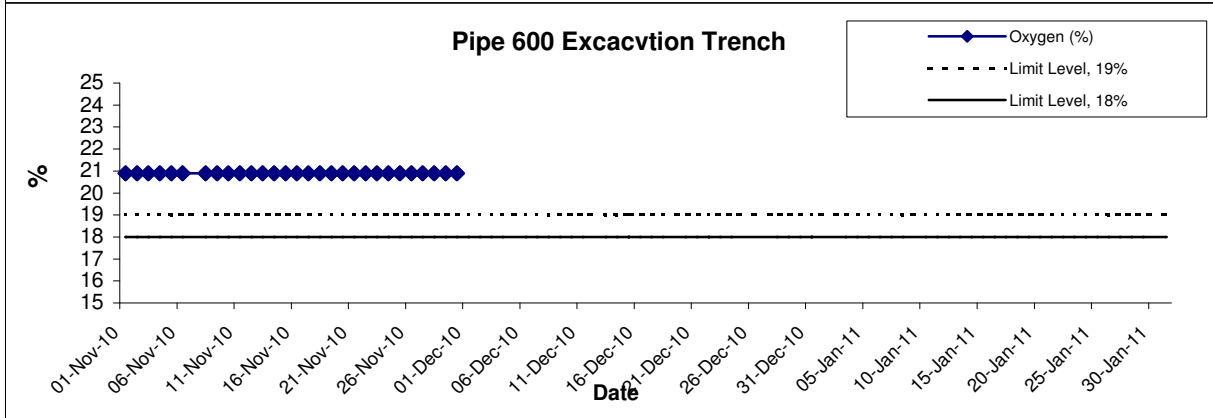
Title Contract No. DC/2009/09 Construction of Tai Po Sewage Treatment Works - Stage V Phase II B Graphical Presentation of Landfill Gas Measurement	Scale N.T.S	Project No. MA0010	CINOTECH
	Date Jan 11	Appendix G

Oxygen
