# China Harbour Engineering Company Limited

Contract No. DC/2009/09  
Construction of Tai Po Sewage Treatment  
Works – Stage V Phase II B

## Monthly Environmental Monitoring and Audit Report for August 2011

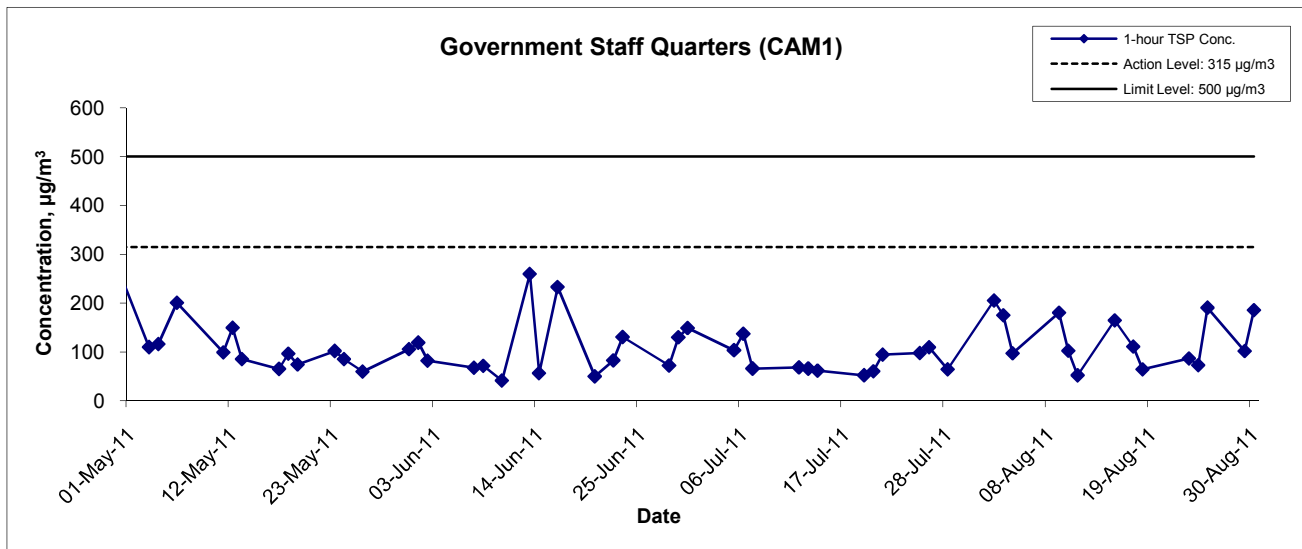
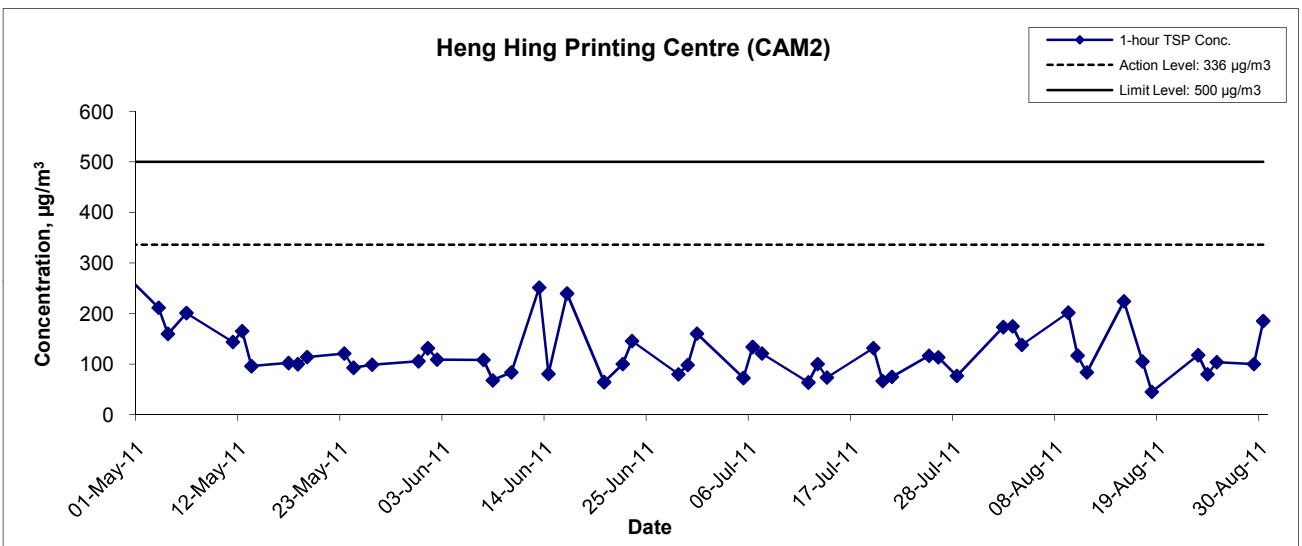
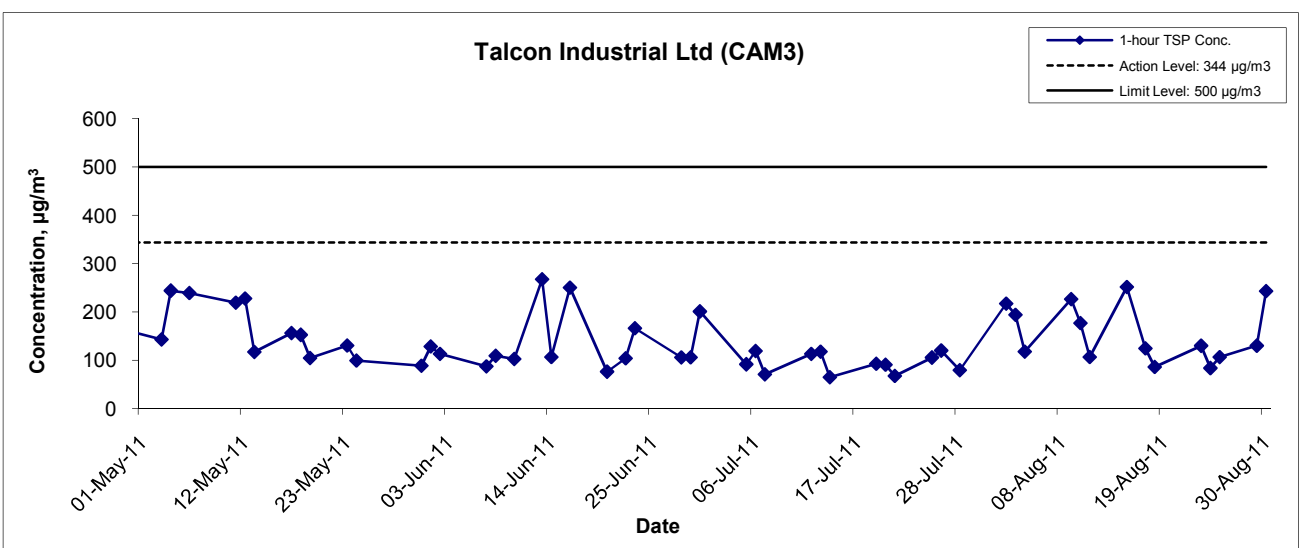
Title	Contract No. DC/2009/09	Scale	Project No. MA0010	CINOTECH
	Construction of Tai Po Sewage Treatment Works - Stage V Phase II B	N.T.S		
Graphical Presentation of 1-hour TSP Impact Monitoring Results		Date	Appendix D	
		Aug 11

### 1-hr TSP Concentration Levels

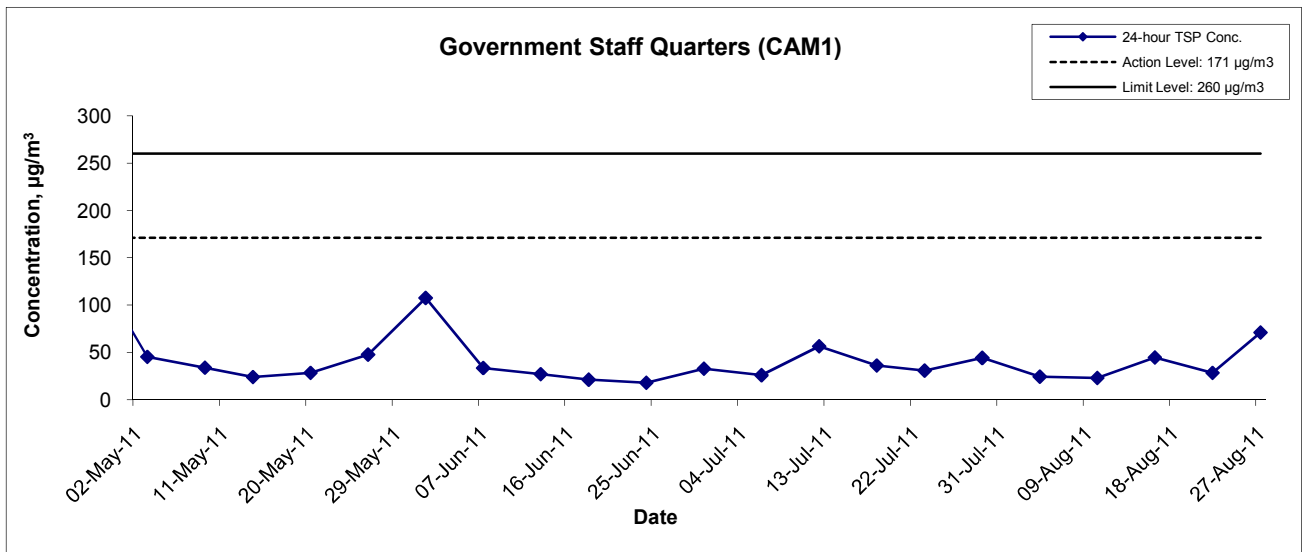
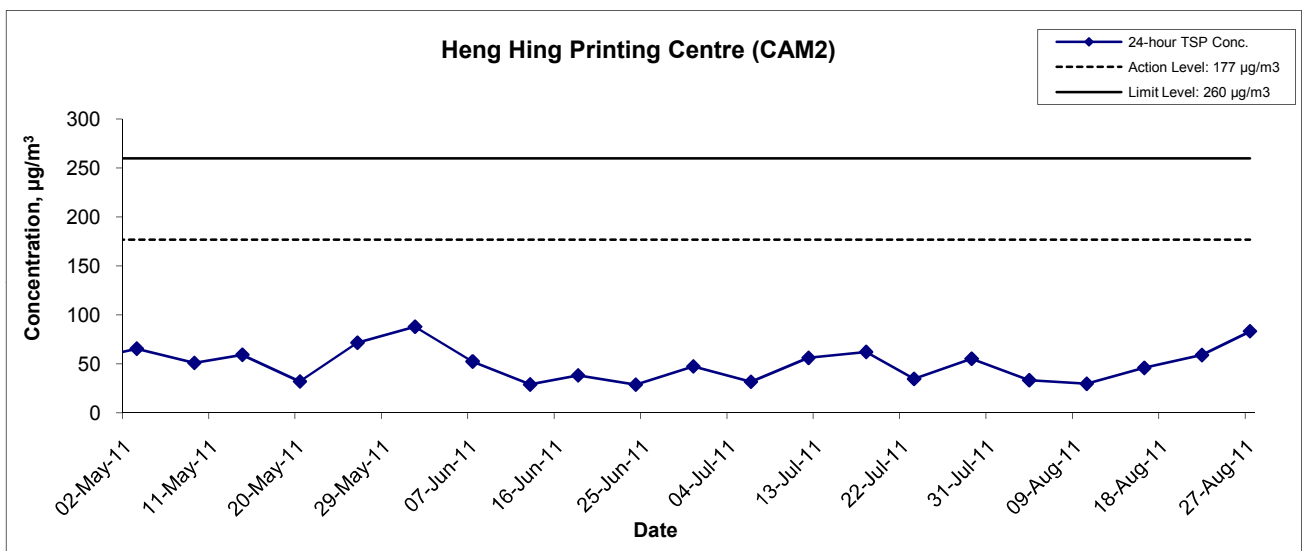
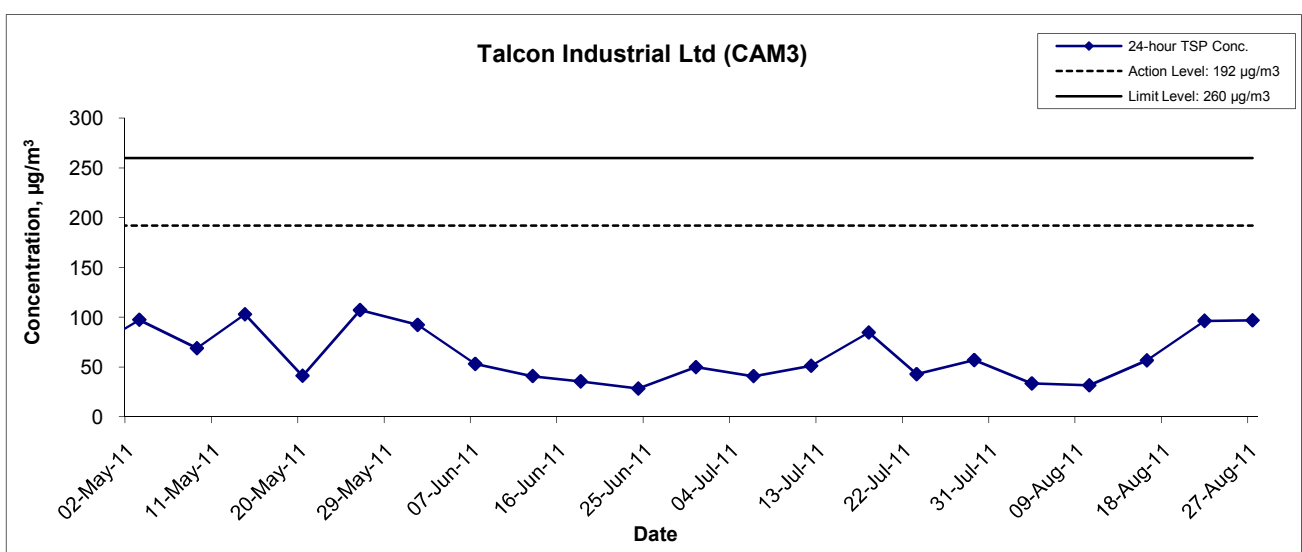
Title Contract No. DC/2009/09 Construction of Tai Po Sewage Treatment Works - Stage V Phase II B Graphical Presentation of 24-hour TSP Impact Monitoring Results	Scale	Project No.		
		N.T.S		MA0010
	Date	Aug 11		Appendix E

### 24-hr TSP Concentration Levels

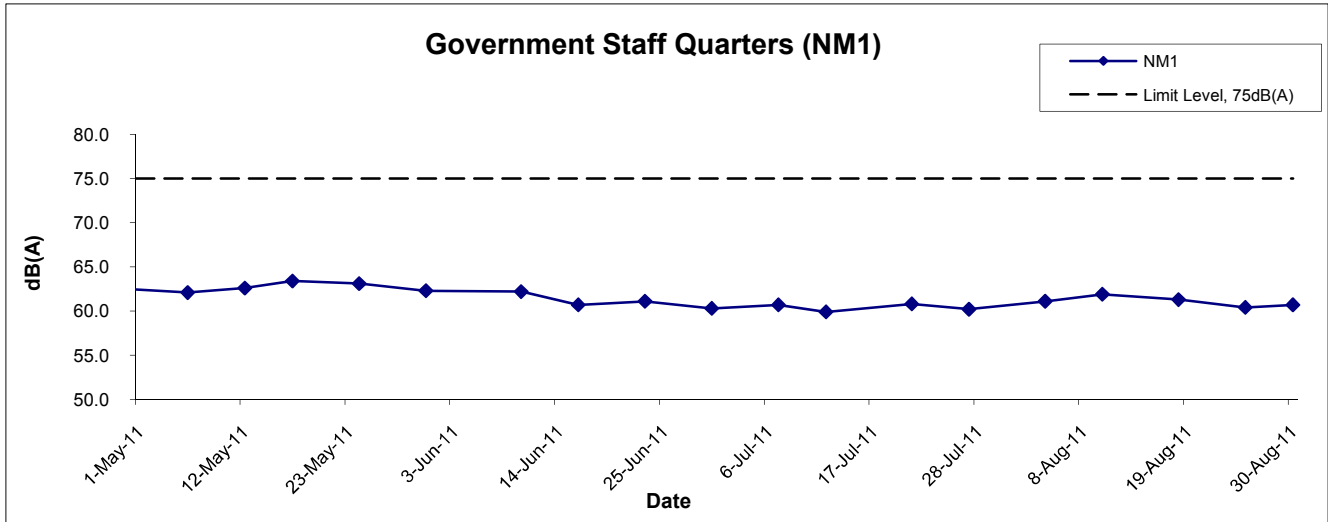
Title Contract No. DC/2009/09 Construction of Tai Po Sewage Treatment Works - Stage V Phase II B Graphical Presentation of Construction Noise Monitoring Results	Scale N.T.S	Project No. MA0010	
	Date Aug 11	Appendix F

## Noise Levels
