Contract No. DC/2009/09
Construction of Tai Po Sewage Treatment
Works – Stage V Phase II B

**Monthly Environmental Monitoring
and Audit Report for
December 2011**

(Version 1.1)

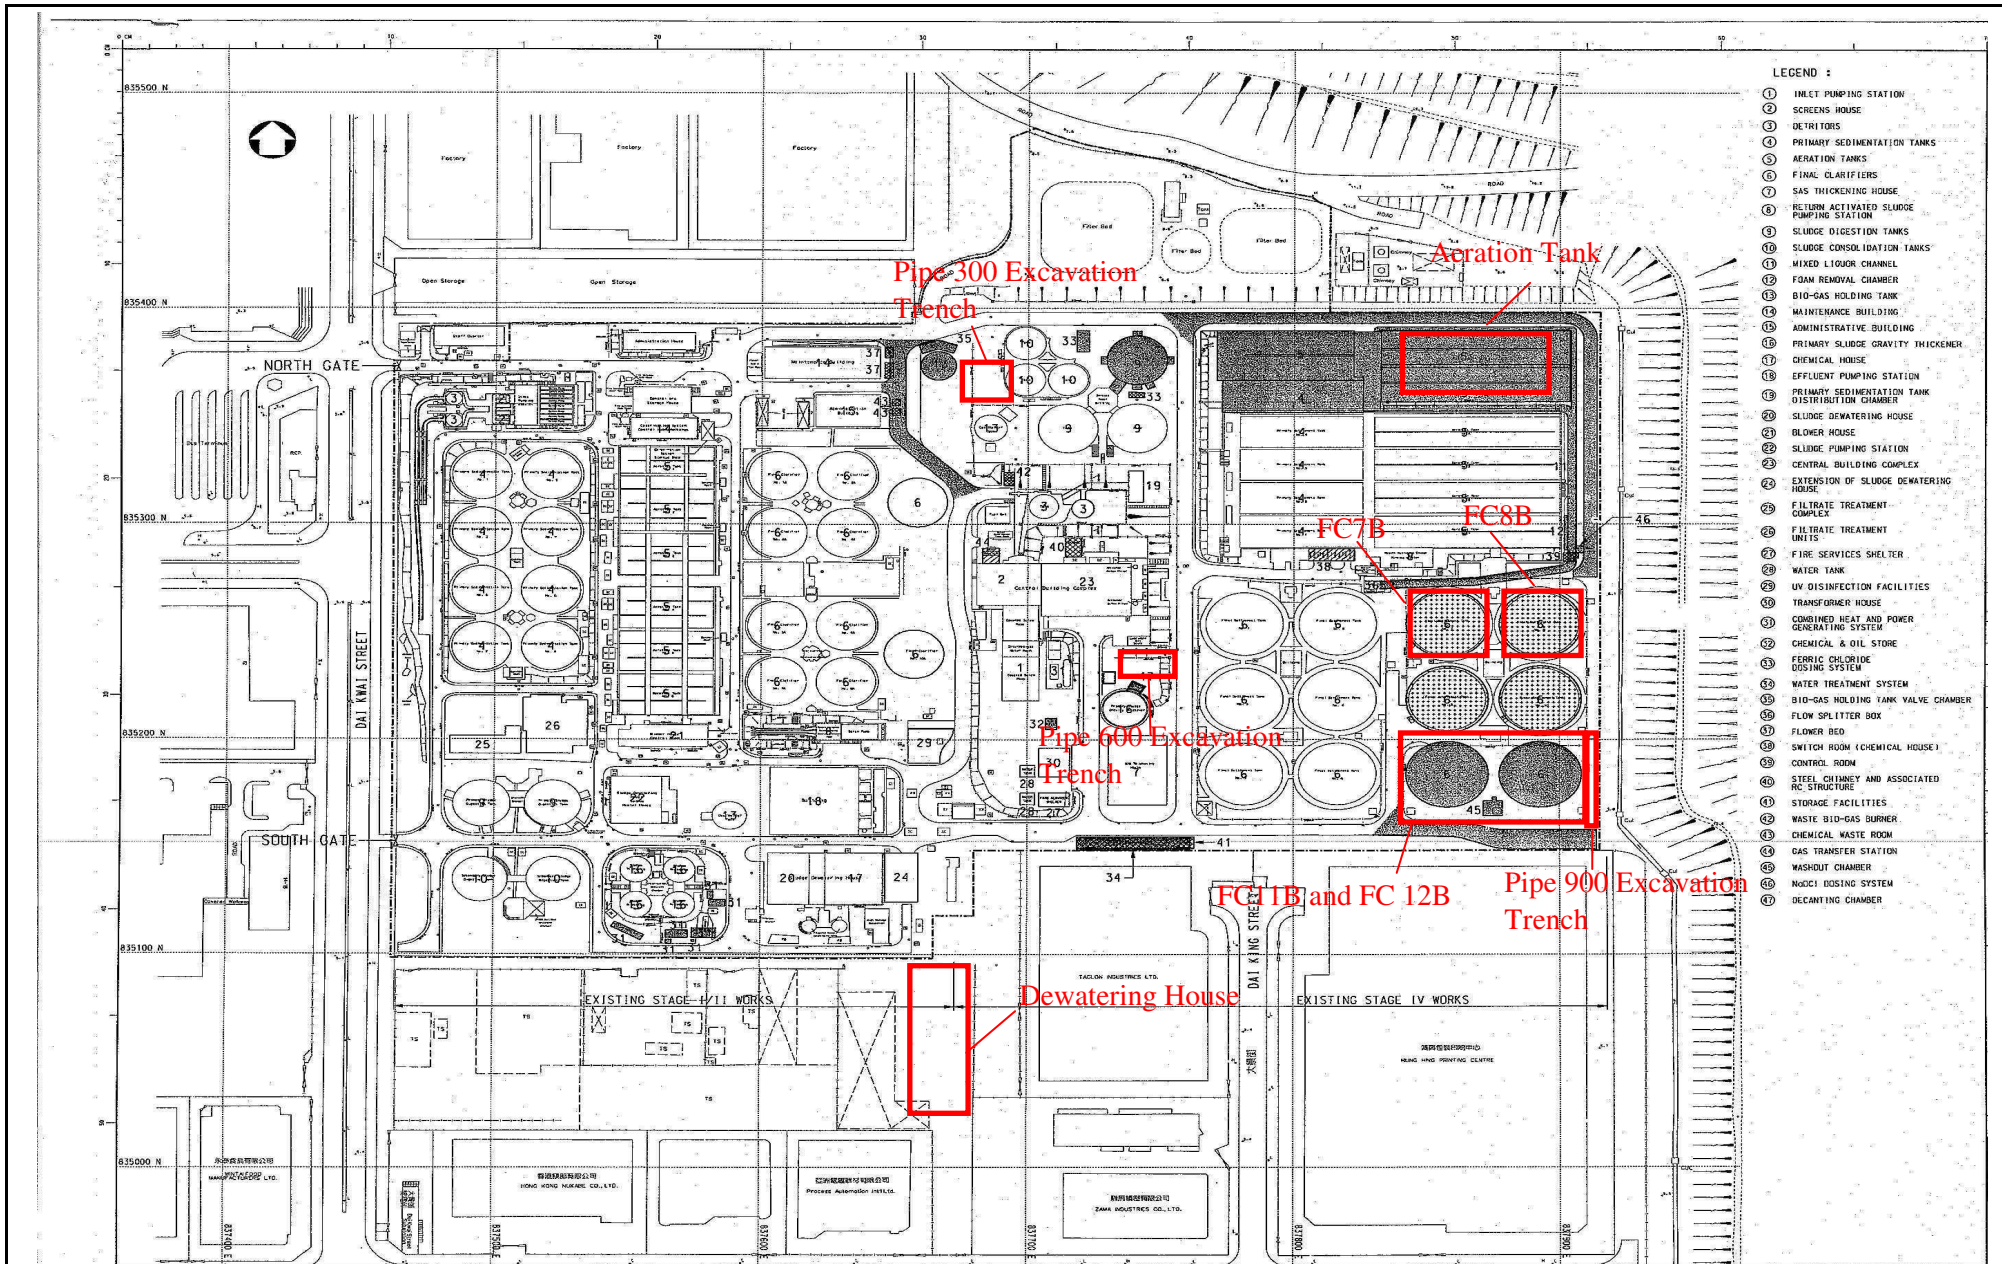
TAI PO SEWAGE TREATMENT WORKS, STAGE V, PHASE IIB

Landfill Gas Monitoring Area(TPSTW)

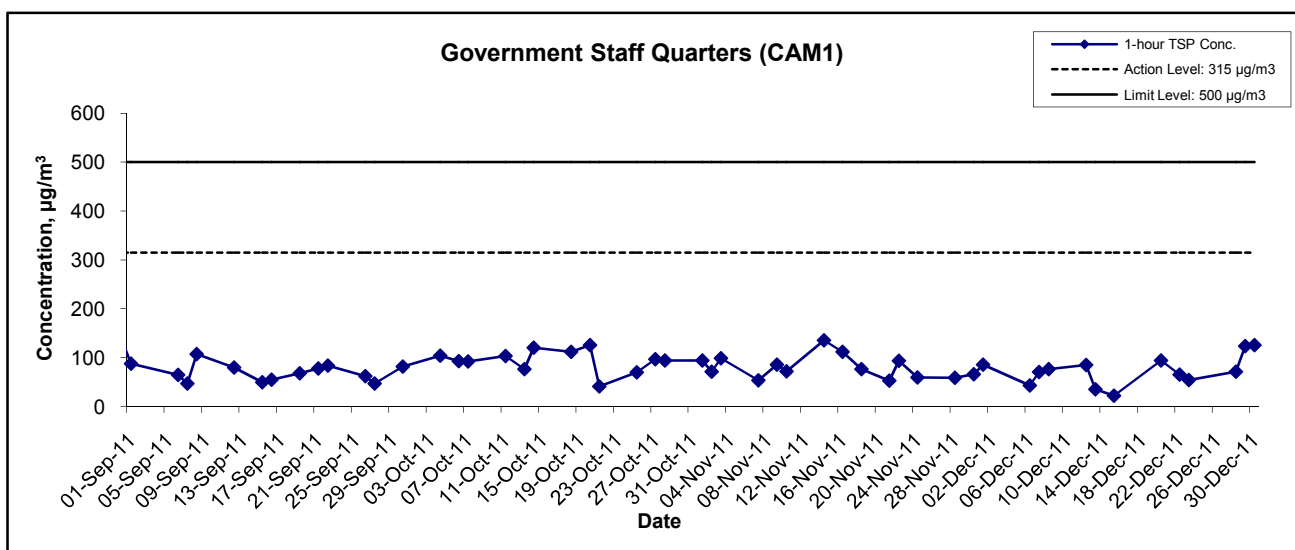
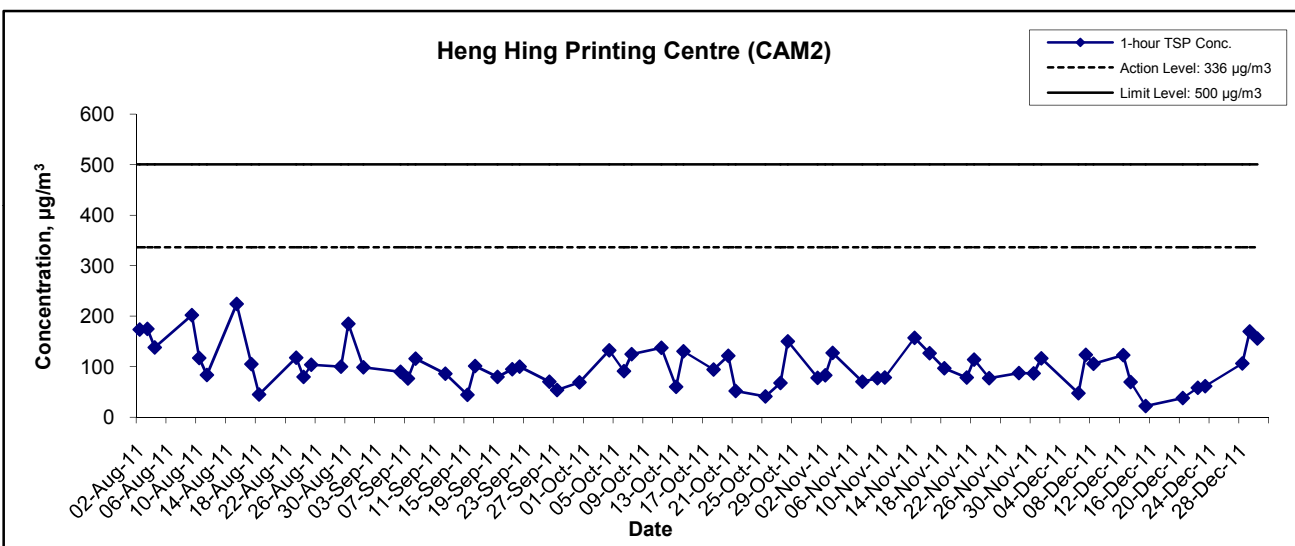
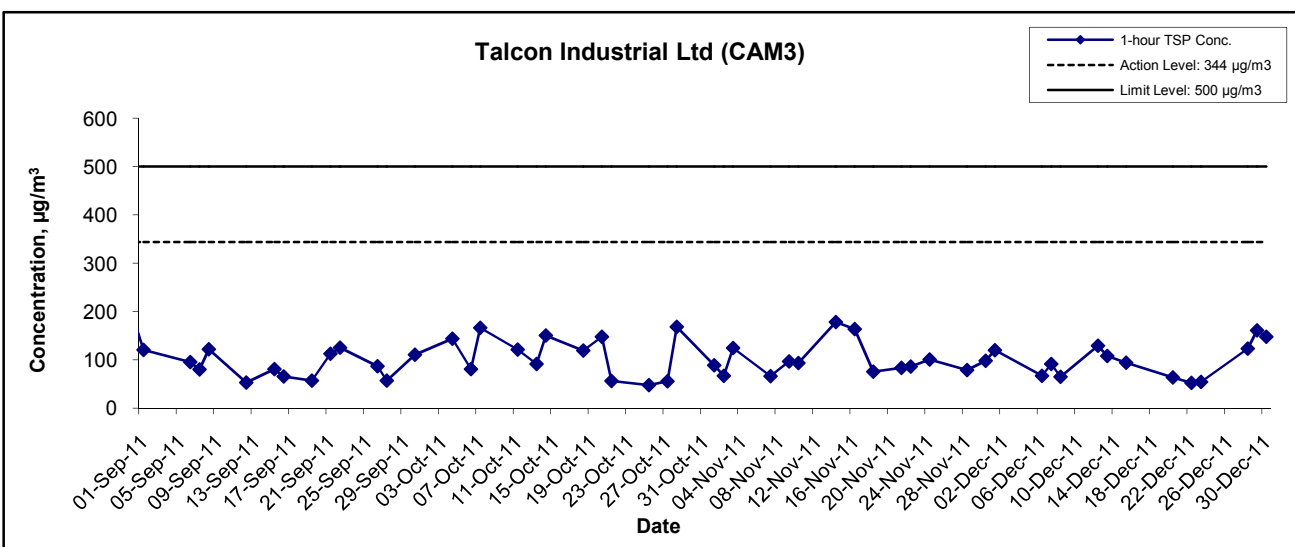
1-hr TSP Concentration Levels

Title	Contract No. DC/2009/09	Scale	Project No.	CINOTECH
	Construction of Tai Po Sewage Treatment Works - Stage V Phase II B	N.T.S	MA0010	
Graphical Presentation of 1-hour TSP Impact Monitoring Results		Date	Appendix	
		Dec 11	D

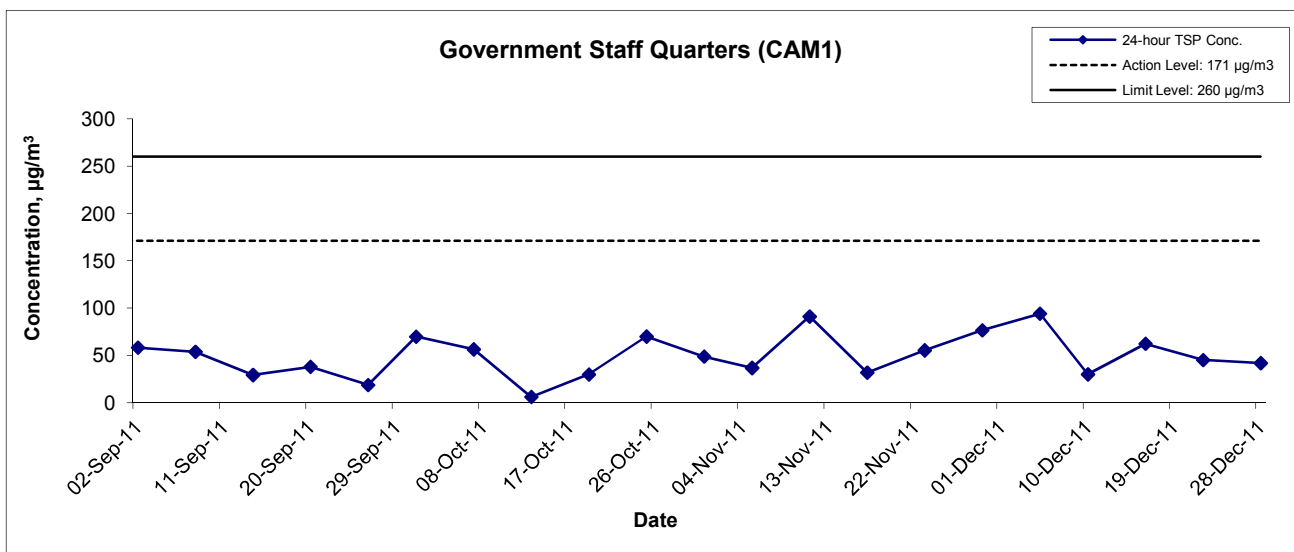
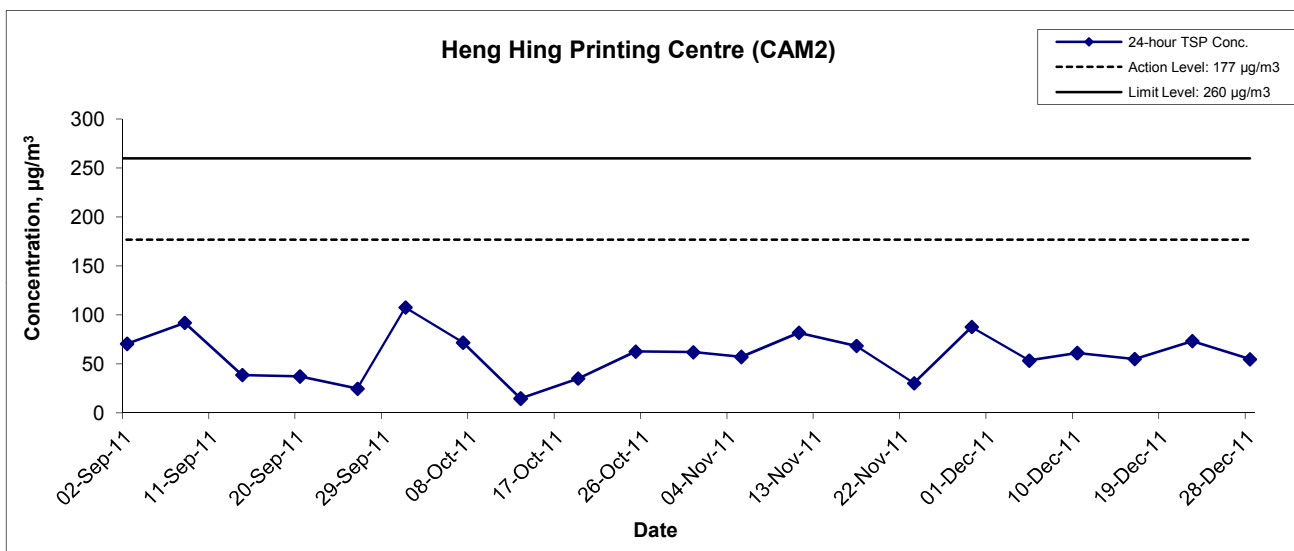
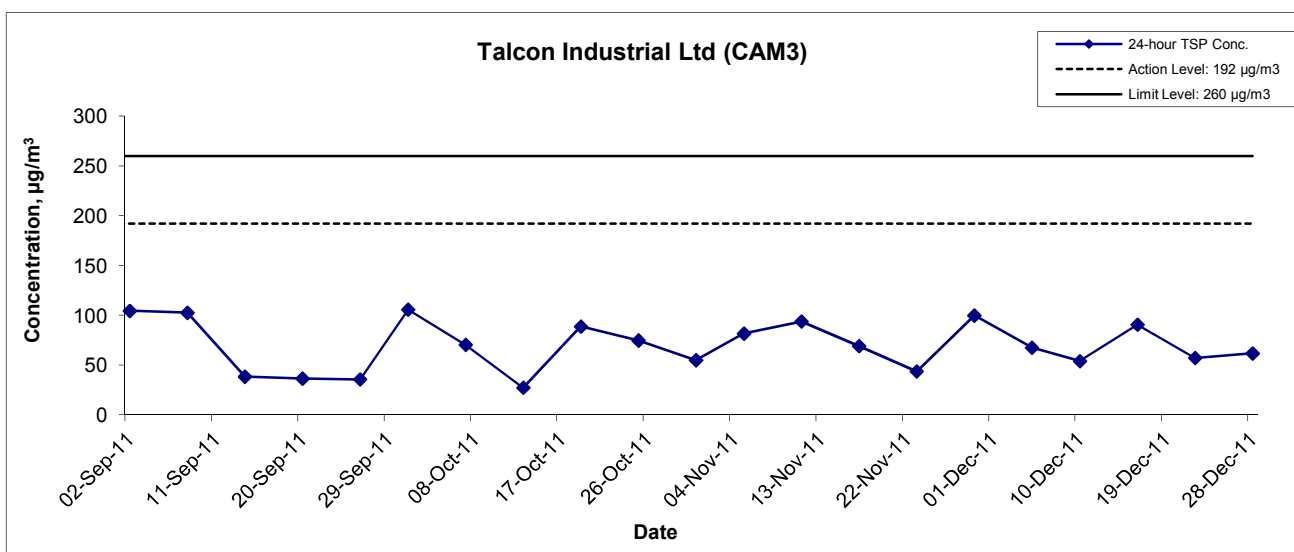
24-hr TSP Concentration Levels

Title Contract No. DC/2009/09 Construction of Tai Po Sewage Treatment Works - Stage V Phase II B Graphical Presentation of 24-hour TSP Impact Monitoring Results	Scale	Project No.		
		N.T.S		MA0010
	Date	Dec 11		Appendix E

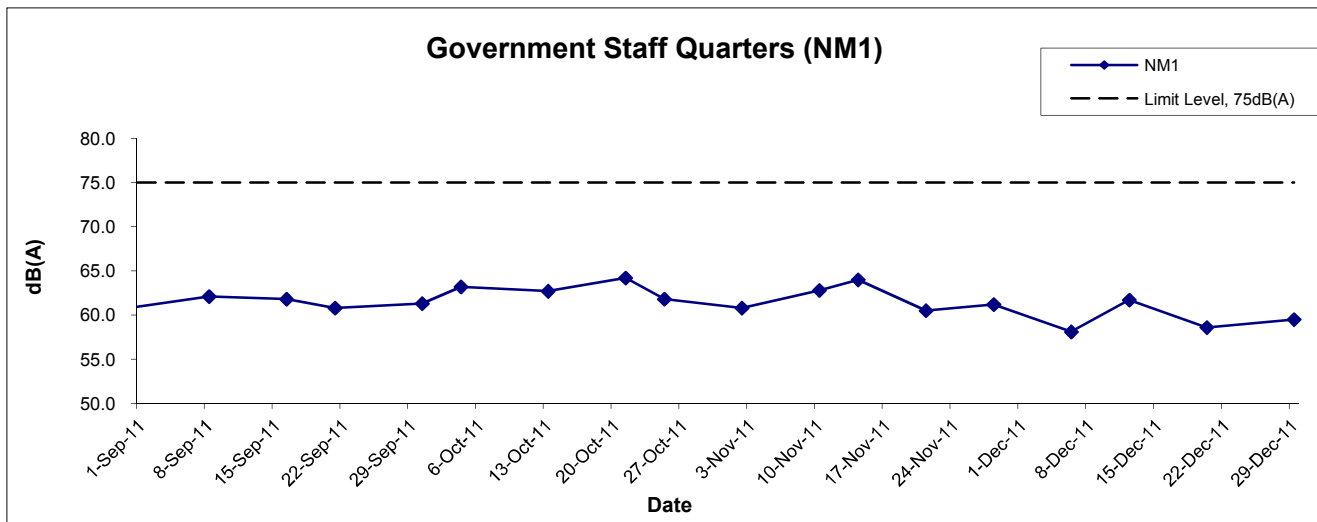
Noise Levels

Title Contract No. DC/2009/09 Construction of Tai Po Sewage Treatment Works - Stage V Phase II B Graphical Presentation of Construction Noise Monitoring Results	Scale N.T.S	Project No. MA0010	
	Date Dec 11	Appendix F
