Contract No. DC/2009/09  
Construction of Tai Po Sewage Treatment  
Works – Stage V Phase II B

**Monthly Environmental Monitoring  
and Audit Report for  
September 2012**

(Version 2.0)

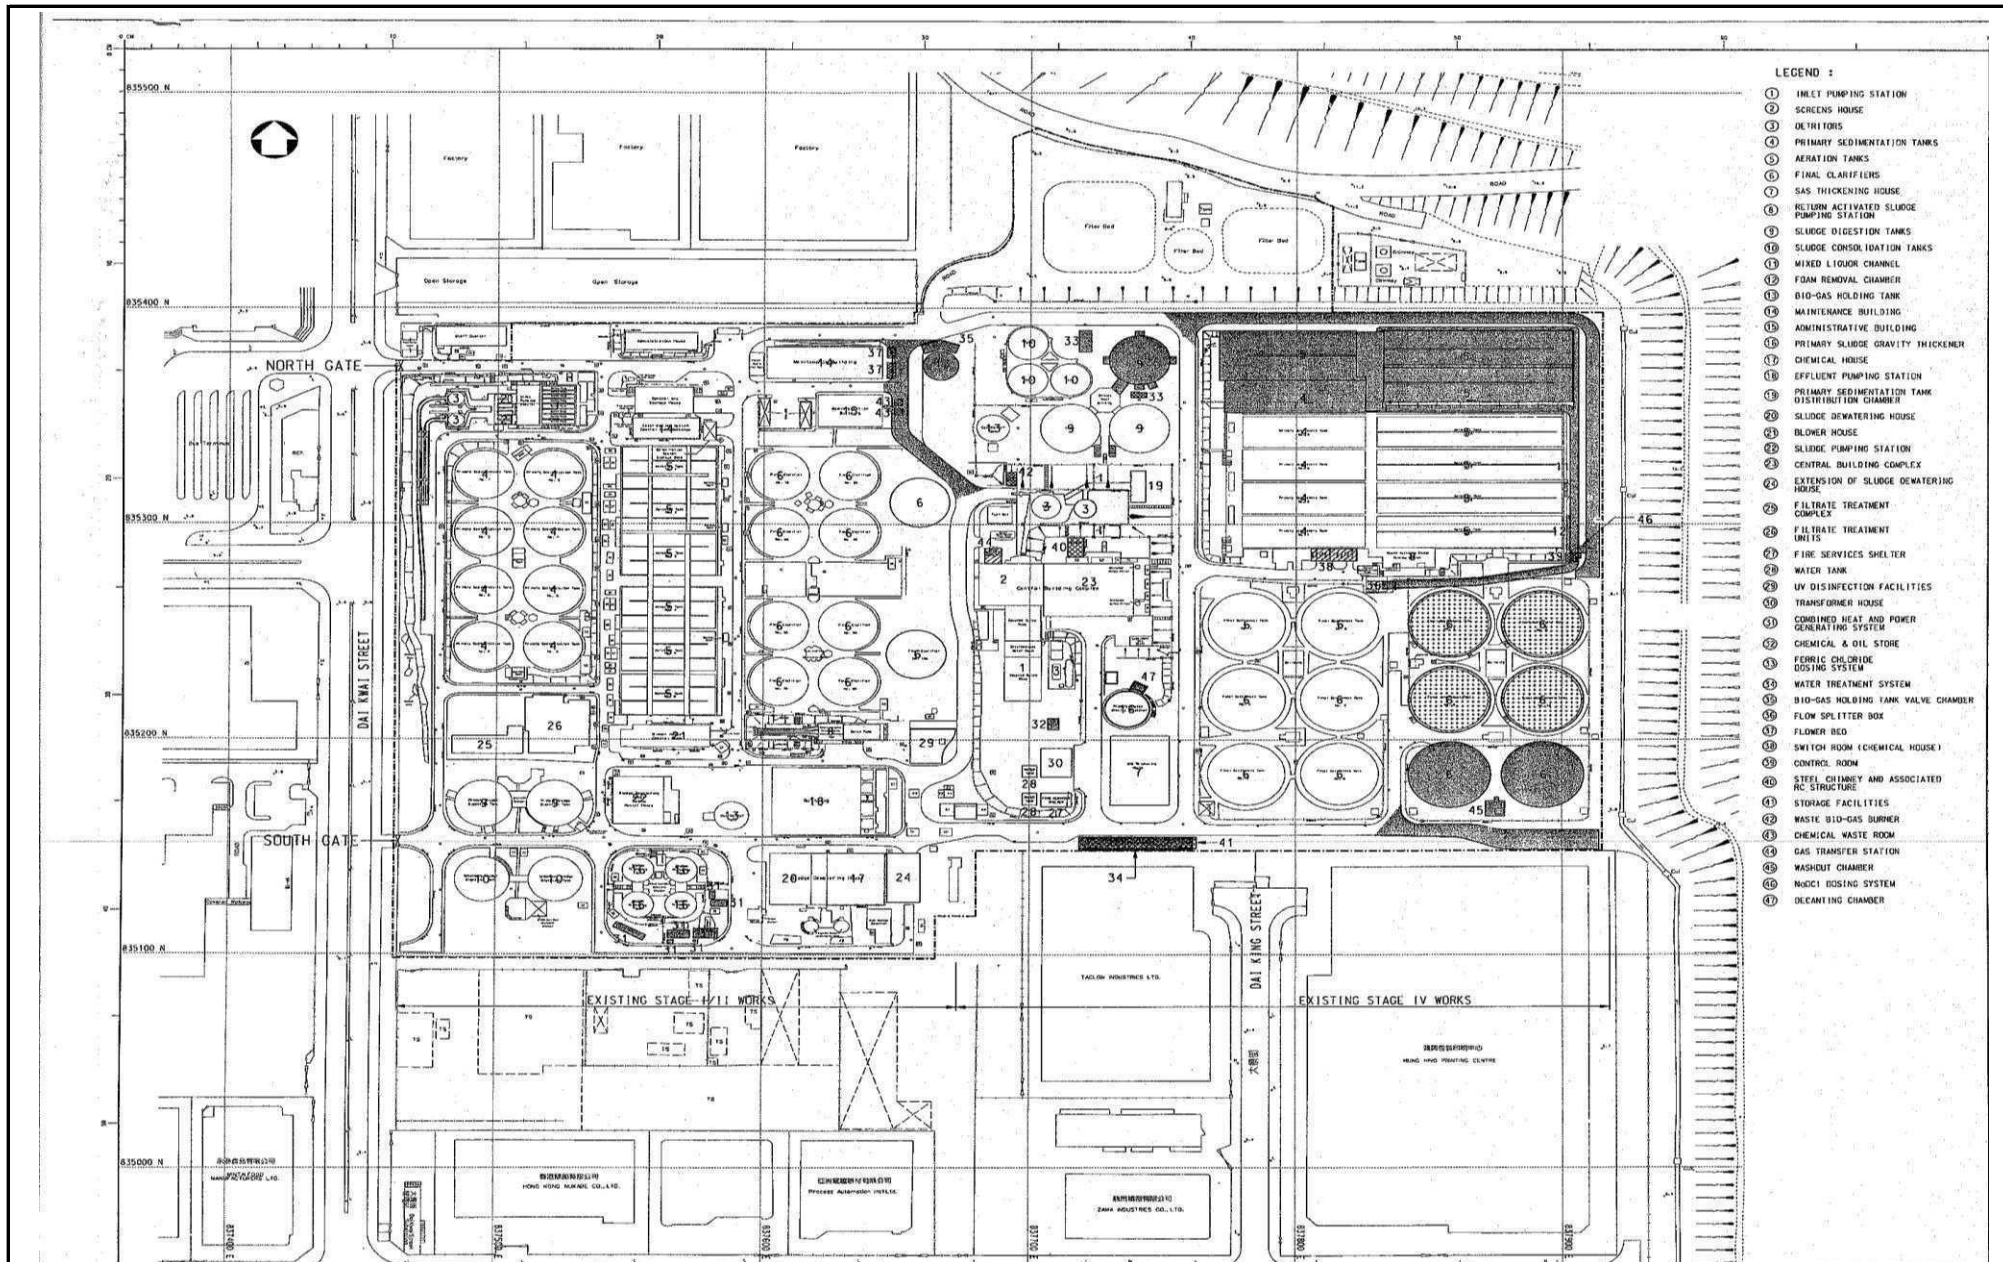
Scale	N.T.S	Project No.	MA0010	<b>CINOTECH</b>
Date	Jul-10	Figure	1.1

**PROJECT SITE LAYOUT PLAN (TPSTW)**

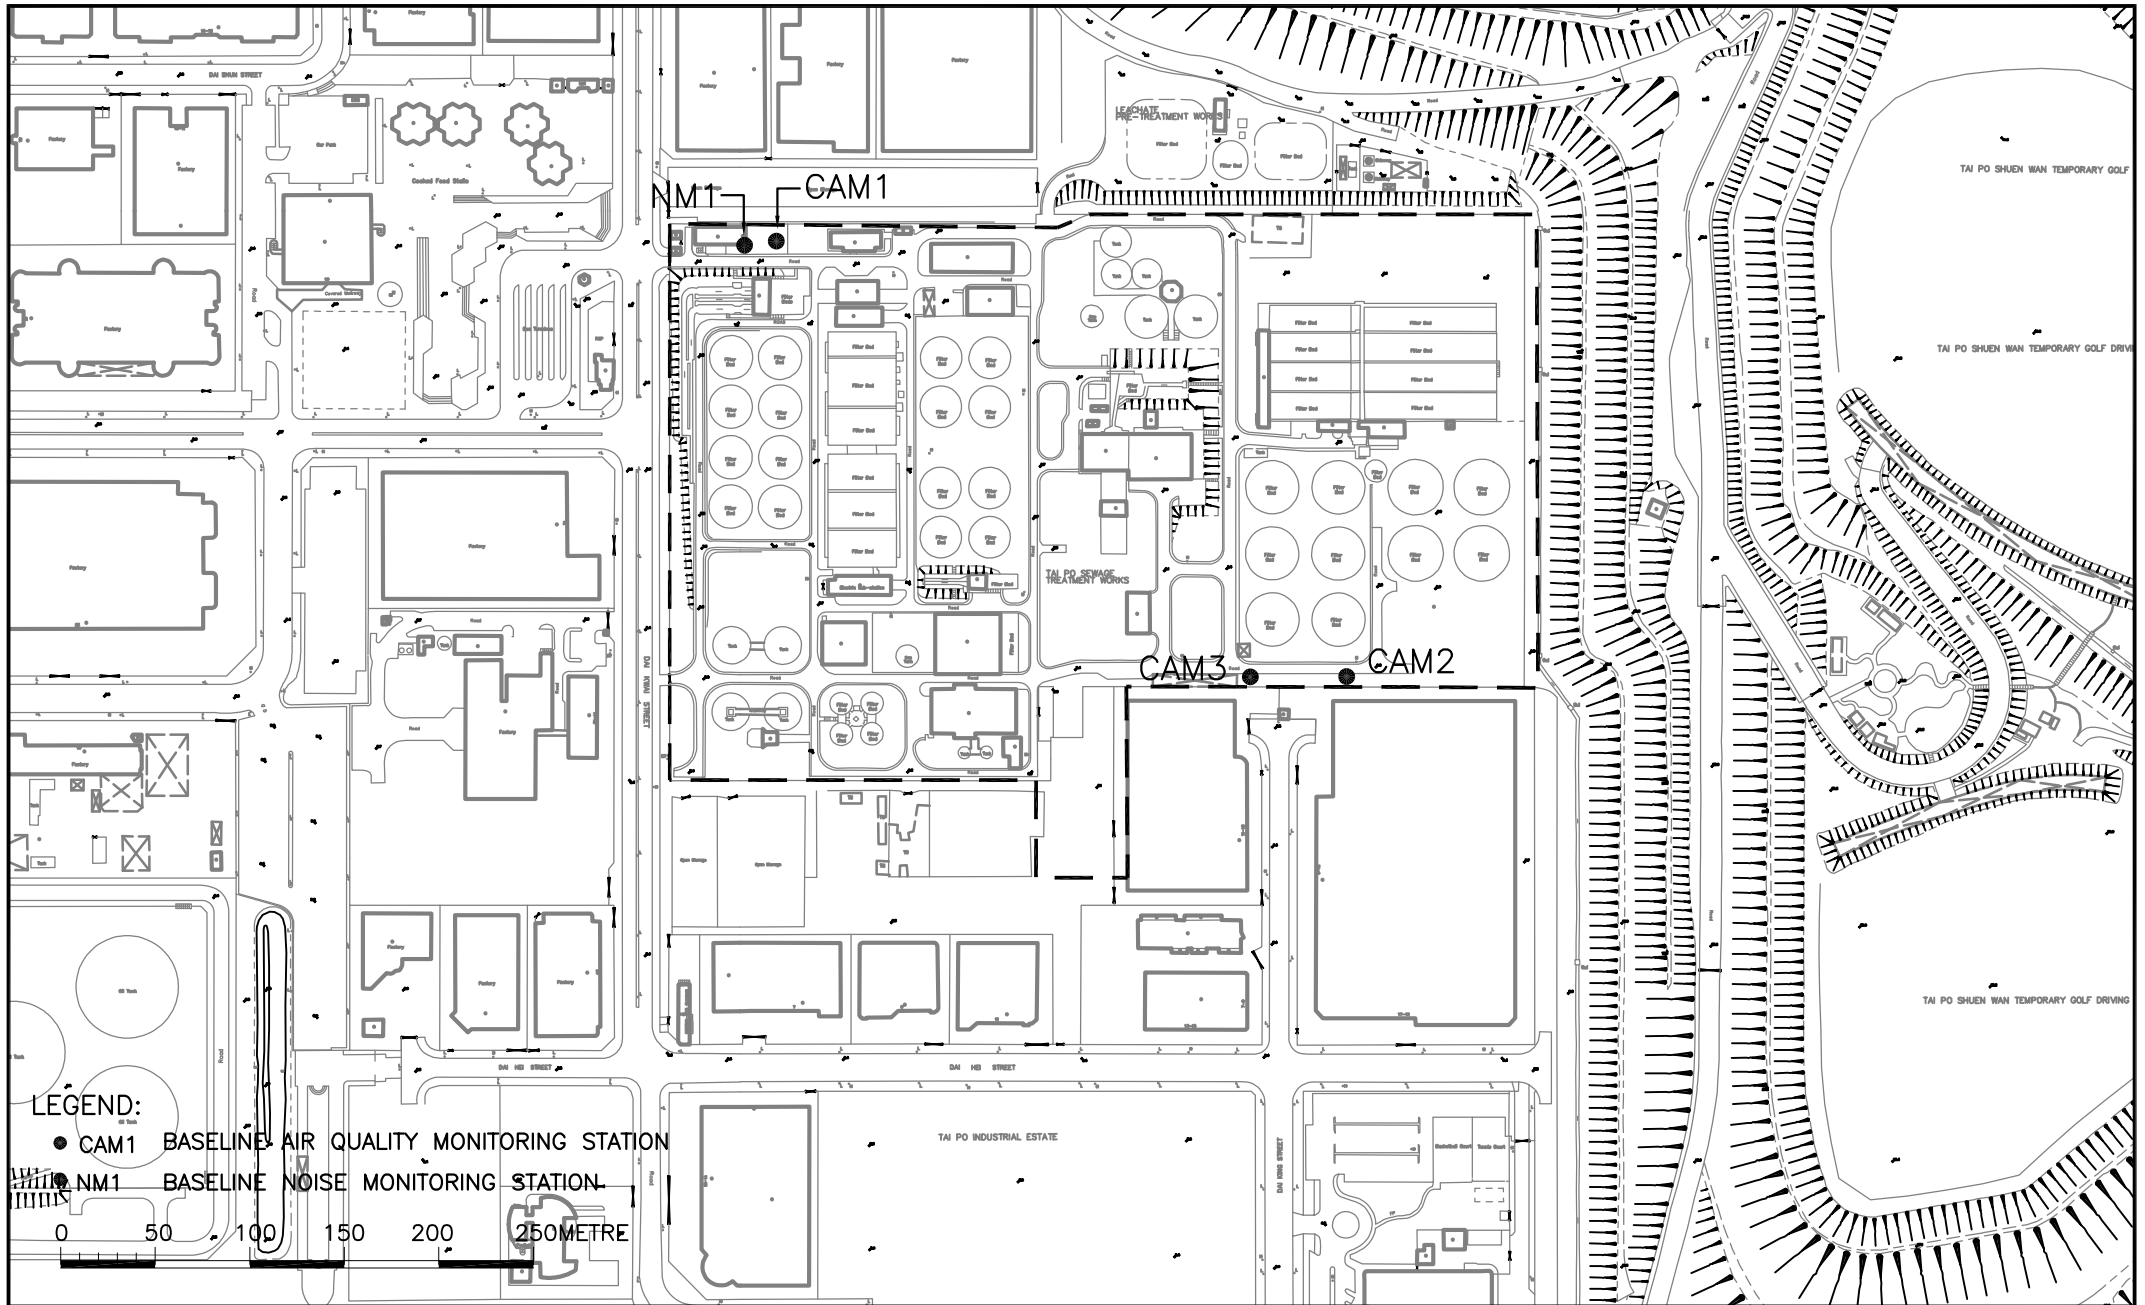
SCALE	A4 1:4000	DATE	2010	
CHECK	IT	DRAWN	SL	
JOB No.	MA0010	DRAWING No.	1.2	REV
				—

Tai Po Sewage Treatment Work, Stage V, Phase IIB  
**LOCATIONS OF AIR QUALITY AND NOISE MONITORING STATIONS**

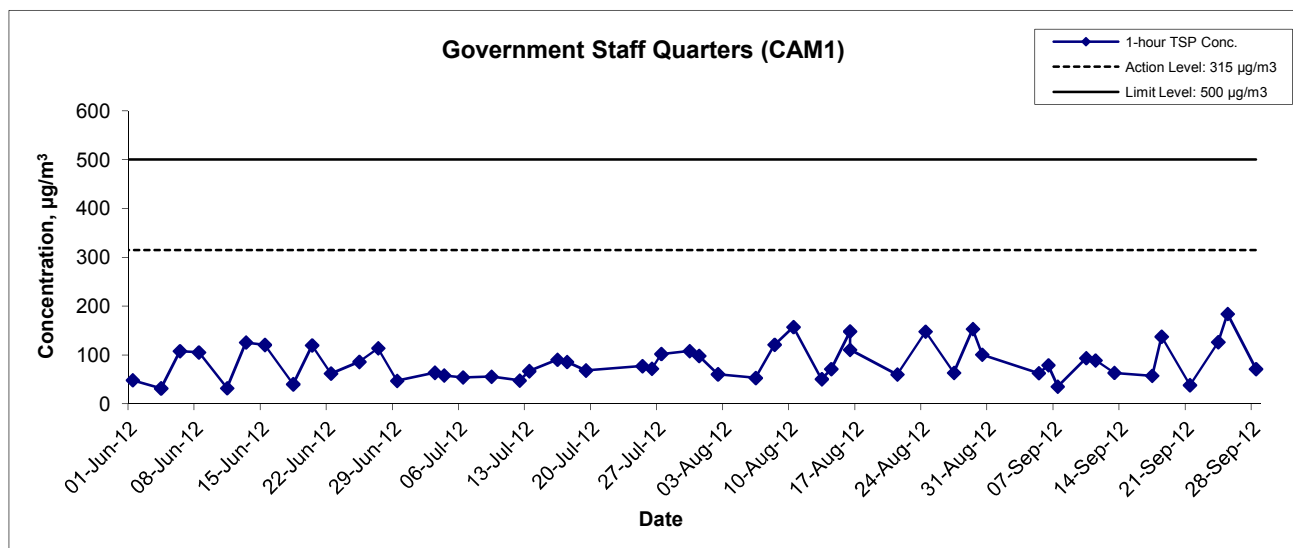
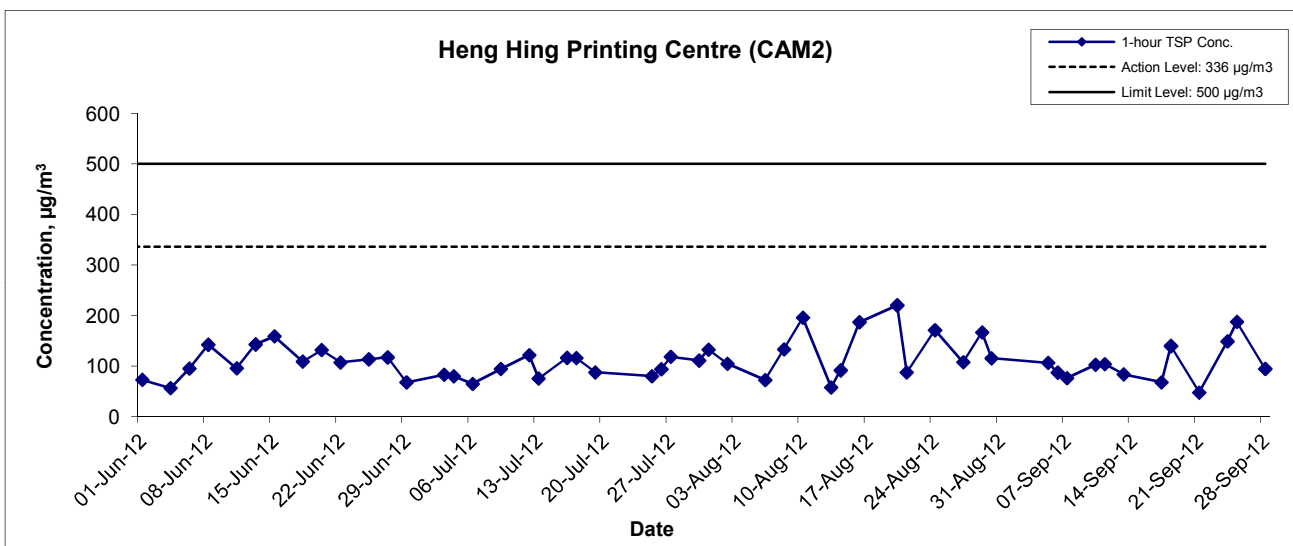
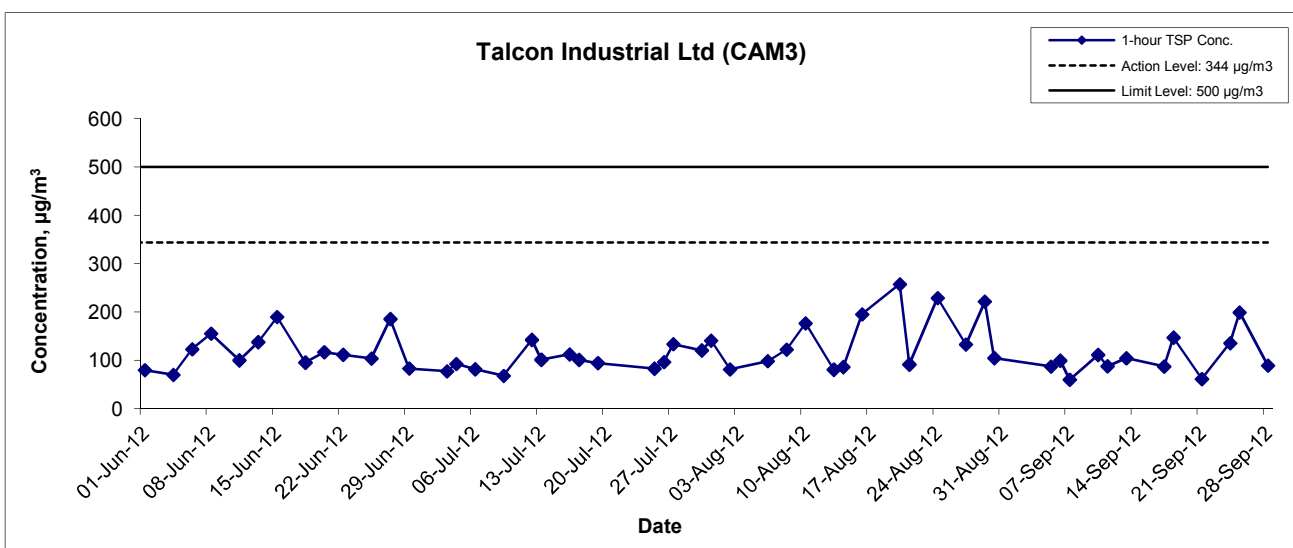
### 1-hr TSP Concentration Levels

Title  
 Contract No. DC/2009/09  
 Construction of Tai Po Sewage Treatment Works - Stage V Phase II B  
 Graphical Presentation of 1-hour TSP Impact Monitoring Results

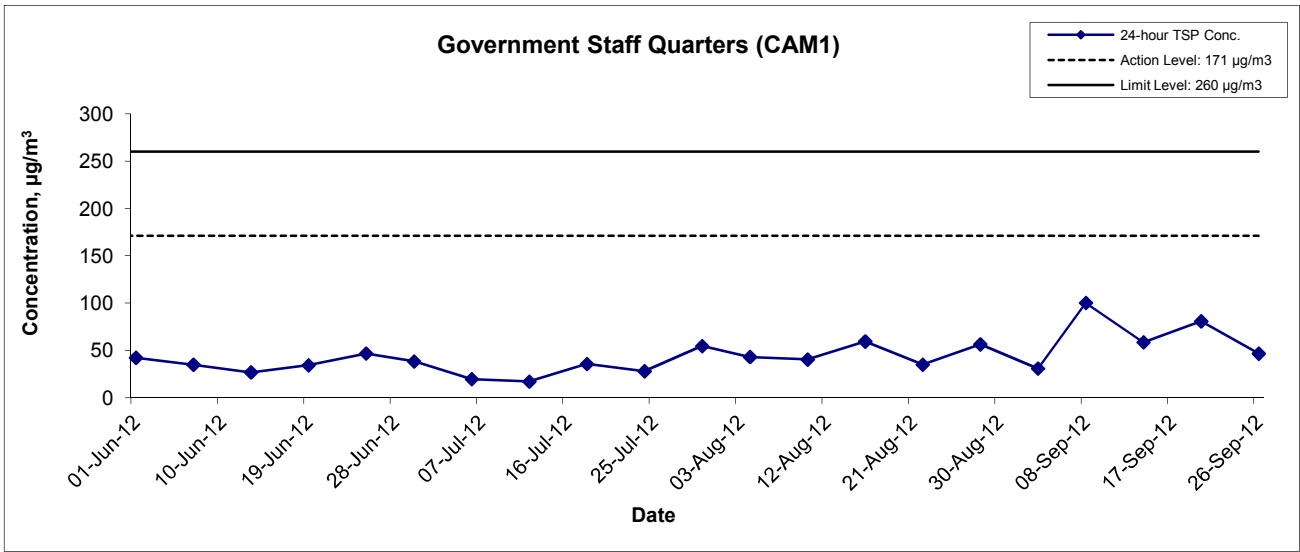
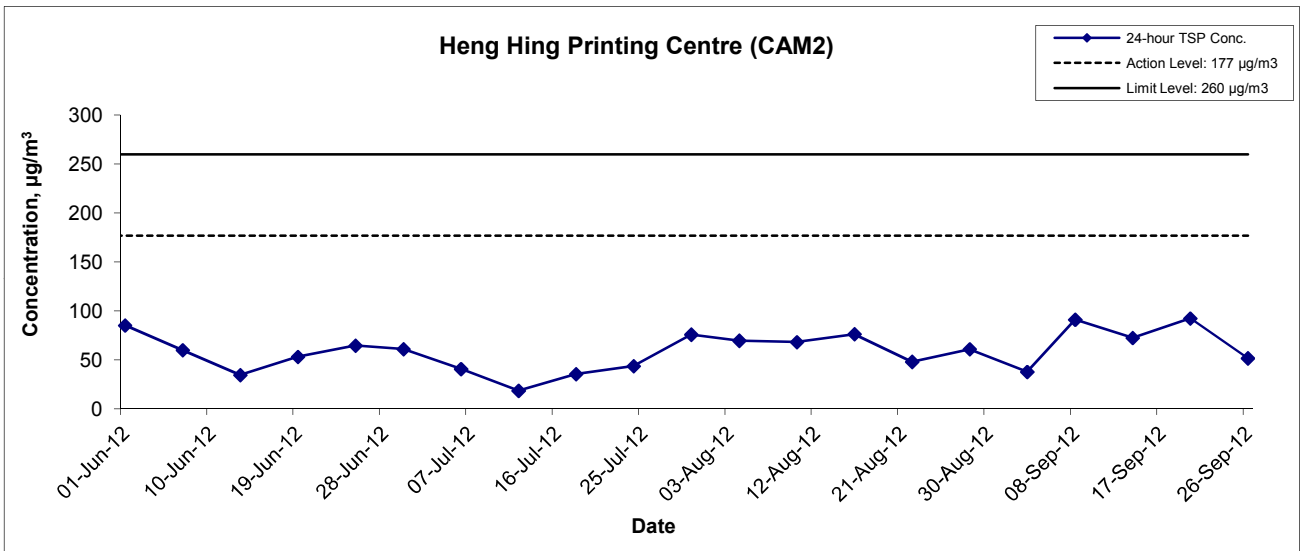
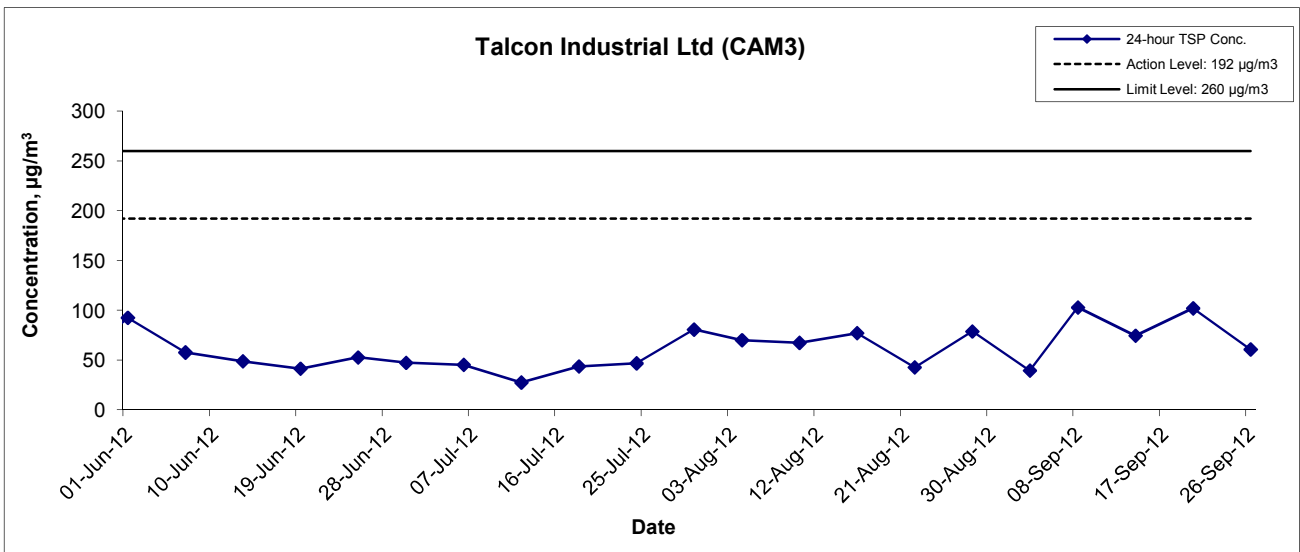
### 24-hr TSP Concentration Levels

Title Contract No. DC/2009/09 Construction of Tai Po Sewage Treatment Works - Stage V Phase II B Graphical Presentation of 24-hour TSP Impact Monitoring Results	Scale	Project No.		
		N.T.S		MA0010
	Date	Sep 12		Appendix E

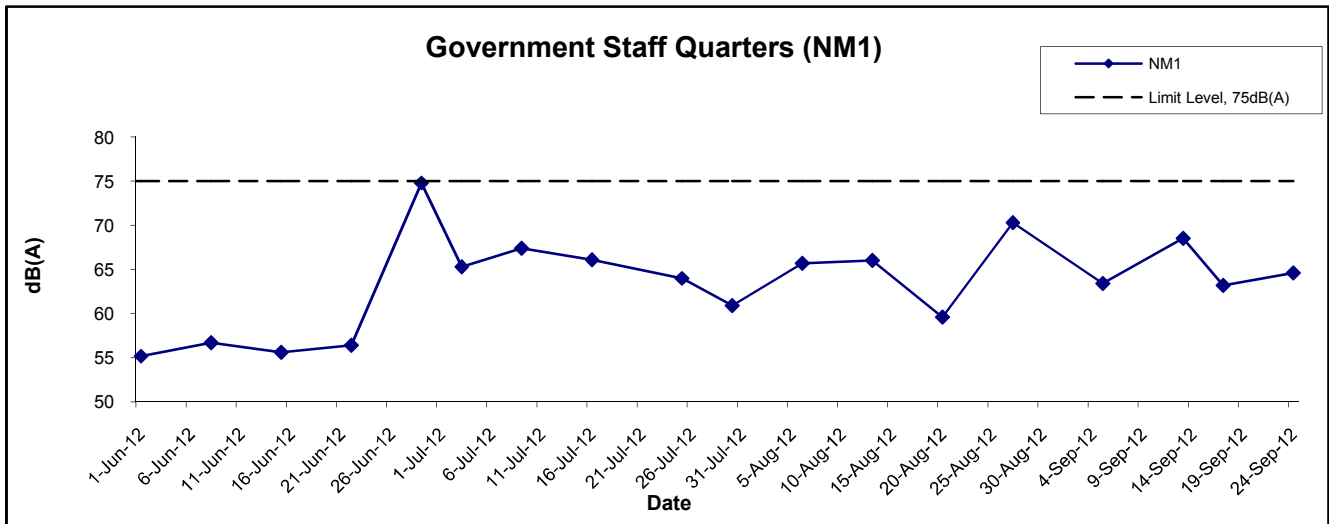
## Noise Levels

Title Contract No. DC/2009/09 Construction of Tai Po Sewage Treatment Works - Stage V Phase II B  Graphical Presentation of Construction Noise Monitoring Results	Scale N.T.S	Project No. MA0010	
	Date Sep 12	Appendix F

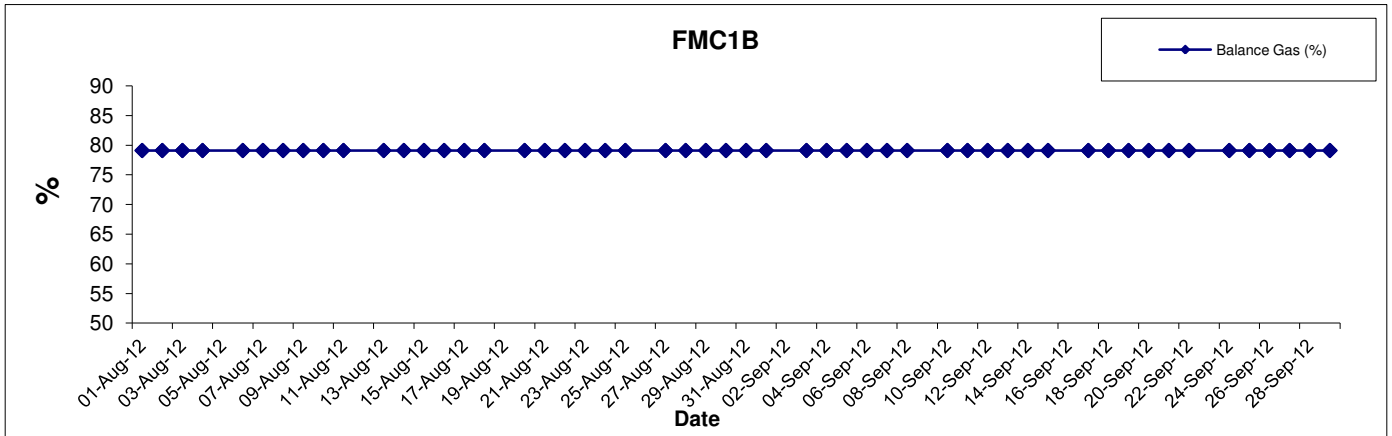
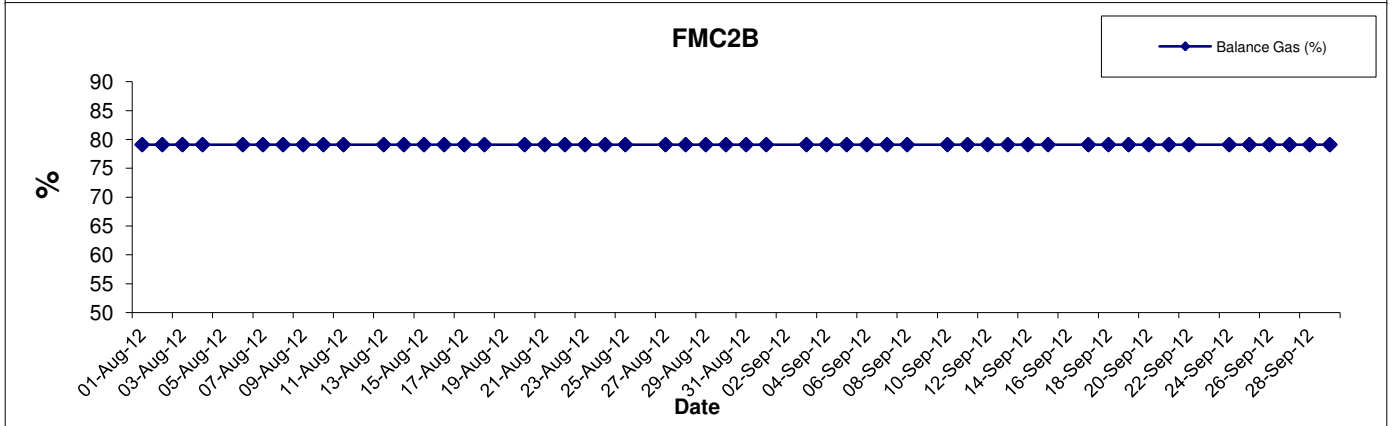
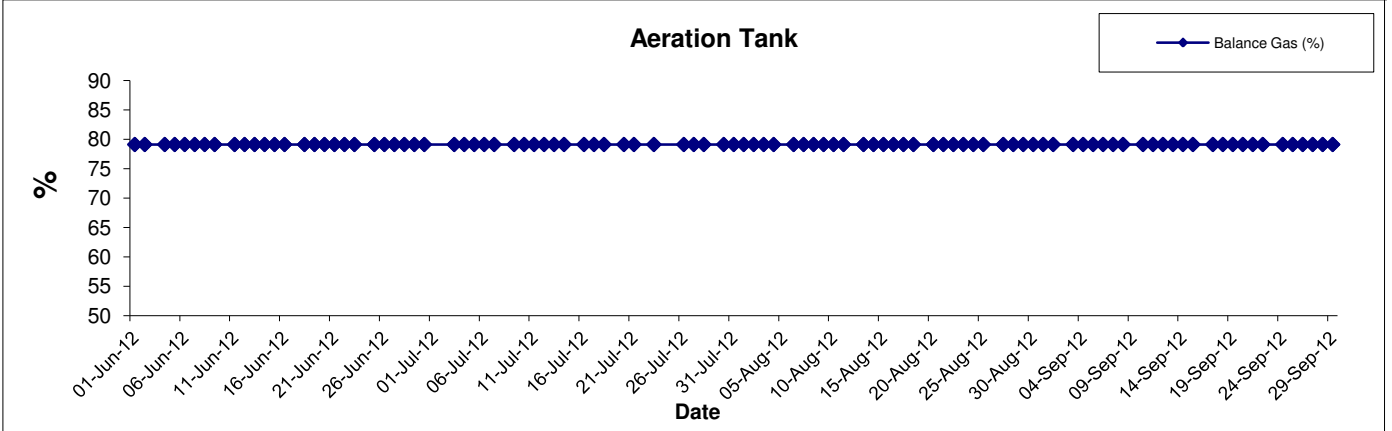
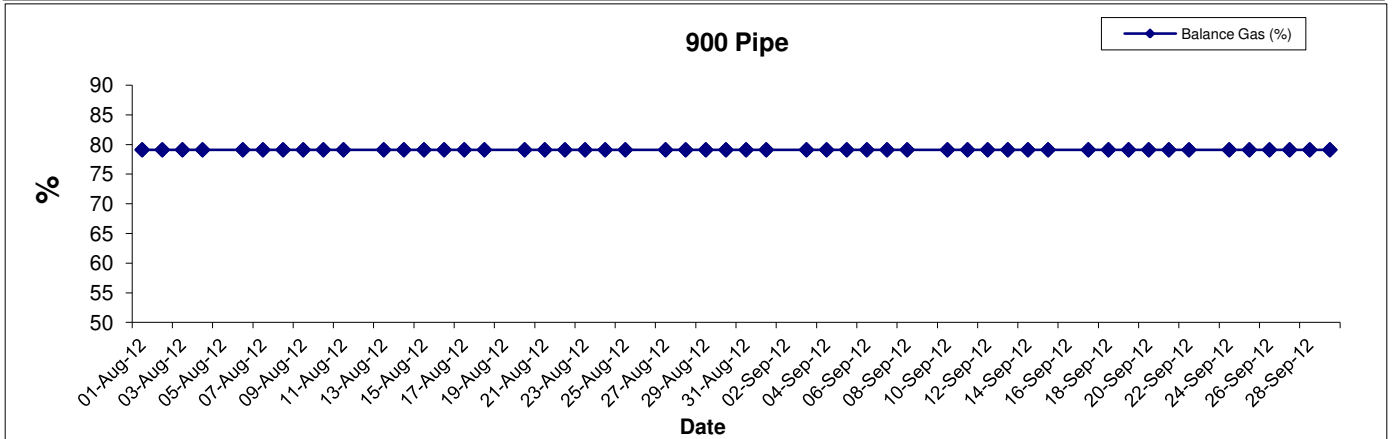
Title  
 Contract No. DC/2009/09  
 Construction of Tai Po Sewage Treatment Works - Stage V Phase II B  
 Graphical Presentation of Landfill Gas Measurement

### Balance Gas

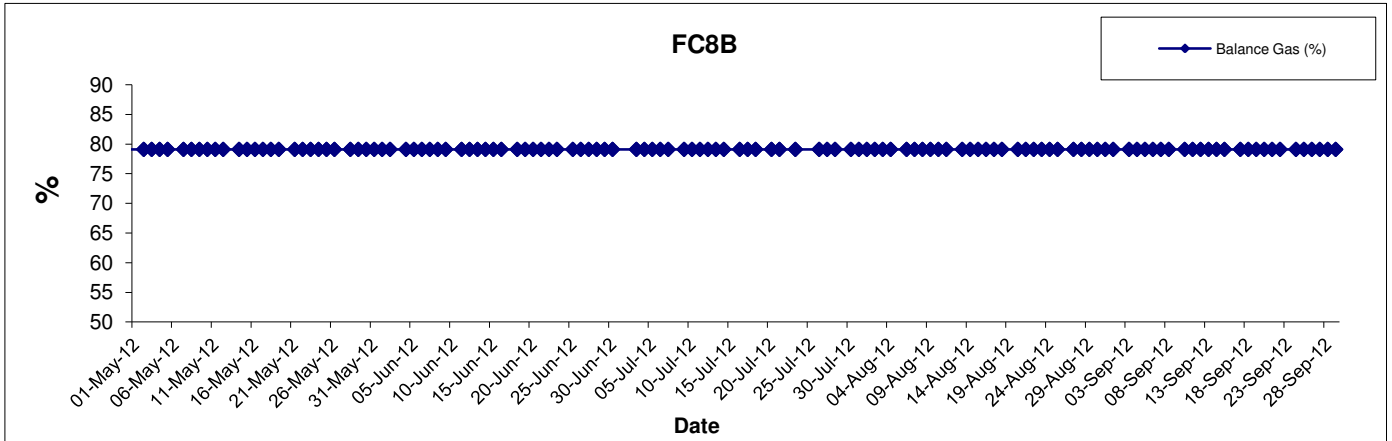
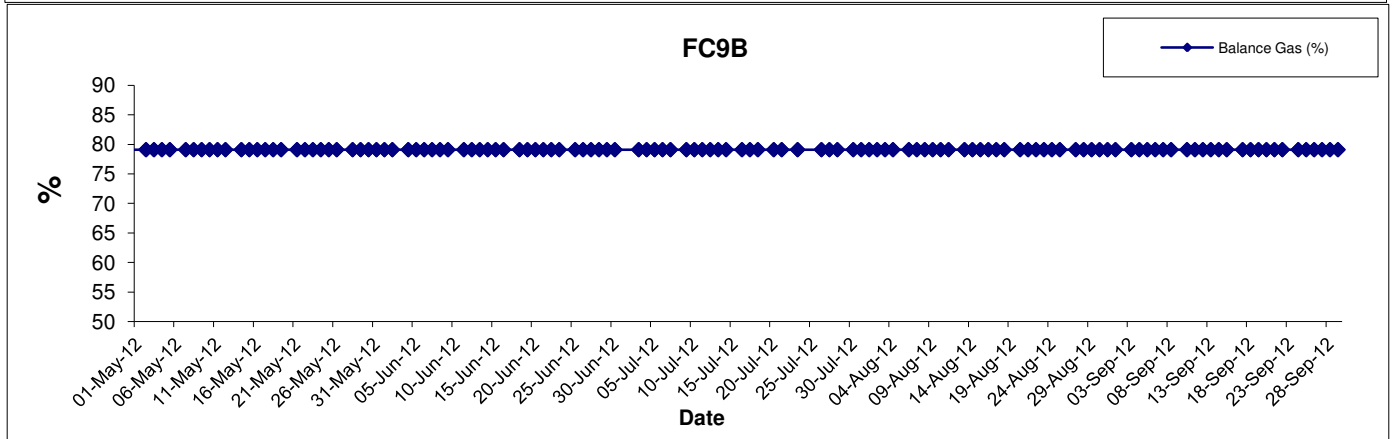
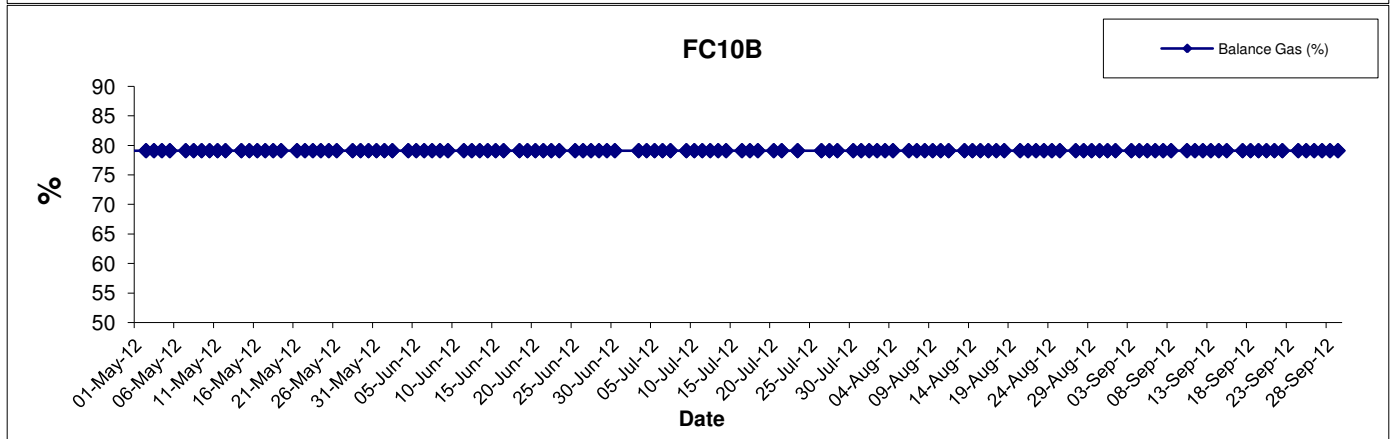
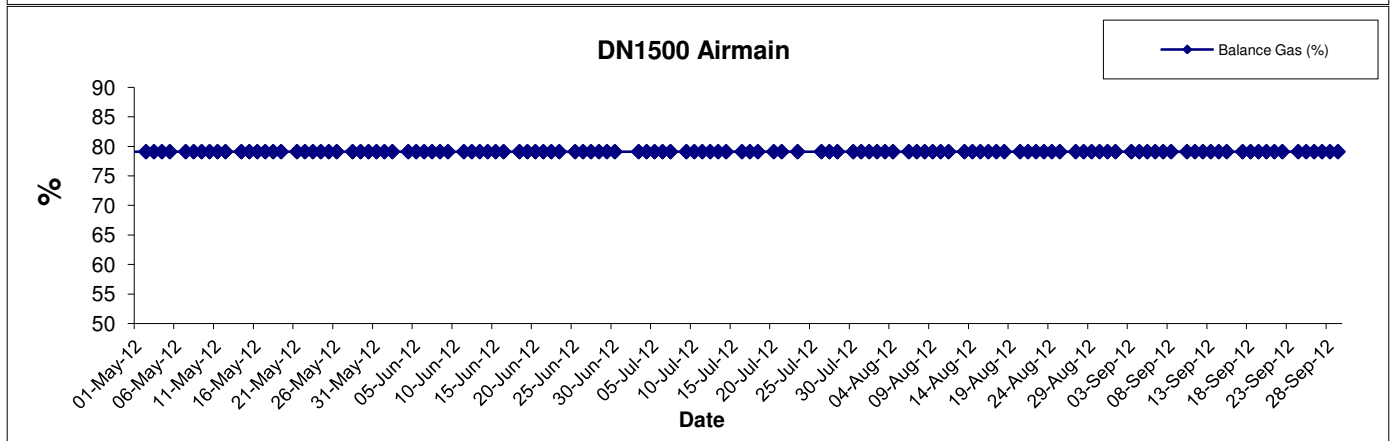
Title Contract No. DC/2009/09 Construction of Tai Po Sewage Treatment Works - Stage V Phase II B  Graphical Presentation of Landfill Gas Measurement	Scale N.T.S	Project No. MA0010	
	Date Sep 12	Appendix G

### Balance Gas

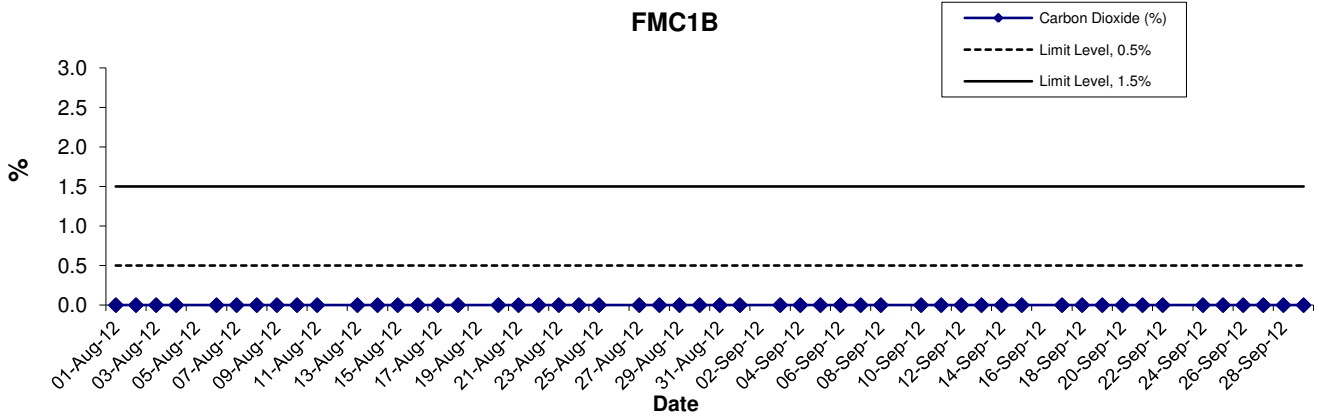
#### FMC1B

### Carbon Dioxide

Title Contract No. DC/2009/09 Construction of Tai Po Sewage Treatment Works - Stage V Phase II B  Graphical Presentation of Landfill Gas Measurement	Scale N.T.S	Project No. MA0010	CINOTECH
	Date Sep 12	Appendix G

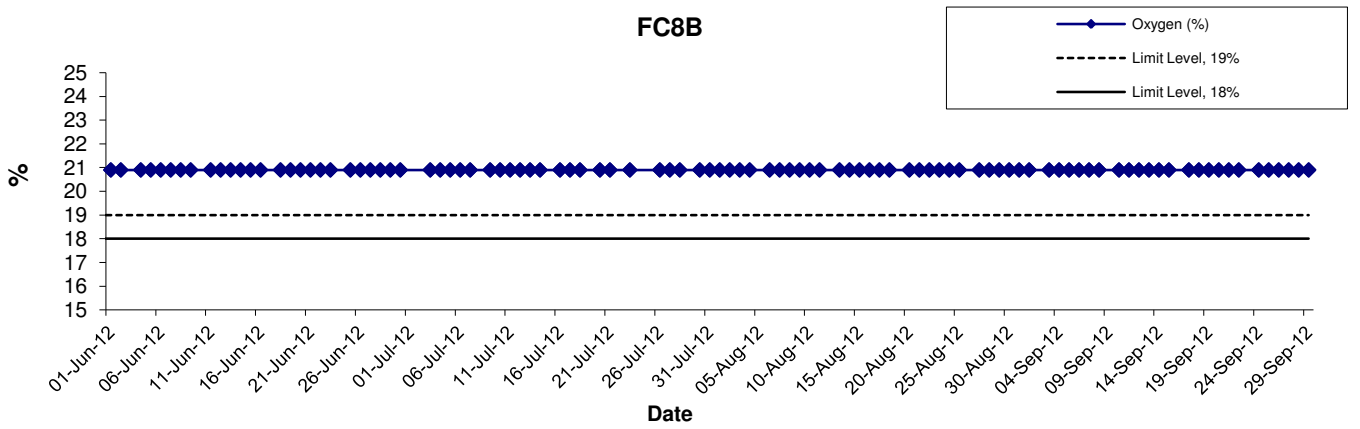
#### FC8B

### Oxygen

Title Contract No. DC/2009/09 Construction of Tai Po Sewage Treatment Works - Stage V Phase II B  Graphical Presentation of Landfill Gas Measurement	Scale N.T.S	Project No. MA0010	
	Date Sep 12	Appendix G
