Contract No. DC/2009/09
Construction of Tai Po Sewage Treatment
Works – Stage V Phase II B

Monthly Environmental Monitoring and Audit Report for November 2012

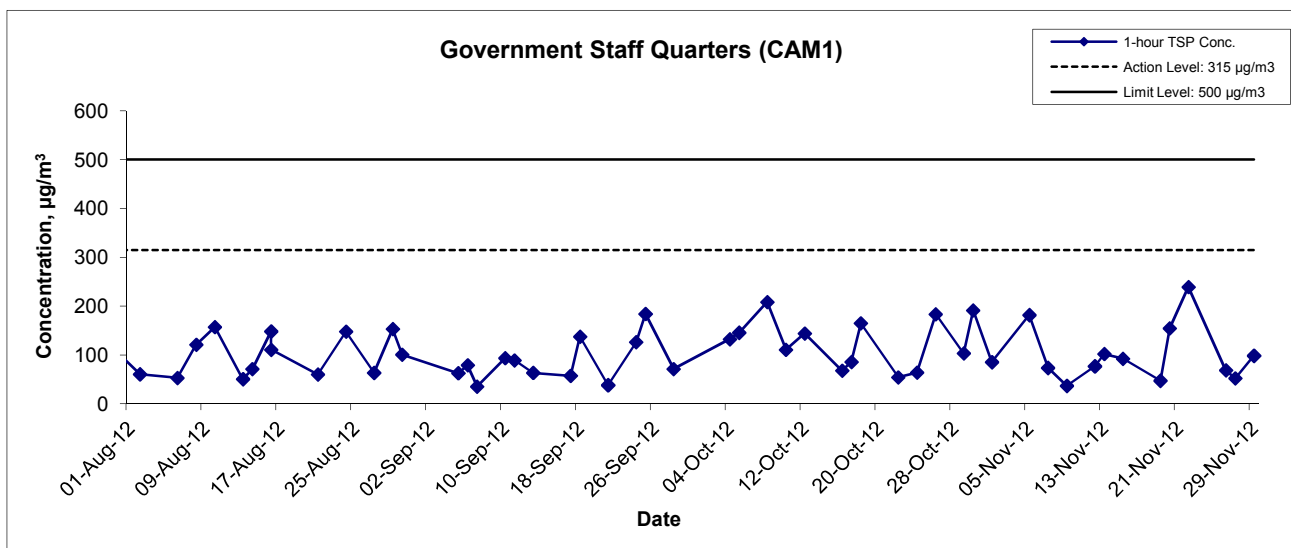
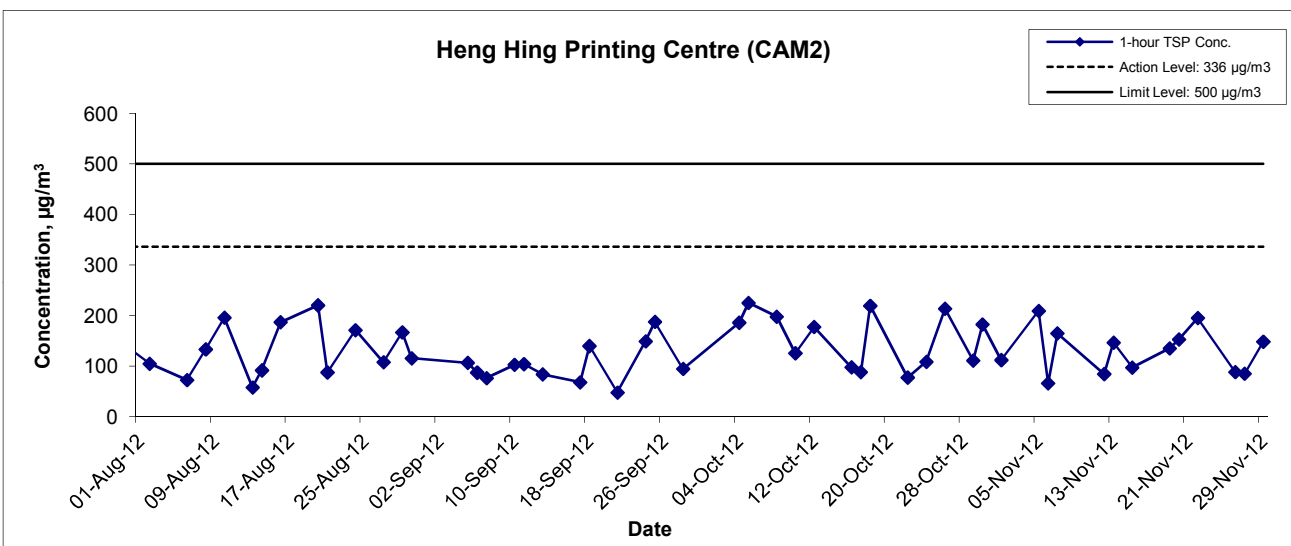
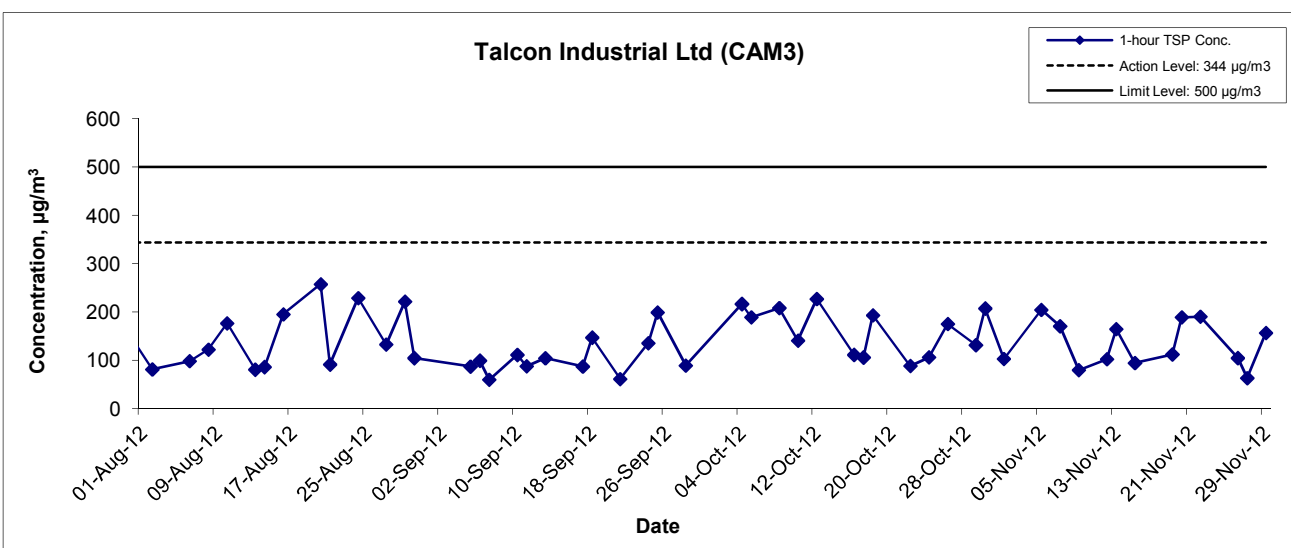
1-hr TSP Concentration Levels

Title
 Contract No. DC/2009/09
 Construction of Tai Po Sewage Treatment Works - Stage V Phase II B
 Graphical Presentation of 1-hour TSP Impact Monitoring Results

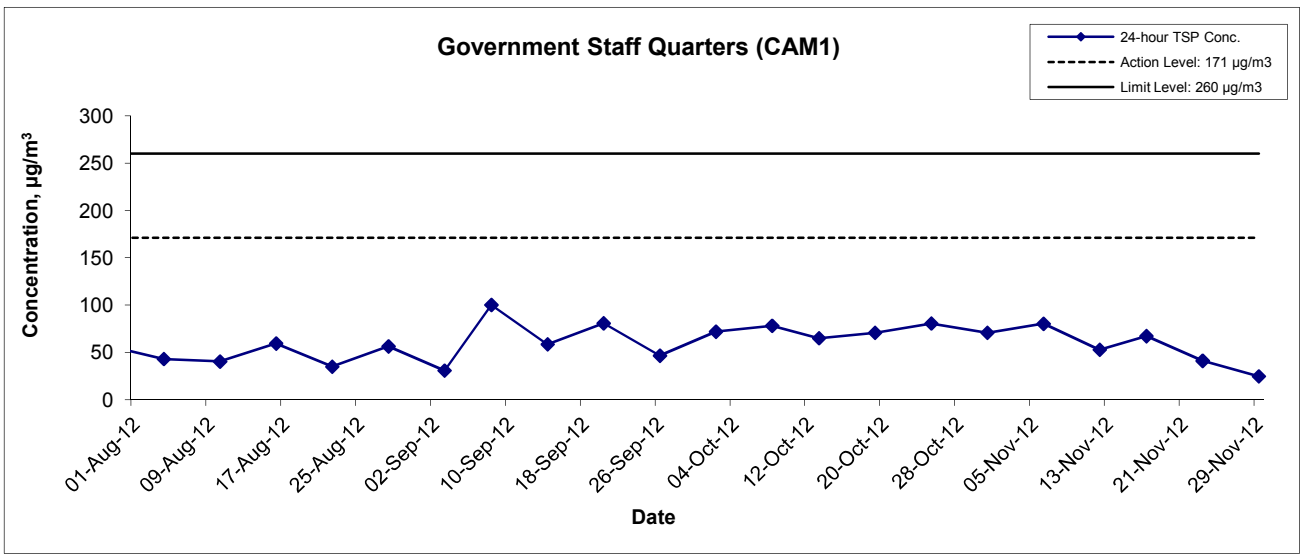
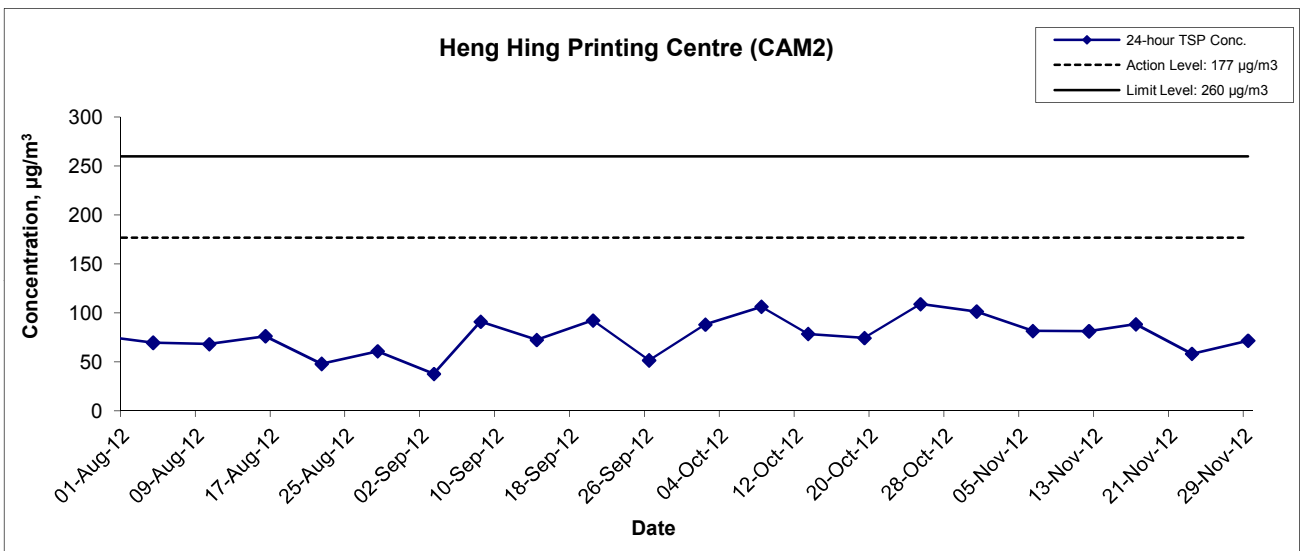
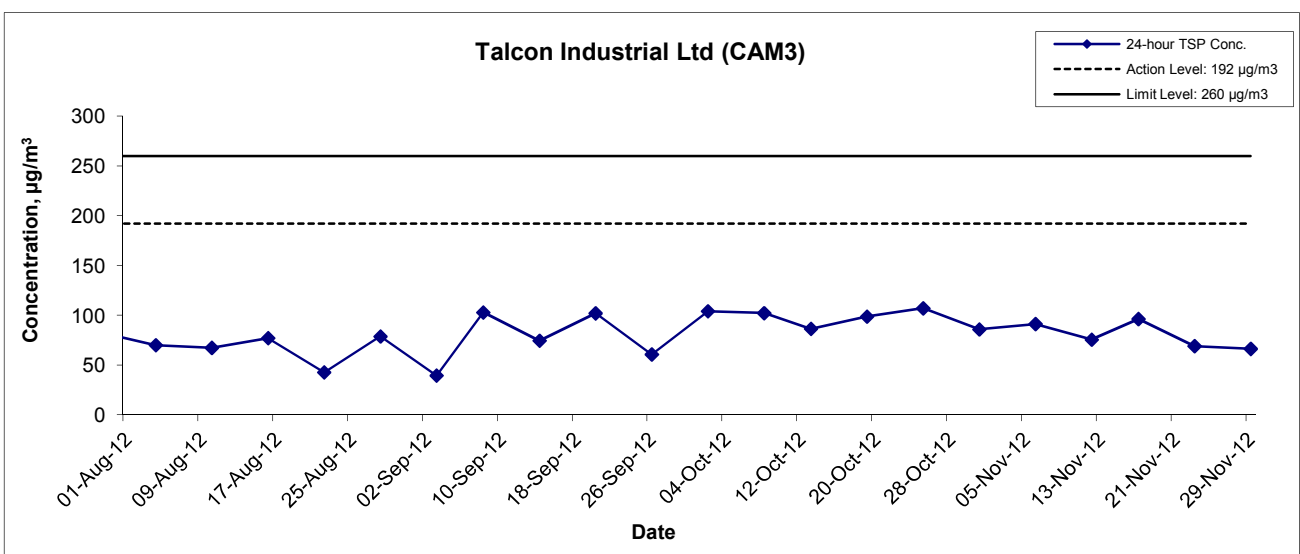
24-hr TSP Concentration Levels

Title Contract No. DC/2009/09 Construction of Tai Po Sewage Treatment Works - Stage V Phase II B Graphical Presentation of 24-hour TSP Impact Monitoring Results	Scale N.T.S	Project No. MA0010	
	Date Nov 12	Appendix E

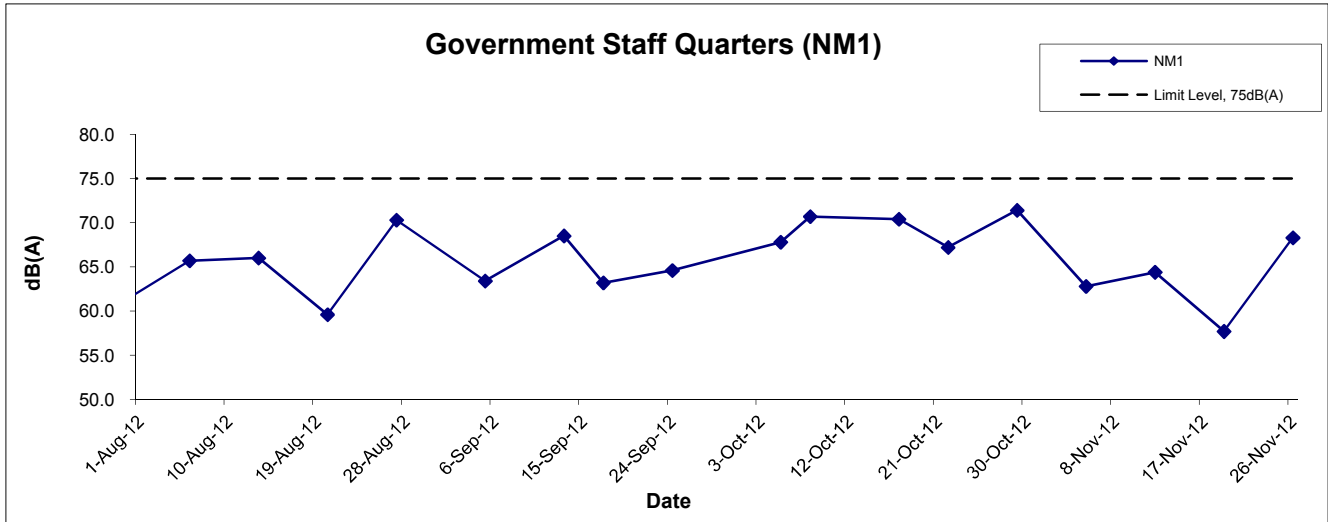
Noise Levels

Title Contract No. DC/2009/09 Construction of Tai Po Sewage Treatment Works - Stage V Phase II B Graphical Presentation of Construction Noise Monitoring Results	Scale N.T.S	Project No. MA0010	
	Date Nov 12	Appendix F
