China Harbour Engineering Company Limited

Contract No. DC/2009/09
Construction of Tai Po Sewage Treatment
Works – Stage V Phase II B

Monthly Environmental Monitoring and Audit Report for December 2012

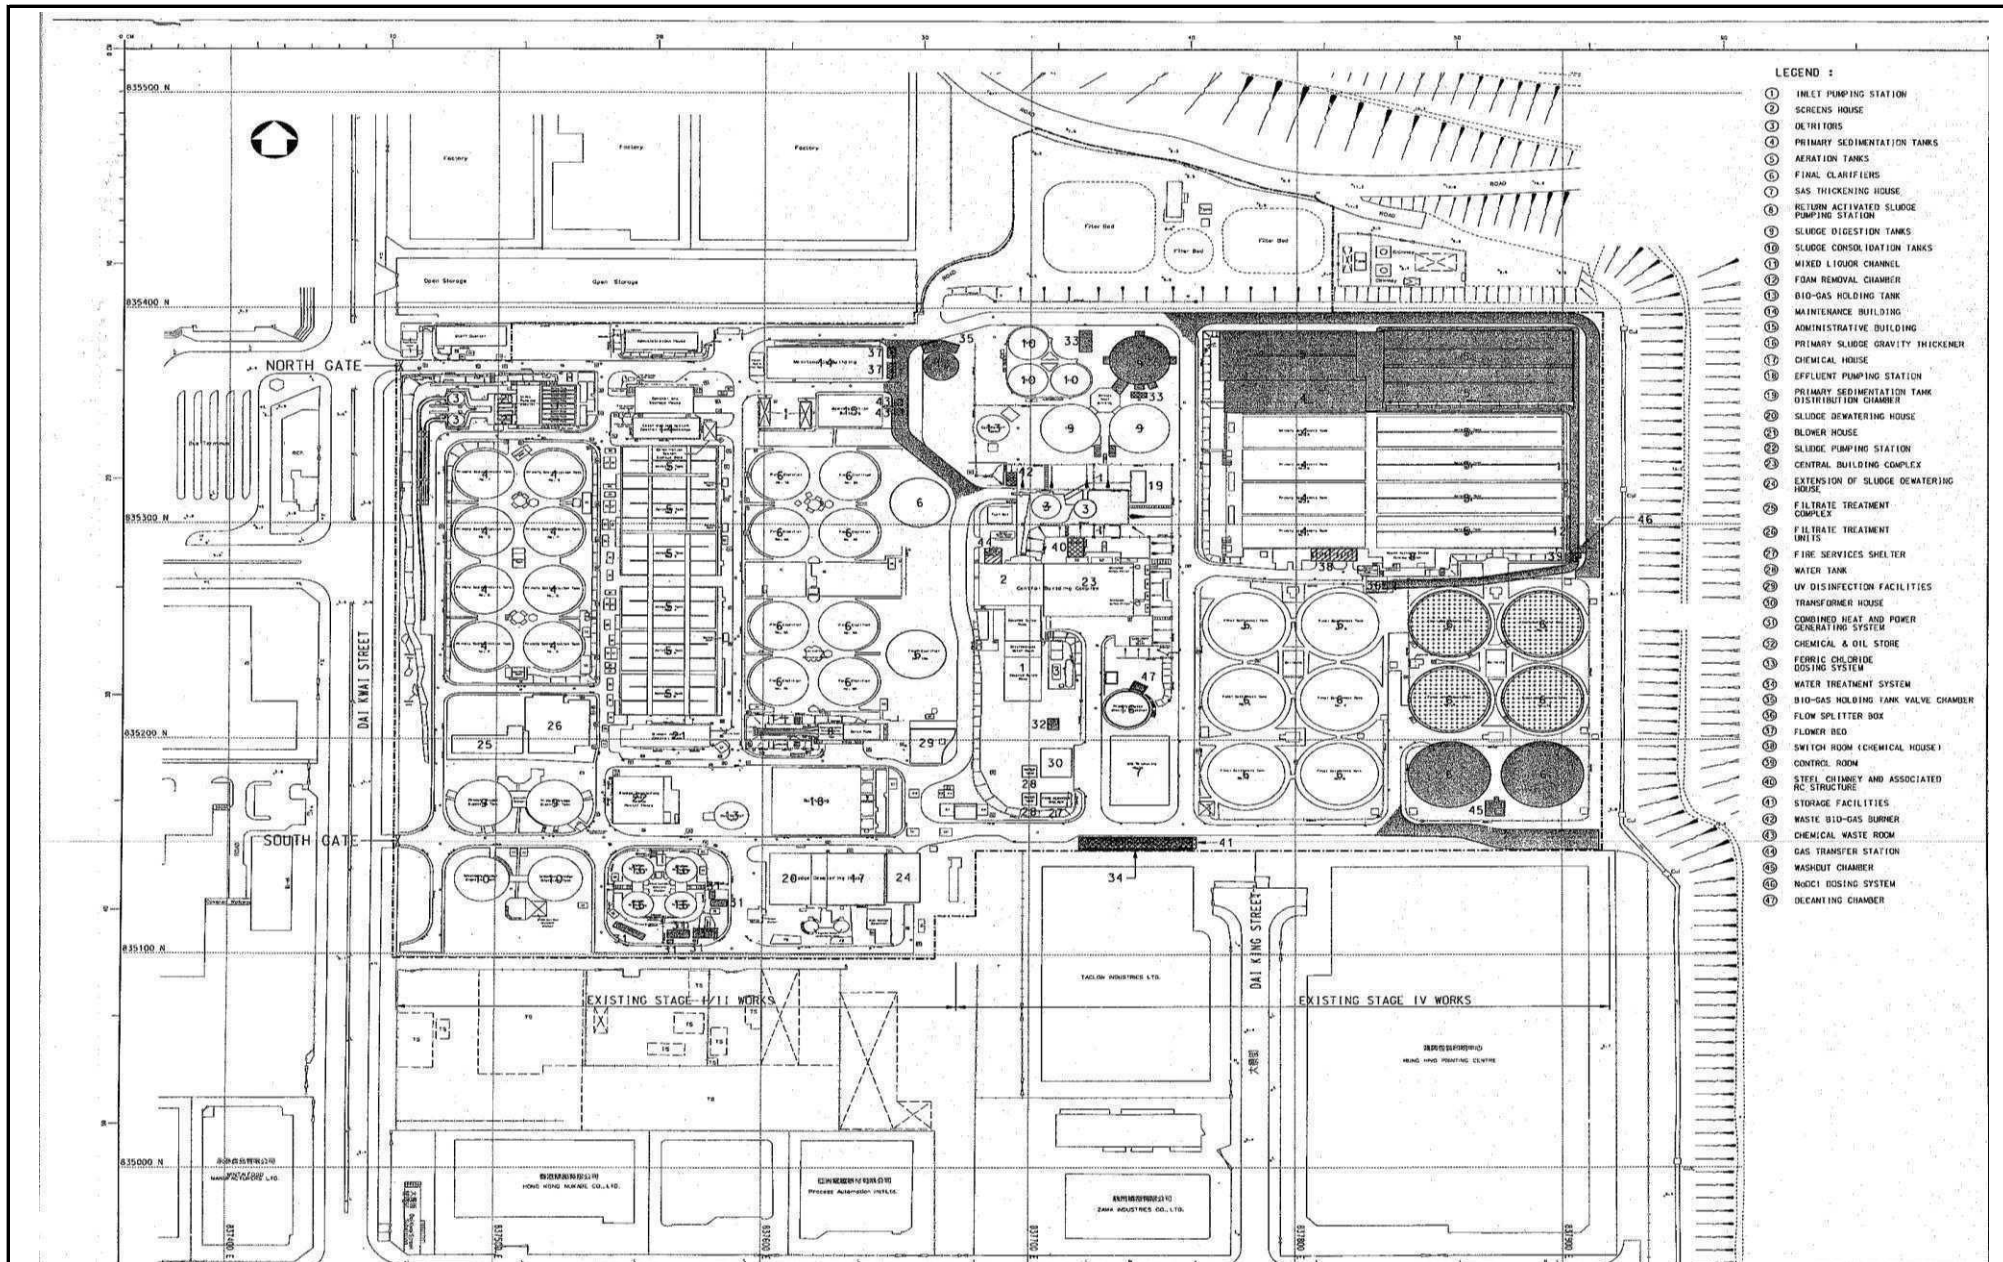
1.1

- LEGEND :**
- ① TRLET PUMPING STATION
 - ② SCREENS HOUSE
 - ③ ULTRAFILTS
 - ④ PRIMARY SEDIMENTATION TANKS
 - ⑤ AERATION TANKS
 - ⑥ FINAL CLARIFIERS
 - ⑦ SAS THICKENING HOUSE

- ⑧ RETURN ACTIVATED SLUDGE PUMPING STATION
 - ⑨ SLUDGE DIGESTION TANKS
 - ⑩ SLUDGE CONSOLIDATION TANKS
 - ⑪ MIXED LIQUOR CHANNEL
 - ⑫ FOAM REMOVAL CHAMBER

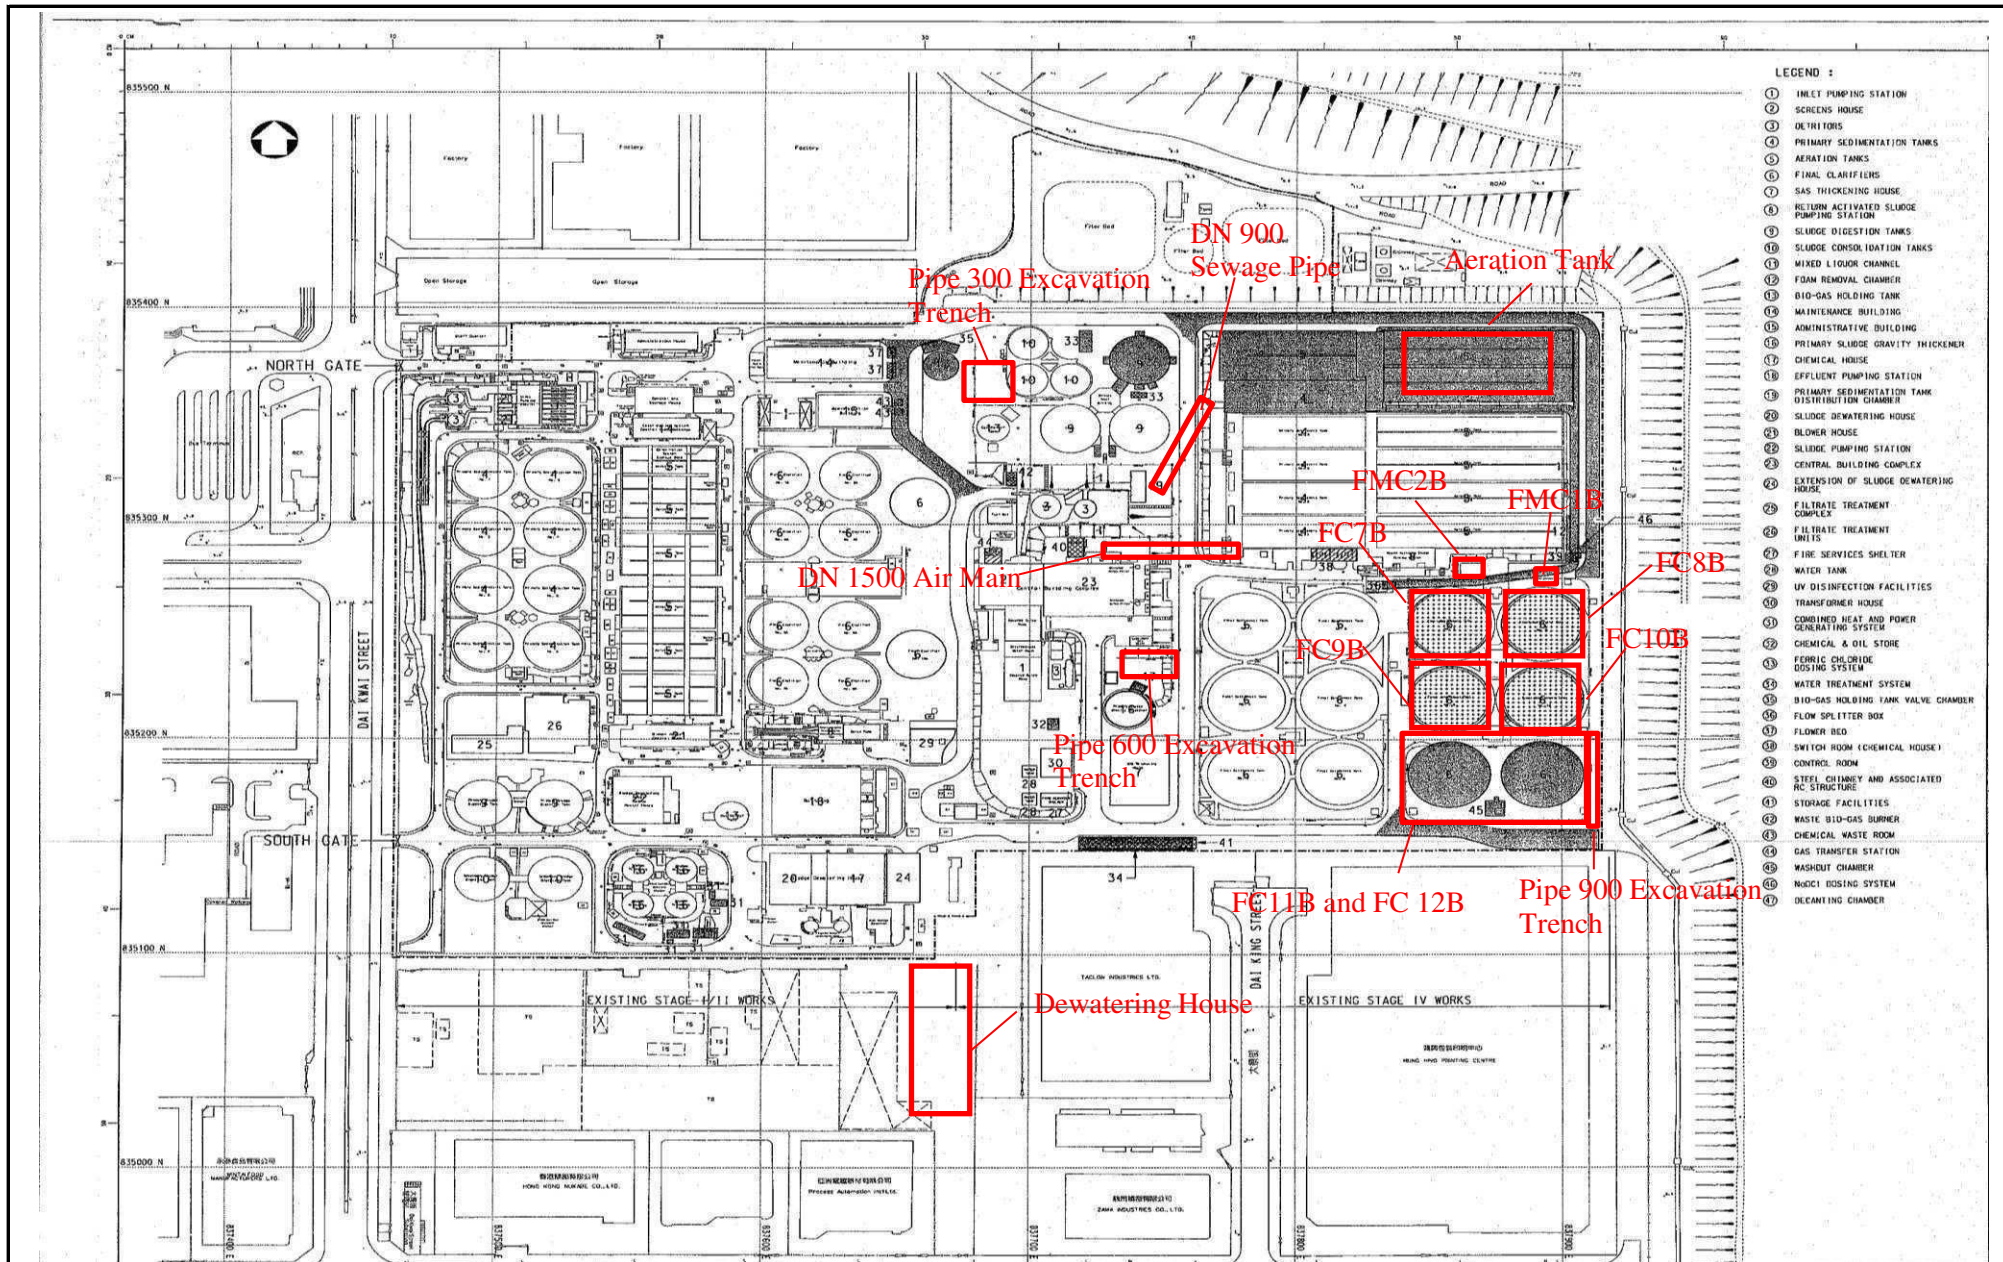
TAI PO SEWAGE TREATMENT WORKS, STAGE V, PHASE IIB

Landfill Gas Monitoring Area(TPSTW)

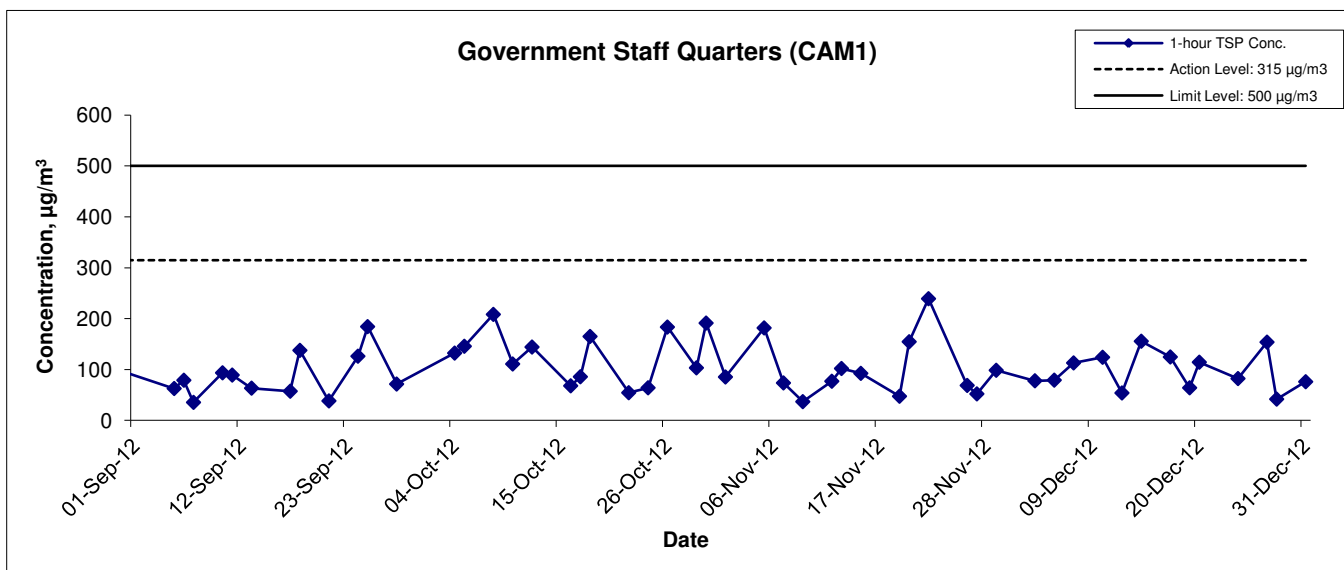
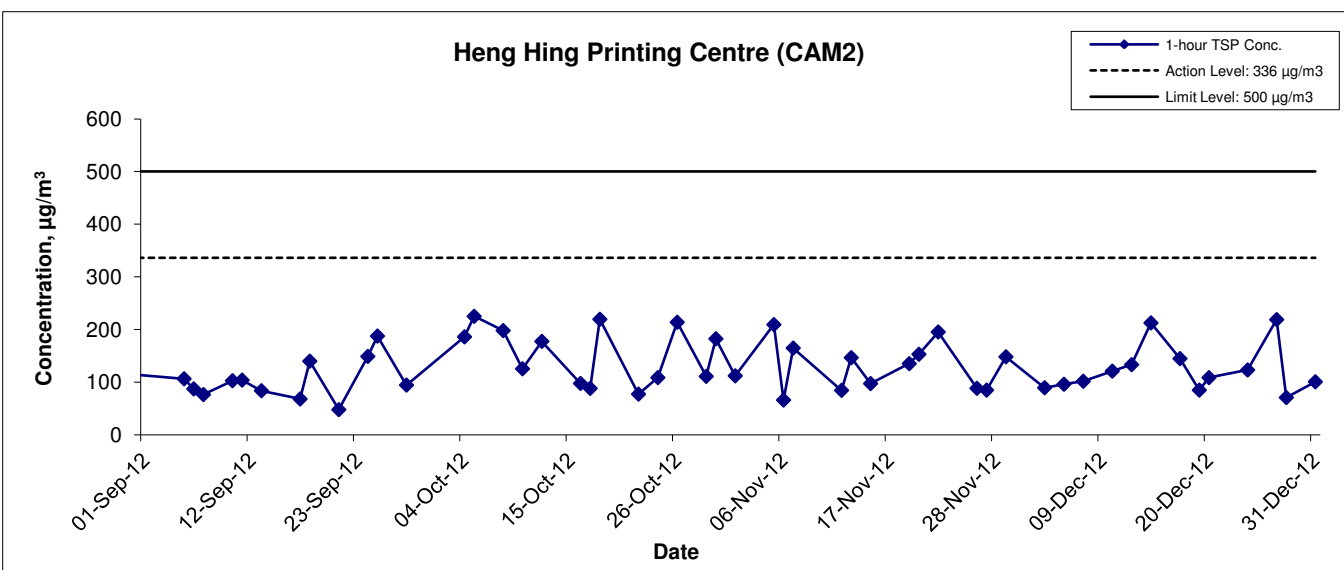
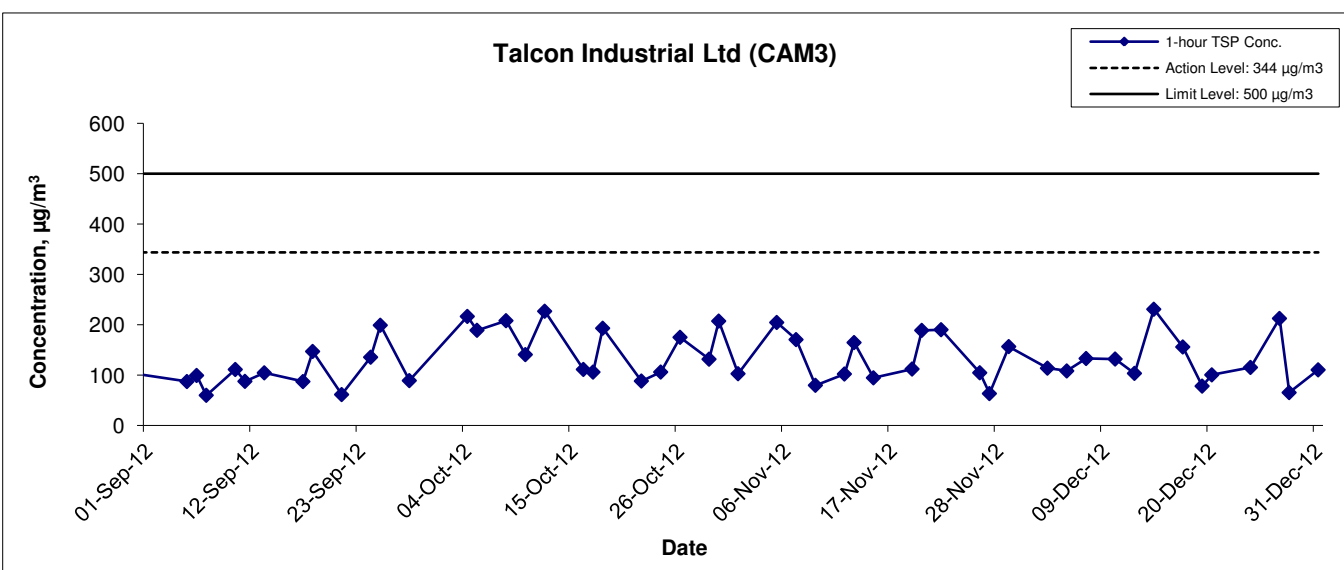
1-hr TSP Concentration Levels

Title Contract No. DC/2009/09 Construction of Tai Po Sewage Treatment Works - Stage V Phase II B Graphical Presentation of 1-hour TSP Impact Monitoring Results	Scale N.T.S	Project No. MA0010	
	Date Dec 12	Appendix D

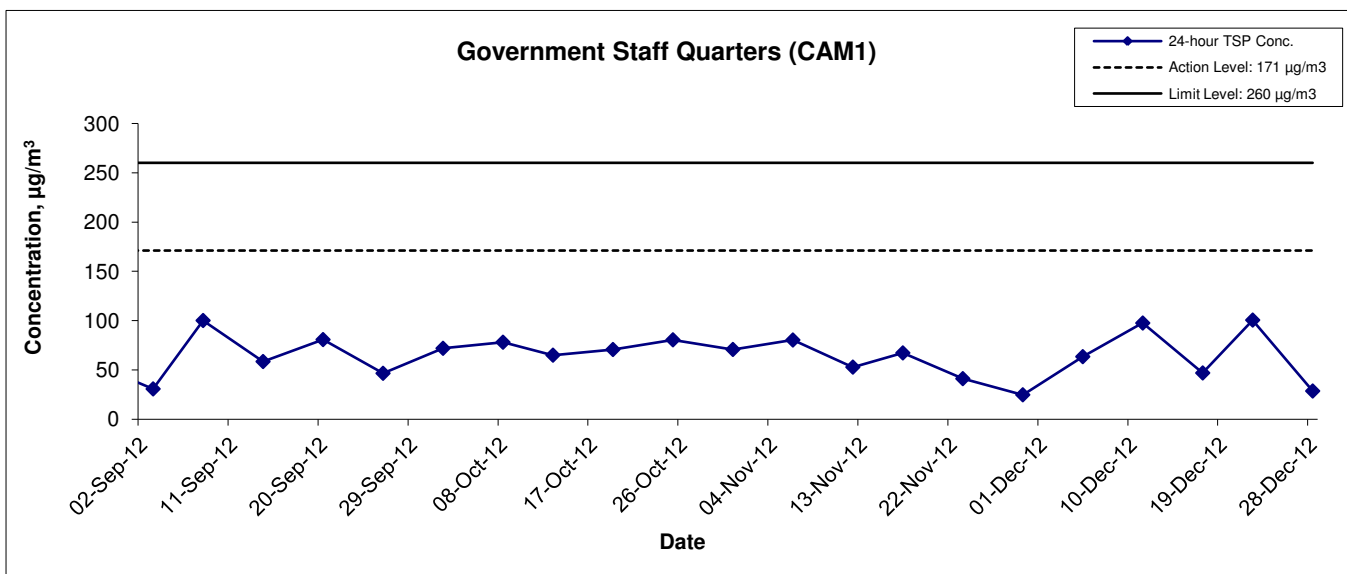
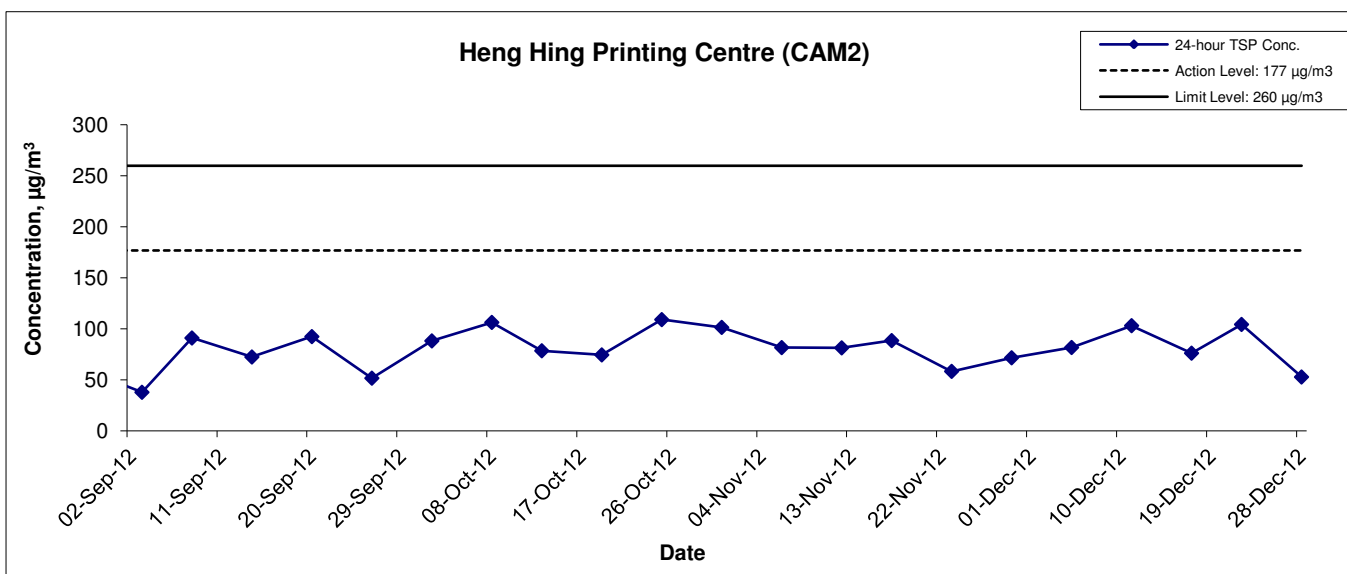
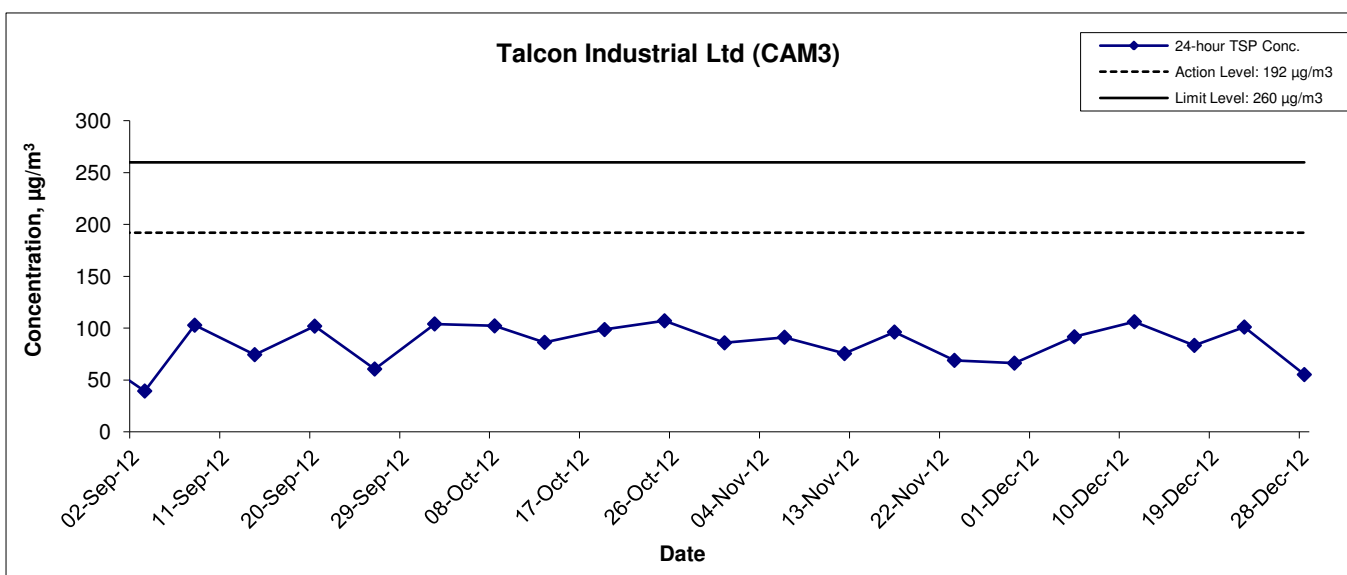
24-hr TSP Concentration Levels

Title Contract No. DC/2009/09 Construction of Tai Po Sewage Treatment Works - Stage V Phase II B Graphical Presentation of 24-hour TSP Impact Monitoring Results	Scale	N.T.S	Project No.	MA0010	CINOTECH
	Date	Dec 12	Appendix	E

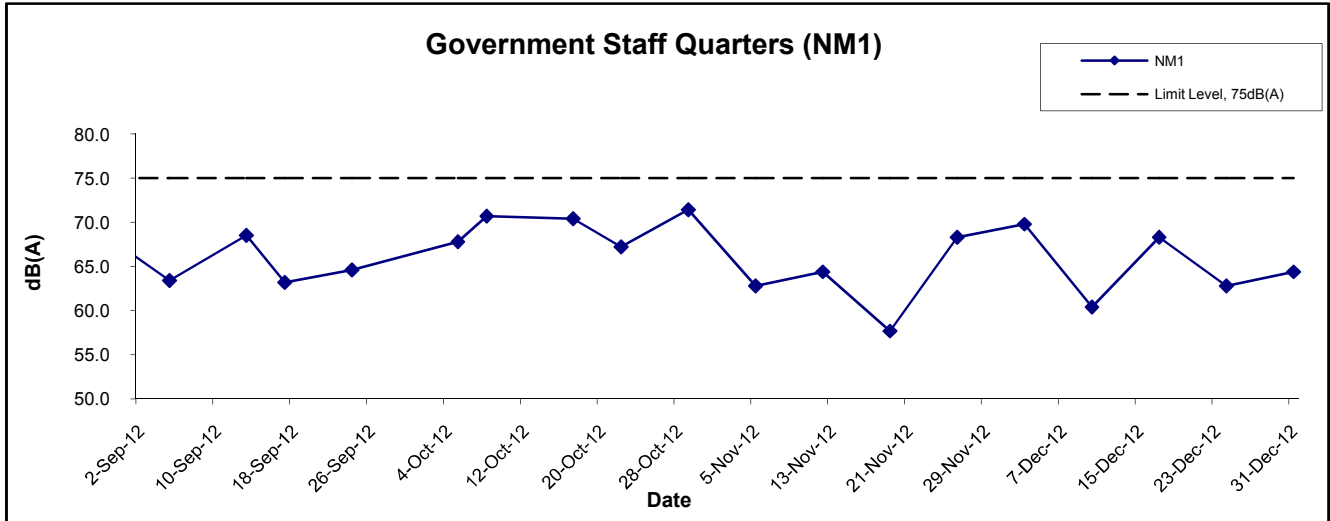
Noise Levels

Title Contract No. DC/2009/09 Construction of Tai Po Sewage Treatment Works - Stage V Phase II B Graphical Presentation of Construction Noise Monitoring Results	Scale N.T.S	Project No. MA0010	
	Date Dec 12	Appendix F
