Contract No. DC/2009/09
Construction of Tai Po Sewage Treatment
Works – Stage V Phase II B

**Monthly Environmental Monitoring
and Audit Report for
January 2013**

(Version 2.0)

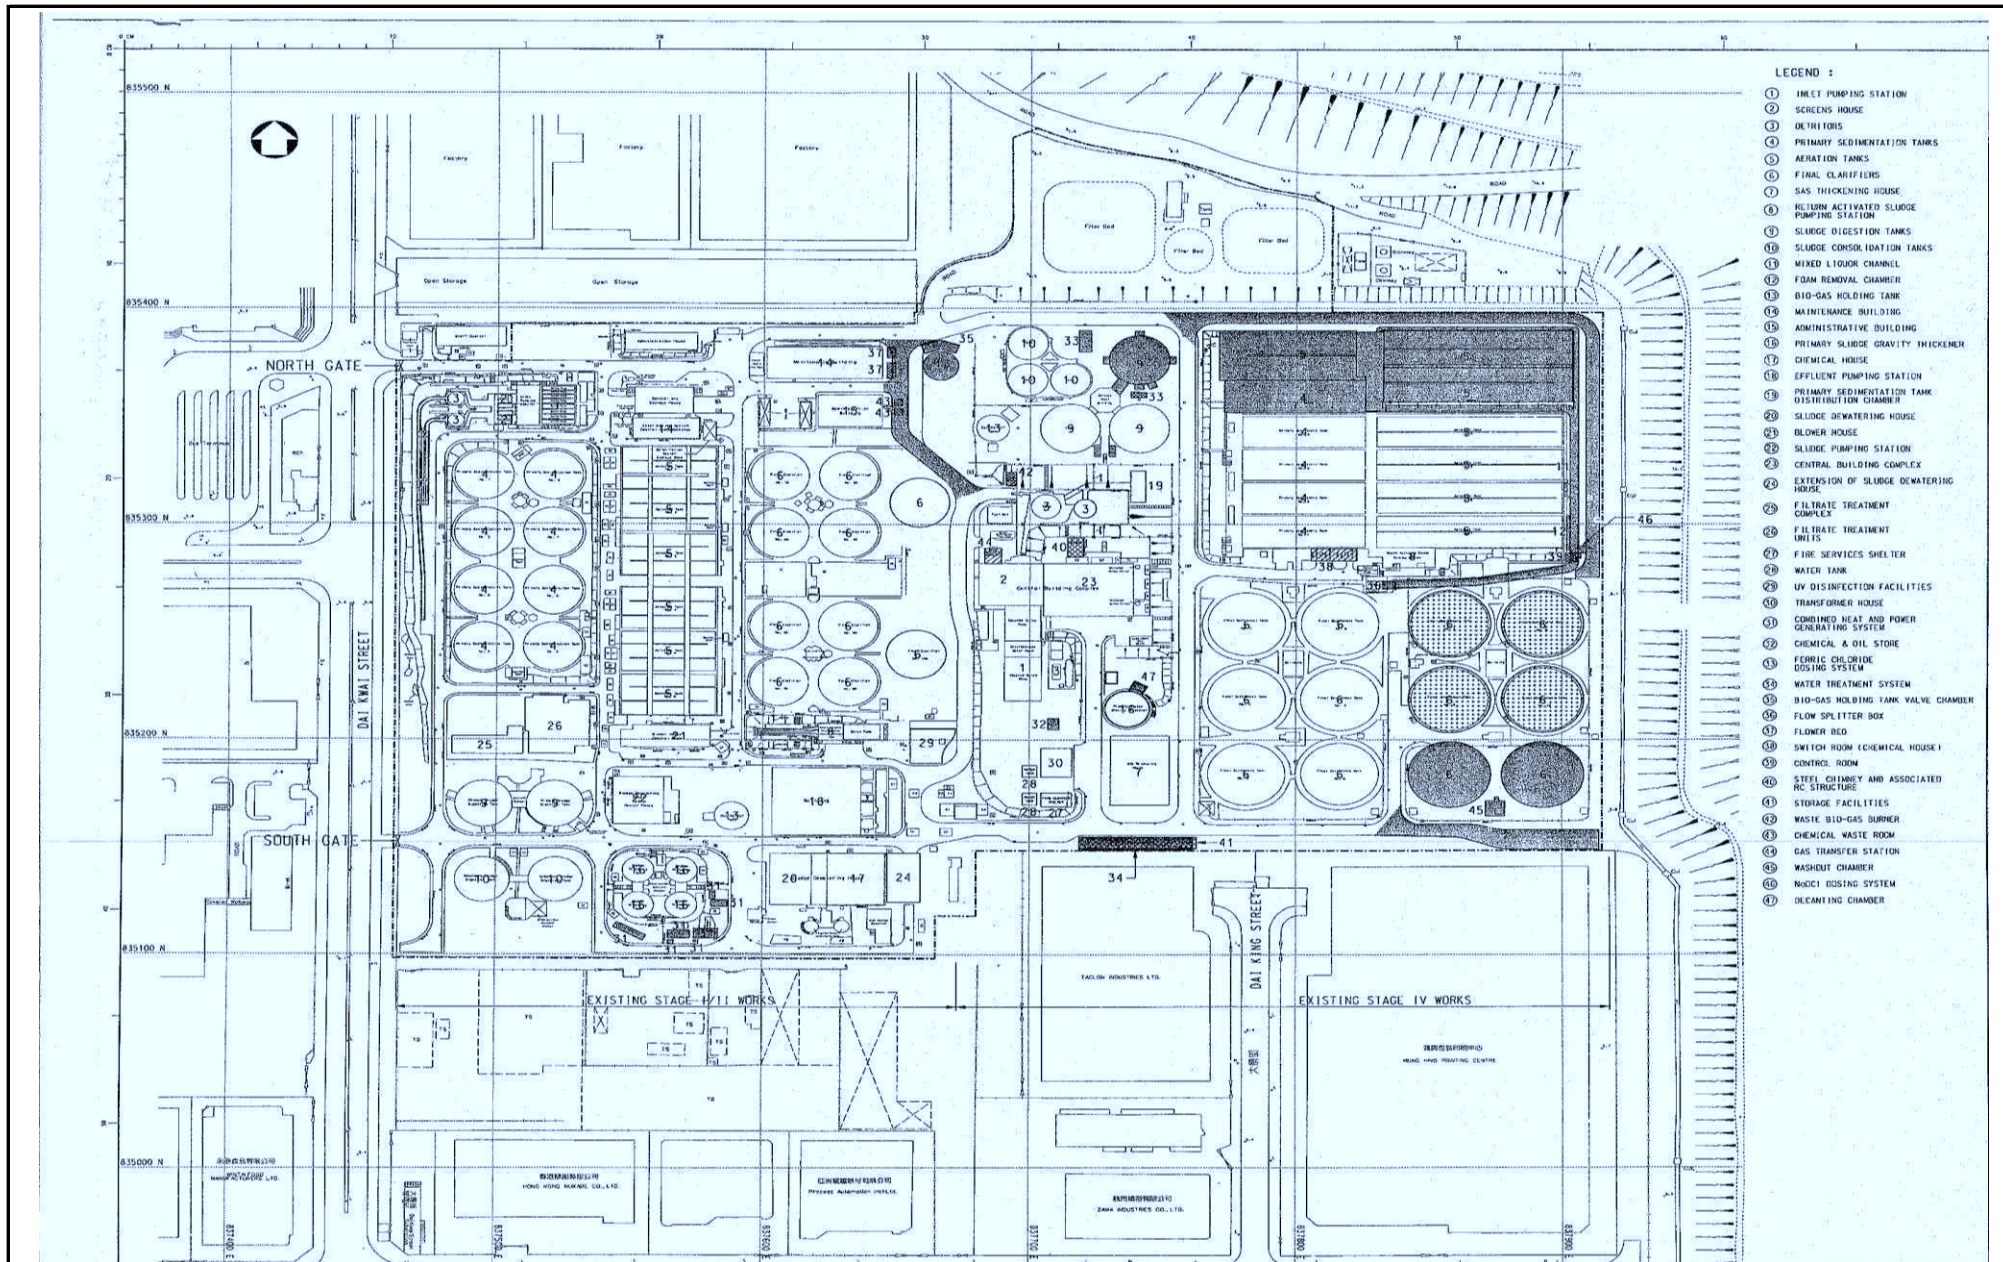
Scale	N.T.S	Project No.	MA0010	CINOTECH
Date	Jul-10	Figure	1.1

PROJECT SITE LAYOUT PLAN (TPSTW)

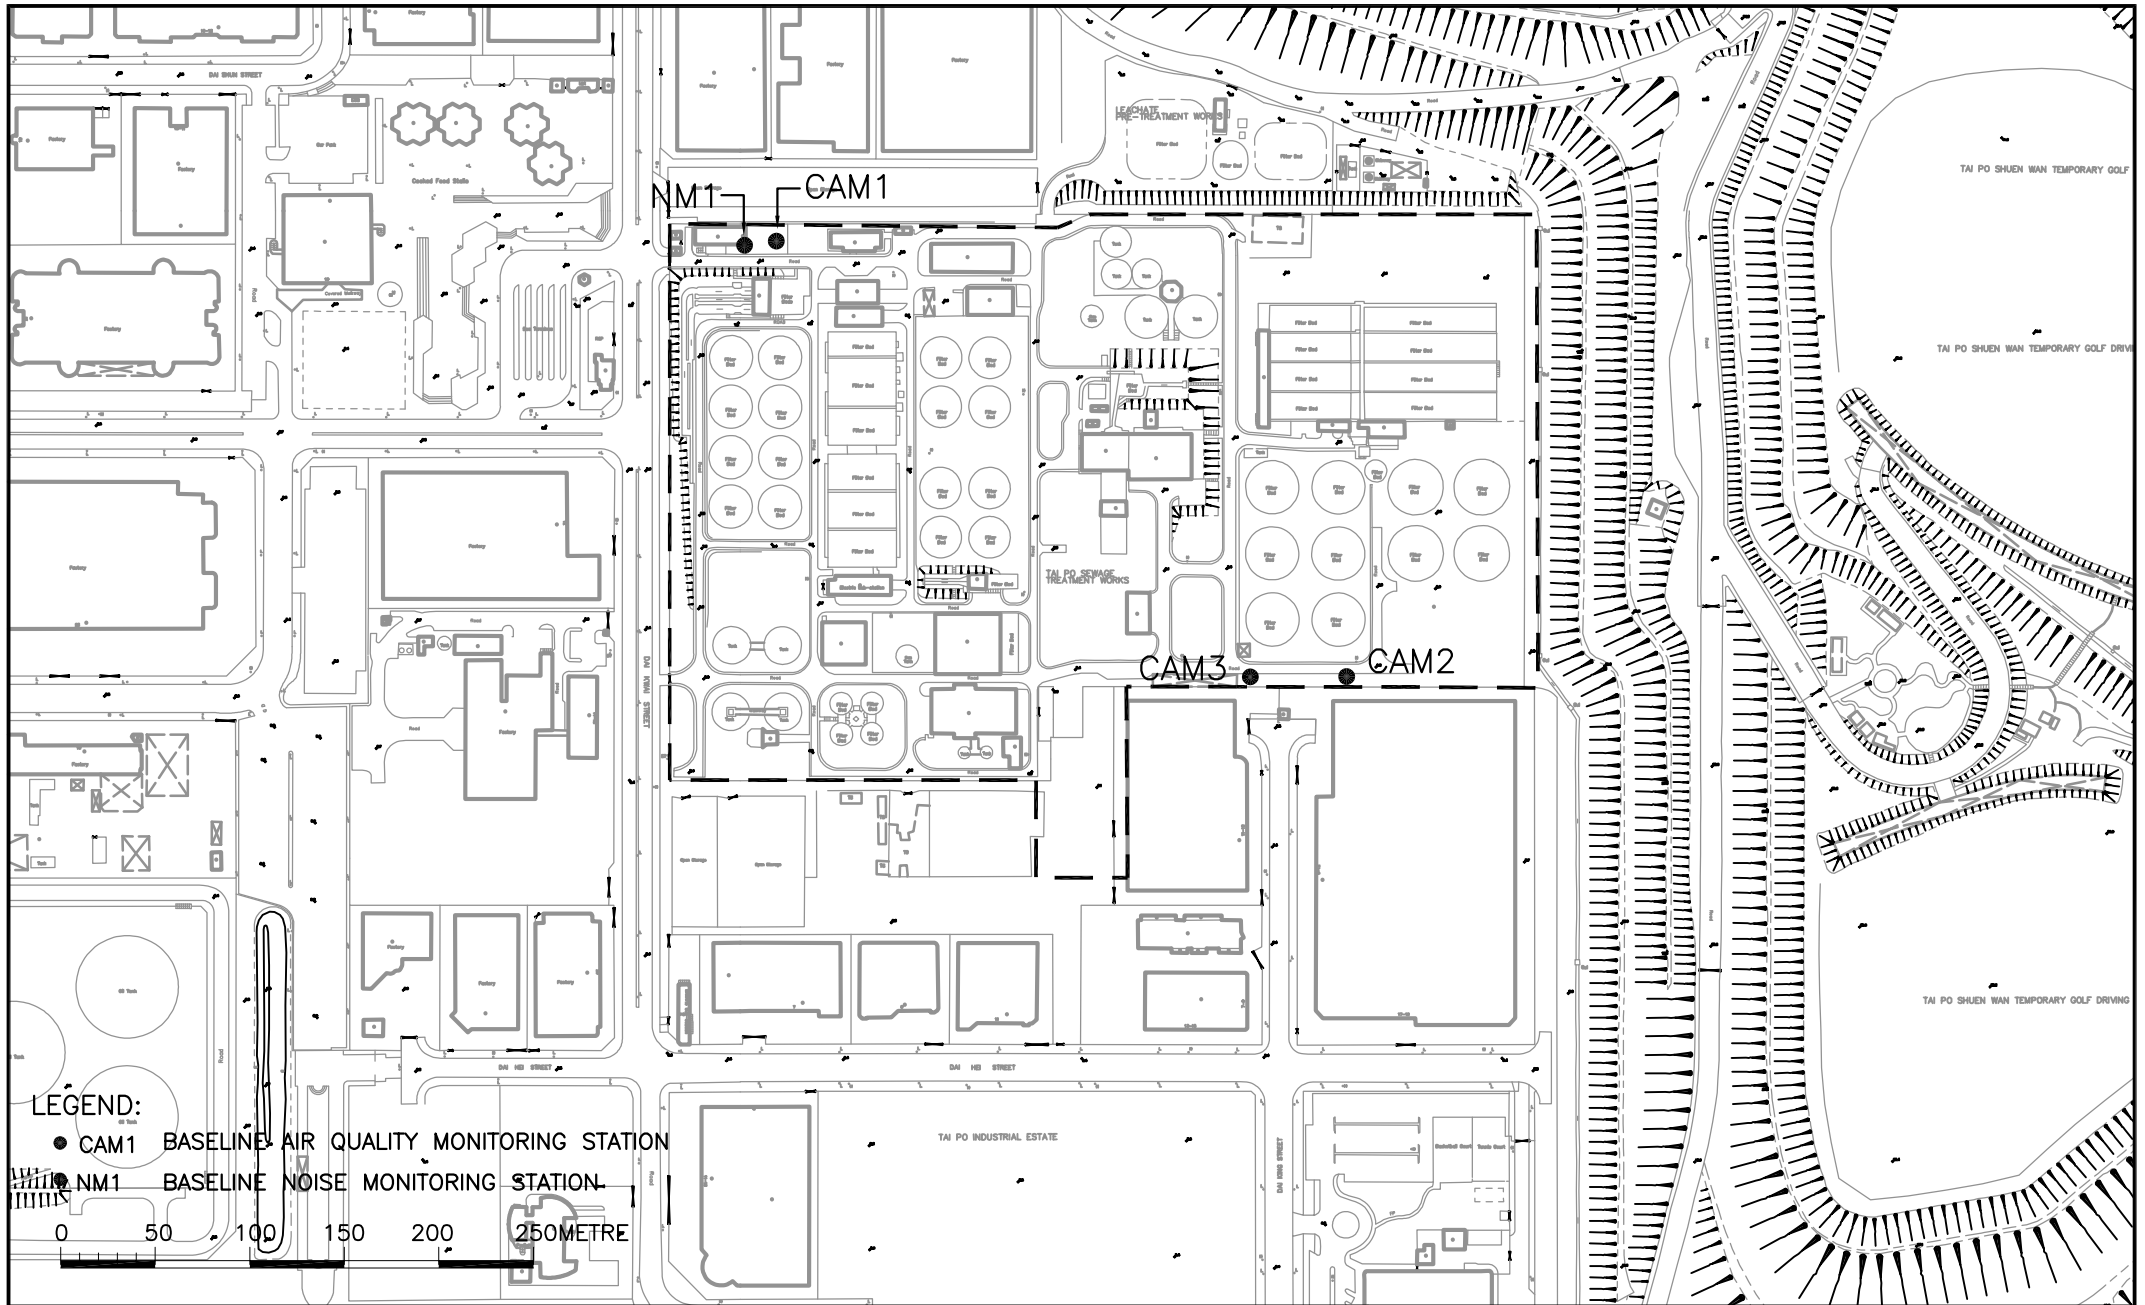
SCALE	A4 1:4000	DATE	2010	
CHECK	IT	DRAWN	SL	
JOB No.	MA0010	DRAWING No.	1.2	REV —

Tai Po Sewage Treatment Work, Stage V, Phase IIB
LOCATIONS OF AIR QUALITY AND NOISE MONITORING STATIONS

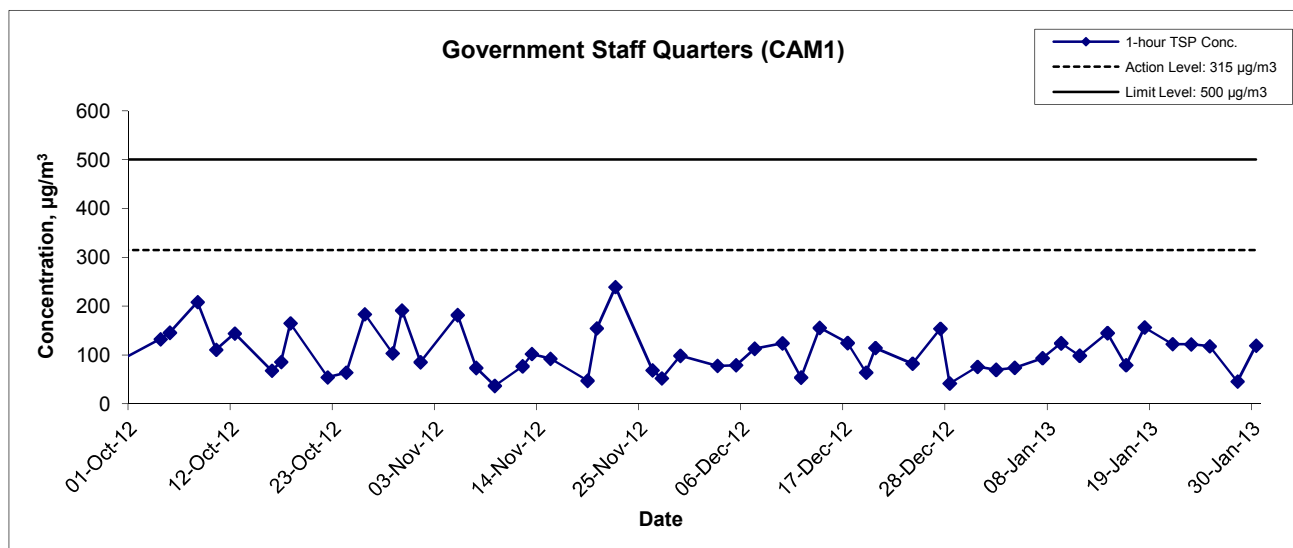
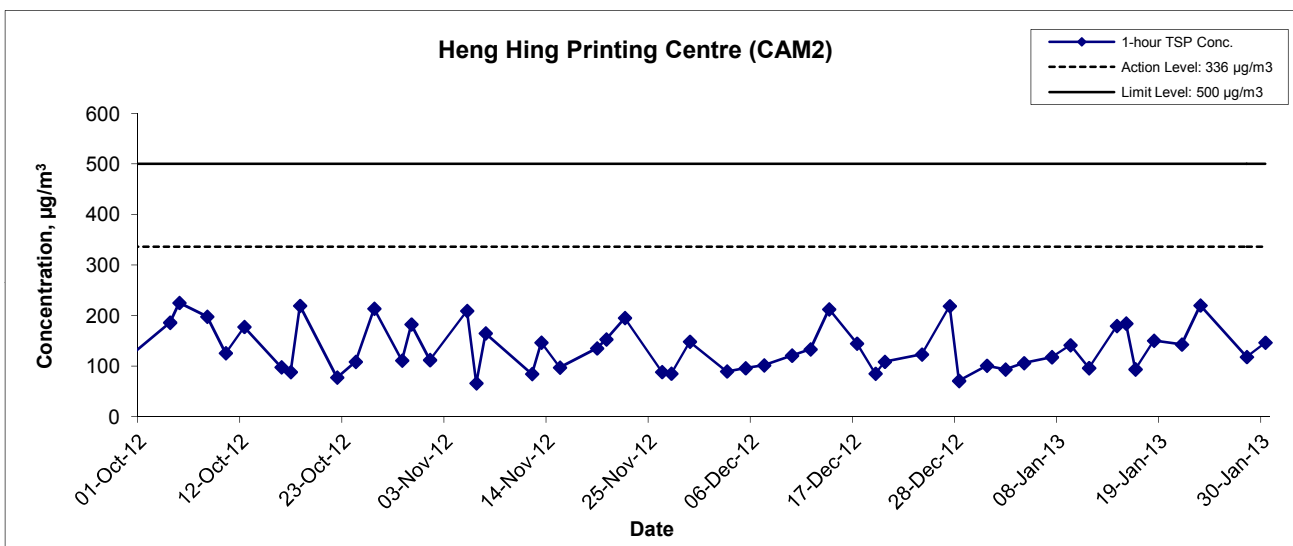
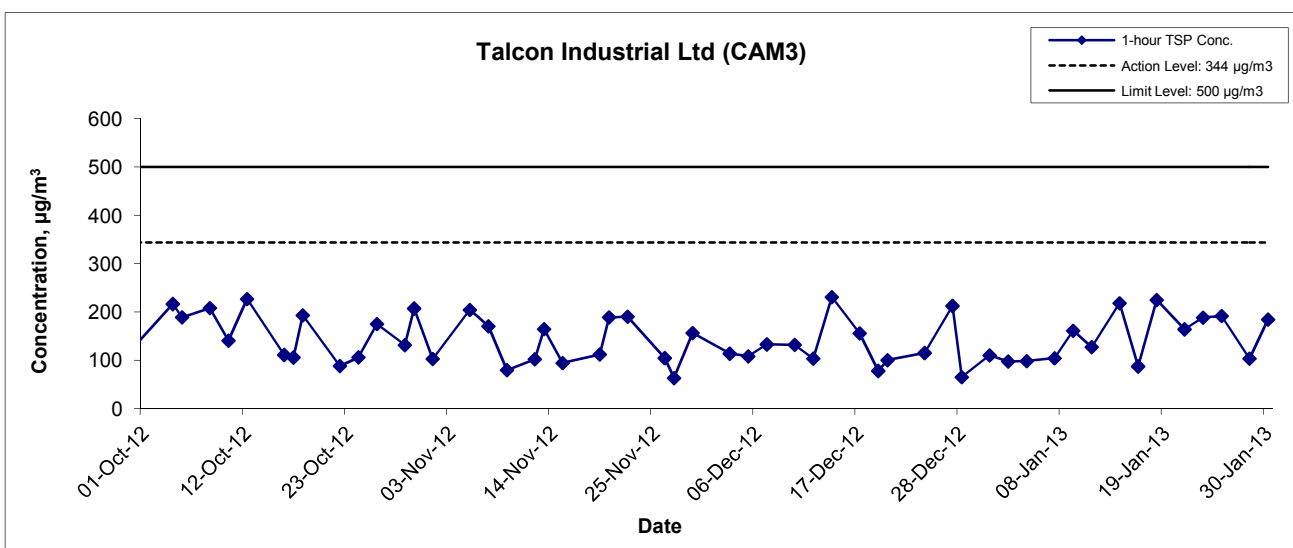
Title
 Contract No. DC/2009/09
 Construction of Tai Po Sewage Treatment Works - Stage V Phase II B
 Graphical Presentation of 1-hour TSP Impact Monitoring Results

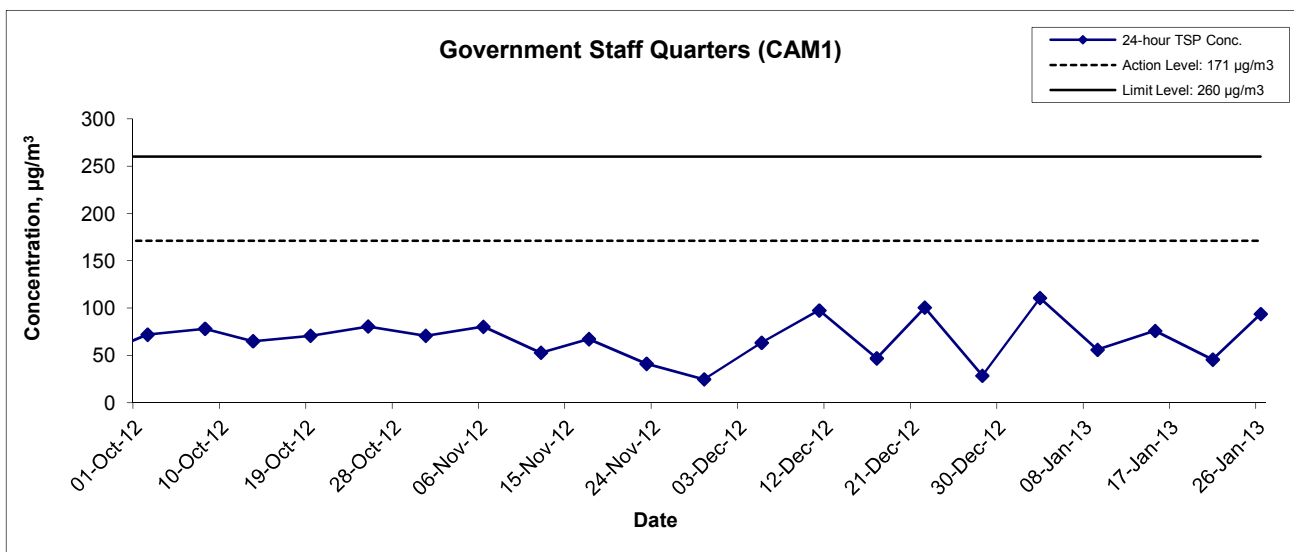
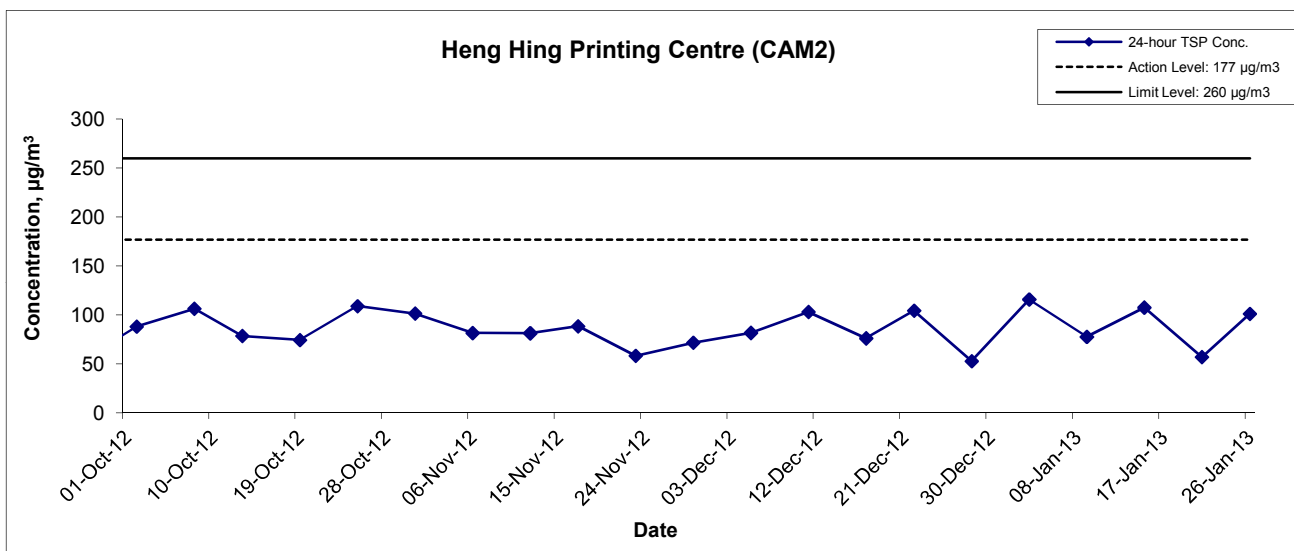
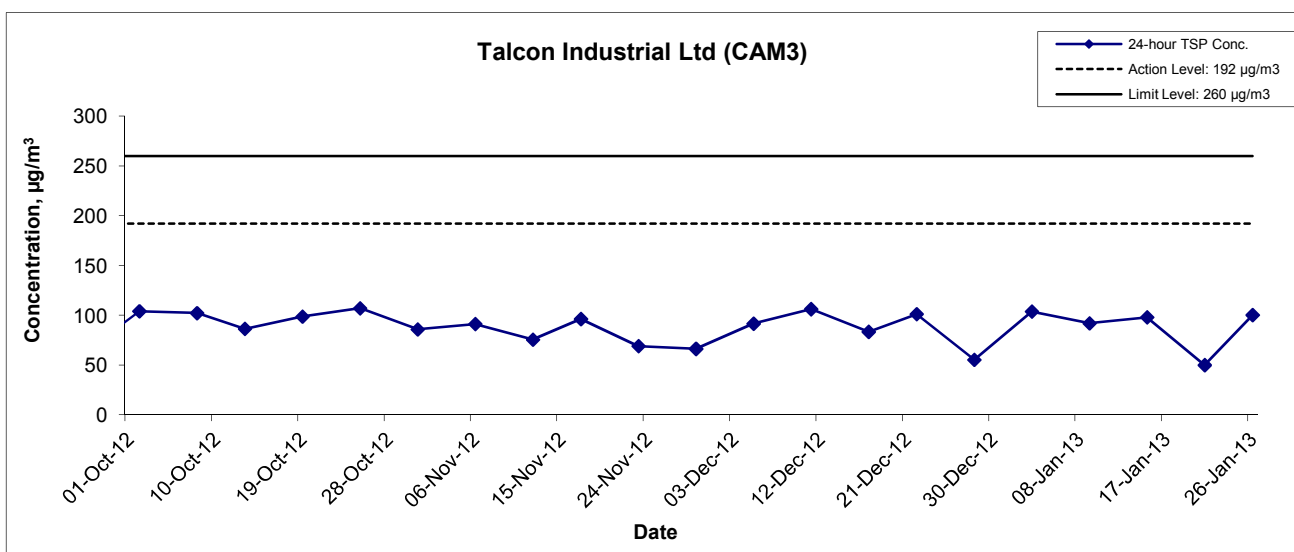
Title Contract No. DC/2009/09 Construction of Tai Po Sewage Treatment Works - Stage V Phase II B Graphical Presentation of 24-hour TSP Impact Monitoring Results	Scale	Project No.		
		N.T.S		MA0010
	Date	Jan 13		Appendix E

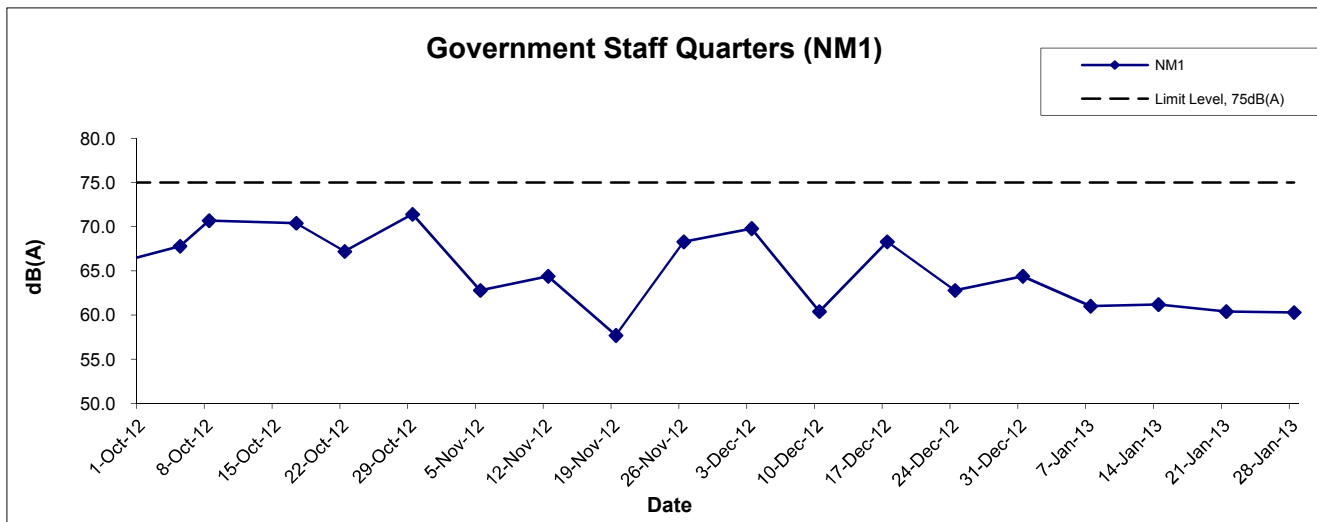
Title Contract No. DC/2009/09 Construction of Tai Po Sewage Treatment Works - Stage V Phase II B Graphical Presentation of Construction Noise Monitoring Results	Scale N.T.S	Project No. MA0010	
	Date Jan 13	Appendix F

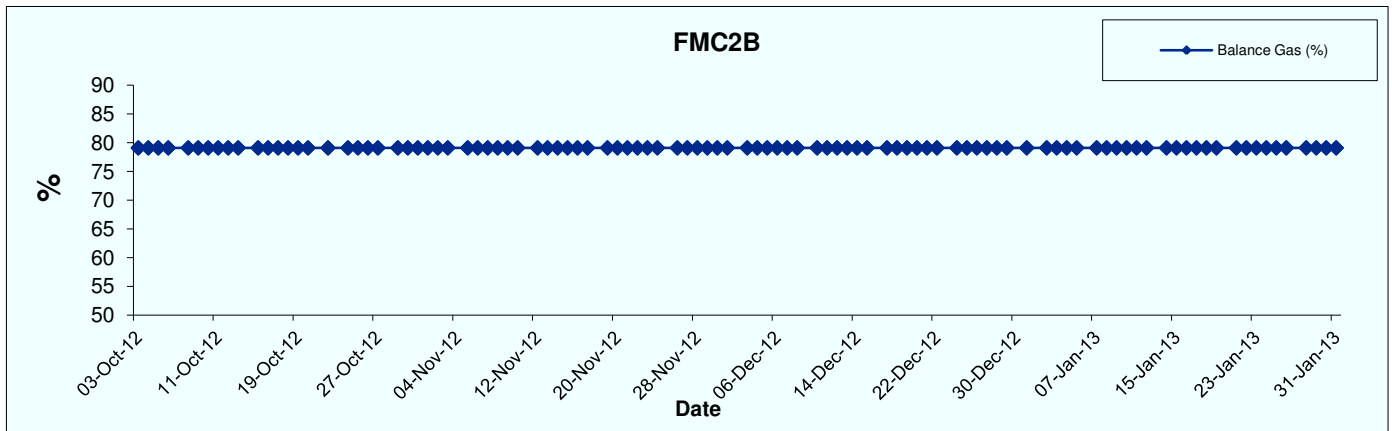
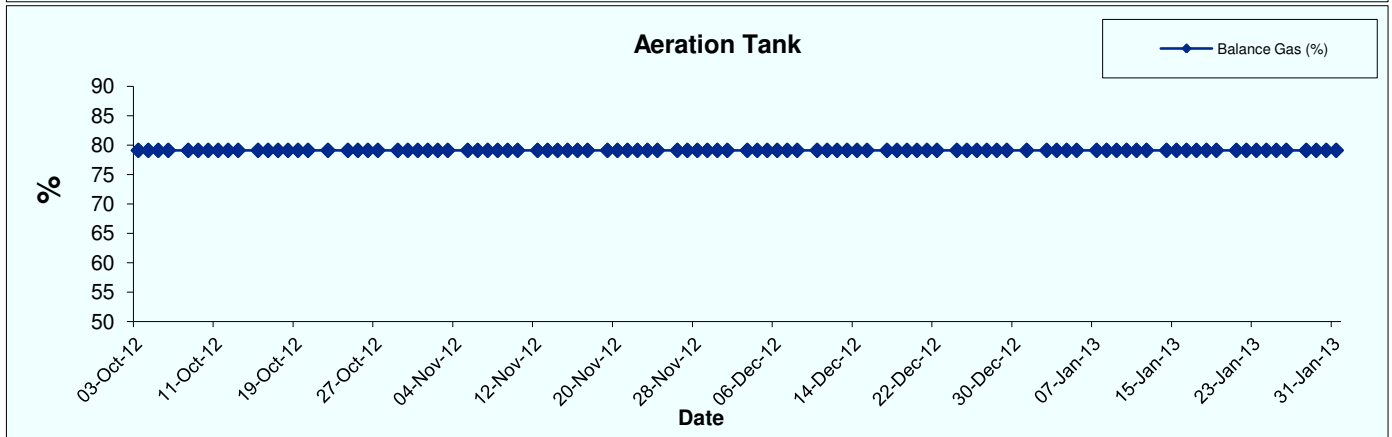
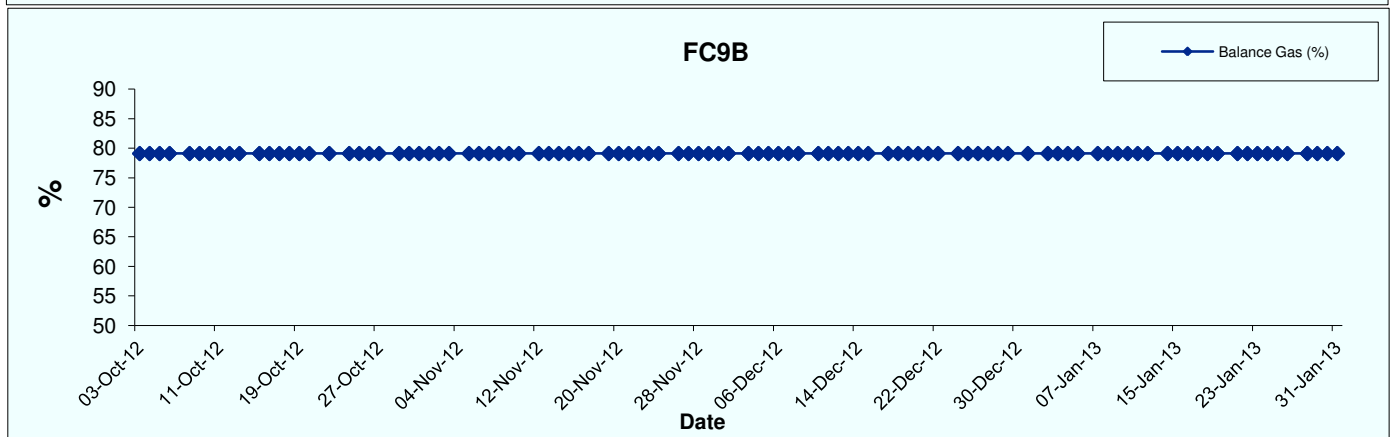
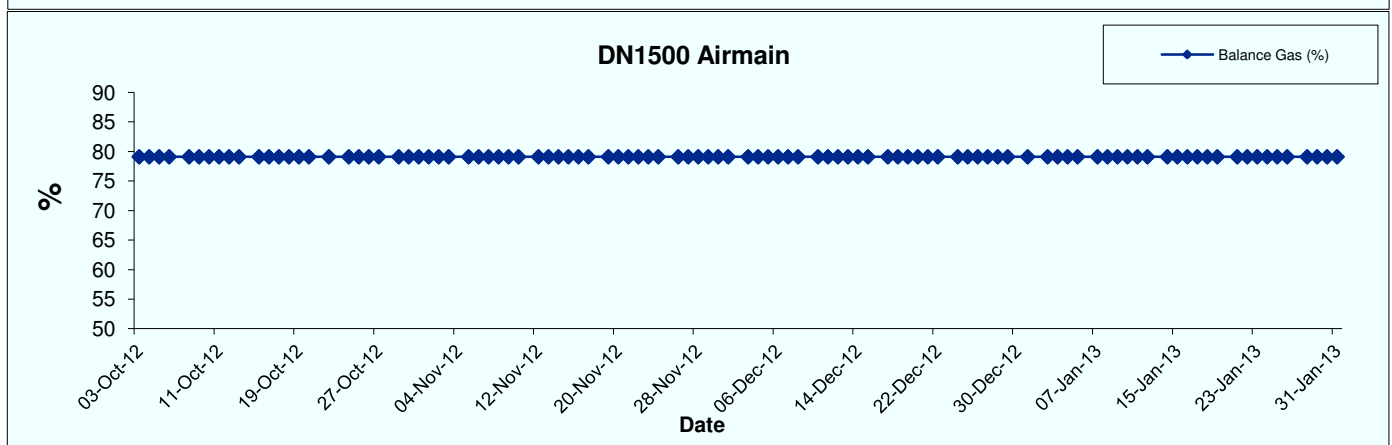
Balance Gas

Title
 Contract No. DC/2009/09
 Construction of Tai Po Sewage Treatment Works - Stage V Phase II B
 Graphical Presentation of Landfill Gas Measurement

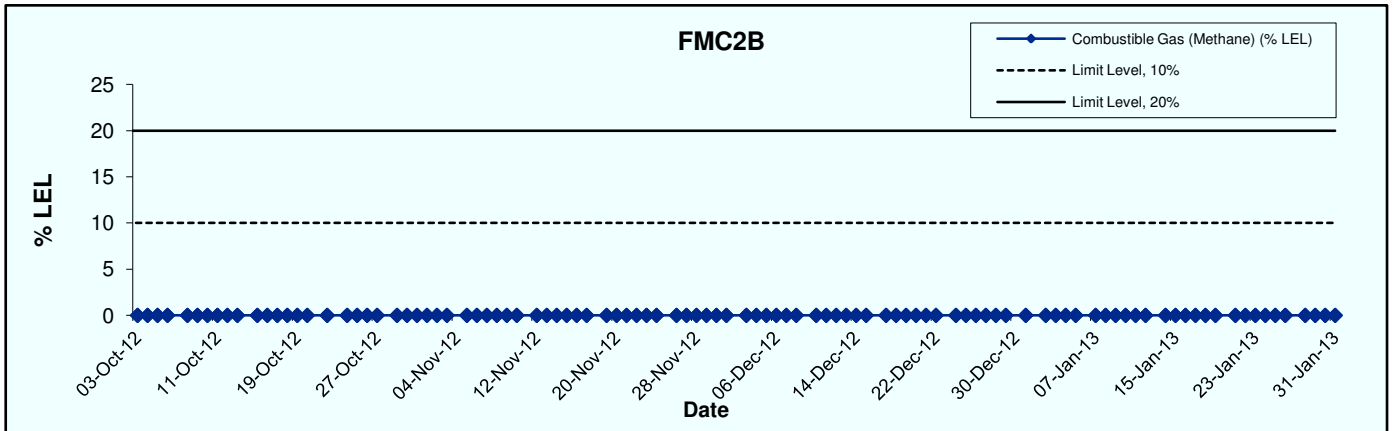
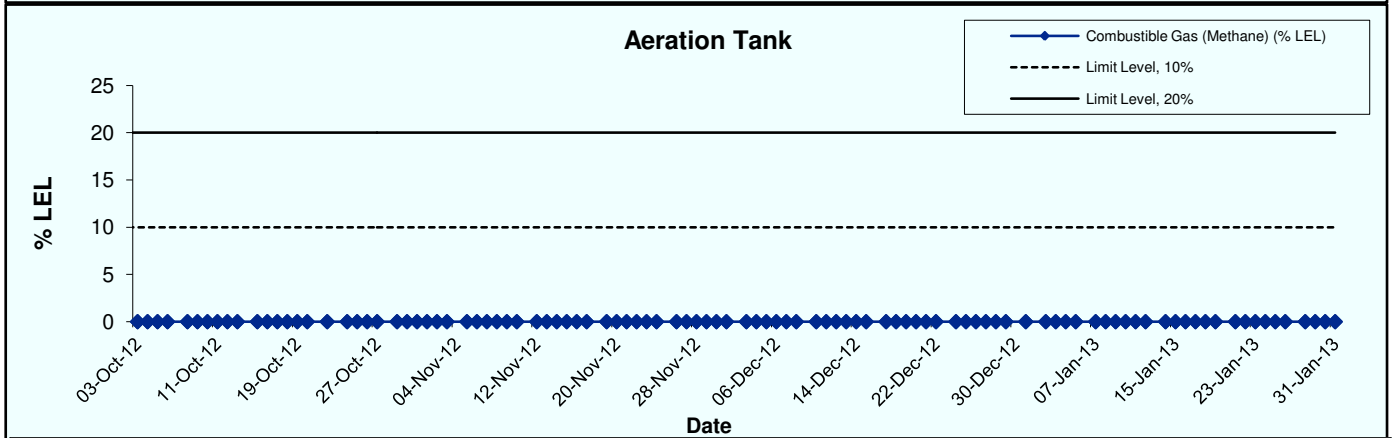
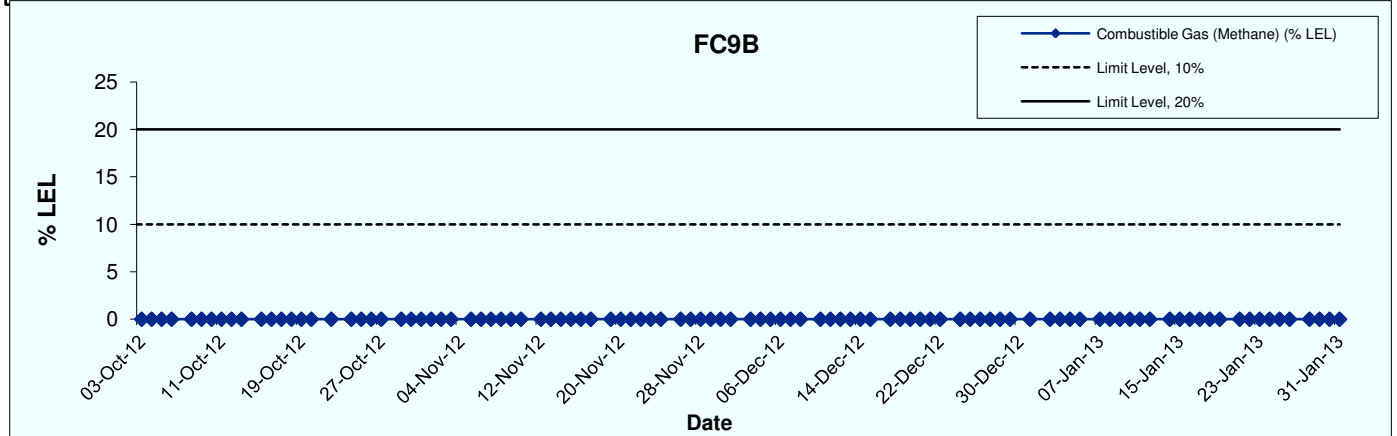
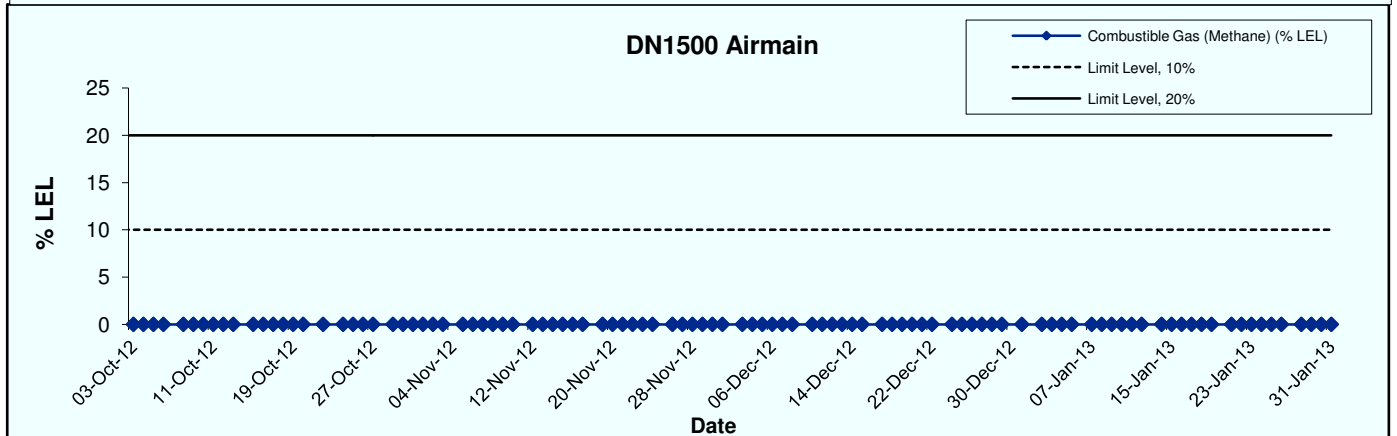
Combustible Gas (Methane)

Title
 Contract No. DC/2009/09
 Construction of Tai Po Sewage Treatment Works - Stage V Phase II B
 Graphical Presentation of Landfill Gas Measurement

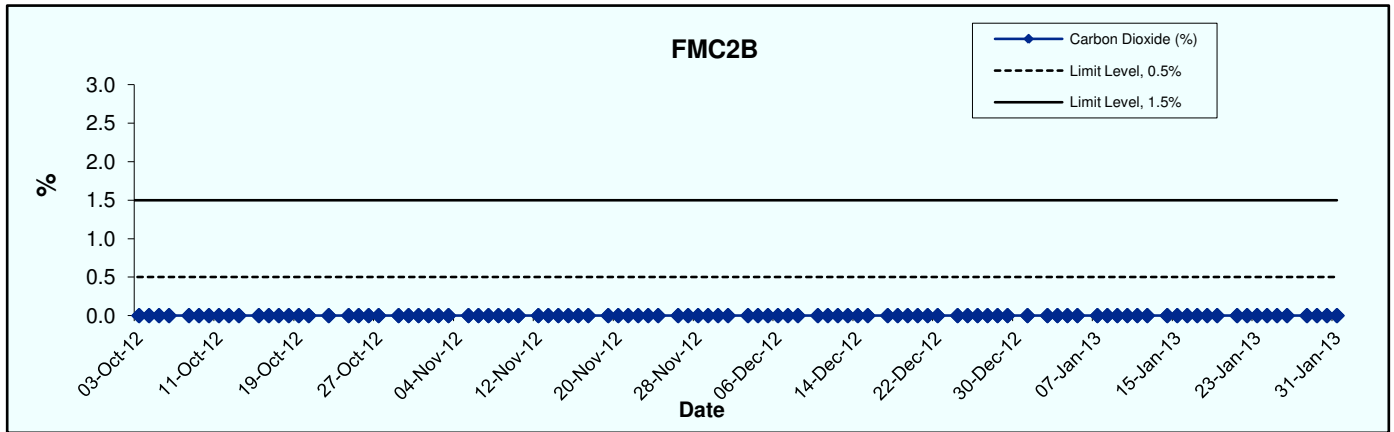
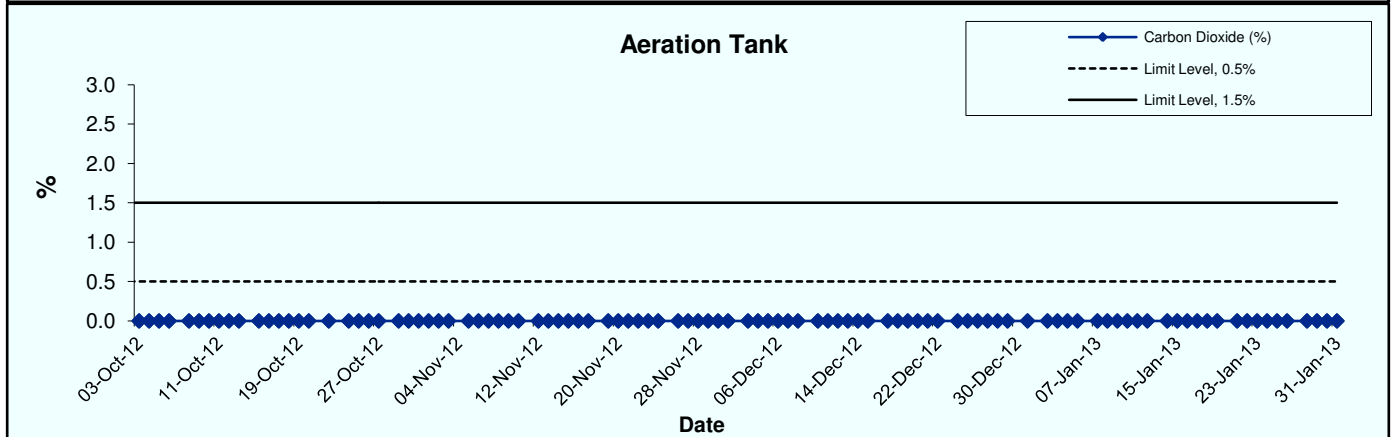
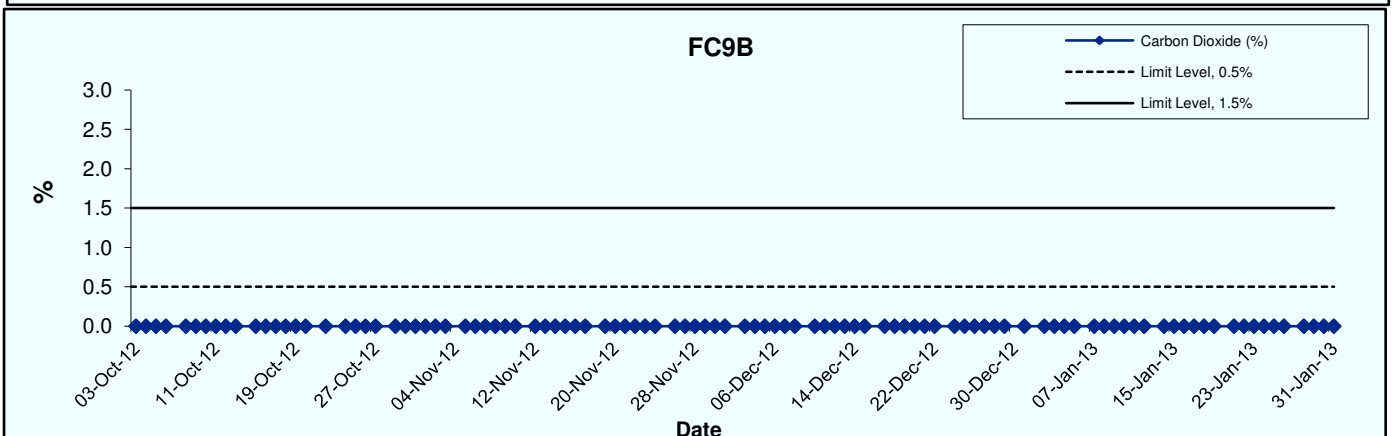
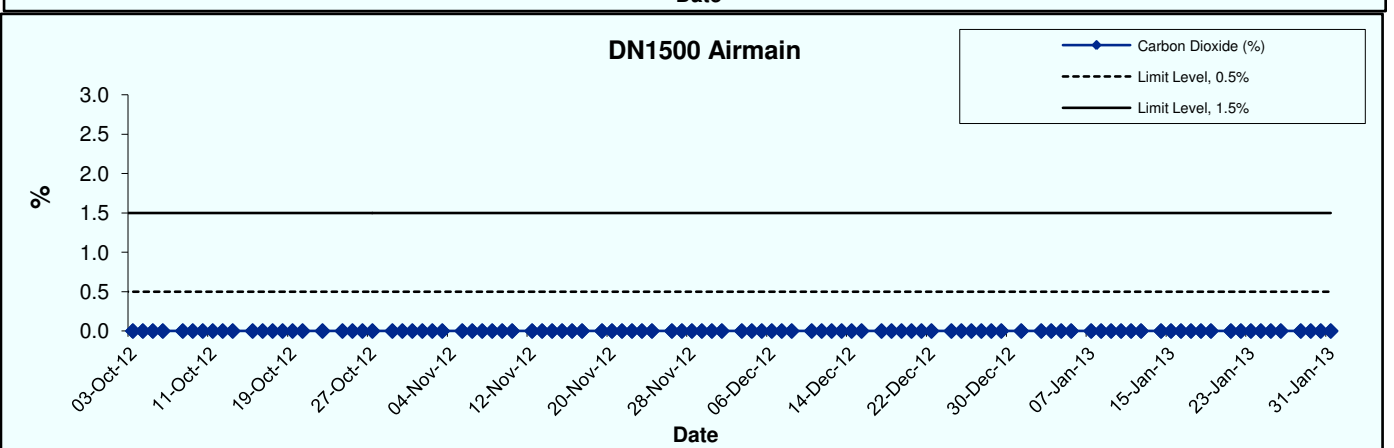
Carbon Dioxide

Title Contract No. DC/2009/09 Construction of Tai Po Sewage Treatment Works - Stage V Phase II B Graphical Presentation of Landfill Gas Measurement	Scale N.T.S	Project No. MA0010	
	Date Jan 13	Appendix G

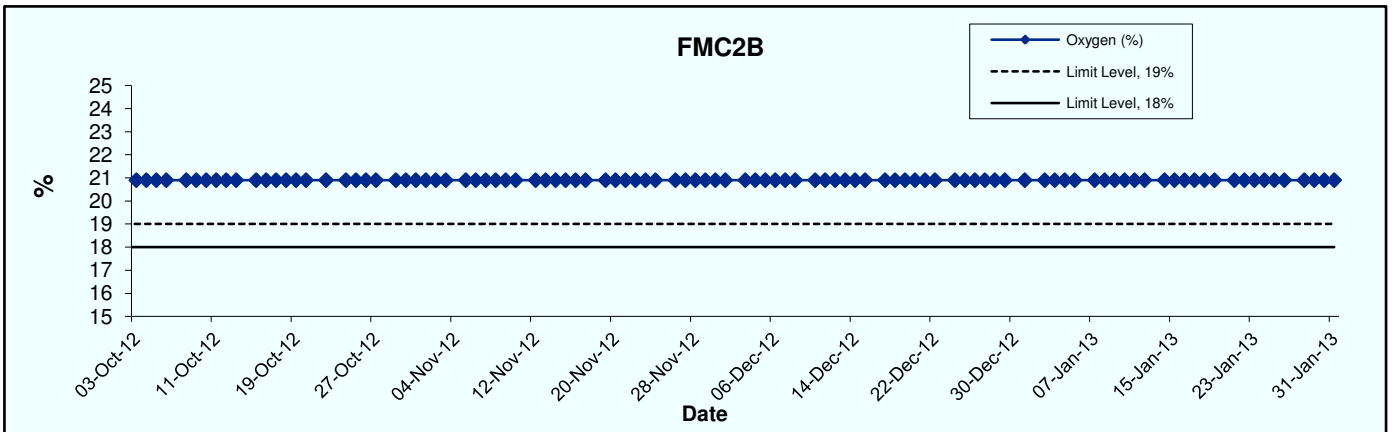
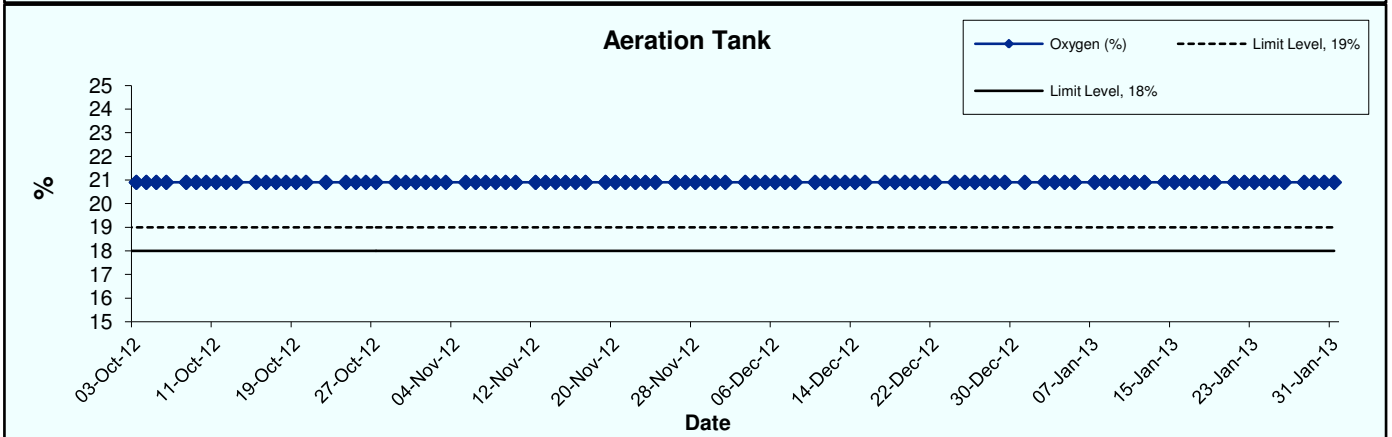
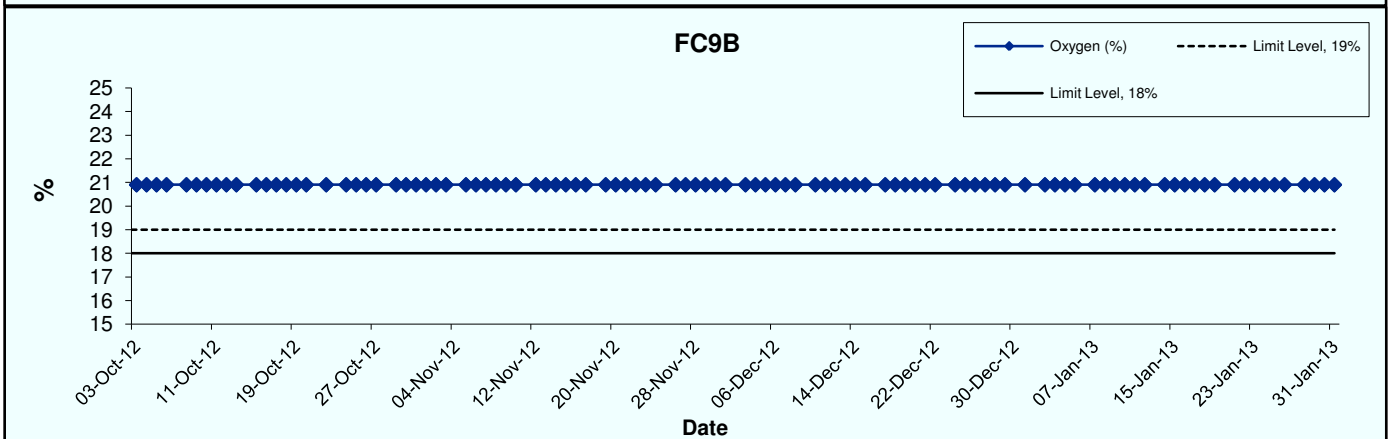
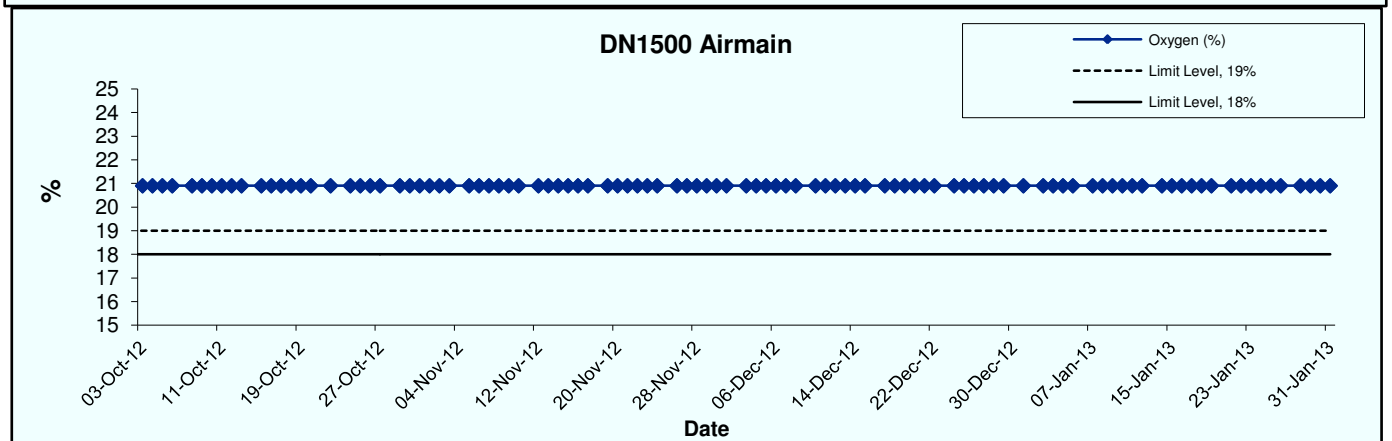
Oxygen

Title
 Contract No. DC/2009/09
 Construction of Tai Po Sewage Treatment Works - Stage V Phase II B
 Graphical Presentation of Landfill Gas Measurement
