Contract No. DE/2009/09  
Supply and Installation of Electrical and  
Mechanical Equipment for Tai Po Sewage  
Treatment Works Stage 5 Phase 2B

**Monthly Environmental Monitoring  
and Audit Report for  
January 2013**

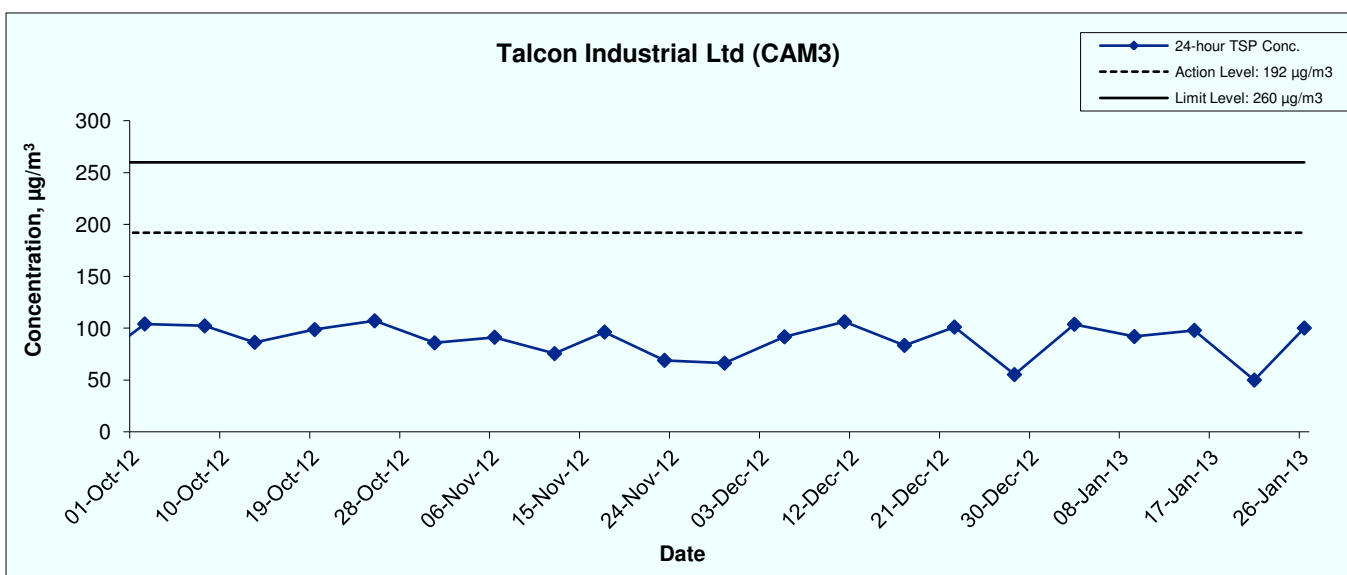
### 24-hr TSP Concentration Levels

Title Contract No. DE/2009/09 Construction of Tai Po Sewage Treatment Works - Stage V Phase II B Graphical Presentation of 24-hour TSP Impact Monitoring Results	Scale N.T.S	Project No. MA10069	
	Date Jan 13	Appendix E
