Contract No. DC/2009/09  
Construction of Tai Po Sewage Treatment  
Works – Stage V Phase II B

**Monthly Environmental Monitoring  
and Audit Report for  
March 2013**

1. This is the 33<sup>rd</sup> monthly Environmental Monitoring and Audit (EM&A) Report prepared by Cinotech Consultants Limited for DSD Contract no. DC/2009/09 “Construction of Tai Po Sewage Treatment Works – Stage V Phase IIB”. This report documents the findings of EM&A Works conducted in March 2013.

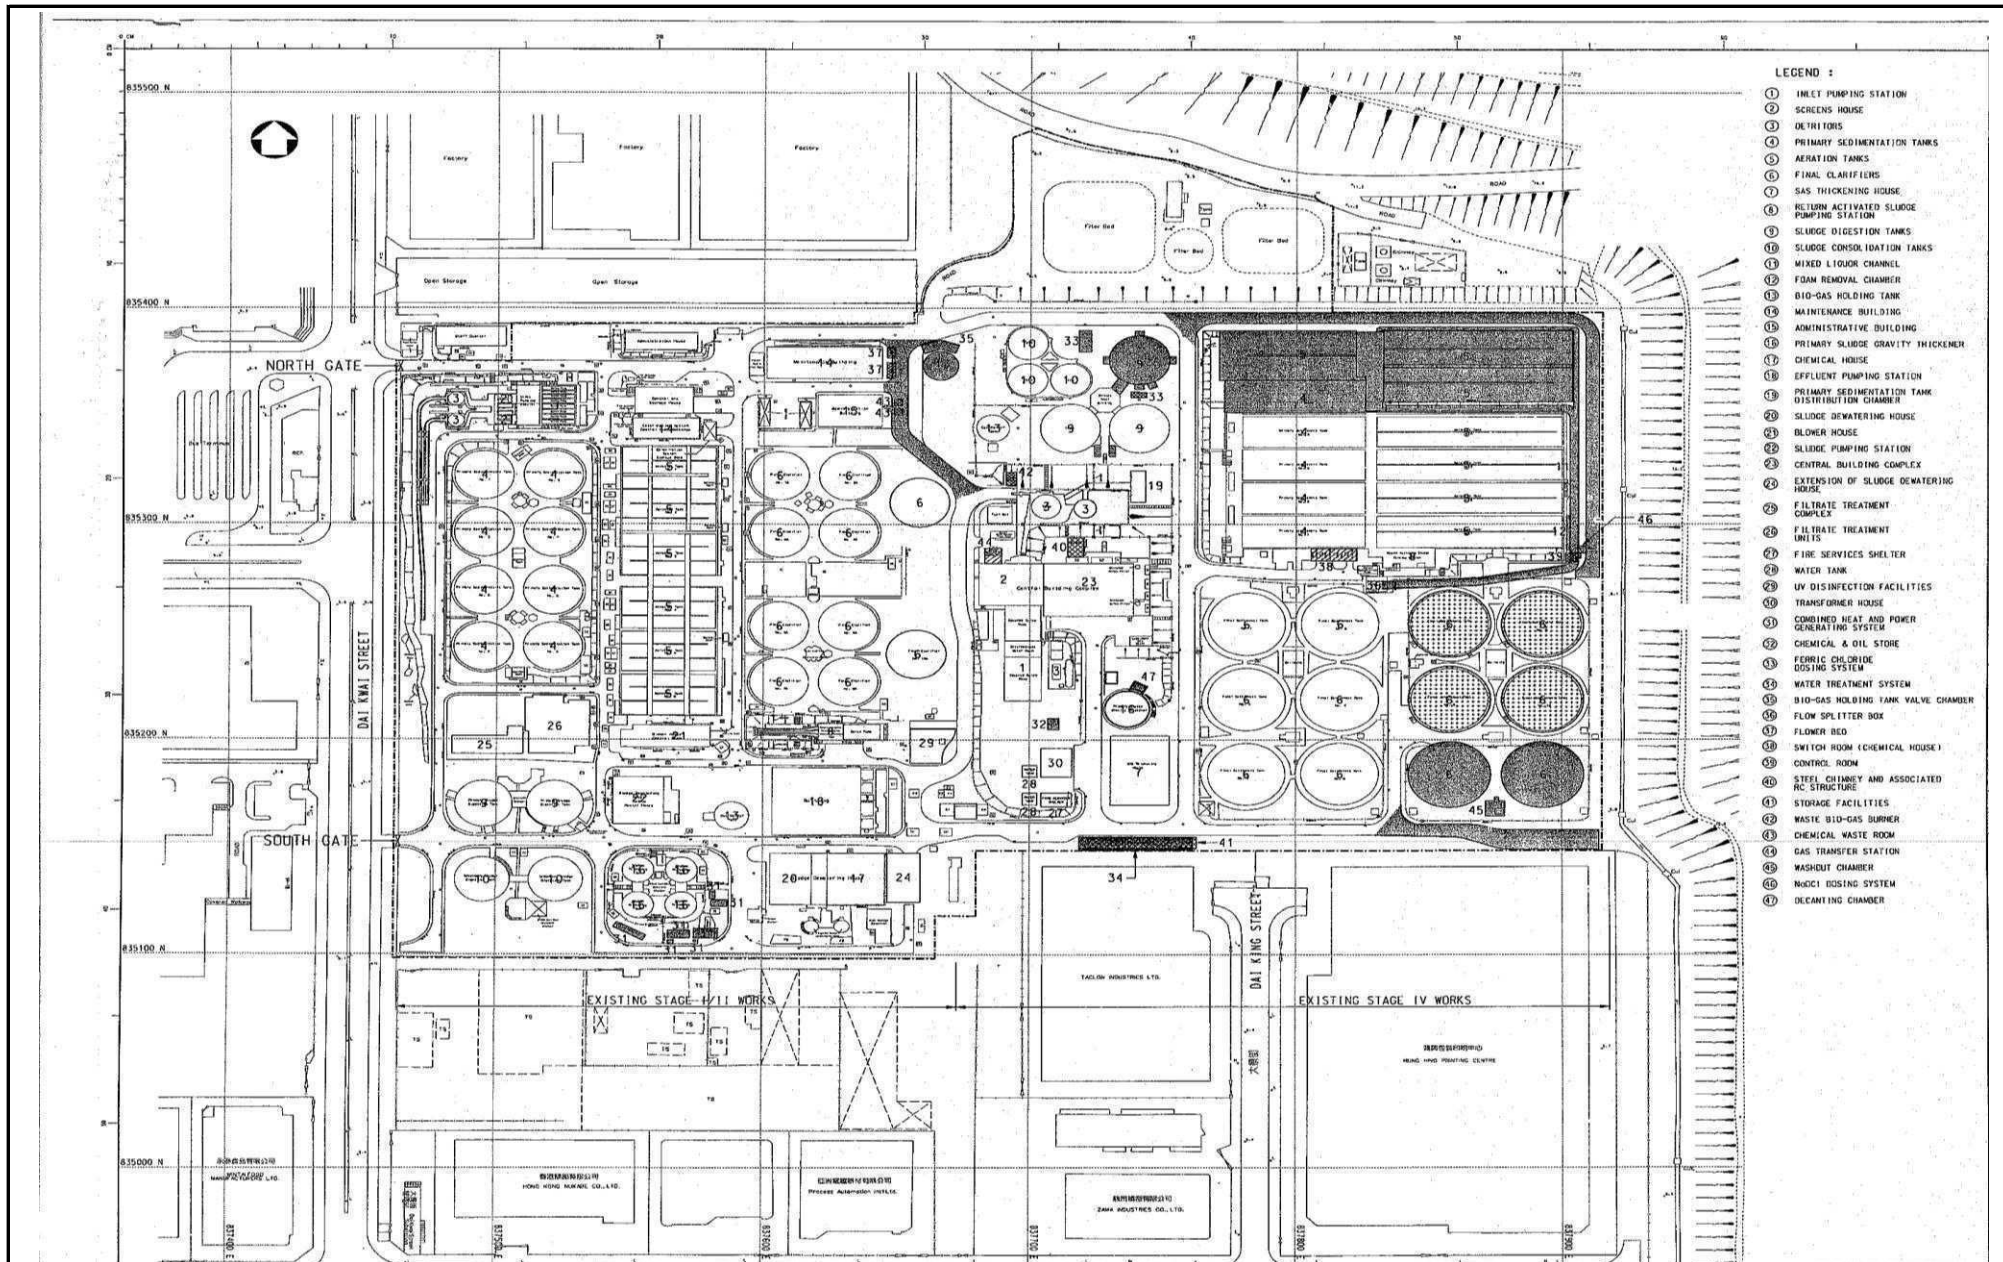
Scale	N.T.S	Project No.	MA0010	<b>CINOTECH</b>
Date	Jul-10	Figure	1.1

**PROJECT SITE LAYOUT PLAN (TPSTW)**

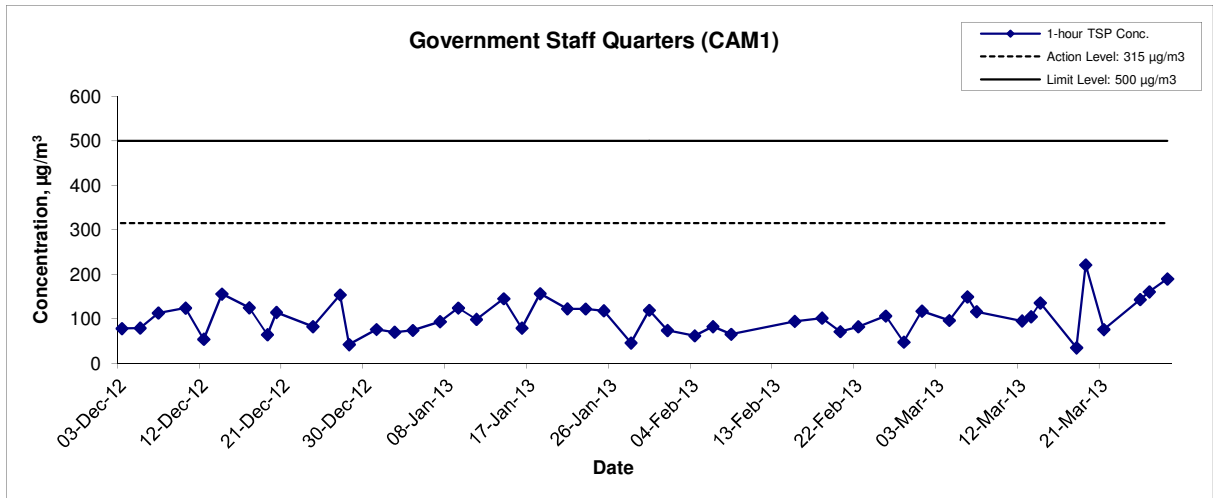
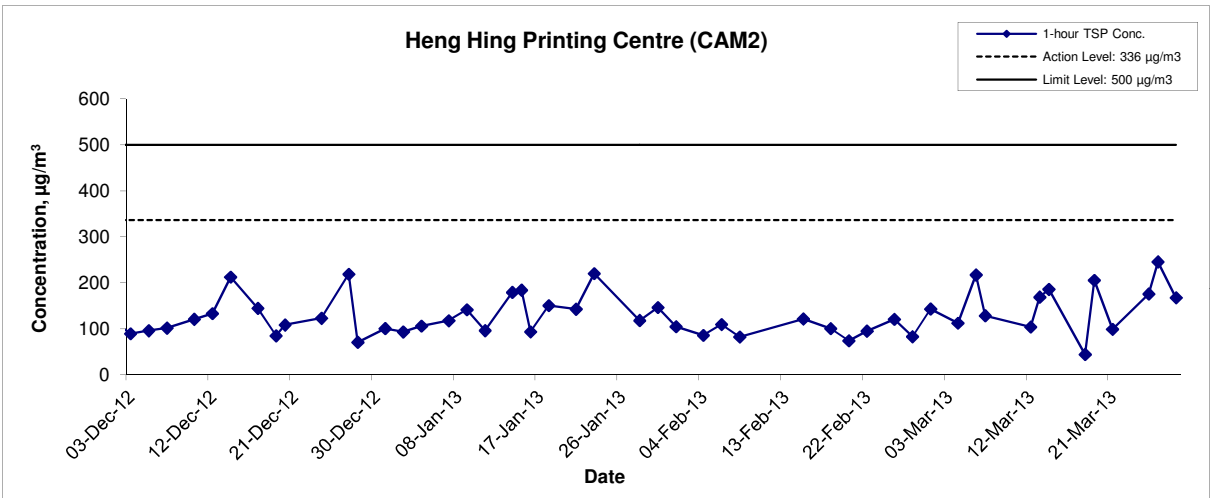
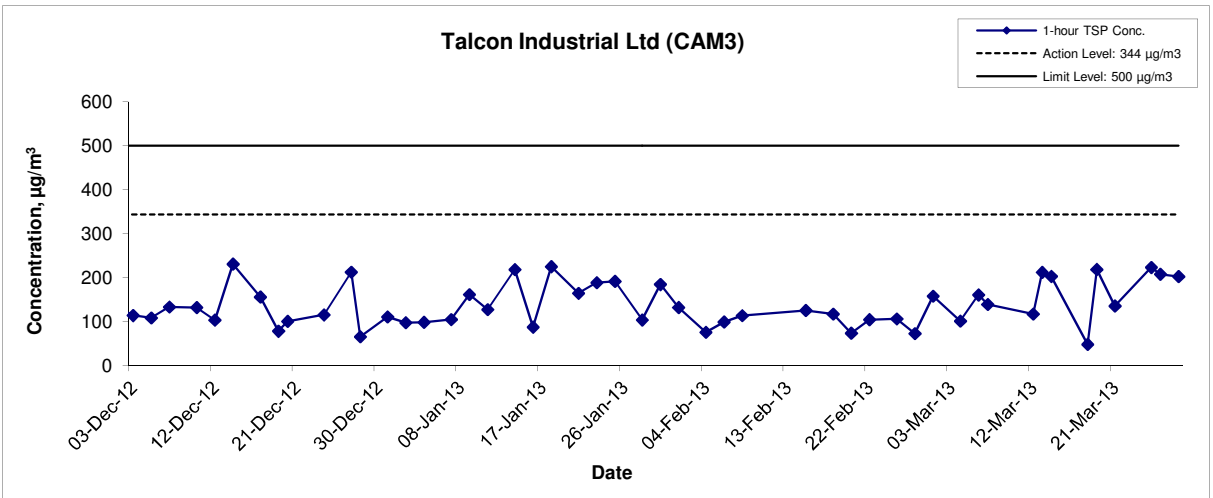
### 1-hr TSP Concentration Levels

Title Contract No. DC/2009/09  
 Construction of Tai Po Sewage Treatment Works - Stage V Phase II B  
 Graphical Presentation of 1-hour TSP Impact Monitoring Results

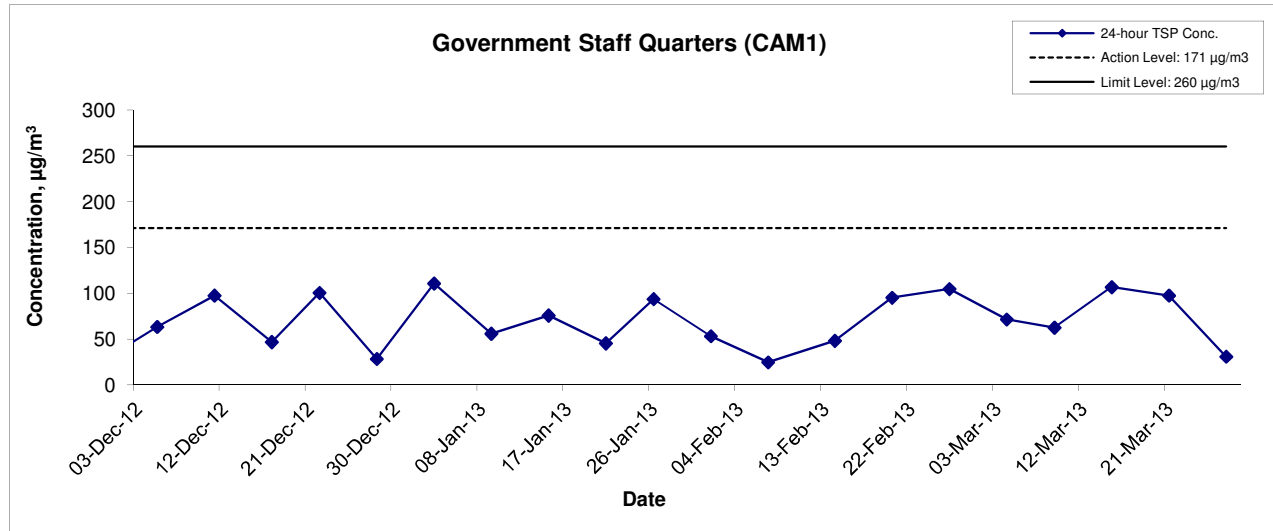
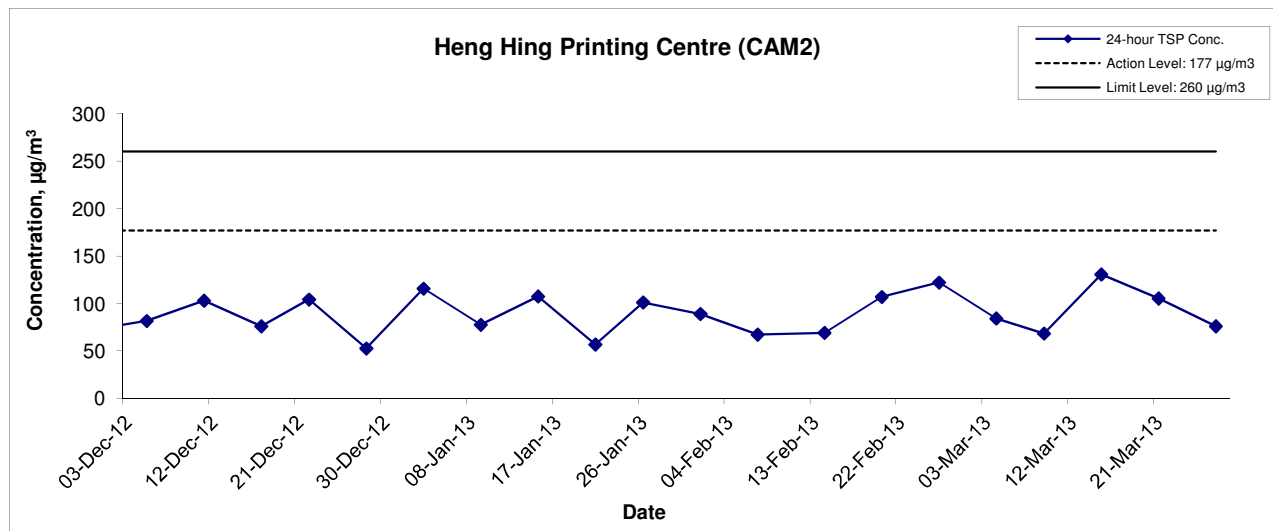
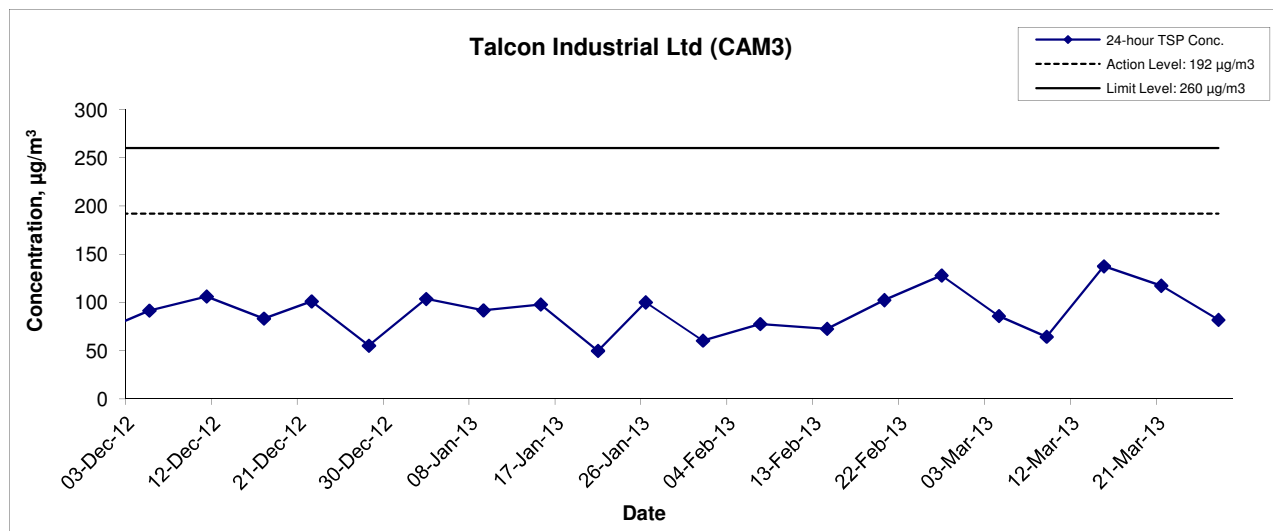
### 24-hr TSP Concentration Levels

Title Contract No. DC/2009/09 Construction of Tai Po Sewage Treatment Works - Stage V Phase II B Graphical Presentation of 24-hour TSP Impact Monitoring Results	Scale N.T.S	Project No. MA0010	
	Date Mar 15	Appendix E

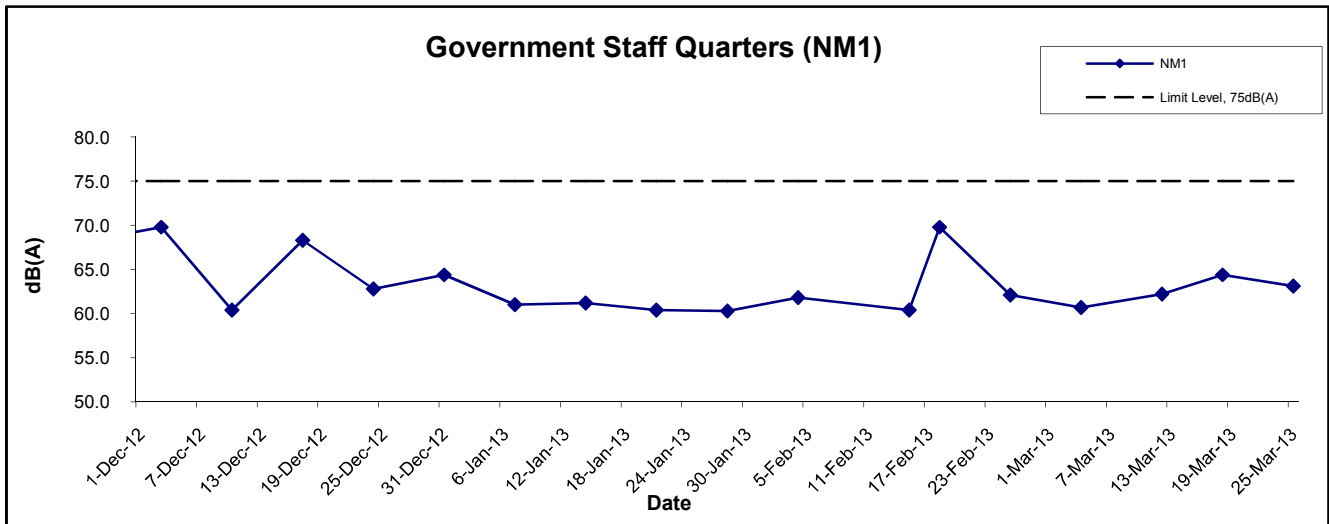
## Noise Levels

Title Contract No. DC/2009/09 Construction of Tai Po Sewage Treatment Works - Stage V Phase II B  Graphical Presentation of Construction Noise Monitoring Results	Scale N.T.S	Project No. MA0010	
	Date Mar 13	Appendix F

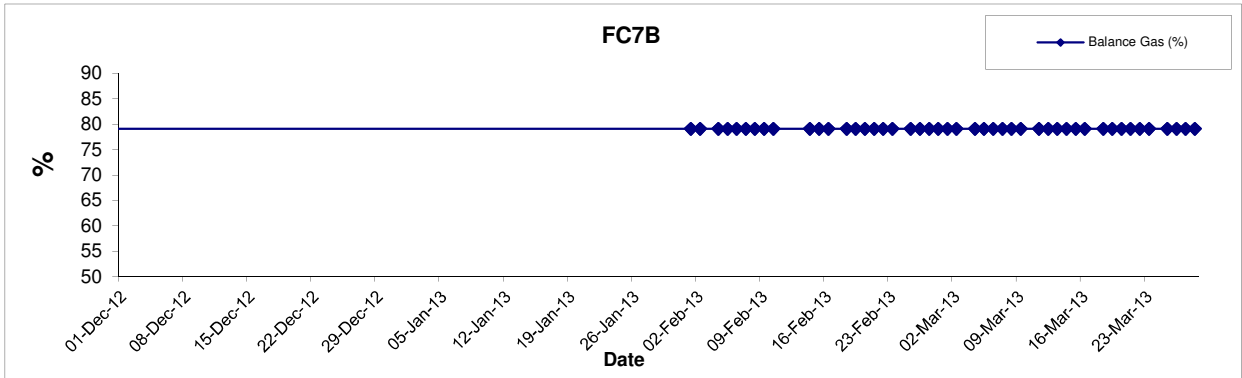
### Balance Gas

Title Contract No. DC/2009/09 Construction of Tai Po Sewage Treatment Works - Stage V Phase II B Graphical Presentation of Landfill Gas Measurement	Scale N.T.S	Project No. MA0010	<b>CINOTECH</b>
	Date Apr 9	Appendix G

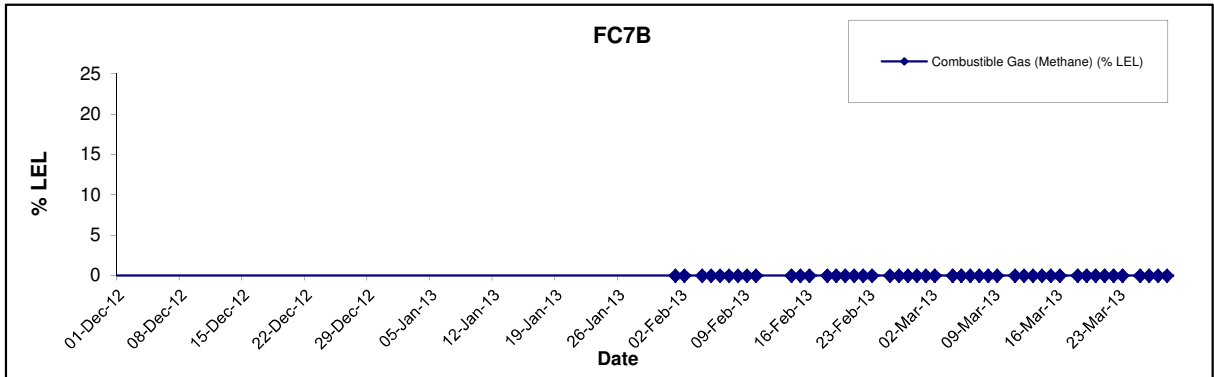
### Combustible Gas (Methane)

Title Contract No. DC/2009/09 Construction of Tai Po Sewage Treatment Works - Stage V Phase II B  Graphical Presentation of Landfill Gas Measurement	Scale N.T.S	Project No. MA0010	<h1 style="margin: 0;">CINOTECH</h1>
	Date Apr 9	Appendix G

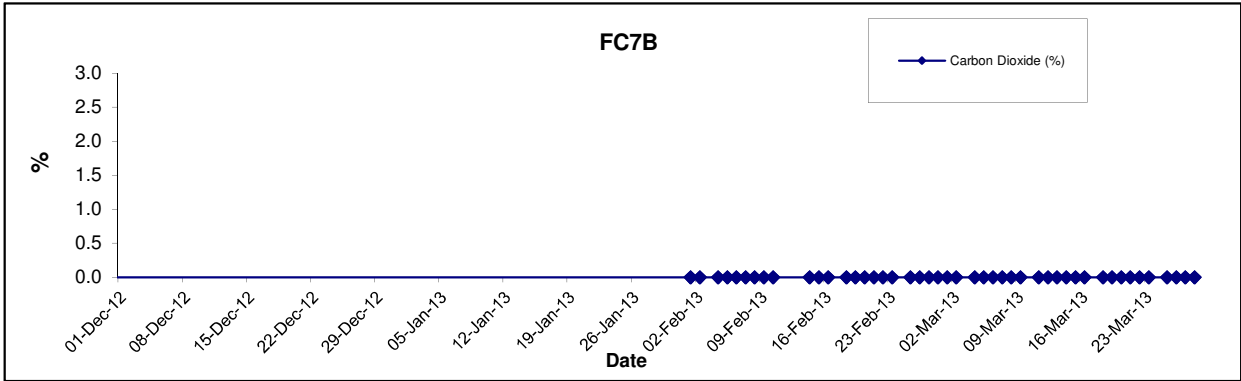
### Carbon Dioxide

Title Contract No. DC/2009/09 Construction of Tai Po Sewage Treatment Works - Stage V Phase II B Graphical Presentation of Landfill Gas Measurement	Scale N.T.S	Project No. MA0010	<b>CINOTECH</b>
	Date Apr 9	Appendix G

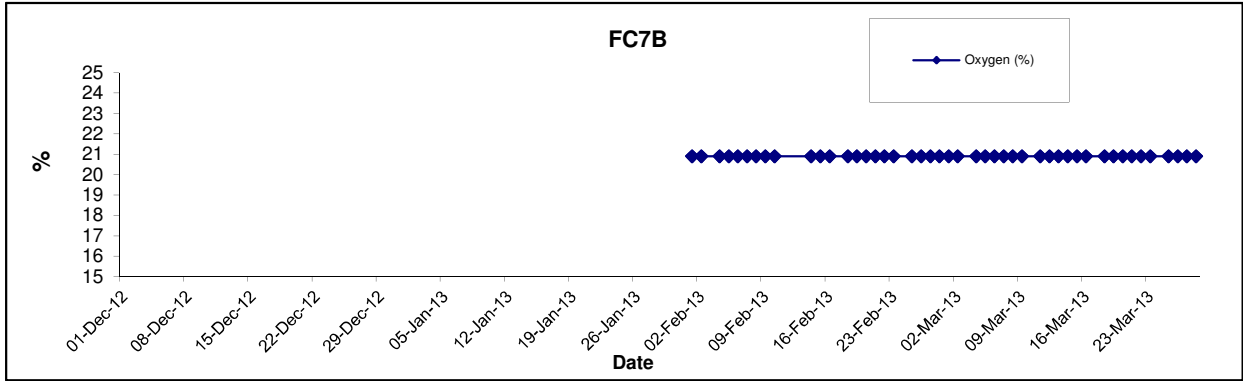
### Oxygen

Title Contract No. DC/2009/09 Construction of Tai Po Sewage Treatment Works - Stage V Phase II B Graphical Presentation of Landfill Gas Measurement	Scale N.T.S	Project No. MA0010	<b>CINOTECH</b>
	Date Apr 9	Appendix G
