Contract No. DC/2009/09
Construction of Tai Po Sewage Treatment
Works – Stage V Phase II B

**Monthly Environmental Monitoring
and Audit Report for
May 2013**

(Version 2.0)

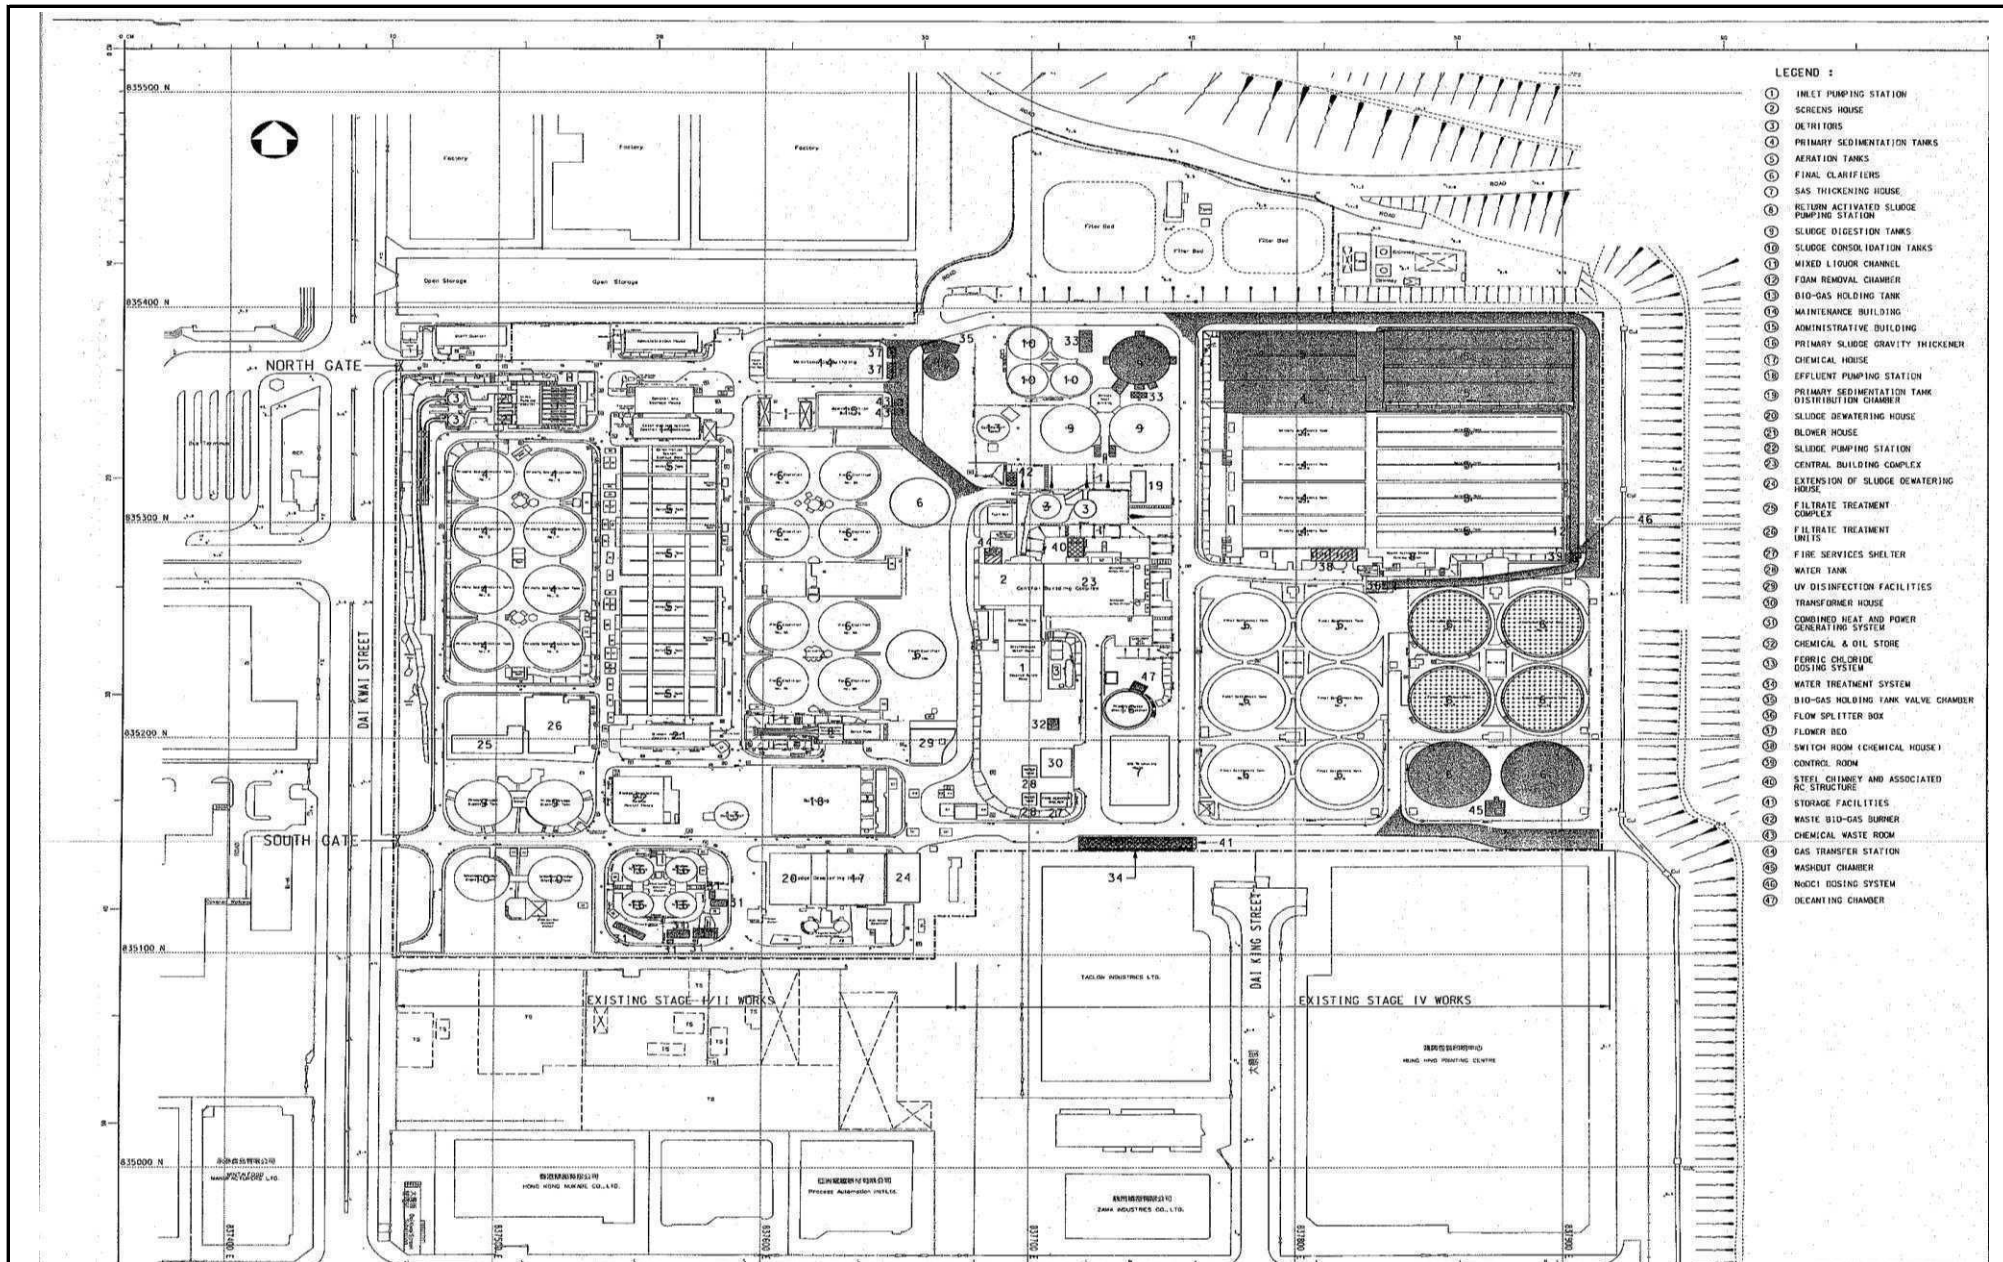
Scale	N.T.S	Project No.	MA0010	CINOTECH
Date	Jul-10	Figure	1.1

PROJECT SITE LAYOUT PLAN (TPSTW)

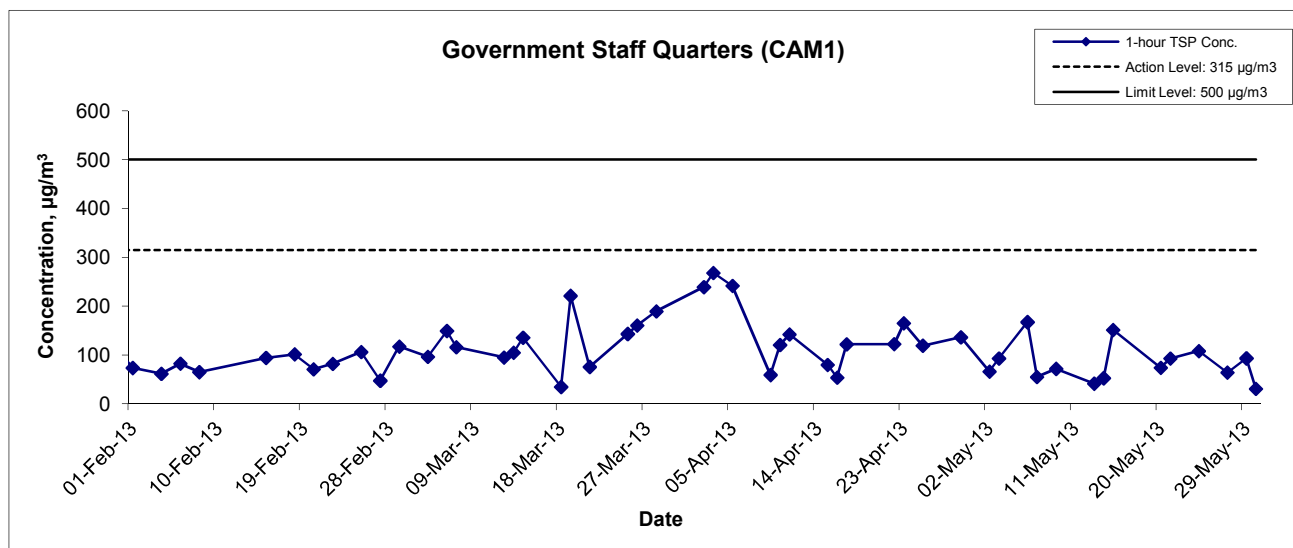
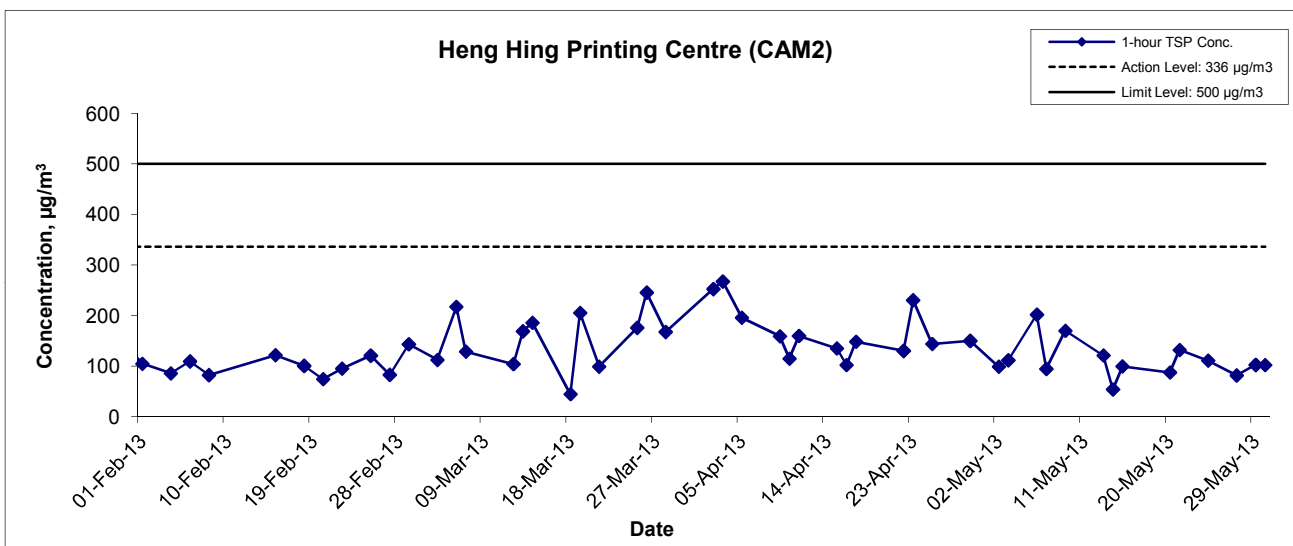
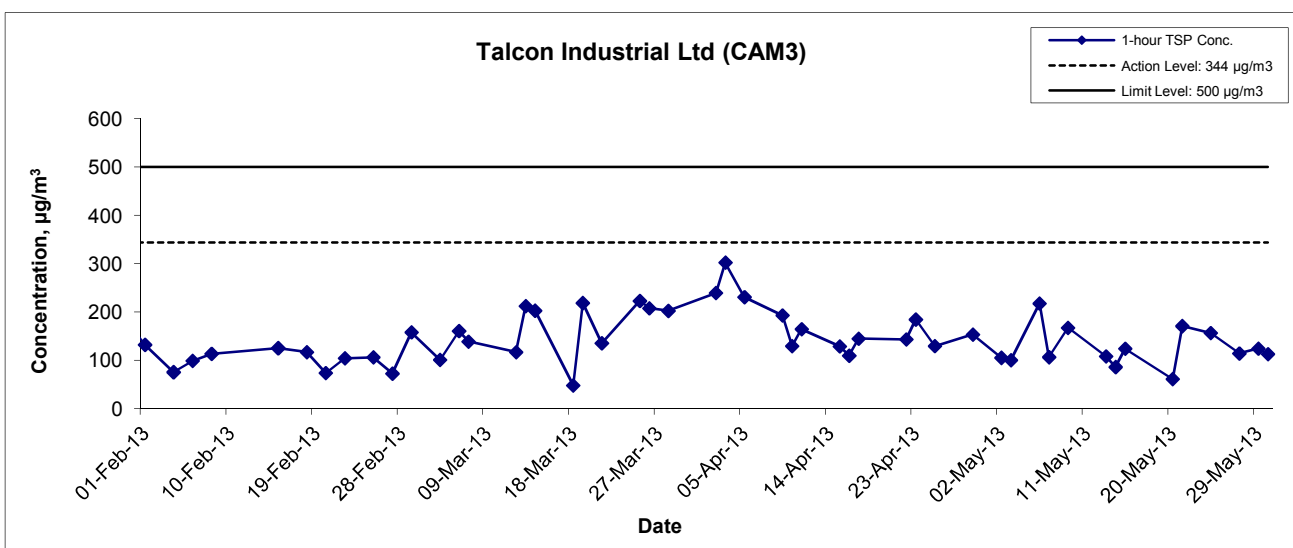
Title
 Contract No. DC/2009/09
 Construction of Tai Po Sewage Treatment Works - Stage V Phase II B
 Graphical Presentation of 1-hour TSP Impact Monitoring Results

1-hr TSP Concentration Levels

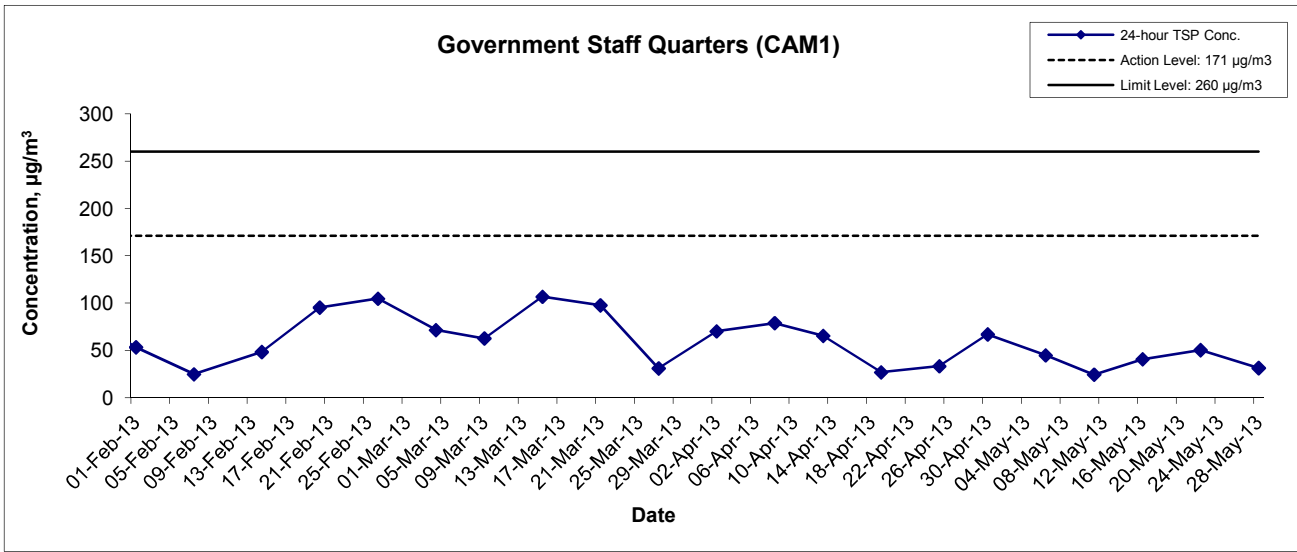
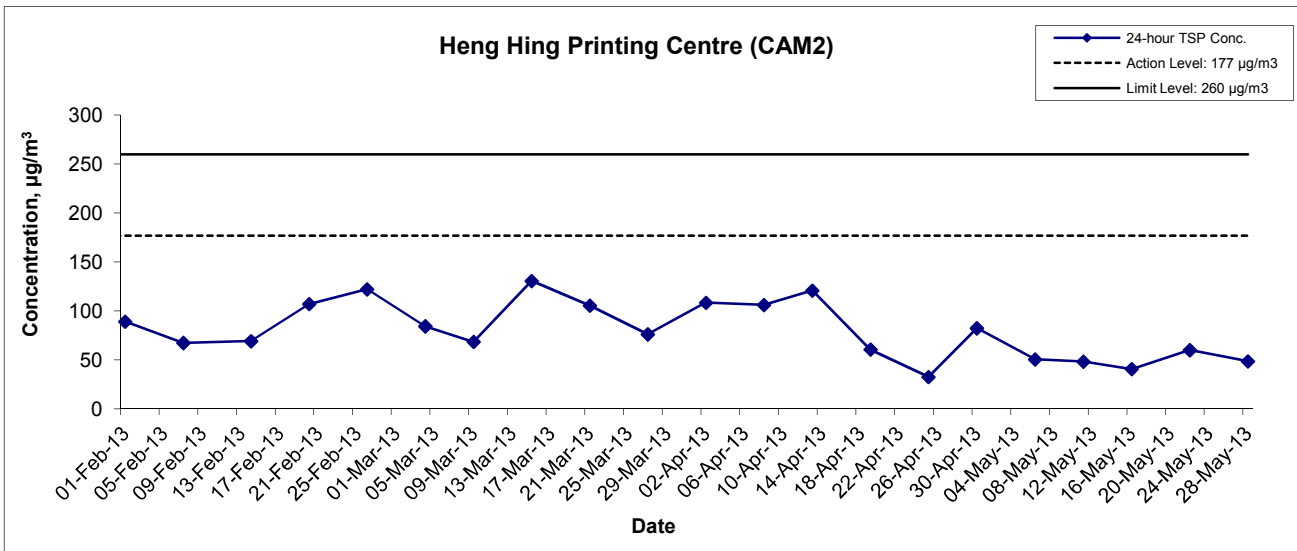
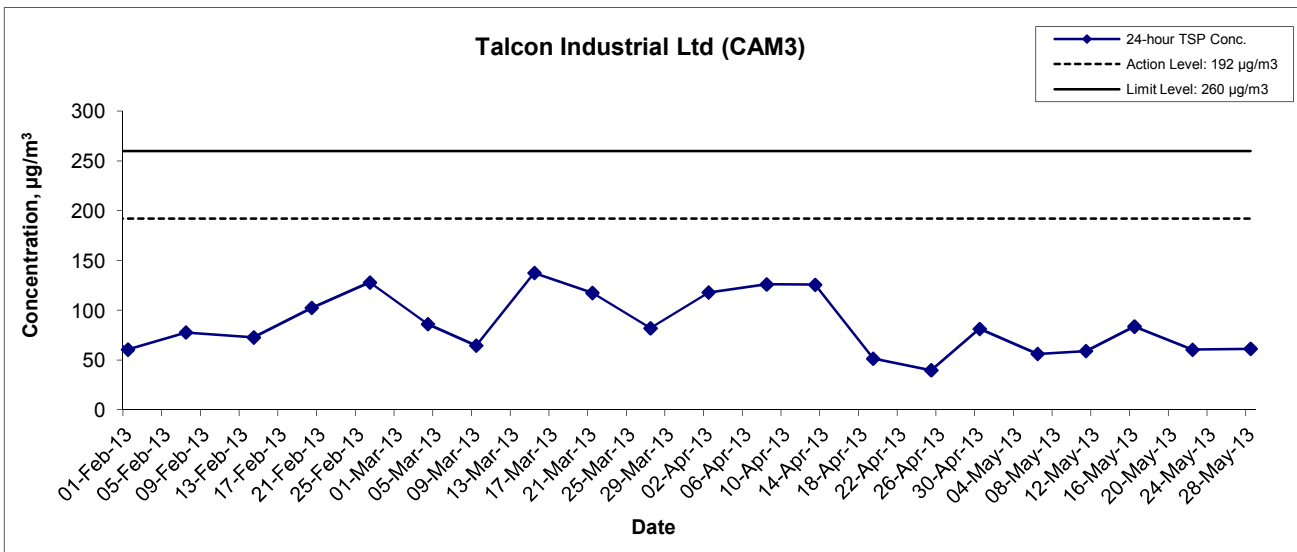
Title Contract No. DC/2009/09 Construction of Tai Po Sewage Treatment Works - Stage V Phase II B Graphical Presentation of 24-hour TSP Impact Monitoring Results	Scale N.T.S	Project No. MA0010	
	Date May 13	Appendix E

24-hr TSP Concentration Levels

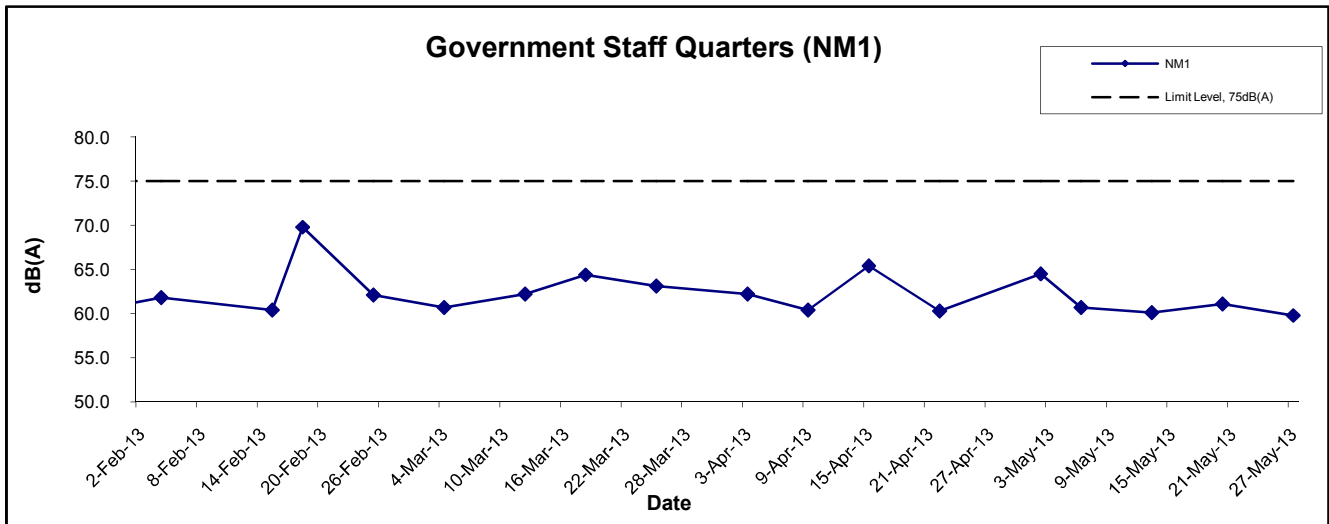
Title Contract No. DC/2009/09 Construction of Tai Po Sewage Treatment Works - Stage V Phase II B Graphical Presentation of Construction Noise Monitoring Results	Scale N.T.S	Project No. MA0010	
	Date May 13	Appendix F

Location NM1 - Government Staff Quarters					
Date	Time	Weather	dB (A) (30-min)		
			L _{eq}	L ₁₀	L ₉₀
2-May-13	11:05	Fine	64.5	67.5	56.5
6-May-13	13:00	Fine	60.7	61.4	58.8
13-May-13	13:00	Cloudy	60.1	61.4	57.7
20-May-13	13:25	Sunny	61.1	62.5	56.9
27-May-13	15:30	Cloudy	59.8	62.2	57.4
		Average	61.6	63.0	57.5
		Minimum	59.8	61.4	56.5
		Maximum	64.5	67.5	58.8

Noise Levels

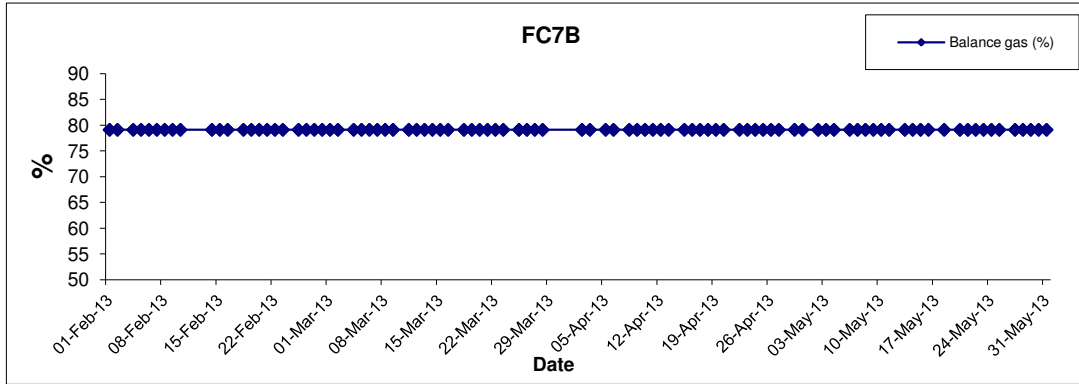
Title Contract No. DC/2009/09 Construction of Tai Po Sewage Treatment Works - Stage V Phase II B Graphical Presentation of Landfill Gas Measurement	Scale N.T.S	Project No. MA0010	
	Date May 13	Appendix G

Balance Gas

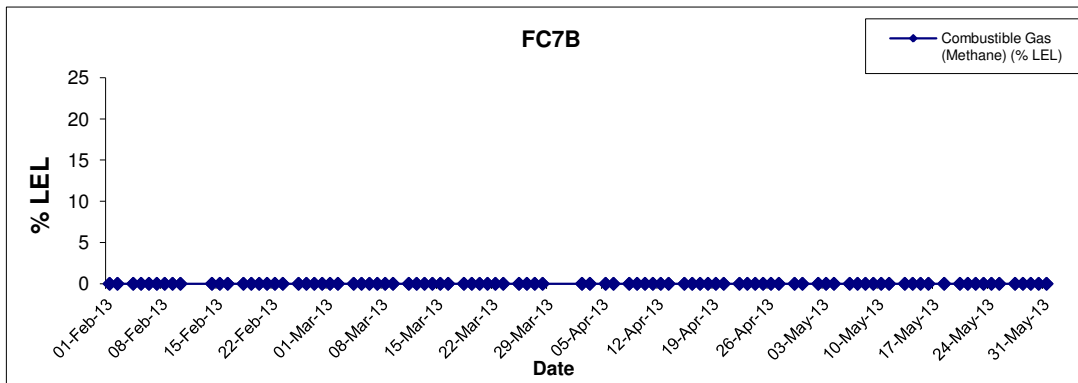
Title Contract No. DC/2009/09 Construction of Tai Po Sewage Treatment Works - Stage V Phase II B Graphical Presentation of Landfill Gas Measurement	Scale N.T.S	Project No. MA0010	CINOTECH
	Date May 13	Appendix G

Combustible Gas (Methane)

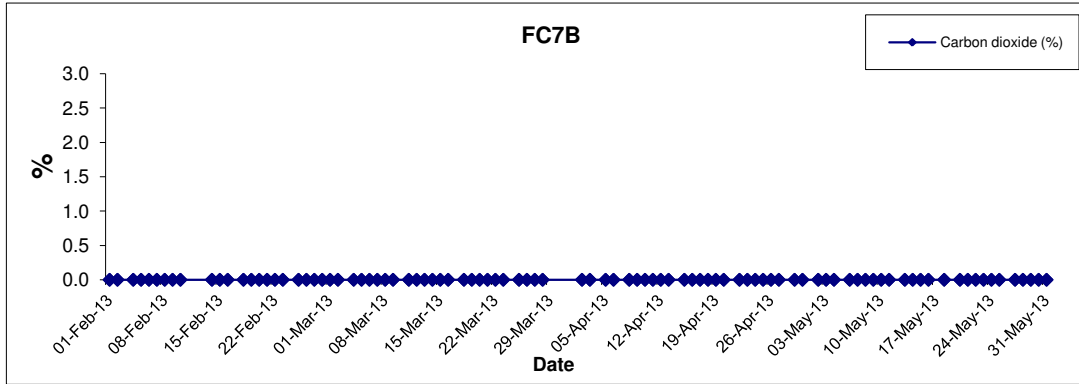
Title Contract No. DC/2009/09 Construction of Tai Po Sewage Treatment Works - Stage V Phase II B Graphical Presentation of Landfill Gas Measurement	Scale N.T.S	Project No. MA0010	CINOTECH
	Date May 13	Appendix G

Carbon Dioxide

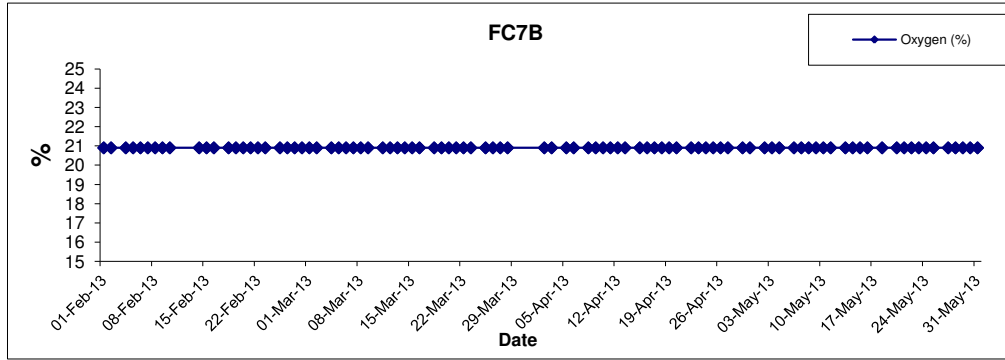
Title	Contract No. DC/2009/09	Scale	Project	CINOTECH
	Construction of Tai Po Sewage Treatment Works - Stage V Phase II B	N.T.S	No. MA0010	
Graphical Presentation of Landfill Gas Measurement		Date	Appendix	
		May 13	G

Oxygen
