Contract No. DC/2009/09
Construction of Tai Po Sewage Treatment
Works – Stage V Phase II B

**Monthly Environmental Monitoring
and Audit Report for
June 2013**

(Version 2.0)

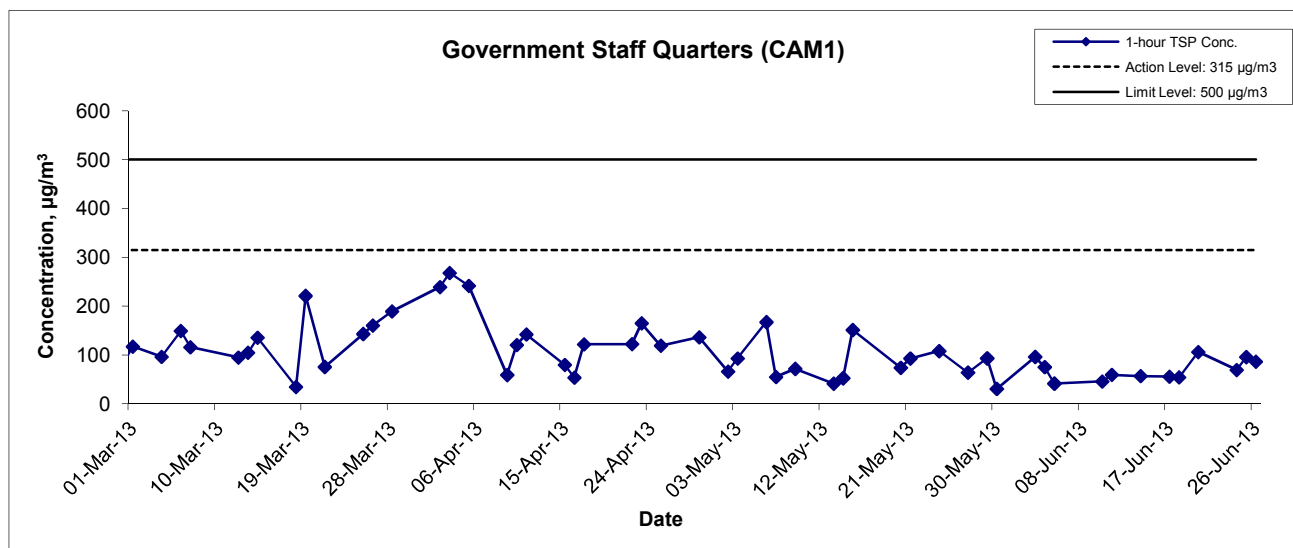
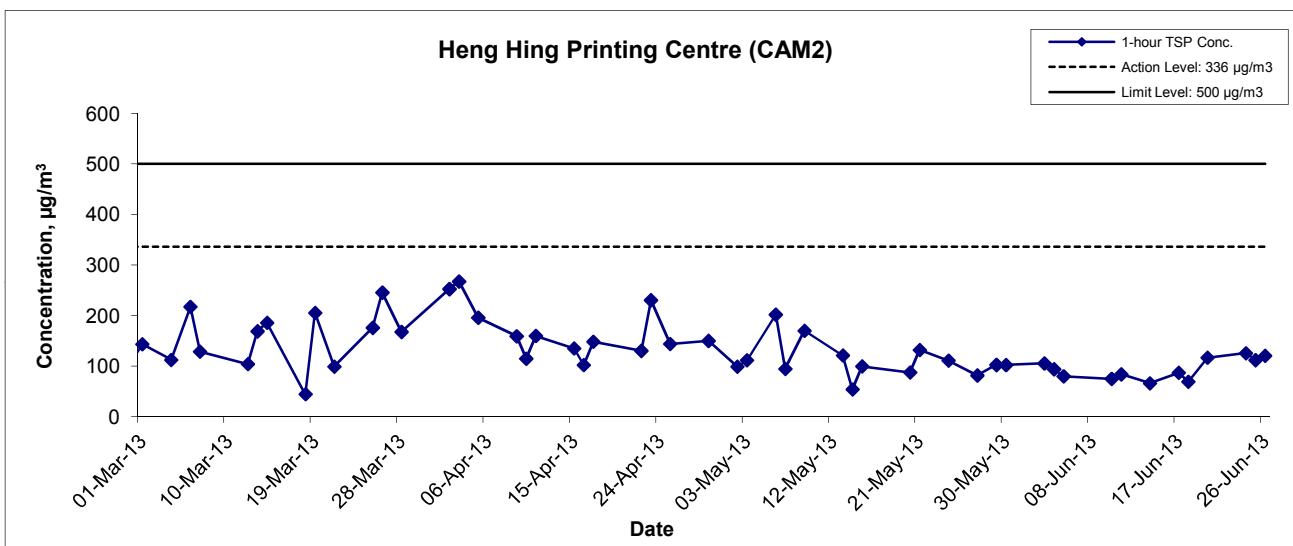
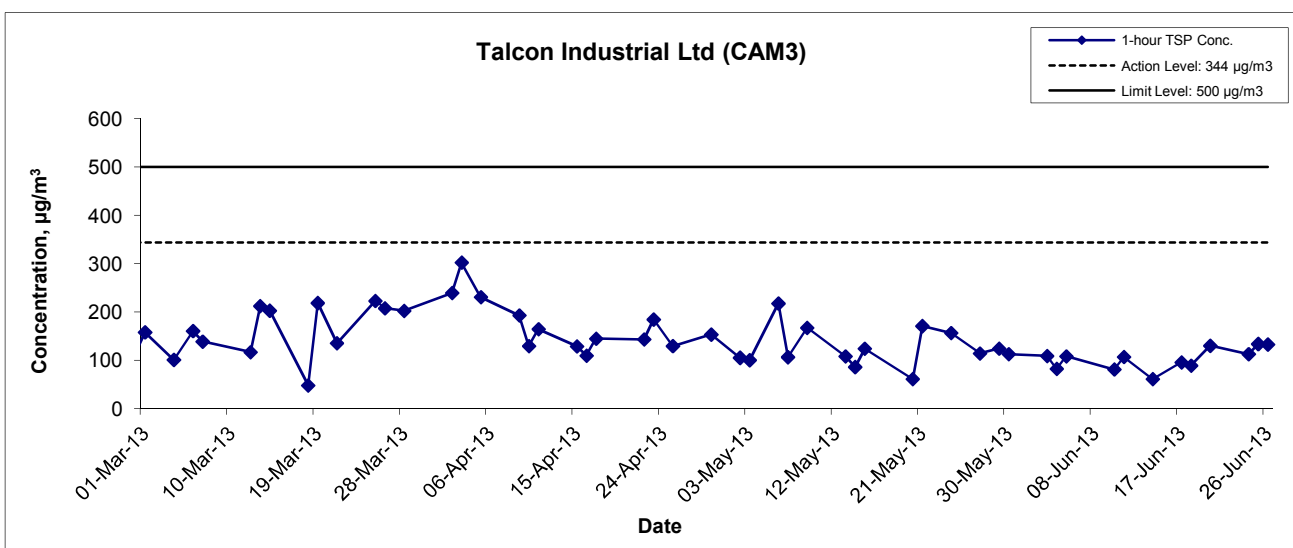
1-hr TSP Concentration Levels

Title
 Contract No. DC/2009/09
 Construction of Tai Po Sewage Treatment Works - Stage V Phase II B
 Graphical Presentation of 1-hour TSP Impact Monitoring Results

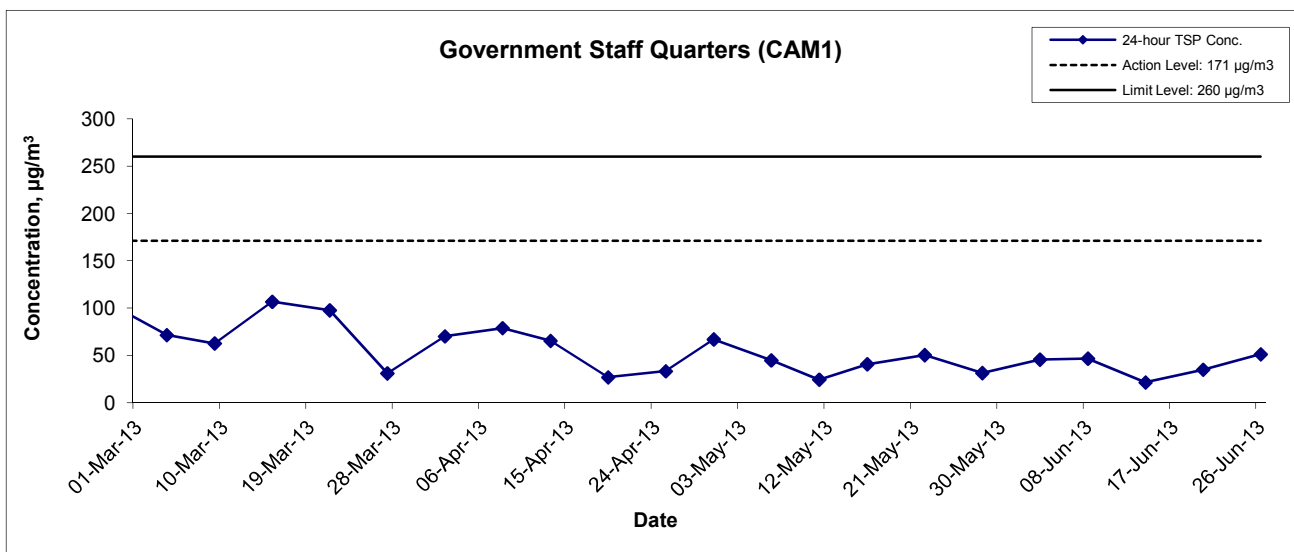
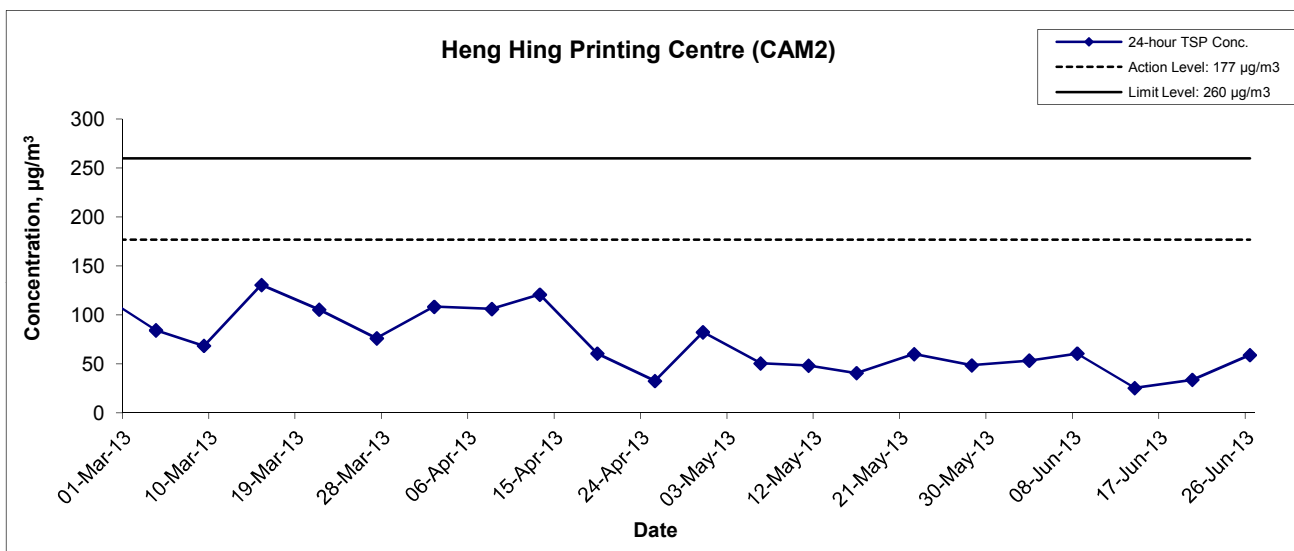
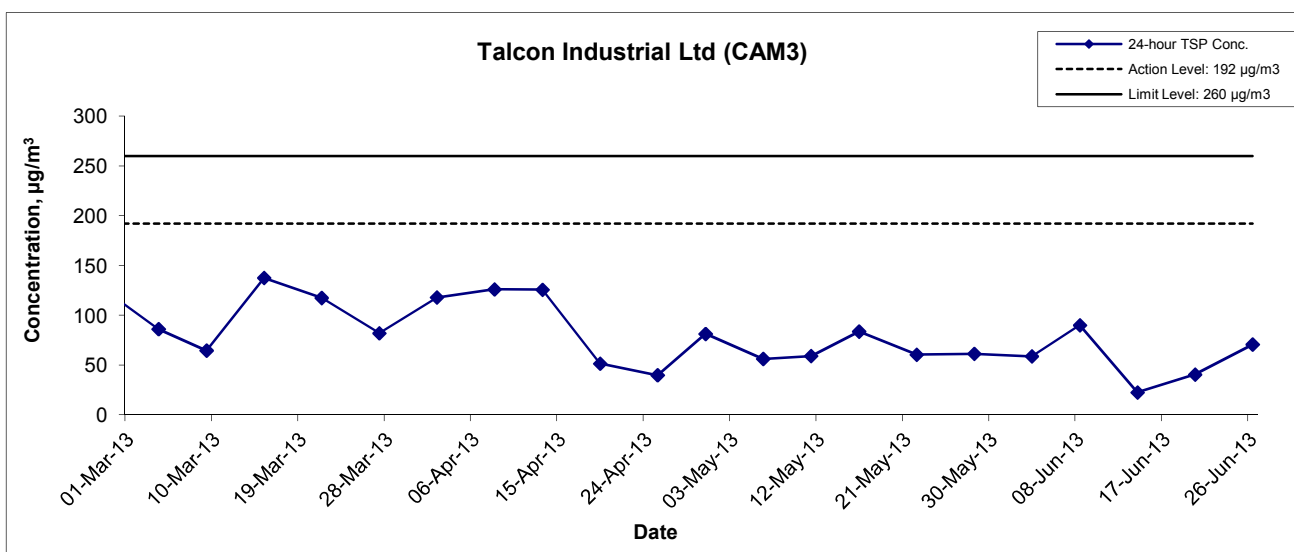
24-hr TSP Concentration Levels

Title Contract No. DC/2009/09 Construction of Tai Po Sewage Treatment Works - Stage V Phase II B Graphical Presentation of 24-hour TSP Impact Monitoring Results	Scale N.T.S	Project No. MA0010	
	Date Jun 13	Appendix E

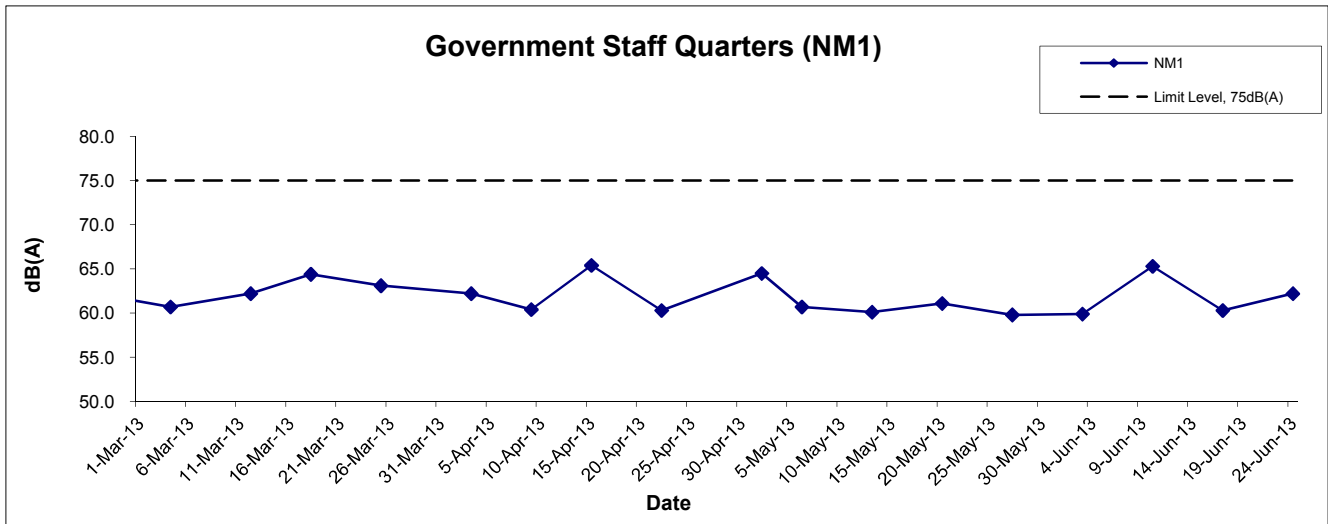
Noise Levels

Title Contract No. DC/2009/09 Construction of Tai Po Sewage Treatment Works - Stage V Phase II B Graphical Presentation of Construction Noise Monitoring Results	Scale N.T.S	Project No. MA0010	
	Date Jun 13	Appendix F

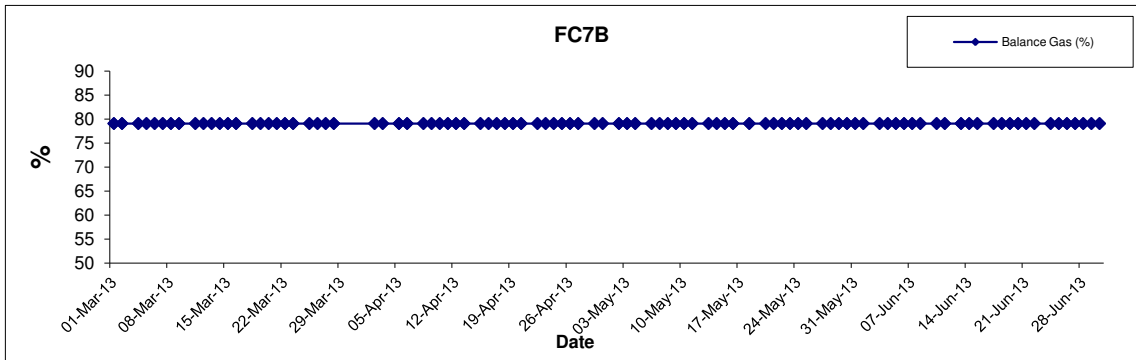
Balance Gas

Title
 Contract No. DC/2009/09
 Construction of Tai Po Sewage Treatment Works - Stage V Phase II B
 Graphical Presentation of Landfill Gas Measurement

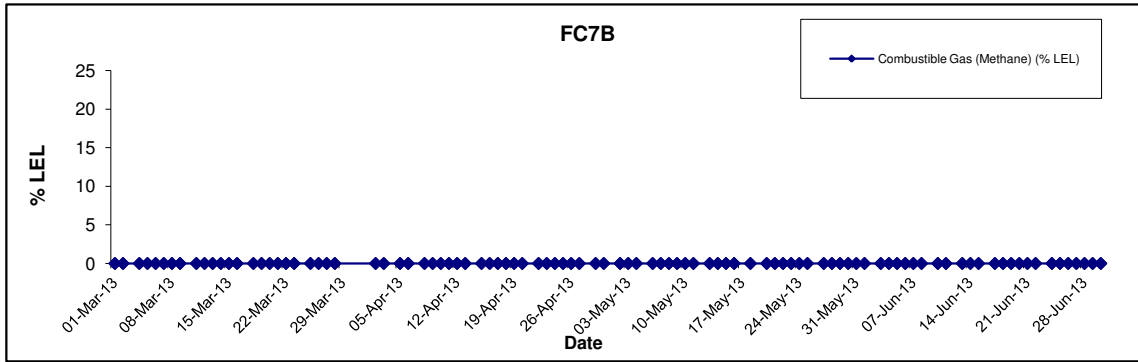
Combustible Gas (Methane)

Title Contract No. DC/2009/09 Construction of Tai Po Sewage Treatment Works - Stage V Phase II B Graphical Presentation of Landfill Gas Measurement	Scale	Project	
	Date	Appendix	
	N.T.S	No. MA0010	
	Jun 13	G

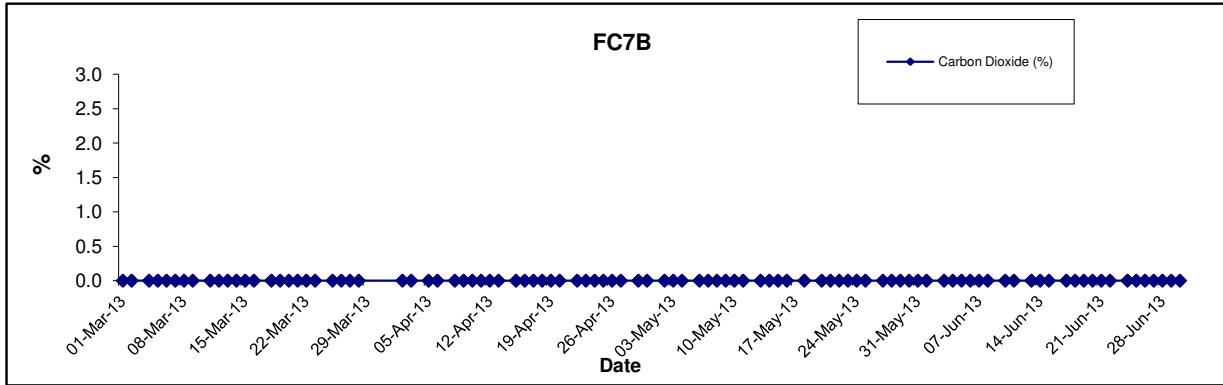
Carbon Dioxide

Title Contract No. DC/2009/09 Construction of Tai Po Sewage Treatment Works - Stage V Phase II B Graphical Presentation of Landfill Gas Measurement	Scale N.T.S	Project No. MA0010	CINOTECH
	Date Jun 13	Appendix G

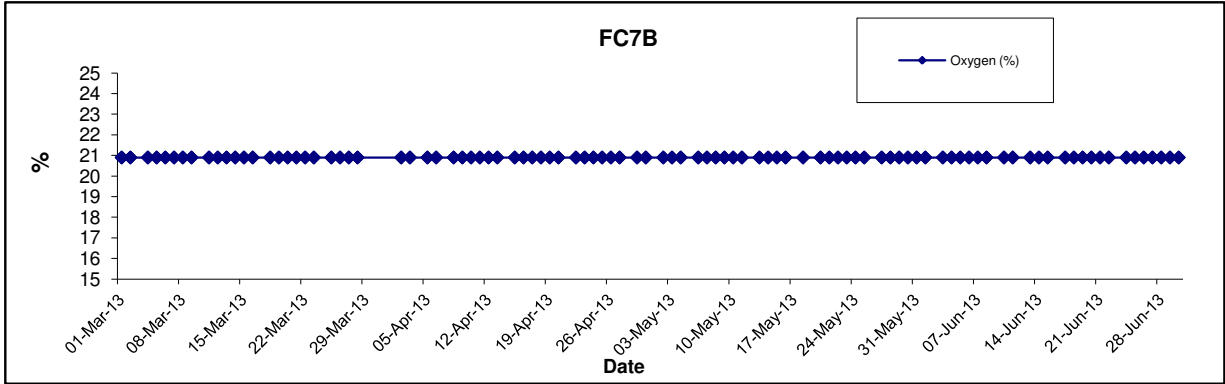
Oxygen

Title Contract No. DC/2009/09 Construction of Tai Po Sewage Treatment Works - Stage V Phase II B Graphical Presentation of Landfill Gas Measurement	Scale N.T.S	Project No. MA0010	CINOTECH
	Date Jun 13	Appendix G
