**China Harbour Engineering Company Limited**

Contract No. DC/2009/09  
Construction of Tai Po Sewage Treatment  
Works – Stage V Phase II B

**Monthly Environmental Monitoring  
and Audit Report for  
July 2013**

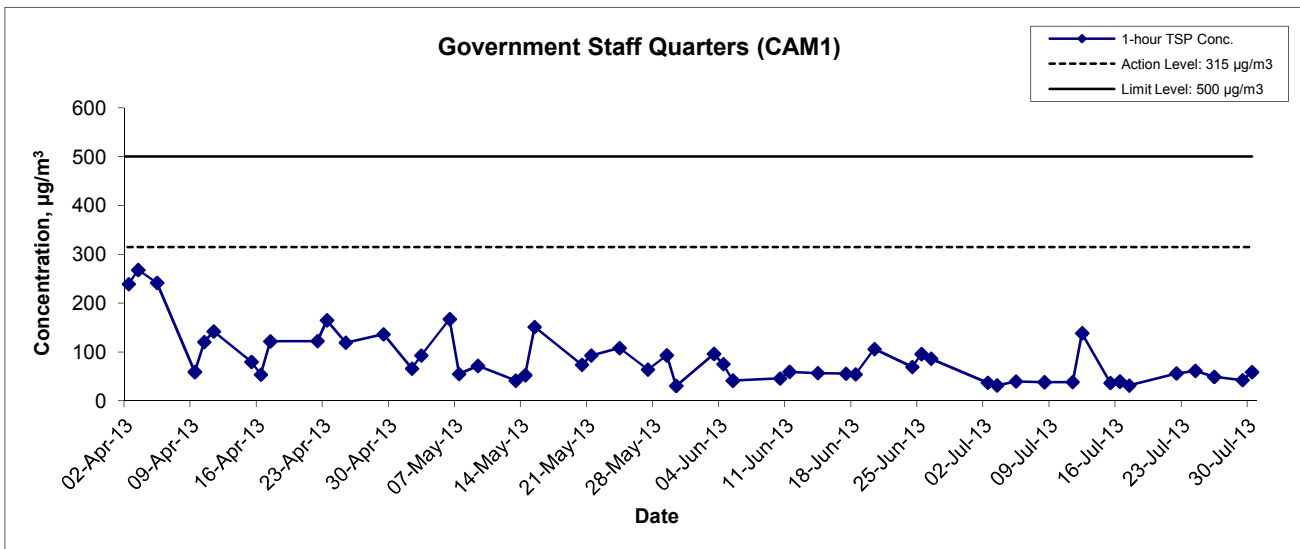
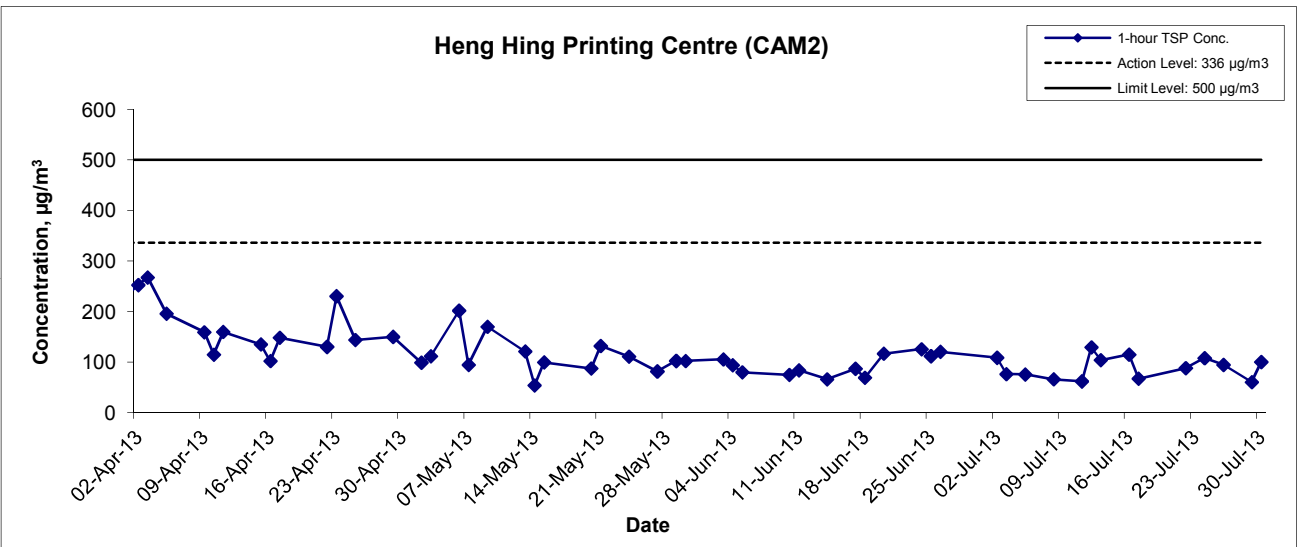
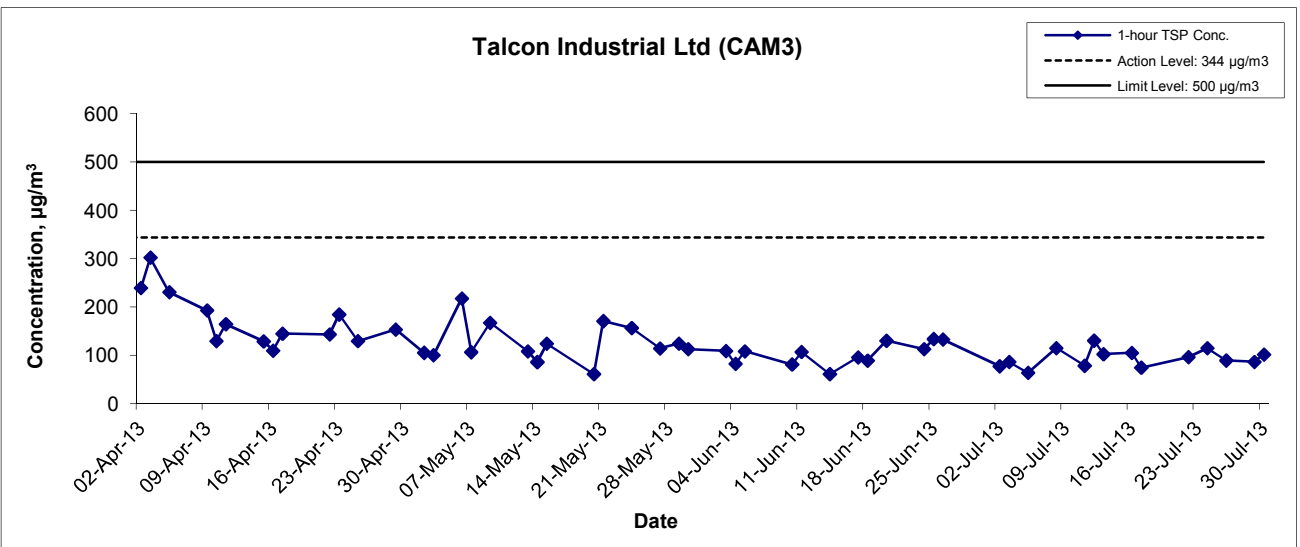
Title Contract No. DC/2009/09 Construction of Tai Po Sewage Treatment Works - Stage V Phase II B Graphical Presentation of 1-hour TSP Impact Monitoring Results	Scale N.T.S	Project No. MA0010	
	Date Jul 13	Appendix D

### 1-hr TSP Concentration Levels

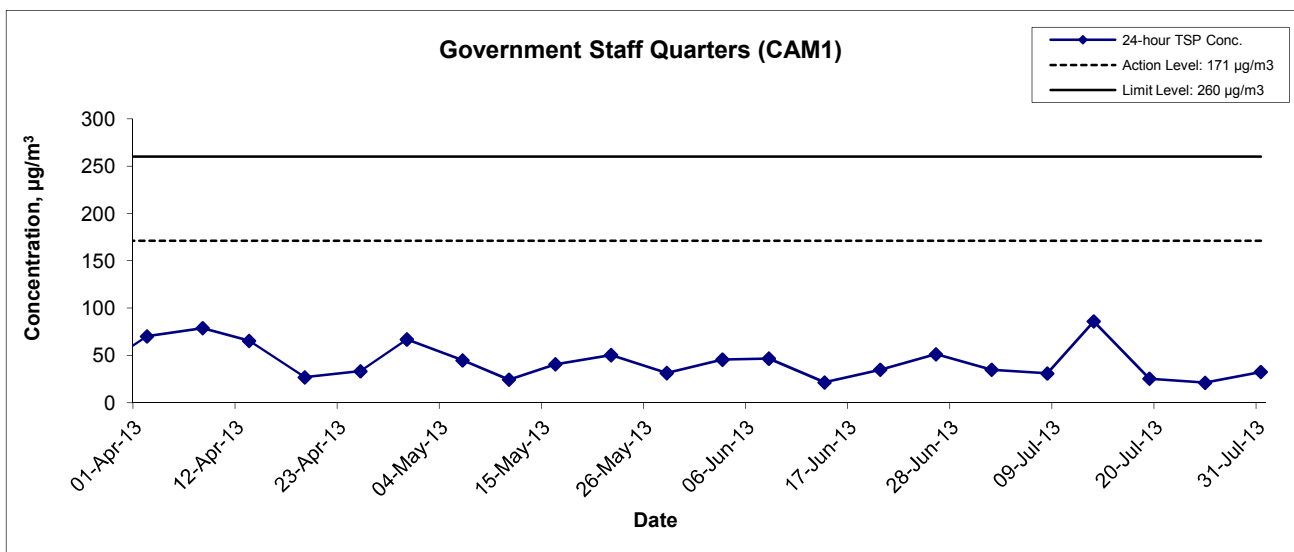
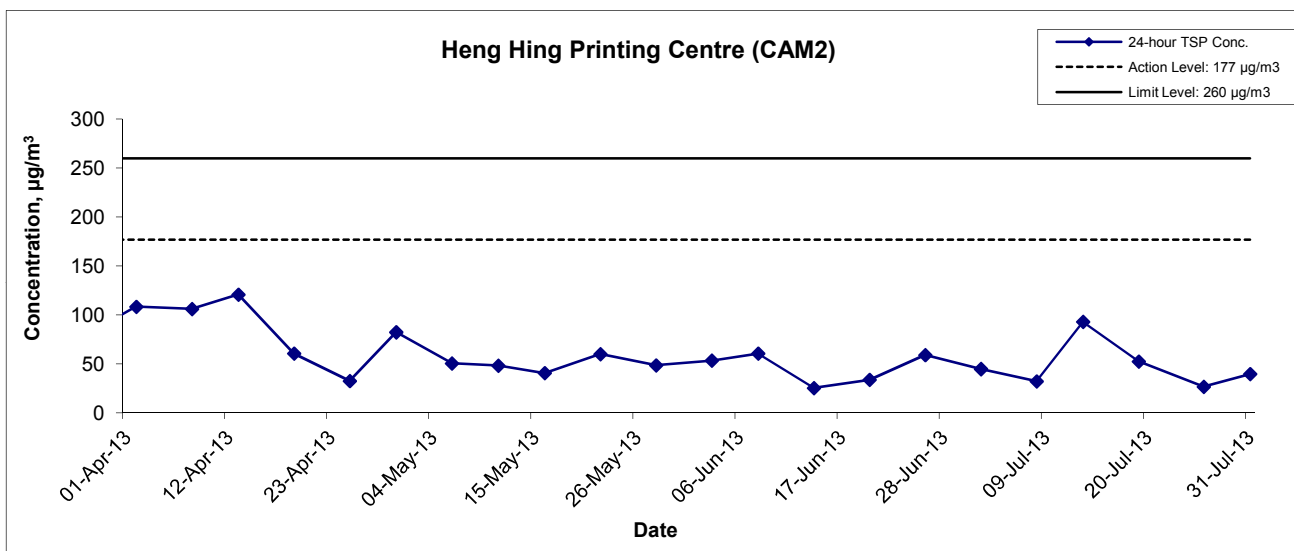
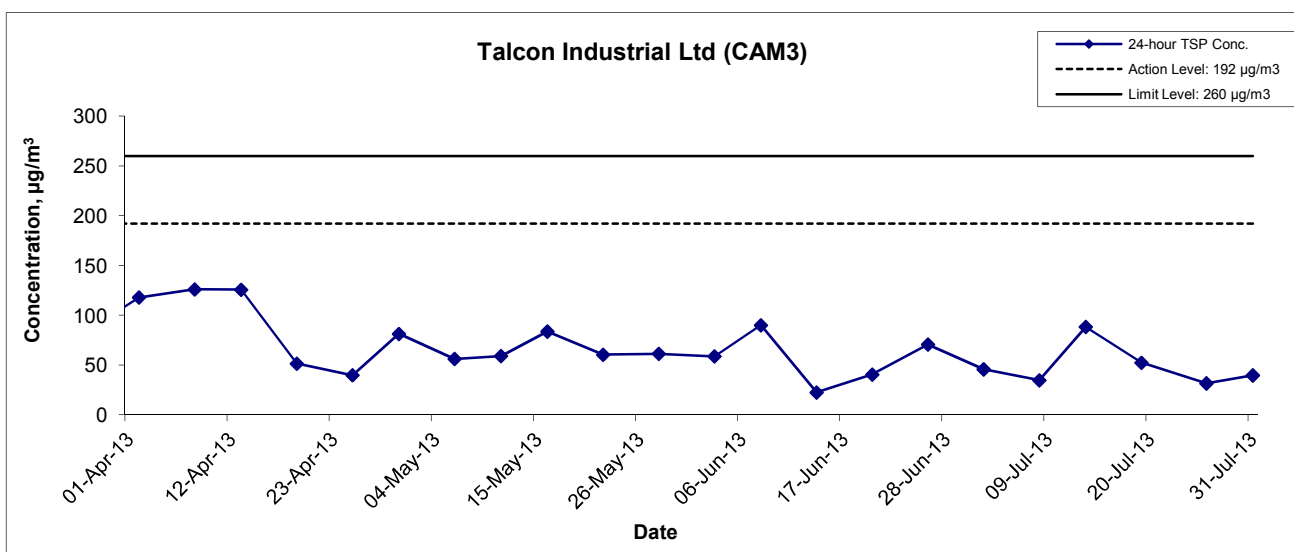
Title Contract No. DC/2009/09 Construction of Tai Po Sewage Treatment Works - Stage V Phase II B Graphical Presentation of 24-hour TSP Impact Monitoring Results	Scale N.T.S	Project No. MA0010	
	Date Jul 13	Appendix E

### 24-hr TSP Concentration Levels

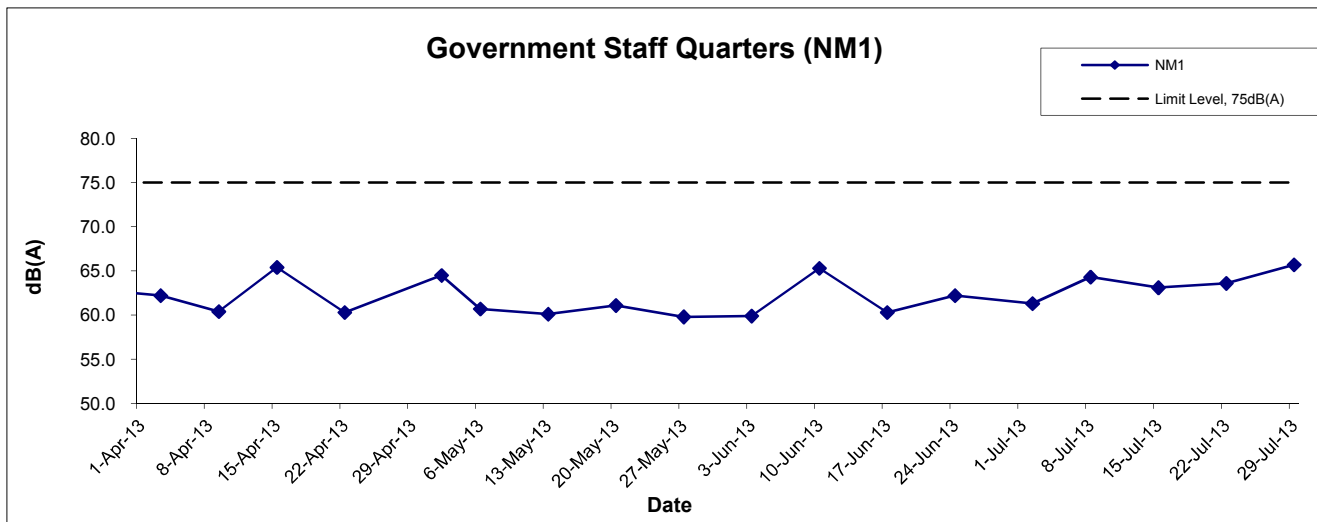
Title Contract No. DC/2009/09 Construction of Tai Po Sewage Treatment Works - Stage V Phase II B  Graphical Presentation of Construction Noise Monitoring Results	Scale N.T.S	Project No. MA0010	
	Date Jul 13	Appendix F

Location NM1 - Government Staff Quarters					
Date	Time	Weather	dB (A) (30-min)		
			L <sub>eq</sub>	L <sub>10</sub>	L <sub>90</sub>
2-Jul-13	13:00	Sunny	61.3	65.5	57.8
8-Jul-13	09:30	Sunny	64.3	67.1	58.4
15-Jul-13	13:00	Cloudy	63.1	64.5	61.4
22-Jul-13	13:20	Sunny	63.6	66.7	60.2
29-Jul-13	10:00	Sunny	65.7	68.4	59.6
		Average	63.8	66.4	59.5
		Minimum	61.3	64.5	57.8
		Maximum	65.7	68.4	61.4

## Noise Levels

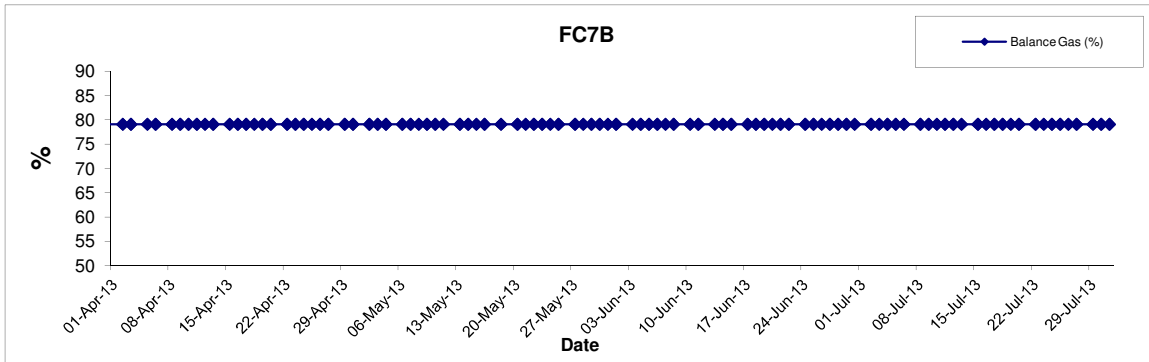
Title Contract No. DC/2009/09 Construction of Tai Po Sewage Treatment Works - Stage V Phase II B Graphical Presentation of Landfill Gas Measurement	Scale N.T.S	Project No. MA0010	<b>CINOTECH</b>
	Date Jul 13	Appendix G

### Balance Gas

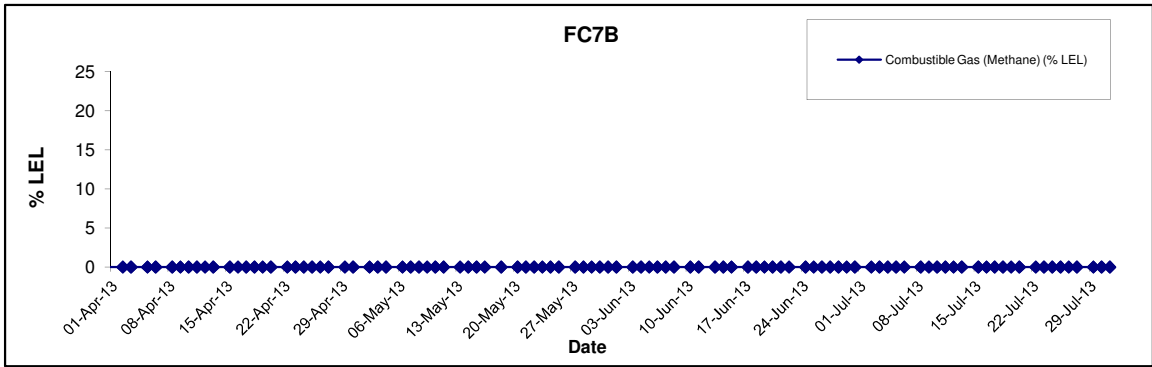
Title Contract No. DC/2009/09 Construction of Tai Po Sewage Treatment Works - Stage V Phase II B Graphical Presentation of Landfill Gas Measurement	Scale N.T.S	Project No. MA0010	<b>CINOTECH</b>
	Date Jul 13	Appendix G

### Combustible Gas (Methane)

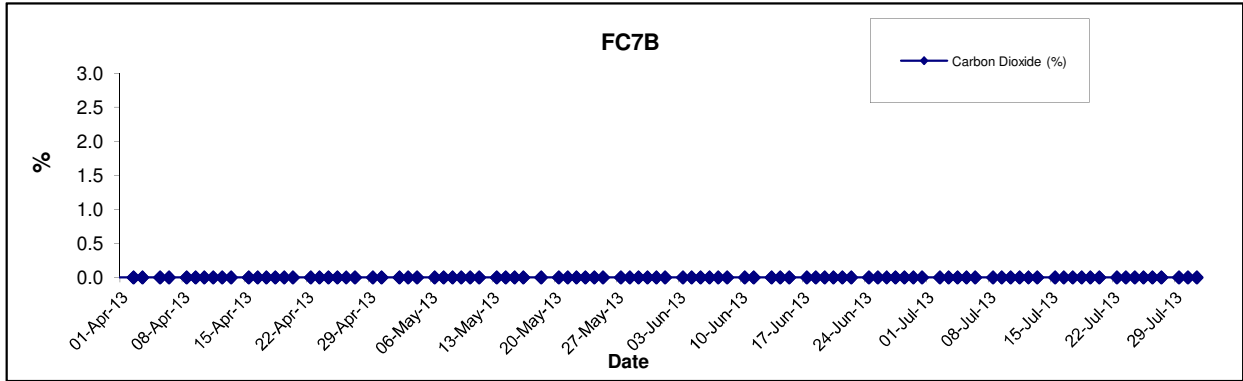
Title Contract No. DC/2009/09 Construction of Tai Po Sewage Treatment Works - Stage V Phase II B  Graphical Presentation of Landfill Gas Measurement	Scale	Project	<b>CINOTECH</b>
	Date	Appendix	
	N.T.S	No. MA0010	
	Jul 13	G

### Carbon Dioxide

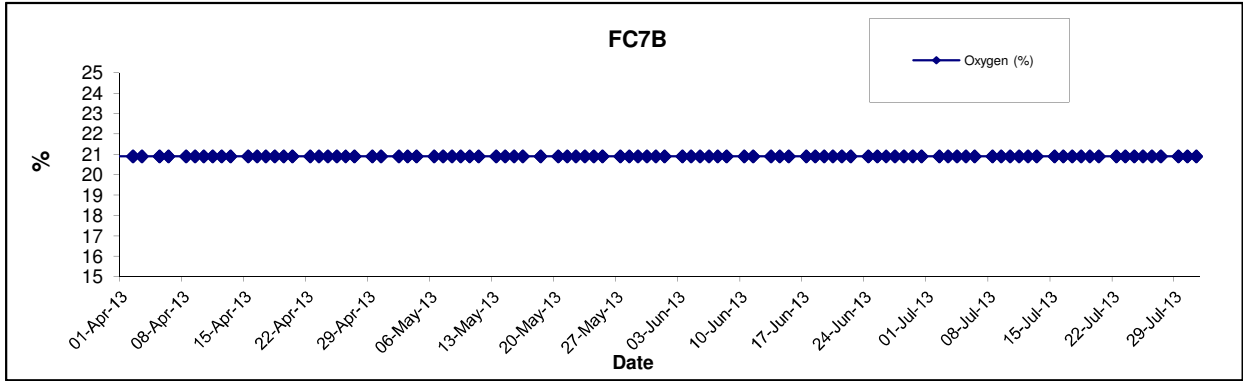
Title Contract No. DC/2009/09 Construction of Tai Po Sewage Treatment Works - Stage V Phase II B Graphical Presentation of Landfill Gas Measurement	Scale	Project	<b>CINOTECH</b>
	Date	Appendix	
	N.T.S	No. MA0010	
	Jul 13	G

### Oxygen
