Contract No. DC/2009/09  
Construction of Tai Po Sewage Treatment  
Works – Stage V Phase II B

**Monthly Environmental Monitoring  
and Audit Report for  
November 2013**

(Version 2.0)

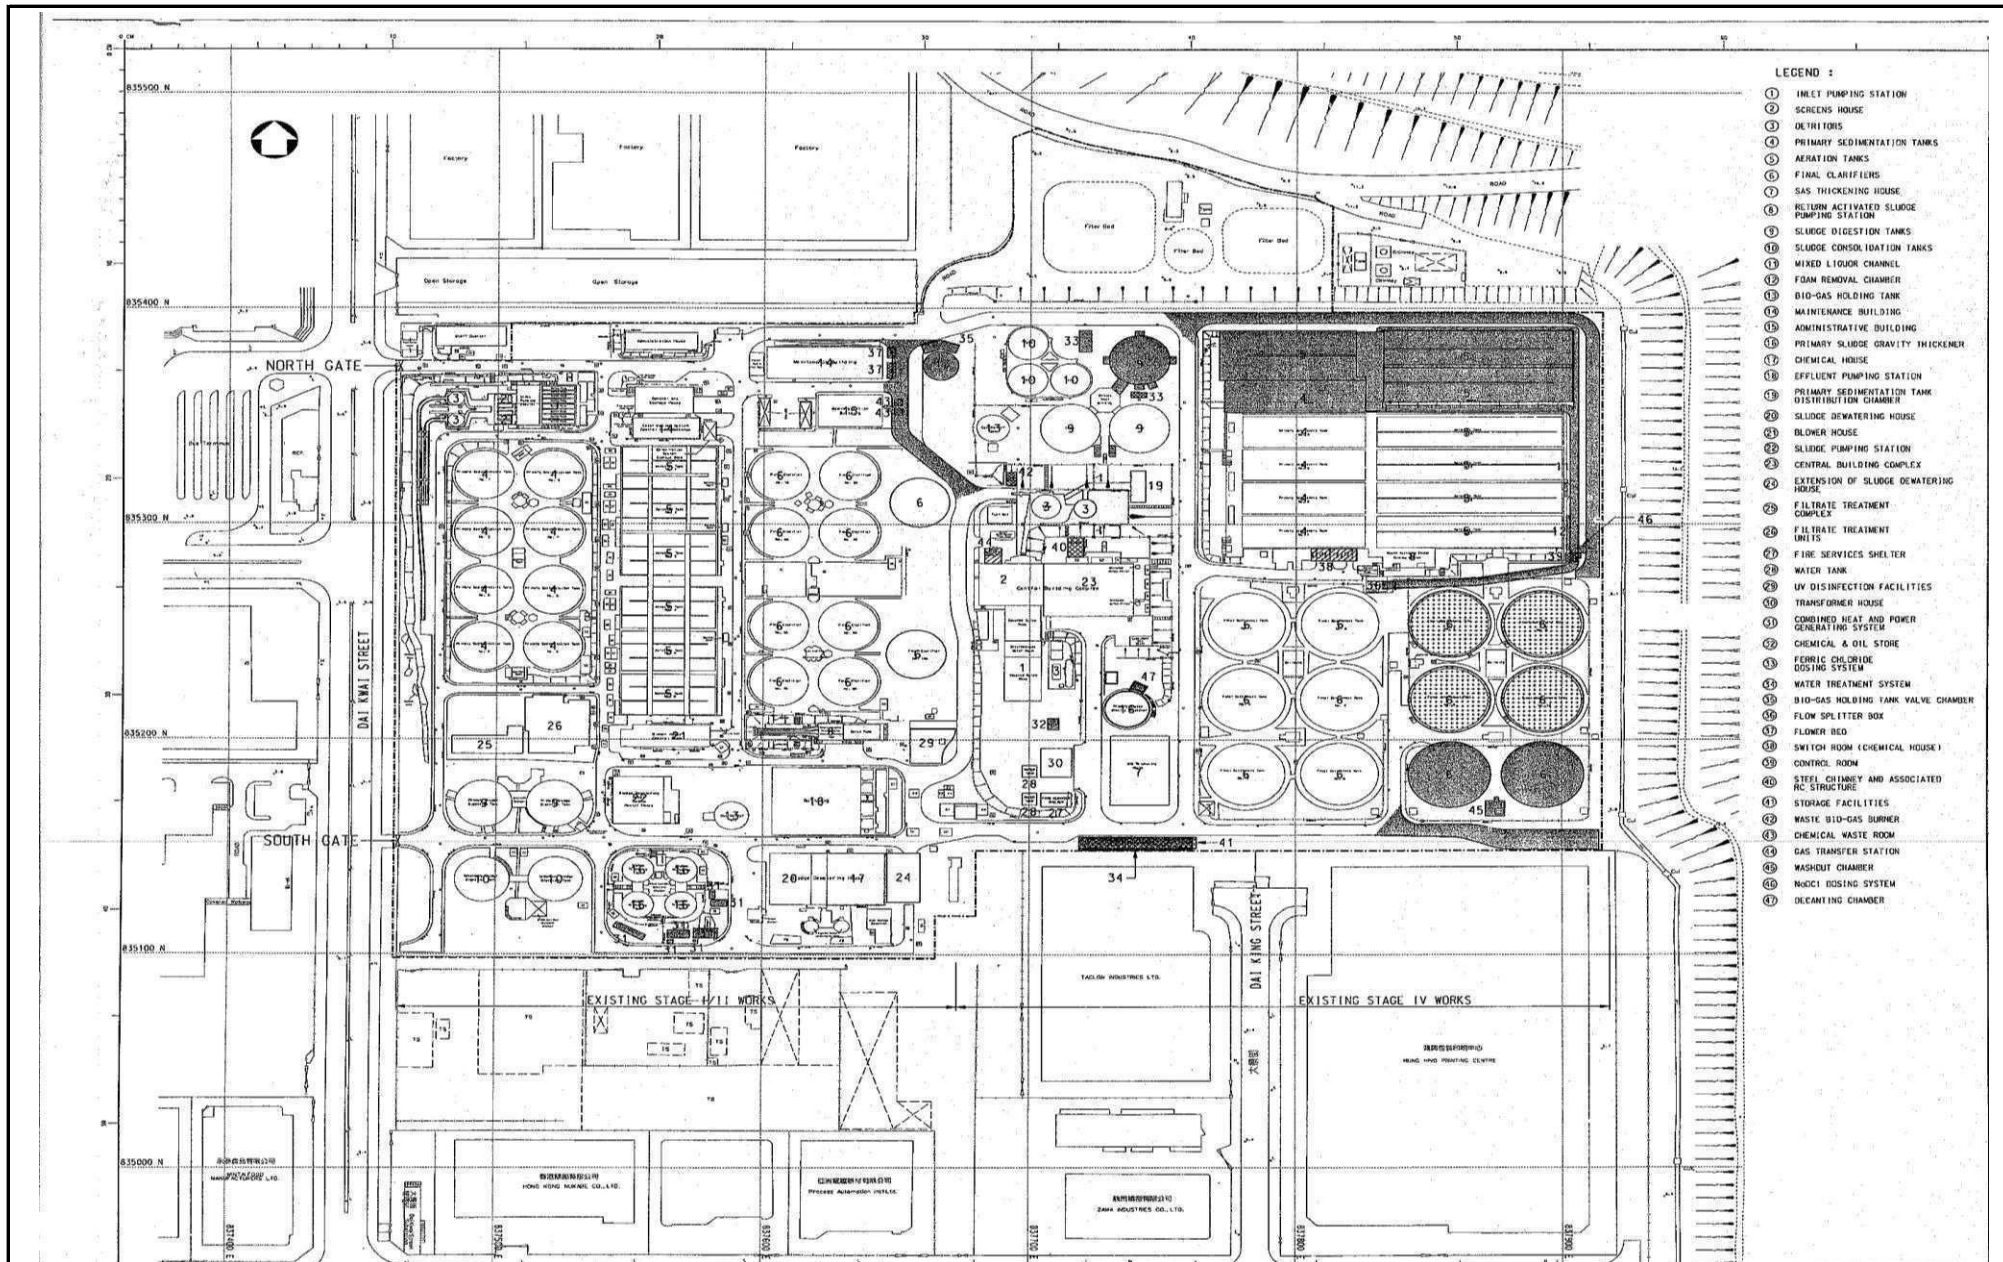
1.1

- LEGEND :**
- ① TRICKLE PUMPING STATION
  - ② SCREENS HOUSE
  - ③ ULTRAFILTRATION
  - ④ PRIMARY SEDIMENTATION TANKS
  - ⑤ AERATION TANKS
  - ⑥ FINAL CLARIFIERS

- ⑦ SAS THICKENING HOUSE
  - ⑧ RETURN ACTIVATED SLUDGE PUMPING STATION
  - ⑨ SLUDGE DIGESTION TANKS
  - ⑩ SLUDGE CONSOLIDATION TANKS
  - ⑪ MIXED LIQUOR CHANNEL

- ㊵ STEEL CHIMNEY AND ASSOCIATED RC STRUCTURE
  - ㊶ STORAGE FACILITIES
  - ㊷ WASTE BIO-GAS BURNER
  - ㊸ CHEMICAL WASTE ROOM
  - ㊹ GAS TRANSFER STATION
  - ㊺ WASHOUT CHAMBER

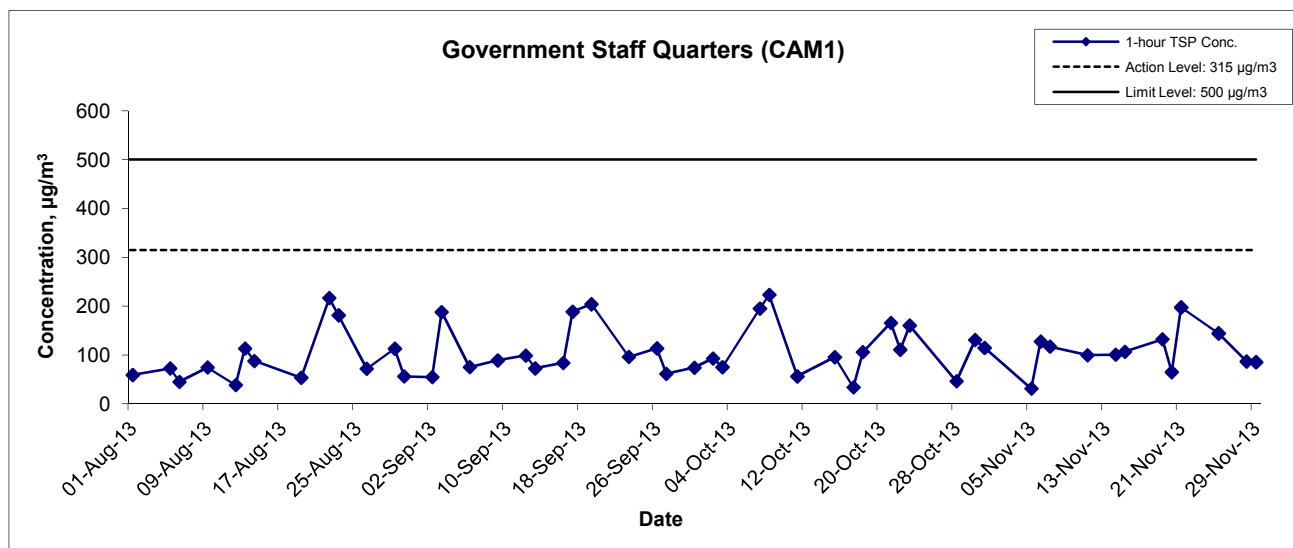
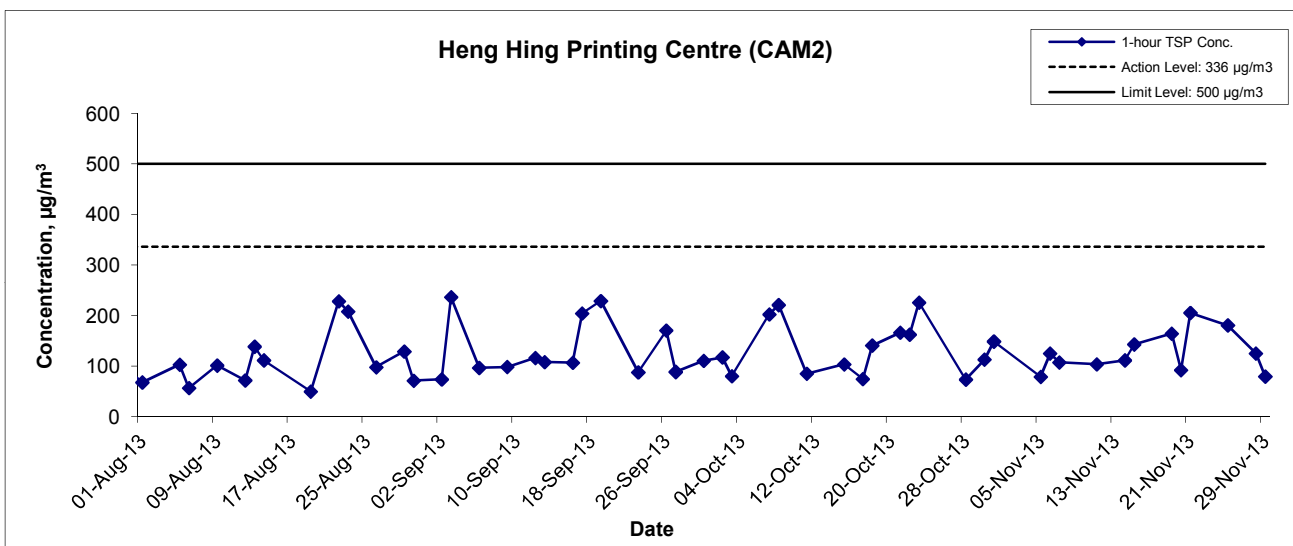
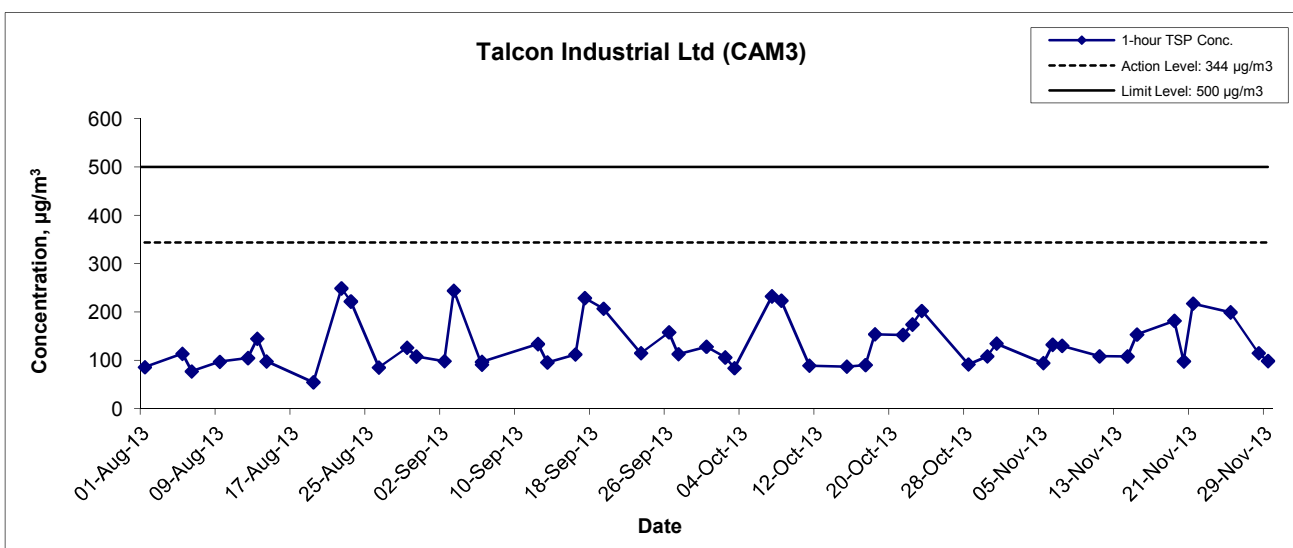
### 1-hr TSP Concentration Levels

Title Contract No. DC/2009/09 Construction of Tai Po Sewage Treatment Works - Stage V Phase II B Graphical Presentation of 1-hour TSP Impact Monitoring Results	Scale N.T.S	Project No. MA0010	
	Date Nov 13	Appendix D

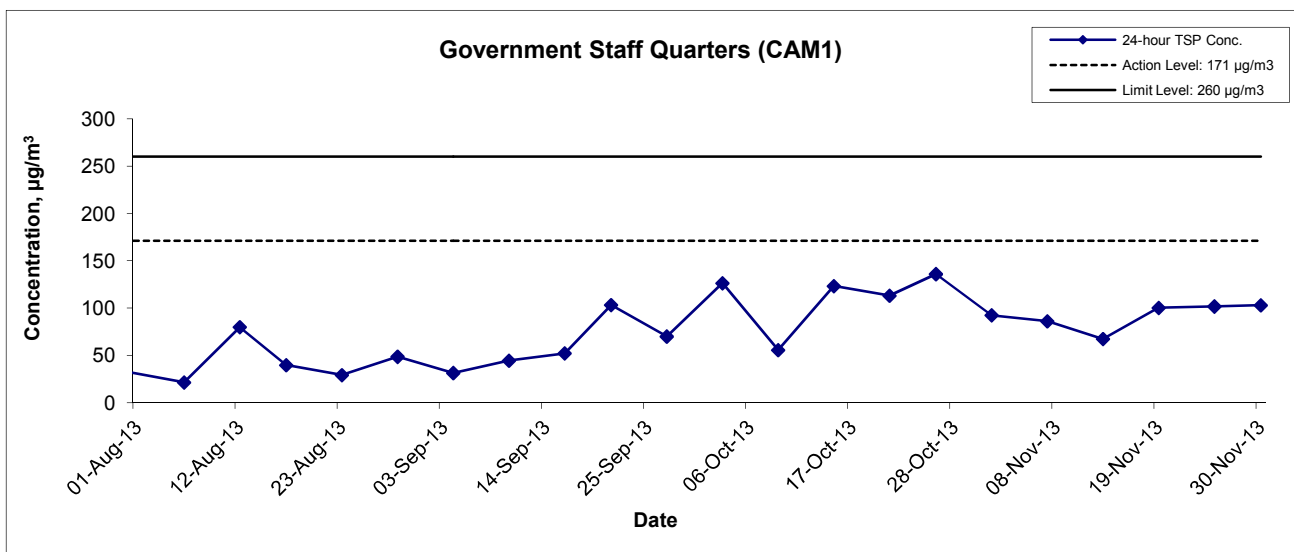
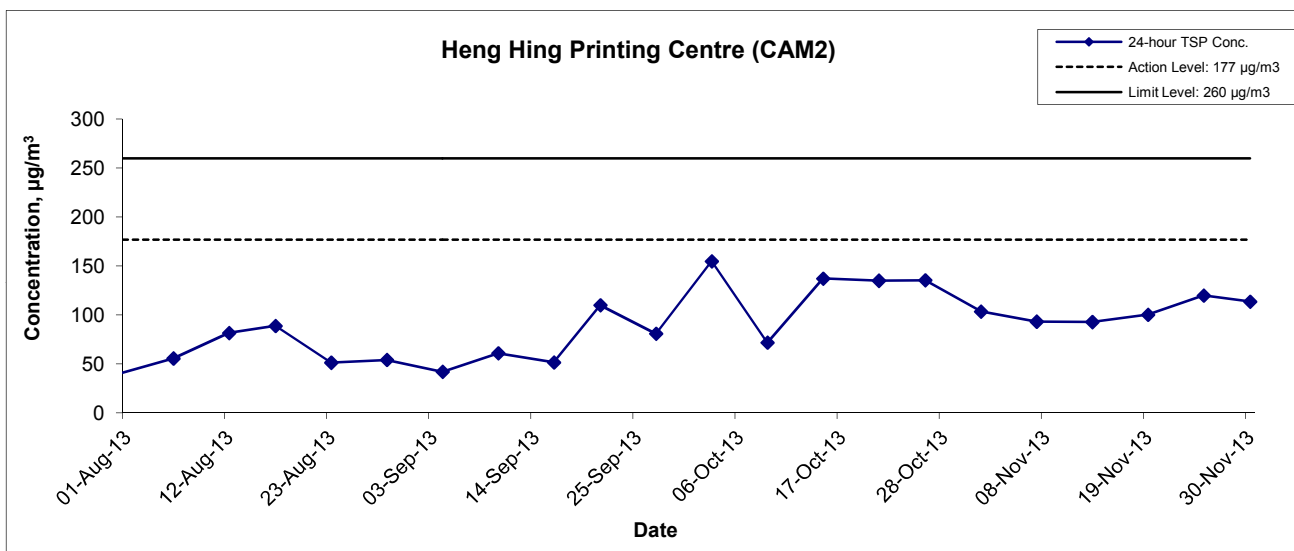
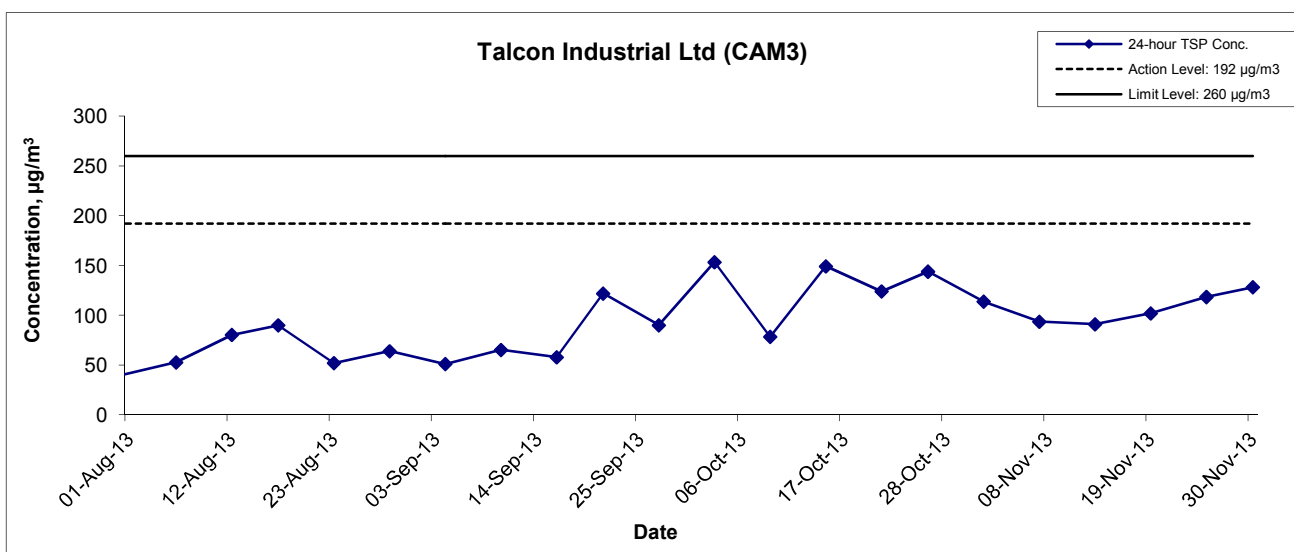
### 24-hr TSP Concentration Levels

Title Contract No. DC/2009/09 Construction of Tai Po Sewage Treatment Works - Stage V Phase II B Graphical Presentation of 24-hour TSP Impact Monitoring Results	Scale N.T.S	Project No. MA0010	
	Date Nov 13	Appendix E

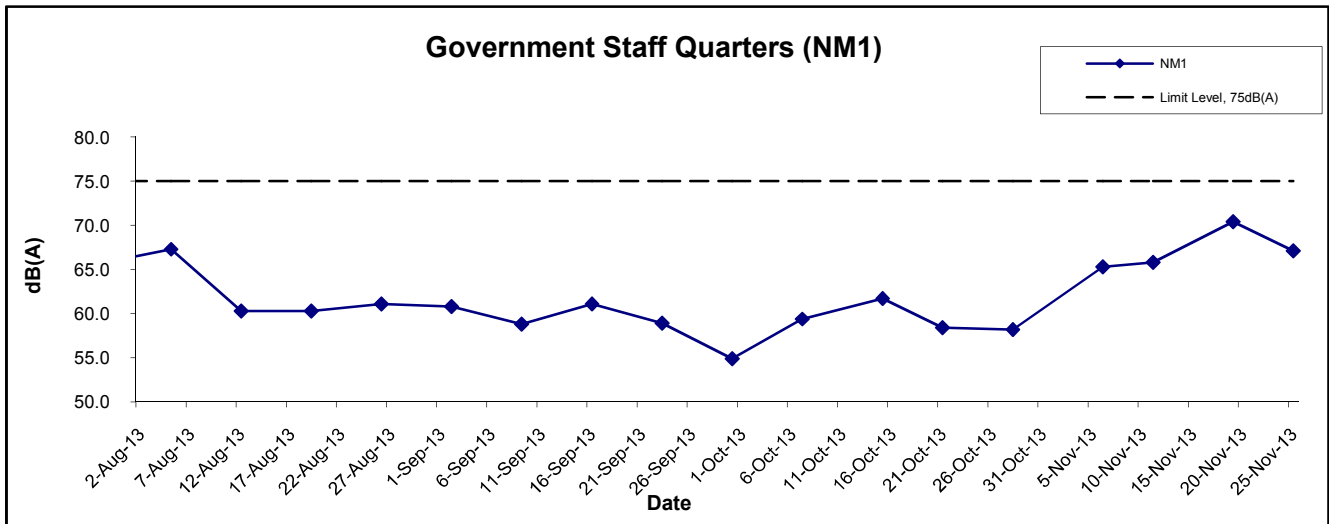
## Noise Levels

Location NM1 - Government Staff Quarters					
Date	Time	Weather	dB (A) (30-min)		
			L <sub>eq</sub>	L <sub>10</sub>	L <sub>90</sub>
6-Nov-13	08:45	Fine	65.3	69.8	63.1
11-Nov-13	15:03	Fine	65.8	67.3	62.6
19-Nov-13	16:30	Fine	70.4	73.0	65.8
25-Nov-13	17:30	Sunny	67.1	68.4	64.3
		Average	67.6	69.6	64.0
		Minimum	65.3	67.3	62.6
		Maximum	70.4	73.0	65.8

Title Contract No. DC/2009/09 Construction of Tai Po Sewage Treatment Works - Stage V Phase II B  Graphical Presentation of Construction Noise Monitoring Results	Scale N.T.S	Project No. MA0010	
	Date Nov 13	Appendix F
