Contract No. DC/2009/09
Construction of Tai Po Sewage Treatment
Works – Stage V Phase II B

**Monthly Environmental Monitoring
and Audit Report for
July 2014**

(Version 2.0)

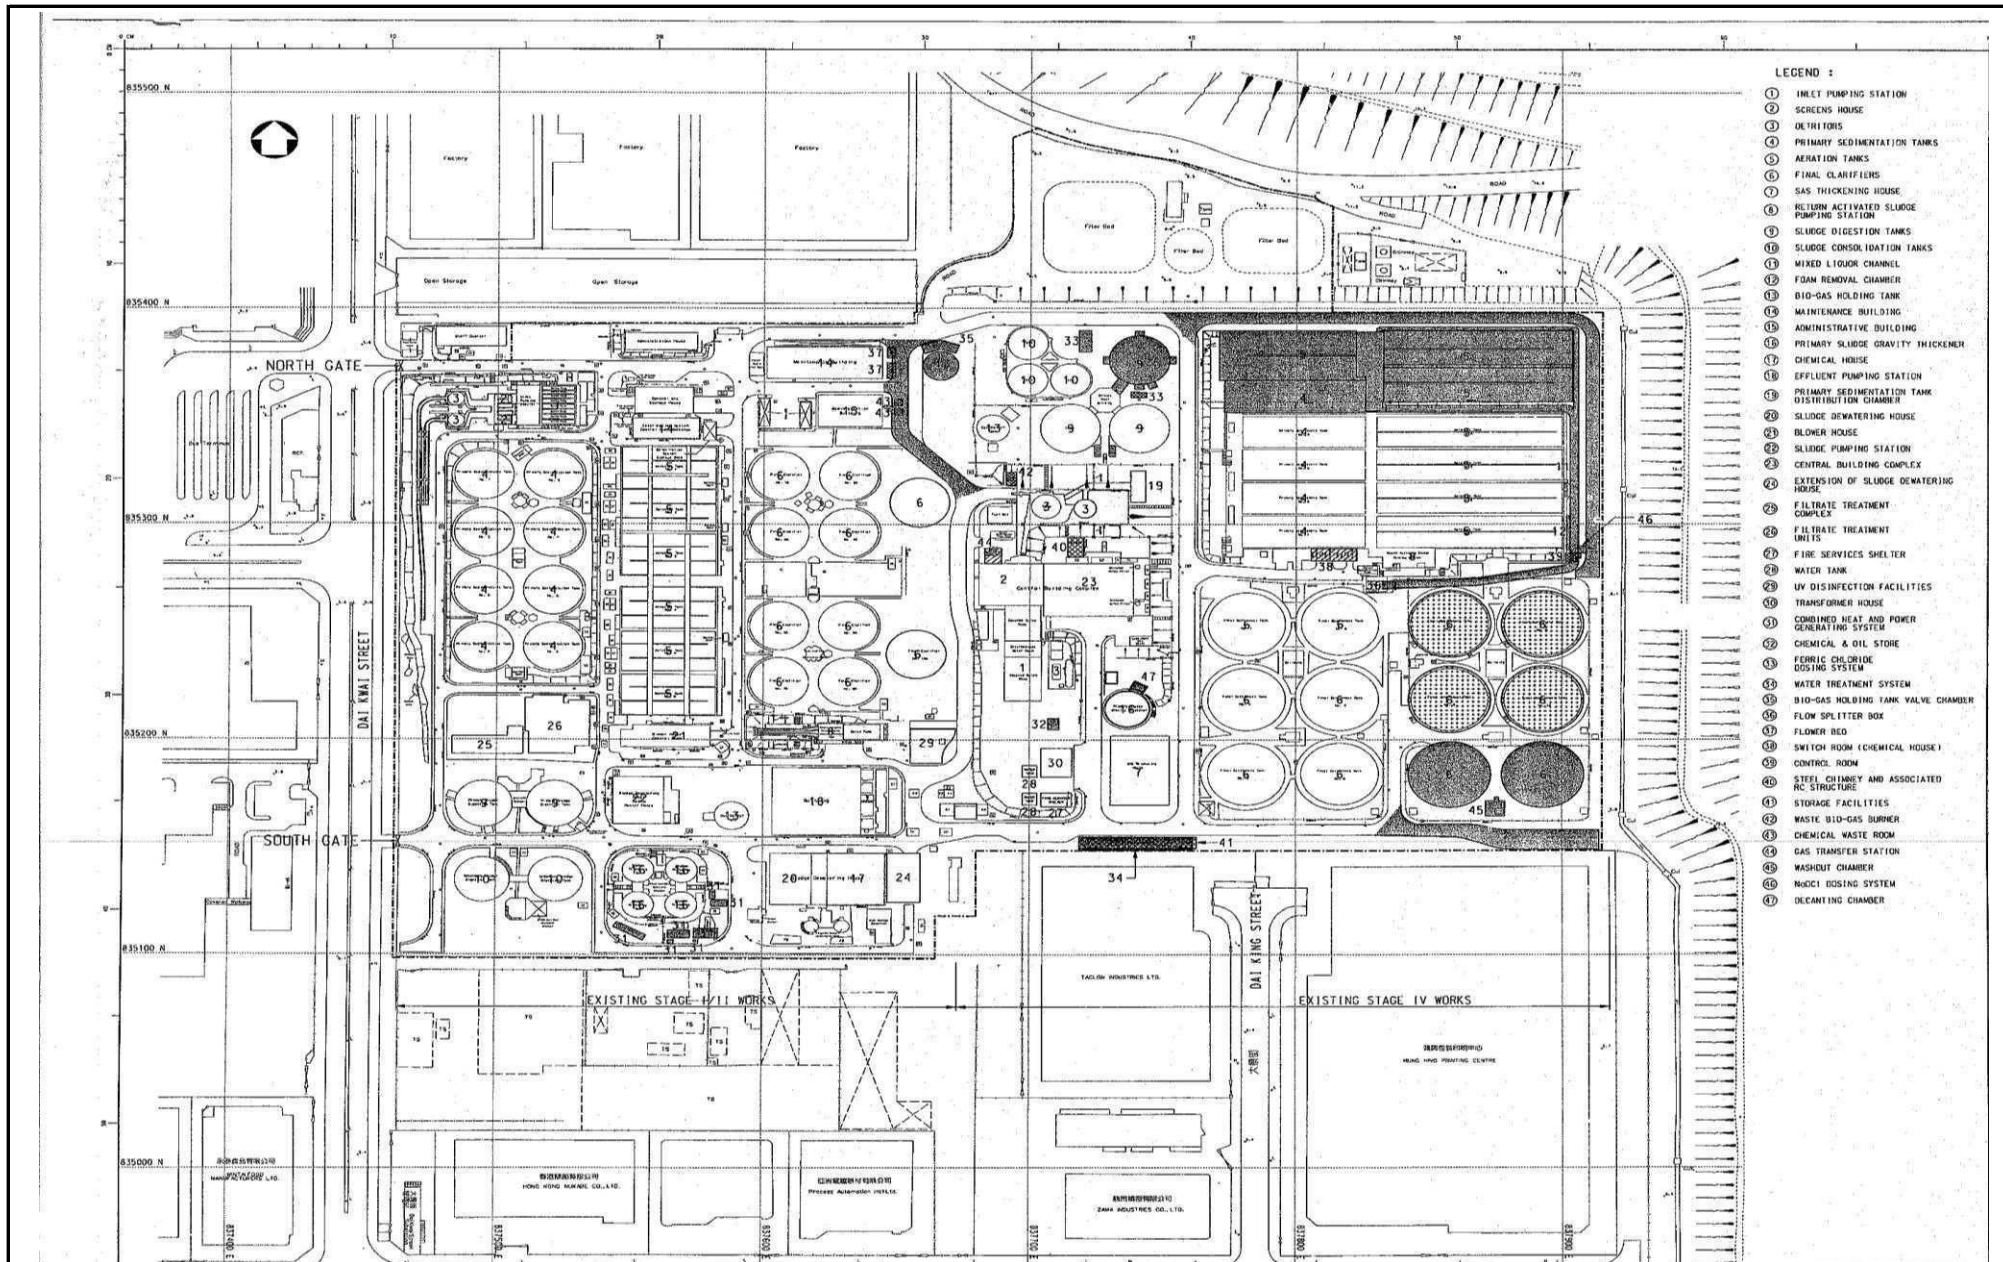
Scale	N.T.S	Project No.	MA0010	CINOTECH
Date	Jul-10	Figure	1.1

PROJECT SITE LAYOUT PLAN (TPSTW)

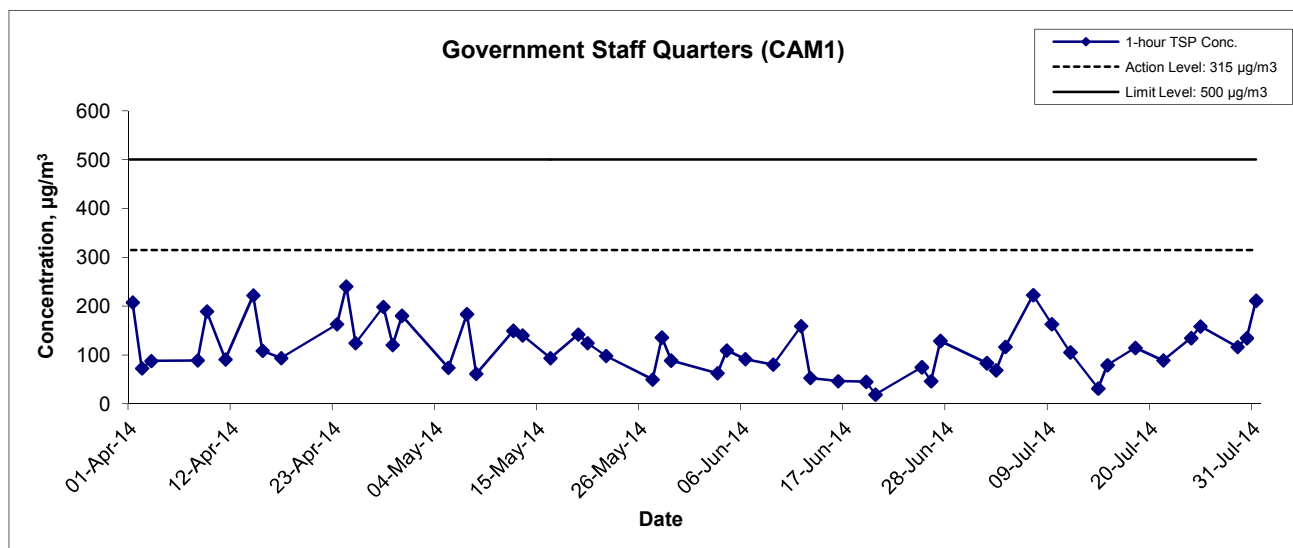
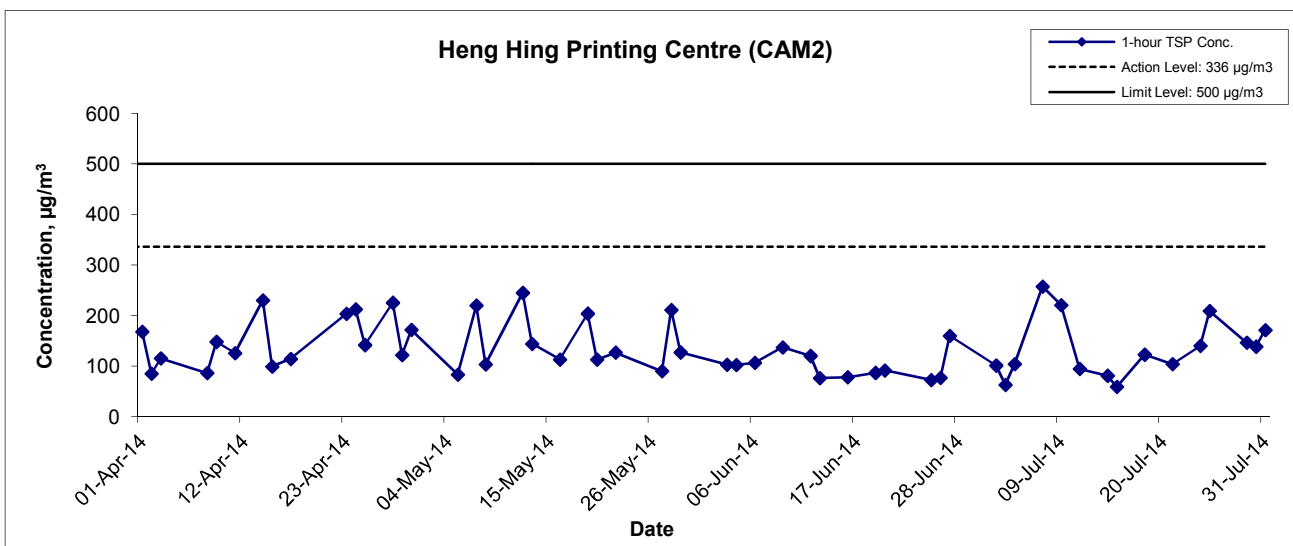
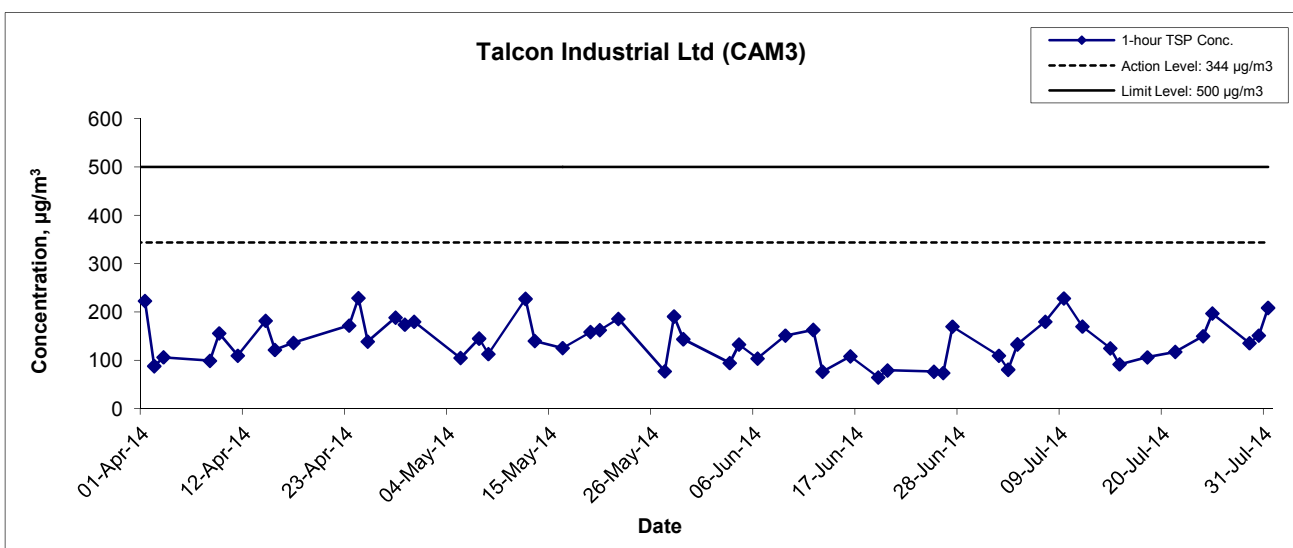
Title Contract No. DC/2009/09 Construction of Tai Po Sewage Treatment Works - Stage V Phase II B Graphical Presentation of 1-hour TSP Impact Monitoring Results	Scale N.T.S	Project No. MA0010	
	Date Jul 14	Appendix D

Date	Sampling Time	Weather Condition	Air Temp. (K)	Atmospheric Pressure (Pa)	Filter Weight (g)		Particulate weight (g)	Elapse Time		Sampling Time(hrs.)	Flow Rate (m ³ /min.)		Av. flow (m ³ /min)	Total vol. (m ³)	Conc. (µg/m ³)
					Initial	Final		Initial	Final		Initial	Final			
2-Jul-14	09:00	Sunny	302.2	758.1	3.1669	3.1749	0.0080	23586.9	23587.9	1.0	1.22	1.22	1.22	73.1	110
3-Jul-14	09:00	Sunny	302.3	756.0	3.2131	3.2190	0.0059	23587.9	23588.9	1.0	1.22	1.22	1.22	72.9	81
4-Jul-14	09:00	Sunny	303.3	755.5	3.1632	3.1729	0.0097	23588.9	23589.9	1.0	1.21	1.21	1.21	72.8	133
7-Jul-14	13:00	Sunny	298.9	754.3	3.2389	3.2521	0.0132	23613.9	23614.9	1.0	1.22	1.22	1.22	73.3	180
9-Jul-14	09:00	Sunny	303.1	754.3	3.1665	3.1831	0.0166	23614.9	23615.9	1.0	1.21	1.21	1.21	72.8	228
11-Jul-14	14:00	Sunny	300.9	753.5	3.1616	3.1740	0.0124	23615.9	23616.9	1.0	1.22	1.22	1.22	73.0	170
14-Jul-14	13:00	Sunny	305.3	758.8	3.2101	3.2192	0.0091	23640.9	23641.9	1.0	1.21	1.21	1.21	72.7	125

15-Jul-14	09:00	Sunny	303.1	759.6	3.2600	3.2667	0.0067	23641.9	23642.9	1.0	1.22	1.22	1.22	73.0	92
18-Jul-14	13:00	Cloudy	299.5	755.0	3.1972	3.2050	0.0078	23666.9	23667.9	1.0	1.22	1.22	1.22	73.2	107
21-Jul-14	09:00	Sunny	301.5	757.0	3.1913	3.1999	0.0086	23667.9	23668.9	1.0	1.22	1.22	1.22	73.1	118
24-Jul-14	10:00	Sunny	303.0	752.5	3.2606	3.2715	0.0109	23692.9	23693.9	1.0	1.21	1.21	1.21	72.7	150
25-Jul-14	09:00	Sunny	301.7	756.4	3.2888	3.3032	0.0144	23693.9	23694.9	1.0	1.22	1.22	1.22	73.0	197
29-Jul-14	09:00	Sunny	302.3	756.9	3.2354	3.2453	0.0099	23694.9	23695.9	1.0	1.22	1.22	1.22	73.0	136
30-Jul-14	11:00	Sunny	304.5	756.9	3.1928	3.2038	0.0110	23719.9	23720.9	1.0	1.21	1.21	1.21	72.7	151
31-Jul-14	09:00	Sunny	303.1	755.4	3.2327	3.2479	0.0152	23720.9	23721.9	1.0	1.21	1.21	1.21	72.8	209
														Min	81
														Max	228
														Average	146

1-hr TSP Concentration Levels

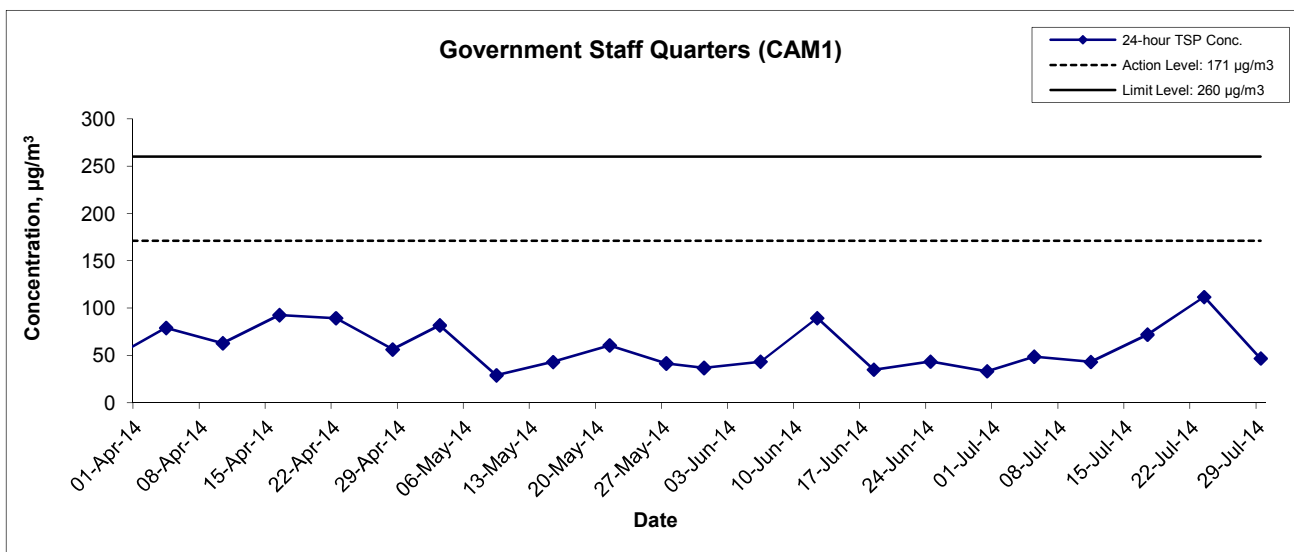
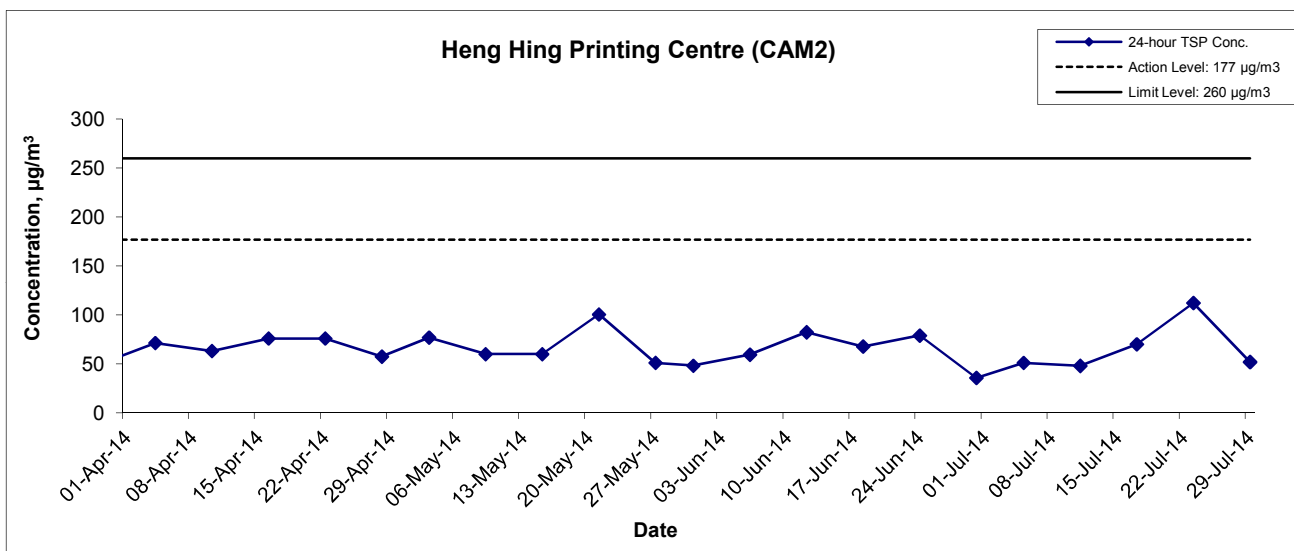
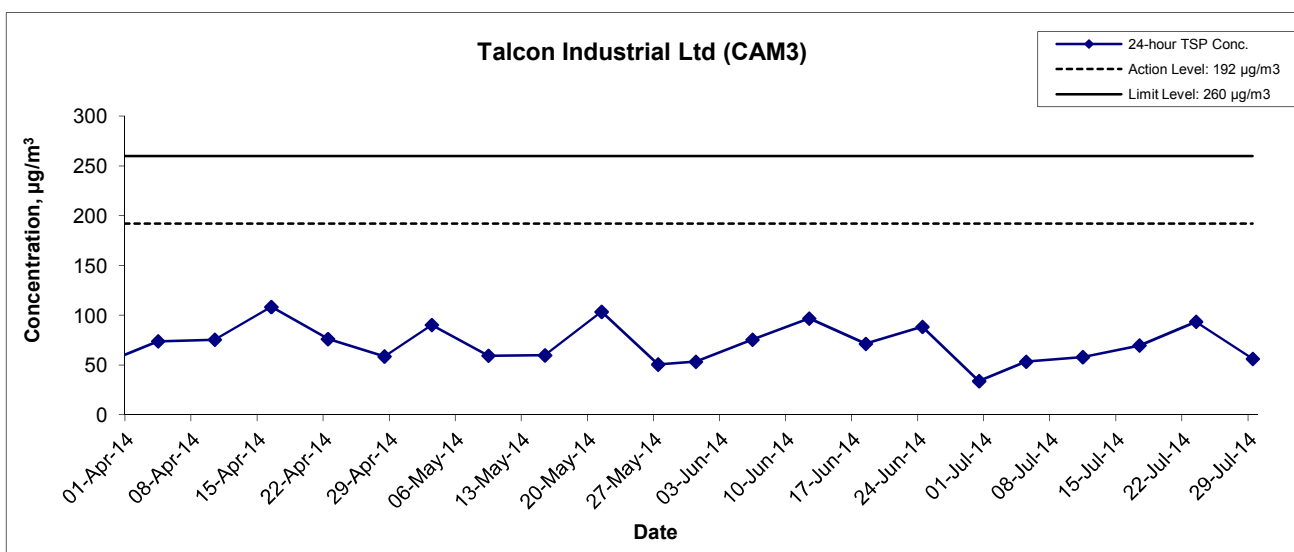
Title Contract No. DC/2009/09 Construction of Tai Po Sewage Treatment Works - Stage V Phase II B Graphical Presentation of 24-hour TSP Impact Monitoring Results	Scale N.T.S	Project No. MA0010	
	Date Jul 14	Appendix E

Start Date	Weather Condition	Air Temp. (K)	Atmospheric Pressure (Pa)	Filter Weight (g)		Particulate weight (g)	Elapse Time		Sampling Time(hrs.)	Flow Rate (m ³ /min.)		Av. flow (m ³ /min)	Total vol. (m ³)	Conc. (µg/m ³)
				Initial	Final		Initial	Final		Initial	Final			
5-Jul-14	Sunny	303.1	755.5	3.2167	3.3099	0.0932	23589.9	23613.9	24.0	1.21	1.21	1.21	1748.0	53
11-Jul-14	Sunny	300.5	752.9	3.3007	3.4023	0.1016	23616.9	23640.9	24.0	1.22	1.22	1.22	1752.5	58
17-Jul-14	Cloudy	303.3	756.1	3.2489	3.3706	0.1217	23642.9	23666.9	24.0	1.21	1.21	1.21	1748.1	70
23-Jul-14	Sunny	303.3	752.3	3.2596	3.4225	0.1629	23668.9	23692.9	24.0	1.21	1.21	1.21	1743.8	93
29-Jul-14	Sunny	303.6	756.5	3.2207	3.3189	0.0982	23695.9	23719.9	24.0	1.21	1.21	1.21	1747.7	56
													Min	53
													Max	93
													Average	66

24-hr TSP Concentration Levels

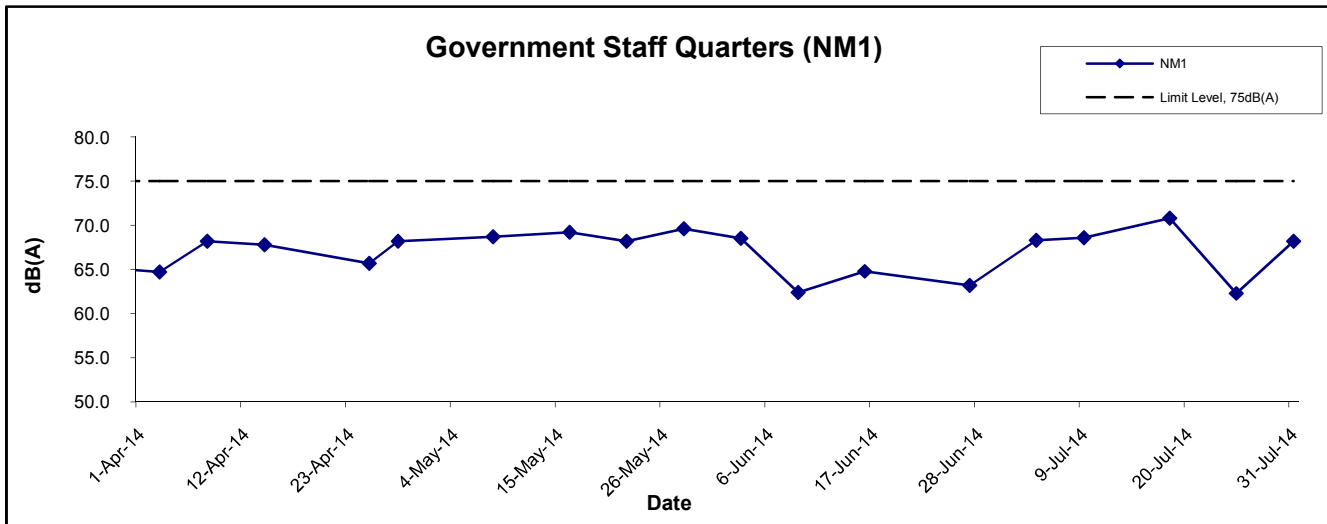
Title Contract No. DC/2009/09 Construction of Tai Po Sewage Treatment Works - Stage V Phase II B Graphical Presentation of Construction Noise Monitoring Results	Scale N.T.S	Project No. MA0010	
	Date Jul 14	Appendix F

Location NM1 - Government Staff Quarters					
Date	Time	Weather	dB (A) (30-min)		
			L _{eq}	L ₁₀	L ₉₀
4-Jul-14	11:30	Sunny	68.3	71.1	64.8
9-Jul-14	10:00	Sunny	68.6	71.2	63.9
18-Jul-14	13:00	Cloudy	70.8	74.2	64.9
25-Jul-14	09:30	Sunny	62.3	65.8	57.6
31-Jul-14	11:00	Sunny	68.2	71.6	64.1
		Average	68.4	70.8	63.1
		Minimum	62.3	65.8	57.6
		Maximum	70.8	74.2	64.9

Noise Levels
