China Harbour Engineering Company Limited

Contract No. DC/2009/09
Construction of Tai Po Sewage Treatment
Works – Stage V Phase II B

Monthly Environmental Monitoring and Audit Report for August 2014

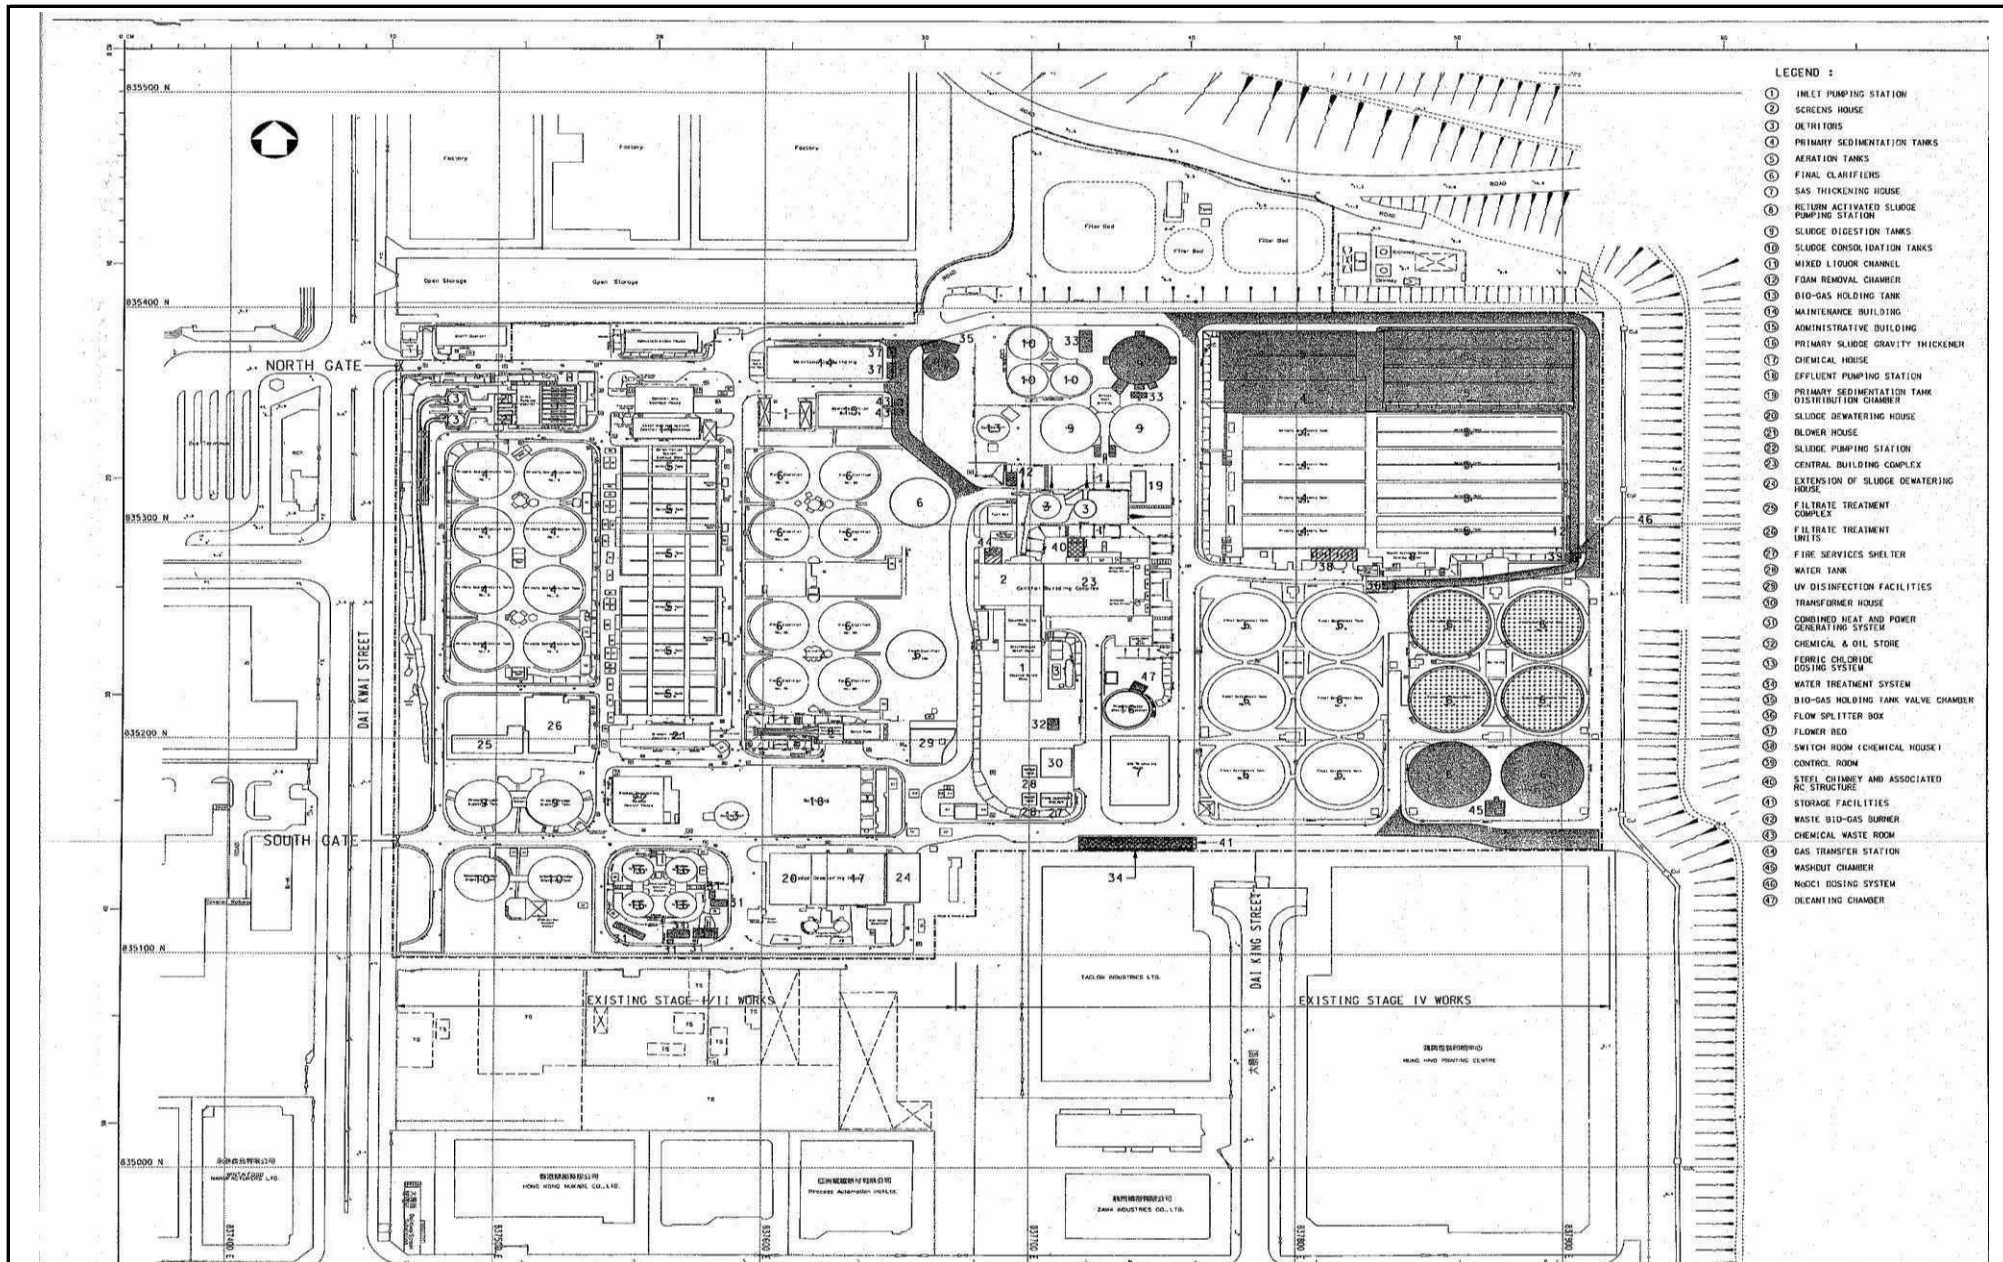
1.1

- LEGEND :
- ① TRLET PUMPING STATION
 - ② SCREENS HOUSE
 - ③ ULTRAFIORS
 - ④ PRIMARY SEDIMENTATION TANKS
 - ⑤ AERATION TANKS
 - ⑥ FINAL CLARIFIERS
 - ⑦ SAS THICKENING HOUSE

- ⑧ RETURN ACTIVATED SLUDGE PUMPING STATION
 - ⑨ SLUDGE DIGESTION TANKS
 - ⑩ SLUDGE CONSOLIDATION TANKS
 - ⑪ MIXED LIQUOR CHANNEL
 - ⑫ FDM REMOVAL CHAMBER

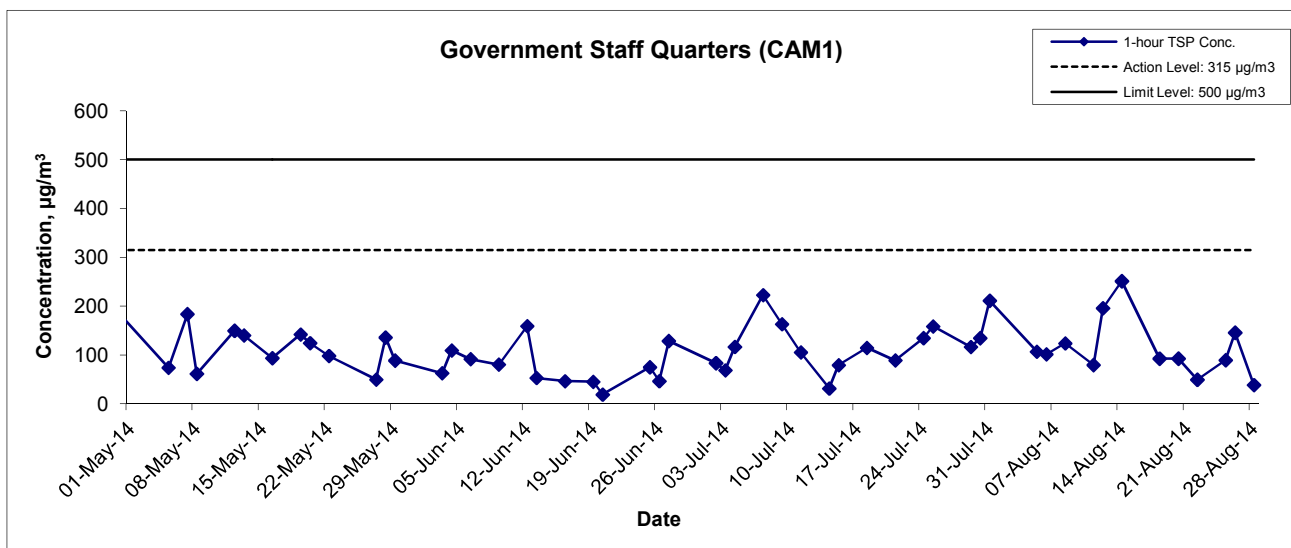
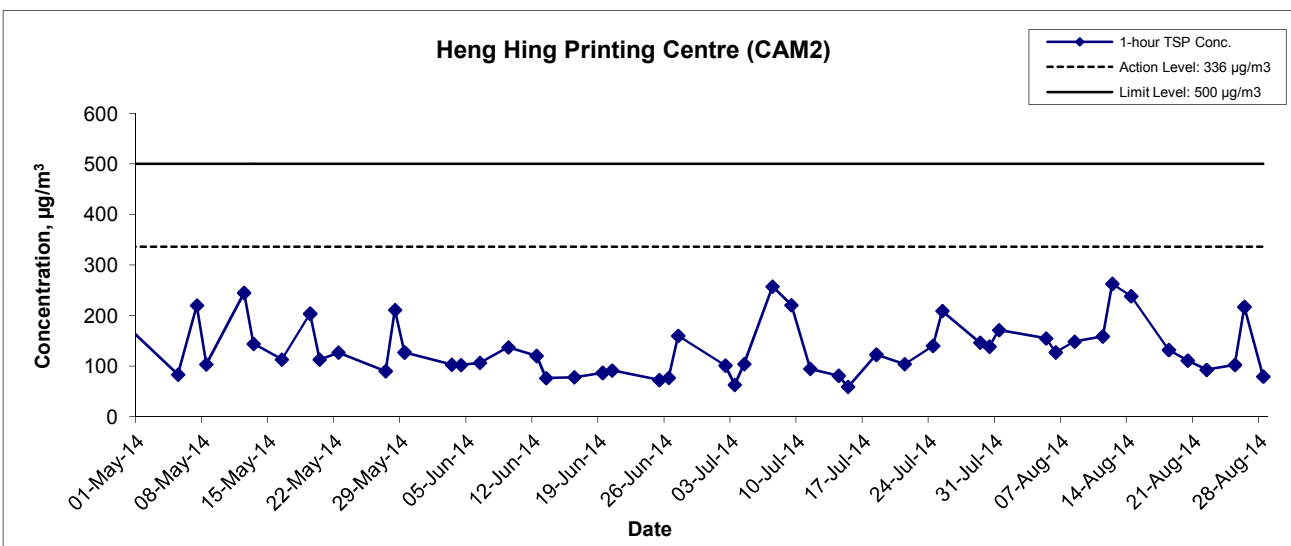
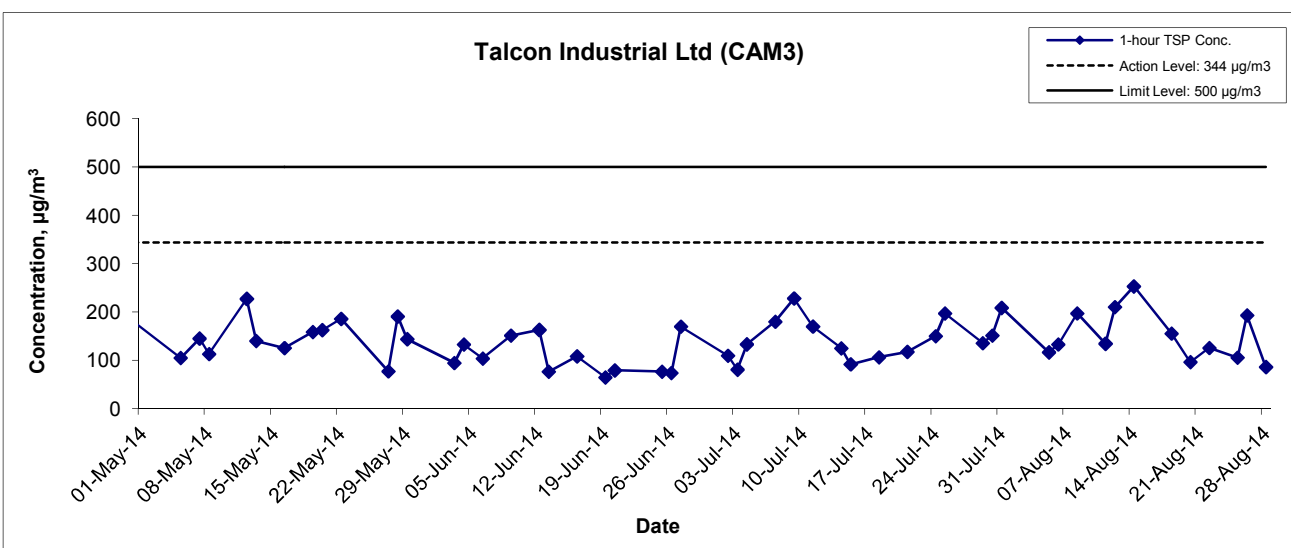
1-hr TSP Concentration Levels

Title Contract No. DC/2009/09 Construction of Tai Po Sewage Treatment Works - Stage V Phase II B Graphical Presentation of 1-hour TSP Impact Monitoring Results	Scale N.T.S	Project No. MA0010	
	Date Aug 14	Appendix D

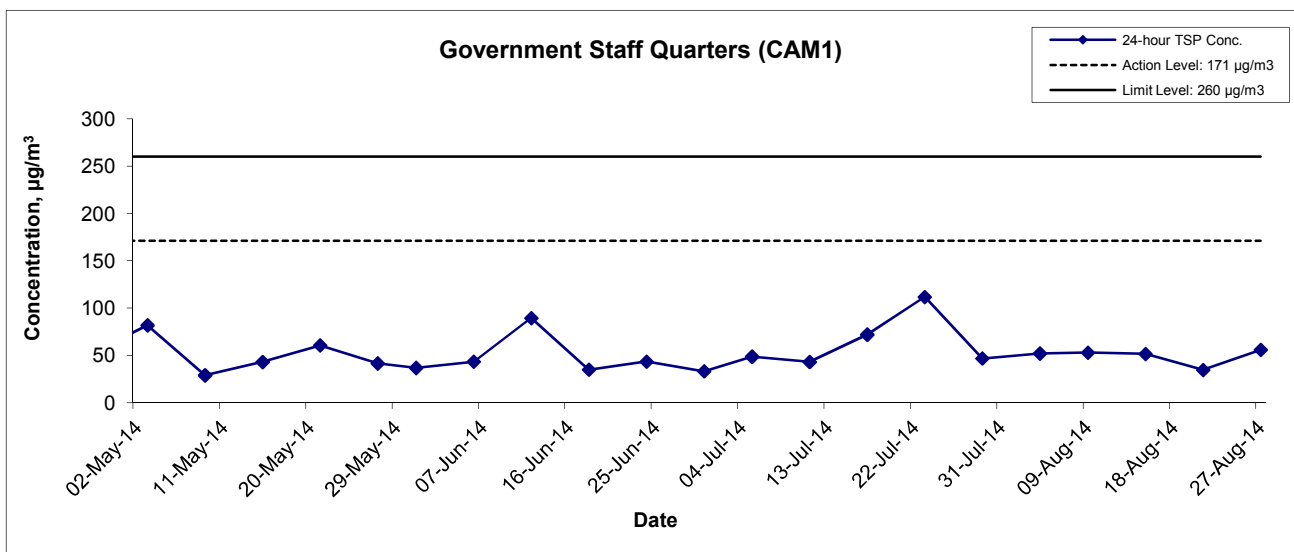
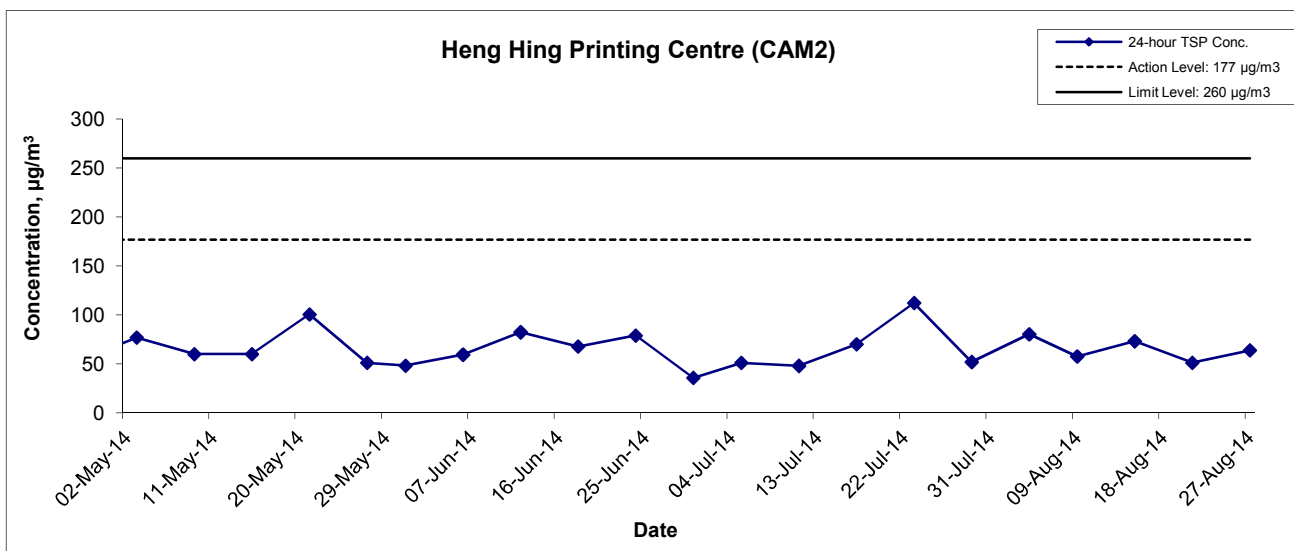
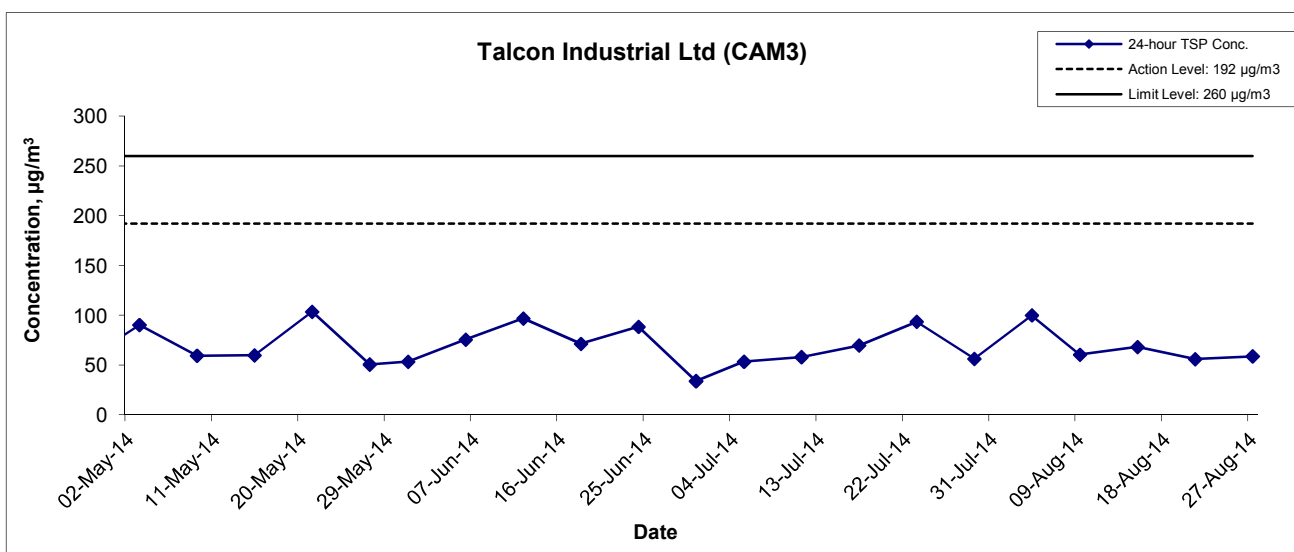
24-hr TSP Concentration Levels

Title Contract No. DC/2009/09 Construction of Tai Po Sewage Treatment Works - Stage V Phase II B Graphical Presentation of 24-hour TSP Impact Monitoring Results	Scale	Project No.		
		N.T.S		MA0010
	Date	Aug 14		Appendix E

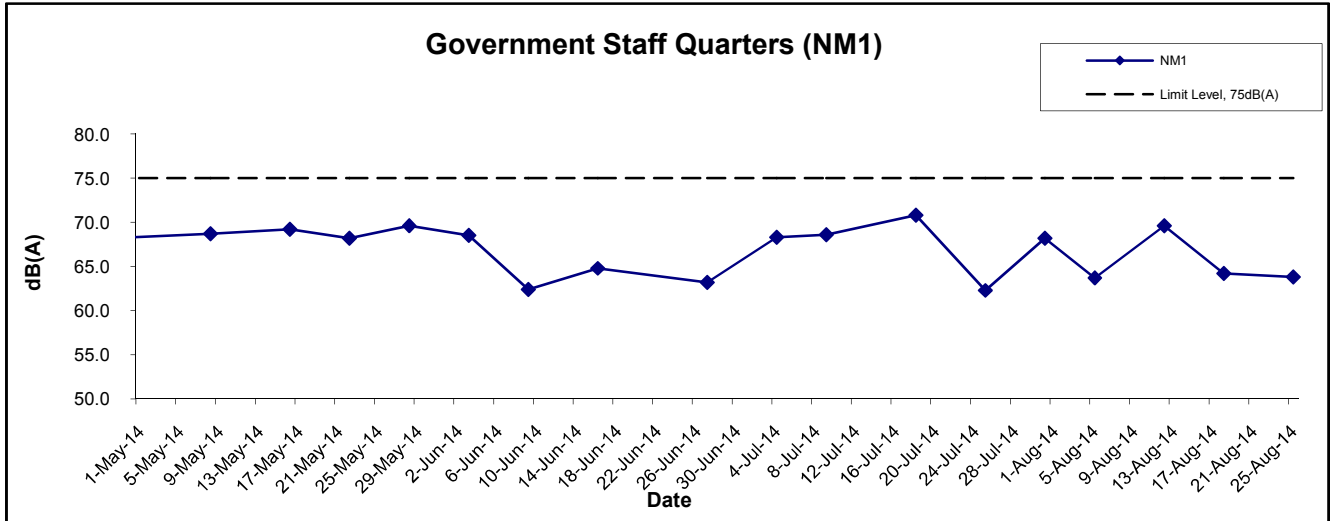
Noise Levels

Location NM1 - Government Staff Quarters					
Date	Time	Weather	dB (A) (30-min)		
			L _{eq}	L ₁₀	L ₉₀
5-Aug-14	11:10	Sunny	63.7	65.4	58.6
12-Aug-14	10:00	Sunny	69.6	71.2	65.5
18-Aug-14	11:00	Sunny	64.2	67.8	59.7
25-Aug-14	10:00	Sunny	63.8	65.2	59.3
		Average	66.2	67.4	60.8
		Minimum	63.7	65.2	58.6
		Maximum	69.6	71.2	65.5

Title Contract No. DC/2009/09 Construction of Tai Po Sewage Treatment Works - Stage V Phase II B Graphical Presentation of Construction Noise Monitoring Results	Scale N.T.S	Project No. MA0010	
	Date Aug 14	Appendix F
