China Harbour Engineering Company Limited

Contract No. DC/2009/09
Construction of Tai Po Sewage Treatment
Works – Stage V Phase II B

Monthly Environmental Monitoring and Audit Report for October 2014

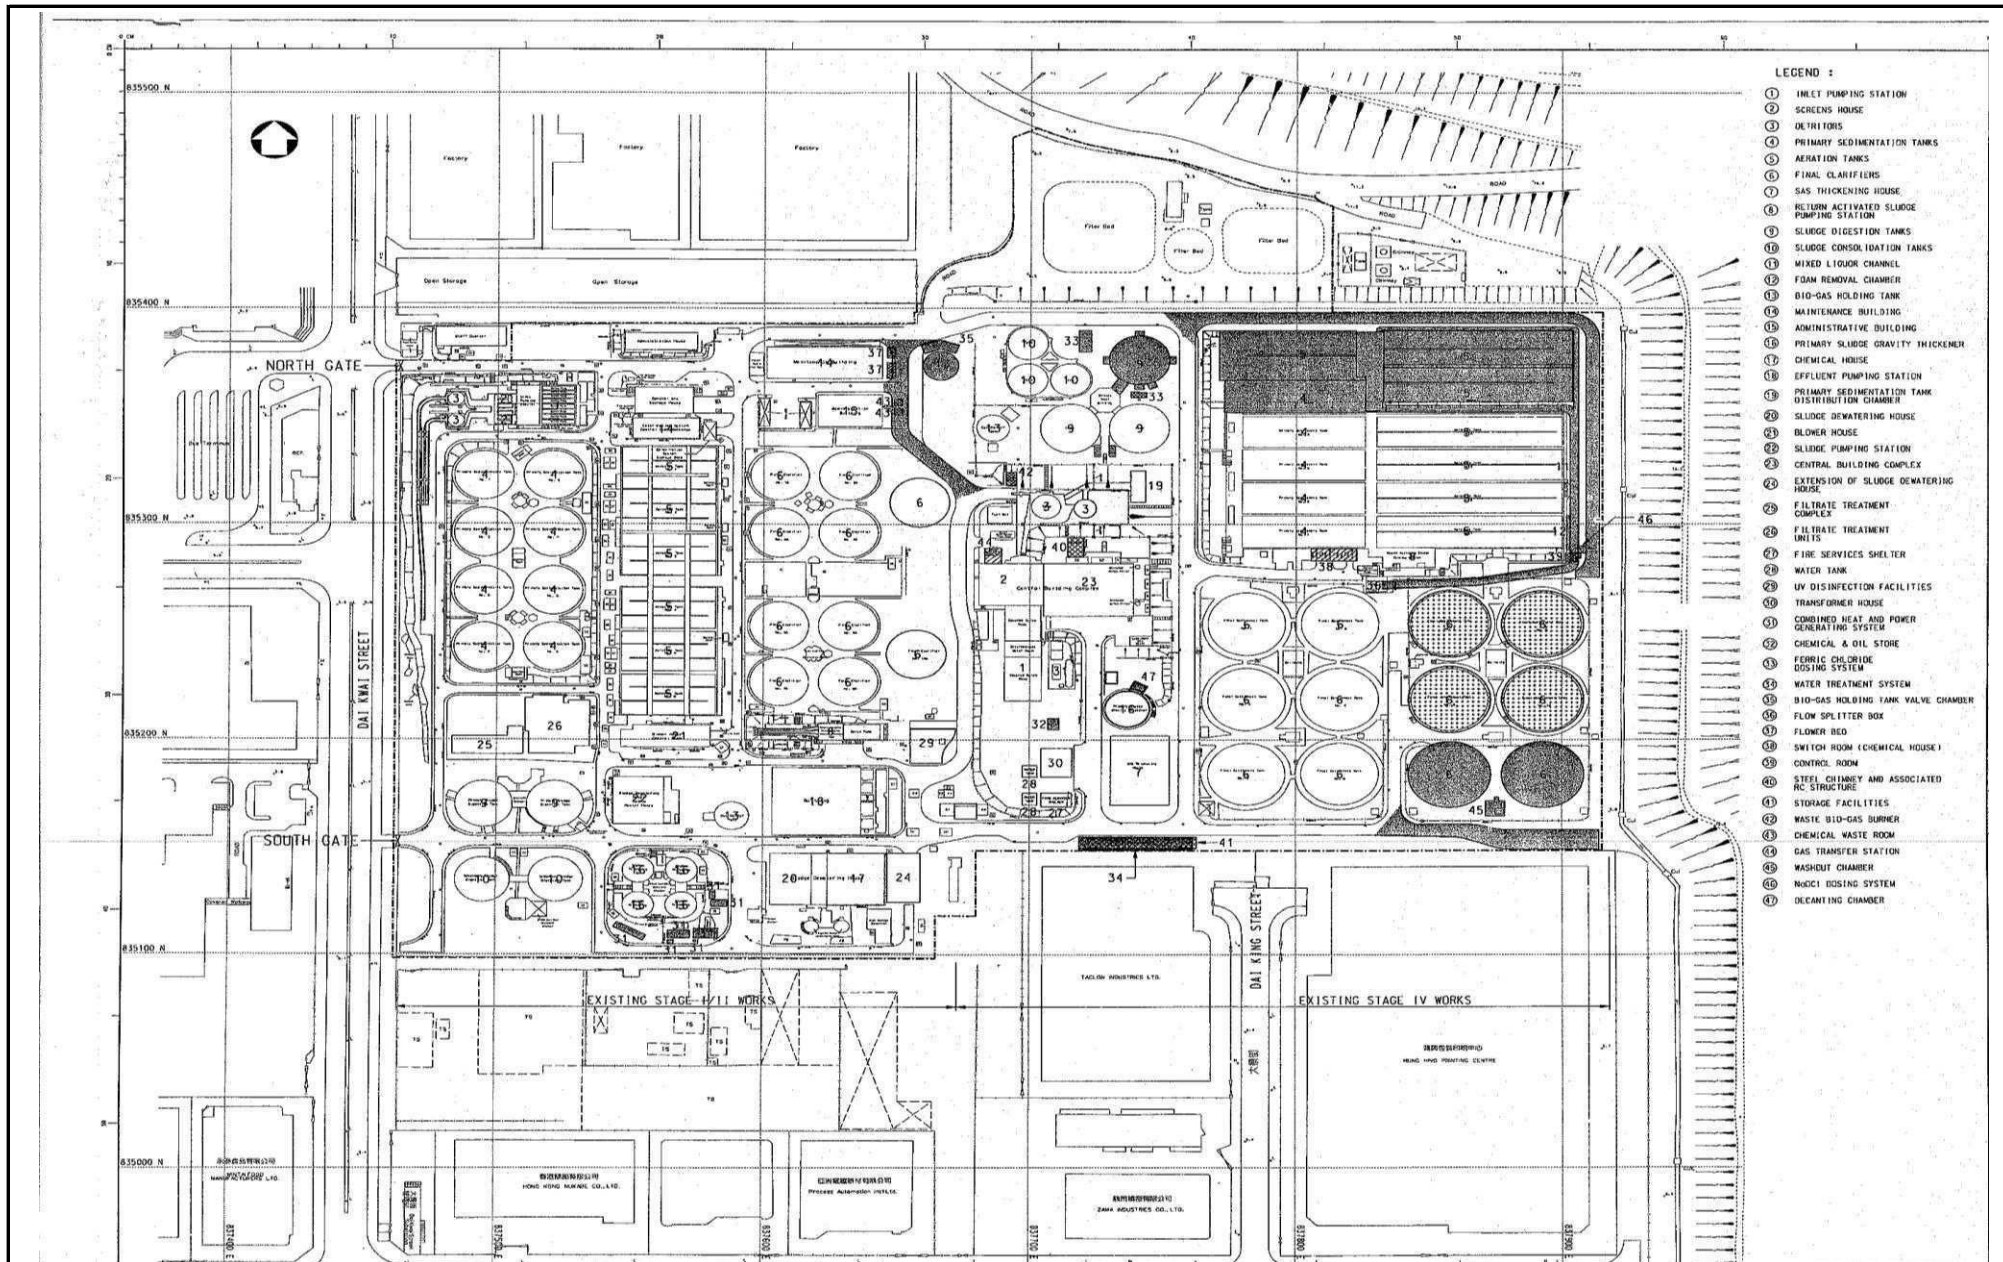
1.1

- LEGEND :**
- ① TRLET PUMPING STATION
 - ② SCREENS HOUSE
 - ③ ULTRAFIORS
 - ④ PRIMARY SEDIMENTATION TANKS
 - ⑤ AERATION TANKS
 - ⑥ FINAL CLARIFIERS
 - ⑦ SAS THICKENING HOUSE

- ⑧ ROTARY ACTIVATED SLUDGE PUMPING STATION
 - ⑨ SLUDGE DIGESTION TANKS
 - ⑩ SLUDGE CONSOLIDATION TANKS
 - ⑪ MIXED LIQUOR CHANNEL
 - ⑫ FDM REMOVAL CHAMBER

- ㊶ STORAGE FACILITIES
 - ㊷ WASTE BIO-GAS BURNER
 - ㊸ CHEMICAL WASTE ROOM
 - ㊹ GAS TRANSFER STATION
 - ㊺ WASHOUT CHAMBER
 - ㊻ NAOCl DOSING SYSTEM
 - ㊼ DECAINING CHAMBER

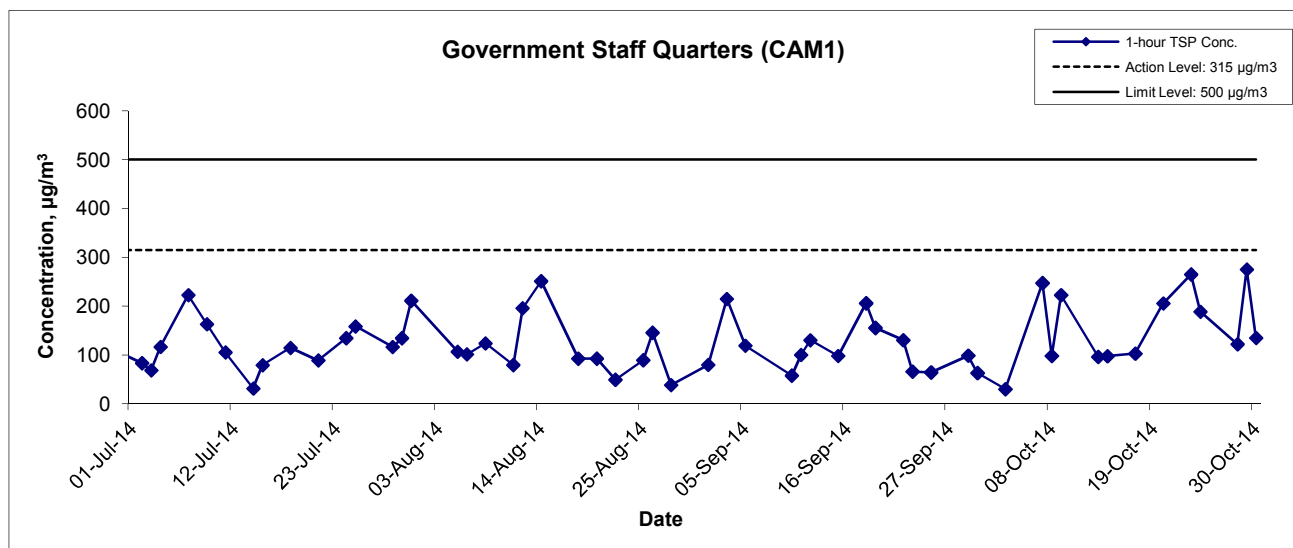
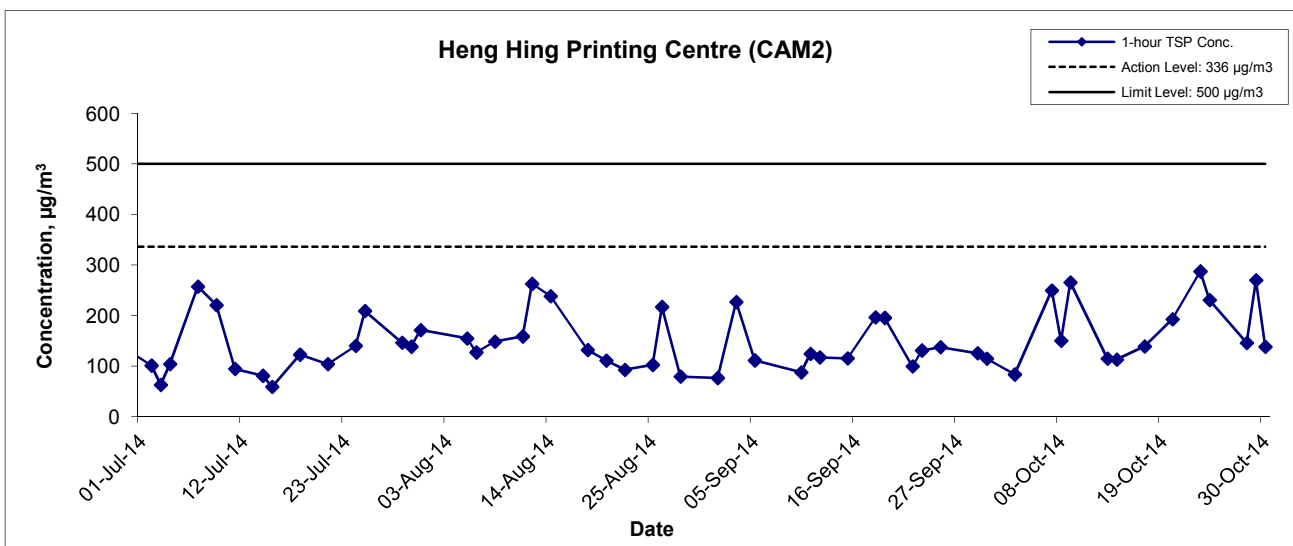
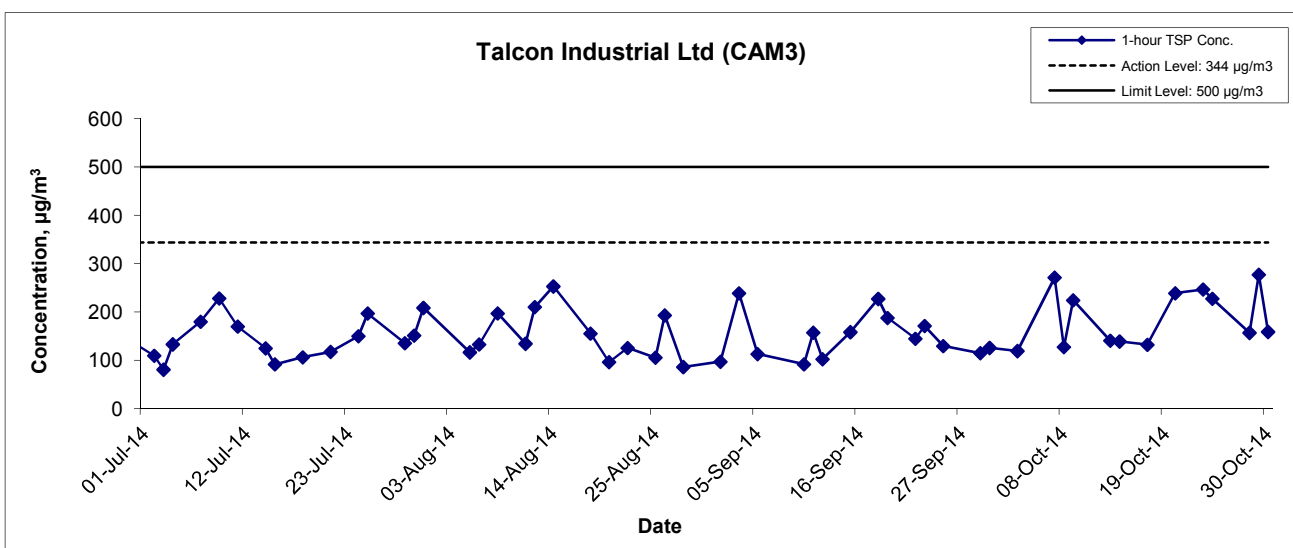
1-hr TSP Concentration Levels

Title Contract No. DC/2009/09 Construction of Tai Po Sewage Treatment Works - Stage V Phase II B Graphical Presentation of 1-hour TSP Impact Monitoring Results	Scale N.T.S	Project No. MA0010	
	Date Oct 14	Appendix D

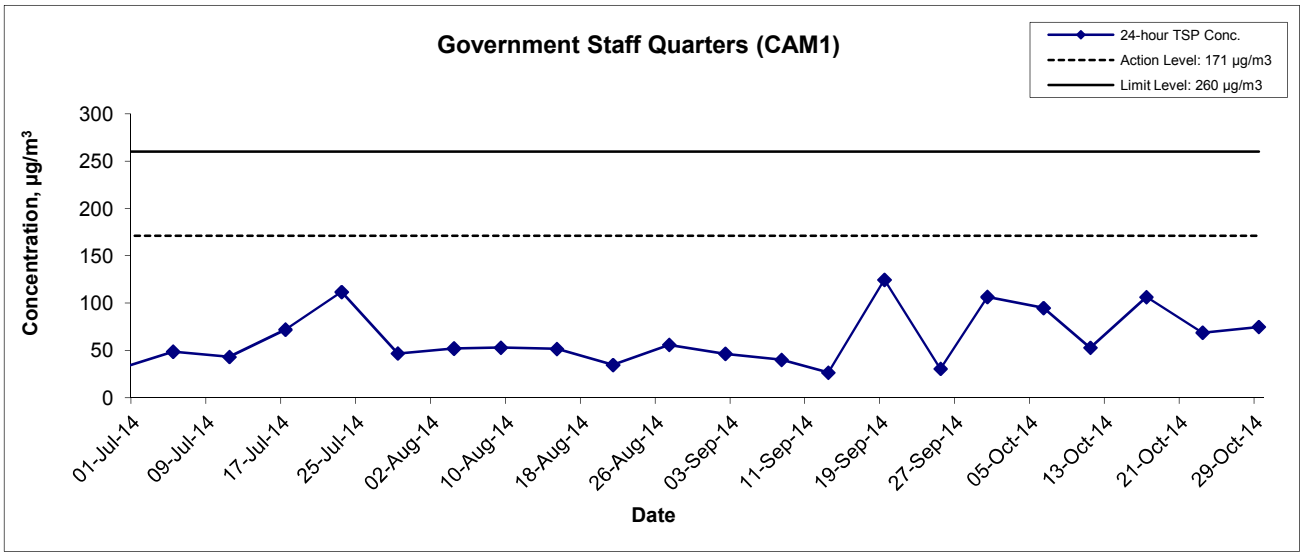
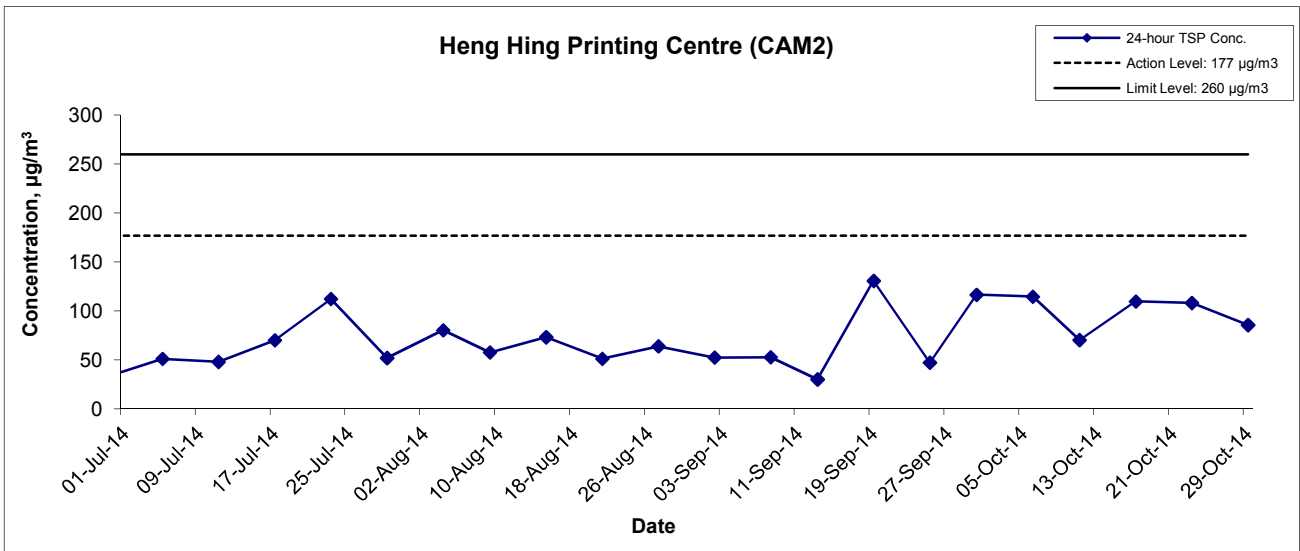
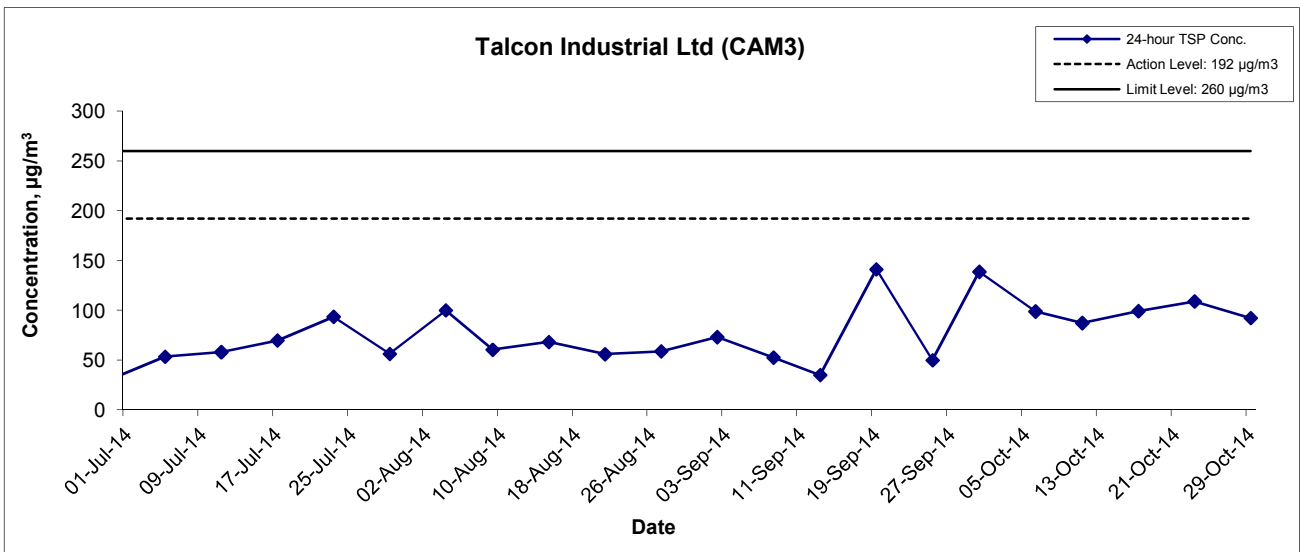
24-hr TSP Concentration Levels

Title Contract No. DC/2009/09 Construction of Tai Po Sewage Treatment Works - Stage V Phase II B Graphical Presentation of 24-hour TSP Impact Monitoring Results	Scale N.T.S	Project No. MA0010	
	Date Oct 14	Appendix E

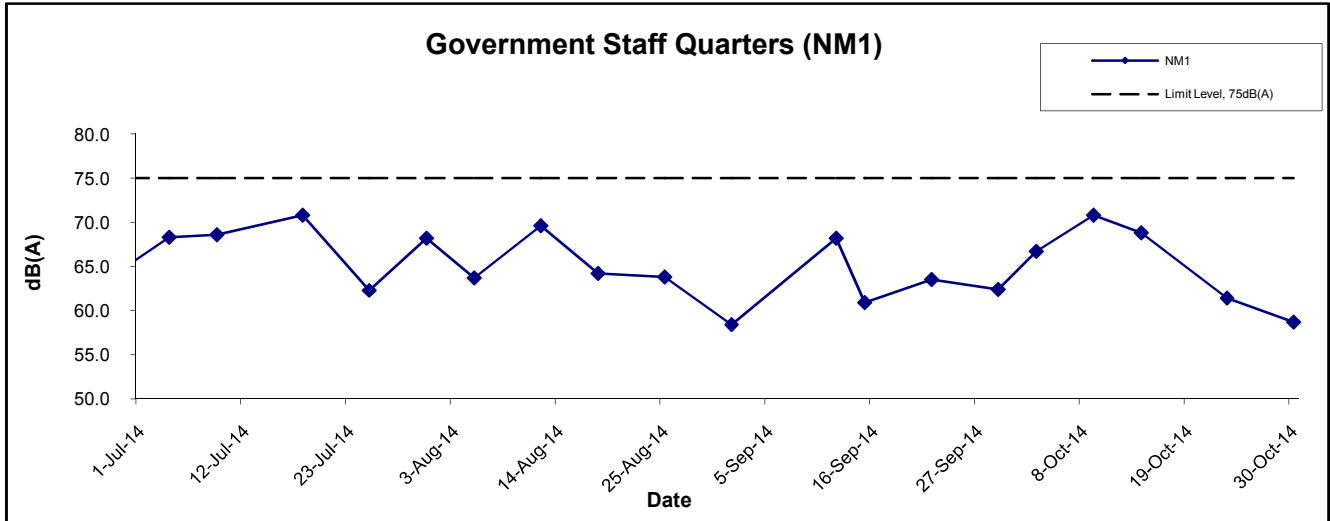
Noise Levels

Title Contract No. DC/2009/09 Construction of Tai Po Sewage Treatment Works - Stage V Phase II B Graphical Presentation of Construction Noise Monitoring Results	Scale N.T.S	Project No. MA0010	
	Date Oct 14	Appendix F
