Contract No. DC/2007/12 - Design and
Construction of Tsuen Wan Drainage Tunnel

Monthly EM&A Report (March 2013)

Report No EB000364R0931

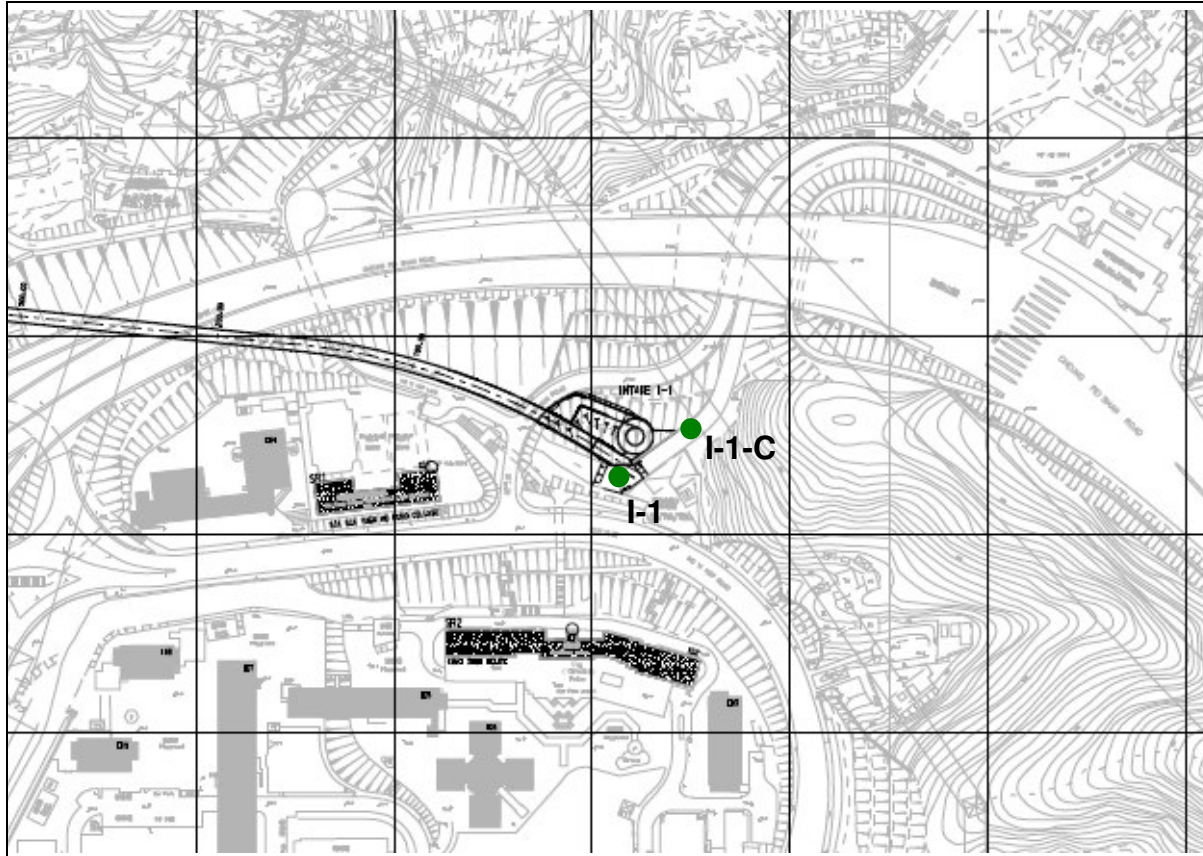
Figure 3 Water Quality Monitoring Stations: I-1 & I-1-C at Intake I-1

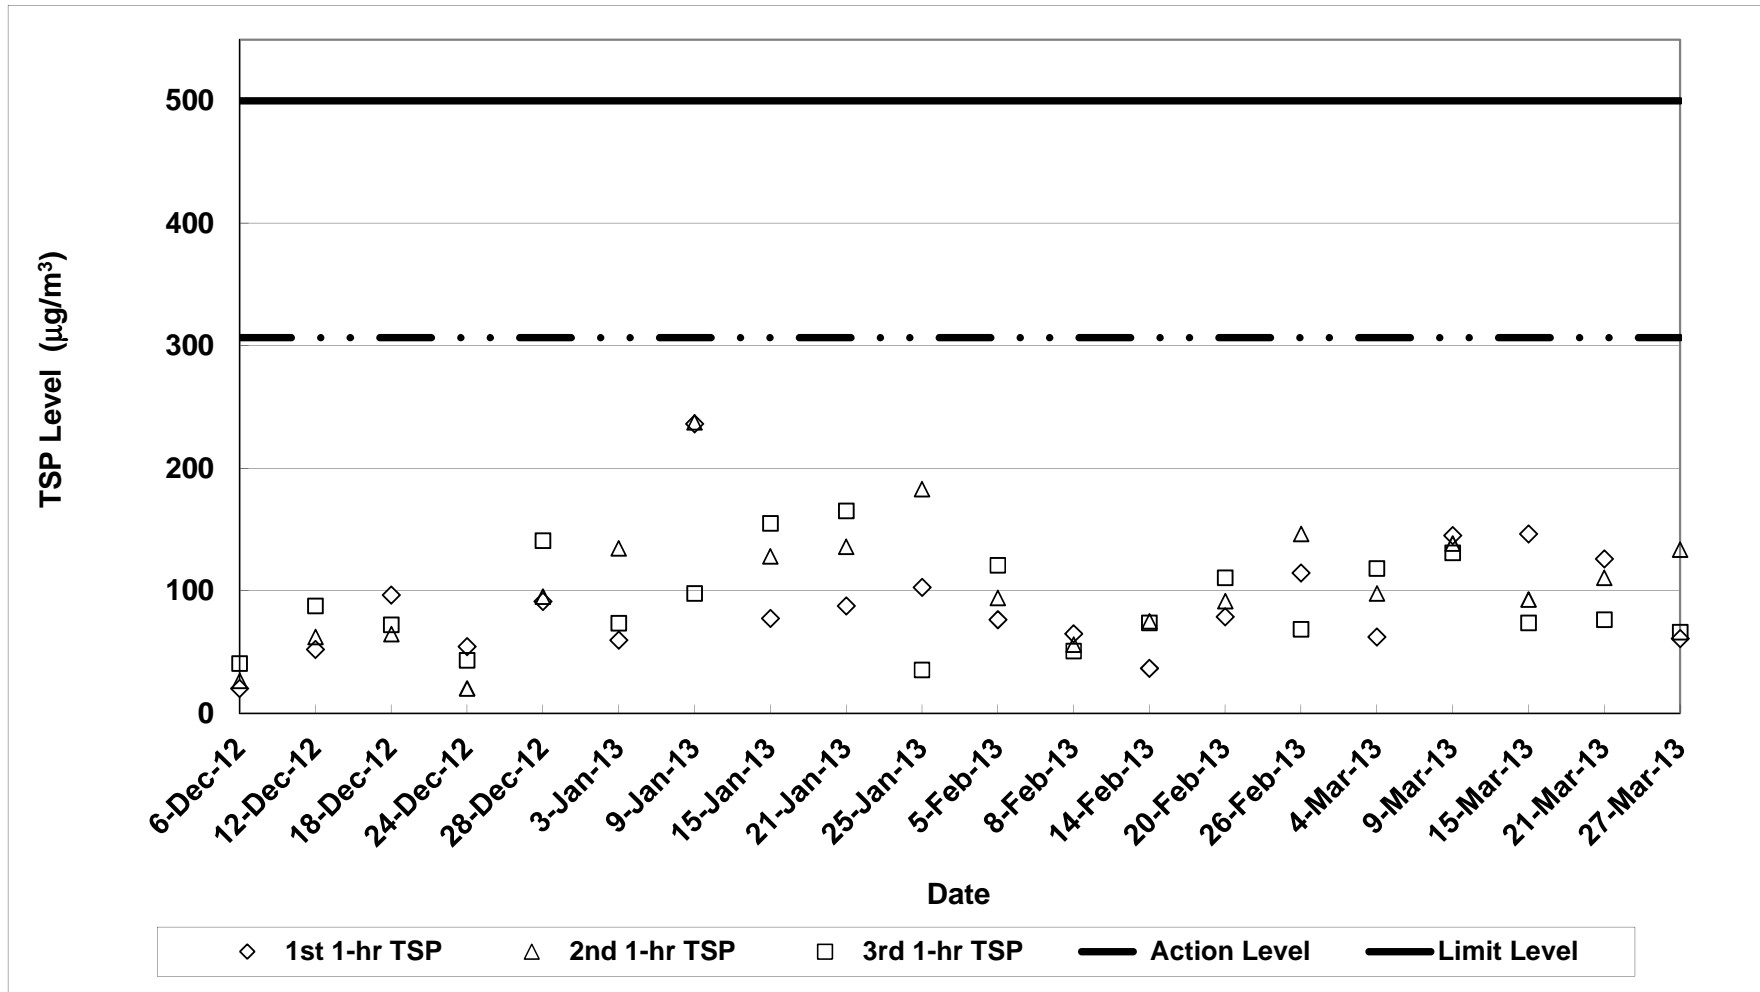
**Contract No. DC/2007/12 - Design and Construction of Tsuen Wan Drainage Tunnel
 Air Quality Monitoring (1-hr TSP) Results at Sik Sik Yuen Ho Fung College - Intake (ASR1)
 Dec-12 to Mar-13**

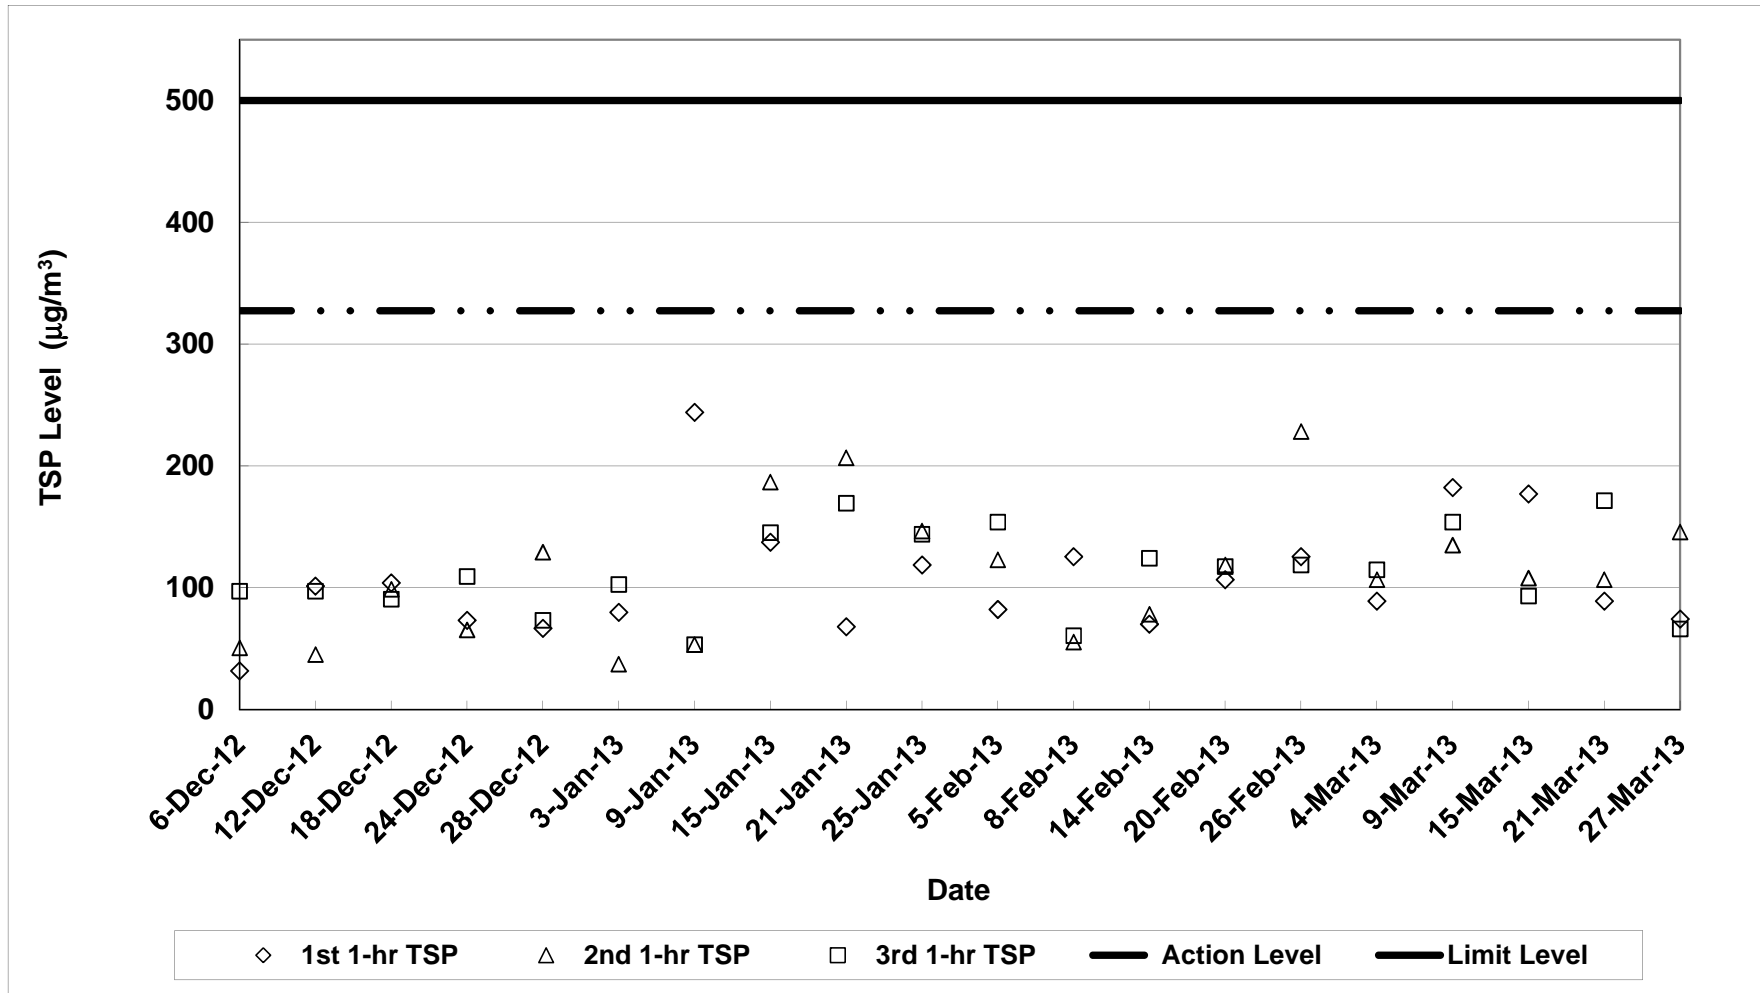
**Contract No. DC/2007/12 - Design and Construction of Tsuen Wan Drainage Tunnel
 Air Quality Monitoring (1-hr TSP) Results at Hong Hoi Chee Hong Temple - Intake (ASR3)
 Dec-12 to Mar-13**

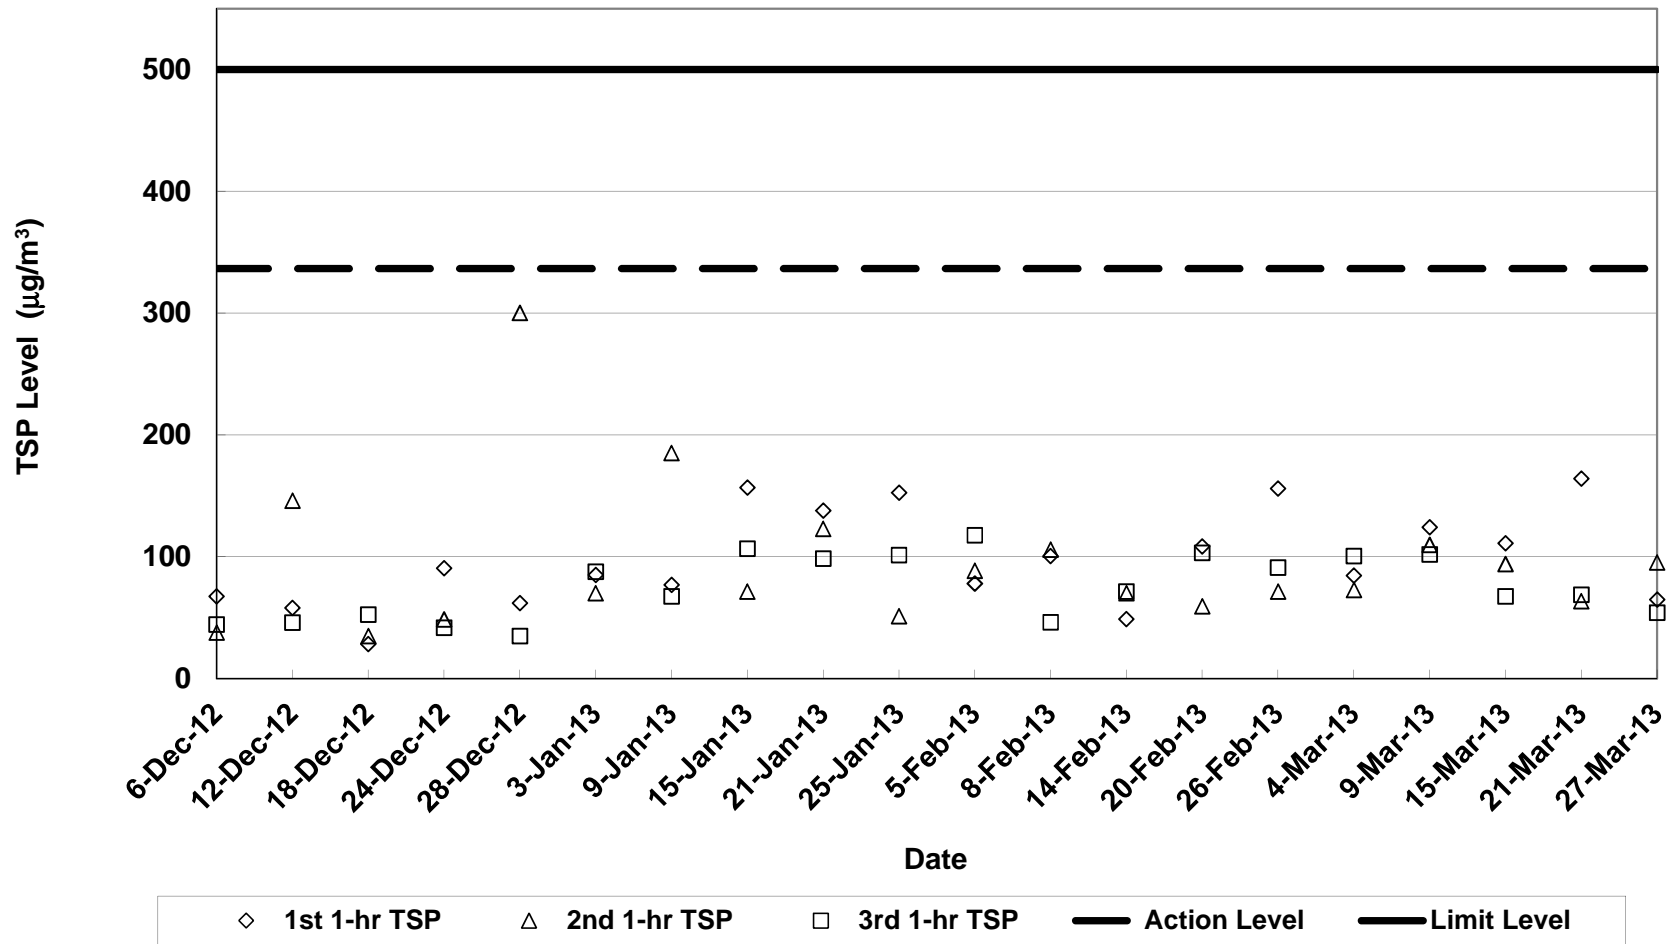
**Contract No. DC/2007/12 - Design and Construction of Tsuen Wan Drainage Tunnel
 Air Quality Monitoring (1-hr TSP) Results at Long Beach Gardens - Outfall (ASR8)
 Dec-12 to Mar-13**

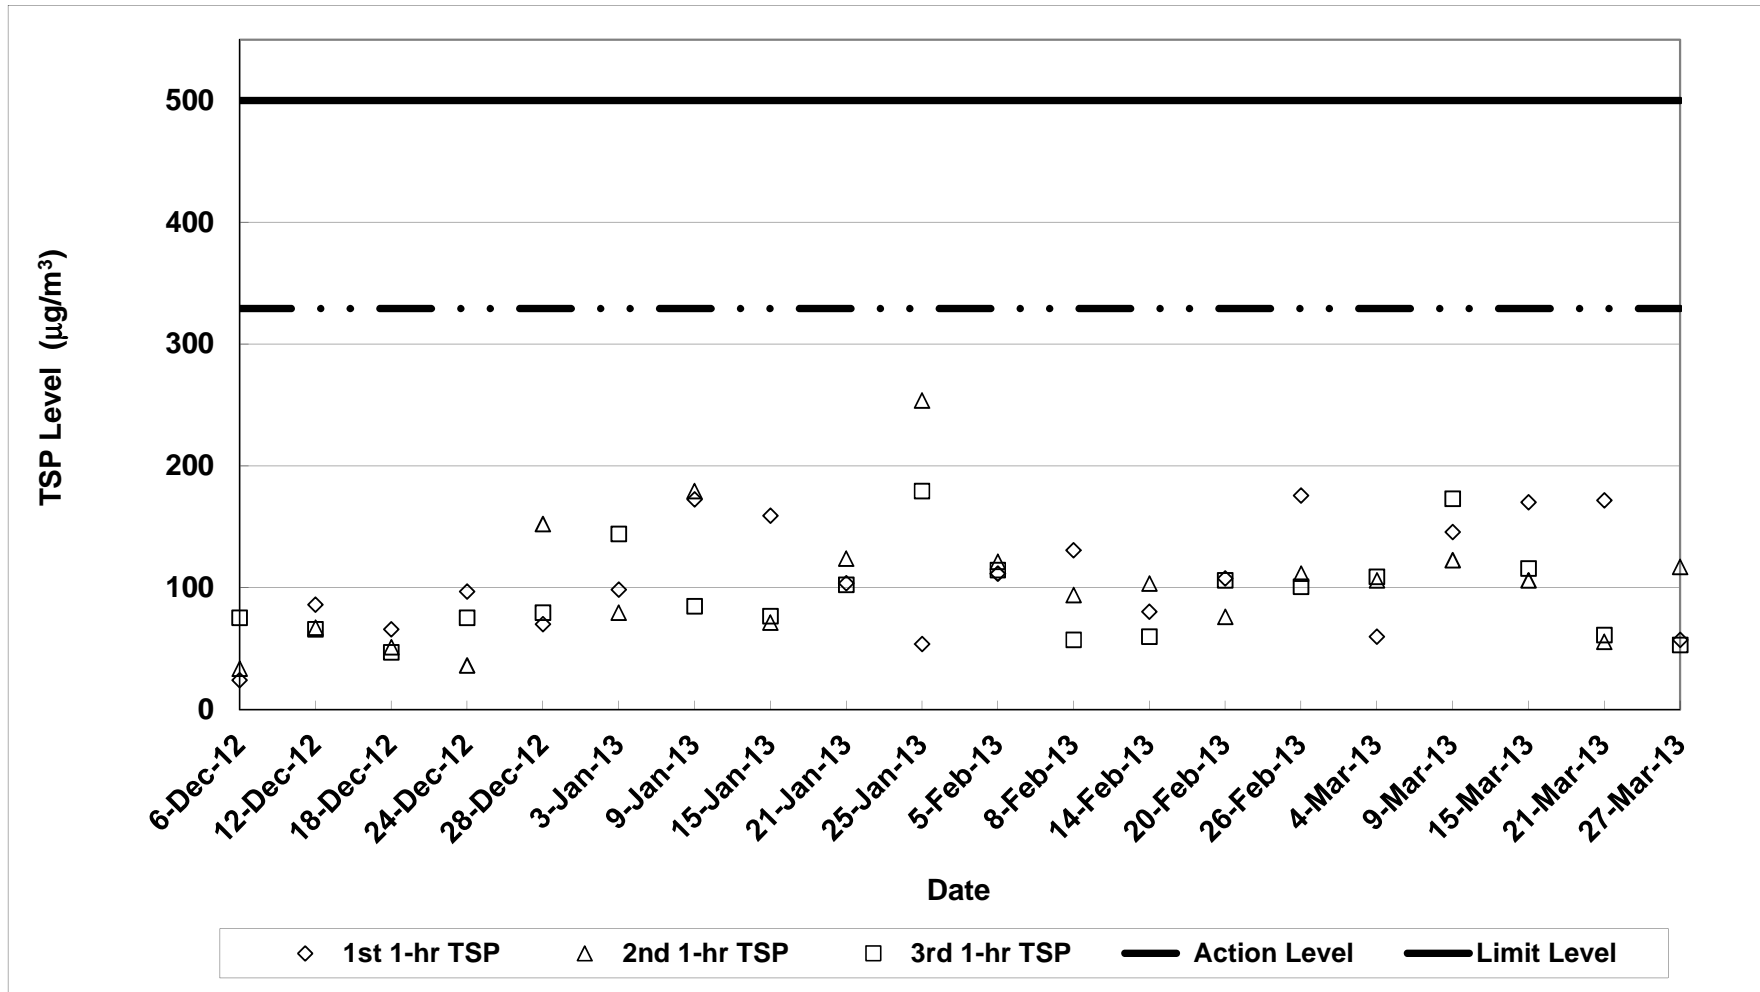
**Contract No. DC/2007/12 - Design and Construction of Tsuen Wan Drainage Tunnel
 Air Quality Monitoring (1-hr TSP) Results at Greenview Terrace - Outfall (ASR9)
 Dec-12 to Mar-13**

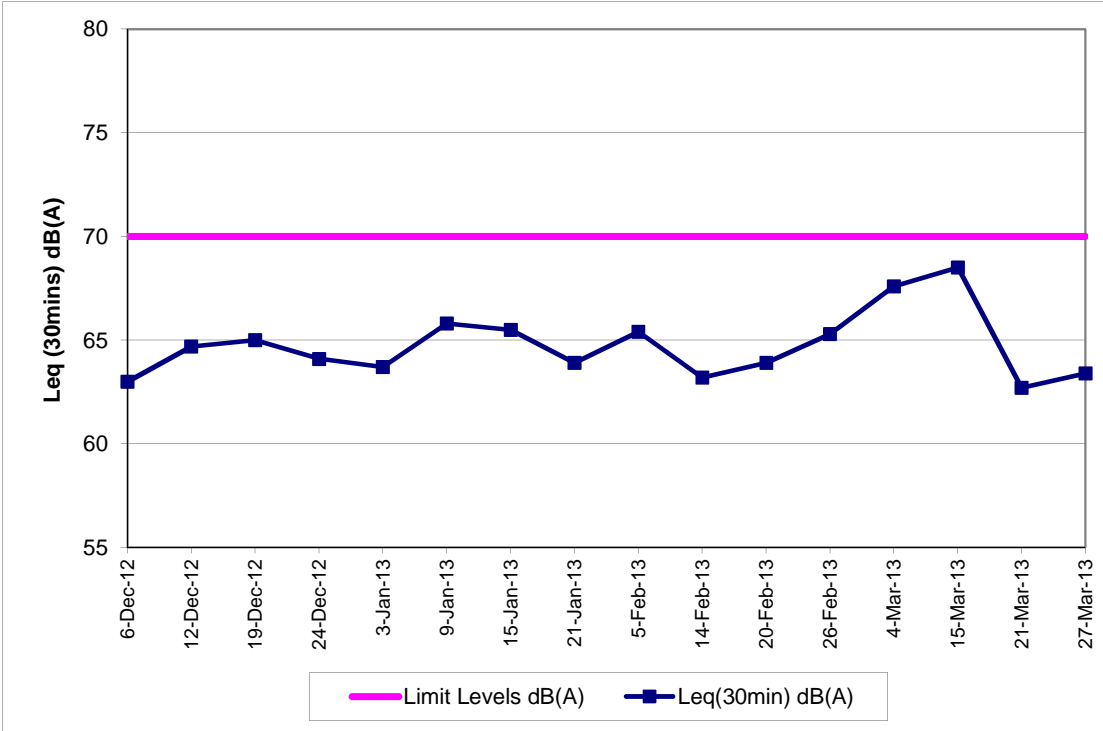
**Contract No. DC/2007/12 - Design and Construction of Tsuen Wan Drainage Tunnel
 Noise Monitoring Results at Sik Sik Yuen Ho Fung College (NSR 1)
 Dec-12 to Mar-13**

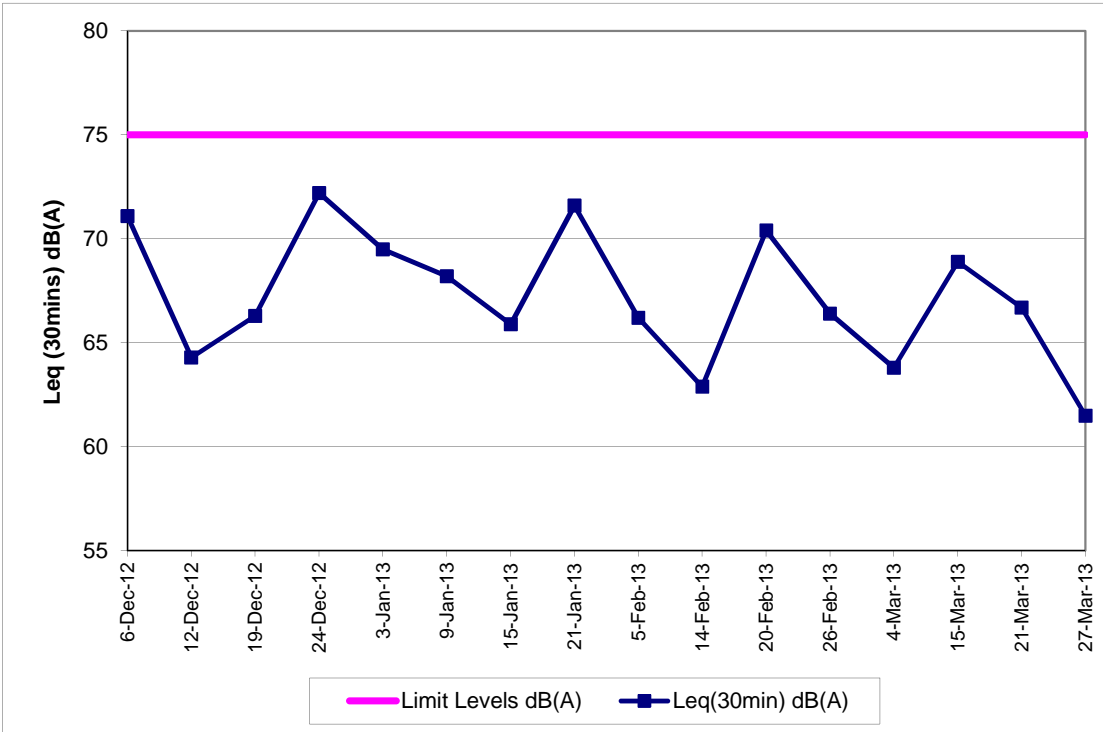
**Contract No. DC/2007/12 - Design and Construction of Tsuen Wan Drainage Tunnel
 Noise Monitoring Results at Hong Hoi Chee Hong Temple (NSR 3)
 Dec-12 to Mar-13**

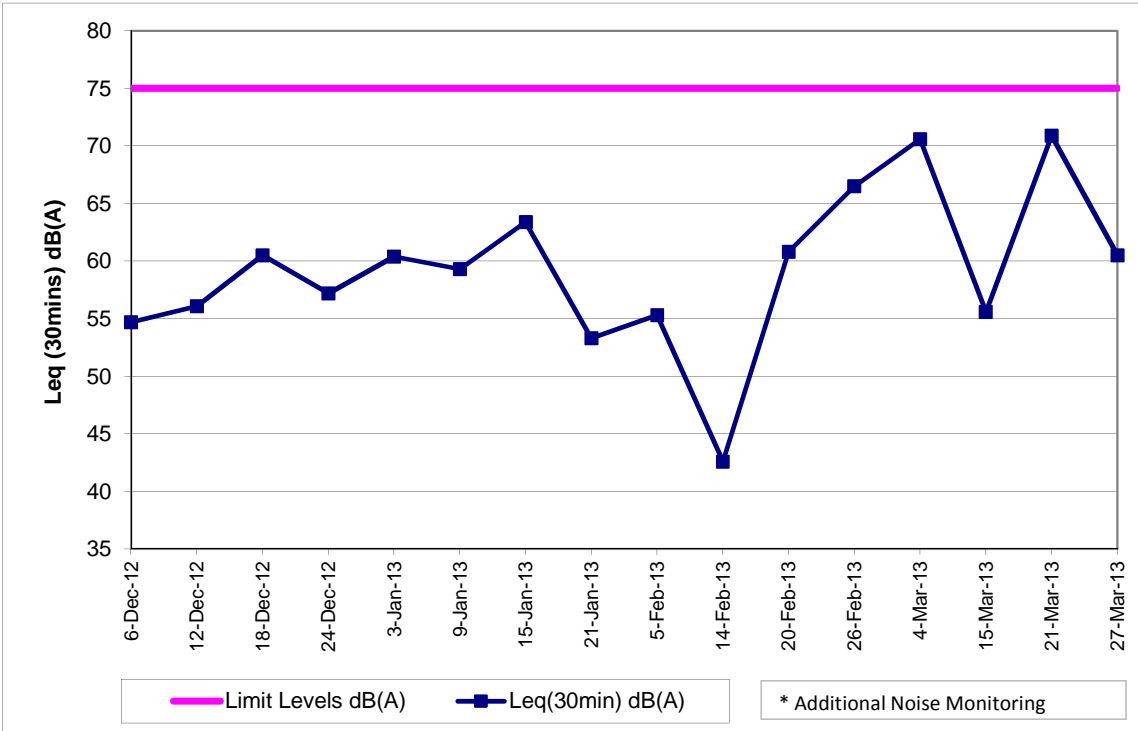
**Contract No. DC/2007/12 - Design and Construction of Tsuen Wan Drainage Tunnel
Noise Monitoring Results at Squatters (NSR 6)
Dec-12 to Mar-13**

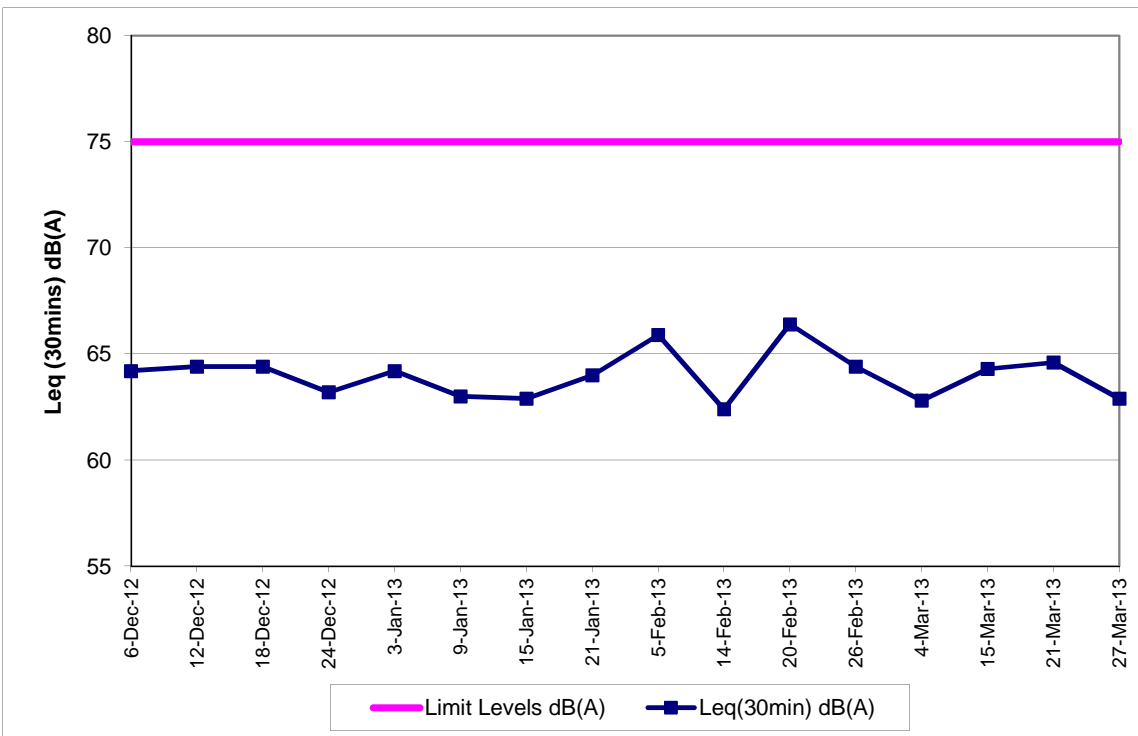
**Contract No. DC/2007/12 - Design and Construction of Tsuen Wan Drainage Tunnel
Noise Monitoring Results at Long Beach Gardens (NSR 8)
Dec-12 to Mar-13**

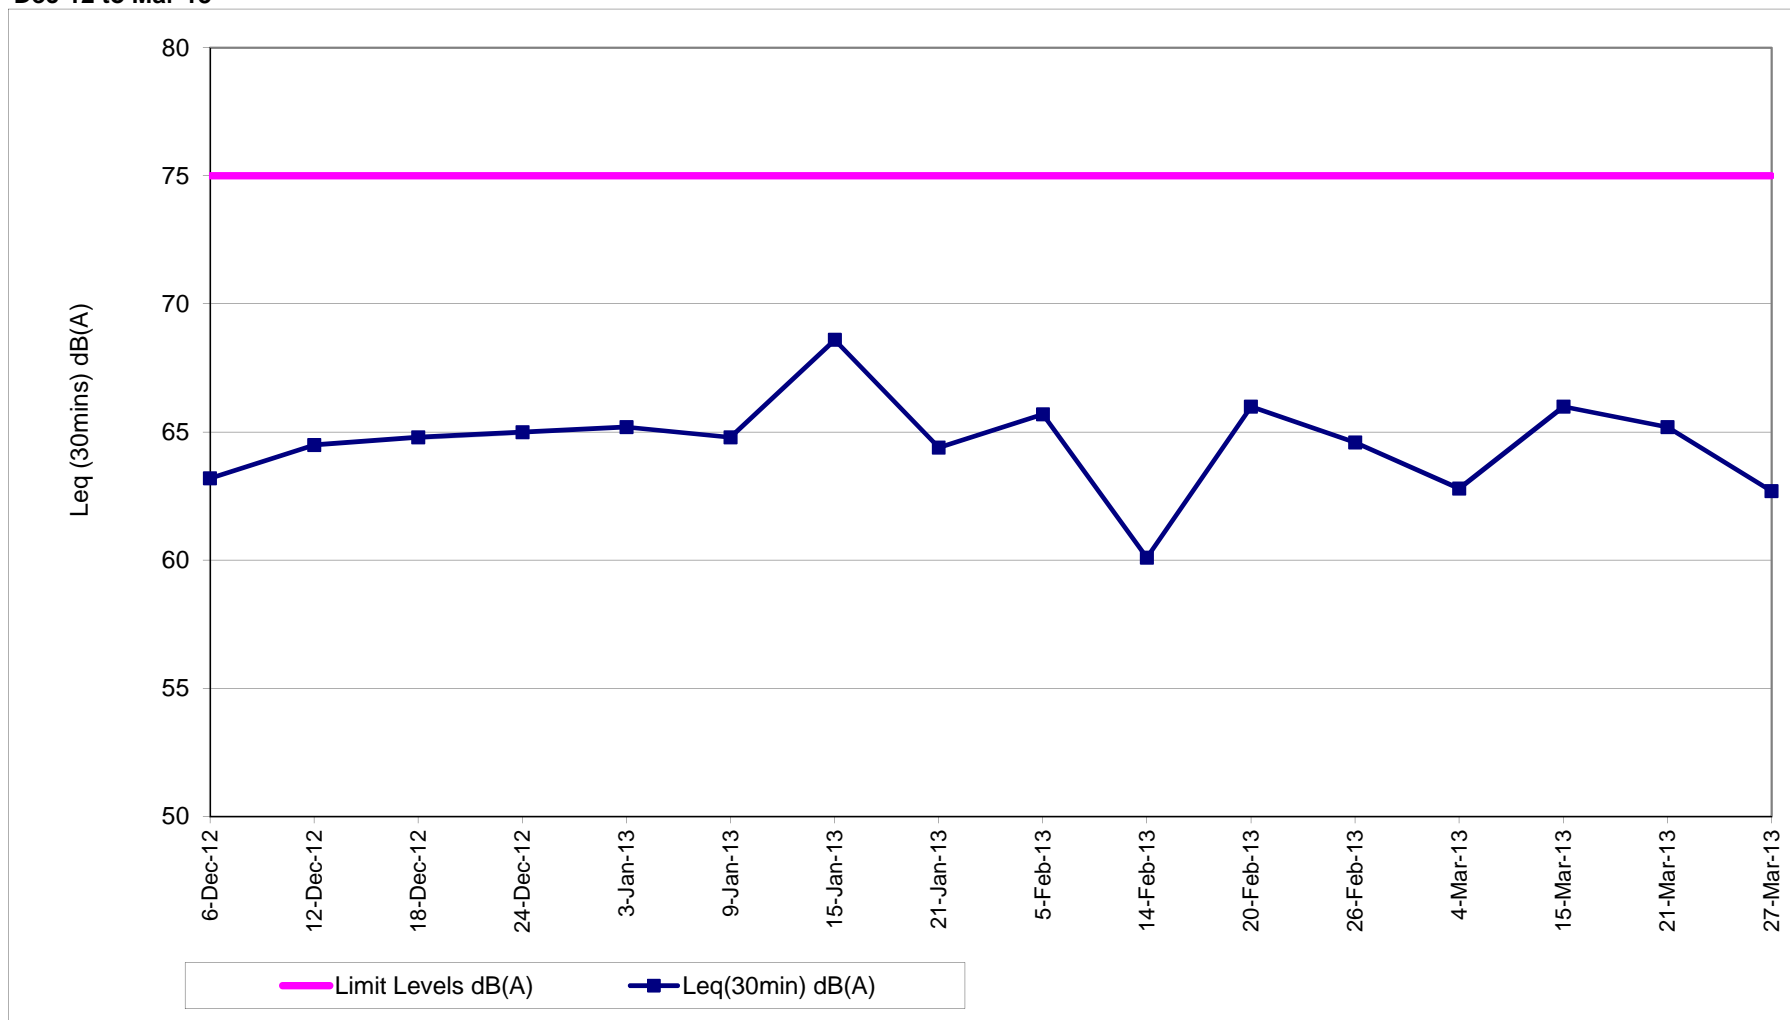
Contract No. DC/2007/12 - Design and Construction of Tsuen Wan Drainage Tunnel
Noise Monitoring Results at Greenview Terrace (NSR 9)
Dec-12 to Mar-13

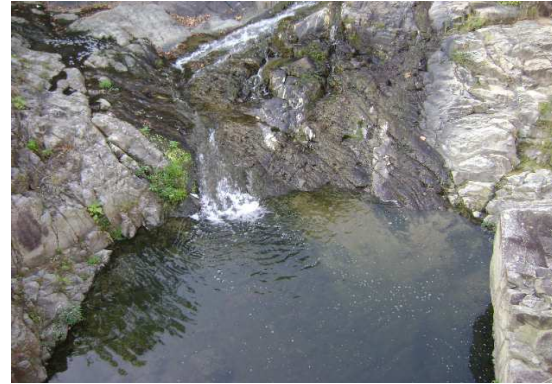
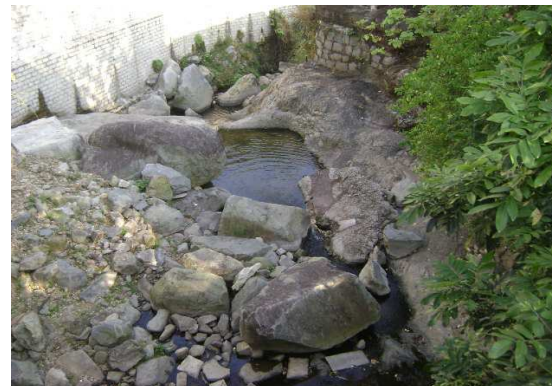
- 4.3.5 One exceedance of SS limit level was recorded at I-2 on 15 March 2013. The measured SS level (2.85 mg/L) was lower than the baseline action / limit level, but higher than 130% of the SS level (<2.00 mg/L) of the upstream control station (I-2-C). Details of the construction activities conducted on the monitoring day are given in Appendix J. No direct disturbance was observed from the site. Therefore, the exceedance was considered to be contributed by natural variation. Since the exceedance was non-project related, no further action was required.

Photographic record for exceedance of Suspended Solids (SS) recorded at Hong Hoi Chee Hong Temple (I-2) on 15-Mar-13

Photo taken at I-2

Photo of I-2-C

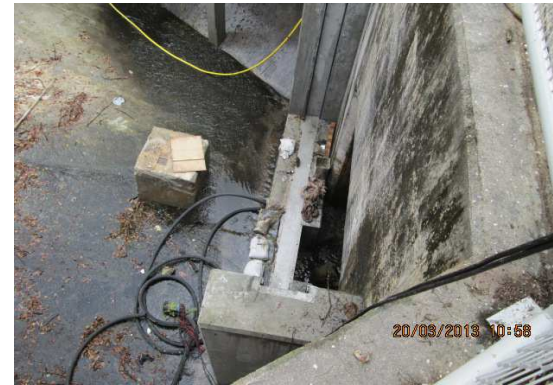
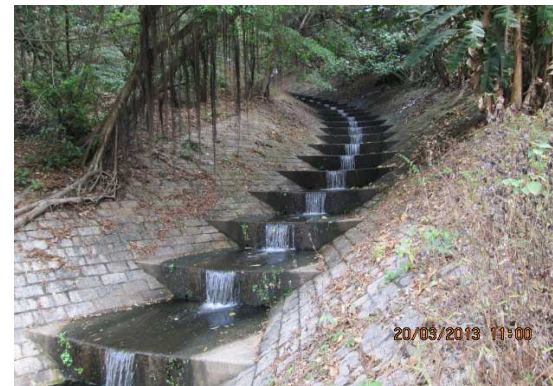
- 4.3.4 One exceedance of SS limit level was recorded at I-1 on 20 March 2013. The measured SS level (2.40 mg/L) was lower than the baseline action / limit level, but higher than 120% of the SS level (<2.00 mg/L) of the upstream control station (I-1-C). Details of the construction activities conducted on the monitoring day are given in Appendix J. No direct disturbance was observed from the site. Therefore, the exceedance was considered to be contributed by natural variation. Since the exceedance was non-project related, no further action was required.

Photographic record for exceedance of Suspended Solids (SS) recorded at Sik Sik Yuen Ho Fung College (I-1) on 20-Mar-13

Photo taken at I-1

Photo taken at I-1-C
