Contract No. DC/2007/12 - Design and
Construction of Tsuen Wan Drainage Tunnel

Monthly EM&A Report (July 2013)

Report No EB000364R1001

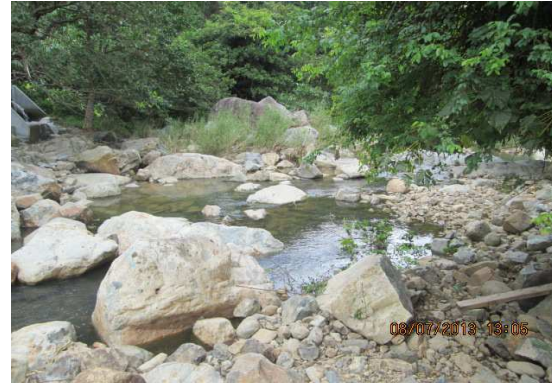
Photo taken at I-3

Photographic record for exceedance of Turbidity recorded at Squatters (I-3) on 08-Jul-13

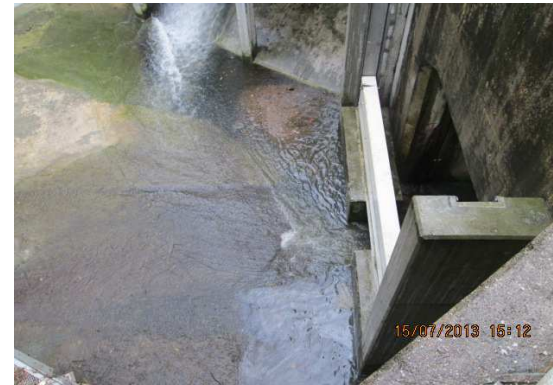
Photo taken at I-1

One exceedance of turbidity limit level was recorded at I-1 on 15 July 2013. The measured turbidity level (21.75 NTU) was higher than the baseline limit level, but lower than 120% of the turbidity level (21.65 NTU) of the upstream control station (I-1-C). Details of the construction activities conducted on the monitoring day are given in Appendix J. No direct disturbance was observed from the site. Heavy rain was observed and about 41 mm rainfall was recorded at Tsuen Wan by the Hong Kong Observatory between 8:45 and 15:45 on the monitoring day. Therefore, the exceedance was considered to be contributed by heavy rainfall and high turbidity level at upstream location. Since the exceedance was non-project related, no further action was required.

Photographic record for exceedance of Turbidity recorded at Sik Sik Yuen Ho Fung College (I-1) on 15-Jul-13

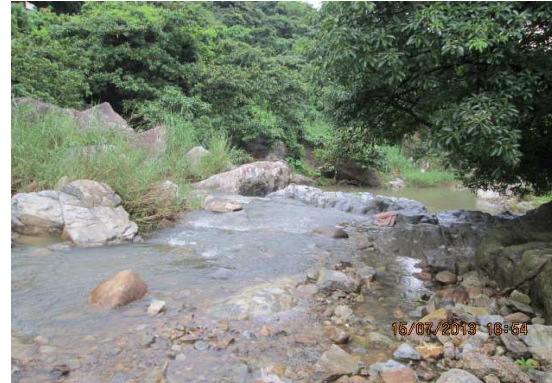
Photo taken at I-3

Photographic record for exceedance of Turbidity recorded at Squatters (I-3) on 15-Jul-13

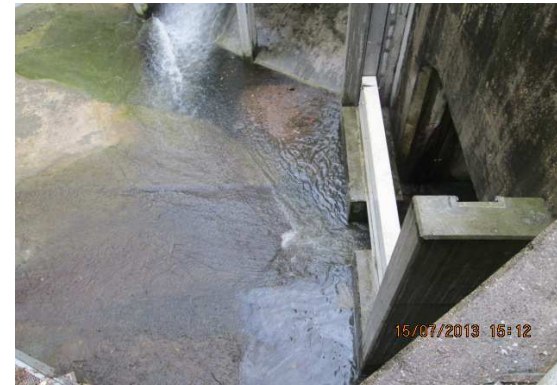
Photo taken at I-1

One exceedance of SS limit level was recorded at I-1 on 15 July 2013. The measured SS level (10.80 mg/L) was higher than the baseline limit level, and lower than 120% of the SS level (10.50 mg/L) of the upstream control station (I-1-C). Details of the construction activities conducted on the monitoring day are given in Appendix J. No direct disturbance was observed from the site. Heavy rain was observed and about 41 mm rainfall was recorded at Tsuen Wan by the Hong Kong Observatory between 8:45 and 15:45 on the monitoring day. Therefore, the exceedance was considered to be contributed by heavy rainfall and high SS level at upstream location. Since the exceedance was non-project related, no further action was required.

Photographic record for exceedance of Suspended Solids (SS) recorded at Sik Sik Yuen Ho Fung College (I-1) on 15-Jul-13

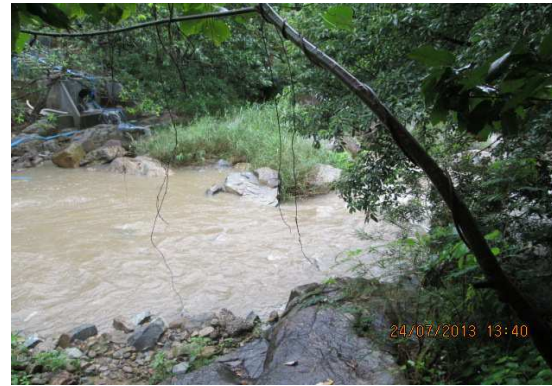
Photo taken at I-3

One exceedance of turbidity limit level was recorded at I-3 on 24 July 2013. The measured turbidity level (72.95 NTU) was higher than the baseline limit level, but lower than the turbidity level (73.05 NTU) of the upstream control station (I-3-C). Details of the construction activities conducted on the monitoring day are given in Appendix J. No direct disturbance was observed from the site. Heavy rain was observed and about 23 mm rainfall was recorded at Tsuen Wan by the Hong Kong Observatory between 0:45 and 10:45 on the monitoring day. Therefore, the exceedance was considered to be contributed by heavy rainfall and high turbidity level at upstream location. Since the exceedance was non-project related, no further action was required.

Photographic record for exceedance of Turbidity recorded at Squatters (I-3) on 24-Jul-13

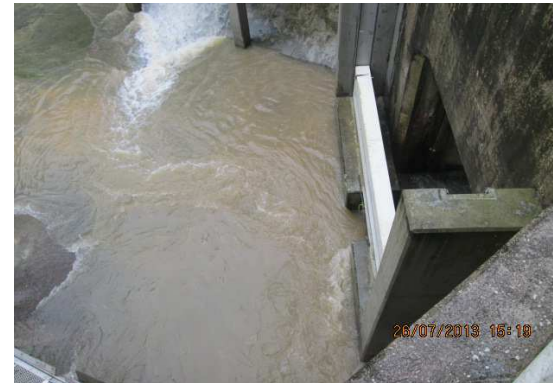
Photo taken at I-1

Project	Tsuen Wan Drainage Tunnel
Date	26-Jul-13
Time	2:16 PM
Monitoring Location	Sik Sik Yuen Ho Fung College (I-1)
Parameter	Turbidity
Action & Limit Levels (NTU)	9.75 / 12.47
Measured Level (NTU)	75.25
Control Station	I-1-C
Measured Level at the Control Station (NTU)	75.45
Possible reason for Action or Limit Level Non-compliance	The measured turbidity level was higher than the baseline limit level, but lower than the turbidity level of the control station (I-1-C). No construction activities were undertaken during the monitoring day. No direct disturbance was observed from the site. Heavy rain was observed and about 73 mm rainfall was recorded at Tsuen Wan by the Hong Kong Observatory between 6:45 and 13:45 on the monitoring day. Therefore, the exceedance was considered to be contributed by heavy rainfall and high turbidity level at upstream location. Since the exceedance was non-project related, no further action was required.

Photographic record for exceedance of Turbidity recorded at Sik Sik Yuen Ho Fung College (I-1) on 26-Jul-13

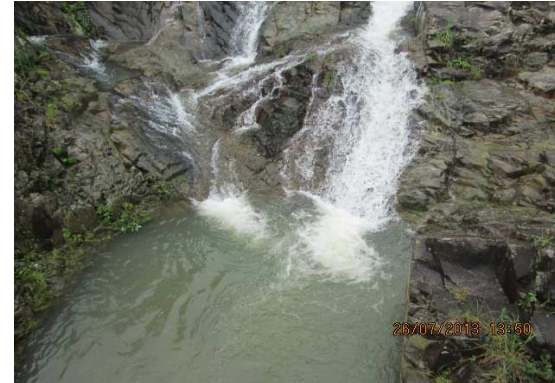
Photo taken at I-2

- 4.3.4 One exceedance of turbidity limit level was recorded at I-2 on 26 July 2013. The measured turbidity level (8.85 NTU) was higher than the baseline limit level, but lower than the turbidity level (8.91 NTU) of the upstream control station (I-2-C). Details of the construction activities conducted on the monitoring day are given in Appendix J. No direct disturbance was observed from the site. Heavy rain was observed and about 73 mm rainfall was recorded at Tsuen Wan by the Hong Kong Observatory between 6:45 and 13:45 on the monitoring day. Therefore, the exceedance was considered to be contributed by heavy rainfall and high turbidity level at upstream location. Since the exceedance was non-project related, no further action was required.

Photographic record for exceedance of Turbidity recorded at Hong Hoi Chee Hong Temple (I-2) on 26-Jul-13

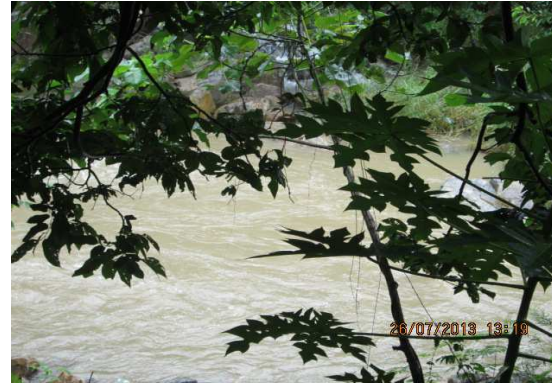
Photo taken at I-3

Project	Tsuen Wan Drainage Tunnel
Date	26-Jul-13
Time	12:10 PM
Monitoring Location	Squatters (I-3)
Parameter	Turbidity
Action & Limit Levels (NTU)	3.99 / 4.18
Measured Level (NTU)	54.45
Control Station	I-3-C
Measured Level at the Control Station (NTU)	54.65
Possible reason for Action or Limit Level Non-compliance	The measured turbidity level was higher than the baseline limit level, but lower than the turbidity level of the control station (I-3-C). General site cleaning and housekeeping, and installation of K1 kerb were undertaken during the monitoring day. No direct disturbance was observed from the site. Heavy rain was observed and about 69 mm rainfall was recorded at Tsuen Wan by the Hong Kong Observatory between 6:45 and 11:45 on the monitoring day. Therefore, the exceedance was considered to be contributed by heavy rainfall and high turbidity level at upstream location. Since the exceedance was non-project related, no further action was required.

Photographic record for exceedance of Turbidity recorded at Squatters (I-3) on 26-Jul-13

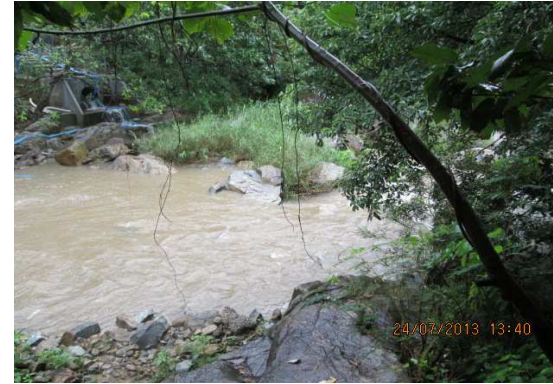
Photo taken at I-3

Photographic record for exceedance of Suspended Solids (SS) recorded at Squatters (I-3) on 24-Jul-13

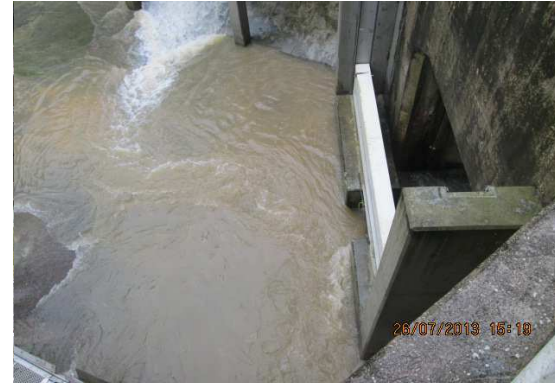
Photo taken at I-1

Project	Tsuen Wan Drainage Tunnel
Date	26-Jul-13
Time	2:16 PM
Monitoring Location	Sik Sik Yuen Ho Fung College (I-1)
Parameter	Suspended Solids (SS)
Action & Limit Levels (mg/L)	8.85 / 10.17
Measured Level (mg/L)	53.20
Control Station	I-1-C
Measured Level at the Control Station (mg/L)	46.95
Possible reason for Action or Limit Level Non-compliance	The measured SS level was higher than the baseline limit level, but lower than 120% of the SS level of the control station (I-1-C). No construction activities were undertaken during the monitoring day. No direct disturbance was observed from the site. Heavy rain was observed and about 73 mm rainfall was recorded at Tsuen Wan by the Hong Kong Observatory between 6:45 and 13:45 on the monitoring day. Therefore, the exceedance was considered to be contributed by heavy rainfall and high SS level at upstream location. Since the exceedance was non-project related, no further action was required.

Photographic record for exceedance of Suspended Solids (SS) recorded at Sik Sik Yuen Ho Fung College (I-1) on 26-Jul-13

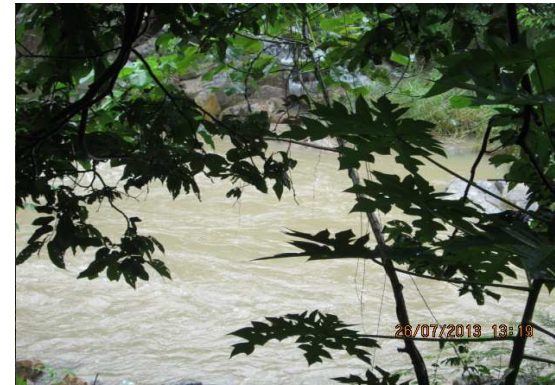
Photo taken at I-3

Photographic record for exceedance of Suspended Solids (SS) recorded at Squatters (I-3) on 26-Jul-13
