Contract NO. DC/2007/12 - Design and
Construction of Tsuen Wan Drainage Tunnel

Quarterly EM&A Report (July to September 2012)

Report No EB000364R0861

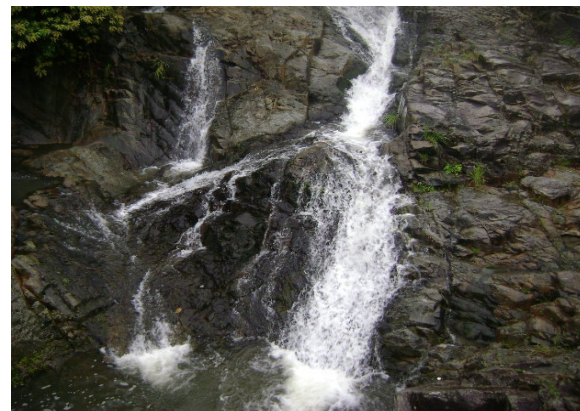
Photo taken at I-2

Photographic record for exceedance of Turbidity recorded at Hong Hoi Chee Hong Temple (I-2) on 05-Jul-12

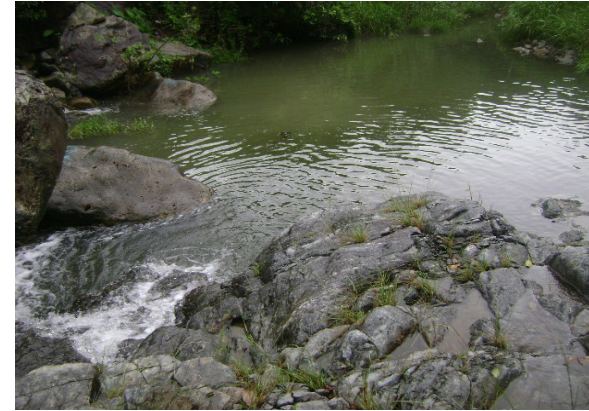
Photo taken at I-3

Photographic record for exceedance of Turbidity recorded at Squatters (I-3) on 05-Jul-12

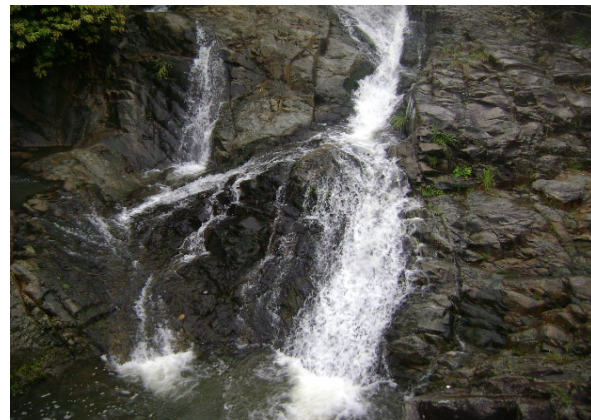
Photo taken at I-2

Photographic record for exceedance of Suspended Solids (SS) recorded at Hong Hoi Chee Hong Temple (I-2) on 05-Jul-12

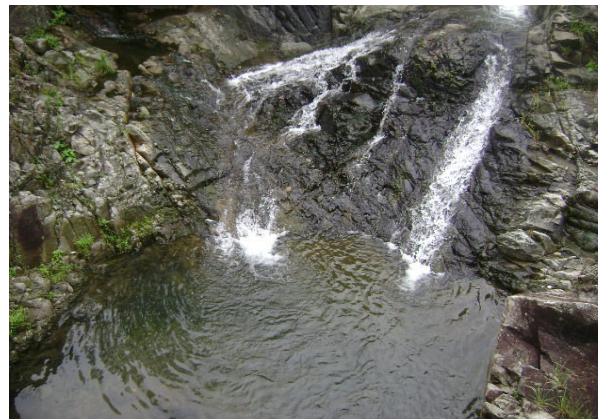
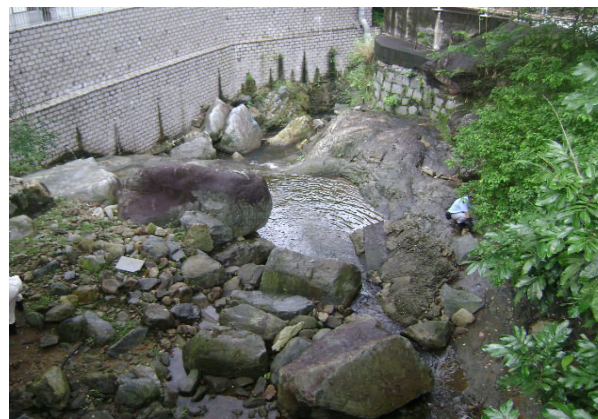
Photographic record for exceedance of Suspended Solids (SS) recorded at Hong Hoi Chee Hong Temple (I-2) on 07-Jul-12

Photo taken at I-2

Photo of I-2-C

- Three exceedances of SS limit level were recorded at I-2 on 5, 7 and 25 July 2012. The measured SS levels on 5 and 25 July 2012 (12.05 and 11.90 mg/L, respectively) were higher than the baseline limit level, but lower than the corresponding SS levels (13.40 and 13.05 mg/L, respectively) of the control station (I-2-C). Details of the construction activities conducted on the monitoring days are given in Appendix G. No direct disturbance was observed from the site. About 22.0 mm and 82.3 mm rainfall was recorded by the Hong Kong Observatory on 5 and 25 July 2012, respectively. Therefore, the exceedances were considered to be contributed by heavy rainfall and high SS level at upstream location. Since the exceedance was non-project related, no further action was required. For 7 July 2012, the measured SS level (4.70 mg/L) was lower than the baseline action / limit level, but higher than 130% of the SS level (<2.00 mg/L) of the control station (I-2-C). Details of the construction activities conducted on the monitoring day are given in Appendix G. No wastewater directly discharged from the site was observed. Although the SS level at I-2 was more than 135% higher than that at I-2-C, no direct sources of impact from the site were identified. As such, no further mitigation measures or actions were recommended.

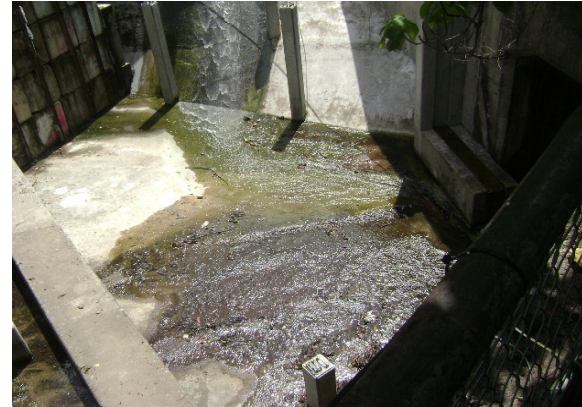
Photo taken at I-1

Photographic record for exceedance of Suspended Solids (SS) recorded at Sik Sik Yuen Ho Fung College (I-1) on 09-Jul-12

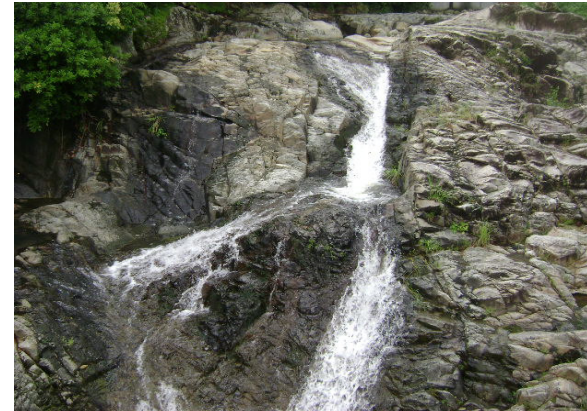
Photo taken at I-2

Photographic record for exceedance of Turbidity recorded at Hong Hoi Chee Hong Temple (I-2) on 18-Jul-12

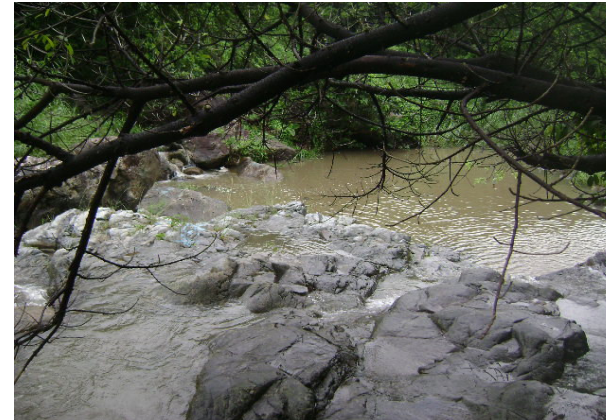
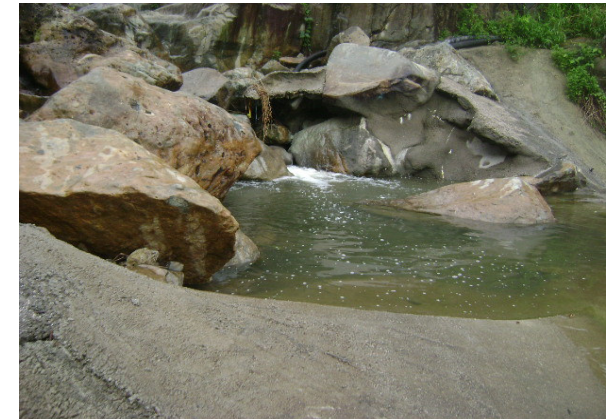
Photographic record for exceedance of Turbidity recorded at Squatters (I-3) on 18-Jul-12

Photo taken at I-3

Photo of I-3-C

- Five exceedances turbidity limit level were recorded at I-3 on 5, 18, 23, 25 and 27 July 2012. The measured turbidity levels on 5, 18, 23, 25 and 27 July 2012 (4.72, 48.05, 14.31, 31.15 and 24.05 NTU, respectively) were higher than the baseline limit level, but lower than the corresponding turbidity levels (4.74, 48.35, 14.47, 31.25 and 24.25 NTU, respectively) of the control station (I-2-C). Details of the construction activities conducted on the monitoring day are given in Appendix G. No direct disturbance was observed from the site. About 22.0 mm, 34.3 mm, 112.0 mm, 82.3 mm and 25.7 mm rainfall were recorded by the Hong Kong Observatory on 5, 18, 23, 25 and 27 July 2012 respectively. The exceedances were considered to be contributed by heavy rainfall and high turbidity level at upstream location. Since the exceedances were non-project related, no further action was required.

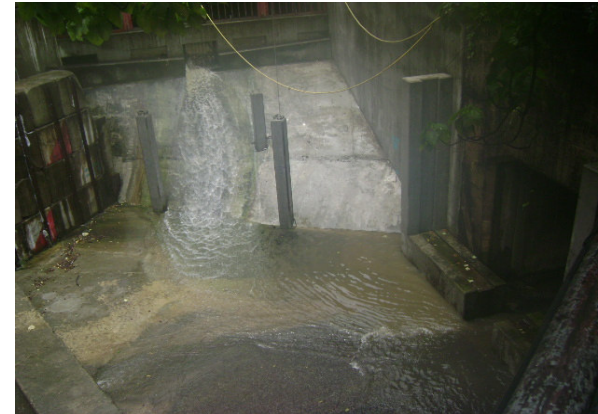
Photo taken at I-1

Photographic record for exceedance of Turbidity recorded at Sik Sik Yuen Ho Fung College (I-1) on 23-Jul-12

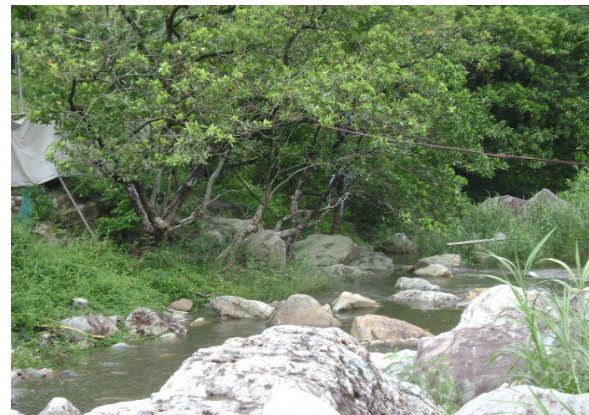
Photo taken at I-3

Photographic record for exceedance of Turbidity recorded at Squatters (I-3) on 23-Jul-12

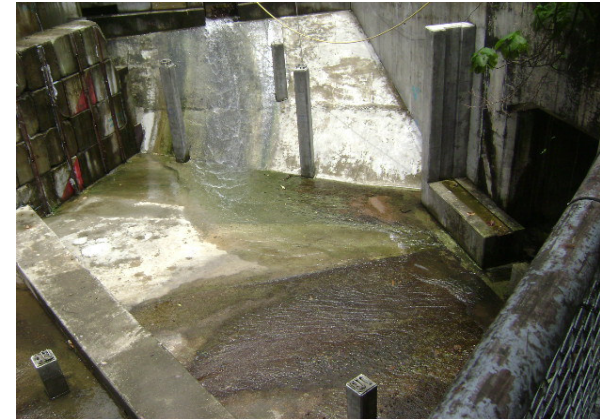
Photographic record for exceedance of Suspended Solids (SS) recorded at Sik Sik Yuen Ho Fung College (I-1) on 18-Jul-12

Photo taken at I-1

- One exceedance of SS action level was recorded at I-1 on 18 July 2012. The measured SS level (3.45 mg/L) was well below the baseline action/limit level, but higher than 120% of the SS level (2.75 mg/L) of the control station (I-1-C). Details of the construction activities conducted on the monitoring day are given in Appendix G. No direct disturbance was observed from the site. The exceedance was considered to be contributed by natural variation. Since the exceedance was non-project related, no further action was required.

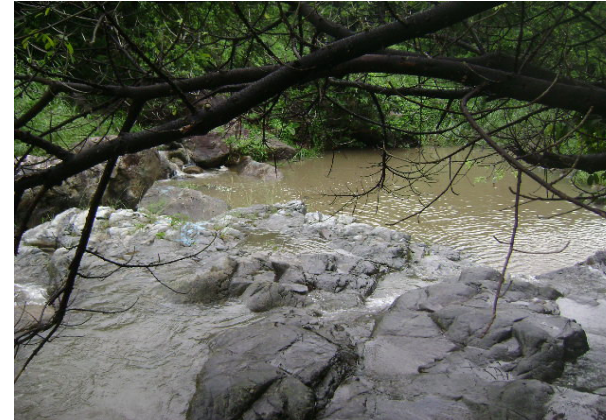
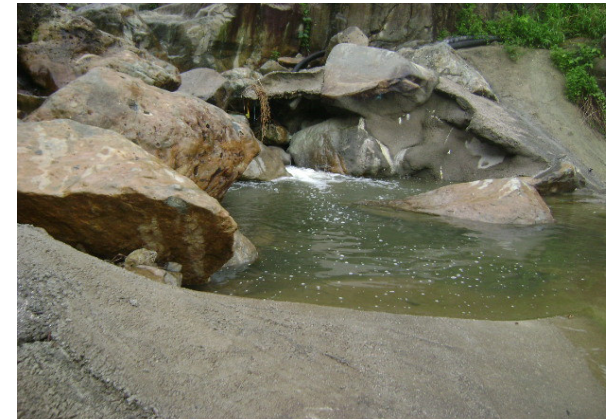
Photographic record for exceedance of Suspended Solids (SS) recorded at Squatters (I-3) on 18-Jul-12

Photo taken at I-3

Photo of I-3-C

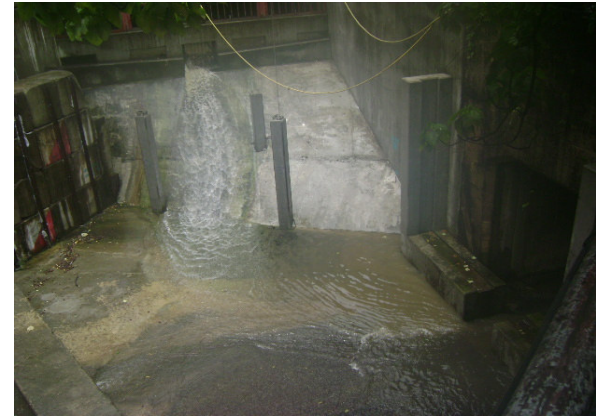
Photo taken at I-1

Photographic record for exceedance of Suspended Solids (SS) recorded at Sik Sik Yuen Ho Fung College (I-1) on 23-Jul-12

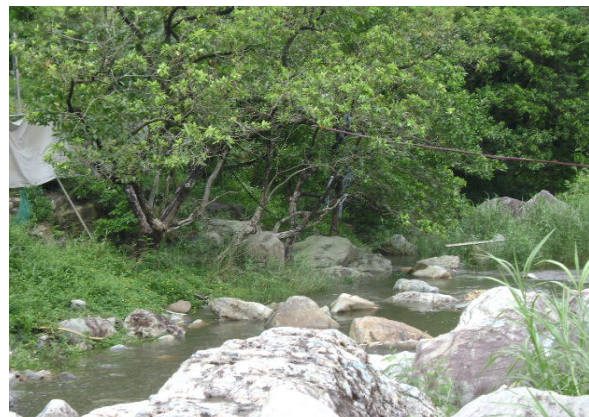
Photo taken at I-3

Photographic record for exceedance of Suspended Solids (SS) recorded at Squatters (I-3) on 23-Jul-12

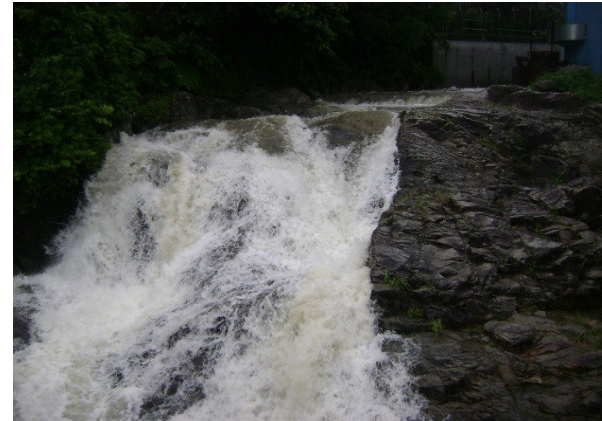
Photographic record for exceedance of Turbidity recorded at Hong Hoi Chee Hong Temple (I-2) on 25-Jul-12

Photo taken at I-2

- Four exceedances of turbidity limit level were recorded at I-2 on 5, 18, 25 and 27 July 2012. The measured turbidity levels on 5, 18, 25 and 27 July 2012 (12.70, 7.29, 23.25 and 8.08 NTU, respectively) were higher than the baseline limit level, but lower than the corresponding turbidity levels (12.75, 7.50, 23.35 and 8.19 NTU, respectively) of the control station (I-2-C). Details of the construction activities conducted on the monitoring days are given in Appendix G. No direct disturbance was observed from the site. About 22.0 mm, 34.3 mm, 82.3 mm and 25.7 mm rainfall were recorded by the Hong Kong Observatory on 5, 18, 25 and 27 July 2012, respectively. The exceedances were considered to be contributed by heavy rainfall and high turbidity level at upstream location. Since the exceedances were non-project related, no further action was required.

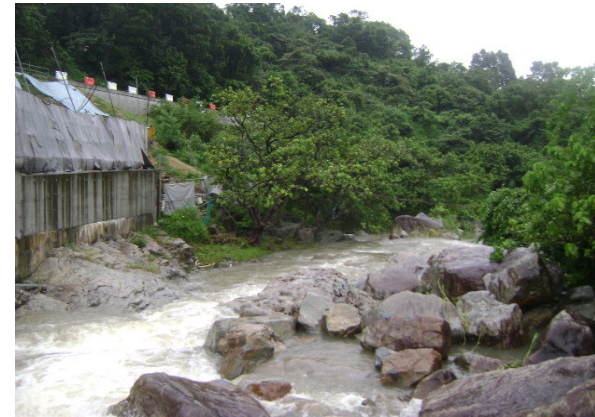
Photo taken at I-3

Photographic record for exceedance of Turbidity recorded at Squatters (I-3) on 25-Jul-12

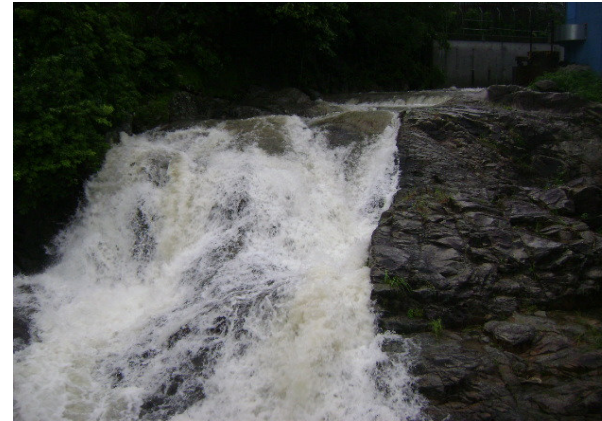
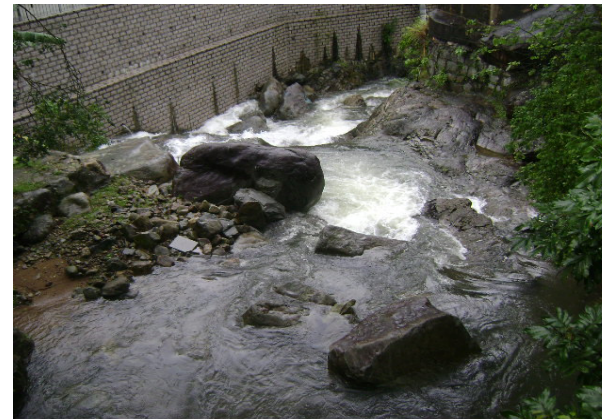
Photographic record for exceedance of Turbidity recorded at Hong Hoi Chee Hong Temple (I-2) on 27-Jul-12

Photo taken at I-2

Photo of I-2-C

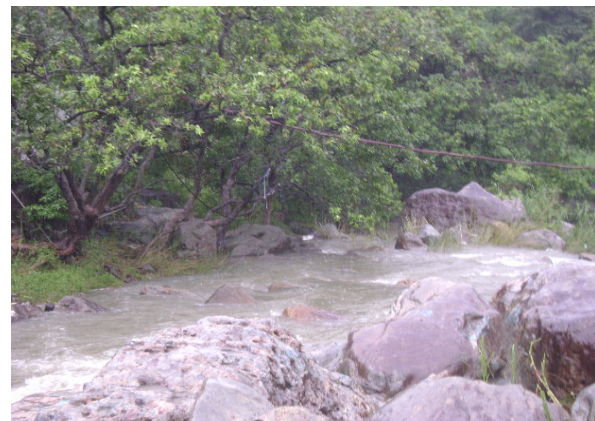
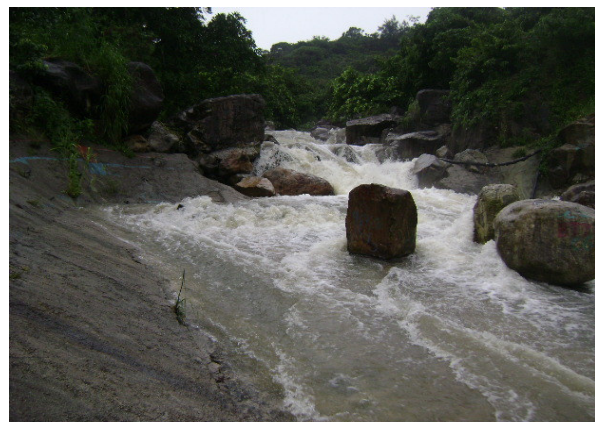
Photographic record for exceedance of Turbidity recorded at Squatters (I-3) on 27-Jul-12

Photo taken at I-3

Photo of I-3-C

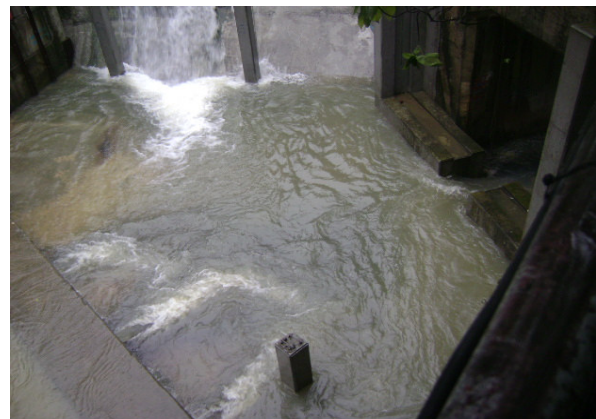
Photographic record for exceedance of Suspended Solids (SS) recorded at Sik Sik Yuen Ho Fung College (I-1) on 25-Jul-12

Photo taken at I-1

Photo of I-1-C

related, no further action was required. For 23 July 2012, the measured SS level (62.10 mg/L) was higher than the baseline limit level, but lower than 120% of the SS level (59.70 mg/L) of the control station (I-1-C). For 25 July 2012, the measured SS level (17.20 mg/L) was higher than the baseline limit level, but lower than the SS level (18.45 mg/L) of the control station (I-1-C). Details of the construction activities conducted on the monitoring days are given in Appendix G. No direct disturbance was observed from the site. About 112.0 mm and 82.3 mm rainfall were recorded by the Hong Kong Observatory on 23 and 25 July 2012, respectively. Therefore, the exceedance was considered to be contributed by heavy rainfall and high SS level at upstream location. Since the exceedances were non-project related, no further action was required.

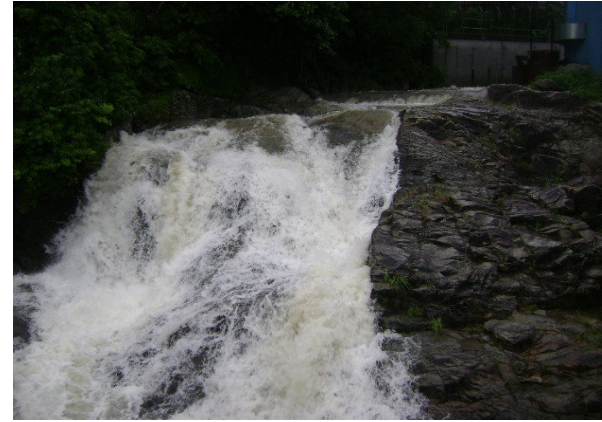
Photographic record for exceedance of Suspended Solids (SS) recorded at Hong Hoi Chee Hong Temple (I-2) on 25-Jul-12

Photo taken at I-2

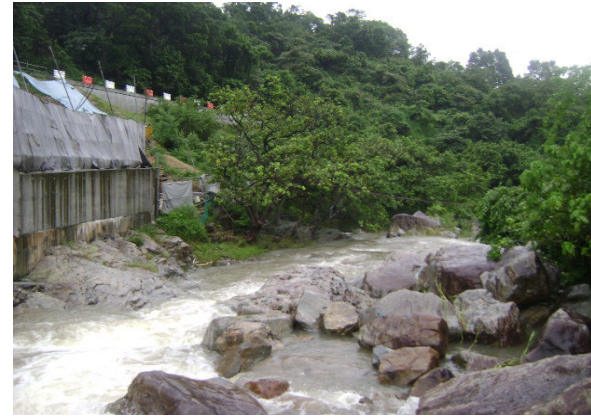
Photo taken at I-3

Photographic record for exceedance of Suspended Solids (SS) recorded at Squatters (I-3) on 25-Jul-12

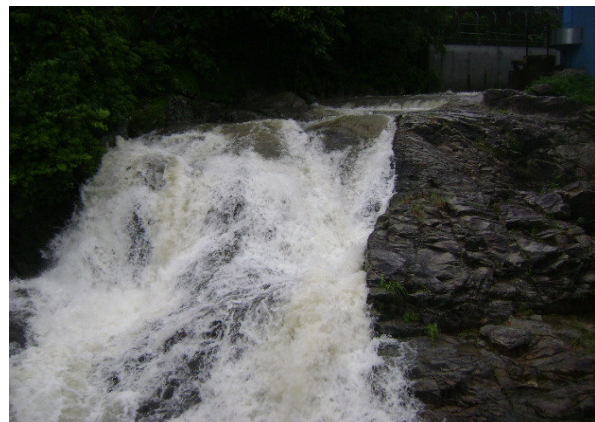
Photographic record for exceedance of Suspended Solids (SS) recorded at Hong Hoi Chee Hong Temple (I-2) on 27-Jul-12

Photo taken at I-2

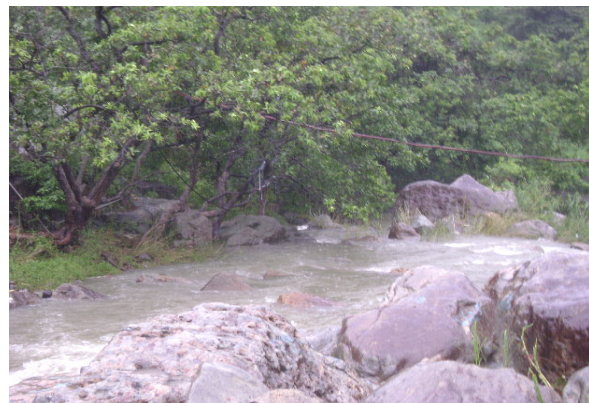
Photo taken at I-3

Photographic record for exceedance of Suspended Solids (SS) recorded at Squatters (I-3) on 27-Jul-12

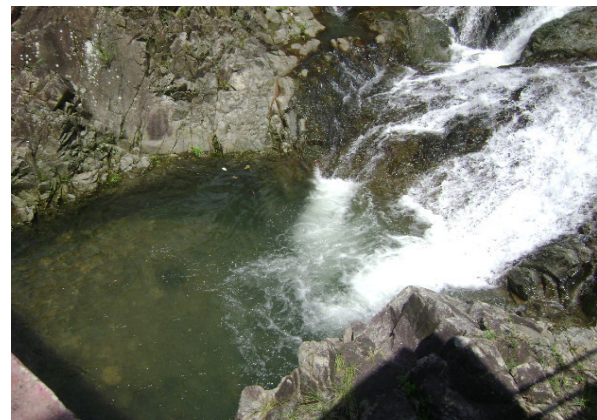
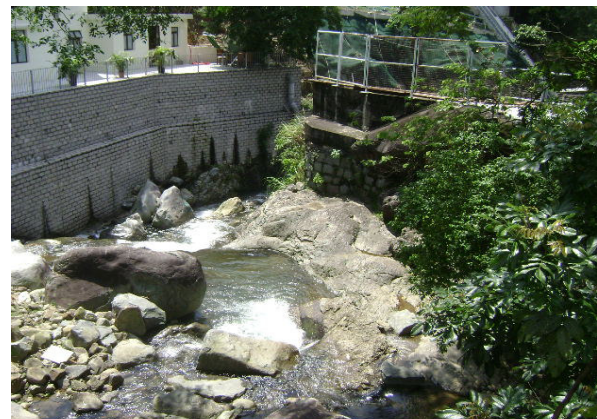
Photographic record for exceedance of Suspended Solids (SS) recorded at Hong Hoi Chee Hong Temple (I-2) on 30-Jul-12

Photo taken at I-2

Photo of I-2-C

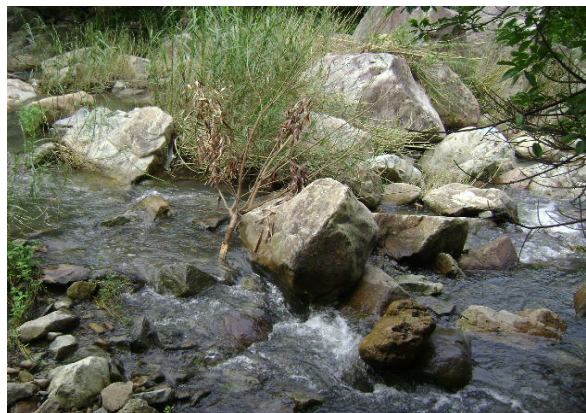
Photo taken at I-3

Photographic record for exceedance of Turbidity recorded at Squatters (I-3) on 06-Aug-12

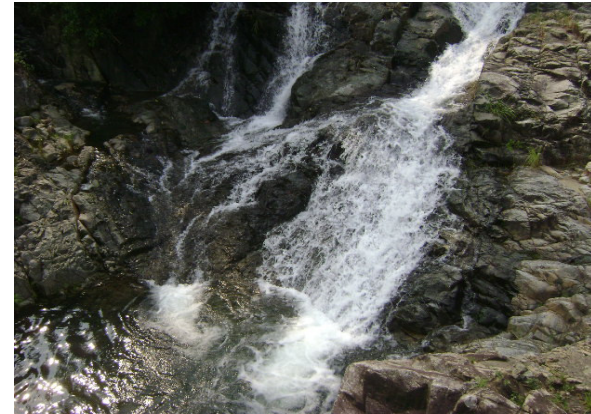
Photo taken at I-2

Photographic record for exceedance of Suspended Solids (SS) recorded at Hong Hoi Chee Hong Temple (I-2) on 01-Aug-12

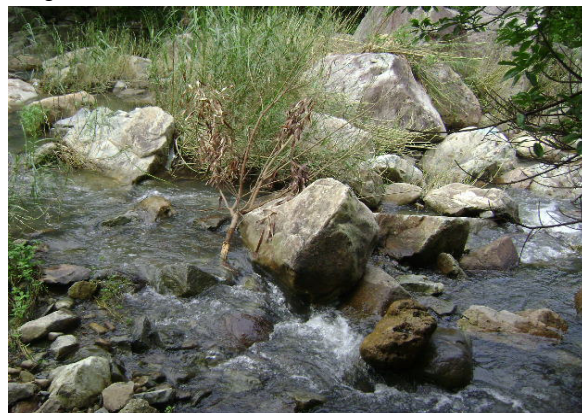
Photo taken at I-3

Photographic record for exceedance of Suspended Solids (SS) recorded at Squatters (I-3) on 06-Aug-12

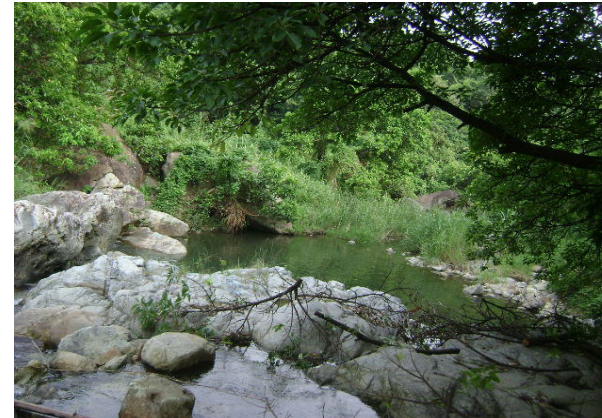
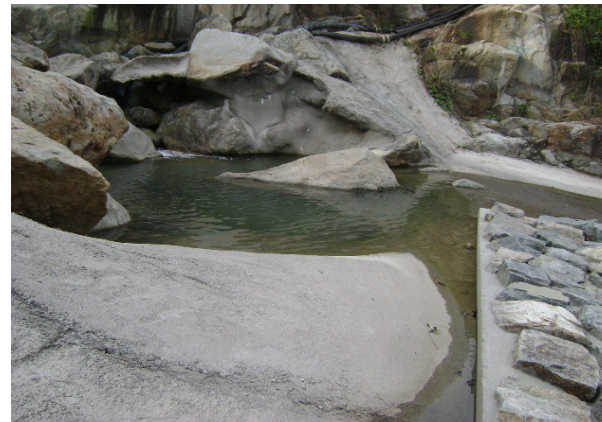
Photographic record for exceedance of Suspended Solids (SS) recorded at Squatters (I-3) on 24-Aug-12

Photo taken at I-3

Photo of I-3-C

- One exceedance of SS action level was recorded at I-3 on 24 August 2012. The measured SS level (3.50 mg/L) was lower than the baseline action / limit level, but higher than 120% of the SS level (2.80 mg/L) of the upstream control station (I-3-C). Details of the construction activities conducted on the monitoring day are given in Appendix G. No direct disturbance was observed from the site. Therefore, the exceedance was considered to be contributed by natural variation. Since the exceedance was non-project related, no further action was required.

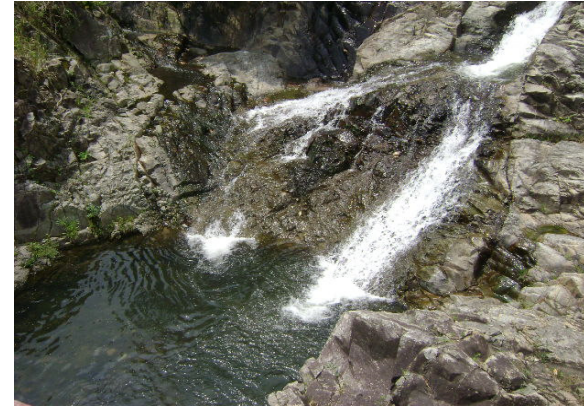
Photo taken at I-2

Photographic record for exceedance of Suspended Solids (SS) recorded at Hong Hoi Chee Hong Temple (I-2) on 27-Aug-12

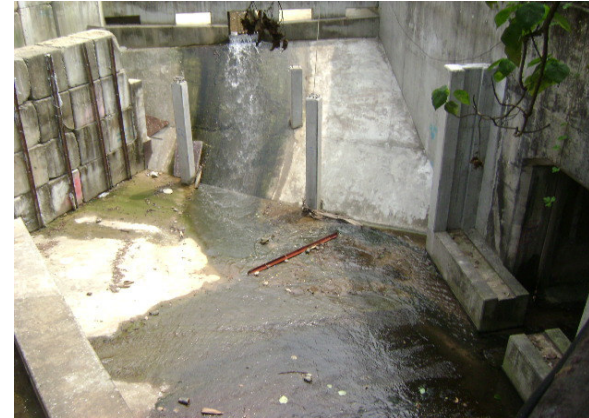
Photo taken at I-1

Photographic record for exceedance of Suspended Solids (SS) recorded at Sik Sik Yuen Ho Fung College (I-1) on 31-Aug-12

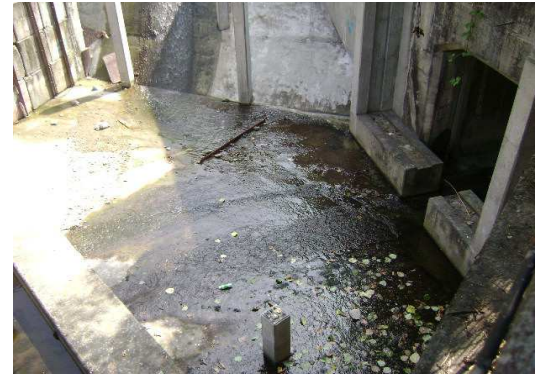
Photo taken at I-1

Photographic record for exceedance of Suspended Solids (SS) recorded at Sik Sik Yuen Ho Fung College (I-1) on 21-Sep-12

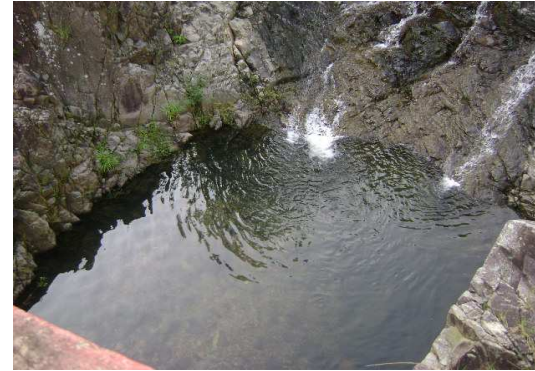
Photographic record for exceedance of Suspended Solids (SS) recorded at Hong Hoi Chee Hong Temple (I-2) on 26-Sep-12

Photo taken at I-2

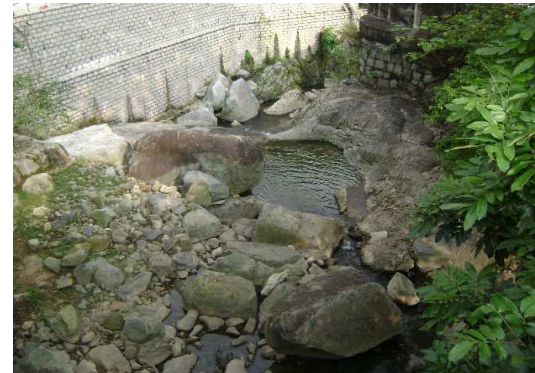
Photo of I-2-C

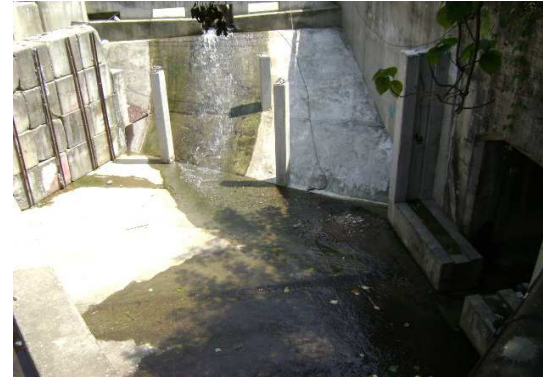
Photographic record for exceedance of Suspended Solids (SS) recorded at Sik Sik Yuen Ho Fung College (I-1) on 28-Sep-12

Photo taken at I-1
