Contract No. DC/2007/12 - Design and
Construction of Tsuen Wan Drainage Tunnel

Quarterly EM&A Report (October to December 2012)

Report No EB000364R0911

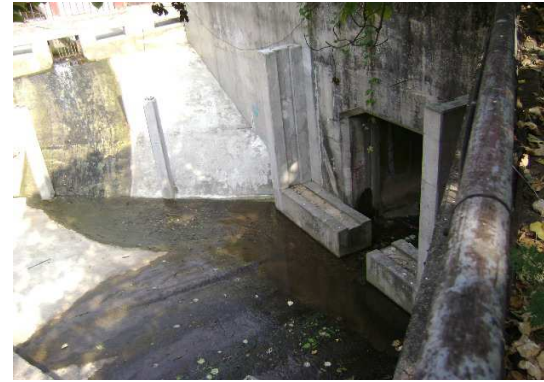
Photo taken at I-1

- One exceedance of SS limit level was recorded at I-1 on 15 October 2012. The measured SS level (14.25 mg/L) was higher than the baseline action / limit level, but lower than 120% of the SS level (12.00 mg/L) of the control station (I-1-C). Details of the construction activities conducted on the monitoring day are given in Appendix G. No direct disturbance was observed from the site. Therefore, the exceedance was considered to be contributed by natural variation. Since the exceedance was non-project related, no further action was required.

Photographic record for exceedance of Suspended Solids (SS) recorded at Sik Sik Yuen Ho Fung College (I-1) on 15-Oct-12

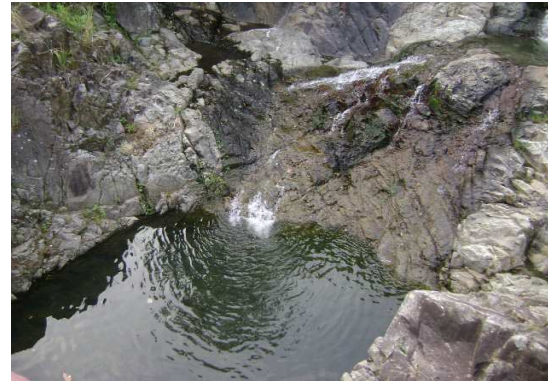
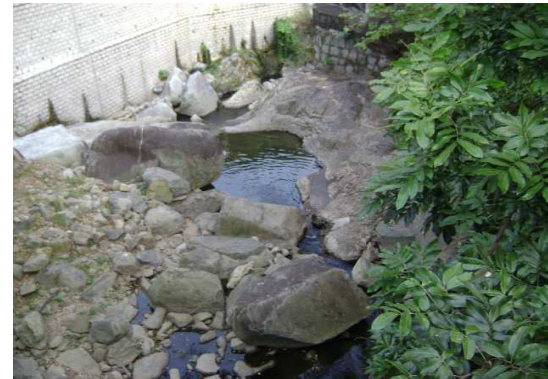
Photo taken at I-2

- One exceedance of SS limit level was recorded at I-2 on 17 October 2012. The measured SS levels (2.70 mg/L) was lower than the baseline limit level, but higher than 130% of the SS levels (<2.00 mg/L) of the control station (I-2-C). Details of the construction activities conducted on the monitoring days are given in Appendix G. No direct disturbance was observed from the site. Therefore, the exceedance was considered to be contributed by natural variation. Since the exceedance was non-project related, no further action was required.

Photographic record for exceedance of Suspended Solids (SS) recorded at Hong Hoi Chee Hong Temple (I-2) on 17-Oct-12

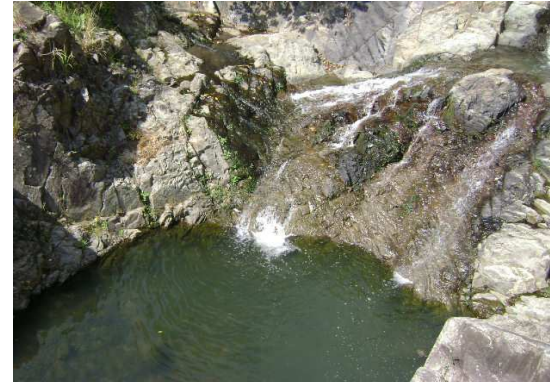
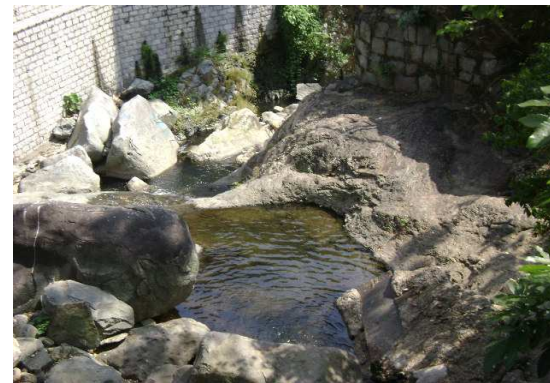
Photo taken at I-2

- One exceedances of SS action level were recorded at I-2 on 24 October 2012. The measured SS level (2.95 mg/L) was lower than the baseline action / limit level, but higher than 120% of the SS level (2.30 mg/L) of the control station (I-2-C). Details of the construction activities conducted on the monitoring day are given in Appendix G. No direct disturbance was observed from the site. Therefore, the exceedance was considered to be contributed by natural variation. Since the exceedance was non-project related, no further action was required.

Photographic record for exceedance of Suspended Solids (SS) recorded at Hong Hoi Chee Hong Temple (I-2) on 24-Oct-12

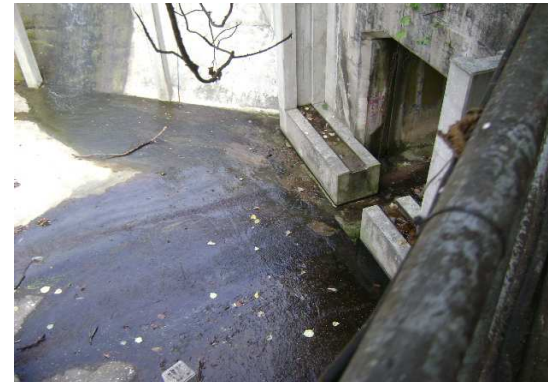
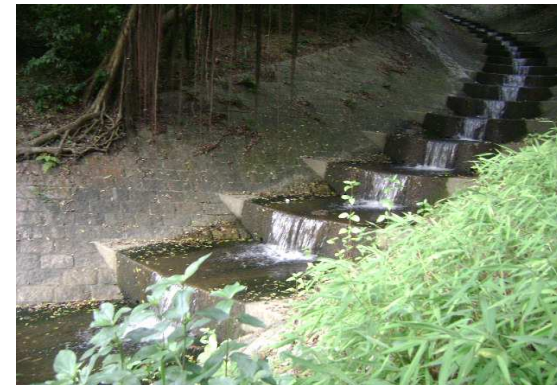
Photo taken at I-1

- One exceedance of turbidity action level was recorded at I-1 on 5 November 2012. The measured turbidity level (9.86 NTU) was higher than the baseline action / limit level, but lower than 120% of the turbidity level (9.81 NTU) of the upstream control station (I-1-C). Details of the construction activities conducted on the monitoring day are given in Appendix G. No direct disturbance was observed from the site. The exceedance was considered to be contributed by the high turbidity level at upstream location. Since the exceedance was non-project related, no further action was required.

Photographic record for exceedance of Turbidity recorded at Sik Sik Yuen Ho Fung College (I-1) on 05-Nov-12

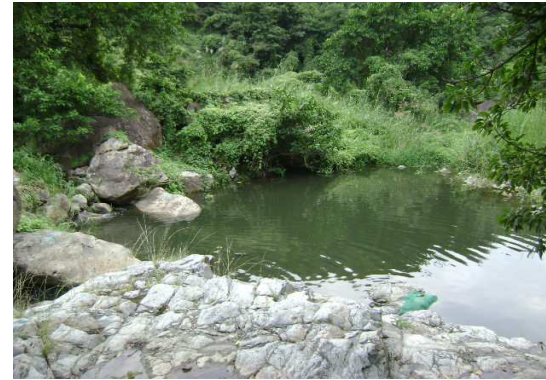
Photo taken at I-3

- One exceedance of turbidity limit level was recorded at I-3 on 23 November 2012. The measured turbidity level (6.79 NTU) was higher than the baseline limit level, but lower than the turbidity level (6.82 NTU) of the upstream control station (I-3-C). Details of the construction activities conducted on the monitoring day are given in Appendix G. No direct disturbance was observed from the site. About 31 mm rainfall was recorded at Tsuen Wan (Ho Koon) between 7:45 am and 11:45 am on the monitoring day. Therefore, the exceedance was considered to be contributed by the rainfall and high turbidity level at upstream location. Since the exceedance was non-project related, no further action was required.

Photographic record for exceedance of Turbidity recorded at Squatters (I-3) on 23-Nov-12

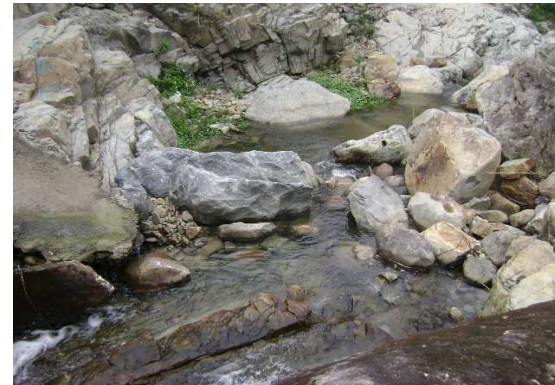
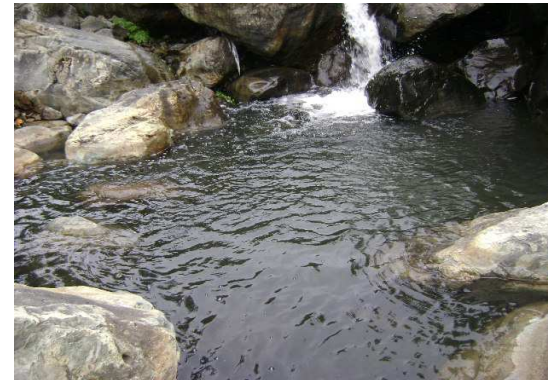
Photo taken at I-3

- One exceedance of turbidity limit level was recorded at I-3 on 3 December 2012. The measured turbidity level (4.19 NTU) was higher than the baseline action / limit level, but lower than the turbidity level (4.29 NTU) of the upstream control station (I-3-C). Details of the construction activities conducted on the monitoring day are given in Appendix G. No direct disturbance was observed from the site. Therefore, the exceedance was considered

Photographic record for exceedance of Turbidity recorded at Squatters (I-3) on 03-Dec-12

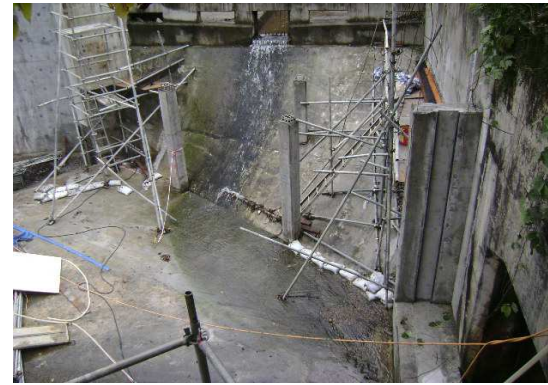
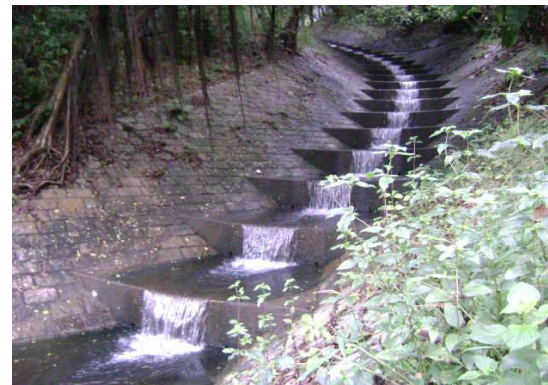
Photo taken at I-1

- Three exceedances of SS limit level were recorded at I-1 on 3, 10 and 29 December 2012. For 3 December 2012, the measured SS level (4.60 mg/L) was lower than the baseline action / limit level, but higher than 130% of the SS levels (3.10 mg/L) of the control station (I-1-C). Details of the construction activities conducted on the monitoring day are given in Appendix G. No direct disturbance was observed from the site. Therefore, the exceedance was considered to be contributed by natural variation. Since the exceedance was non-project related, no further action was required. For 10 December 2012, the measured SS level (9.80 mg/L) was higher than the baseline action level, and higher than 130% of the SS levels (5.60 mg/L) of the control station (I-1-C). Details of the construction activities conducted on the monitoring day are given in Appendix G. No wastewater directly discharged from the site was observed. Although the SS level at I-1 was about 75% higher than that at I-1-C, no direct sources of impact from the site were identified. At such, no further mitigation measures or actions were recommended. For 29 December 2012, the measured SS level (10.20 mg/L) was higher than the baseline action / limit level, but lower than 120% of the SS levels (9.70 mg/L) of the control station (I-1-C). Details of the construction activities conducted on the monitoring day are given in Appendix G. No direct disturbance was observed from the site. About 0.5 to 2 mm of rainfall was observed over the catchment of I-1 between 13:00 and 14:00 on the monitoring day by the Hong Kong Observatory. The exceedance was considered to be contributed by rainfall and high SS level at upstream location. Since the exceedance was non-project related, no further action was required.

Photographic record for exceedance of Suspended Solids (SS) recorded at Sik Sik Yuen Ho Fung College (I-1) on 03-Dec-12

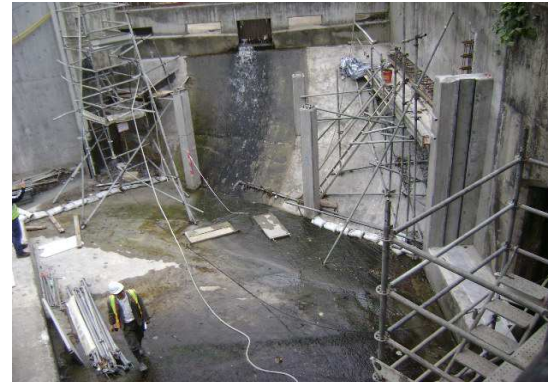
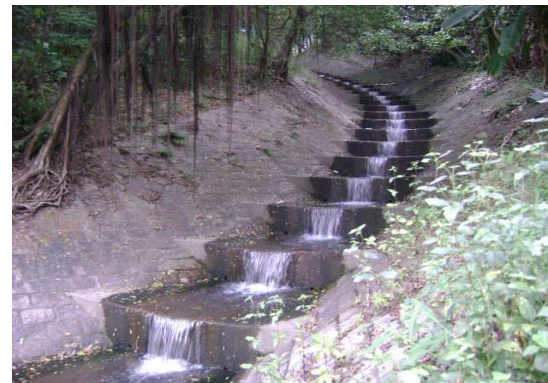
Photo taken at I-1

- One exceedance of turbidity limit level was recorded at I-1 on 10 December 2012. The measured turbidity level (12.76 NTU) was higher than the baseline action / limit level, but lower than the turbidity level (13.23 NTU) of the upstream control station (I-1-C). Details of the construction activities conducted on the monitoring day are given in Appendix G. No direct disturbance was observed from the site. Therefore, the exceedance was considered to be contributed by high turbidity level at upstream location. Since the exceedance was non-project related, no further action was required.

Photographic record for exceedance of Turbidity recorded at Sik Sik Yuen Ho Fung College (I-1) on 10-Dec-12

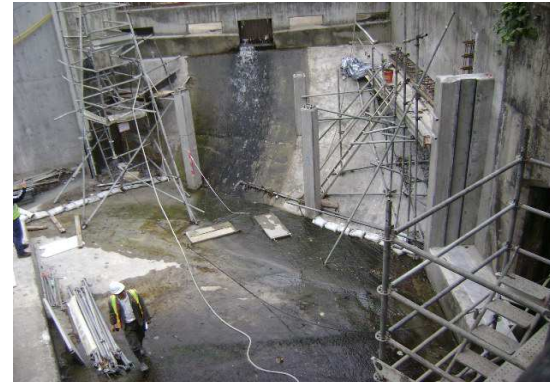
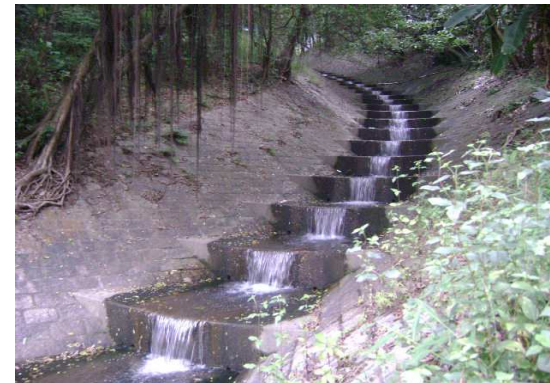
Photo taken at I-1

Photographic record for exceedance of Suspended Solids (SS) recorded at Sik Sik Yuen Ho Fung College (I-1) on 10-Dec-12

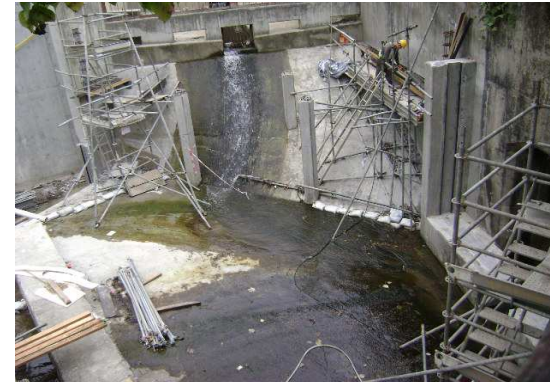
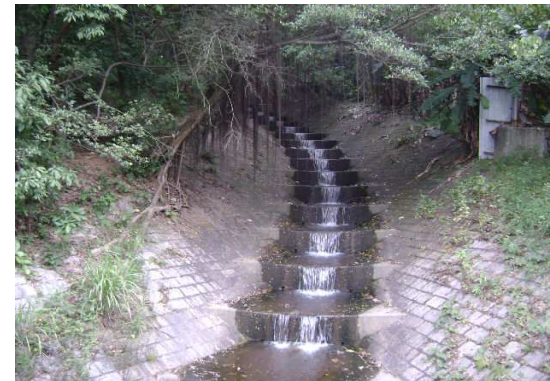
Photo taken at I-1

- Two exceedance of SS action level were recorded at I-1 on 14 and 19 December 2012. For 14 December 2012, the measured SS level (9.15 mg/L) was higher than the baseline action / limit level, but lower than the SS level (12.40 mg/L) of the upstream control station (I-1-C). Details of the construction activities conducted on the monitoring day are given in Appendix G. No direct disturbance was observed from the site. Therefore, the exceedance was considered to be contributed by SS level at upstream location. Since the exceedance was non-project related, no further action was required. For 19 December 2012, the measured SS level (6.70 mg/L) was lower than the baseline action / limit level, but higher than 120% of the SS level (5.45 mg/L) of the upstream control station (I-1-C). Details of the construction activities conducted on the monitoring day are given in Appendix G. No direct disturbance was observed from the site. Therefore, the exceedance was considered to be contributed by natural variation. Since the exceedance was non-project related, no further action was required.

Photographic record for exceedance of Suspended Solids (SS) recorded at Sik Sik Yuen Ho Fung College (I-1) on 14-Dec-12

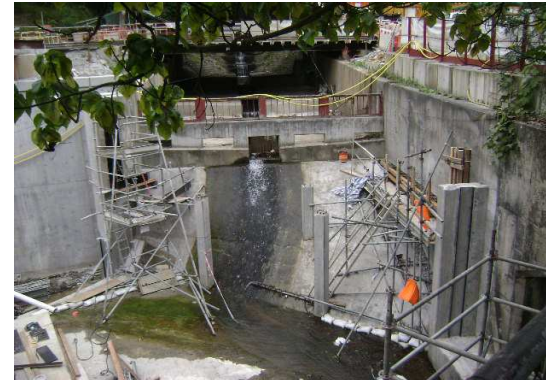
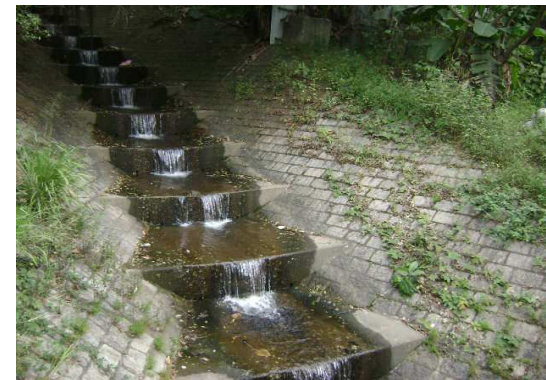
Photo taken at I-1

Photographic record for exceedance of Suspended Solids (SS) recorded at Sik Sik Yuen Ho Fung College (I-1) on 19-Dec-12

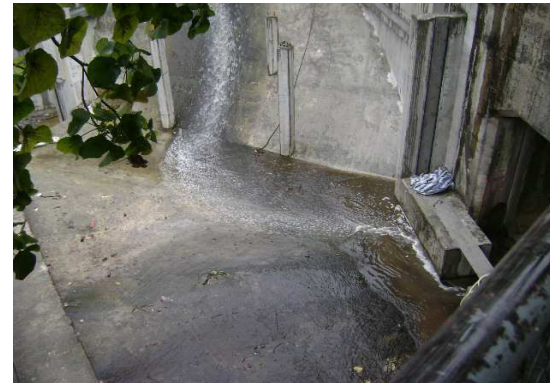
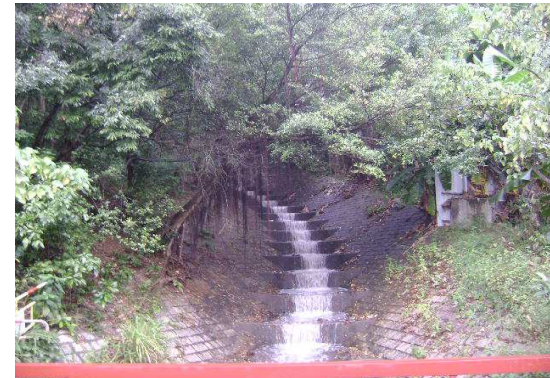
Photo taken at I-1

- One exceedance of turbidity action level was recorded at I-1 on 29 December 2012. The measured turbidity level (11.11 NTU) was higher than the baseline action level, but lower than the turbidity level (11.26 NTU) of the upstream control station (I-1-C). Details of the construction activities conducted on the monitoring day are given in Appendix G. No direct disturbance was observed from the site. About 0.5 to 2 mm of rainfall was observed over the catchment of I-1 between 13:00 and 14:00 on the monitoring day by the Hong Kong Observatory. The exceedance was considered to be contributed by rainfall and high turbidity level at upstream location. Since the exceedance was non-project related, no further action was required.

Photographic record for exceedance of Turbidity recorded at Sik Sik Yuen Ho Fung College (I-1) on 29-Dec-12

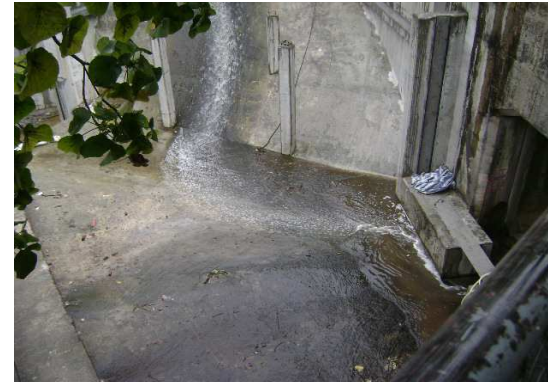
Photo taken at I-1

Photographic record for exceedance of Suspended Solids (SS) recorded at Sik Sik Yuen Ho Fung College (I-1) on 29-Dec-12
