Reprovisioning and Upgrading of Salt  
Water Service Reservoirs in Western  
District for Water Supplies Department:  
*Monthly Environmental Monitoring  
and Audit Report for 1<sup>st</sup> Construction  
Period (21 July – 20 August 2007)*

September 2007

MONTHLY ENVIRONMENTAL  
MONITORING & AUDIT REPORT

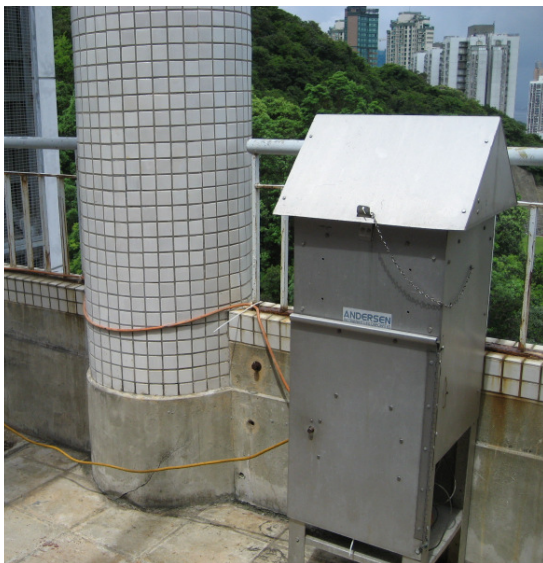
Air Quality Monitoring Station (AM1)

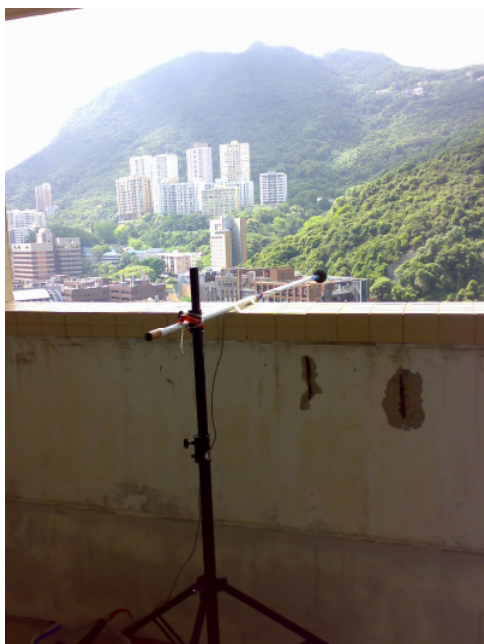
Noise Monitoring Station (NM1)

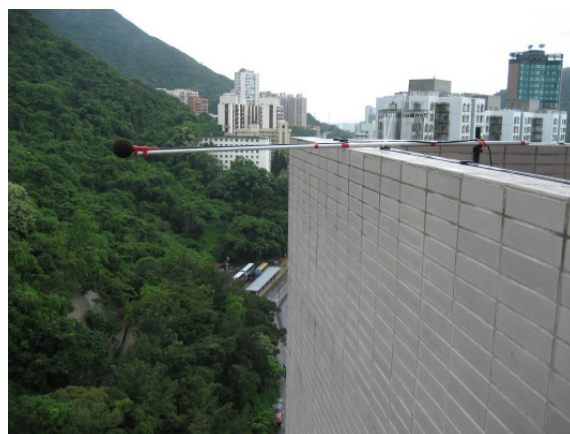
Baseline Noise Monitoring Station (NM2)

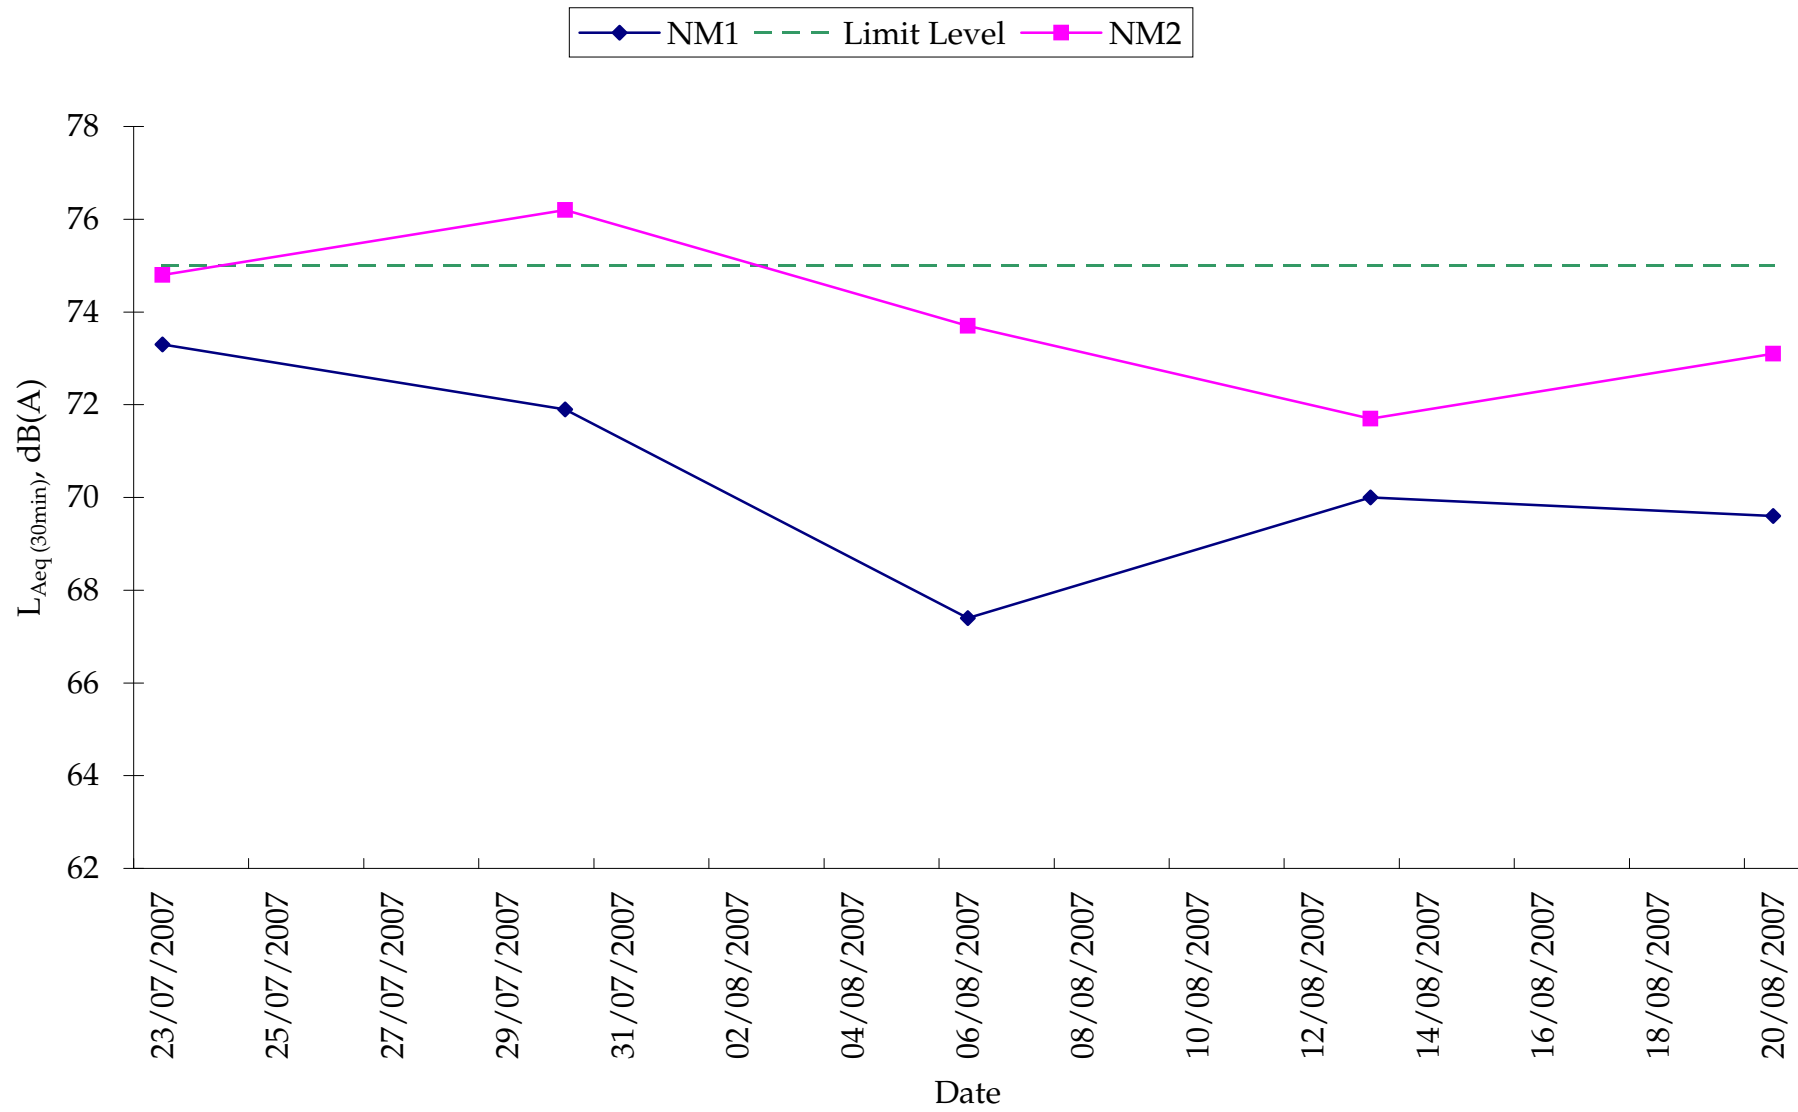
Figure I1 - Noise Monitoring Results ( $L_{eq, 30min}$ )

Five sets of 30-minute construction noise measurements were carried out at monitoring stations NM1 & NM2 during the reporting period. The monitoring results together with graphical presentations are presented in *Annex I*. The local impacts observed near the monitoring stations were mainly traffic noise from Pok Fu Lam Road and the concurrent projects undertaken in the vicinity.

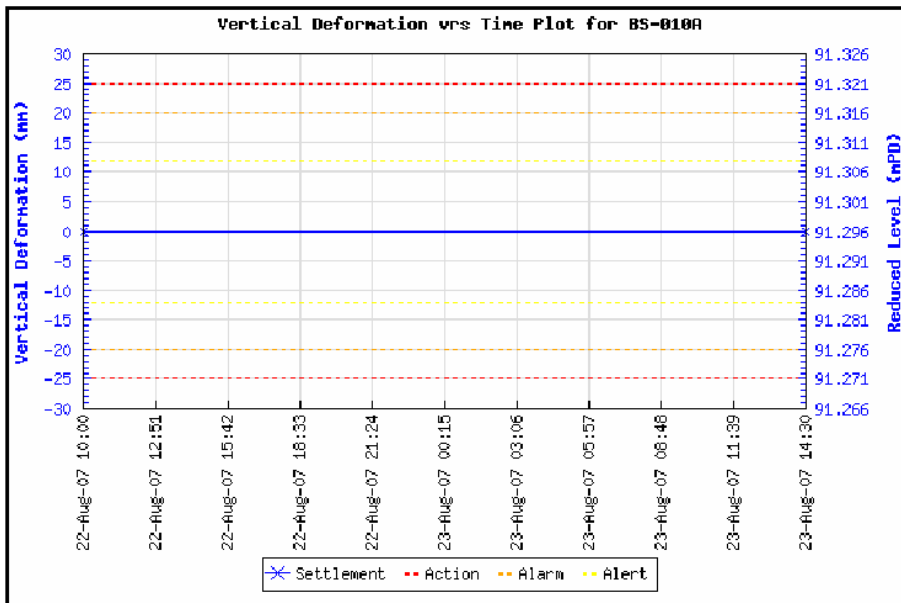
Instrument ID : BS-010A  
 Easting : 831808.247  
 Location : Valve House  
 Remark :

Type : Building Settlement Marker Type DMP5  
 Northing : 816016.001      Initial Level : 91.296 mPD

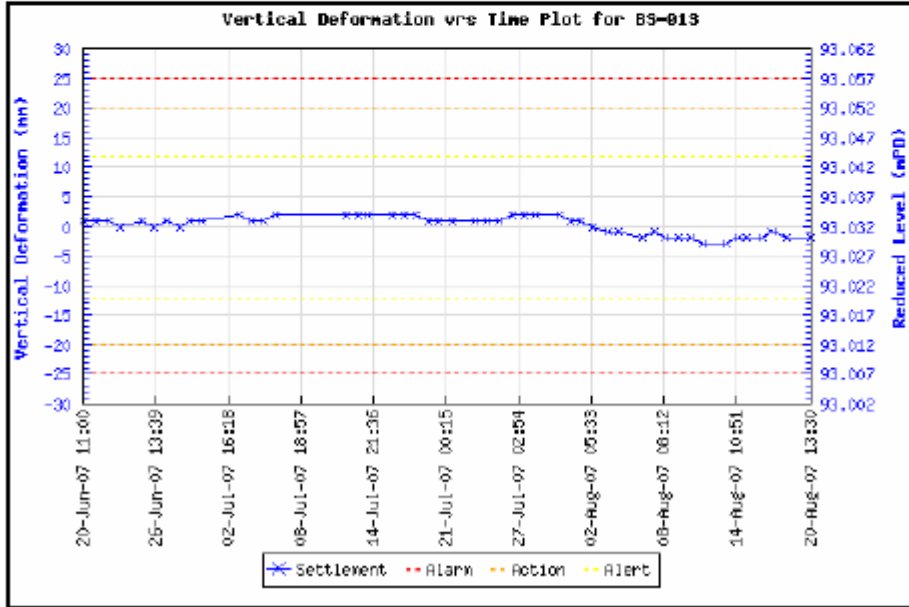
Instrument ID : BS-013  
 Easting : 831800.605  
 Location : Valve House  
 Remark :

Type : Building Settlement Marker Type DMP5  
 Northing : 816020.664  
 Initial Level : 93.032 mPD
