Reprovisioning and Upgrading of Salt
Water Service Reservoirs in Western
District for Water Supplies Department:
*Fourth Monthly Environmental
Monitoring and Audit Report*

6th December 2007

Reference 0067560

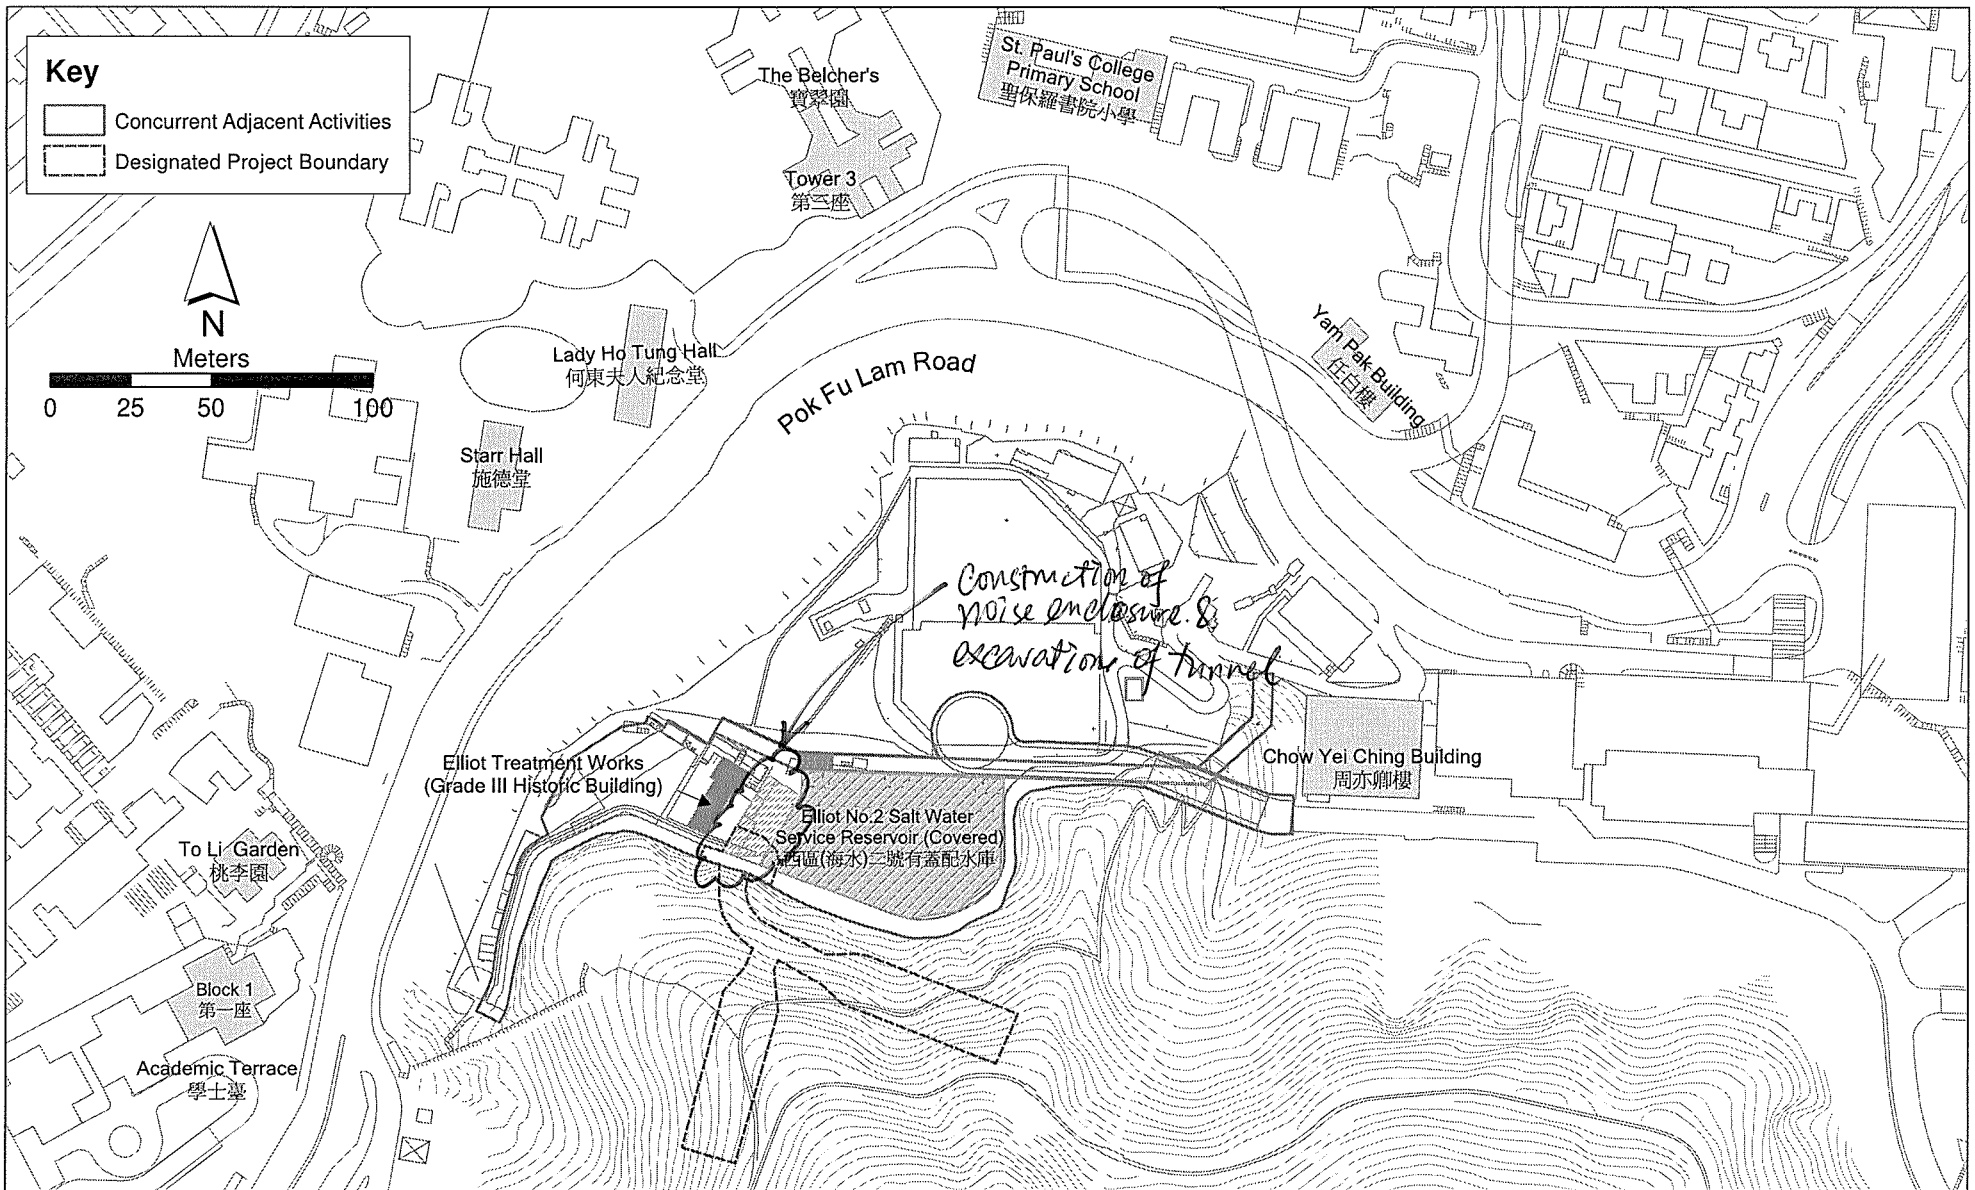
Figure A1

Project Location and Works Location

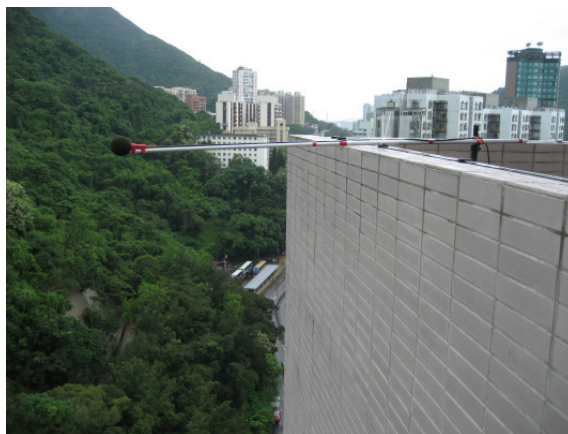
Baseline Noise Monitoring Station (NM2)

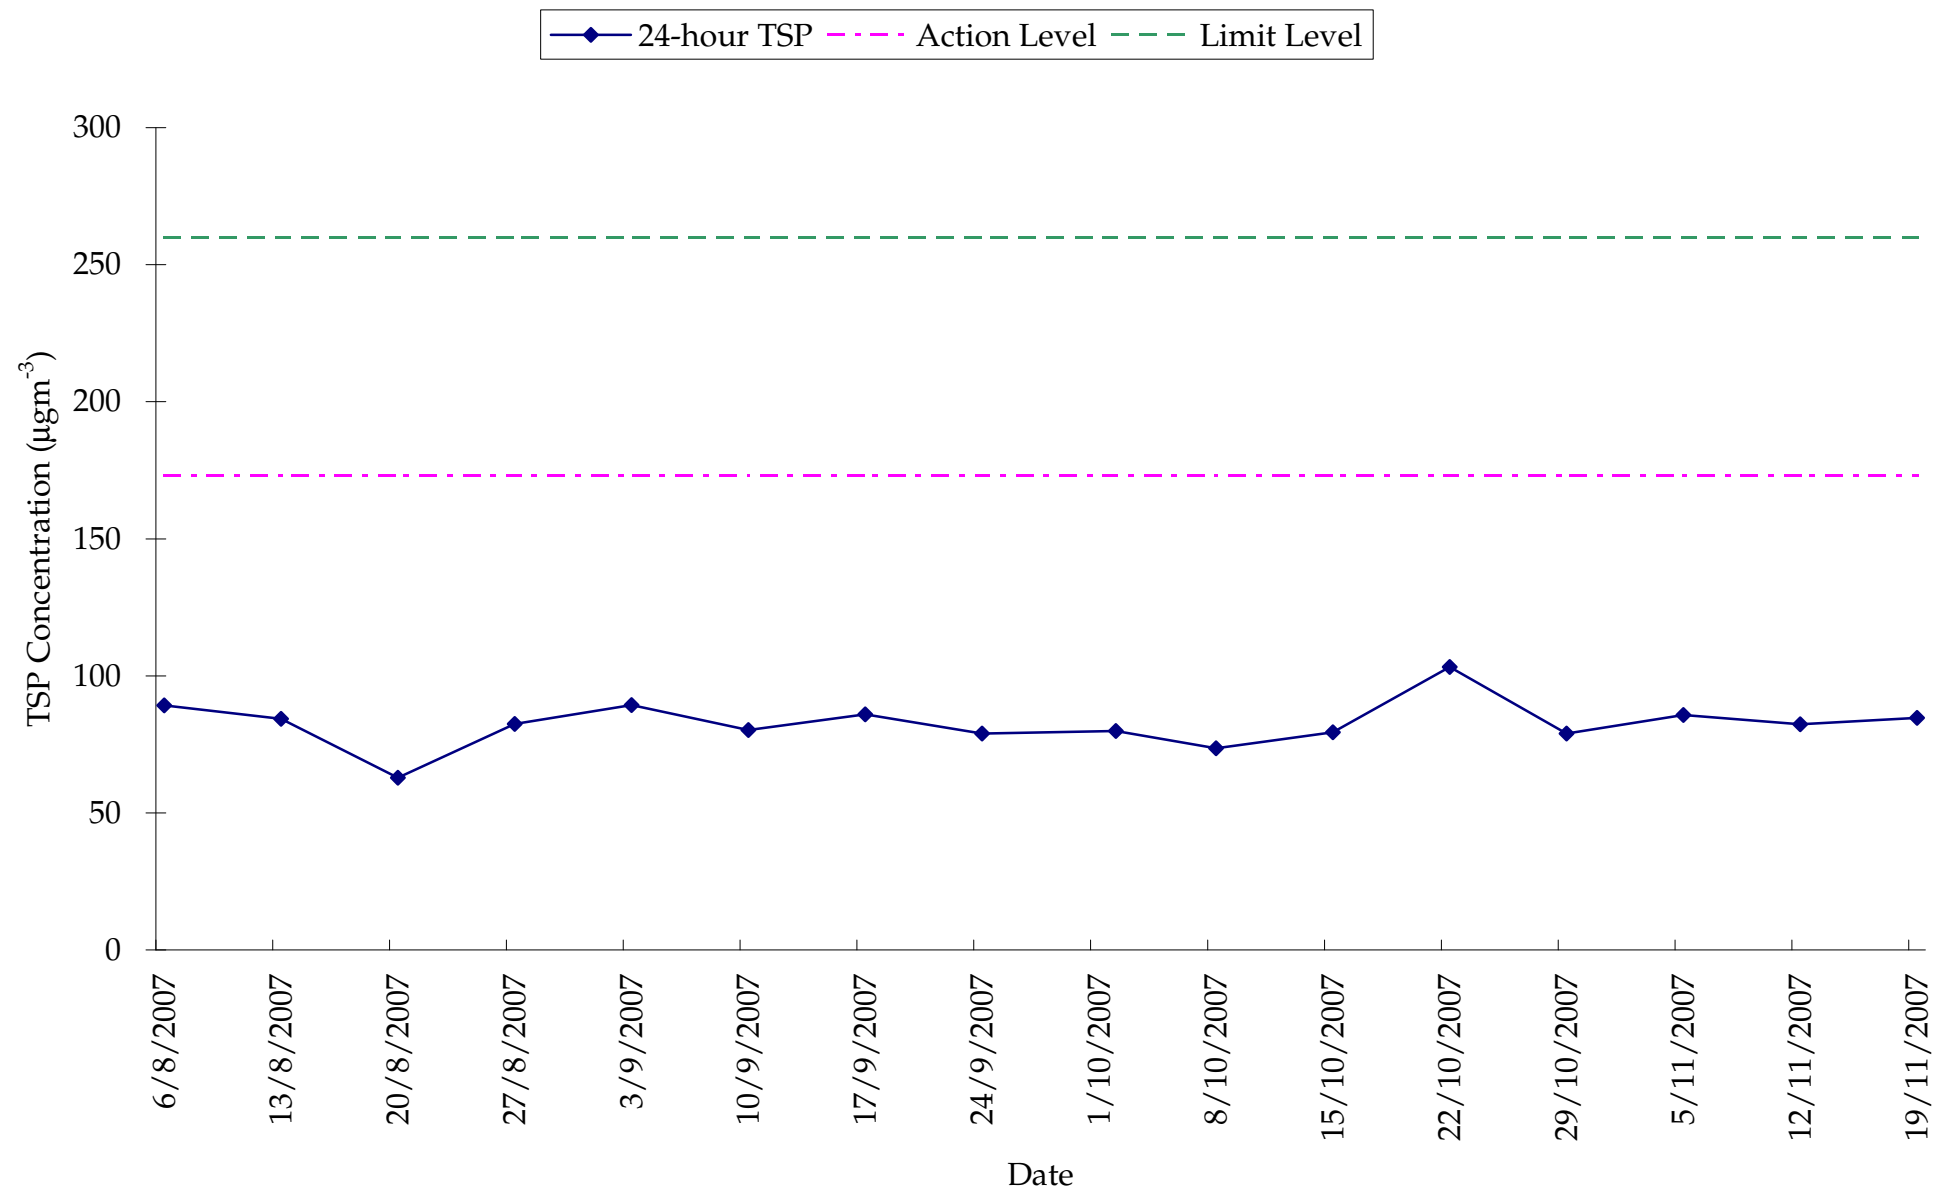
Five sets of 24-hour TSP measurements were carried out at monitoring station AM1 during the reporting period. The monitoring data for 24-hour TSP together with wind data and graphical presentations are presented in *Annex F*. The weather condition during the monitoring period varied from sunny to fine. The local impacts near the monitoring station were mainly associated with vehicular emissions from the road traffic along Pok Fu Lam Road. No exceedance of Action and Limit Levels of 24-hour TSP were recorded during the reporting period.

Figure H1 - Measured 24-hour TSP Concentration (μgm^{-3}) at AM1

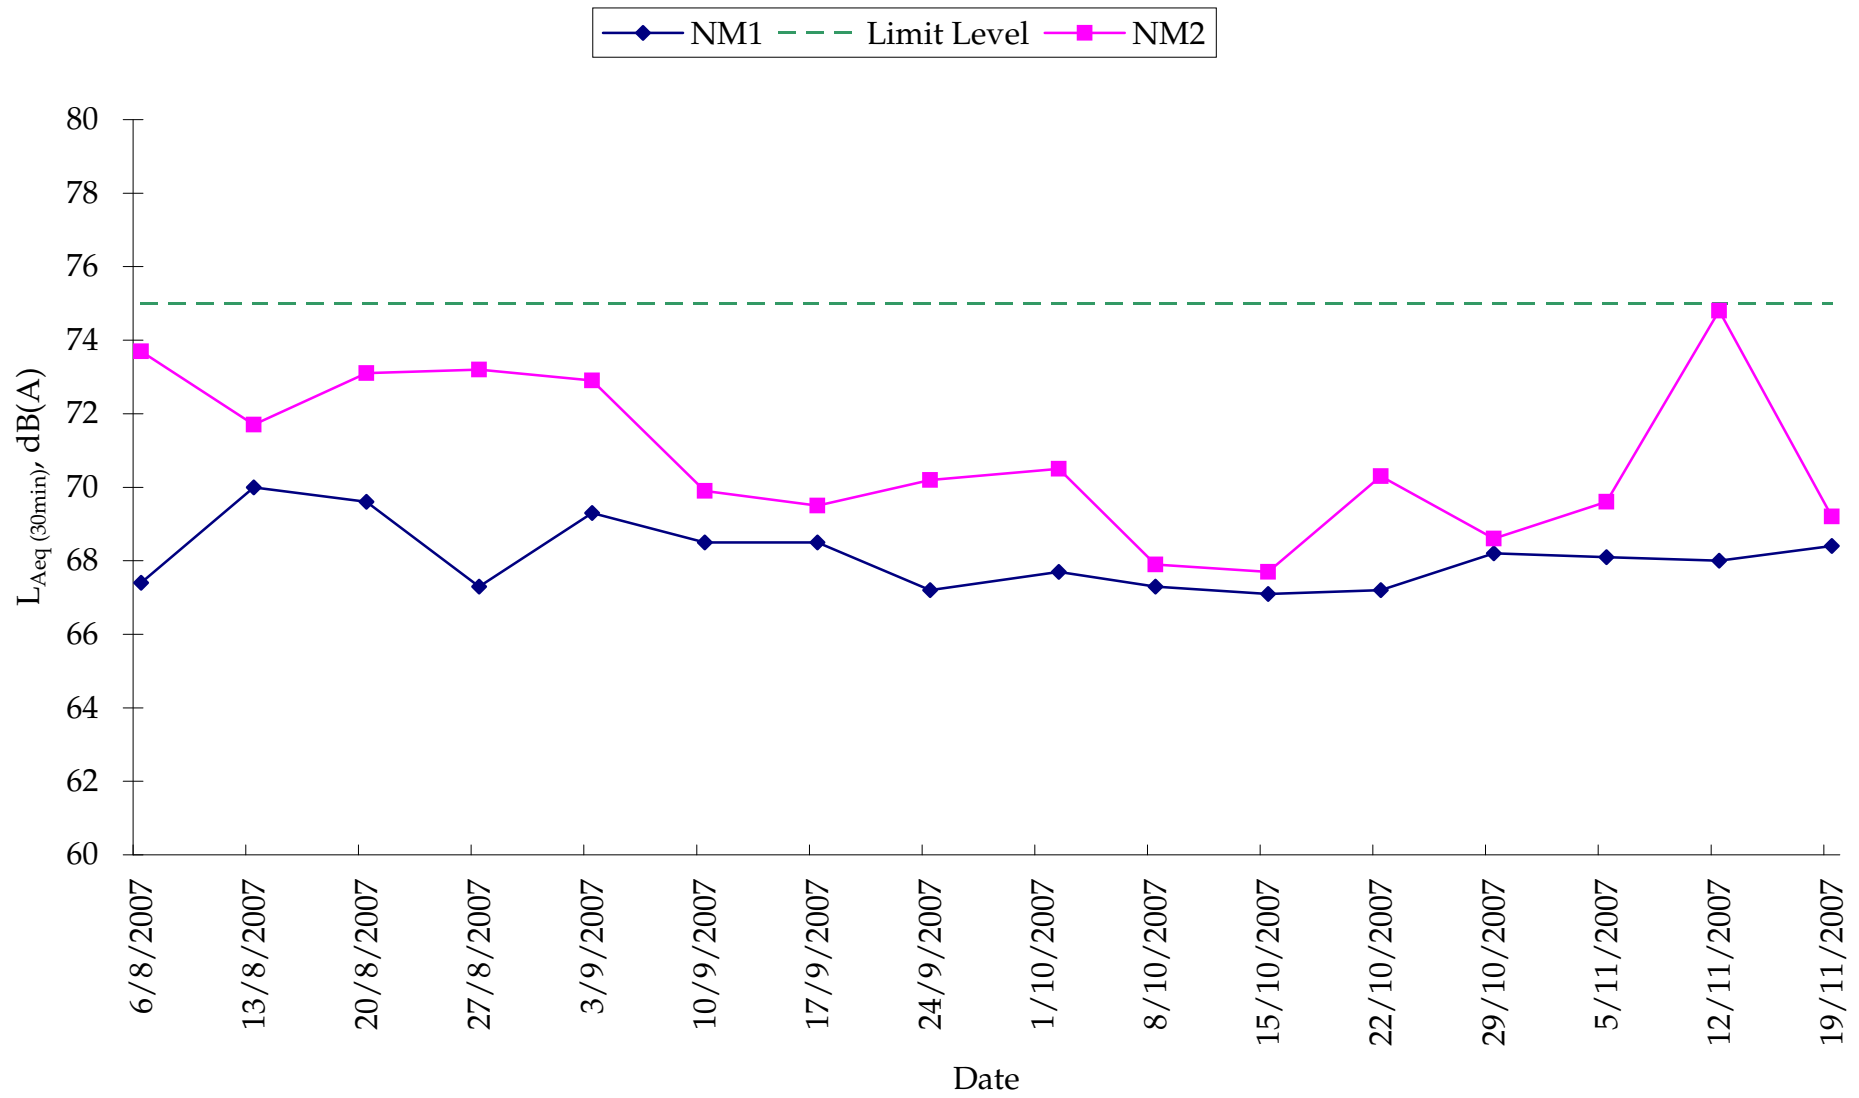
Five sets of 30-minute construction noise measurements were carried out at monitoring stations NM1 & NM2 during the reporting period. The monitoring results together with graphical presentations are presented in *Annex G*. The local impacts observed near the monitoring stations were mainly traffic noise from Pok Fu Lam Road and the concurrent projects undertaken in the vicinity. No exceedance of Action and Limit Levels of construction noise was recorded during the reporting period.

Figure G1 - Noise Monitoring Results ($L_{eq, 30min}$)

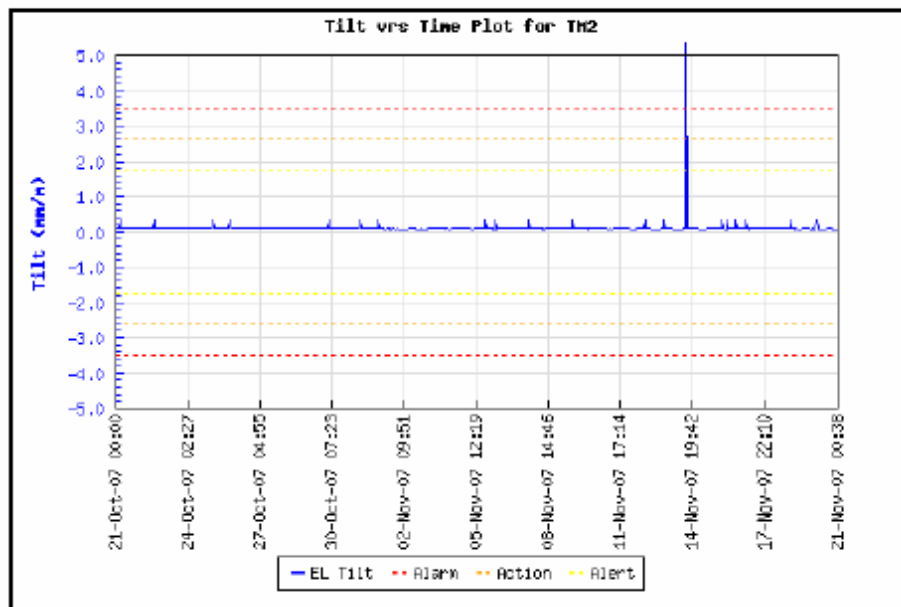
ELECTROLEVEL TILT SENSOR MONITORING RECORD SHEET

Instrument ID : TM2 Type : Electro Level
Easting : 831797.083 Northing : 816014.766 Initial Level : 92.664 mPD
Location : Valve House
Remark : Radio Transmitter Serial No. 50348; +ve Reading => Rotation towards West South

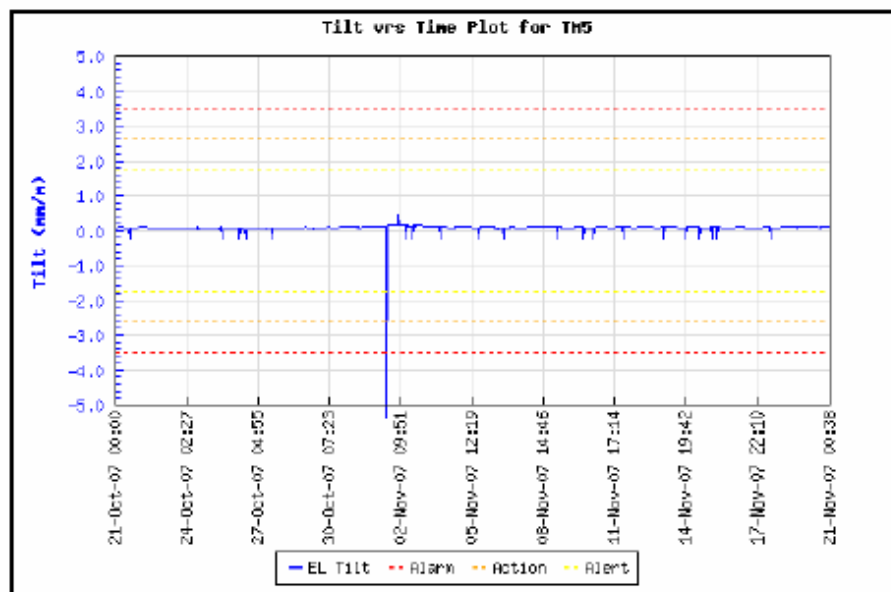
**ELECTROLEVEL TILT SENSOR MONITORING RECORD SHEET**

Instrument ID : TM5 Type : Electro Level
Easting : 831792.223 Northing : 816014.081 Initial Level : 92.714 mPD
Location : Valve House
Remark : Radio Transmitter Serial No. 50194; +ve Reading => Rotation towards West South

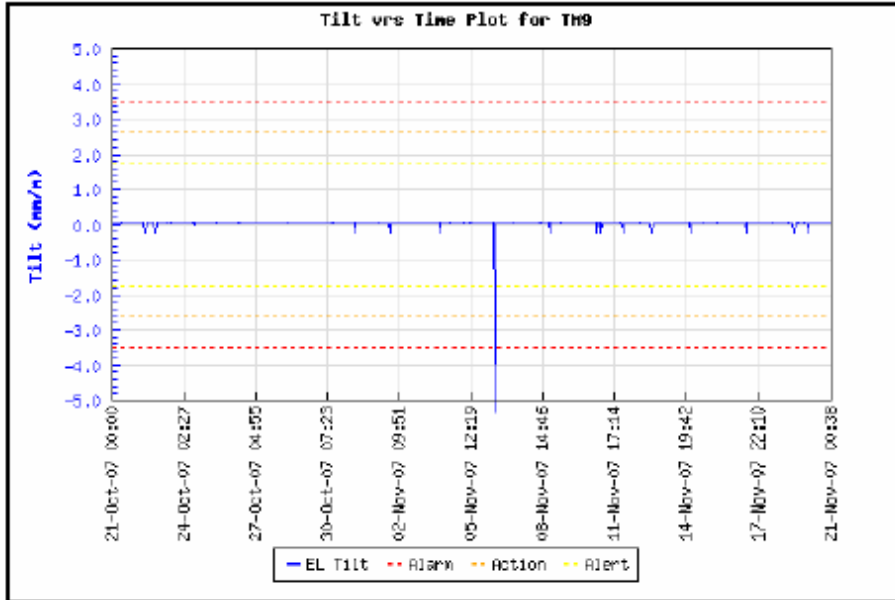
ELECTROLEVEL TILT SENSOR MONITORING RECORD SHEET

Instrument ID : TM9 Type : Electro Level
Easting : 831797.988 Northing : 816000.532 Initial Level : 92.709 mPD
Location : Valve House
Remark : Radio Transmitter Serial No. 50284; +ve Reading => Rotation towards North East

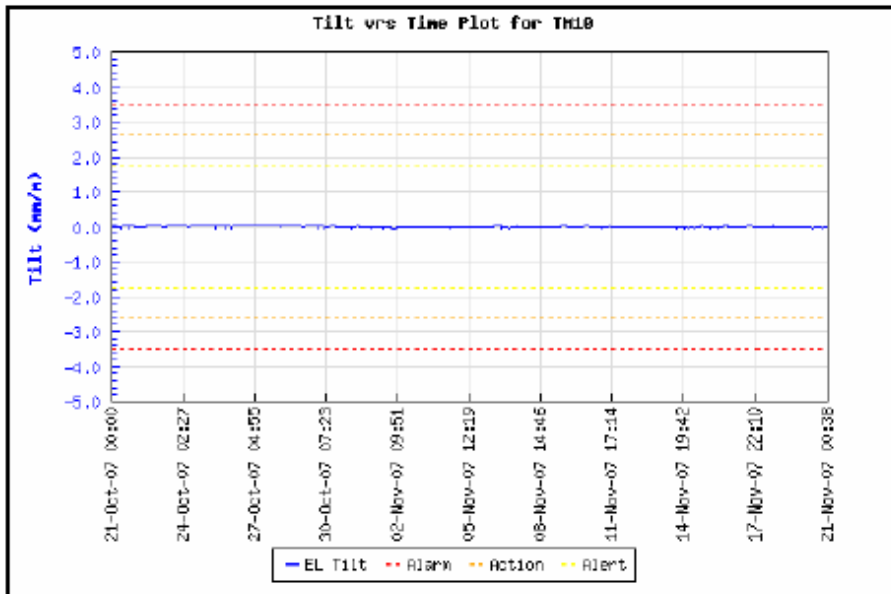
ELECTROLEVEL TILT SENSOR MONITORING RECORD SHEET

Instrument ID : TM10 Type : Electro Level
Easting : 831805.802 Northing : 816017.577 Initial Level : 92.744 mPD
Location : Valve House
Remark : Radio Transmitter Serial No. 50318; +ve Reading => Rotation towards West North

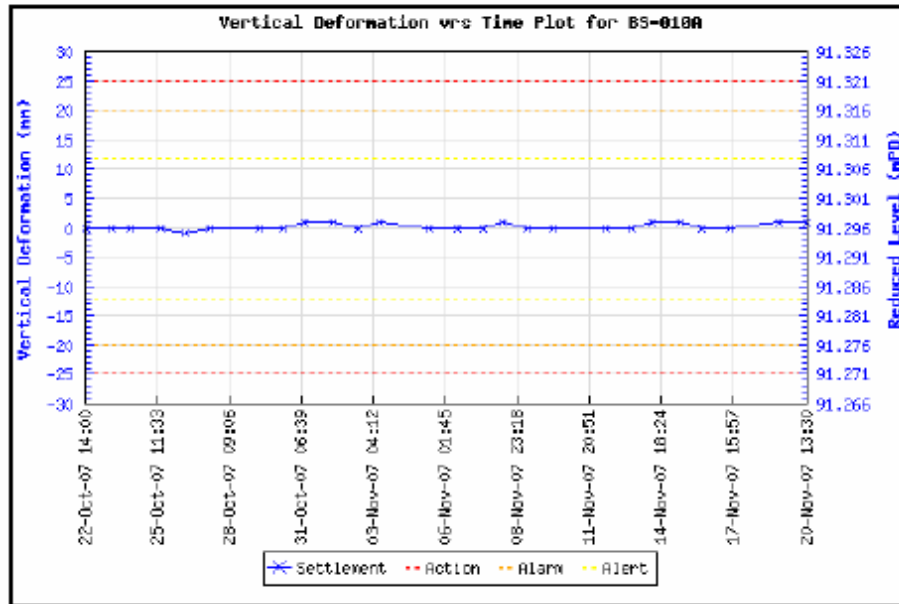
SETTLEMENT MONITORING RECORD SHEET

Instrument ID : BS-010A
 Easting : 831808.247
 Location : Valve House
 Remark :

Type : Building Settlement Marker Type DMP5
 Northing : 816016.001 Initial Level : 91.296 mPD

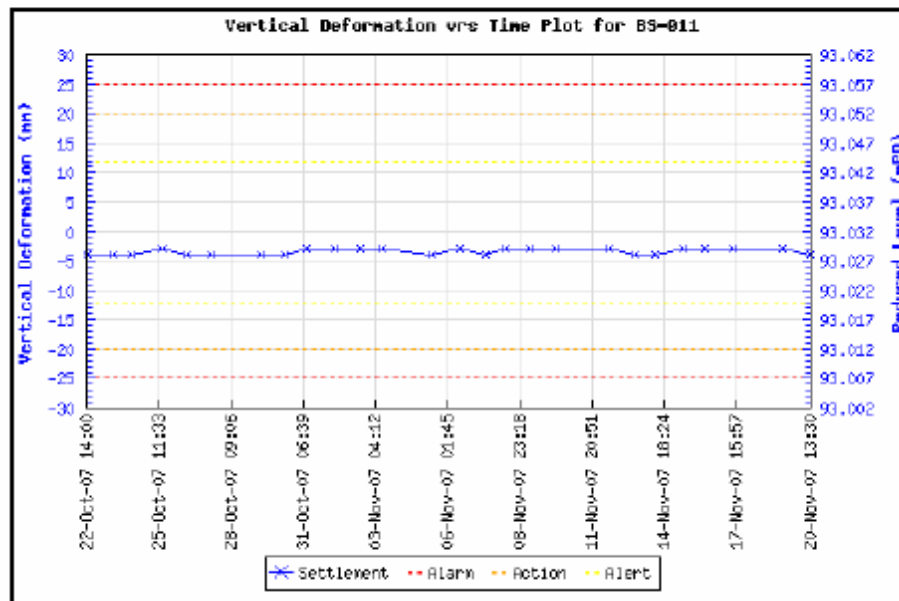
SETTLEMENT MONITORING RECORD SHEET

Instrument ID : BS-011
 Easting : 831795.830
 Location : Valve House
 Remark :

Type : Building Settlement Marker Type DMP5
 Northing : 815997.133 Initial Level : 93.032 mPD

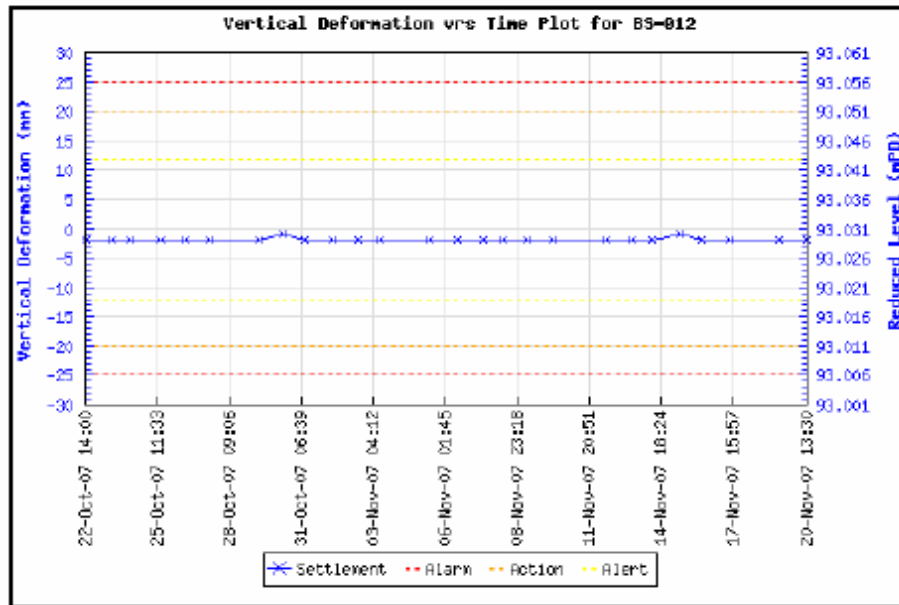
SETTLEMENT MONITORING RECORD SHEET

Instrument ID : BS-012
 Easting : 831796.239
 Location : Valve House
 Remark :

Type : Building Settlement Marker Type DMP5
 Northing : 816000.503 Initial Level : 93.031 mPD

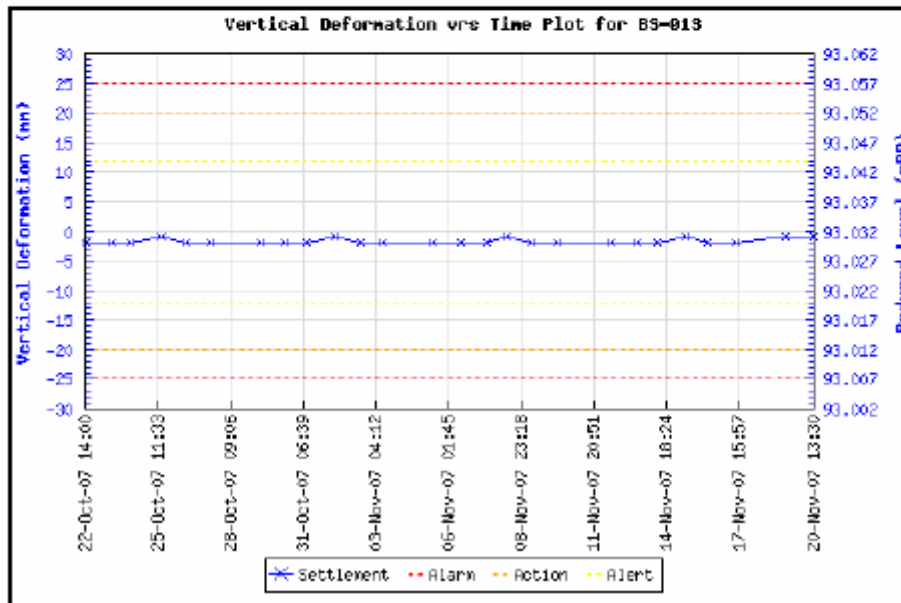
SETTLEMENT MONITORING RECORD SHEET

Instrument ID : BS-013
 Easting : 831800.605
 Location : Valve House
 Remark :

Type : Building Settlement Marker Type DMP5
 Northing : 816020.664 Initial Level : 93.032 mPD

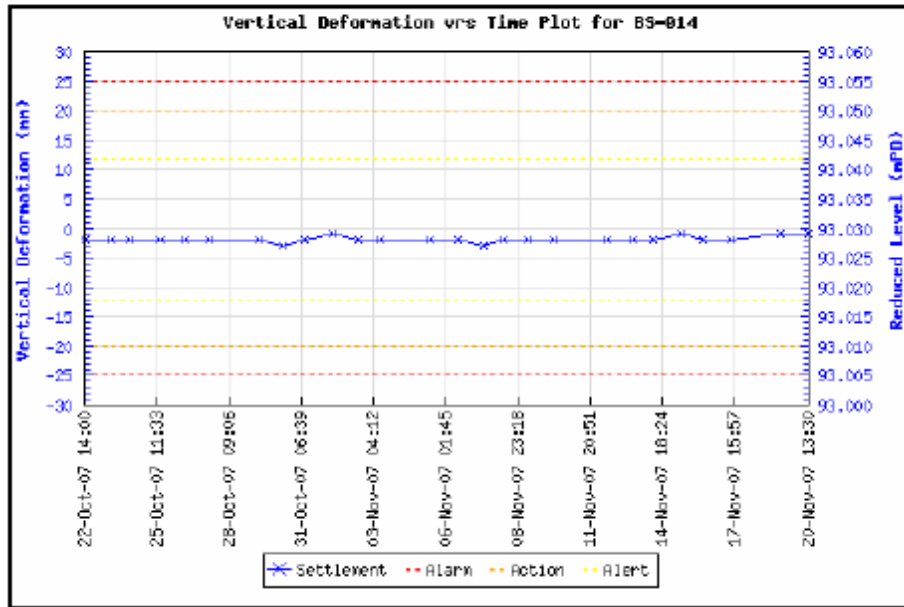
SETTLEMENT MONITORING RECORD SHEET

Instrument ID : BS-014
 Easting : 831781.965
 Location : Reservoir
 Remark :

Type : Building Settlement Marker Type DMP5
 Northing : 816004.142 Initial Level : 93.030 mPD
