Contract No. DC/2008/03  
Design, Build and Operate Pillar  
Point Sewage Treatment Works:  
*Second Monthly EM&A Report*

December 2010

**Environmental Resources Management**

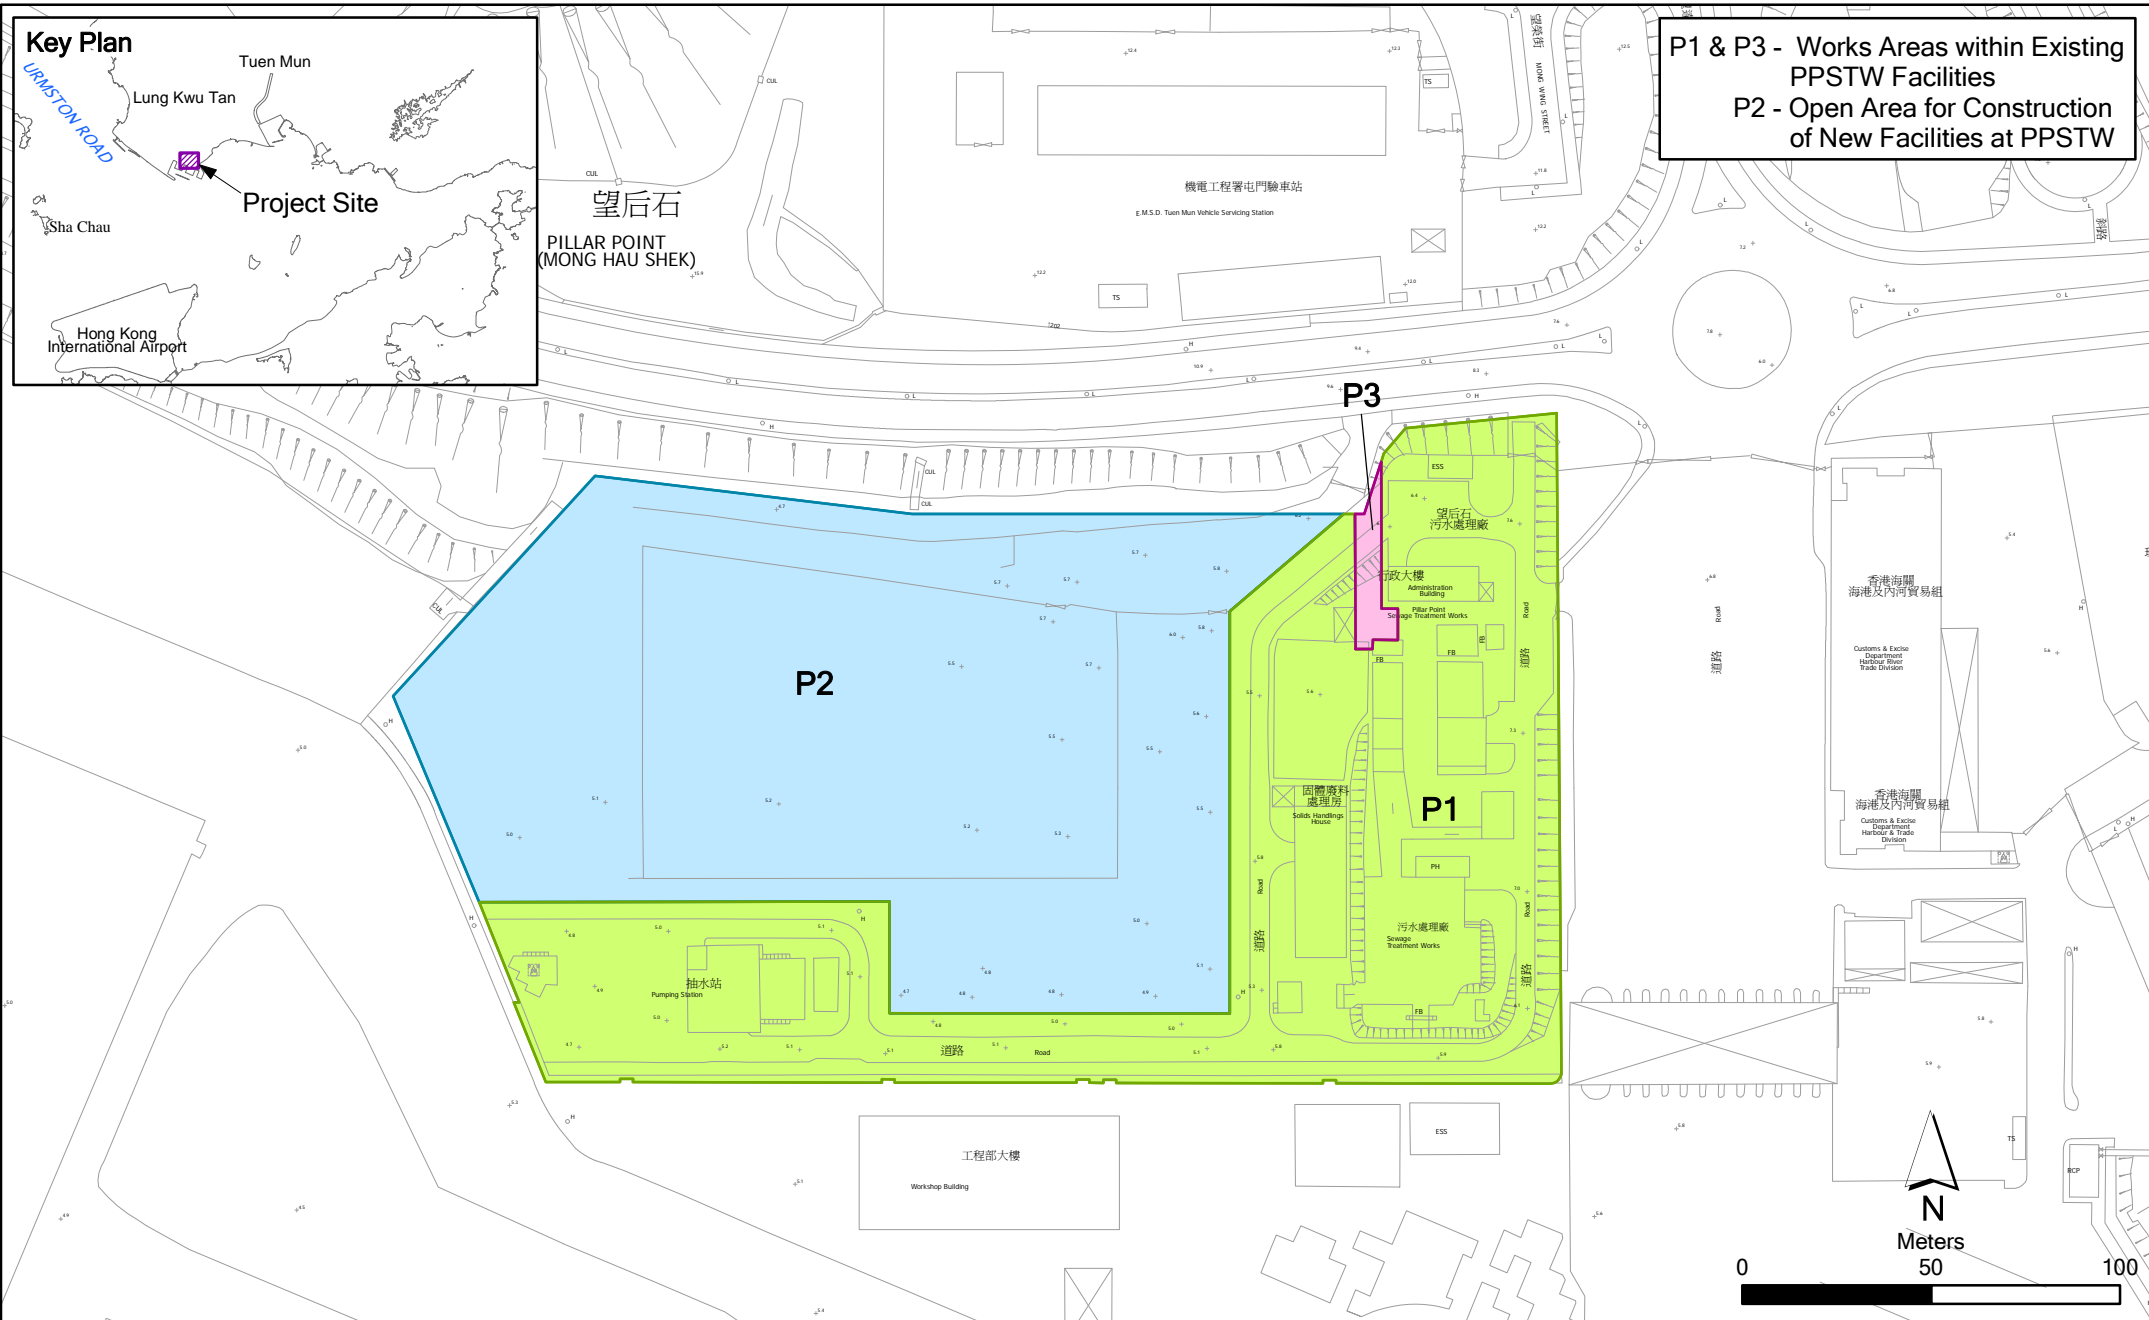
## Works Location

P1 & P3 - Works Areas within Existing PPSTW Facilities  
P2 - Open Area for Construction of New Facilities at PPSTW

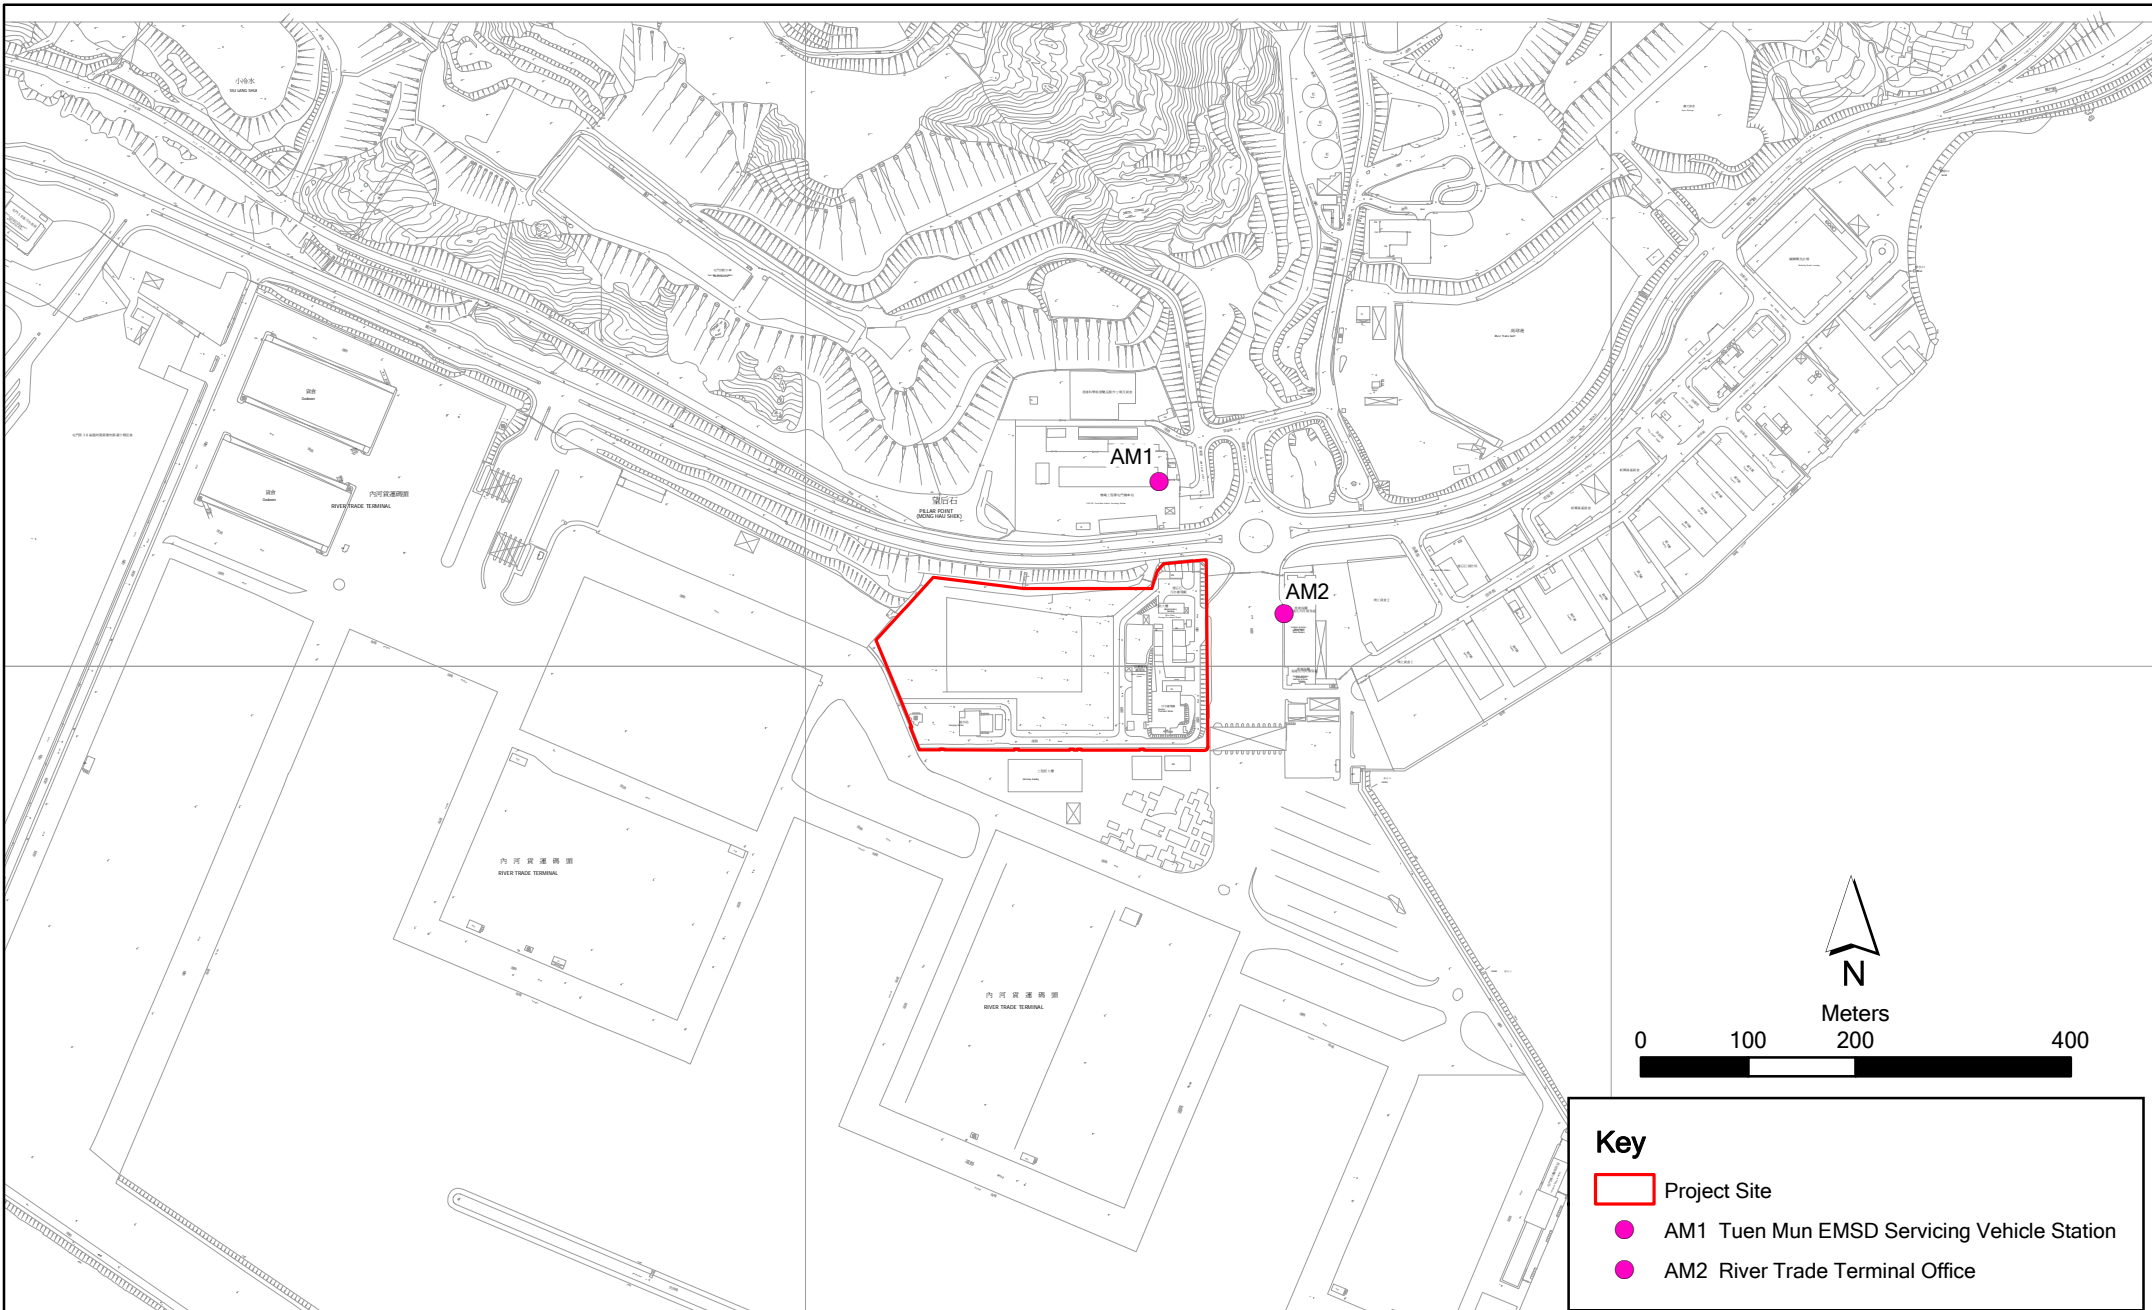
## Locations of Air Quality Monitoring Stations

- Project Site
- AM1 Tuen Mun EMSD Servicing Vehicle Station
- AM2 River Trade Terminal Office
