Contract No. DC/2008/03
Design, Build and Operate Pillar
Point Sewage Treatment Works:
Sixth Monthly EM&A Report

April 2011

Environmental Resources Management

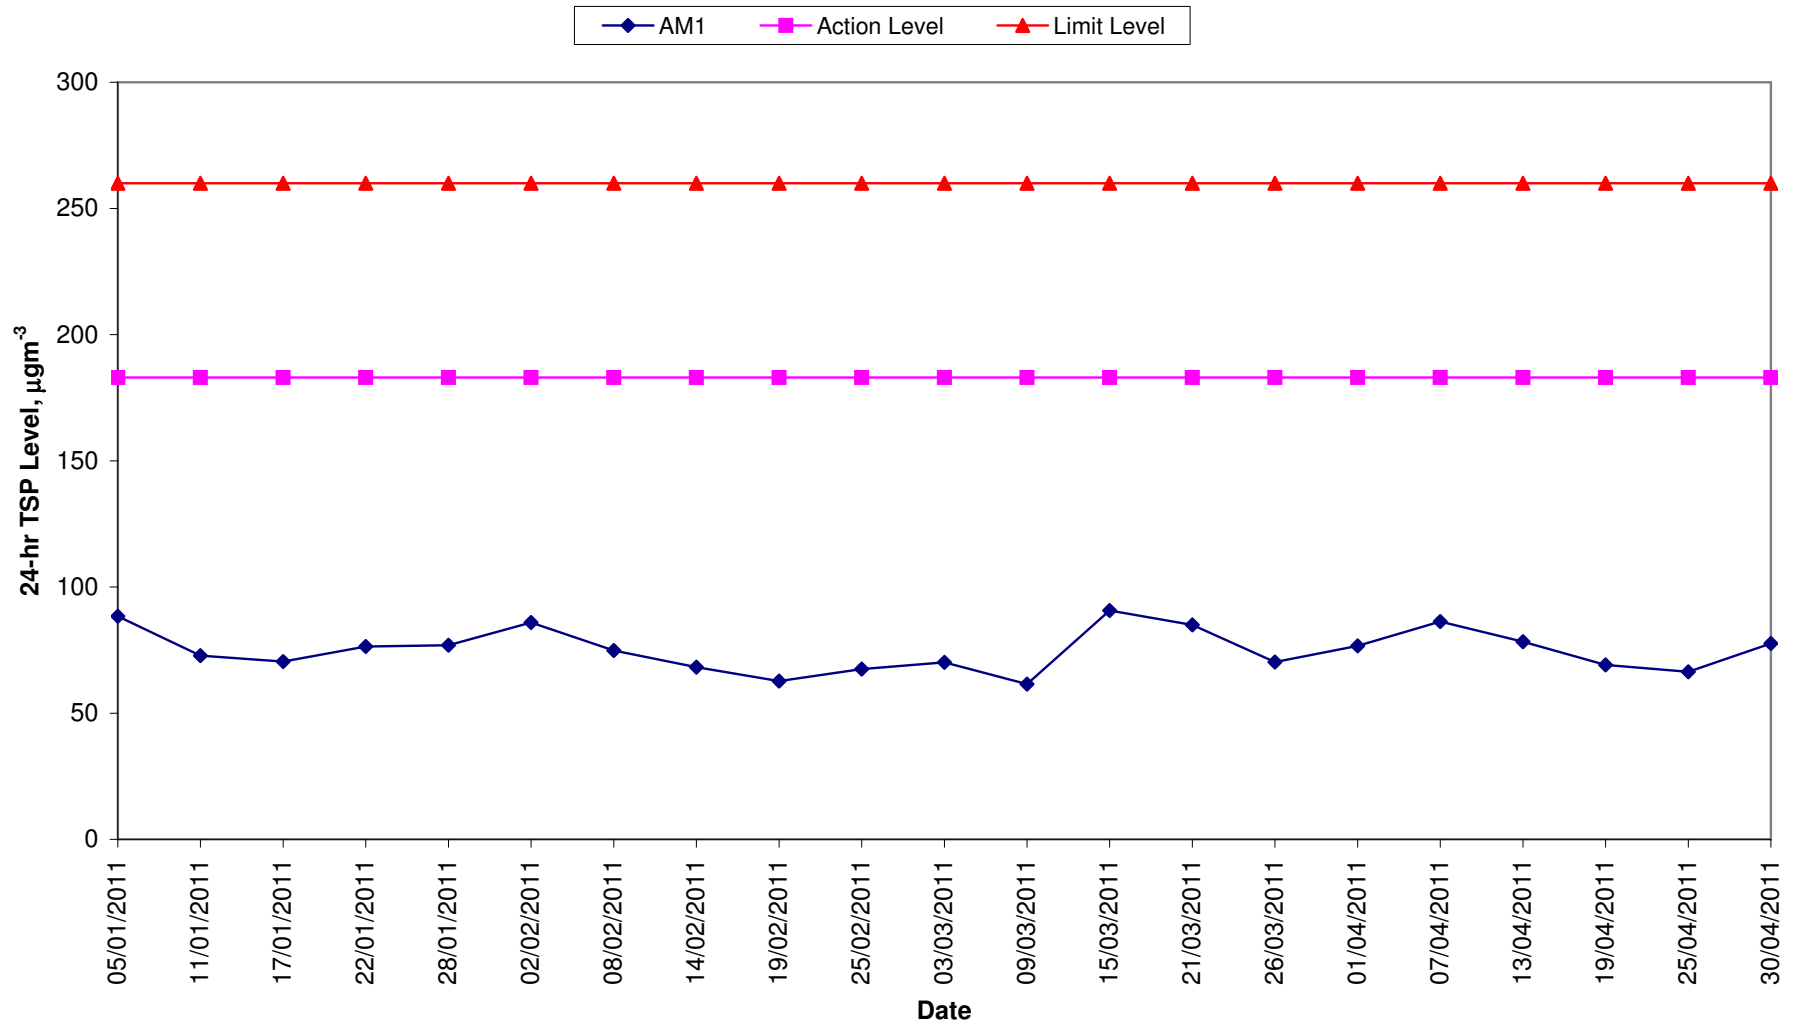
24-hr TSP Levels for the Past 4 Months AM1 (Tuen Mun EMSD Vehicle Servicing Station)

A total of 6 sets of 24-hour and 18 sets of 1-hour TSP measurements were carried out at each of the monitoring stations (AM1 and AM2) during the reporting period. The monitoring data for 24-hour TSP and 1-hour TSP together with wind data and graphical presentations for the past 4 months are presented in *Annex F*. The weather conditions during the monitoring period were Sunny. The local impacts near the monitoring stations of AM1 and AM2 were mainly associated with vehicular emissions. No exceedance of Action and Limit Level of 1-hr and 24-hr TSP was recorded during the reporting period.
