Contract No. DC/2008/03
Design, Build and Operate Pillar
Point Sewage Treatment Works:
Eighth Monthly EM&A Report

July 2011

Environmental Resources Management

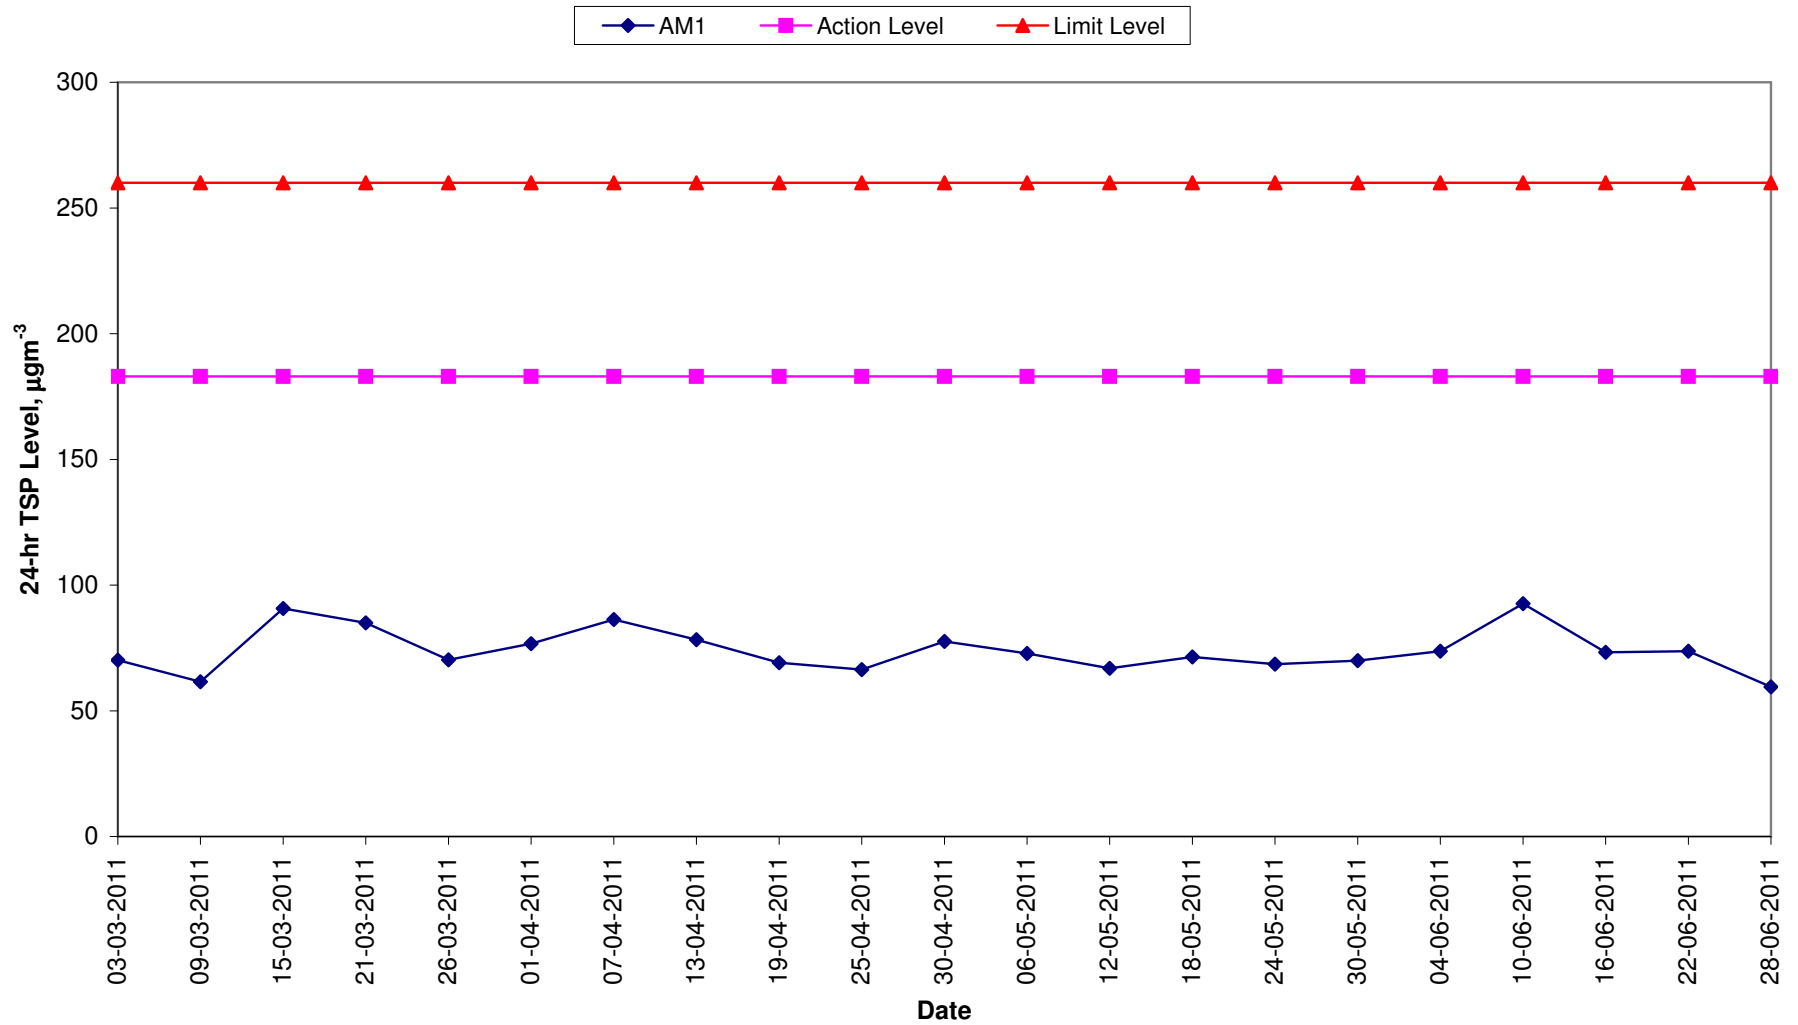
24-hr TSP Levels for the Past 4 Months AM1 (Tuen Mun EMSD Vehicle Servicing Station)

A total of 5 sets of 24-hour and 15 sets of 1-hour TSP measurements have been undertaken at each of the monitoring stations (AM1 and AM2) during the reporting period. The monitoring data for 24-hour TSP and 1-hour TSP together with wind data and graphical presentations for the past 4 months are presented in *Annex F*. The weather conditions during the monitoring period were ranges from Rainy to Fine. The local impacts near the monitoring stations of AM1 and AM2 were mainly associated with vehicular emissions. No exceedance of Action and Limit Level of 1-hr and 24-hr TSP was recorded during the reporting period.
