ATAL-Degrémont-China State Joint Venture

Contract No. DC/2008/03  
Design, Build and Operate Pillar  
Point Sewage Treatment Works:  
*Nineteenth Monthly EM&A Report*

June 2012

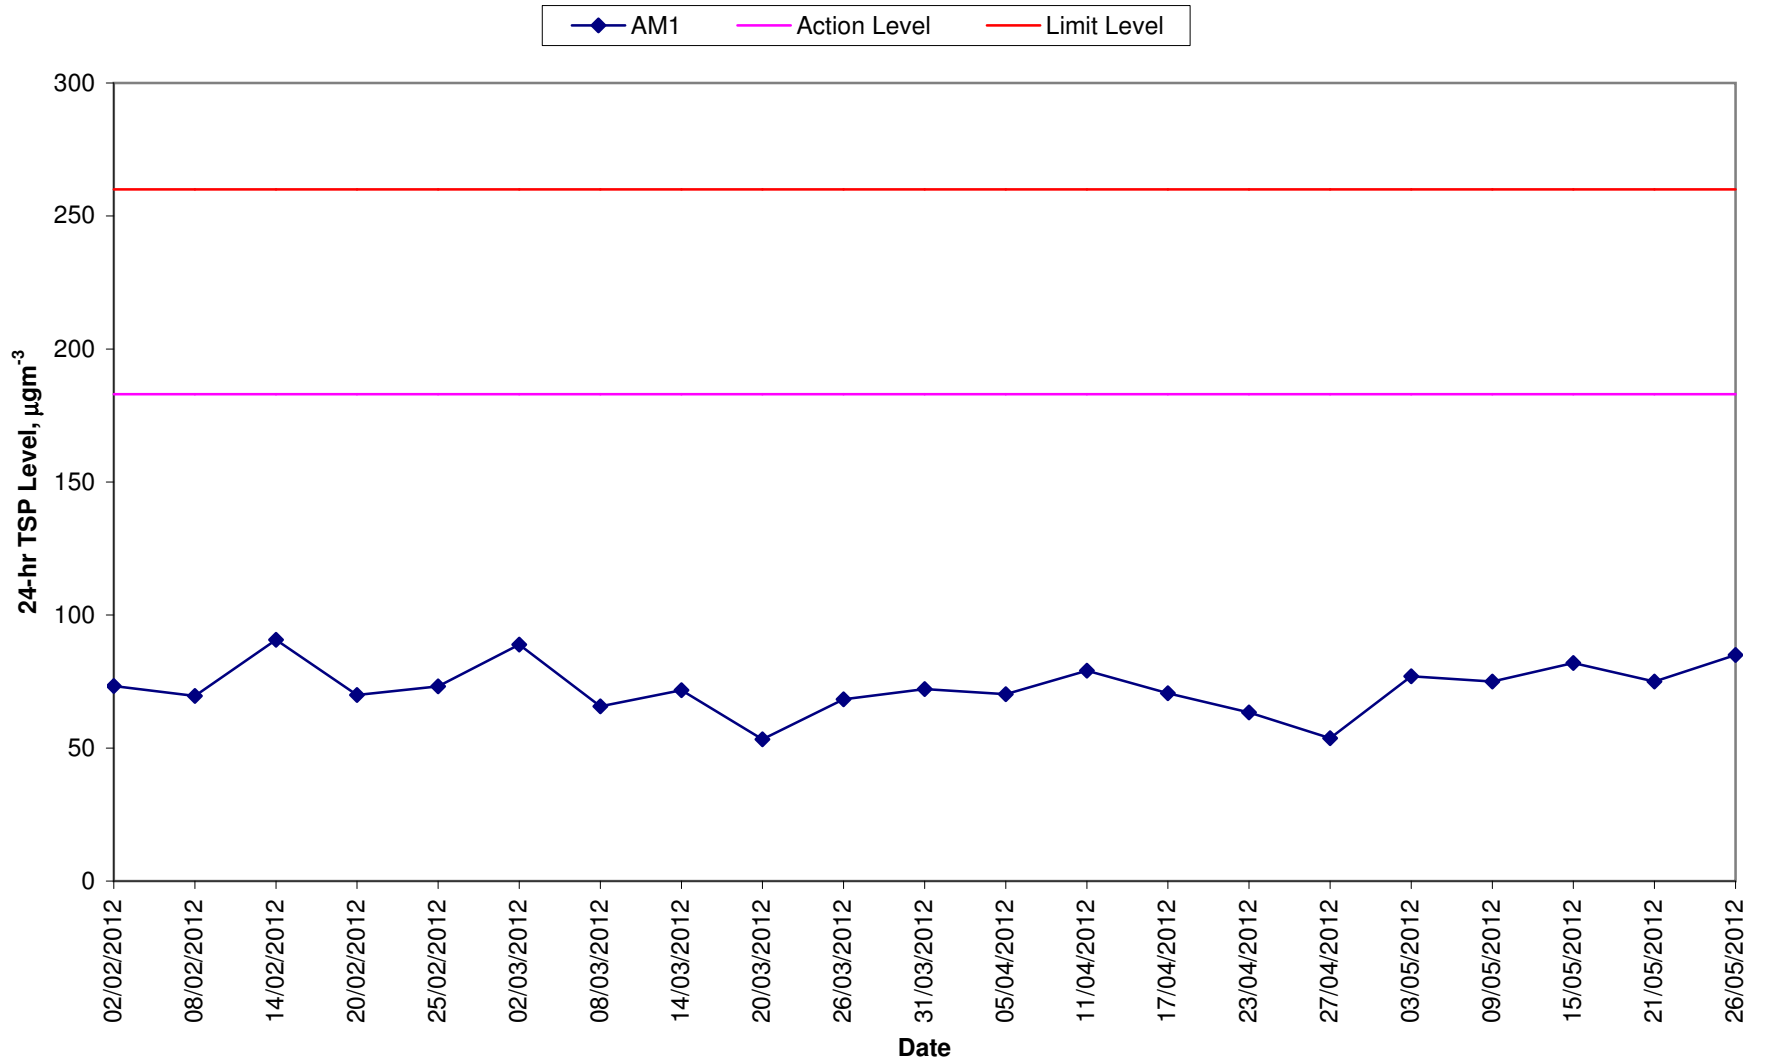
## 24-hr TSP Levels for the Past 4 Months AM1 (Tuen Mun EMSD Vehicle Servicing Station)

A total of 5 sets of 24-hour and 15 sets of 1-hour TSP measurements were taken at each of the monitoring stations (AM1 and AM2) during the reporting period. The monitoring data for 24-hour TSP and 1-hour TSP together with wind data and graphical presentations for the past 4 months are presented in *Annex F*. The weather conditions during the monitoring period were ranged from sunny to rainy. The local impacts near the monitoring stations of AM1 and AM2 were mainly associated with vehicular emissions. No exceedance of Action and Limit Level of 1-hr and 24-hr TSP was recorded during the reporting period.

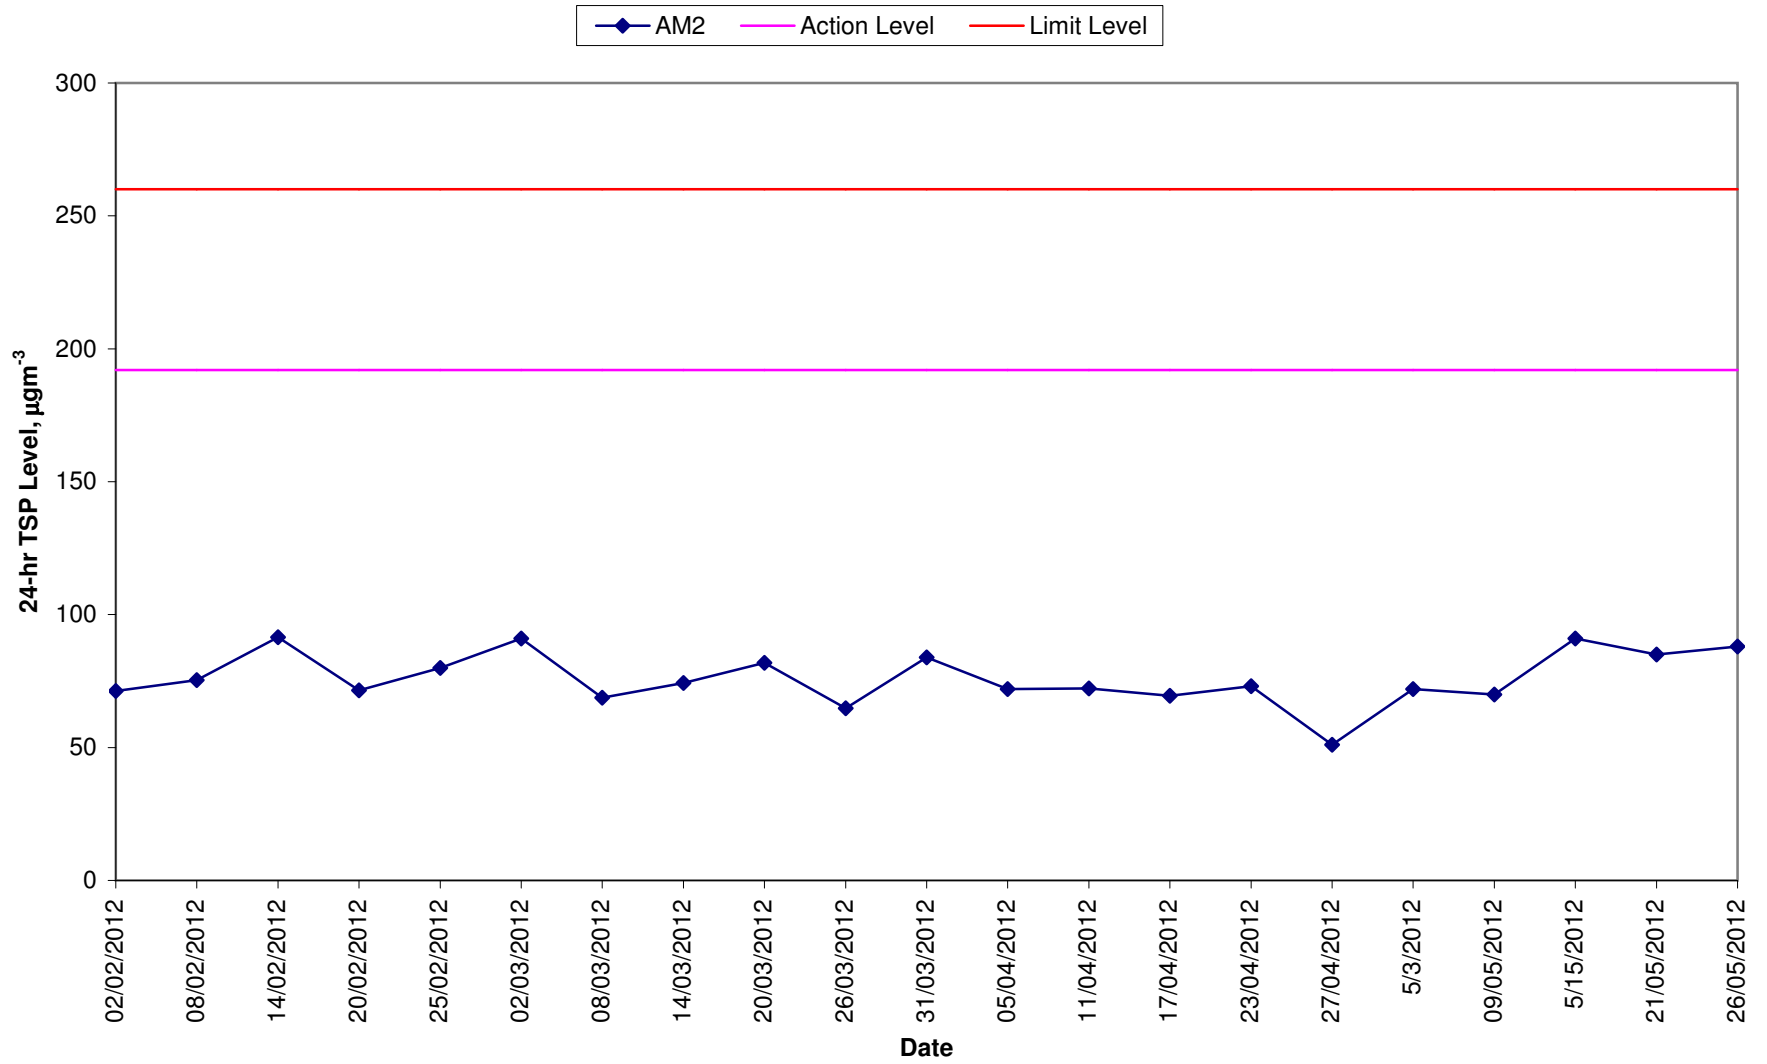
## 24-hr TSP Levels for the Past 4 Months AM2 (River Trade Terminal Office)

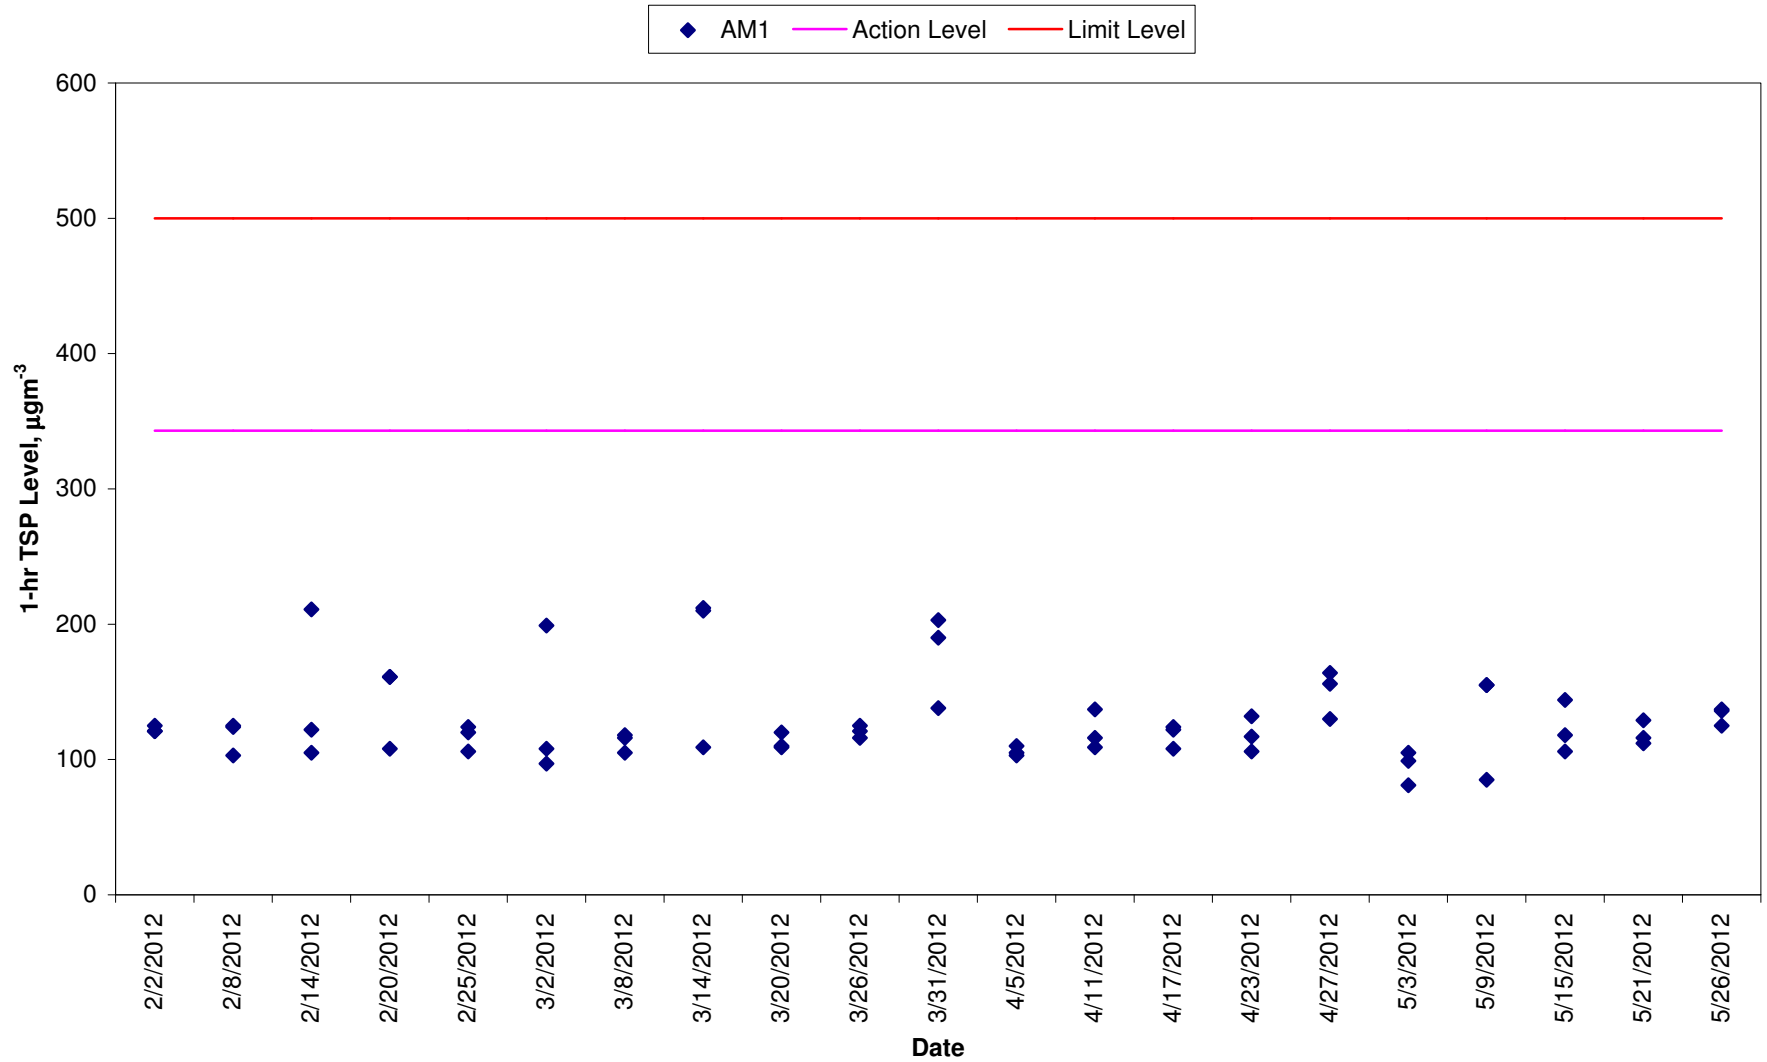
## 1-hr TSP Levels for the Past 4 Months AM1 (Tuen Mun EMSD Vehicle Servicing Station)

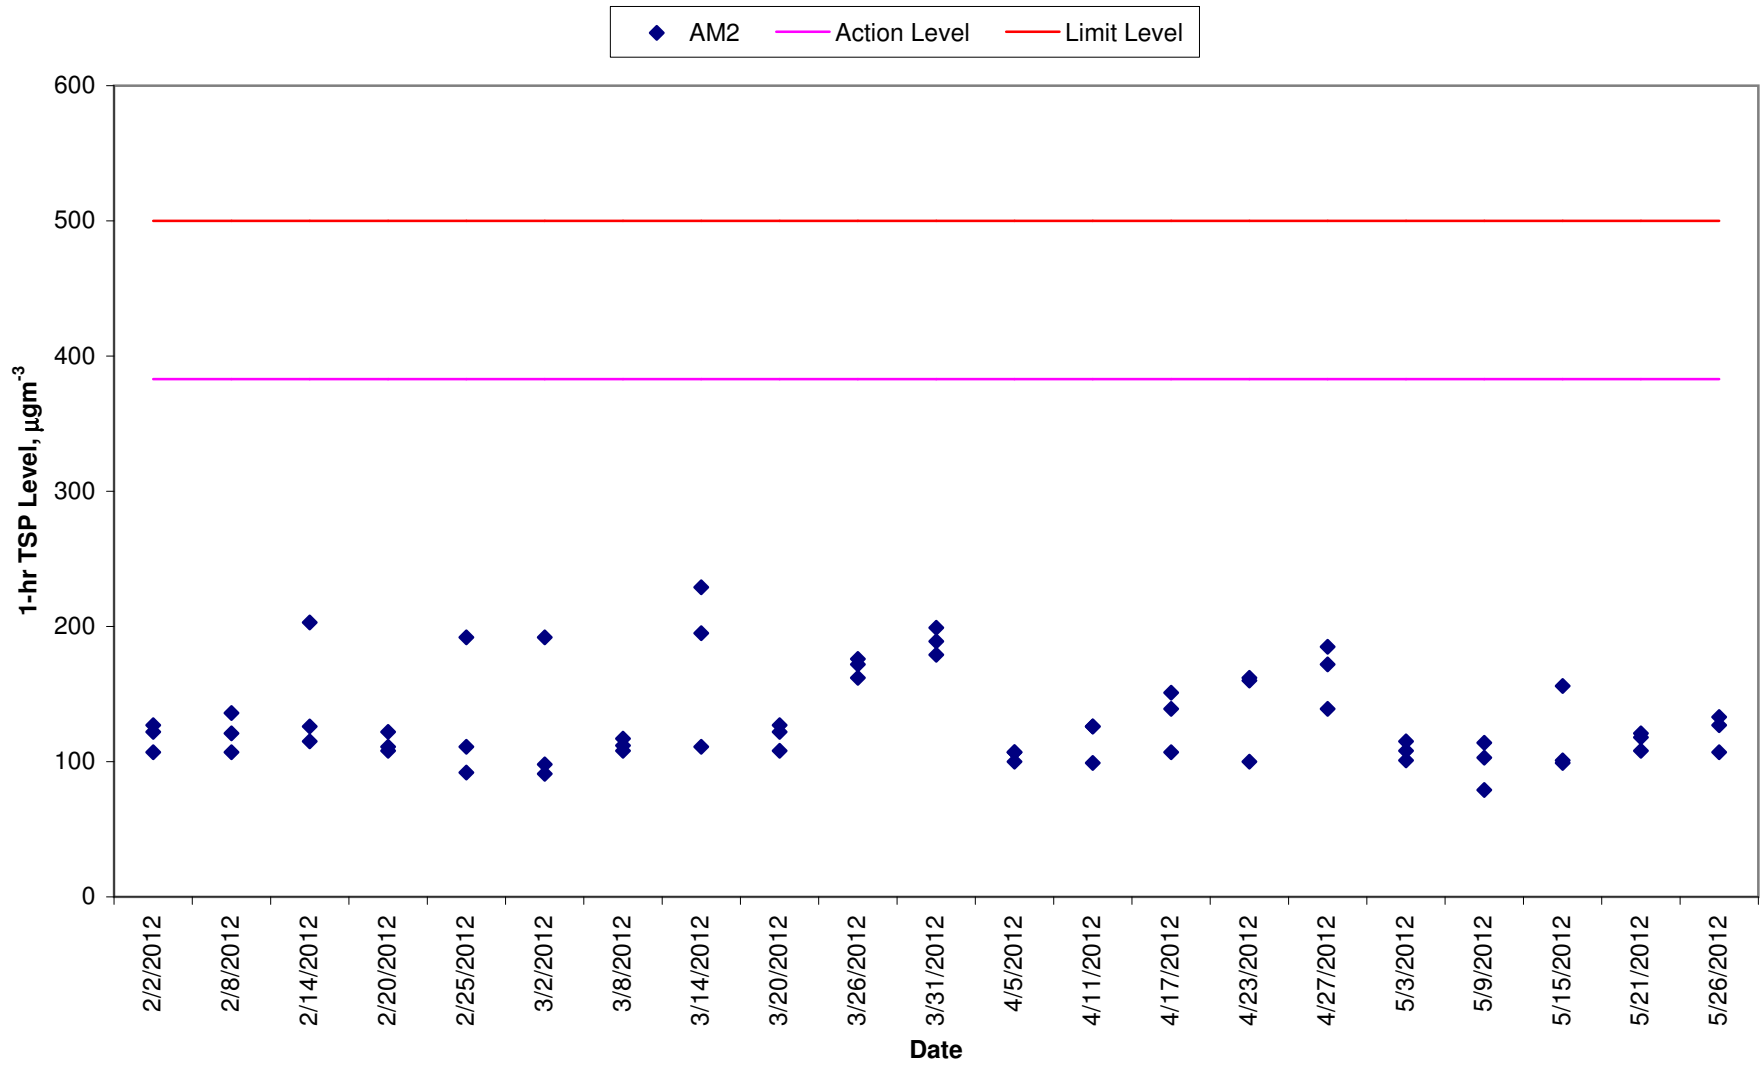
## 1-hr TSP Levels for the Past 4 Months AM2 (River Trade Terminal Office)
