ATAL-Degrémont-China State Joint Venture

Contract No. DC/2008/03
Design, Build and Operate Pillar
Point Sewage Treatment Works:
*Twentieth-second Monthly EM&A
Report*

September 2012

Monthly EM&A Report for August 2012

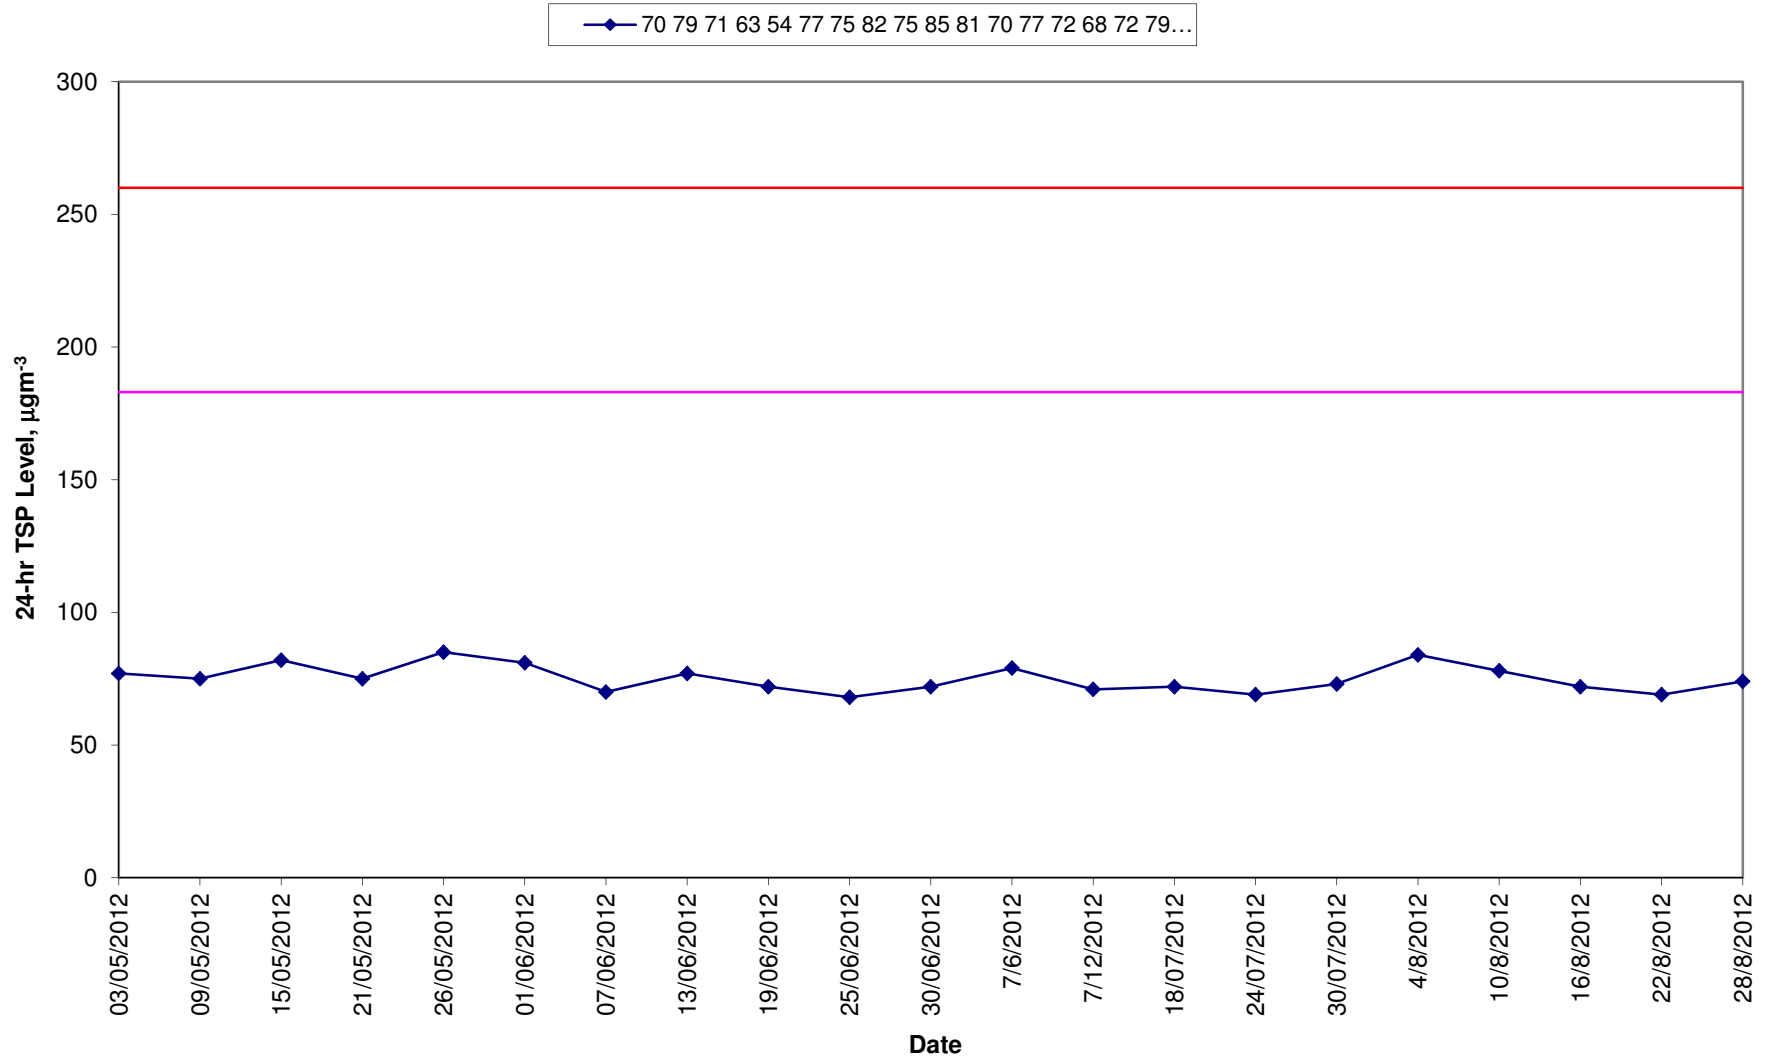
24-hr TSP Levels for the Past 4 Months AM1 (Tuen Mun EMSD Vehicle Servicing Station)

A total of 5 sets of 24-hour and 15 sets of 1-hour TSP measurements were taken at each of the monitoring stations (AM1 and AM2) during the reporting period. The monitoring data for 24-hour and 1-hour TSP together with wind data and graphical presentations for the past 4 months are presented in *Annex F*. The weather conditions during the monitoring period ranged from sunny to cloudy. The local impacts near the monitoring stations of AM1 and AM2 were mainly associated with vehicular emissions. No exceedance of Action and Limit Level of 1-hr and 24-hr TSP was recorded during the reporting period.
