**Independent Environmental Checker for
Contract No. YL/2009/01 – Hang Hau Tsuen Channel at
Lau Fau Shan**

Post Construction Mangrove Monitoring

Final Report

Date:
May 2015

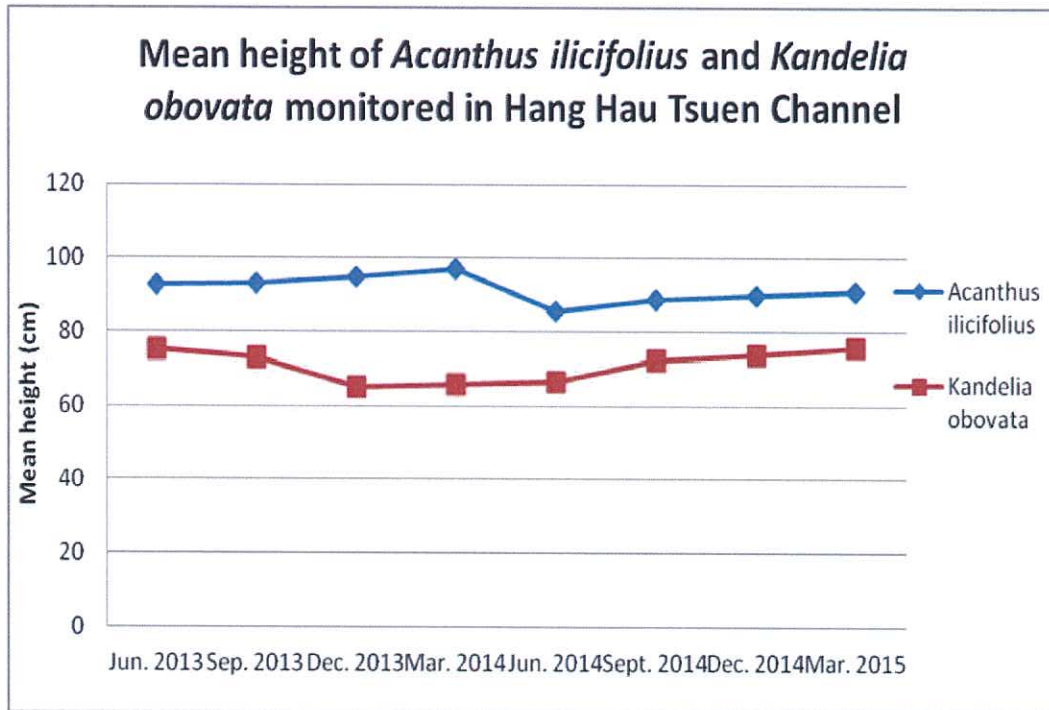
Figure 1 - Mean height (cm) of *Acanthus ilicifolius* and *Kandelia obovata* monitored at Hang Hau Tsuen Channel from June 2013 to March 2015

calculated and shown in **Tables 10 & 11**. The change of measurement parameters since June 2013 was shown in **Figures 1 & 2**.

- 4.2.3 A positive growth in mean height and diameter of selected individuals were constantly recorded in every quarterly monitoring except one monitoring conducted in June 2014, in which reduction in mean height and diameter was observed due to the death of the highest plants. Reselected shorter and smaller plant resulted in a reduction in mean height and diameter.

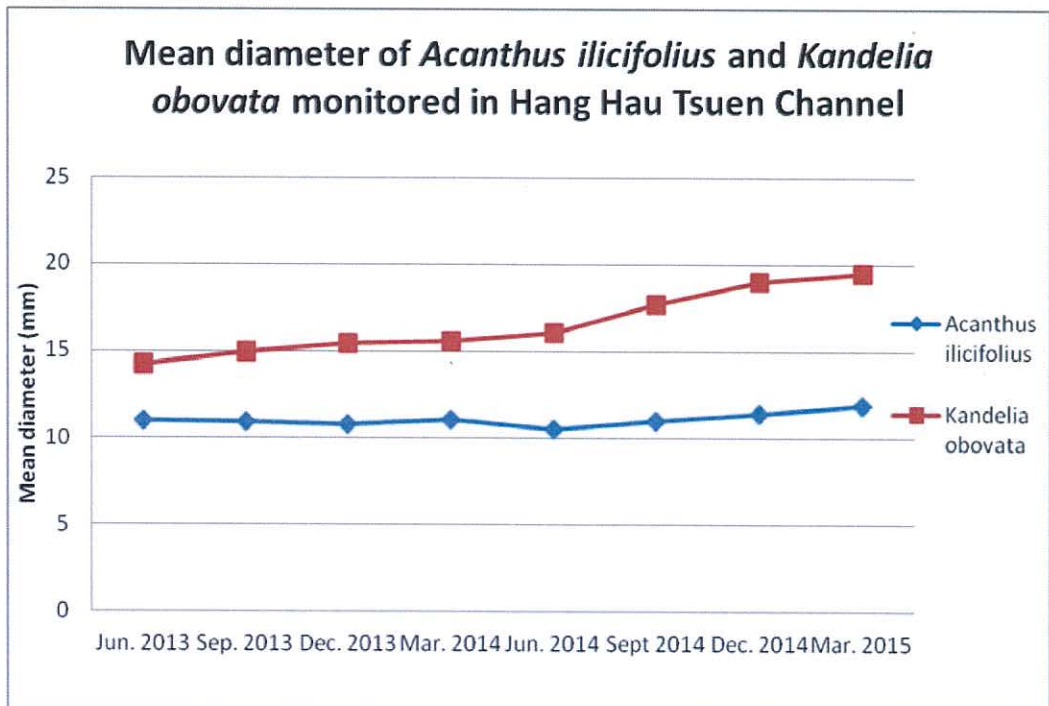
Figure 2 - Mean diameter (mm) of *Acanthus ilicifolius* and *Kandelia obovata* monitored at Hang Hau Tsuen Channel from June 2013 to March 2015

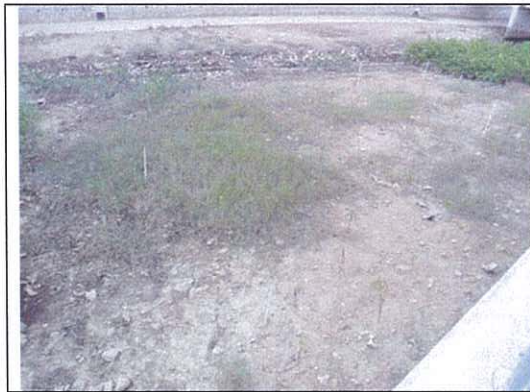
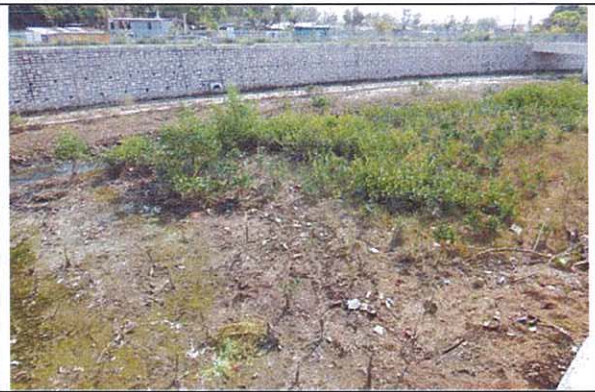
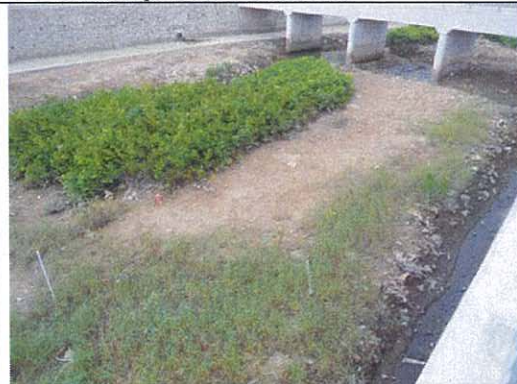
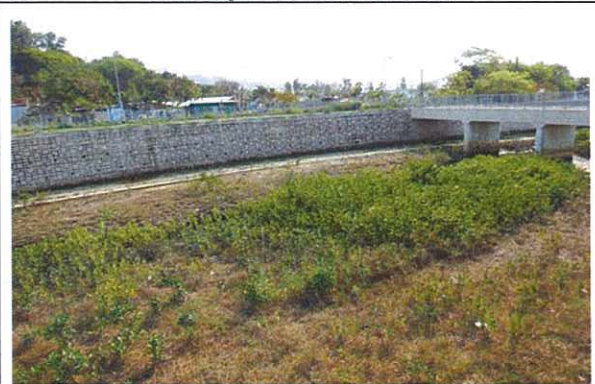
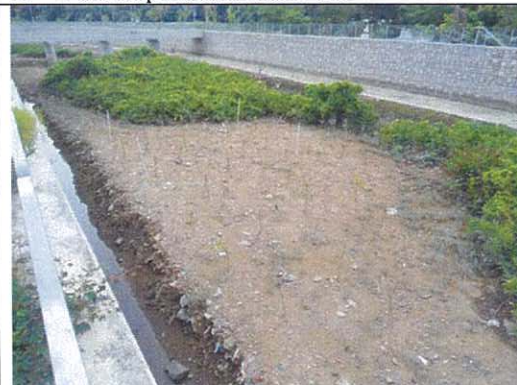
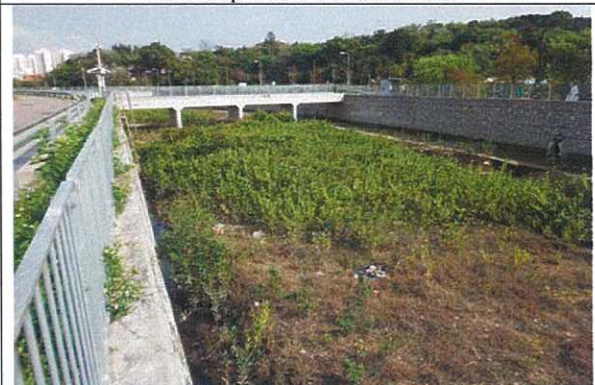
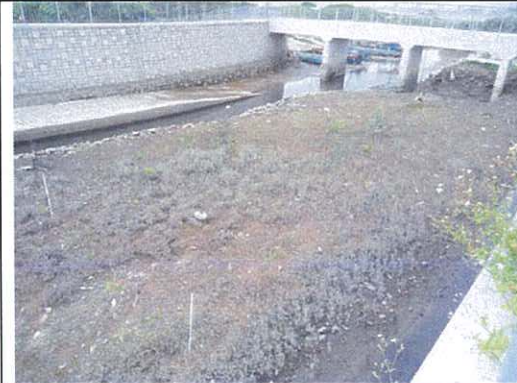
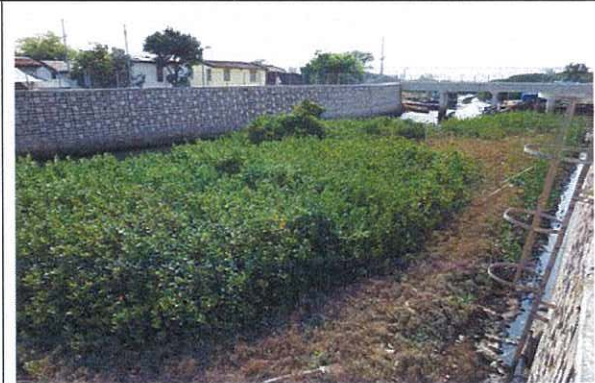
Photo 1 - 8

Overall view of mangrove compensation area for both last and current inspection

- 4.3.1 The overall view of the mangrove compensation area and each quadrat was presented by a number of photos taken at specific location along the channel. The photos are useful to illustrate and compare the mangrove plant condition. The overall view of the mangrove compensation area and each quadrat for both last and current inspection was presented in **Annex B, Photo 1-8** and **Photo 9-18** respectively. The current view of the surveyed area is shown in **Photo 19-20**.
- 4.3.2 By comparing the photographic record for both last and current inspection, more new plants were observed established in the channel and the original planted species have become higher and denser.

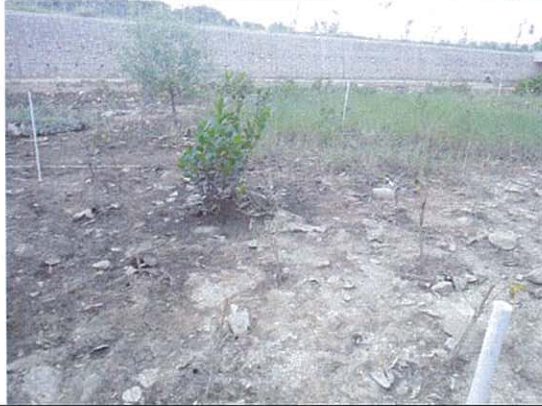
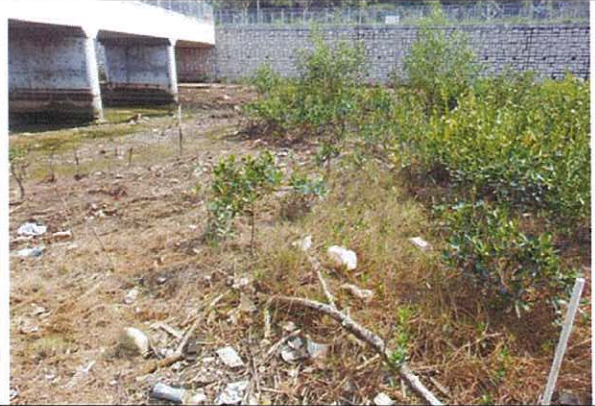
- 4.1.3 The overall health conditions of the selected individuals were assessed as “Fair” condition during two years monitoring period except some individuals were dead in Quadrat 1 and 2 respectively. Individuals in Quadrat 1 were observed in high mortality rate since the inspection conducted in December 2013. As that side of Quadrat 1 was nearest to an outfall, it was believed that eastern side of Quadrat 1 was immersed by the discharge from outfall, which leads to the death of mangrove tree on that area. However, the affected area was small compare to the whole compensatory site, and a total of 0.07 (1:1 ratio) compensation area is still complied as regeneration in other area was observed. Thus the loss of small proportion of trees is minor.

9. First inspection in June 2013

10. Last inspection in March 2015

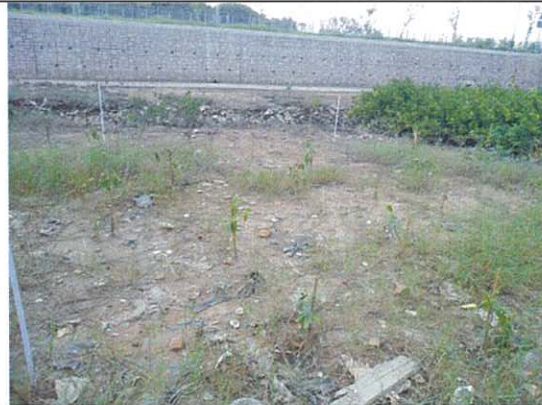
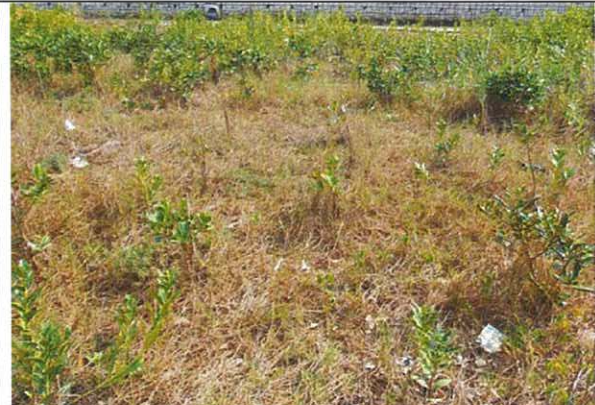
- 4.1.4 One of the selected *Kandelia obovata* was found dead in Quadrat 2 during the last inspection. As the rest of trees in the same quadrat were observed in positive growth without significant change, it was believed that the tree was dead naturally and reason of the death is not related to any impacts raised from the compensatory site.

11. First inspection in June 2013

12. Last inspection in March 2015

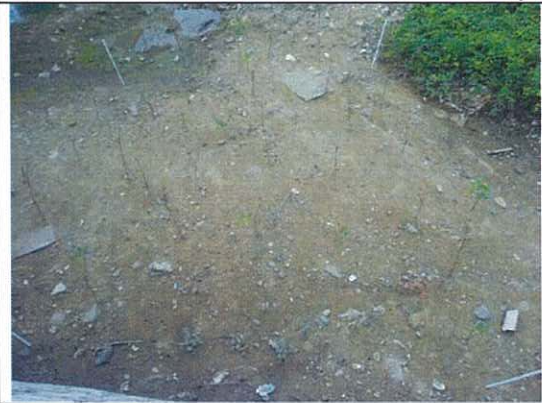
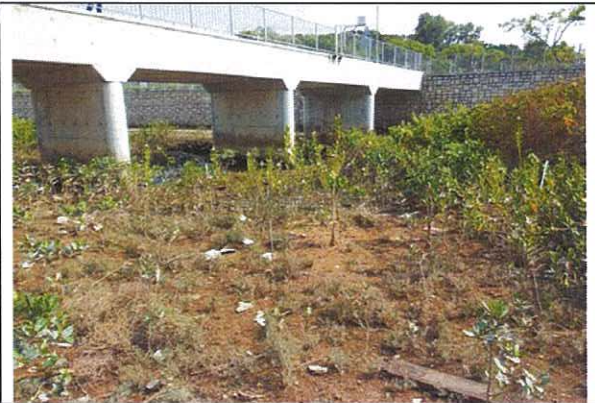
Quadrat 3

13. First inspection in June 2013

14. Last inspection in March 2015

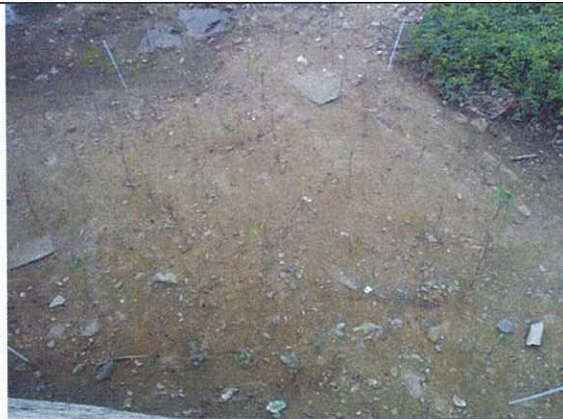
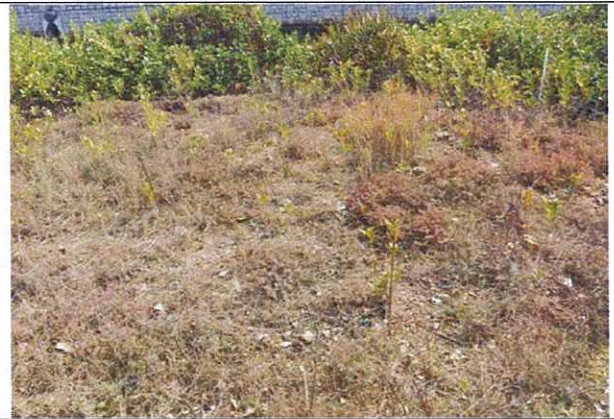
Quadrat 4

15. First inspection in June 2013

16. Last inspection in March 2015

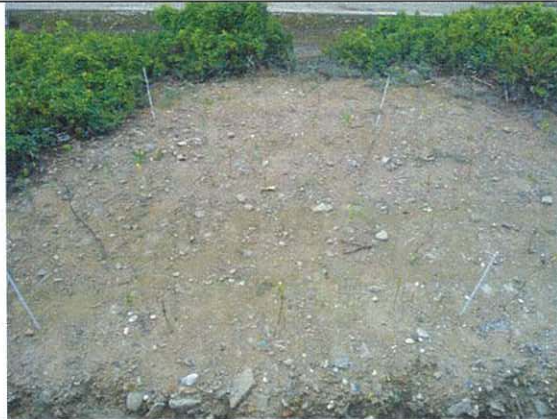
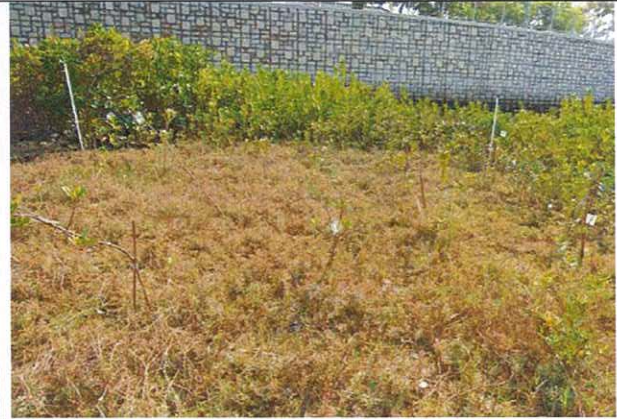
Quadrat 5

17. First inspection in June 2013

18. Last inspection in March 2015

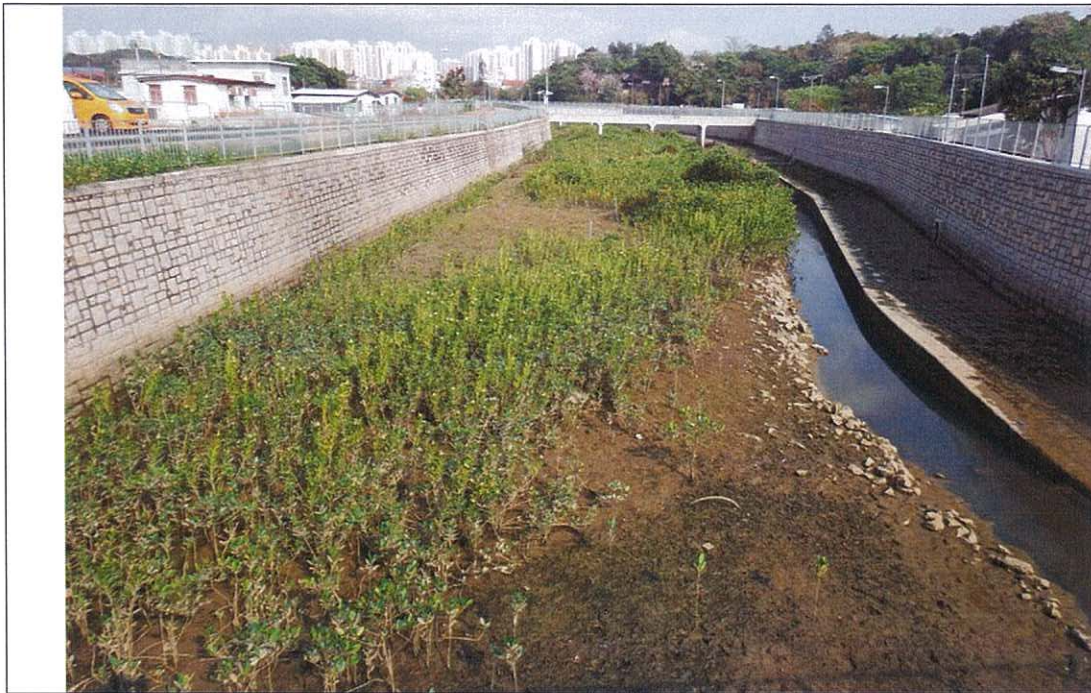
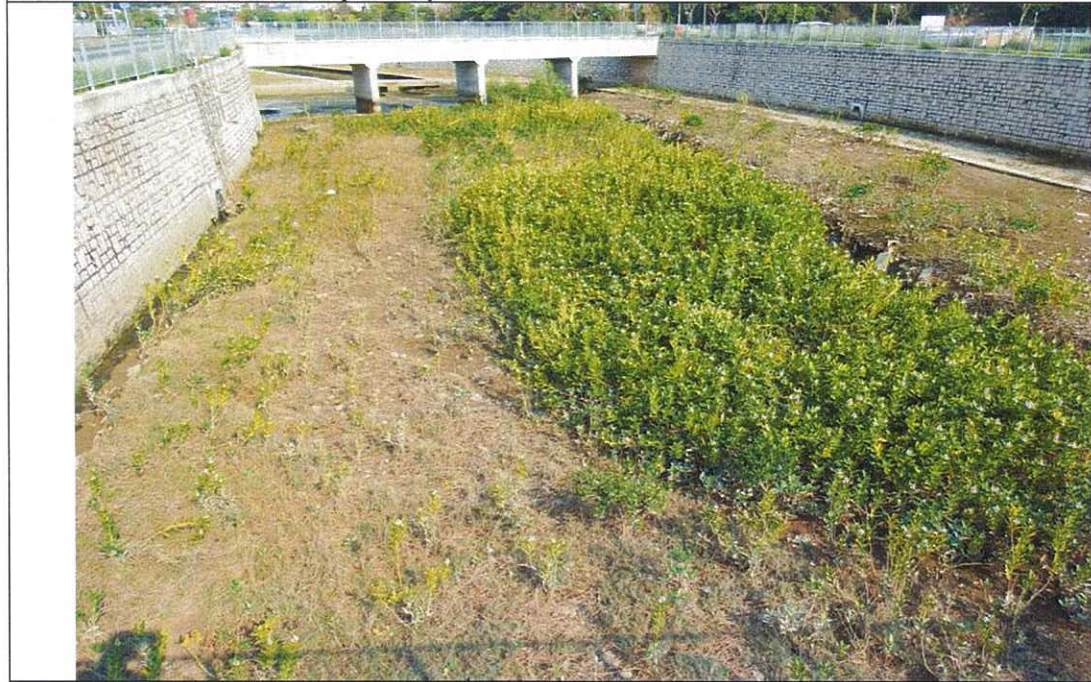
Photo 19-20

19 The current view of the compensatory area

20 The current view of the compensatory area
