# Contract No. HY/2012/07 Tuen Mun - Chek Lap Kok Link Southern Connection Viaduct Section

Ninth Quarterly Environmental Monitoring & Audit (EM&A) Report

26 July 2016

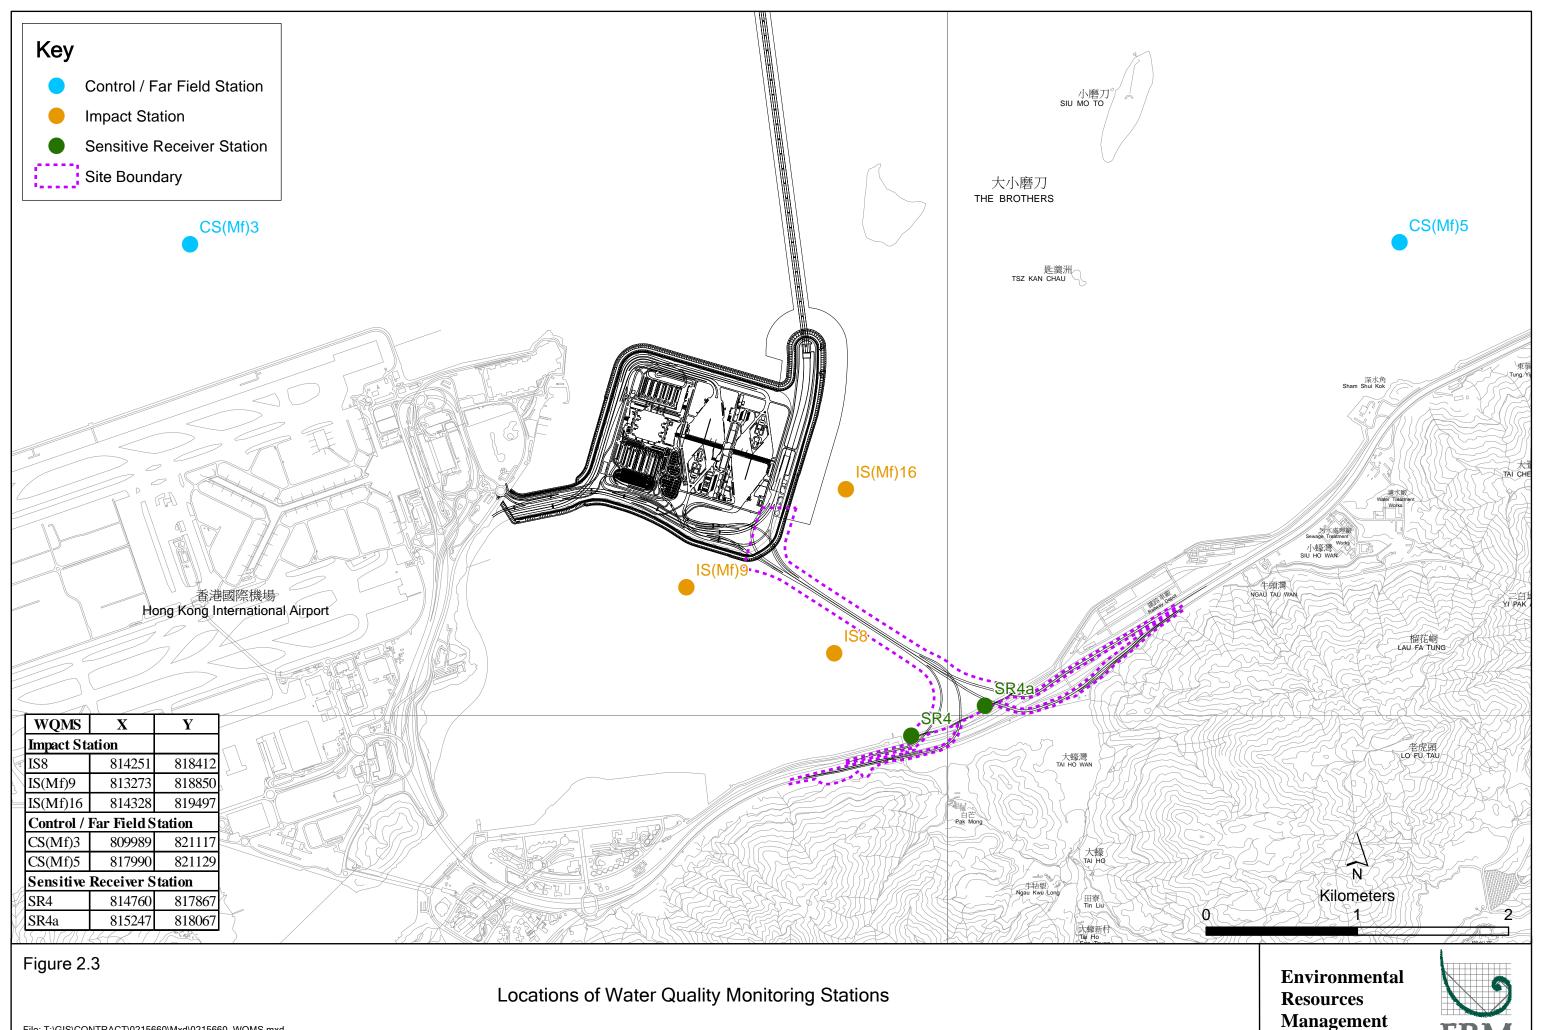
Impact water quality monitoring was carried out to ensure that any deterioration of water quality was detected, and that timely action was taken to rectify the situation. Impact water quality monitoring was undertaken three days per week during the construction period at seven water quality monitoring stations in accordance with the Updated EM&A Manual (*Figure* 2.3; *Table* 2.8).

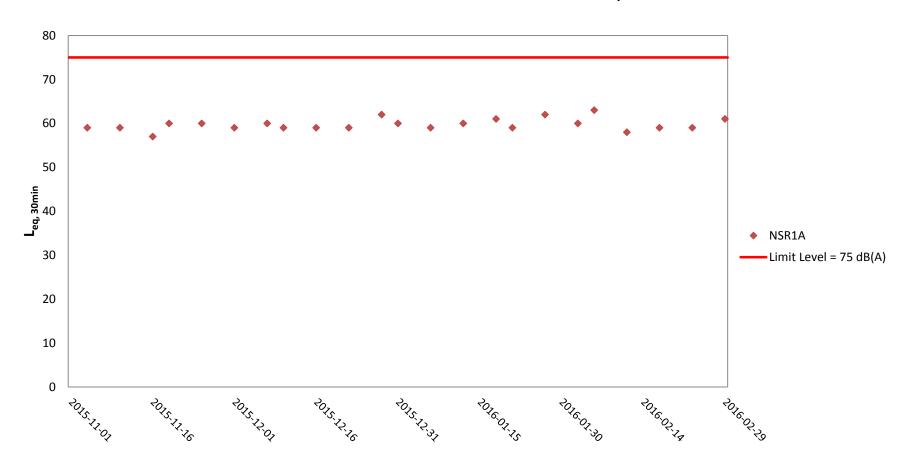
### Noise Monitoring Results at NSR 1A ( $L_{eq, 30min}$ )

Weather condition within the reporting period varied between sunny to rainy.

Major construction works undertaken within the reporting period include Pier construction; Re-alignment of Cheung Tung Road; Predrilling at Viaduct F; Additional land GI, trial pits & lab testing; Installation of pier head and deck segments; and Slope work of Viaducts A, B & C.

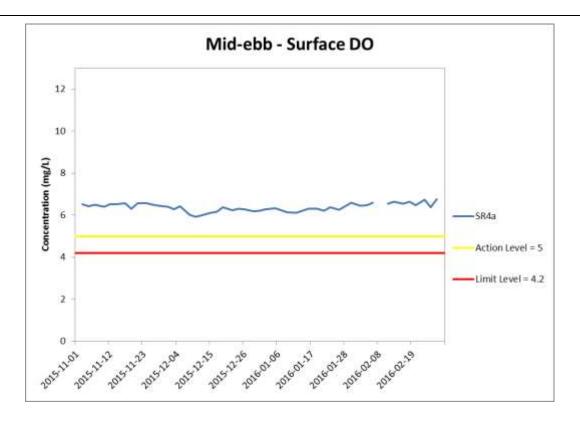
Figure H4 Impact Monitoring - Mean Level of Dissolved Oxygen (mg/L) in surface waters during mid-ebb tide between 1 November 2015 and 29 February 2016 at SR4a.

WQM was cancelled on 9 February 2016 due to suspension of marine works. (Weather condition varied between sunny to rainy within the reporting period.) Marine works within the reporting period include Construction and installation of pile caps; Uninstallation of marine piling platform; Pier construction; Launching gantry operation; and Installation of deck segment and pier head segment.

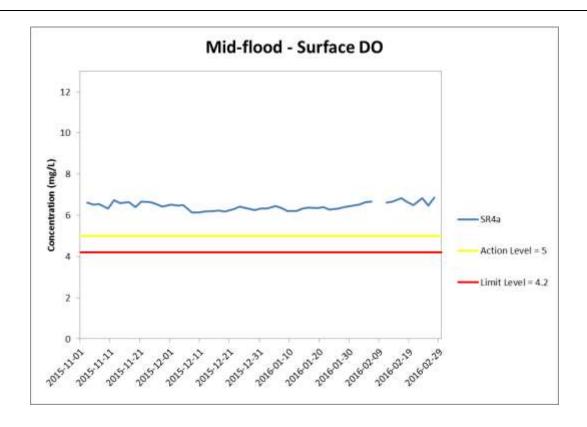
Figure H8 Impact Monitoring – Mean Level of Dissolved Oxygen (mg/L) in surface waters during mid-flood tide between 1 November 2015 and 29 February 2016 at SR4a.

WQM was cancelled on 9 February 2016 due to suspension of marine works. (Weather condition varied between sunny to rainy within the reporting period.) Marine works within the reporting period include Construction and installation of pile caps; Uninstallation of marine piling platform; Pier construction; Launching gantry operation; and Installation of deck segment and pier head segment.

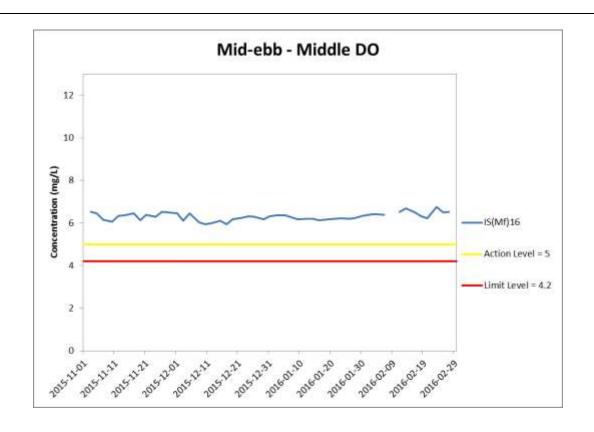
Figure H10 Impact Monitoring – Mean Level of Dissolved Oxygen (mg/L) in mid-depth waters during mid-ebb tide between 1 November 2015 and 29 February 2016 at IS(Mf)16.

WQM was cancelled on 9 February 2016 due to suspension of marine works. (Weather condition varied between sunny to rainy within the reporting period.) Marine works within the reporting period include Construction and installation of pile caps; Uninstallation of marine piling platform; Pier construction; Launching gantry operation; and Installation of deck segment and pier head segment.

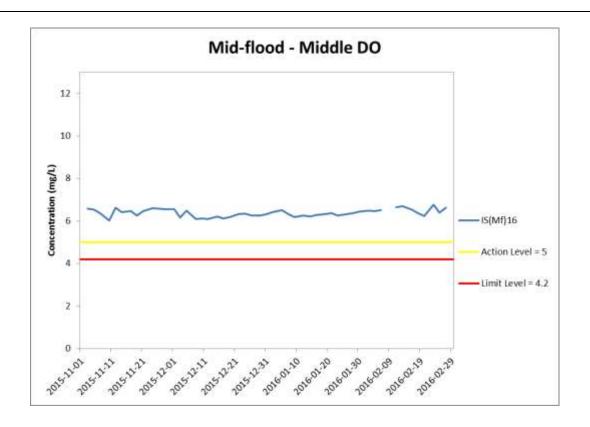
Figure H12 Impact Monitoring – Mean Level of Dissolved Oxygen (mg/L) in mid-depth waters during mid-flood tide between 1 November 2015 and 29 February 2016 at IS(Mf)16.

WQM was cancelled on 9 February 2016 due to suspension of marine works. (Weather condition varied between sunny to rainy within the reporting period.) Marine works within the reporting period include Construction and installation of pile caps; Uninstallation of marine piling platform; Pier construction; Launching gantry operation; and Installation of deck segment and pier head segment.

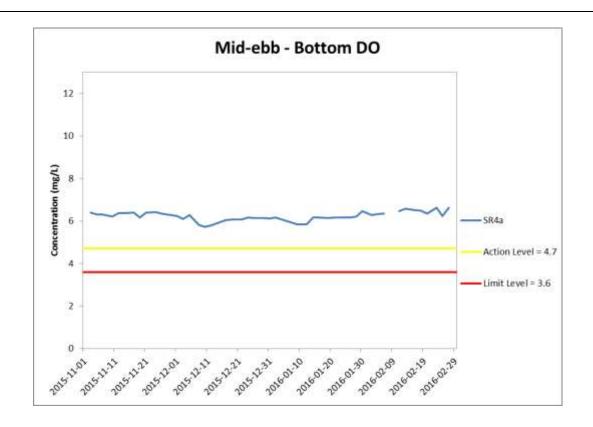
Figure H16 Impact Monitoring - Mean Level of Dissolved Oxygen (mg/L) in bottom waters during mid-ebb tide between 1 November 2015 and 29 February 2016 at SR4a.

WQM was cancelled on 9 February 2016 due to suspension of marine works. (Weather condition varied between sunny to rainy within the reporting period.) Marine works within the reporting period include Construction and installation of pile caps; Uninstallation of marine piling platform; Pier construction; Launching gantry operation; and Installation of deck segment and pier head segment.

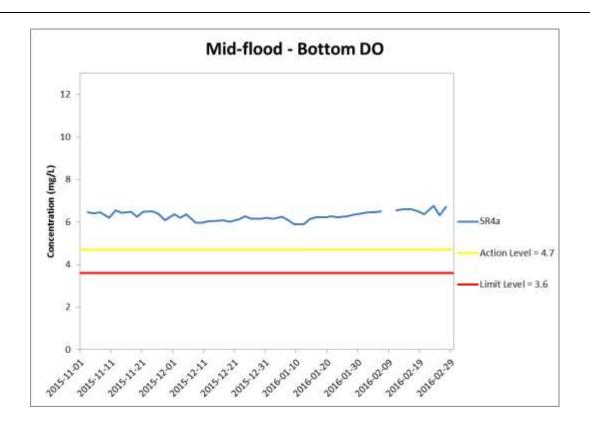
Figure H20 Impact Monitoring – Mean Level of Dissolved Oxygen (mg/L) in bottom waters during mid-flood tide between 1 November 2015 and 29 February 2016 at SR4a.

WQM was cancelled on 9 February 2016 due to suspension of marine works. (Weather condition varied between sunny to rainy within the reporting period.) Marine works within the reporting period include Construction and installation of pile caps; Uninstallation of marine piling platform; Pier construction; Launching gantry operation; and Installation of deck segment and pier head segment.

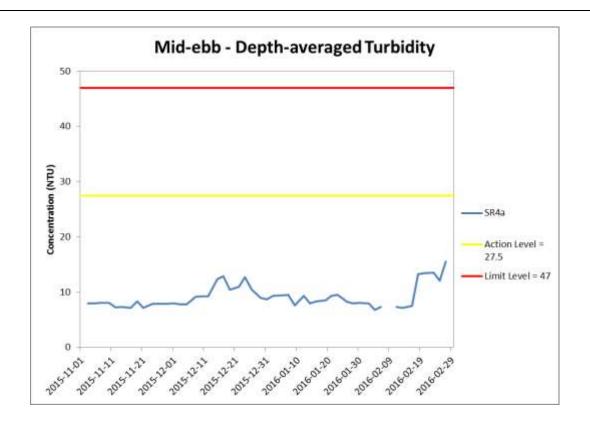
Figure H24 Impact Monitoring – Mean Level of depth-averaged Turbidity (NTU) during mid-ebb tide between 1 November 2015 and 29 February 2016 at SR4a.

WQM was cancelled on 9 February 2016 due to suspension of marine works. (Weather condition varied between sunny to rainy within the reporting period.) Marine works within the reporting period include Construction and installation of pile caps; Uninstallation of marine piling platform; Pier construction; Launching gantry operation; and Installation of deck segment and pier head segment.

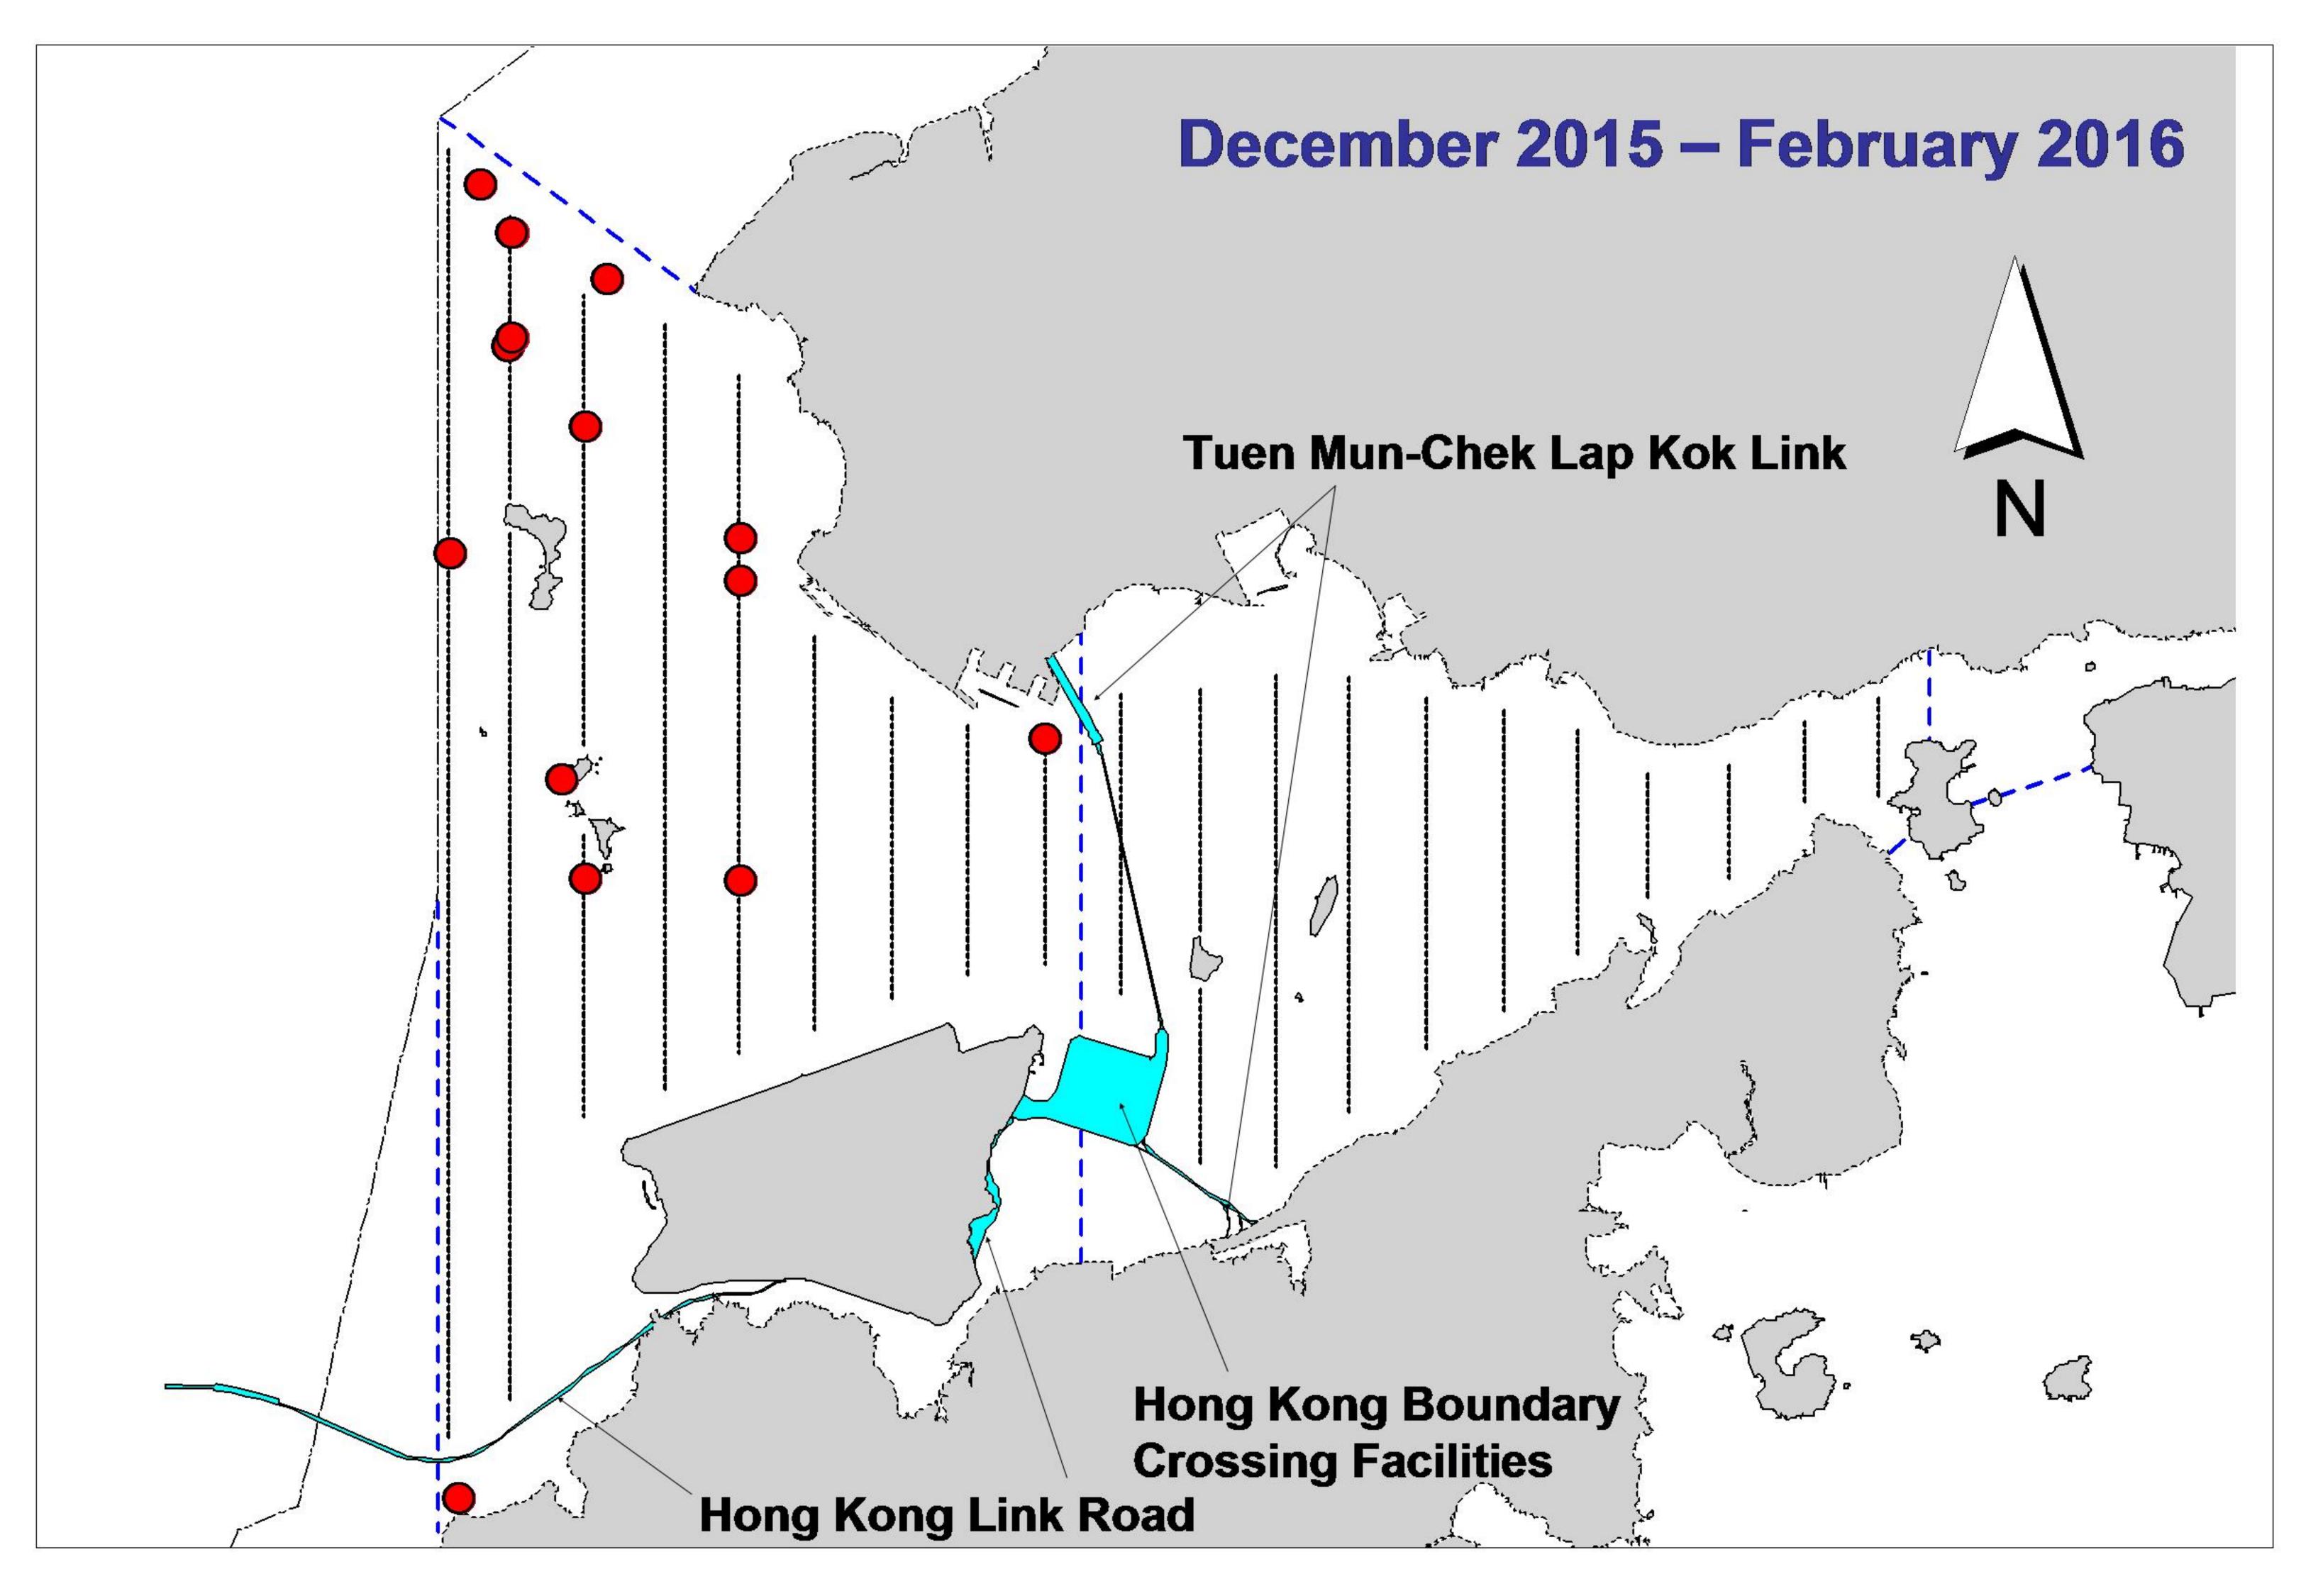
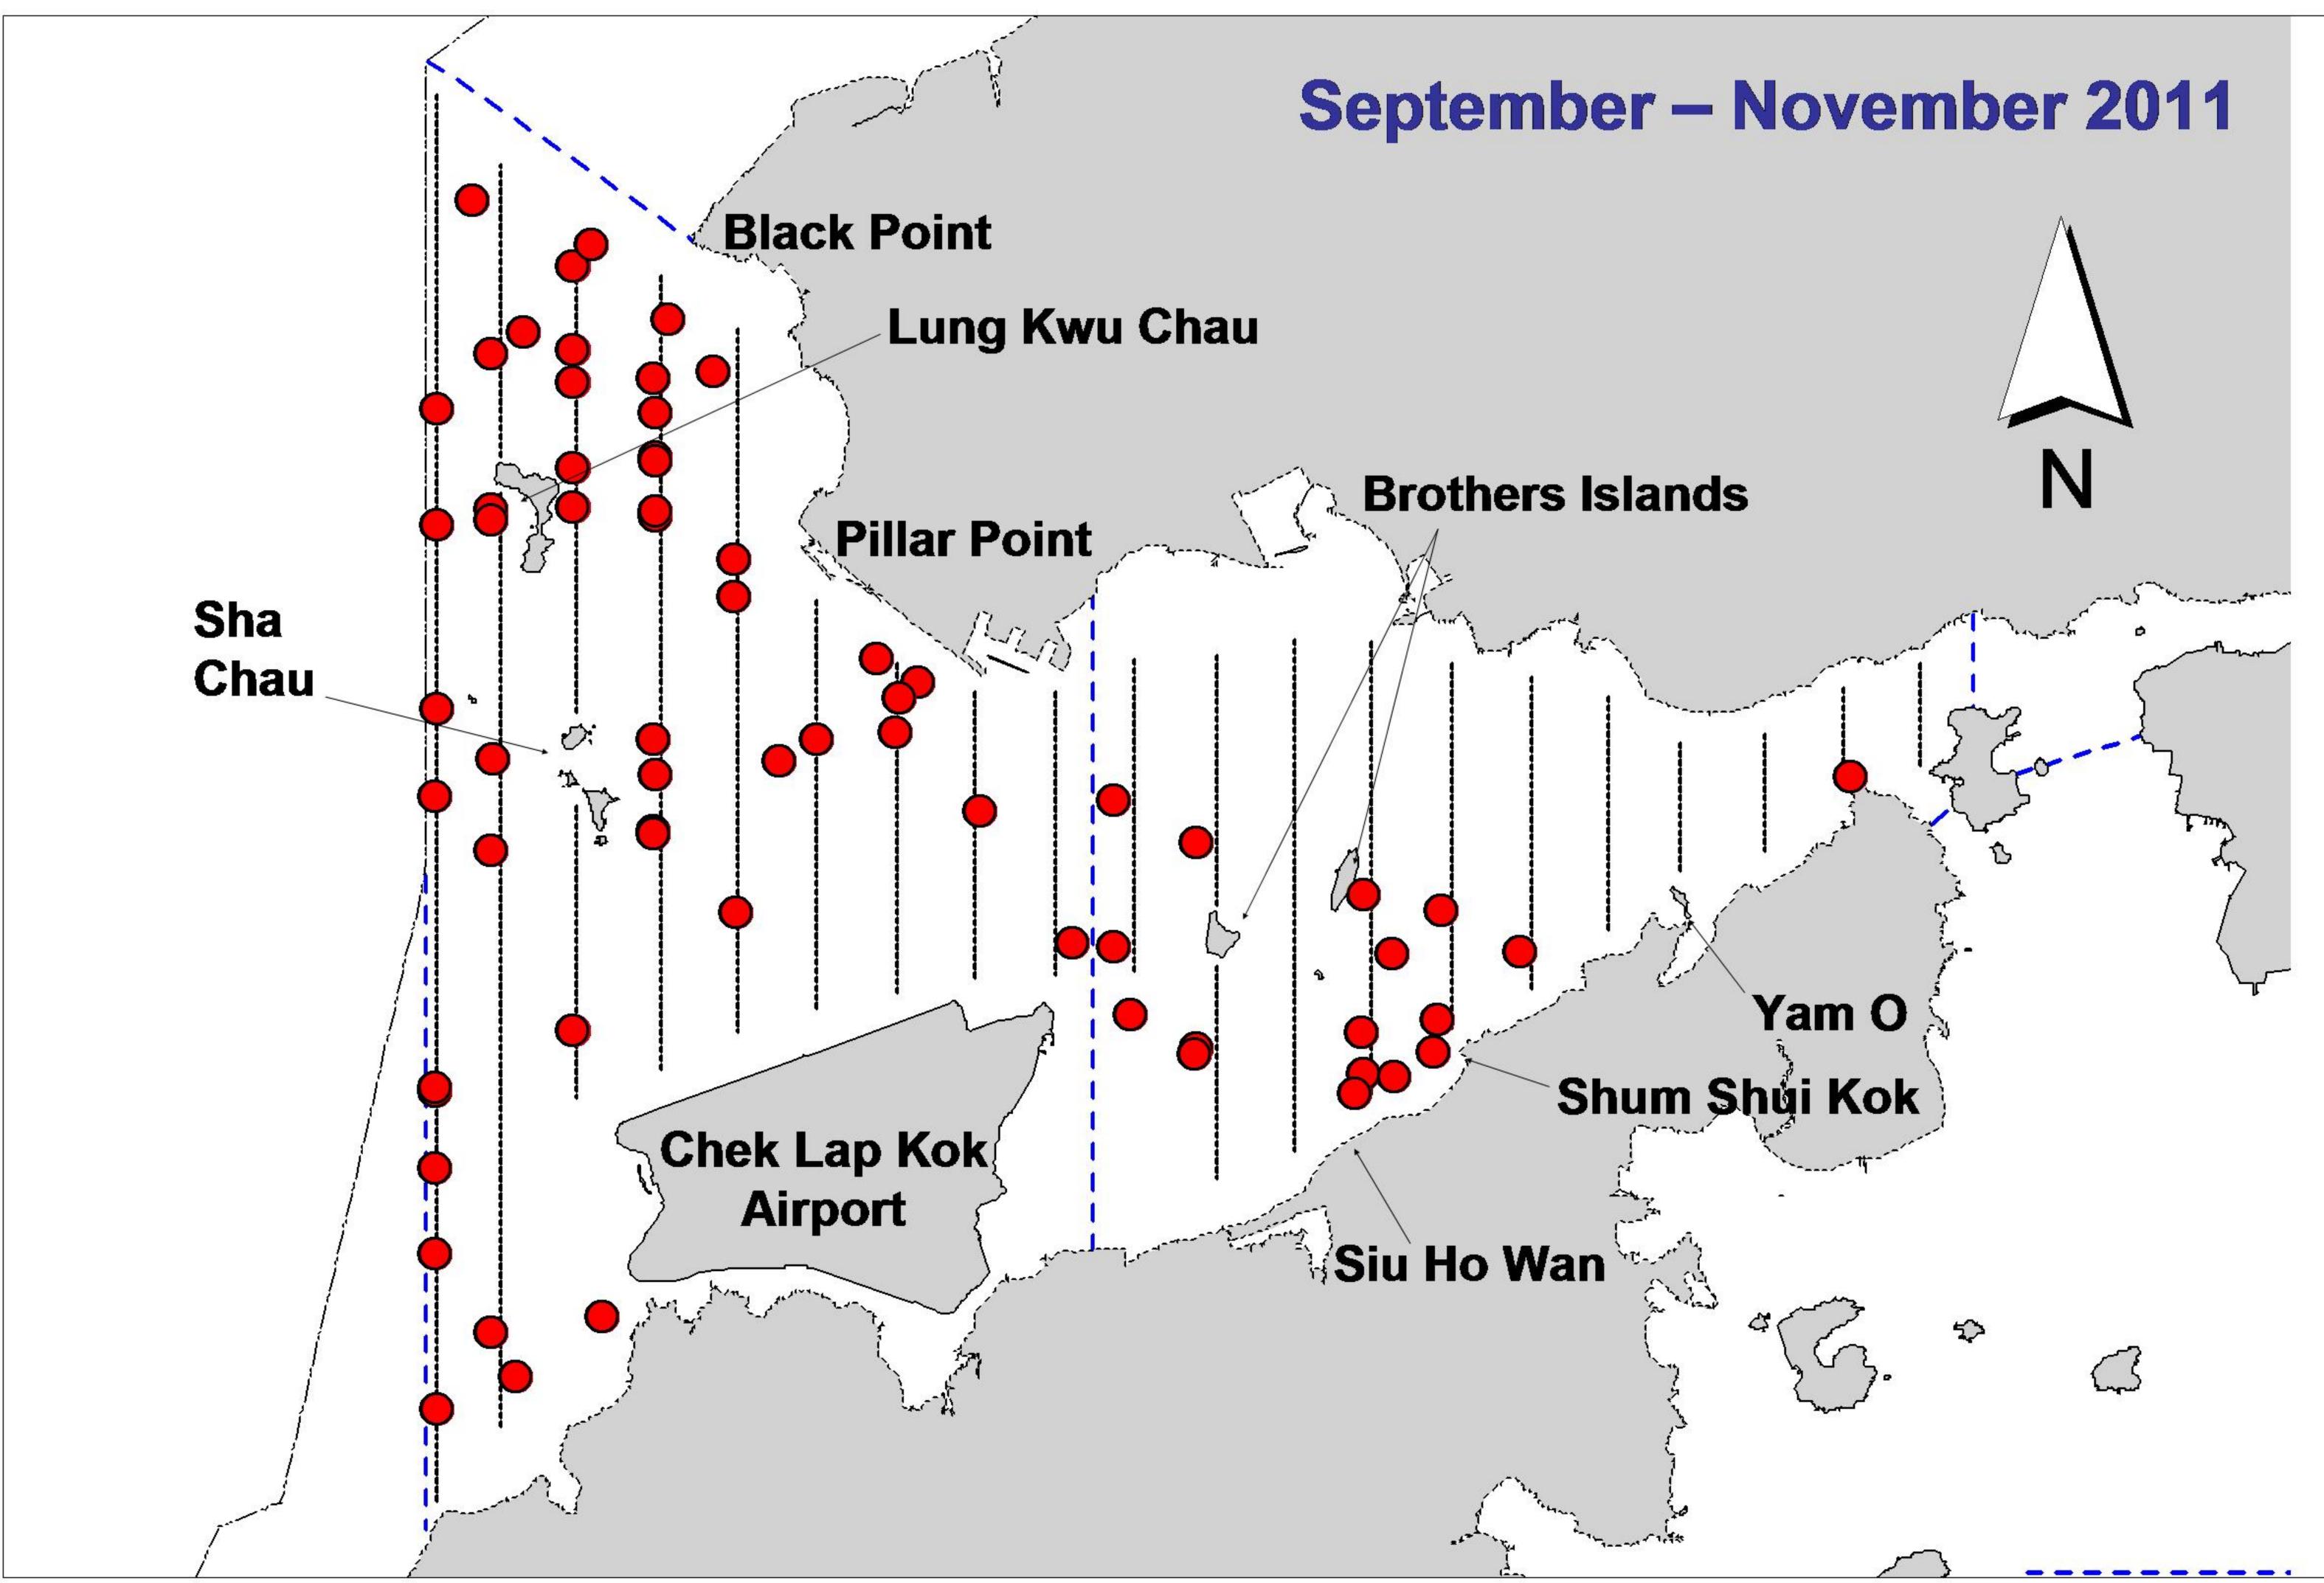
Figure 1. Distribution of Chinese white dolphin sighting in Northwest and Northeast Lantau during HKLR03 impact phase (top) and baseline monitoring surveys (bottom)

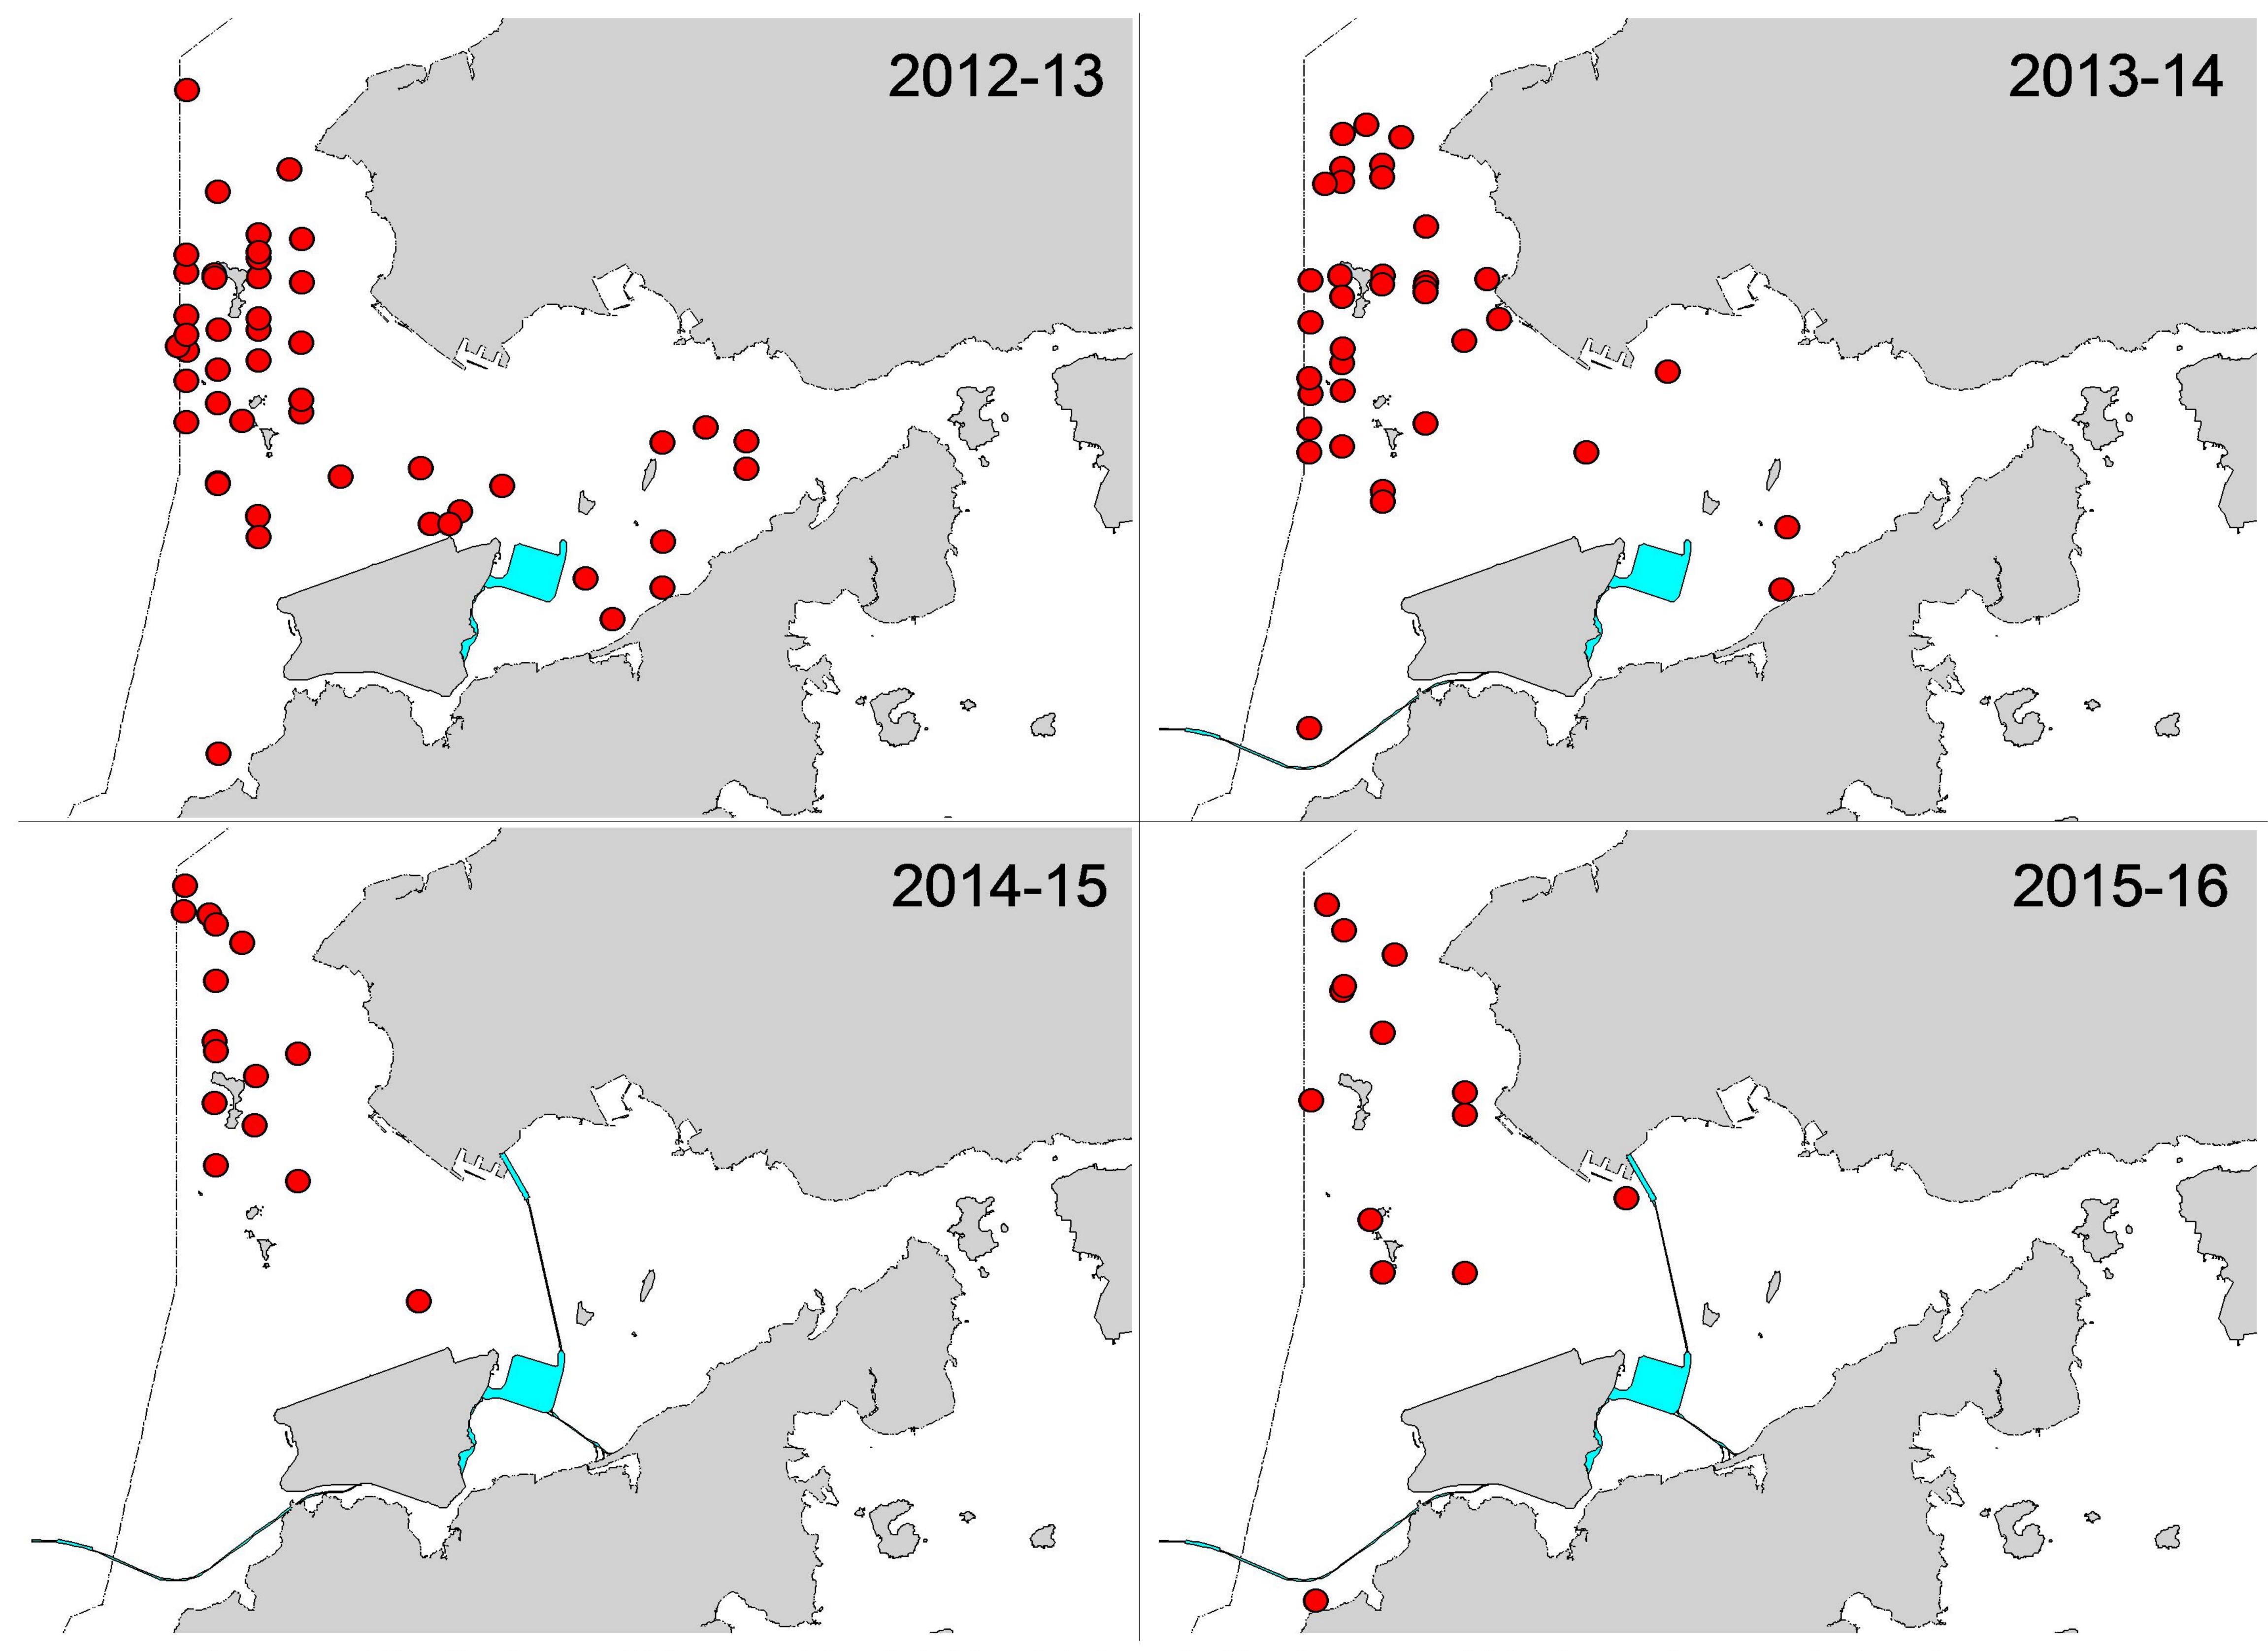
Figure 2. Distribution of Chinese white dolphin sightings in Northwest and Northeast Lantau during the same winter quarters (December - February) of HKLR03 impact phase in 2013-16

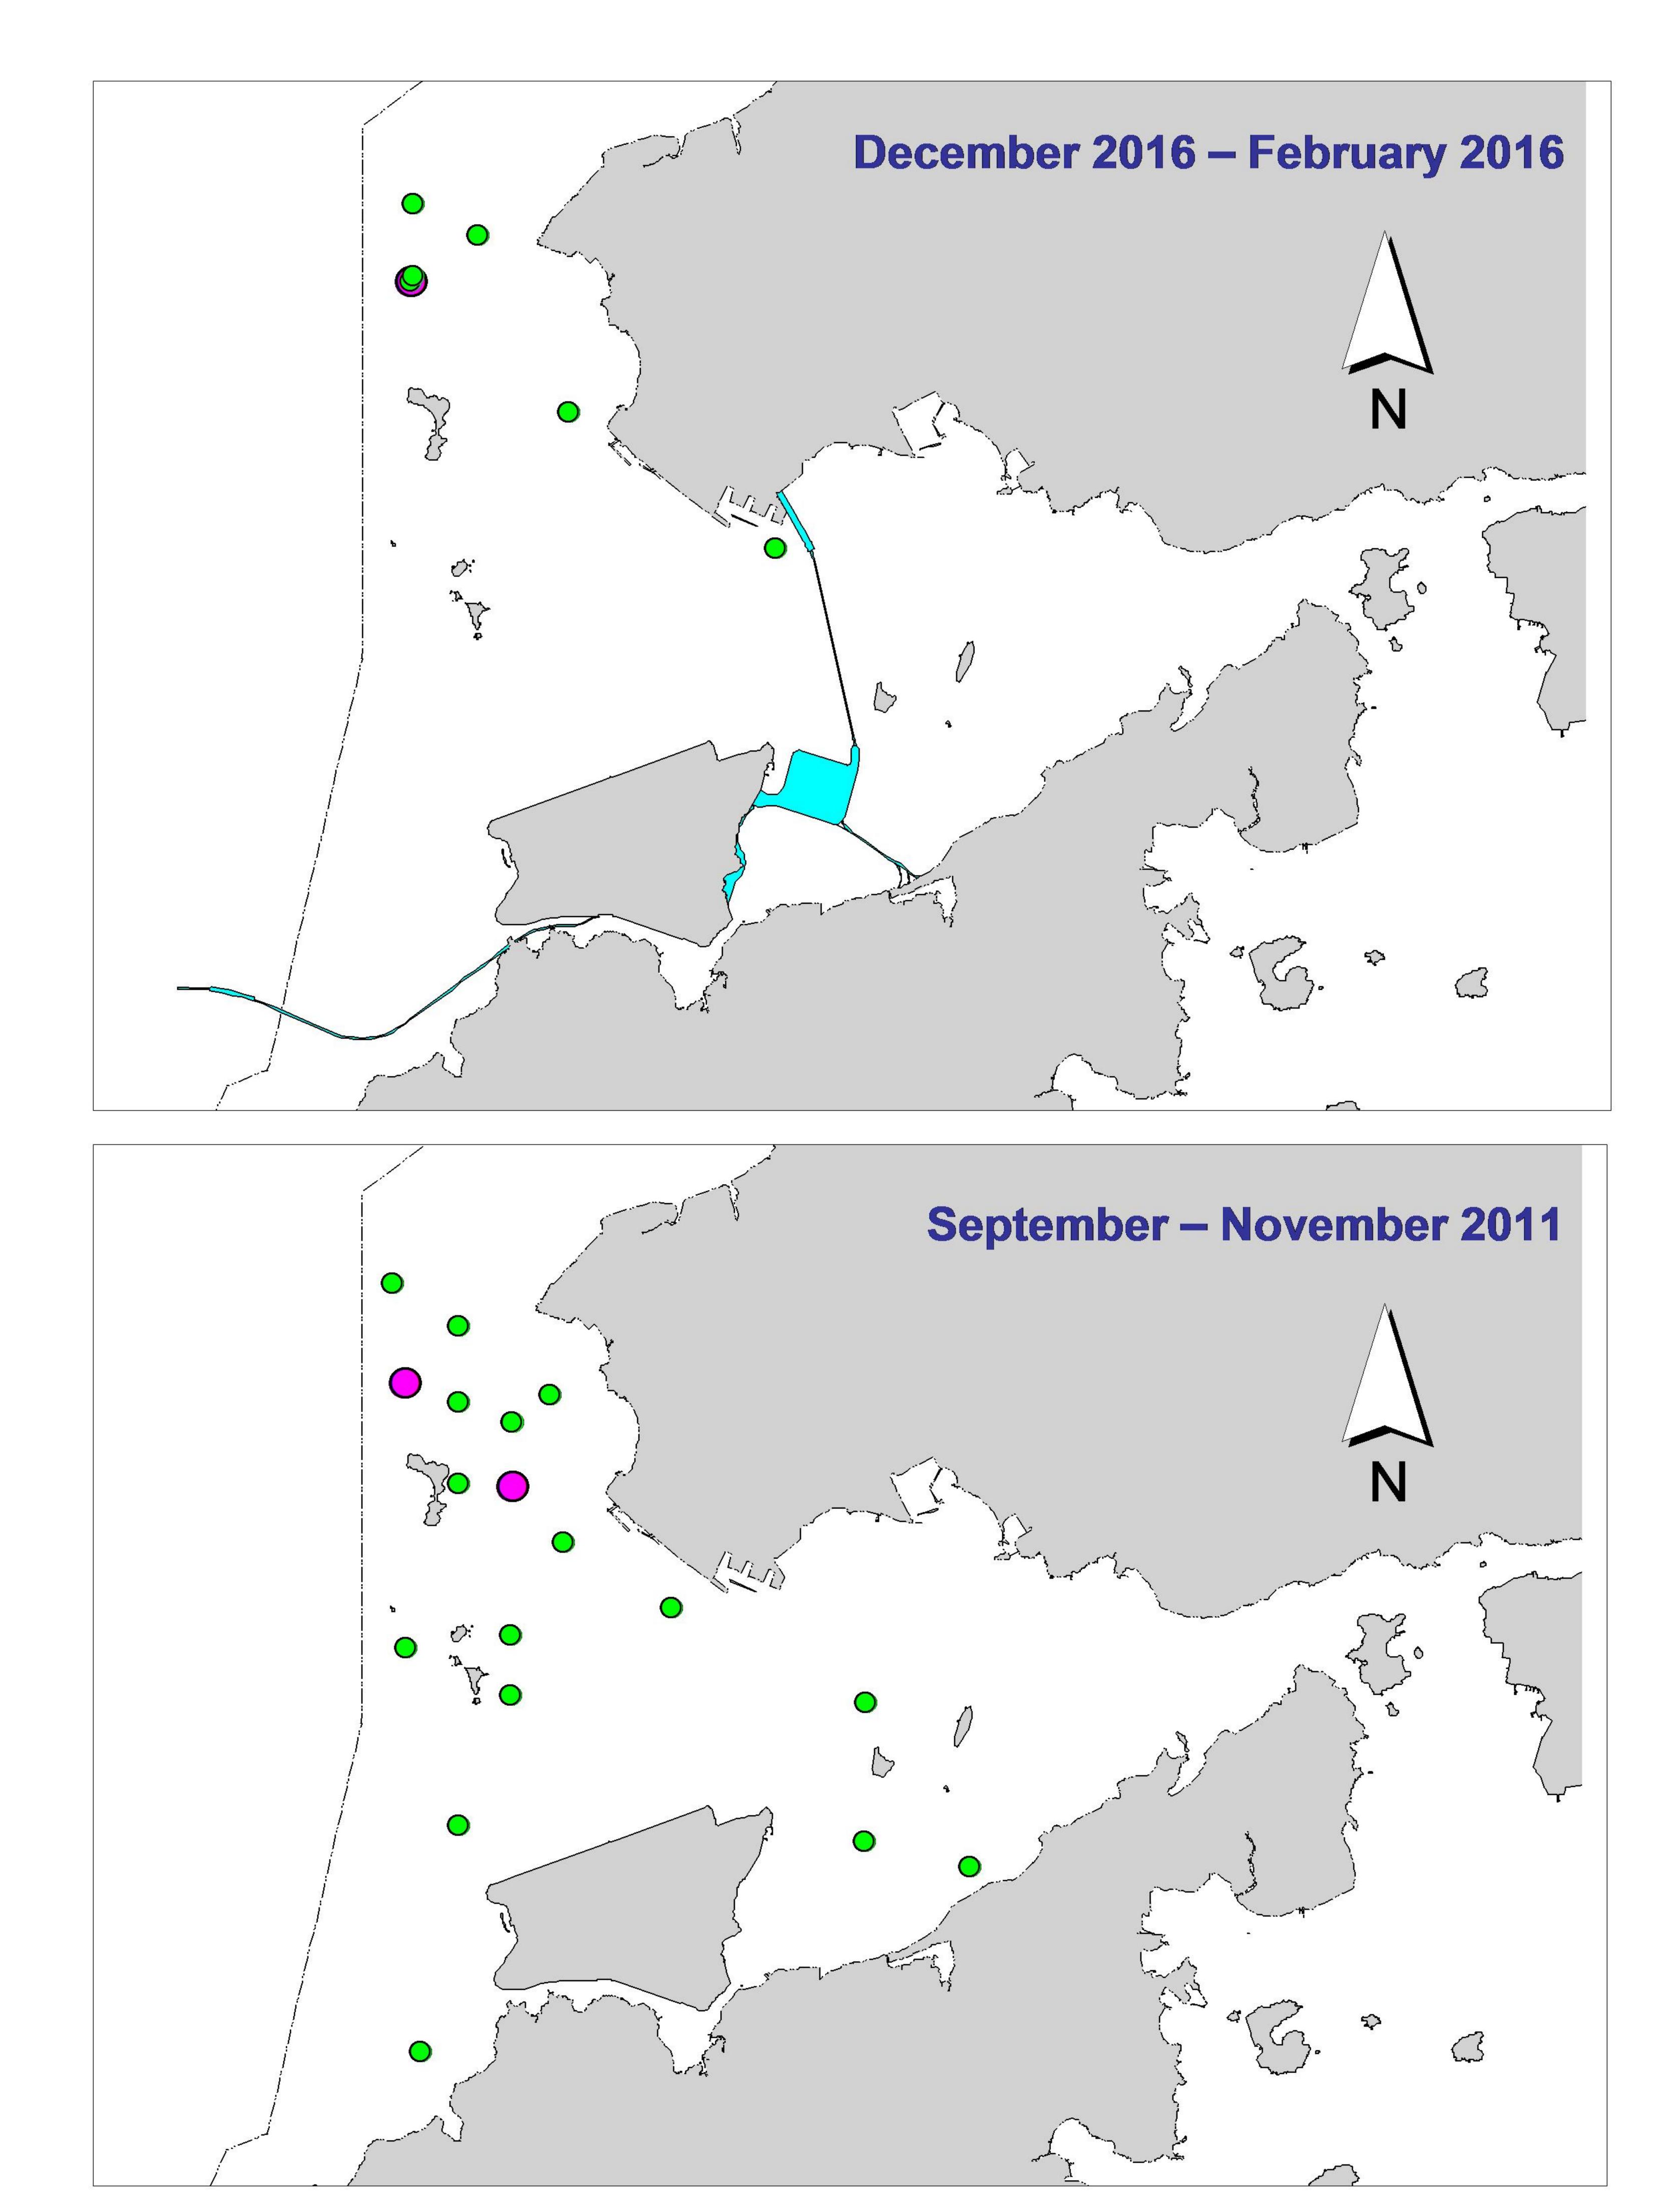
Figure 3. Distribution of Chinese white dolphins with larger group sizes during HKLR03 impact phase (top) and baseline monitoring surveys (bottom) (green dots: group sizes of 5 or more; purple dots: group sizes of 10 or more)
