# Contract No. HY/2012/07 Tuen Mun - Chek Lap Kok Link Southern Connection Viaduct Section

Ninth Quarterly Environmental Monitoring & Audit (EM&A) Report

26 July 2016

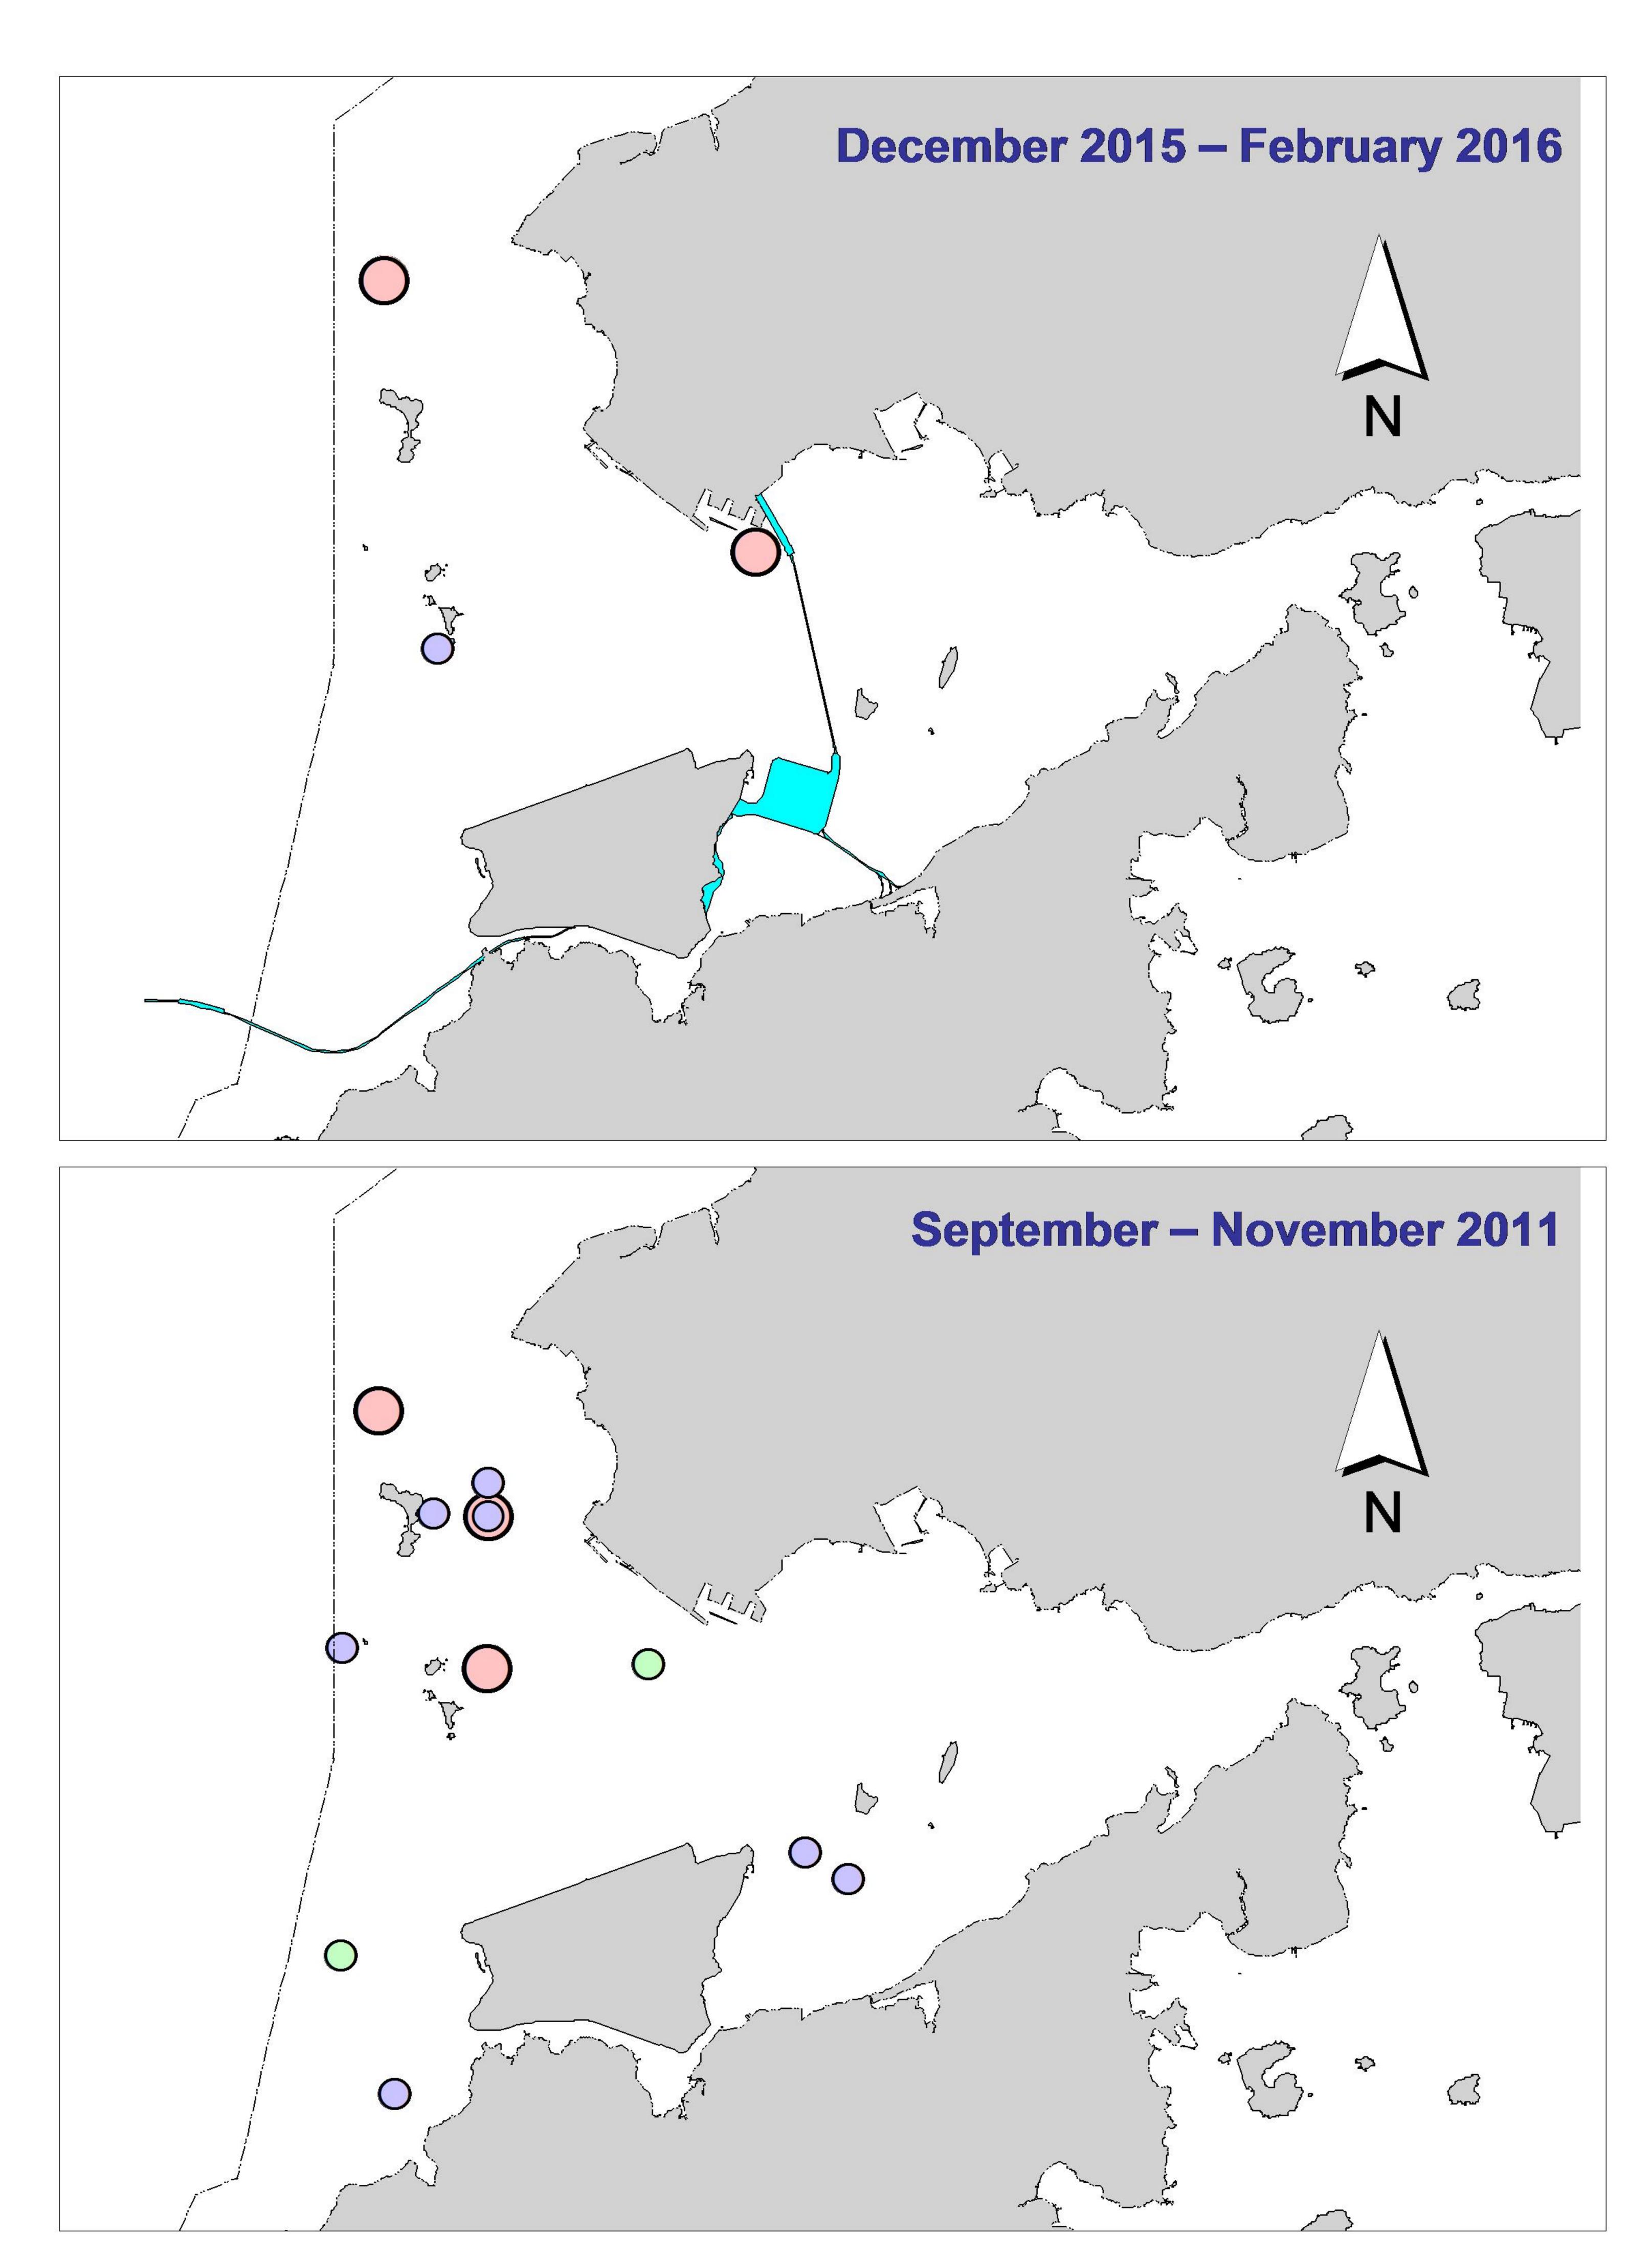
Figure 6. Distribution of Chinese white dolphins engaged in feeding (purple dots), socializing (pink dots) and traveling (green dots) activities during HKLR03 impact phase (top) and baseline monitoring surveys (bottom)

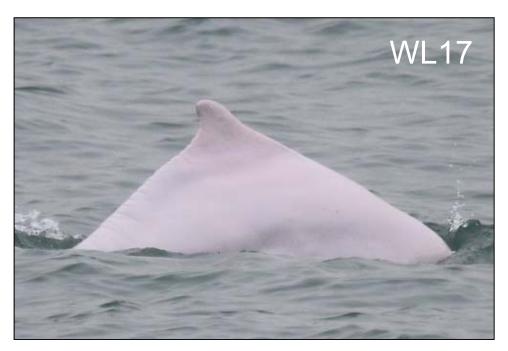
Appendix V. Ranging patterns (95% kernel ranges) of 21 individual dolphins that were sighted during HKLR03 impact phase monitoring period (note: yellow dots indicates sightings made in December 2015 – February 2016)
