**Contract No. HY/2012/08
Tuen Mun – Chek Lap Kok Link –
Northern Connection Sub-sea Tunnel
Section**

*Tenth Quarterly Environmental Monitoring &
Audit (EM&A) Report*

27 October 2016

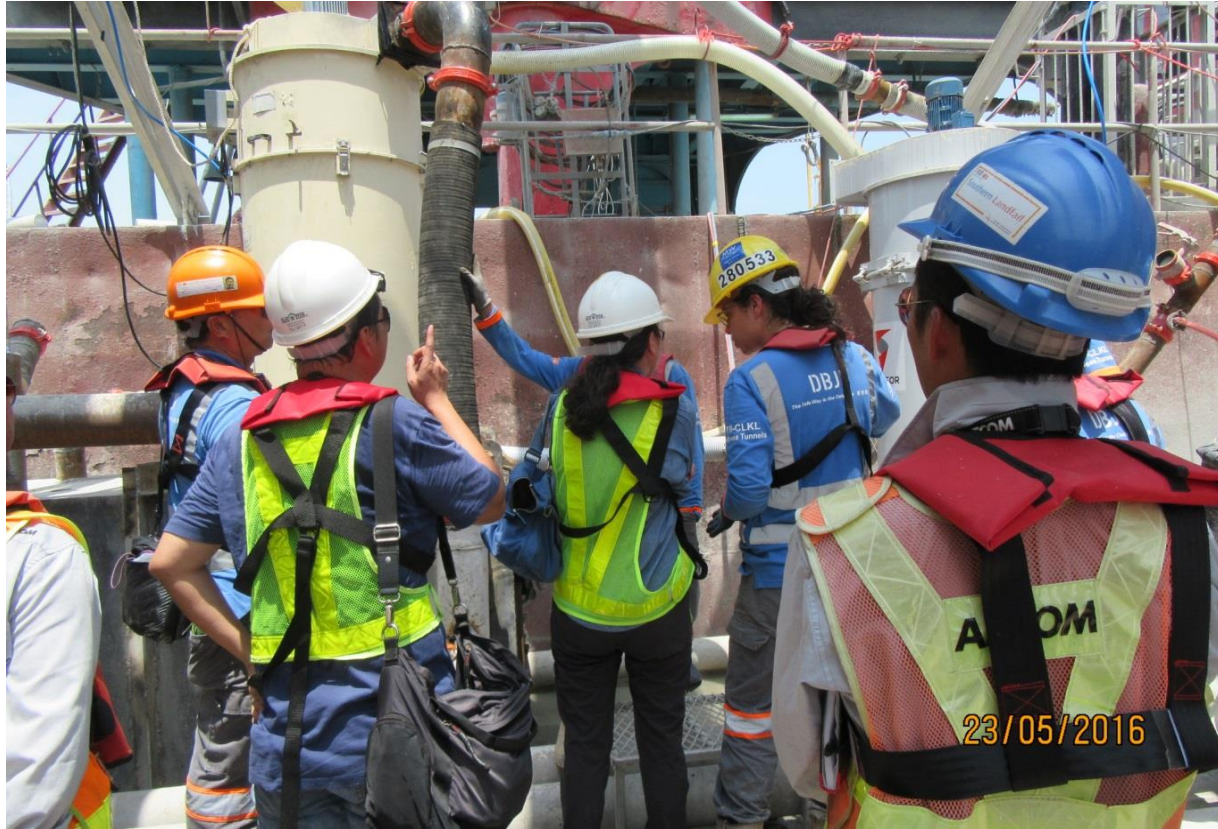
A joint site inspection was carried out by the ET, the Contractor, SOR and EPD on 23 May 2016.
(Barge area - Southern Landfall)
