**Contract No. HY/2012/08  
Tuen Mun – Chek Lap Kok Link –  
Northern Connection Sub-sea Tunnel  
Section**

*First Annual Environmental Monitoring & Audit  
(EM&A) Report*

12 July 2016

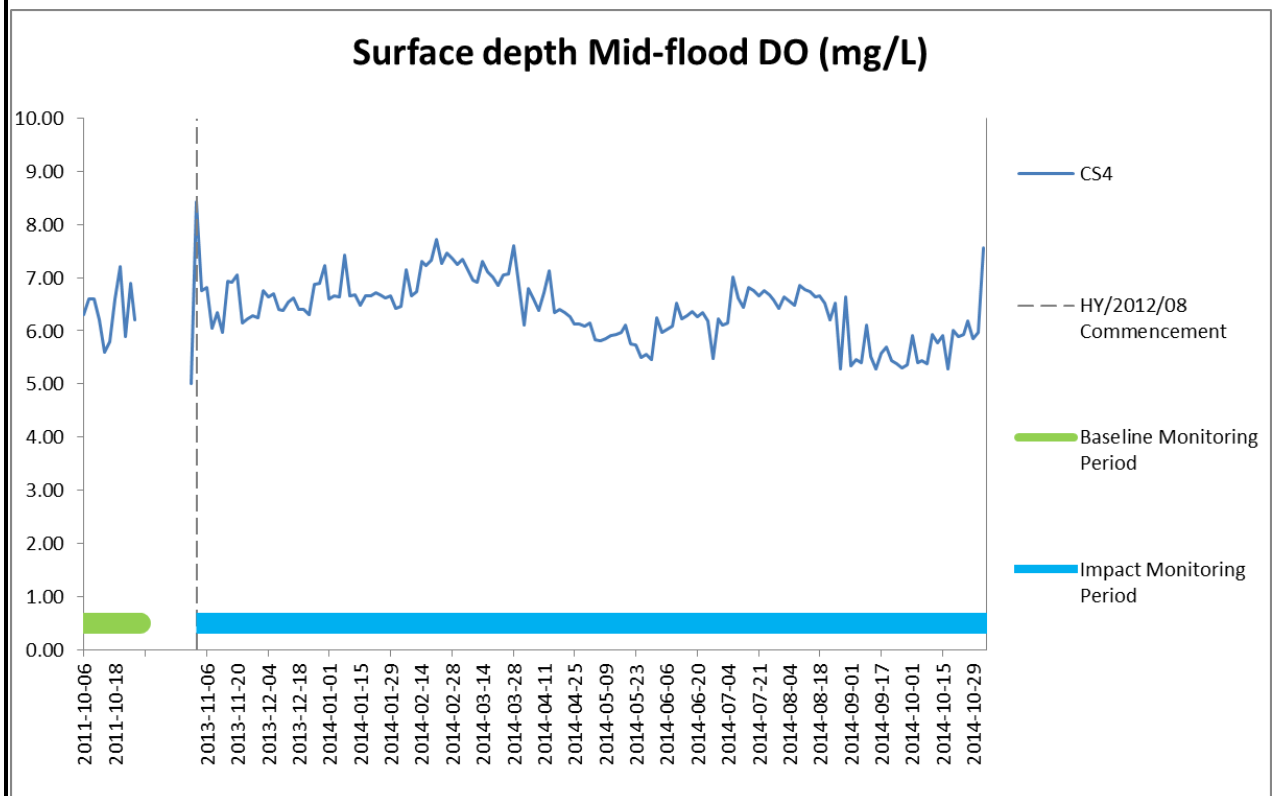
Figure E1 Baseline & Impact Monitoring - Mean Level of Dissolved Oxygen (mg/L) in surface waters between Baseline monitoring period: 6/10/2011 to 31/10/2011 and Impact monitoring period: 1/11/2013 to 31/10/2014 at CS4. Weather condition within the reporting period varied between sunny to rainy. The overall monitoring results were not affected by weather conditions. Major marine construction activities included: Dredging; Vertical and Sloping Seawall construction; Marine Sheet Piling for box culvert extension; Reclamation filling; and Box Culvert extension. Please note WQM Mid-Ebb on 15-Sep was cancelled due to adverse weather. Ref: 0212330\_Impact-WQM\_1st annual.xlsx

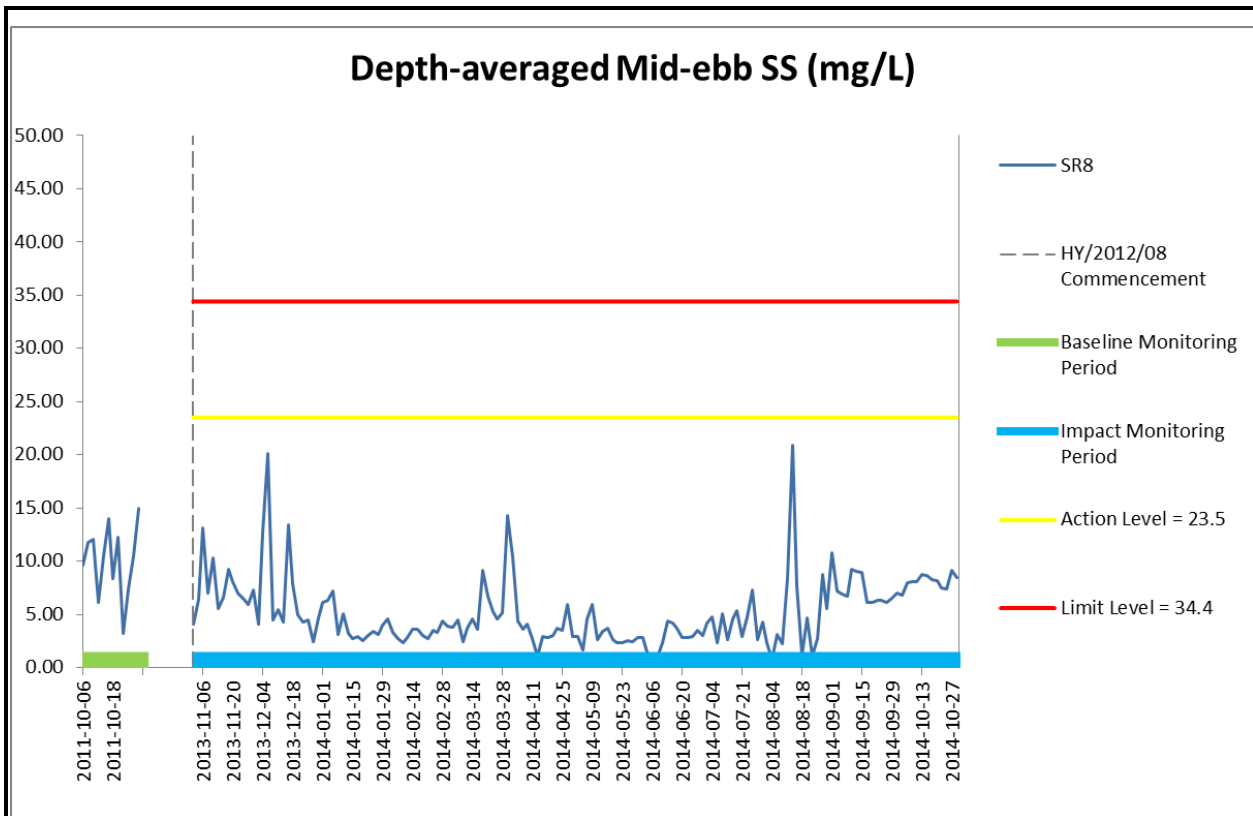
**Figure E42 Baseline & Impact Monitoring – Mean Depth-averaged Level of Suspended Solids (mg/L) between Baseline monitoring period: 6/10/2011 to 31/10/2011 and Impact monitoring period: 1/11/2013 to 31/10/2014 at SR8. Weather condition within the reporting period varied between sunny to rainy. The overall monitoring results were not affected by weather conditions. Major marine construction activities included: Dredging; Vertical and Sloping Seawall construction; Marine Sheet Piling for box culvert extension; Reclamation filling; and Box Culvert extension. Please note WQM Mid-Ebb on 15-Sep was cancelled due to adverse weather. Ref: 0212330\_Impact-WQM\_1st annual.xlsx**

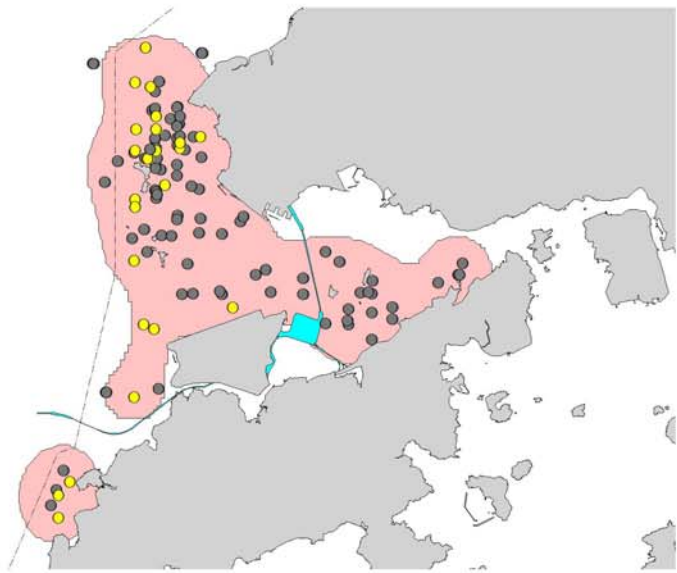
**CH34**

Appendix V. Temporal changes in range use of individual dolphins during baseline, transitional & impact phase of TMCLKL construction (note: yellow dots indicates sightings made in corresponding period)

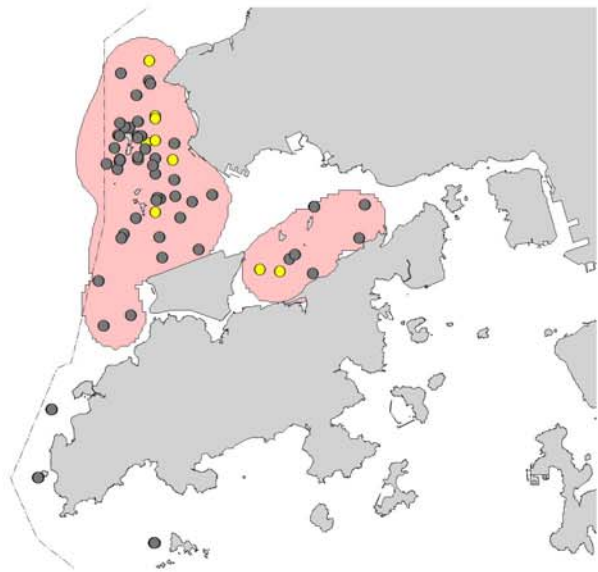
**NL259**

**Baseline Phase  
(2011-12)**
