Environmental Permit No. EP-388/2010

Development of a Bathing Beach at Lung Mei, Tai Po

FIRST 7 DAYS SEAHORSE POST- TRANSLOCATION MONITORING

Revised on 21 June 2021

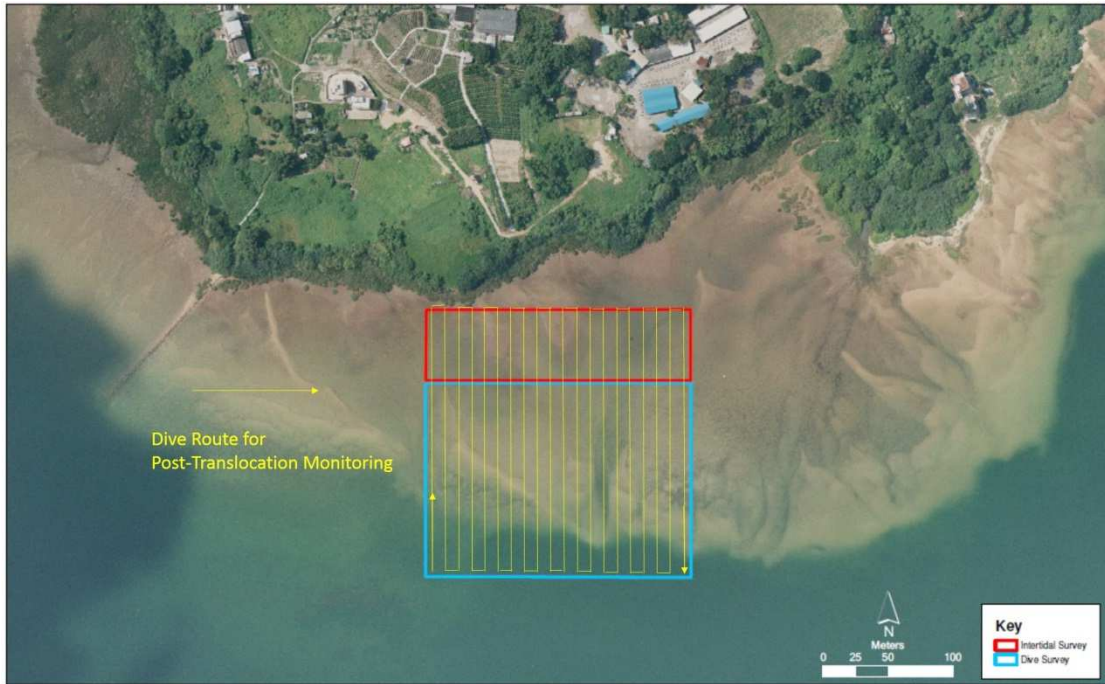
Figure 1. Post-Translocation Monitoring Survey Route at Ting Lok East

survey event included not less than four man-hours of day survey and four man-hours of night survey. At least a total of 16 man-hours would be spent over the two survey events. The actual man-hours spent during each survey was recorded. Six SCUBA divers were parallel to each other and dived in a zigzag route (Figure 2) within the survey area to locate the tagged seahorses #051 and #052 during each subtidal dive survey. Since the two tagged seahorses #051 and #052 were not recorded during the 2 days post-translocation monitoring survey at Ting Kok East reception site while three seahorses were recorded during the First 7 days post-translocation monitoring at depth of more than -1.5 m CD, divers extended the original survey area (Figure 1) away from Ting Kok East towards the deeper depth as shown in Figure 2.

2.6 Seven to nine SCUBA divers were parallel to each other and dived in a zigzag route (Figure 1) along the survey areas to locate the tagged seahorses #051 and #052 encountered during each dive survey. At least 28 man-hours were spent on each daily survey. Tagged seahorses #051 and #052 were released to their natural habitat after data collection. Specimens were handled with care to reduce disturbance to seahorses as low as reasonably practicable. At least two photos, comprising both side profile of the seahorse and close-up of the side profile of the head, were taken. Video footage was also taken for each individual countered.

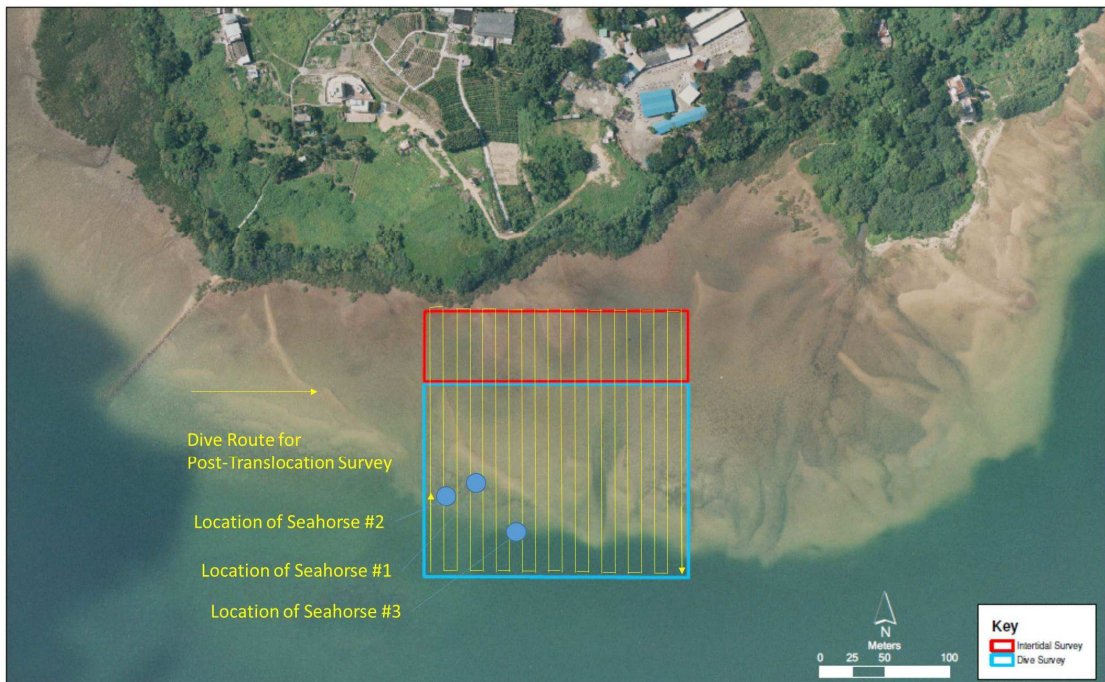
Figure 2. Locations of Local Seahorses Recorded at Ting Kok East

4.3 The three local seahorses found at Ting Kok East reception site were located at the subtidal area. So the tagged seahorses #051 and #052 may be still searching for their name home at the deeper water of Ting Kok East. Therefore, coming post-translocation monitoring will focus in the subtidal region that deeper than 1m.

3.3 A total of 28 to 32 man-hours were done each day during the 7 days survey (Table 2) with 7 to 9 divers including the fish expert. Details of diver survey man-hours were shown in Table 2. The two tagged seahorses #051 and #052 were not recorded during the 7 days post-translocation monitoring survey at Ting Kok East reception site. The two tagged seahorses #051 and #052 were missing during the survey and it may be due to the reason that they are still moving around and looking for new home to settle. Besides the tagged seahorses #051 and #052, three female seahorses were recorded at Ting Kok reception site (Table 3) during the 7 days post-translocation monitoring (Photo Plate A) and they all belonged to the same species of *Hippocampus kuda*. They were found at the depth of 1.5 to 3.6 meter of sandy bottom with scattered rocks (Appendix B-1).

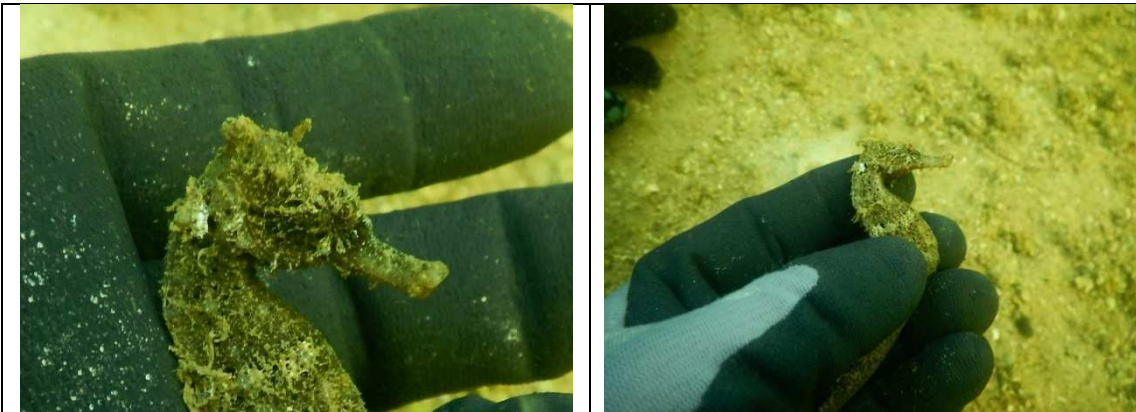
Local Ting Kok East Seahorse #1

Seahorse #	Species	Sex	Reproductive Status* ¹	Torso Length (cm)	Total Length (cm) (Body + Head)	Sighting Location	Depth (m)	Holdfast	Proximity to the nearest seahorse* ²	Sign of stress or injury
1	<i>H. kuda</i>	F	N/A	4.4	11.5	Sandy Bottom	1.3	No	25 m	No
2	<i>H. kuda</i>	F	N/A	4.5	11.8	Sandy Bottom	1.8	No	25 m	No
3	<i>H. kuda</i>	F	N/A	4.6	12.2	Sandy Bottom	3.6	No	N/A	No

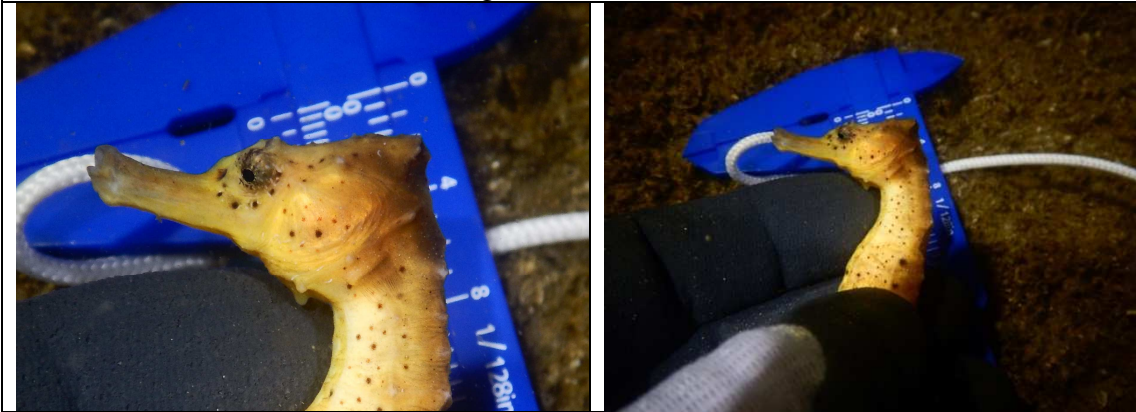
Local Ting Kok East Seahorse #3
